Salt, C & Kjeldsen, T 2019, 'Infiltration capacity of cracked pavements', *Proceedings of the ICE - Water Management*, vol. 172, no. 6, pp. 291-300. <https://doi.org/10.1680/jwama.18.00001>

Infiltration capacity of cracked pavements

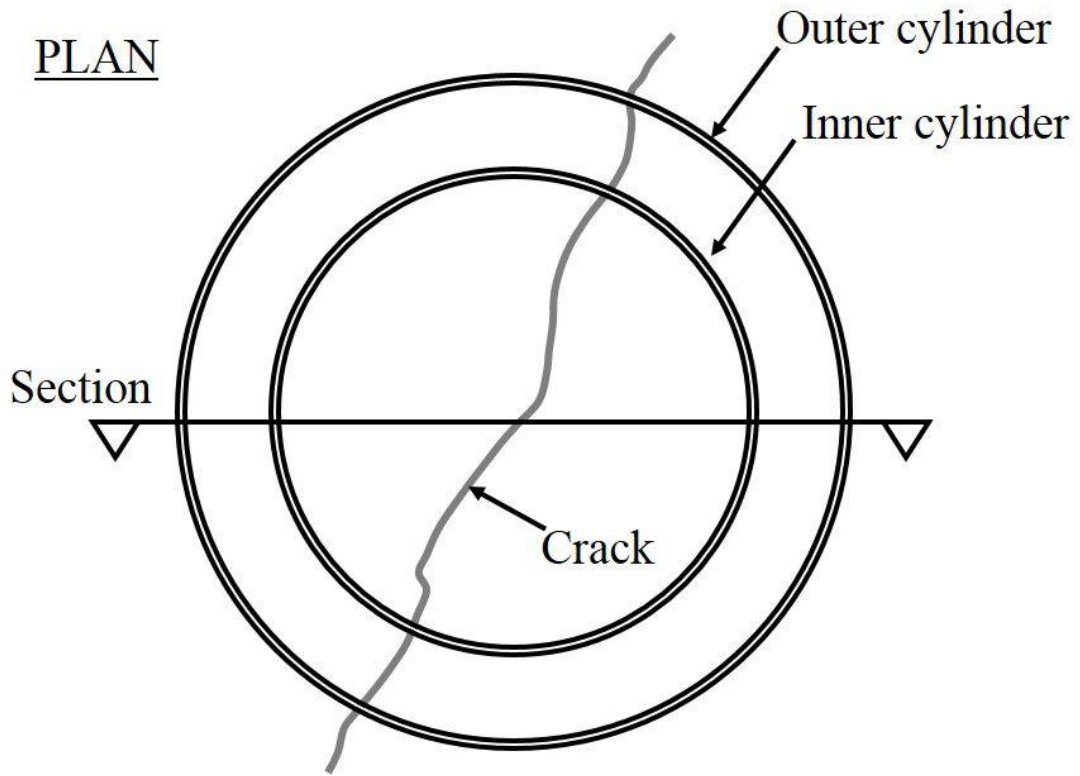
FIGURE 1

545 Figure 1. Schematic diagram of the infiltration test set-up

79 The methodology followed in this study used a double-ring infiltrometer consisting of an inner
80 and outer cylinder, similar to the set-up used in the ASTM C1701 Method for pervious concrete
81 (ASTM International, 2009). The purpose of the outer cylinder was to reduce any horizontal
82 flow through the pavement and cracks which extend beyond the test cylinder, as described by
83 Bean (2005) and Wiles and Sharp (2008). This experimental set-up is shown in Figure 1 and
84 Figure 2. Both cylinders were filled with water and water depth measurements taken within the
85 inner cylinder using digital callipers at intervals of between one and two minutes, or longer
86 where draining of the cylinder was slow. The water in the outer cylinder was topped up
87 throughout the test to maintain a constant depth (head) and therefore flow. The duration of
88 each test was two hours, or until all of the water had drained out of the inner cylinder, whichever

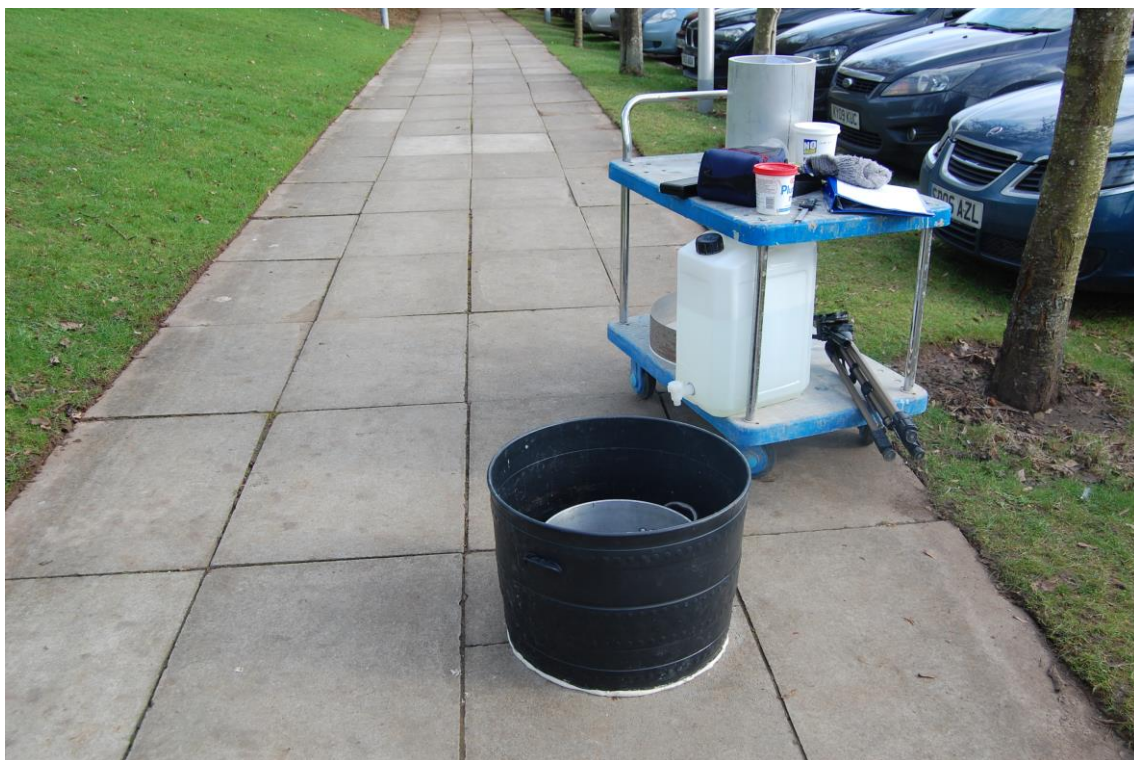
FIGURE 2

546 Figure 2. Image of the *in-situ* infiltration test equipment

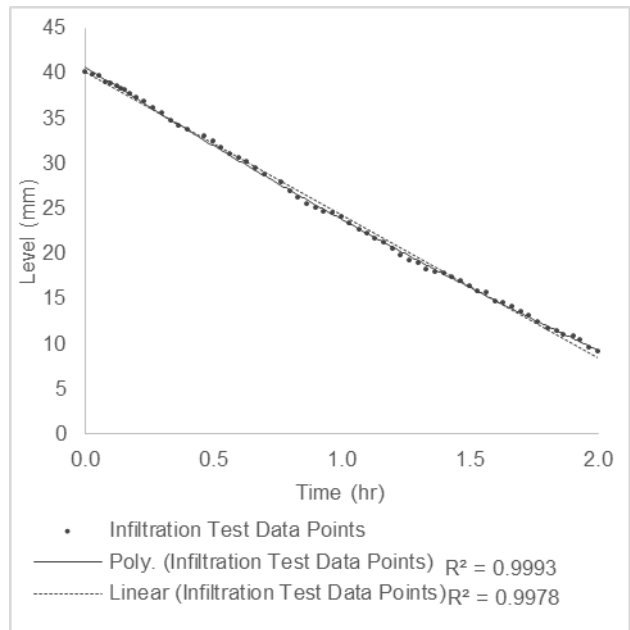
FIGURE 3

547 Figure 3. Infiltration test data example: Test No. 3 – Graph of water level against time

89 occurred first. Recorded water levels were plotted as a function of time for each test; an
90 example of the test data is shown in Figure 3.

100 estimation technique, as shown in Figure 3. The fitted linear of the model for the test shown in

101 Figure 3 is of the form:

$$103 \qquad \qquad \qquad d = -15.77 t + 40.03 \qquad \qquad \qquad [1]$$

116 For the data in Figure 3 the IR was estimated using Method 2 to be 15.49 mm/hour.

121 water depth was determined using the equation of this line (equation [3] for Figure 3) and the IR
122 calculated using equation [2].

$$124 \quad \quad \quad d = 1.20 t^2 - 18.12 t + 40.73 \quad \quad \quad [3]$$

126 For the data in Figure 3, the IR was calculated using Method 3 to be 15.05 mm/hour.

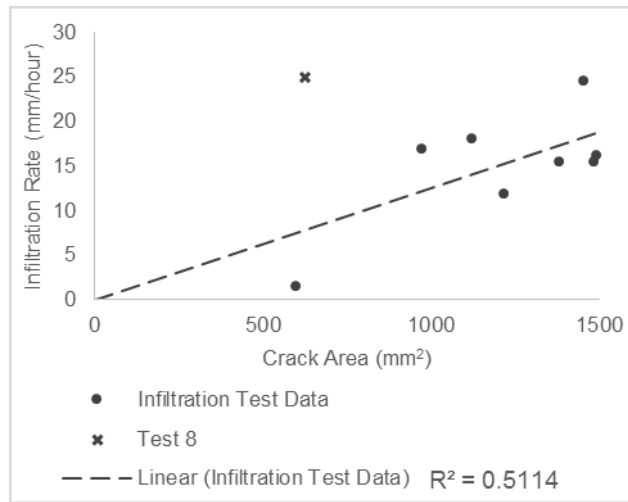
FIGURE 4

548 Figure 4. Infiltration rate against crack width

232 The infiltration rates calculated were plotted against crack area, width and percentage area
233 cracked for each test, as shown in Figure 4, Figure 5 and Figure 6 respectively. Due to the
234 limited number of data points, linear least squares regression lines were considered most
235 appropriate and were fitted through the data points in each figure. An intact slab is considered
236 to completely prevent infiltration through its surface and therefore the y-intercepts for the
237 regression lines were set to zero in order to represent this, thereby reducing the complexity of
238 the model to a single parameter; the slope of the lines.

245 Inspection of Figures 4, 5 and 6 indicates that Test 8 may represent an outlier, with a higher
246 infiltration rate than expected. As discussed previously, the infiltration through pavement
247 surfaces can be affected by a number of factors which were considered impractical to control
248 and were beyond the scope of this study. It was noted that the slab tested in Test 8 was
249 smoother and lighter in colour than other slabs tested and it is possible that it could have been
250 newer and / or of different construction. It was also observed that the crack contained less
251 sediment than found in other cracks tested. It could also be possible that leakage from the inner
252 test cylinder could have occurred undetected during the test, leading to a higher rate than
253 anticipated.

255 This aspect was investigated further by fitting linear regression lines through the dataset
256 including and excluding Test 8, and extrapolating these trendlines to find the y-intercept in each
257 case. As mentioned previously, the infiltration rate through an intact slab is expected to be
258 close to or equal to zero, thus the y-intercept of the linear trendlines is also expected to be close
259 to or equal to zero. Inclusion of the Test 8 data point gave y-intercepts of around 10 mm/hour.
260 Removal of Test 8 from the dataset results in values just below 0 mm/hour. It was therefore
261 considered appropriate to remove Test 8 from the data analysis. The linear regression lines
262 plotted on Figures 4, 5 and 6 therefore exclude Test 8.

264 Figure 4, 5 and 6 indicate that infiltration rates increase as crack area, width and PAC increase
265 and these relationships are summarised in Table 3. The p-values reported in the Table shows
266 that the estimated slope coefficients are significantly different from zero, thus supporting the
267 hypothesis that infiltration rates can be estimated using crack characteristics. This was
268 anticipated as cracks provide a preferential pathway for water ingress into pavements.

278 Comparison of Figure 4 and Figure 5 shows that the IR- A_c and IR-W relationships are very
279 similar and are therefore both influencing factors on the amount of infiltration, as expected.
280 Their similarity can largely be attributed to the strong correlation between crack width and area.
281 Similarly, the IR- A_c and IR-PAC relationships are correlated due to the method of calculation of
282 PAC.

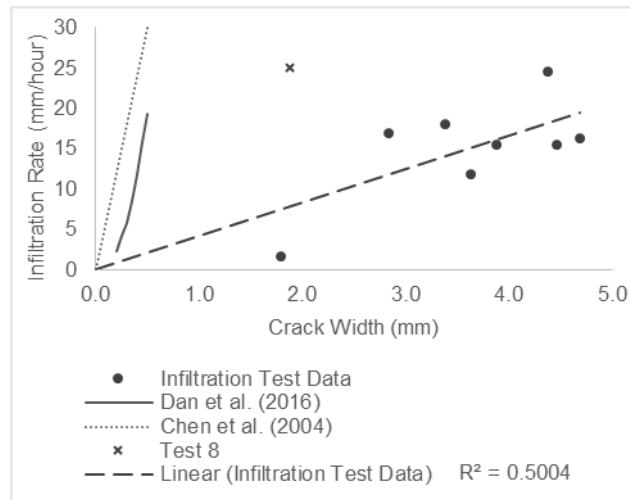
FIGURE 5

549 Figure 5. Infiltration rate against crack area

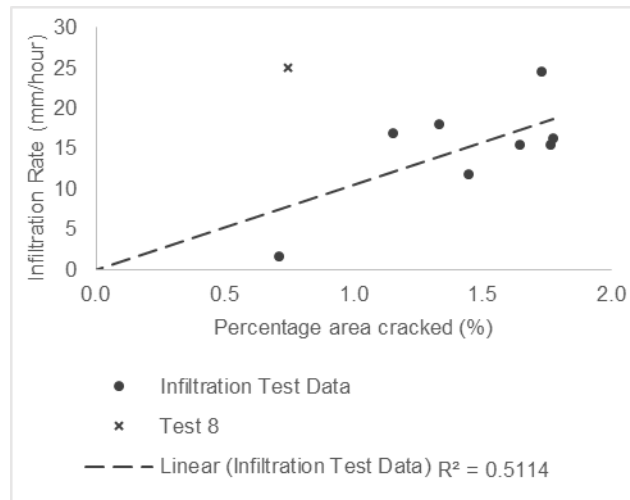
FIGURE 6

550 Figure 6. Infiltration rate against percentage area cracked

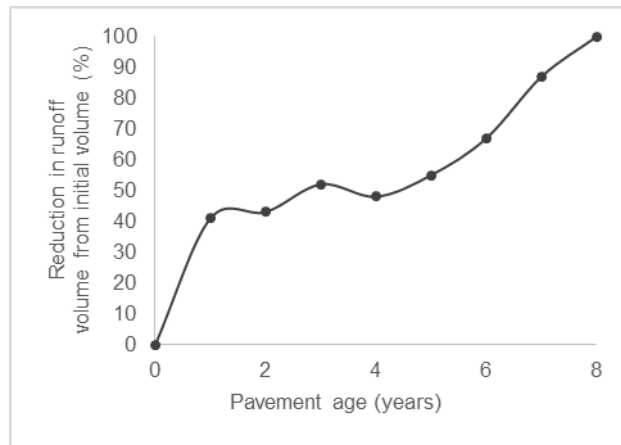
FIGURE 7

551 Figure 7. Reduction in runoff volume due to infiltration through impervious surfaces over the
552 lifetime of the pavement

366 The critical volumetric storm duration, D_{VOL} , is defined in this study as that which produces the
367 largest value of V , which was different for different road ages. Figure 7 shows that there is a
368 significant reduction in runoff volume associated with an increase in road cracking of around
369 40% in the first year of a pavement's life.

405 The results in Figure 8 show that, as for the runoff volume, there is significant reduction in
406 storage volume required of around 40% in the first year of a road's life when considering
407 infiltration through cracks. Note that the values of runoff and storage volumes are directly
408 related as the outflow volume for each storm duration does not change over time; thus Figures 7
409 and 8 show identical relationships.
