## **Ph.D. Programme in Civil, Chemical and Environmental Engineering**

### **Curriculum in Structural and Geotechnical Engineering, Mechanics and Materials**

### **Damage assessment of churches exposed to slope displacements in sliding areas**

DAMAGE ASSESSMENT OF CHURCHES EXPOSED TO SLOPE  
DISPLACEMENTS IN SLIDE AREAS

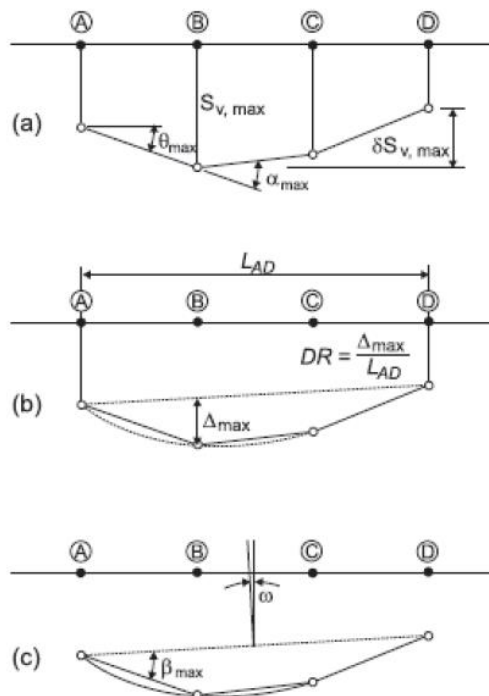
Figure 7 - Terminology and definitions provide by Burland (1995)

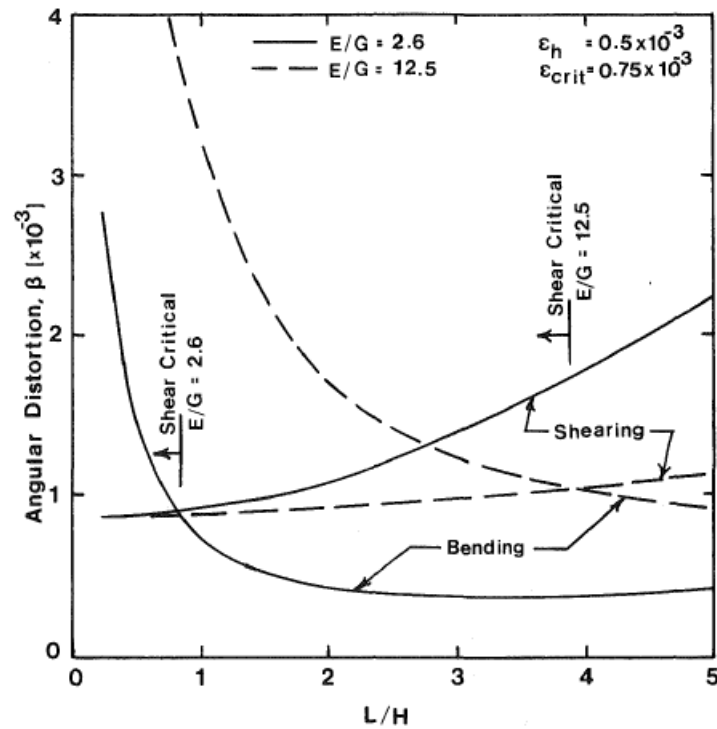
Figure 10 - Relationship between angular distortion and L/H for rectangular beams deflecting due to combined bending and shear after Burland and Wroth, 1974.

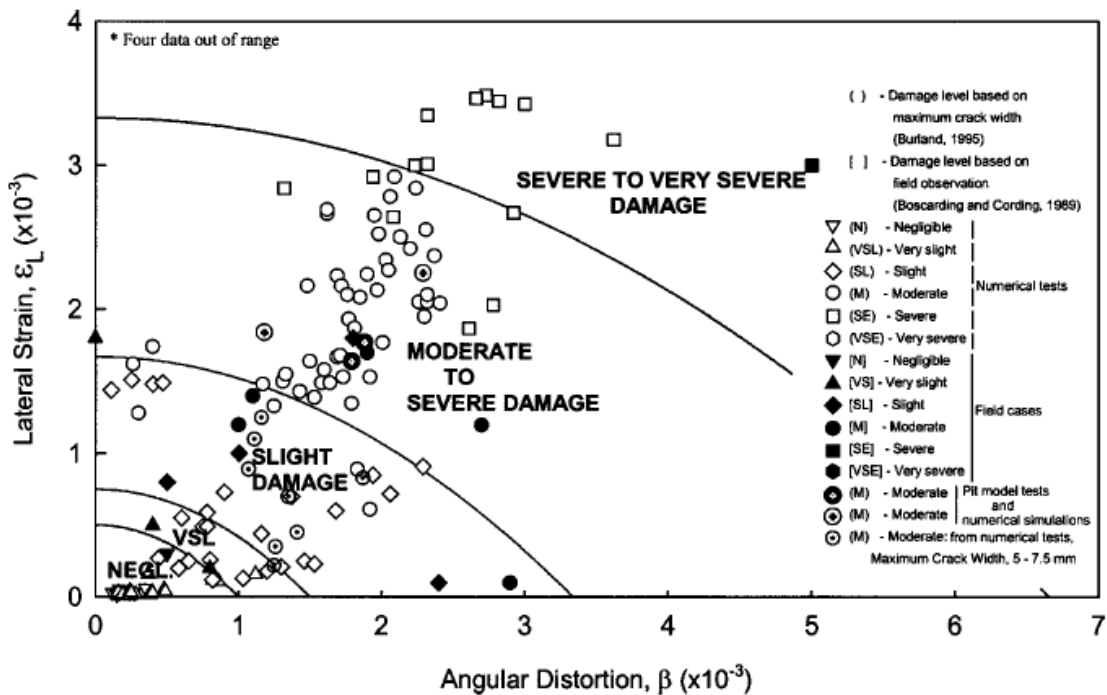
Figure 12 - Comparisons between damage estimation criterion and damage levels resulting from field observations, physical model tests, and numerical parametric studies. (From Son and Cording 2005)

In Figure 12, the critical tensile strain boundaries of the zone classified as “very slight” damage were taken as  $0.5 \cdot 10^{-3}$  and  $0.75 \cdot 10^{-3}$ , which are the strains suggested by Burland and Wroth (1974) and Polshin and Tokar (1957) for the formation of a first visible crack.

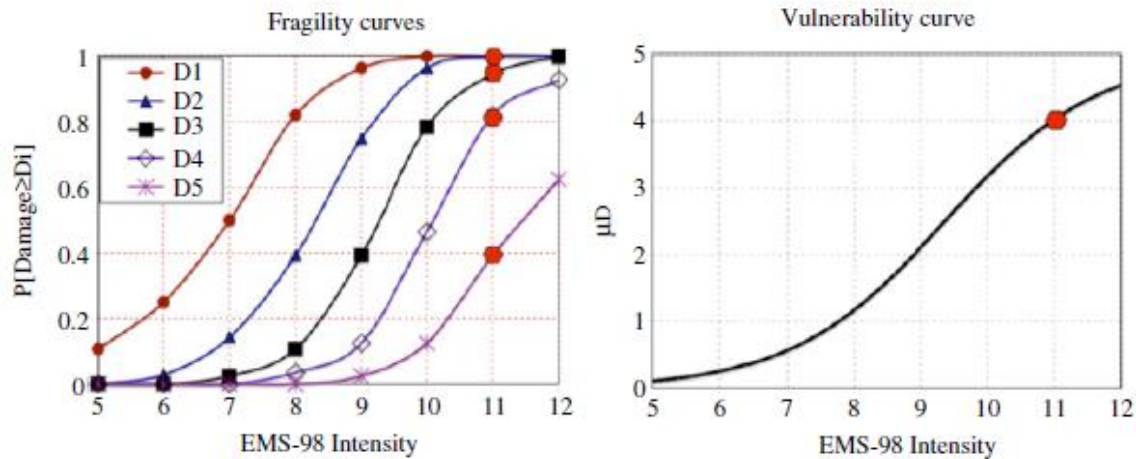
Figure 13- Fragility (a) and vulnerability (b) curve for seismic action

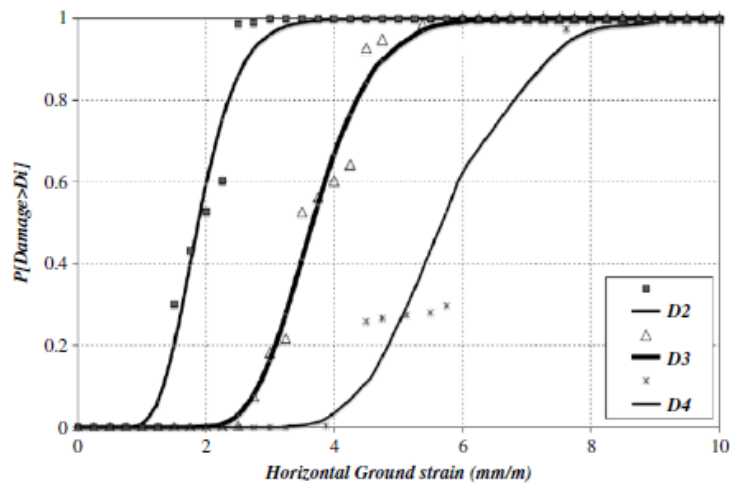
Figure 14 – Fragility curve from Saeidi et al. 2009 for subsidence

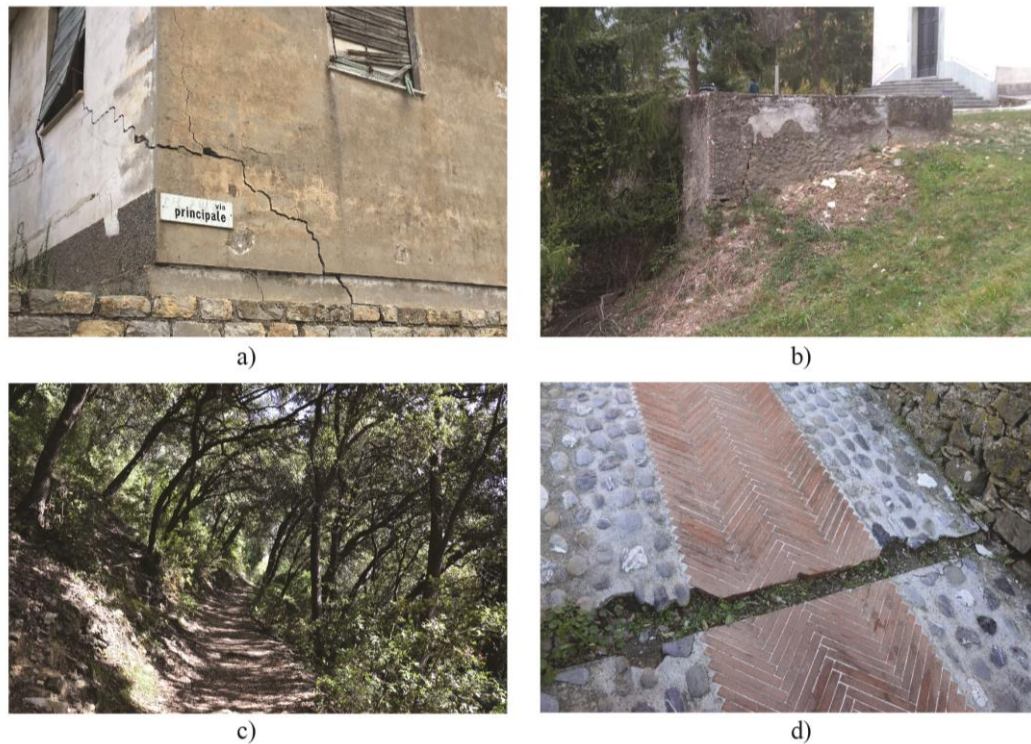
Figure 20 - Inspection of the surroundings to detect the presence of soil movements: a) cracks in neighbouring buildings, b) cracks in the retaining wall of the embankment on which the church parvis is resting, c) inclined trees, d) cracking in road surfaces.

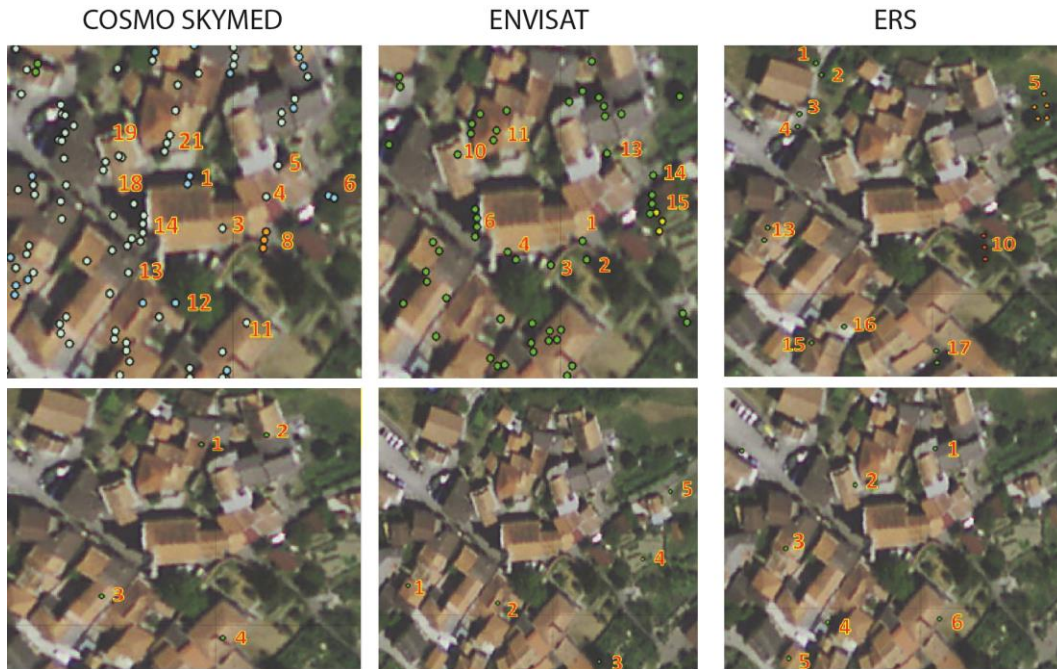
Figure 21 – Target available for all the SAR satellite (CH\_32), respectively on the top ascending and on the bottom descending orbits

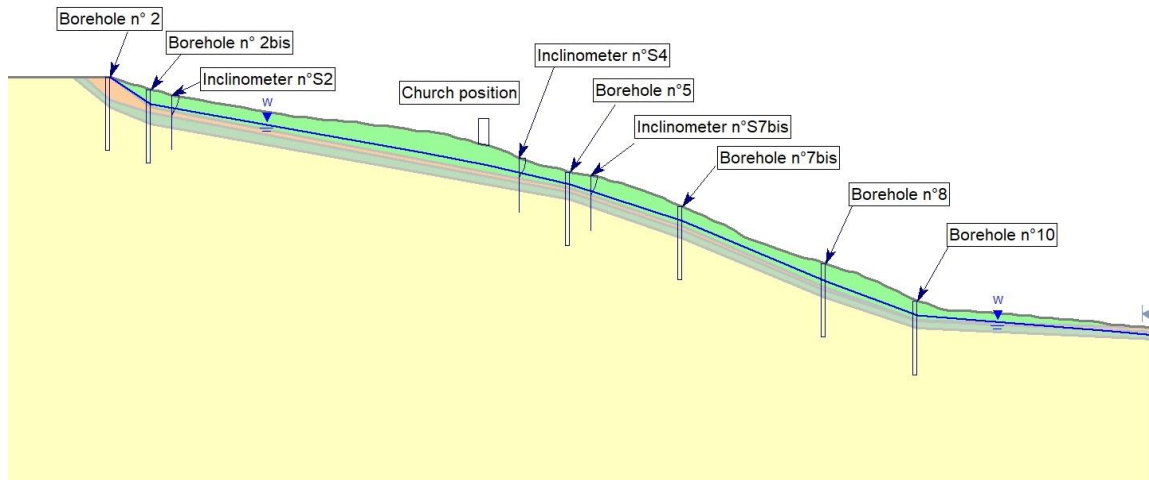
Figure 22 - Geotechnical and instrumentation information for CH28

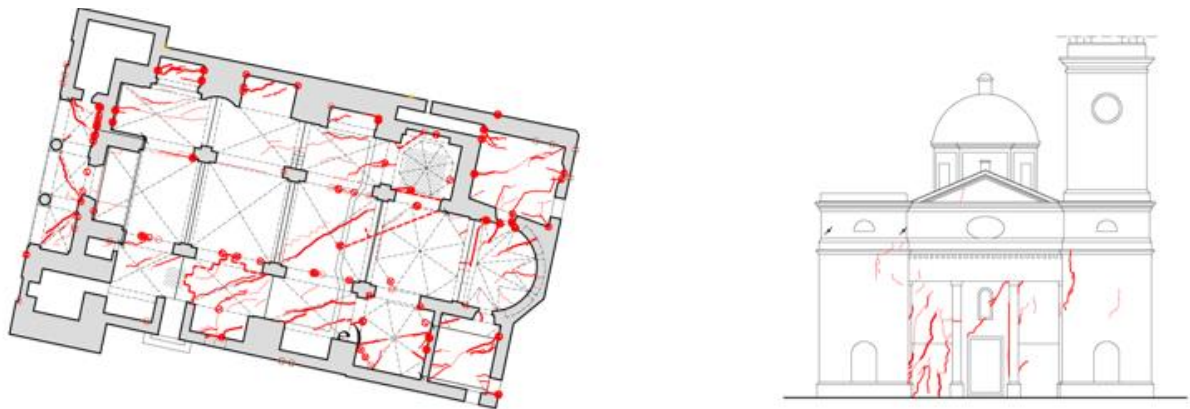
Figure 23- Crack pattern for CH\_22

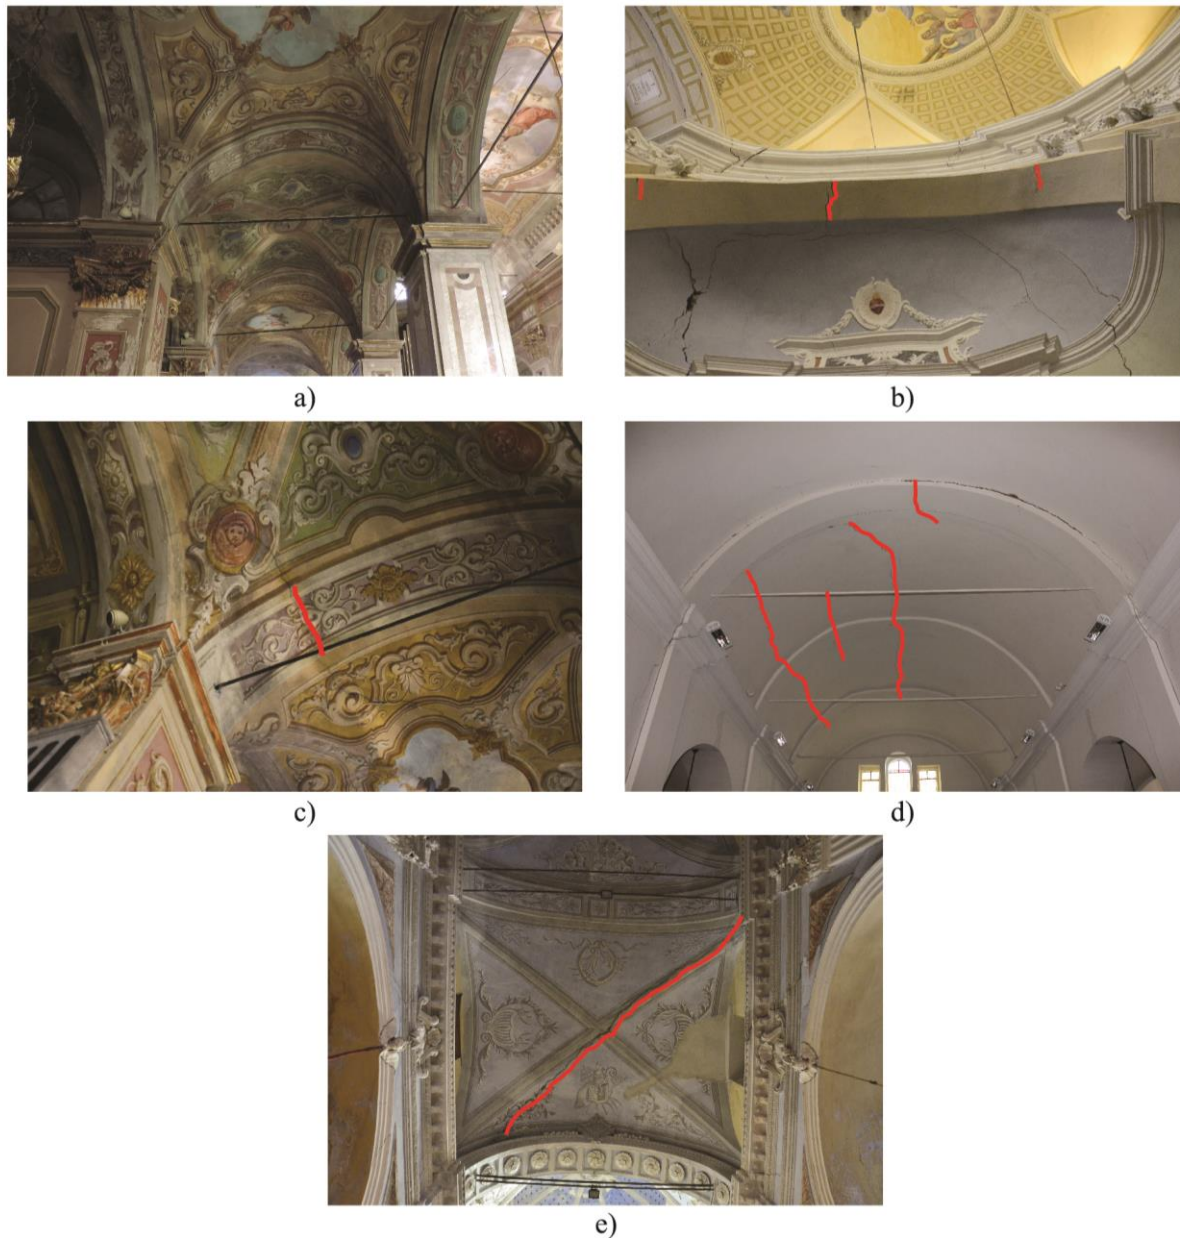
Figure 26 - Damage and deformation in arches and vaults a) large deformations (CH\_13), b) symmetrical crack pattern (CH\_4), c) asymmetrical crack pattern (CH\_13), d) longitudinal cracks along the vaults (CH\_22), e) diagonal cracks along one of the ribs in cross vaults (CH\_22)

- 3) Recurrent damage patterns are identified in arches and vaults. As shown in Figure 26a, large deformations are observed in the arches, which are accompanied by the occurrence of some cracks along the section of the arch. The cracking pattern observed in the arches can be in general symmetrical (Figure 26b) or asymmetrical (Figure 26c). This behaviour can be due to the formation of rotational or sliding hinges, which results in an asymmetrical or symmetrical crack distribution respectively. However, it can also be reasonably explained by different combinations of differential vertical and horizontal displacements at the supports. As for the vaults, a different behaviour and type of damage is exhibited by different types of vaults. Barrel vaults, which are made of a continuous series of arches and, hence, are characterized by a bi-dimensional response, usually show a cracking pattern similar to the one exhibited by arches, with the opening of some cracks along their sections (Figure 26d). Conversely, cross vaults, which have a double curvature leading to a tri-dimensional behaviour (DeJong, 2016), mainly present diagonal shear cracks (Figure 26e). It is important to note that these cracks are usually repeated in the different bays of the church, thus composing a well-defined damage pattern that can be related to the direction of the moving landslide.

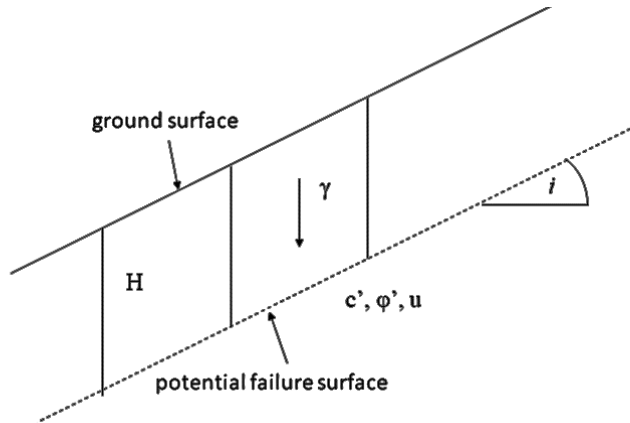
Figure 29 - Infinite slope scheme

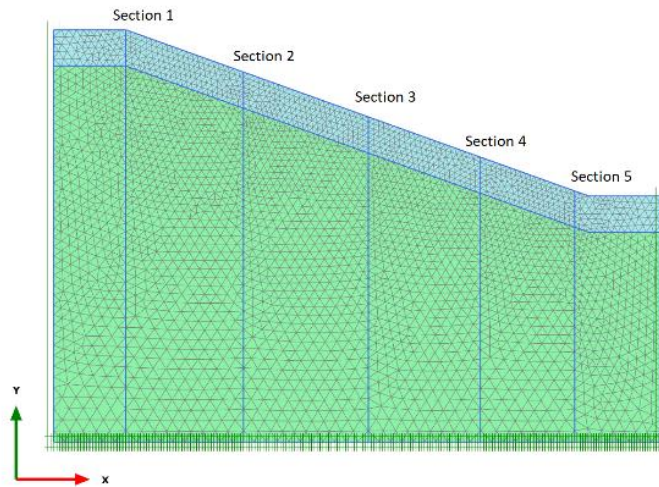
Figure 30 – Mesh and sections analysed

The slope, so schematized, has been studied through five sections of interest (Figure 30) placed in different positions (one on the top of the slope, three in the middle and one at the bottom), in order to correlate each safety factor FS with the computed vertical and horizontal displacements ( $u_y$  and  $u_x$  respectively). Figure 36 illustrates a schematization referred to a generic section.

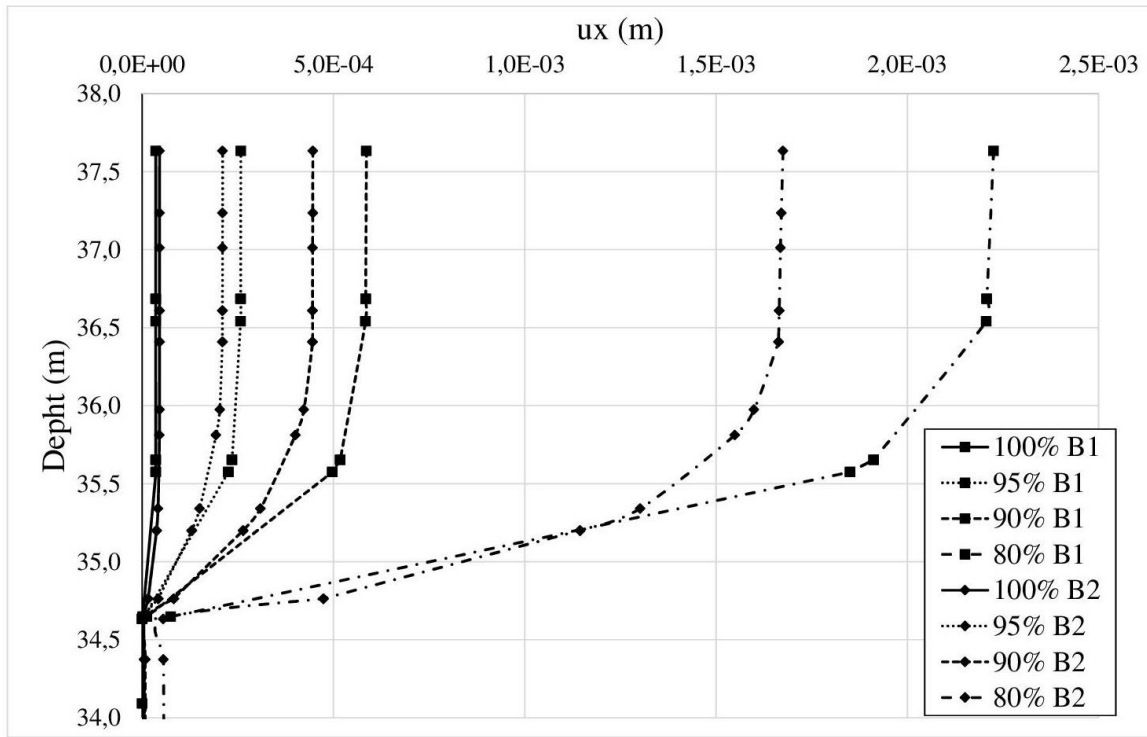
Figure 31 – Horizontal displacements as strength parameters decrease,  $E=40\text{MPa}$  vs  $E=60\text{MPa}$

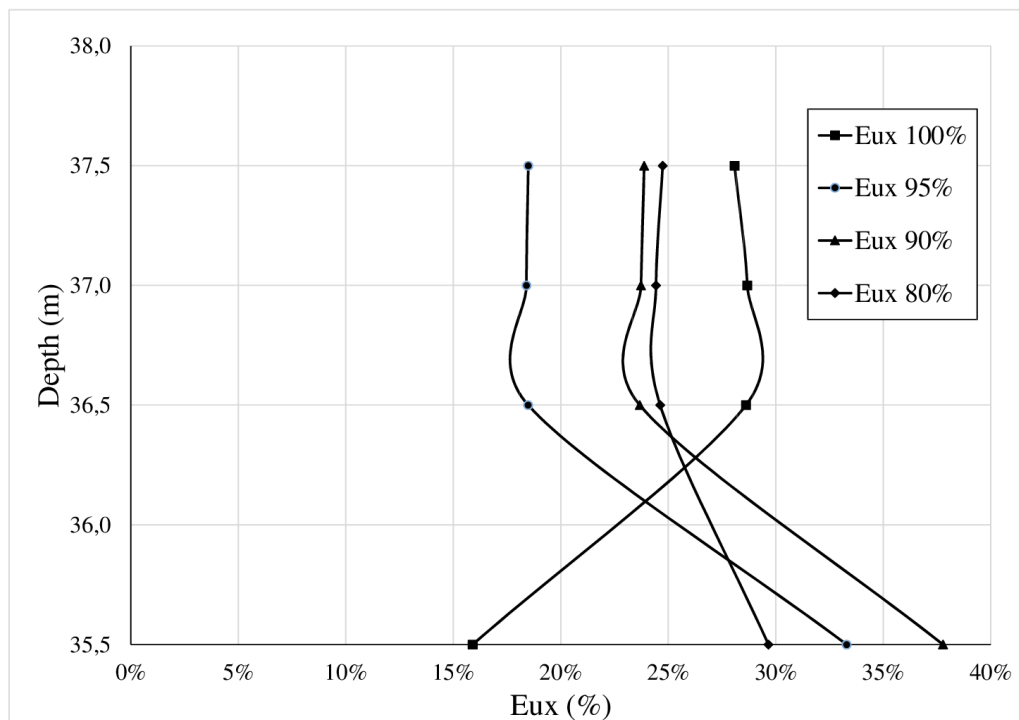
Figure 32- Trends of Eux

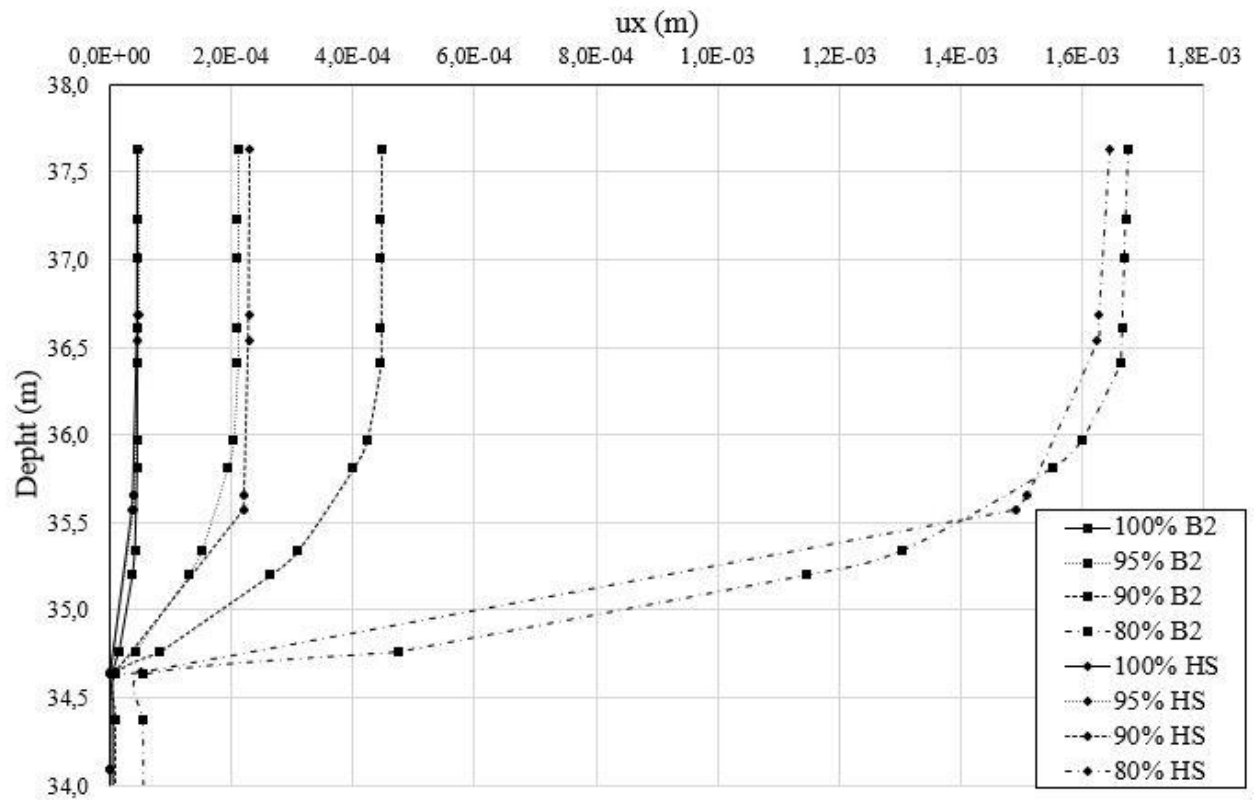
Figure 34 – ux profile: comparison between HSM and MCM

Figure 34 shows the pattern of the horizontal displacements in one section of the slope. As it can be seen, no relevant difference occurs between HS model and MC model when strength parameters are 80% of the initial values and failure occurs while, when the slope is not closed to failure condition (from 100% to 85% of the initial values), displacement obtained with MCM are two times bigger than the HSM ones.

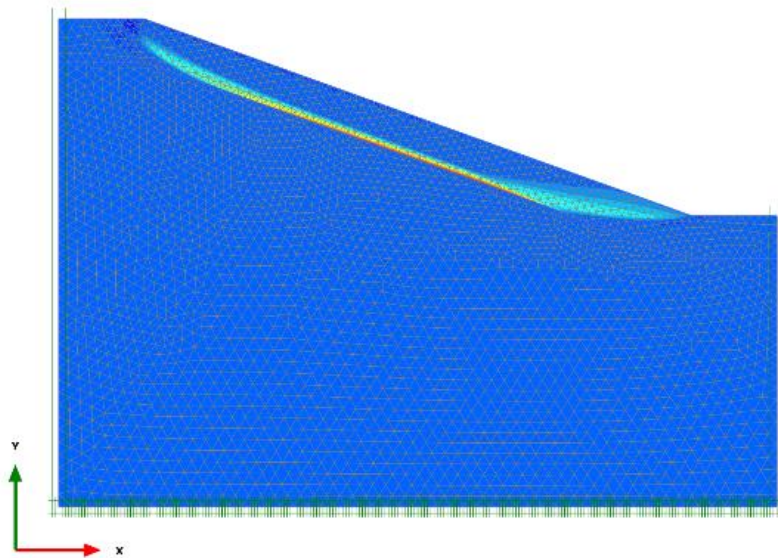
Figure 35 – Failure surface in case B3

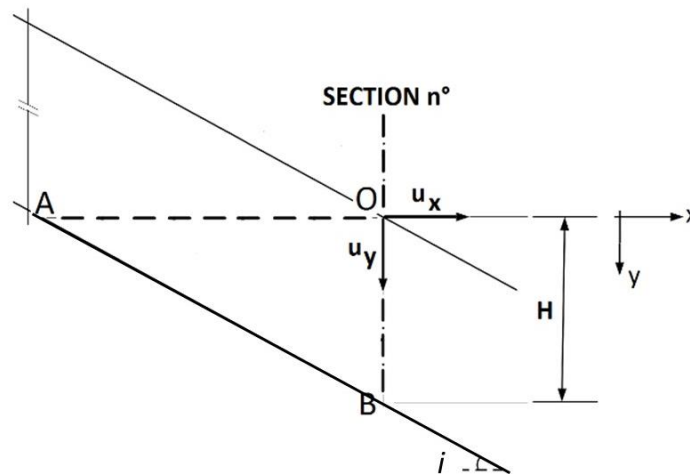
Figure 36 - Schematization of vertical and horizontal displacements in a generic section

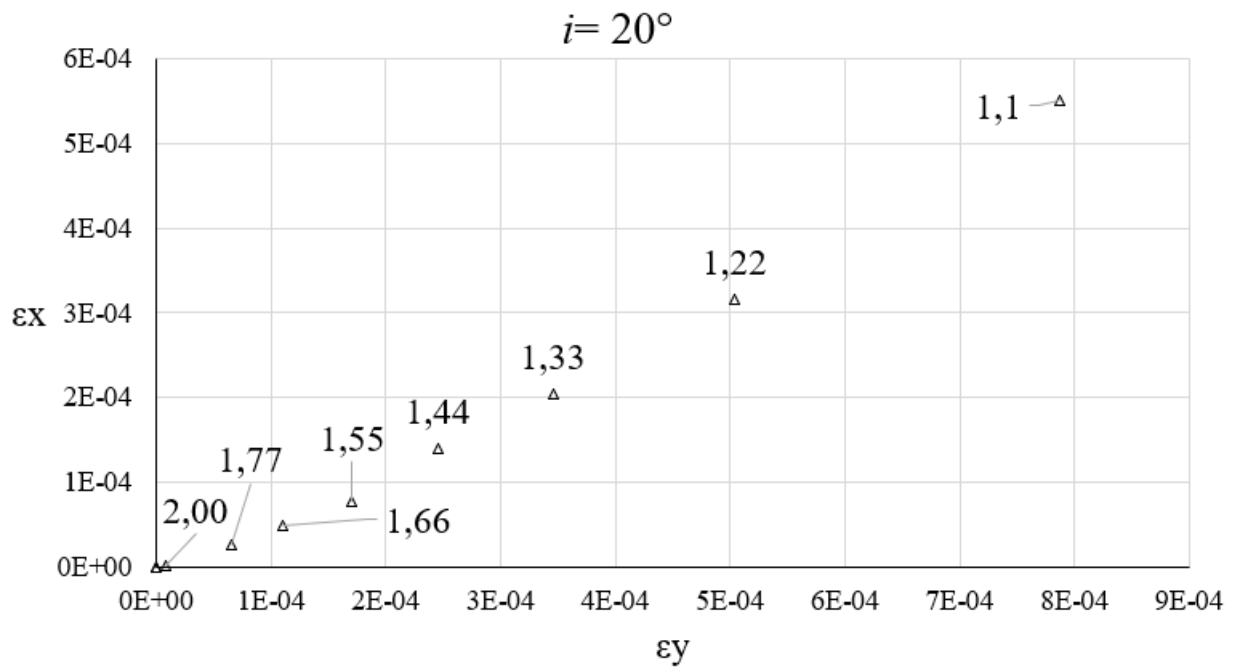
Figure 39 - Case A3 – section 3,  $i=20^\circ$ ,  $H=5m$ ,  $E=40MPa$

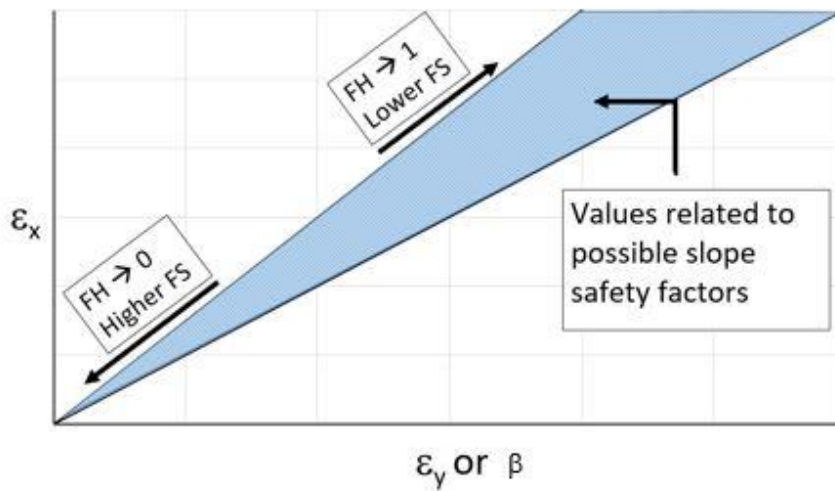
Figure 44. Schematic representation of relationship between strain levels and hazard factor

where  $FS_0$  is the initial safety factor of the slope and  $FS$  the safety factor associated with a given strain level. The hazard factor here introduced is a parameter useful to depict the evolution of the safety factor from a certain initial value of  $FS$ .  $FH$  does not have a probabilistic meaning but indicates, when it is close to 1, the approach of the failure conditions for the slope. From the results referred to the infinite slope scheme, it is expected that the strain levels vary with  $FH$  as depicted in Figure 44.

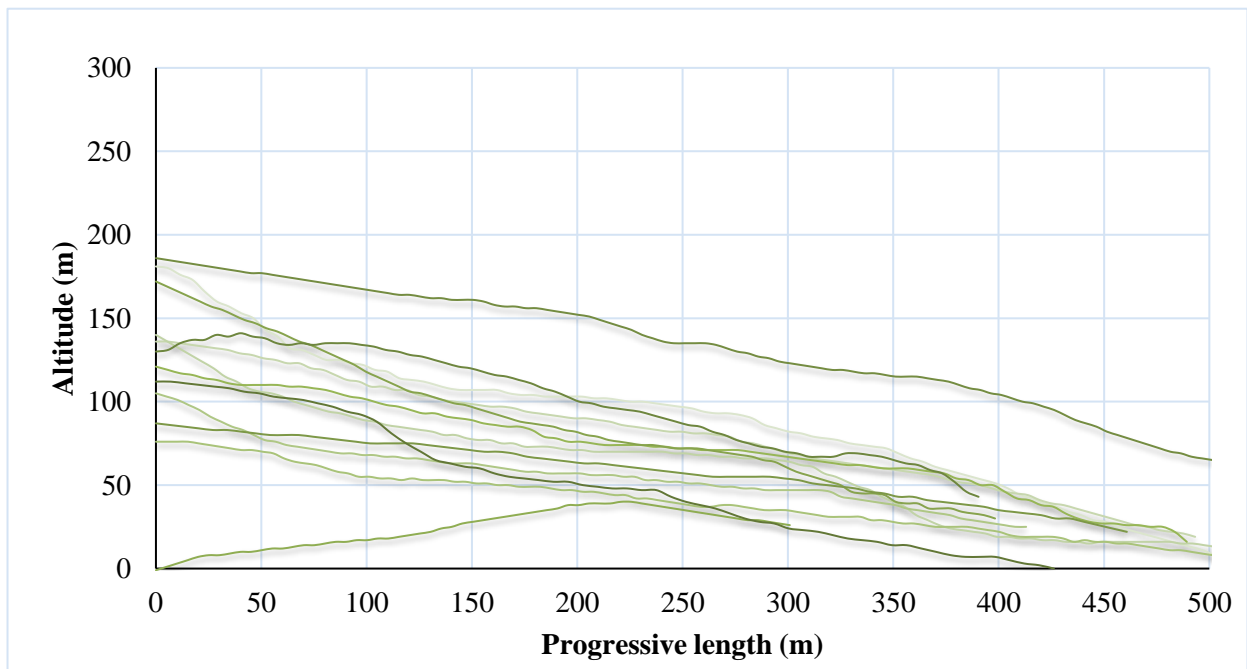
Figure 46 – Set of slopes with uphill angle=15°

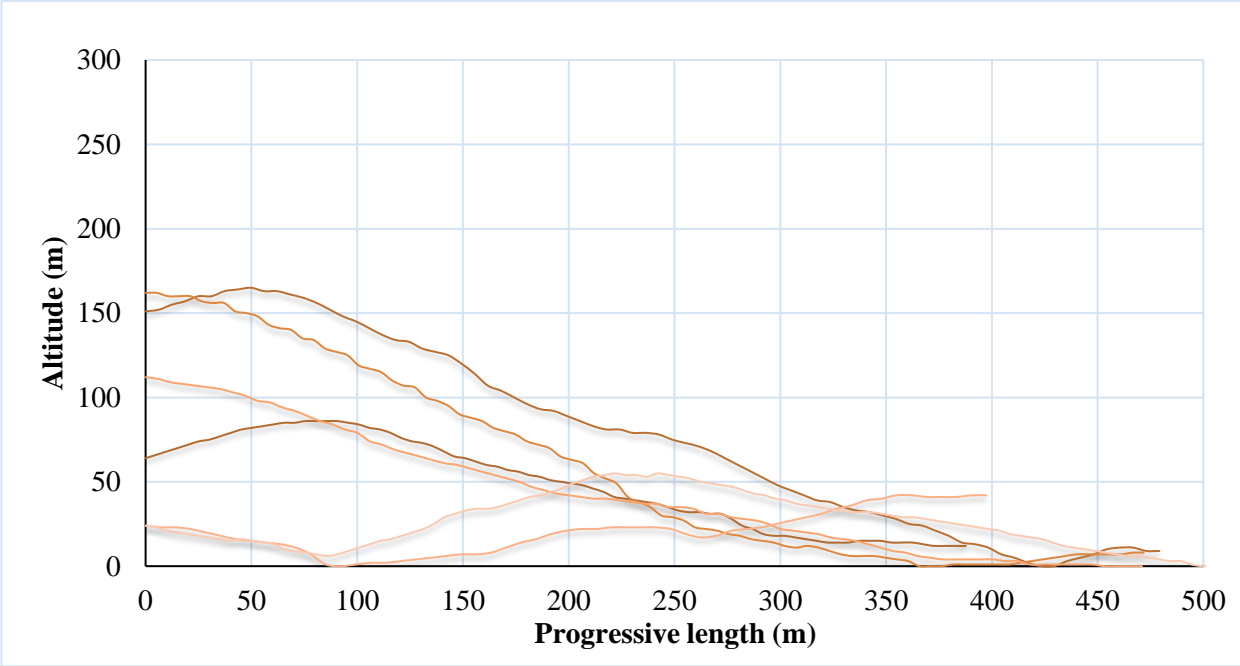
Figure 47 - Set of slopes with uphill angle=20°

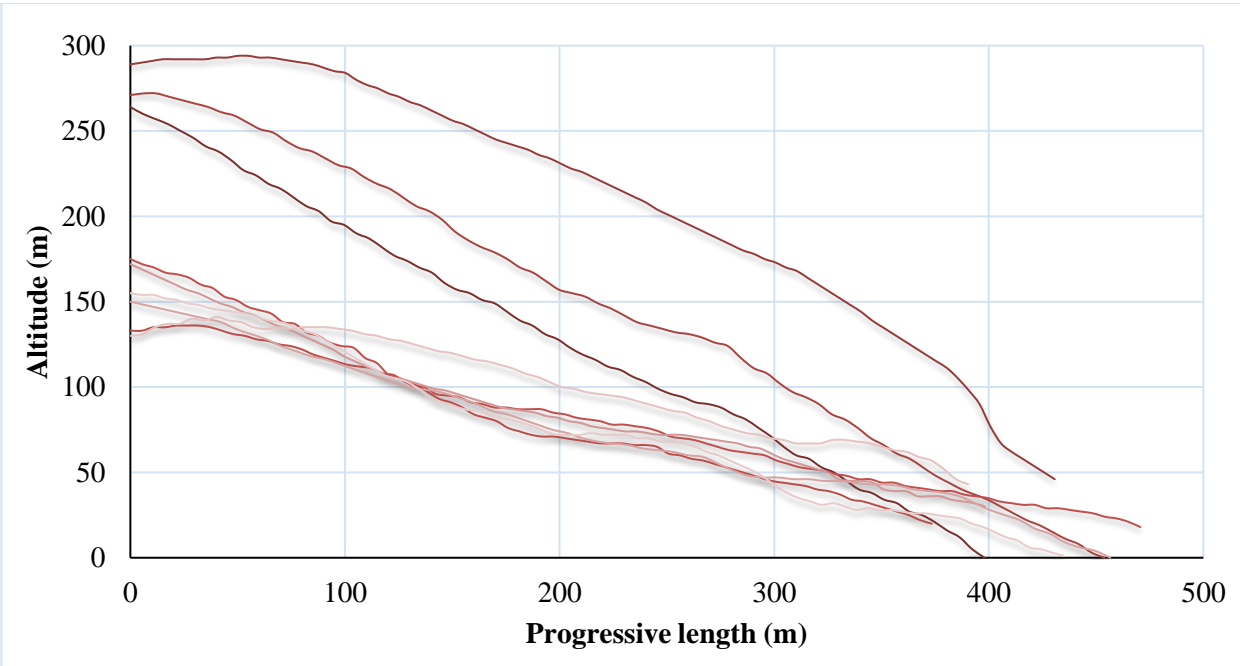
Figure 48 - Set of slopes with uphill angle=25°

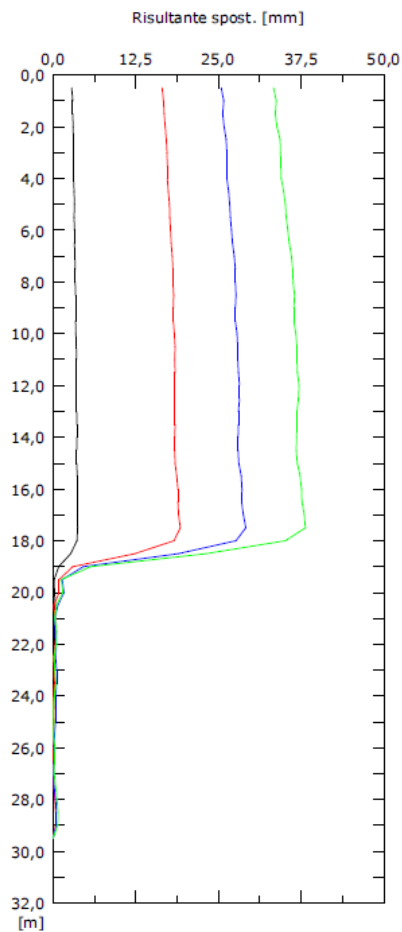
Figure 50 – Example of inclinometer reading

Regarding the depth of the soil layer to the potential failure surface H, analysing the data from the inclinometer readings available for each slope studied (Figure 50 represents an example of the inclinometric data for one of the case studies), it has been observed that its value is ranged from 12 and 30 m below ground level. For this reason, a representative value of H=25 m has been adopted.

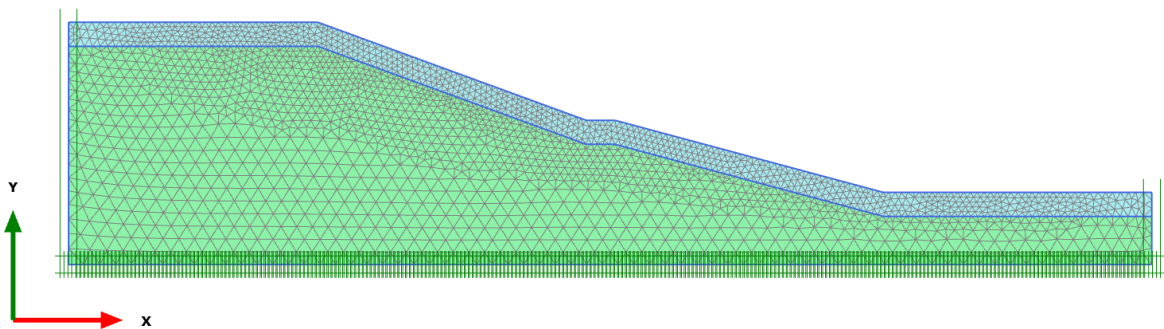
Figure 51 – Mesh adopted for the analysis

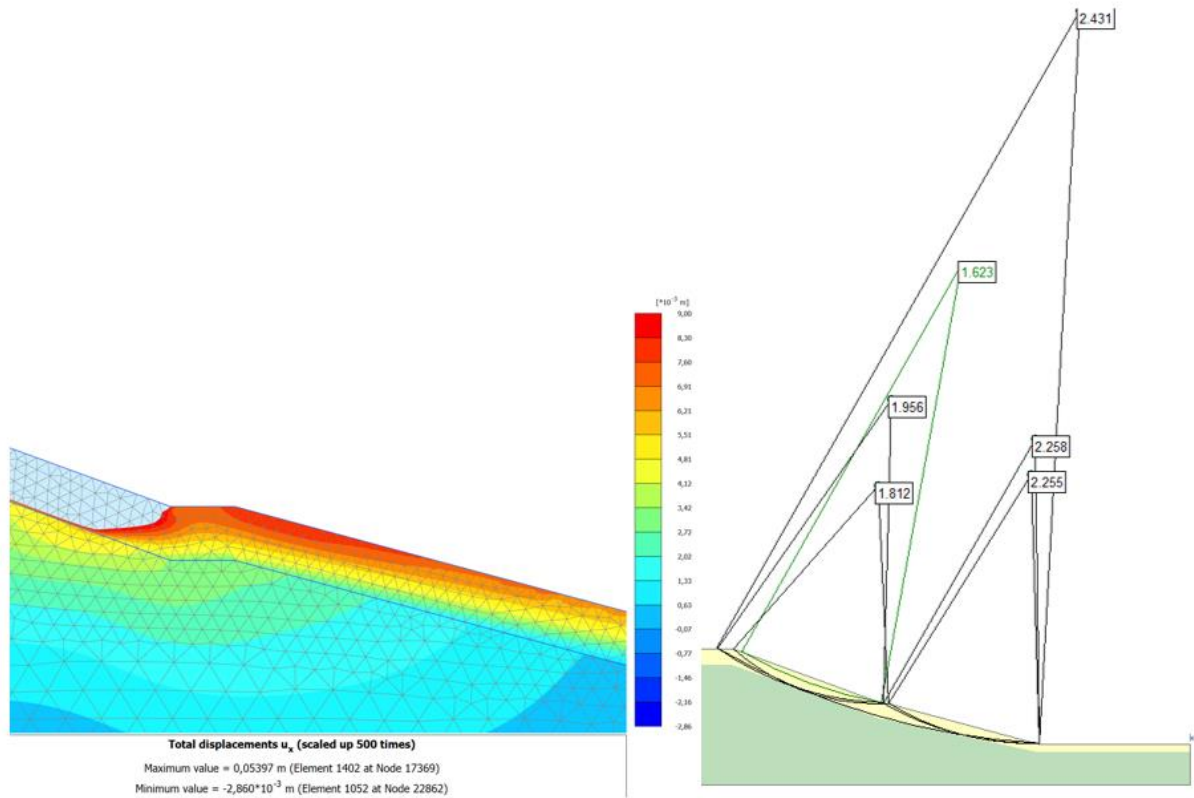
Figure 57 – FEM and LEM comparison for the selection of the sliding surface.

A first step concerned the selection of the failure surface among the five identified in SLIDE. By the examination of the displacement patterns obtained in FEM analyses, the potential failure surfaces that involved the area of interest are the two positioned downhill. Figure 57 shows the comparison between LEM and FEM for the selection of the sliding surface.

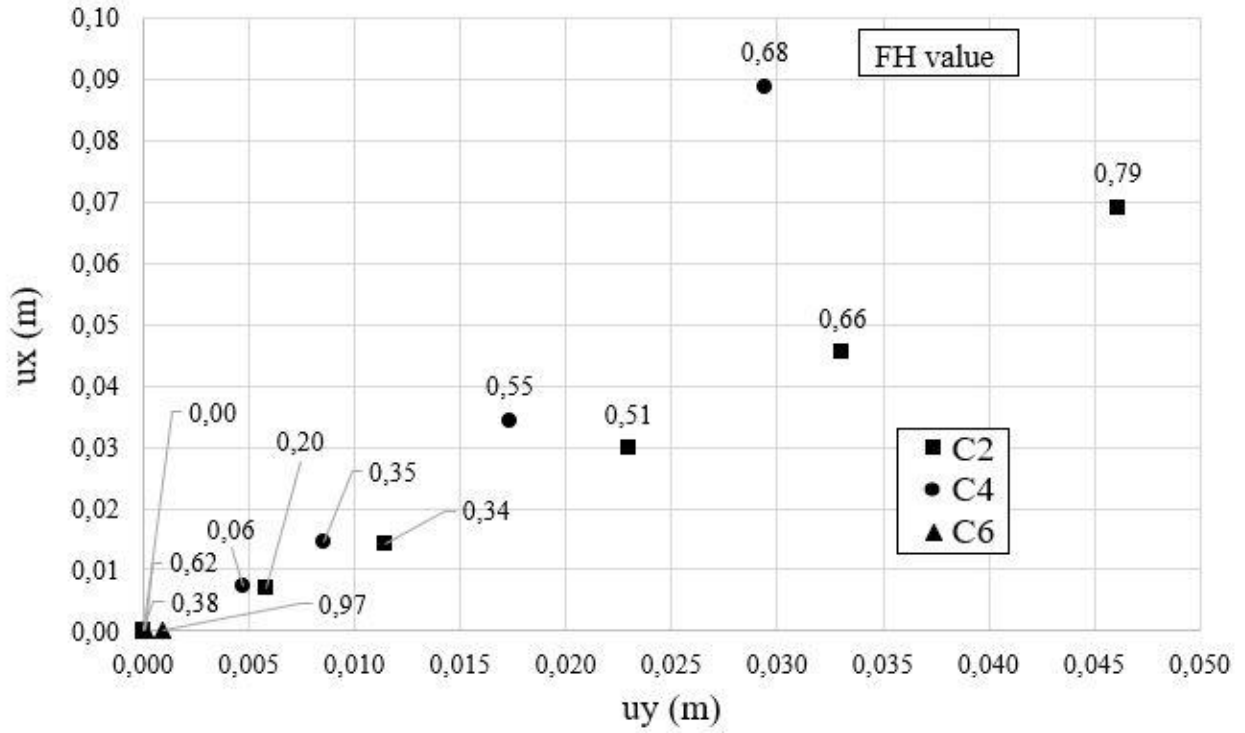
Figure 58 – Horizontal and vertical displacements for C2, C4 and C6 cases

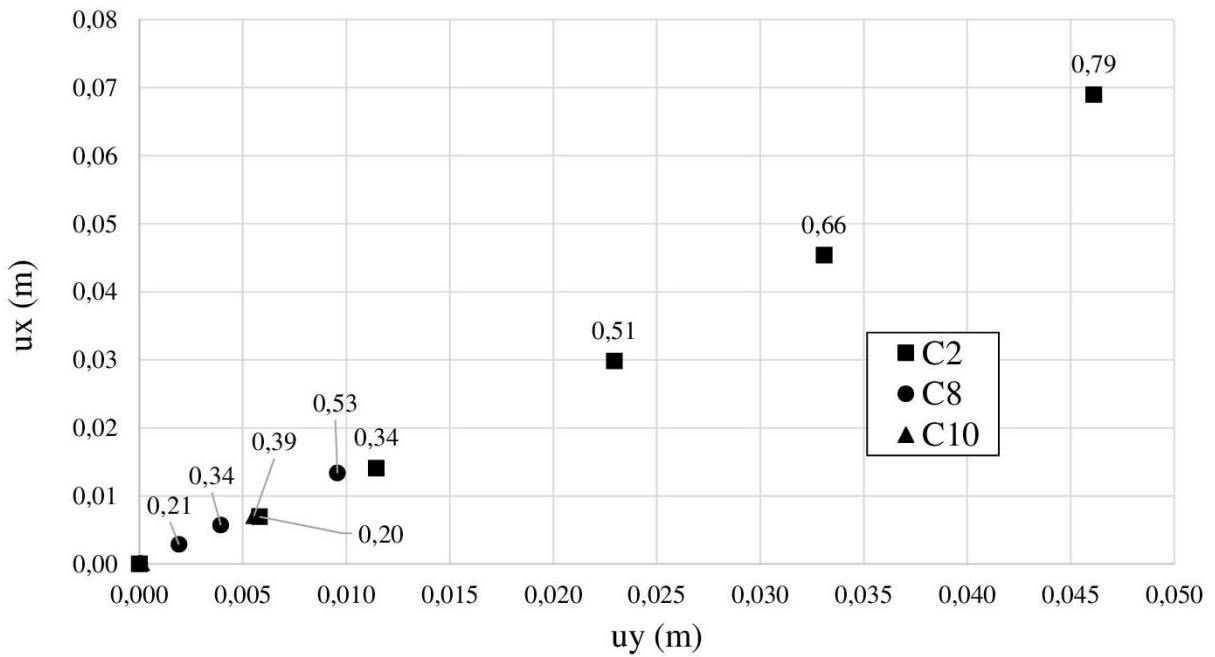
Figure 59 - Horizontal and vertical displacements for C2, C8 and C10 cases

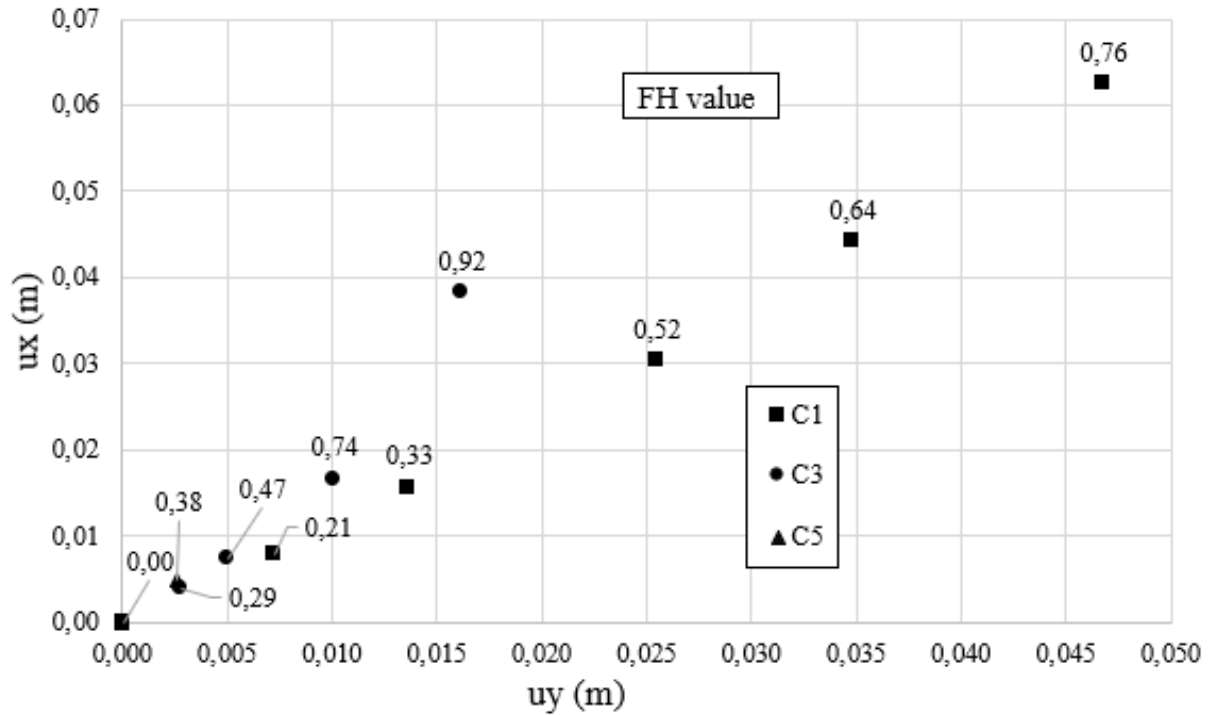
Figure 60 - Horizontal and vertical displacements for C1, C3 and C5 cases

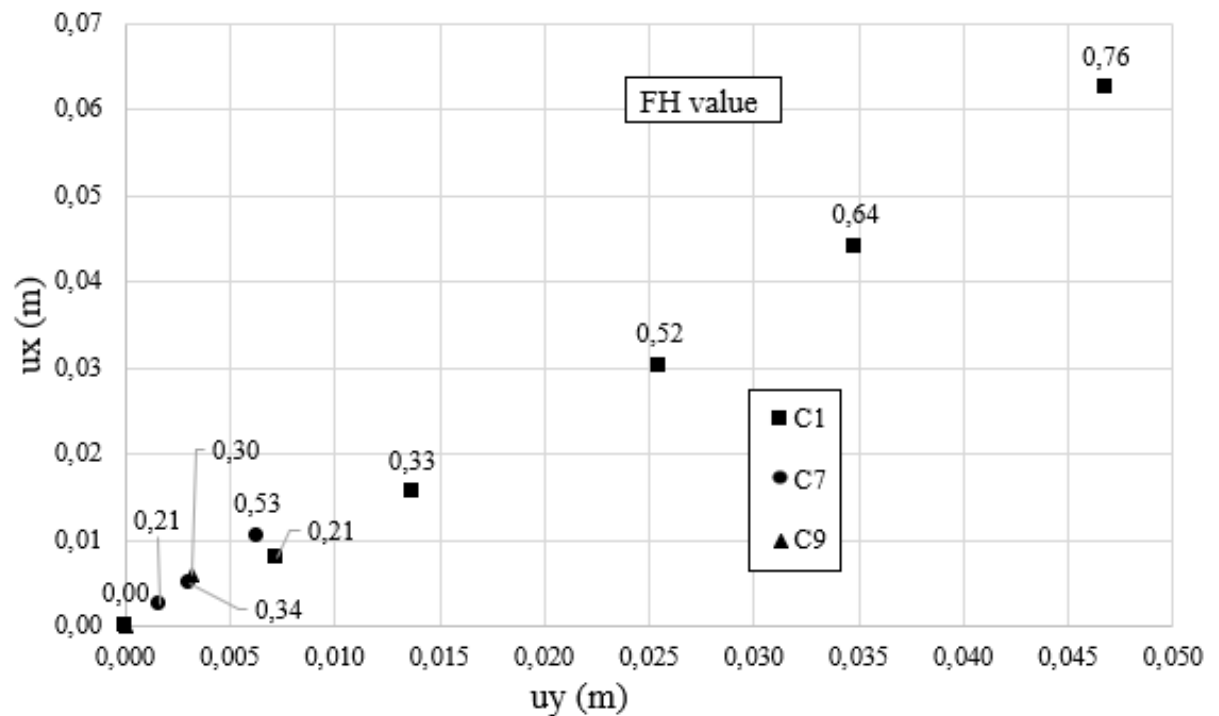
Figure 61 - Horizontal and vertical displacements for C1, C7 and C9 cases

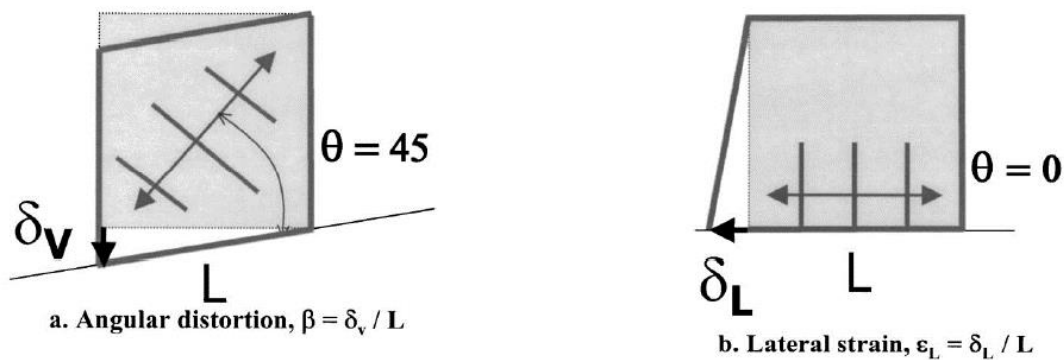
Figure 62 – Angular distortion and lateral strain definition by Son and Cording 2005

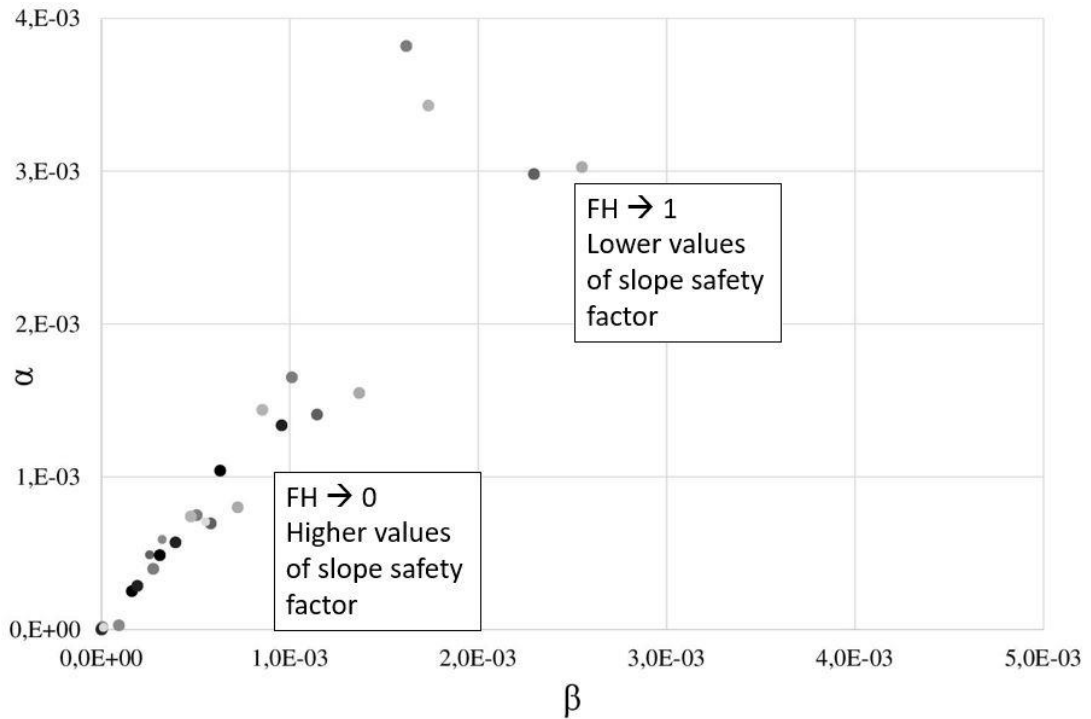
Figure 63 - Relation between angular distortion and lateral strain from the results of the analyses

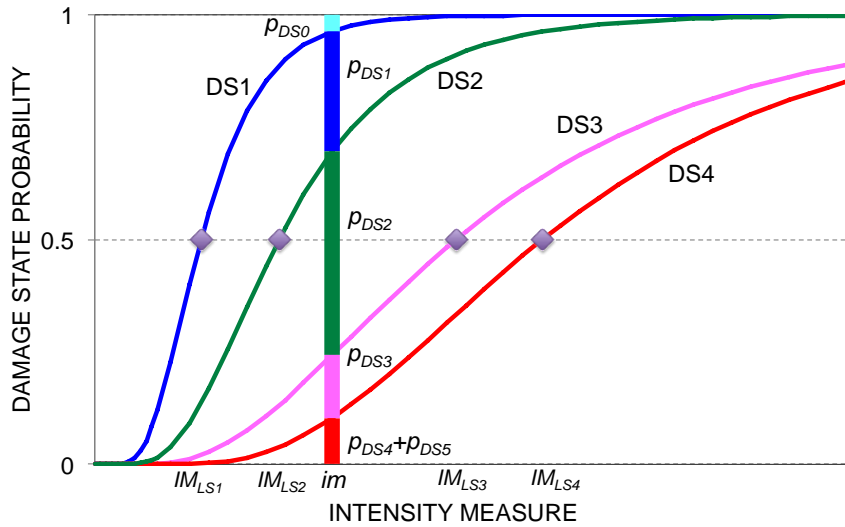
Figure 75- Example of fragility curves to quantify the conditional probability of being or exceeding a certain level of seismic damage ( $D_i$ ) given a seismic intensity measure (IM).
