## **Ph.D. Programme in Civil, Chemical and Environmental Engineering**

### **Curriculum in Structural and Geotechnical Engineering, Mechanics and Materials**

### **Damage assessment of churches exposed to slope displacements in sliding areas**

DAMAGE ASSESSMENT OF CHURCHES EXPOSED TO SLOPE  
DISPLACEMENTS IN SLIDE AREAS

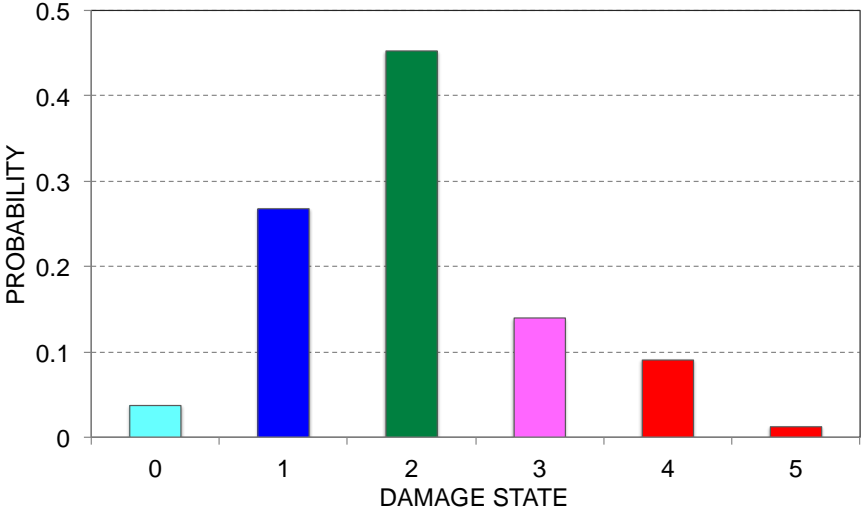
Figure 76 - Damage States probability distribution

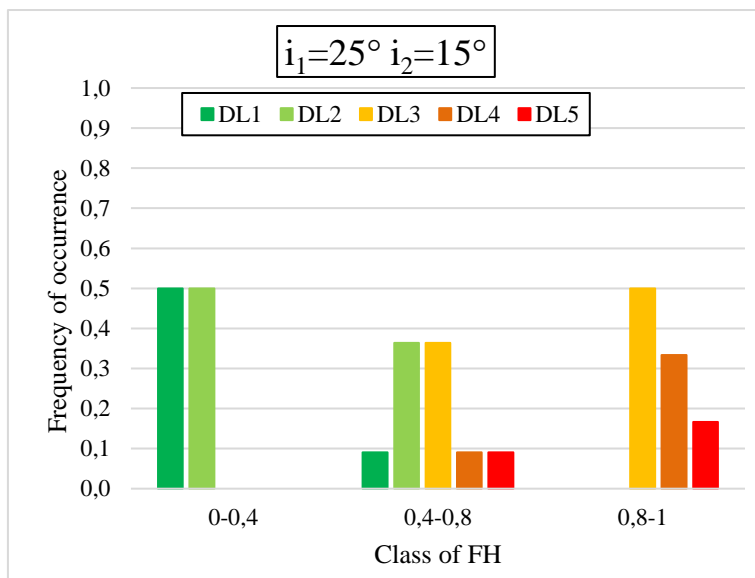
Figure 82 - Frequency of occurrence con case  $i_1=25^\circ, i_2=15^\circ$

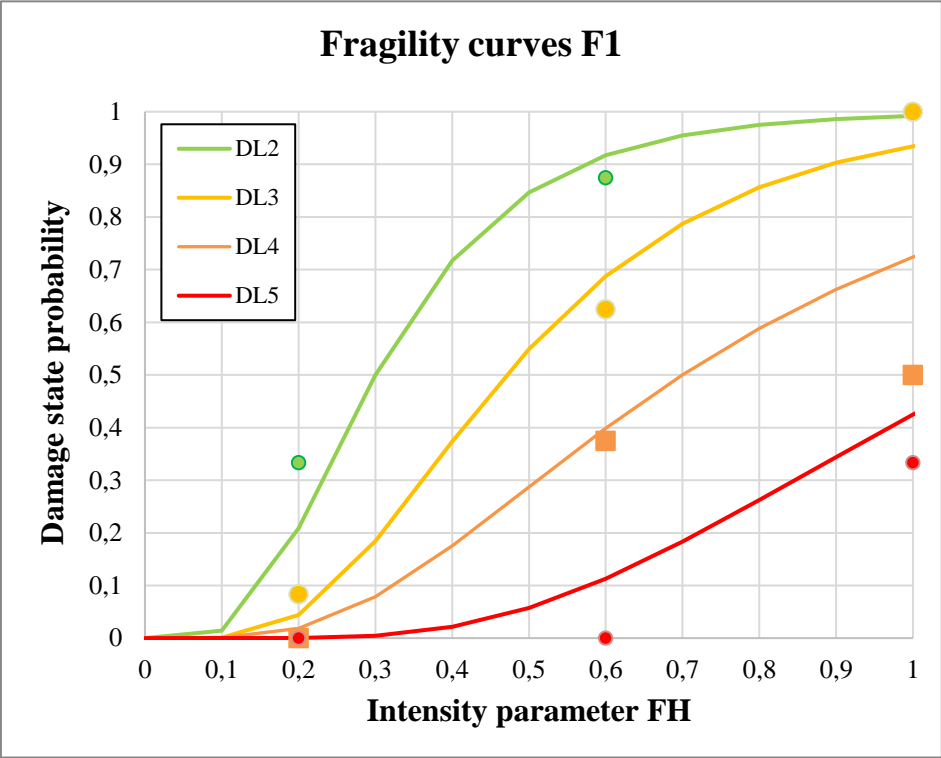
Figure 83 - Fragility curves F1

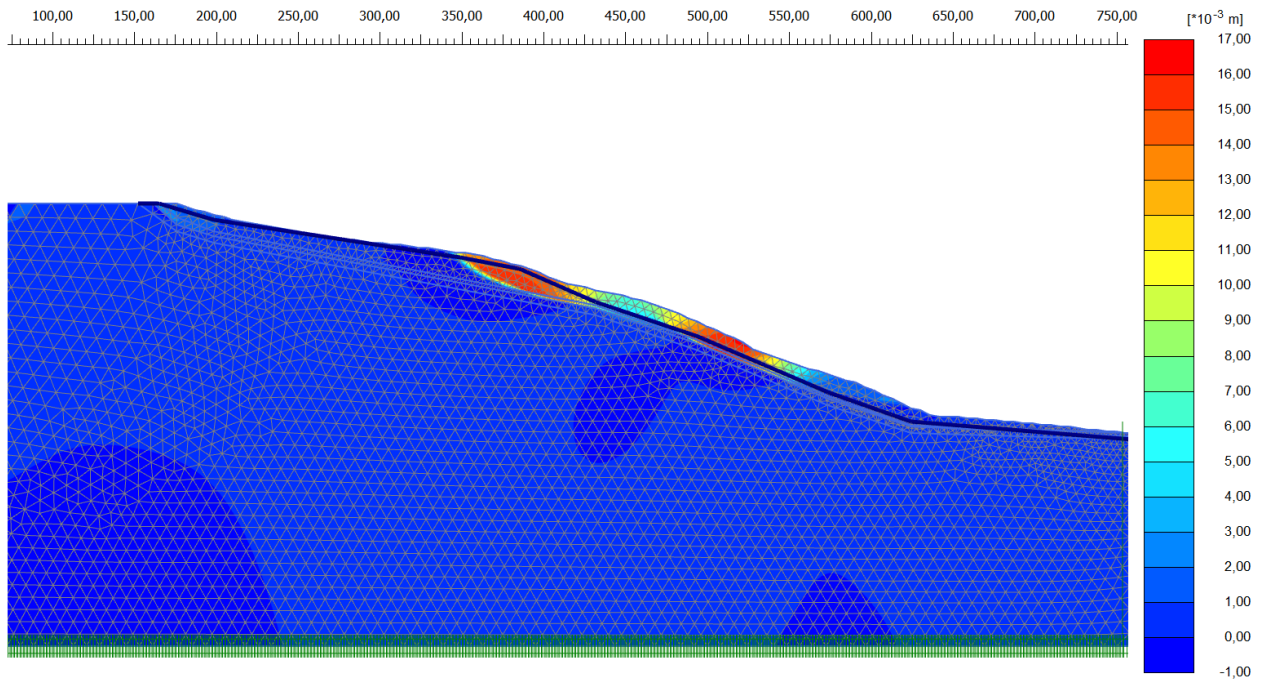
Figure 90 - Horizontal displacements ( $u_x$  profile, in mm) obtained in FEM analyses

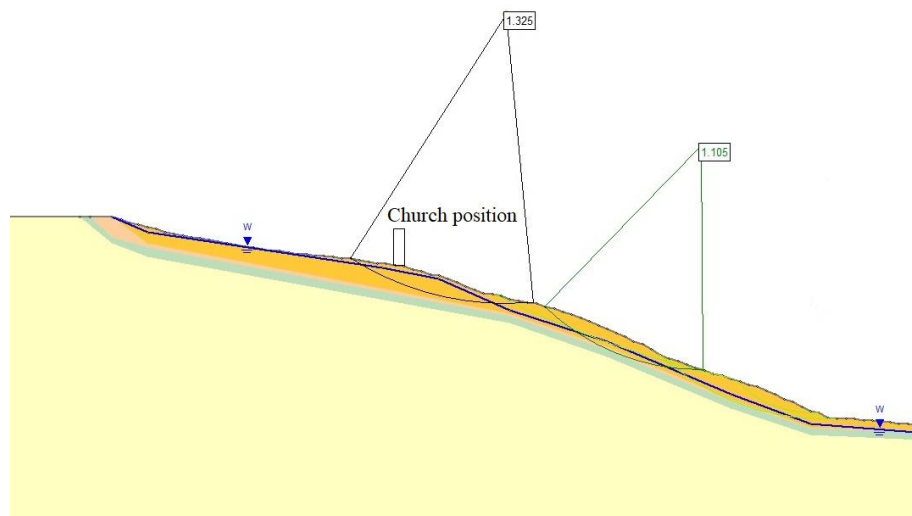
Figure 91 - Potential failure surfaces and factors of safety obtained in LEM analyses

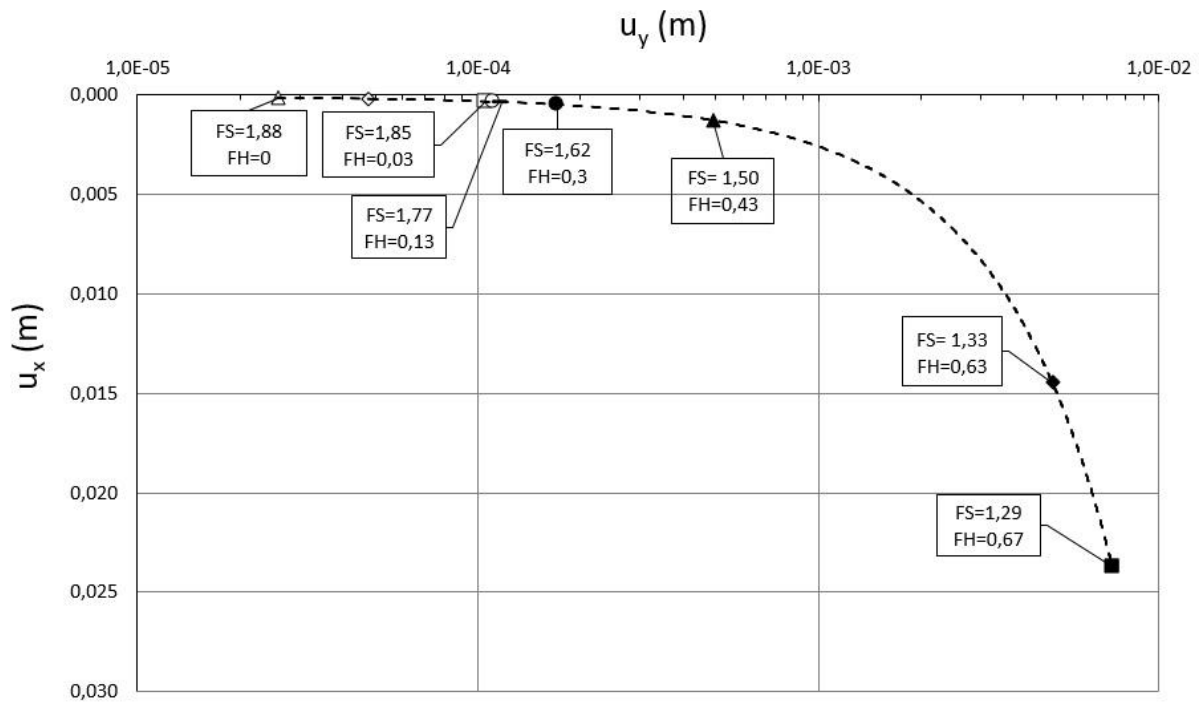
Figure 92 - Horizontal and vertical displacements in the church area associated to the hazard factor FH

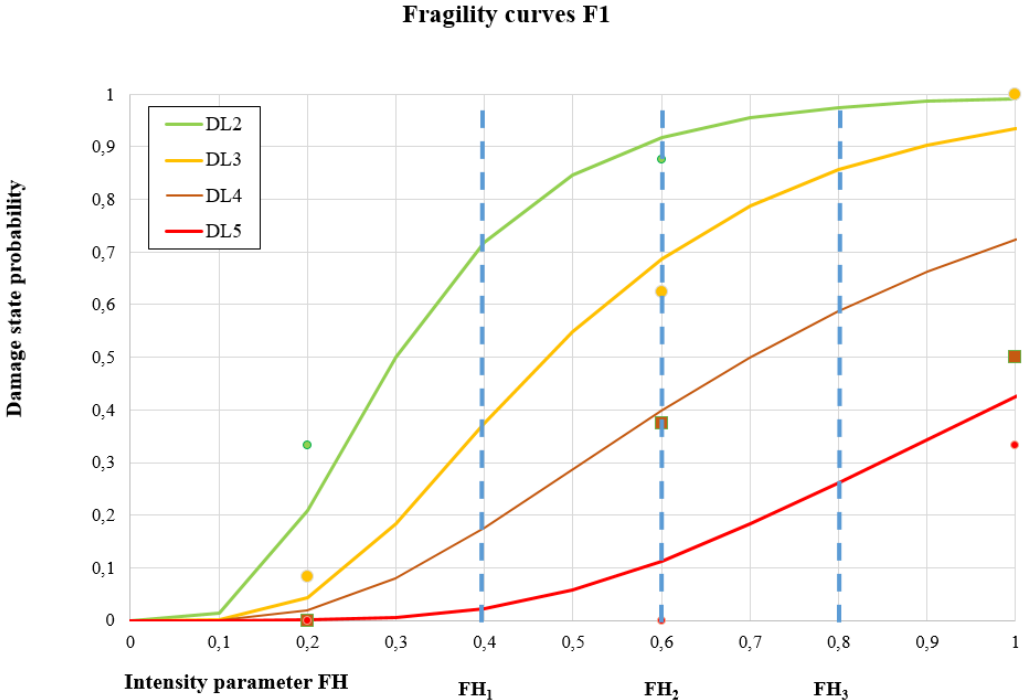
Figure 93 – Fragility curves F1 with fixed FH value

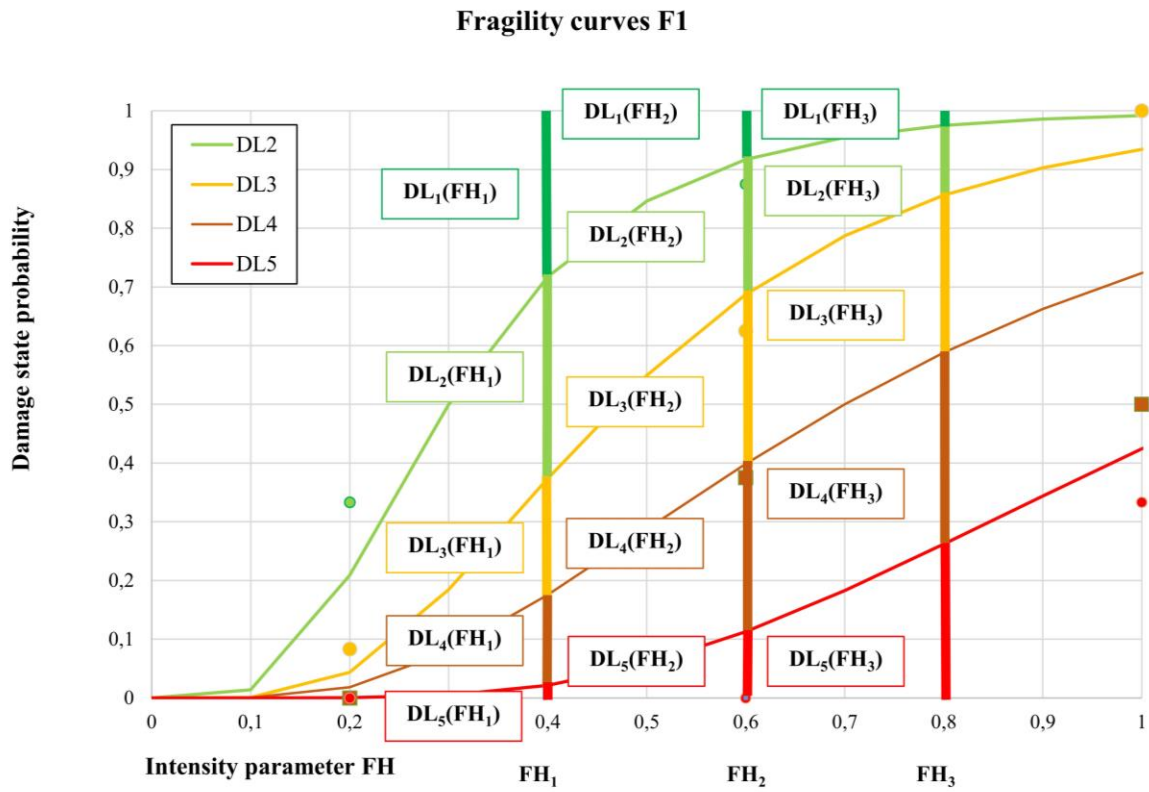
Figure 94 - Fragility curves F1 and damage state probability

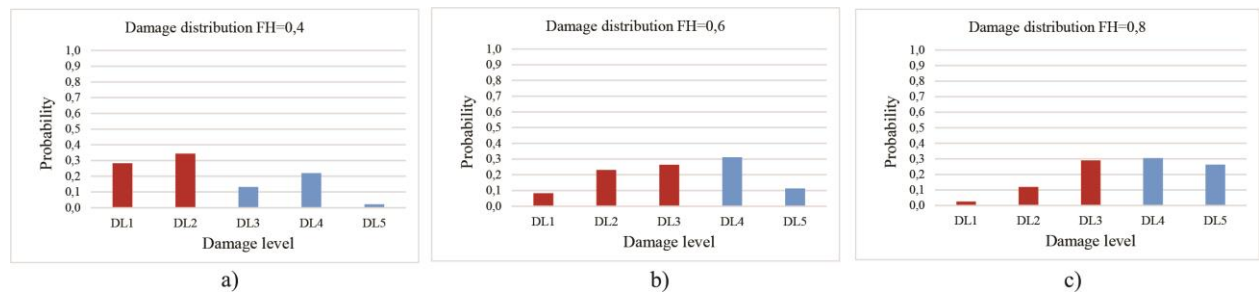
Figure 95 – Damage distribution as FH increase

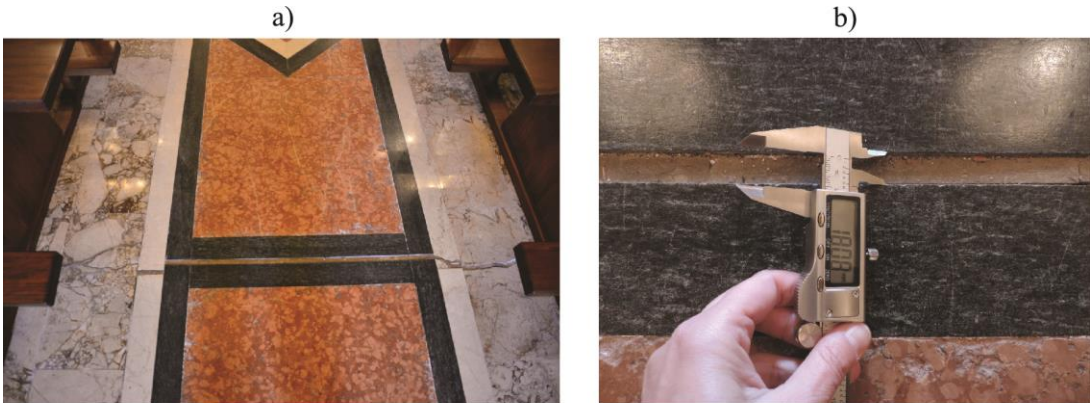
Figure 96 – Cracks of the floor (a) and its measured (b)

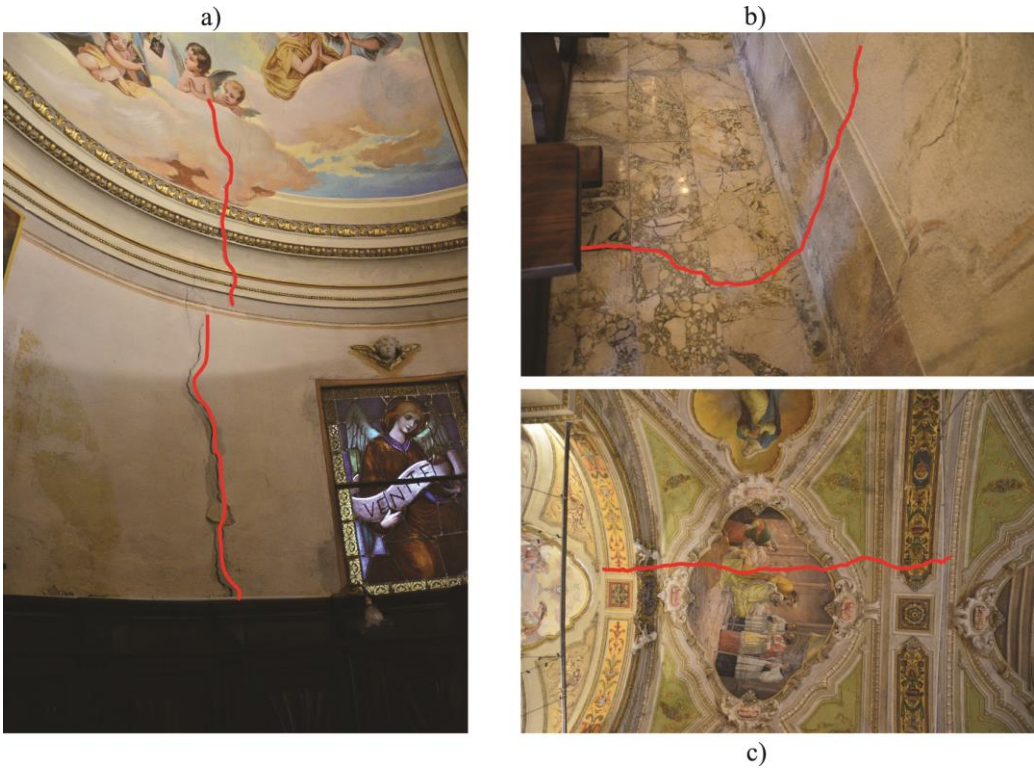
Figure 97 – Cracks on the apse wall (a), cracks propagating from the floor to the walls (b), cracks of the vault

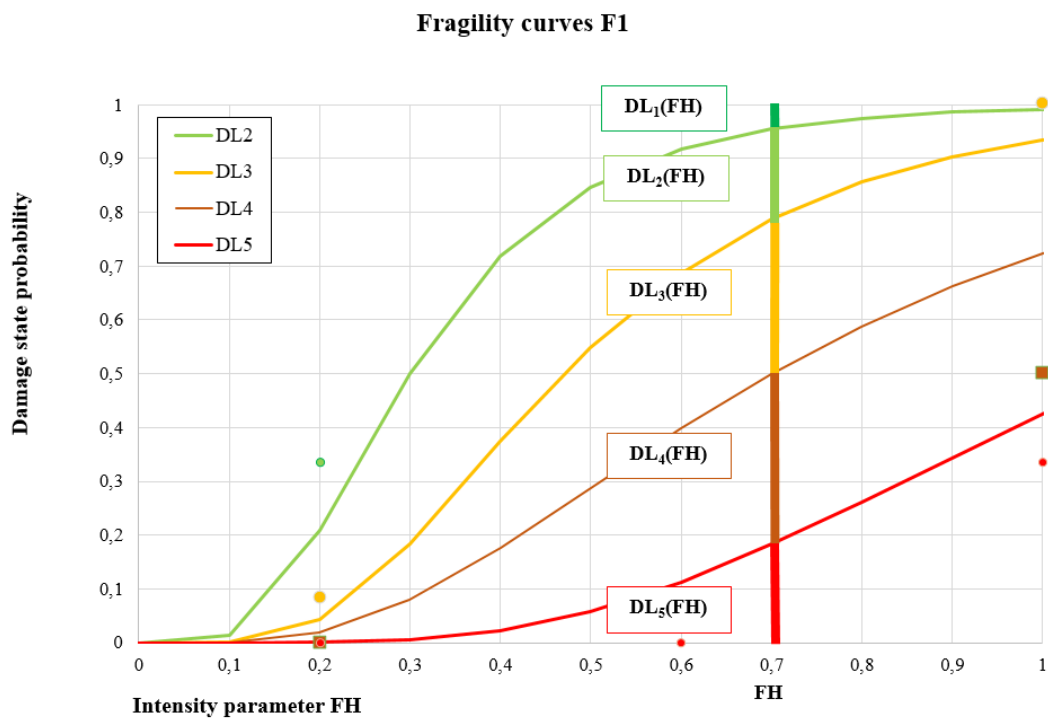
Figure 100 – Fragility curves when FH=0.7

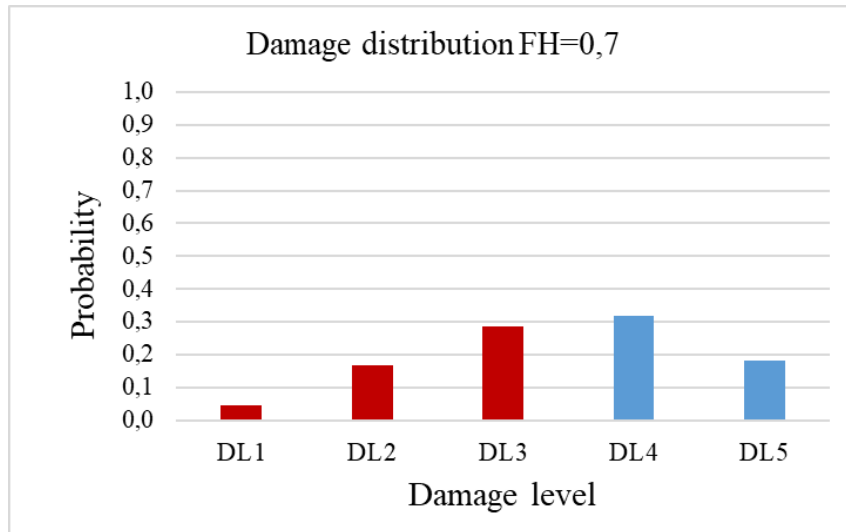
Figure 101 – Damage distribution when FH=0.7
