CODE 363**THE CONSTRUCTION OF THE TRANSHUMANCE TERRITORY OF THE
GERÊS-XURÉS: VERNACULAR HERITAGE IDENTIFICATION, ANALYSIS AND
CHARACTERIZATION****Barroso, Carlos E.¹; Barros, Fernando C.²; Riveiro, Belén³, Oliveira, Daniel V.⁴;
Ramos, Luís F.⁵; Lourenço, Paulo B.;⁶ Vale, Clara Pimenta do⁷**

KEYWORDS: Vernacular heritage; architecture; corbelled domes; granite; laser scanning.

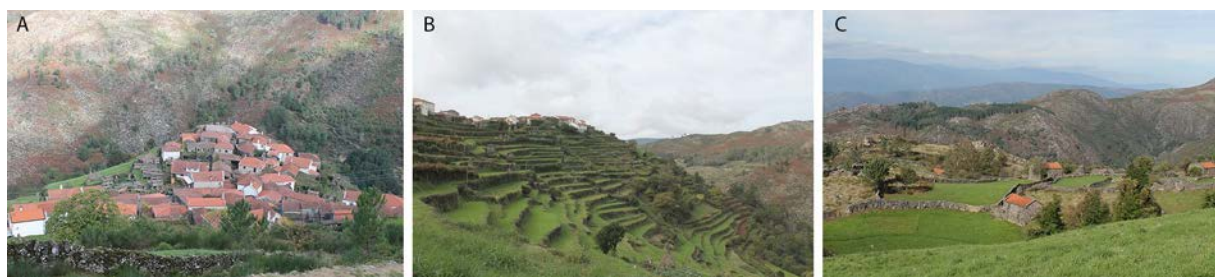
Figure 3 - Examples of the territory occupation of the Padrão settlement area: A - the settlement; B - the surrounding farming terraces; C - the mountain range plateau temporary settlement of Alhal.

To make the most of geography and the scarce available fertile soil, a vertical organized human occupation was developed, see Figure 3 and Figure 4 (labels A,B and C), based in: *i*) concentrated settlements (A), where communities formed organized parishes, based at a rural catholic church, either in a larger single or several small individual settlements, spread around a specific mountain range territory, placed near a water source, nearby fertile soil and with sun exposure; *ii*) farmland by using fertile land at the bottom of the valleys or by the transformation of the mountain slope (B), around the settlement or nearby, in to farming terraces; *iii*) the use, during warmer months, of the mountain range plateaus for livestock and/or farming (if natural conditions allowed it) (C1 to 4 of Figure 6); *iv*) a very dense and vast network of dry stack small size farm walls (average 1 m of height) to help manage and guide livestock and to set property and territory boundaries; *v*) a vast spider web style mountain range network of earth or granite paved roads, allowing mobility all around the mountain. The use of the corbelled dome vernacular technologies comes as part of the local vertical transhumance strategies, being an authentic expression of inventiveness of resources management in the survival effort facing a very demanding natural environment [7].

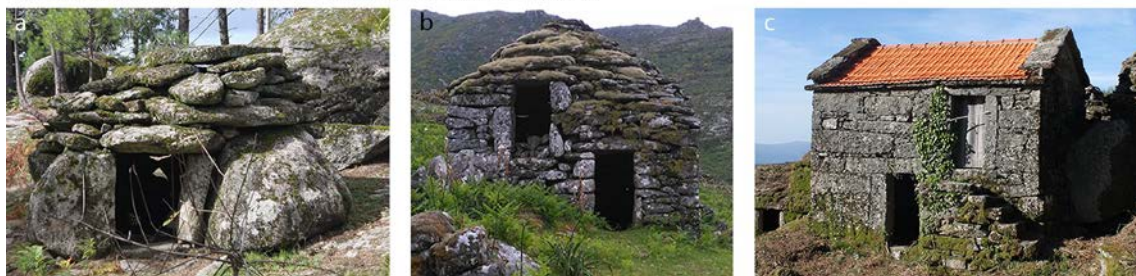
Figure 5 - Schematic examples of corbelled domes buildings morphological and typological main features, based in the “brandas” de Padrão study cases [1]. Examples of: a - single-storey shelter (“branda” of Travanca); b - two-storey shelter (“branda” of Rio Côvo); c - two-storey “branda” house (“branda” of Gêmea).

Concerning the use of corbelled dome technique in individual buildings, three main typologies were identified during the fieldwork surveys [1]: *i*) the single-storey shelter; *ii*) the two-storey shelter; and *iii*) the gable roof “branda” house of one or two-storey. As shown in Figure 5, these buildings were either observed individually or combined and part of groups of buildings [1].

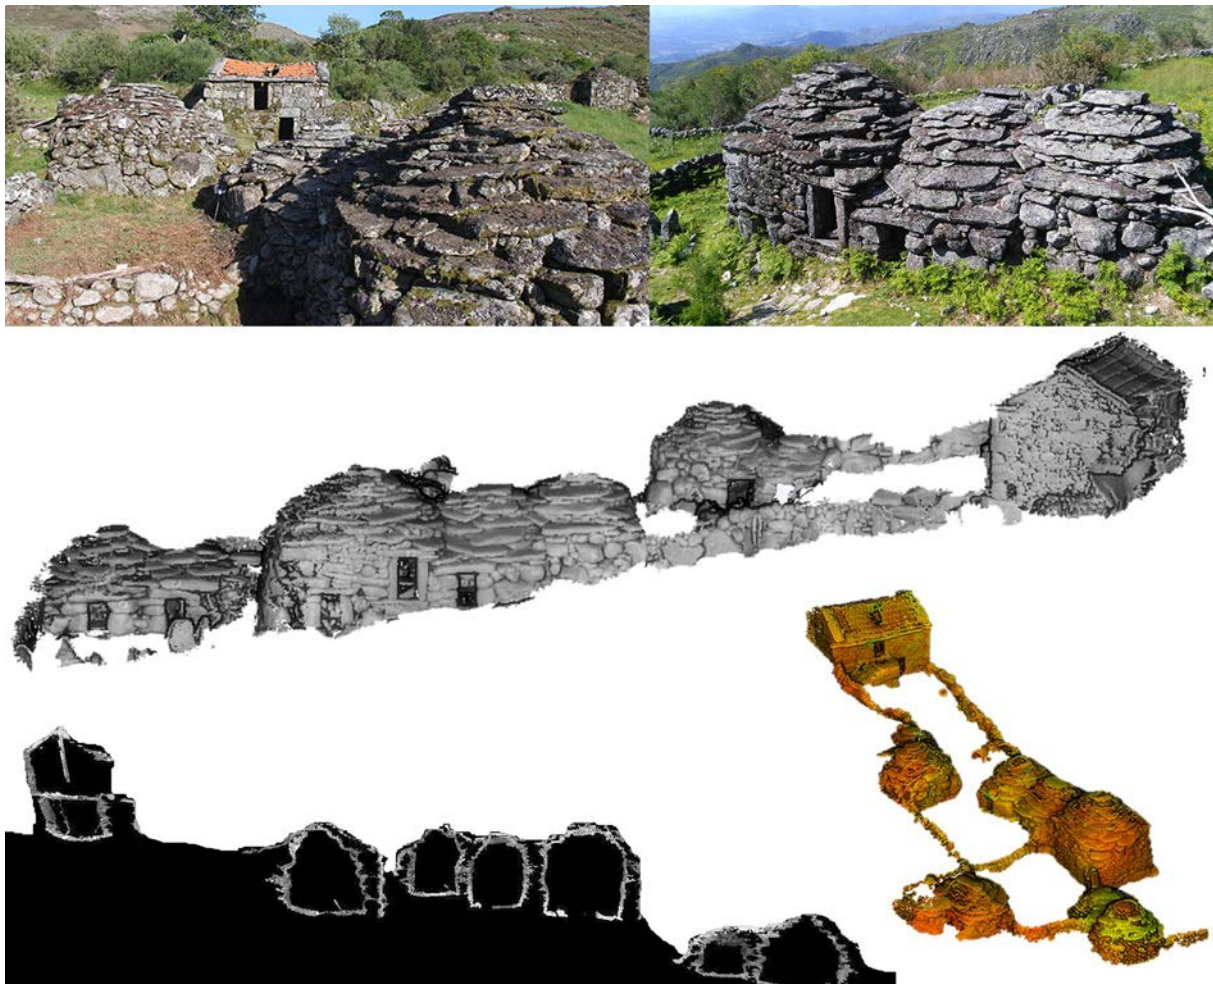
Figure 7 - Images of the study case Group A of “*branda*” of Gêmea (above). Examples of the 3D images obtained from the 3D point clouds using *CloudCompare*® and *RiscanPro*® (cross-section) [1,4].

The initially visual identification survey, that allowed a global view concerning morphologies and typologies, was later followed by an accurate laser-scanner [8] survey on study cases of “*branda*” of Gêmea [1]. Some results are shown in Figure 7.

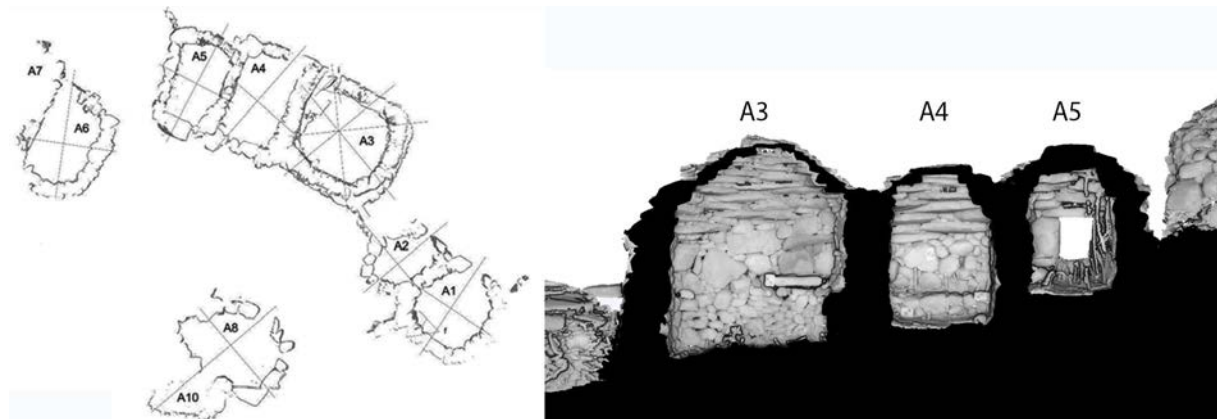
Figure 8 - Base plan (using *RiscanPro*®) and longitudinal cross-section (using *CloudCompare*®) [1,4].

Although seeming buildings of vertical proportion, due to the corbelled dome cone shape, the laser scanner survey showed that in fact, these are horizontal proportion buildings. Comparison between buildings vertical and larger horizontal axis shows a ration of 1:1, being at the walls level of 1:2, and at the domes level from 1:2 to 1:3. Base plan geometric analysis, see Figure 8, a predominant quadrangular proportion, with a dominating axis either, perpendicular or transverse to entrance.

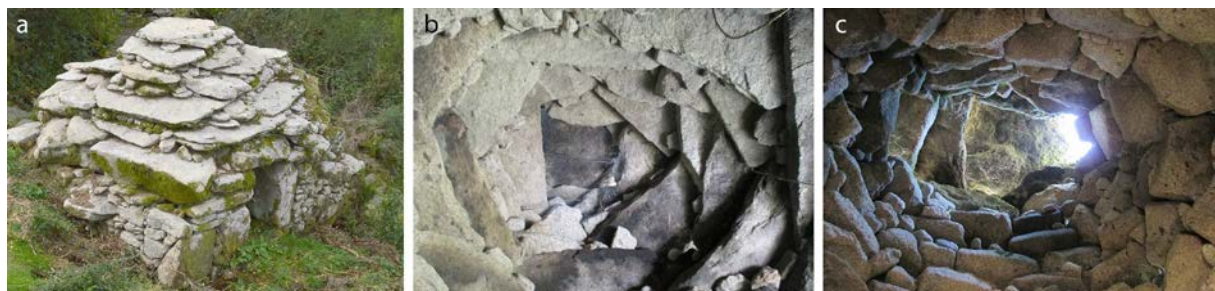
Figure 9 - a and b - external and internal views of a corbelled dome built with large-size plate shape granite units; c - internal view of a corbelled dome built with irregular plate shape granite units [1]. (“*branda*” of Gêmea).

The corbelled domes were built by overlapping plate shape stones, laid out jutting towards the centre, supported in an average of 2/3 of its horizontal section over at least two larger underneath masonry units, and leaving its central portion working as cantilever (see Figure 9). Wedges were used by the inside of the dome, to give the stone blocks a slope outside to drain rain water, and by the exterior, to fill larger holes. Vertical load is passed thru the very irregular stone blocks interface and thru the wedges to the walls, and the structure is stabilized by friction between the stone blocks interface [1].

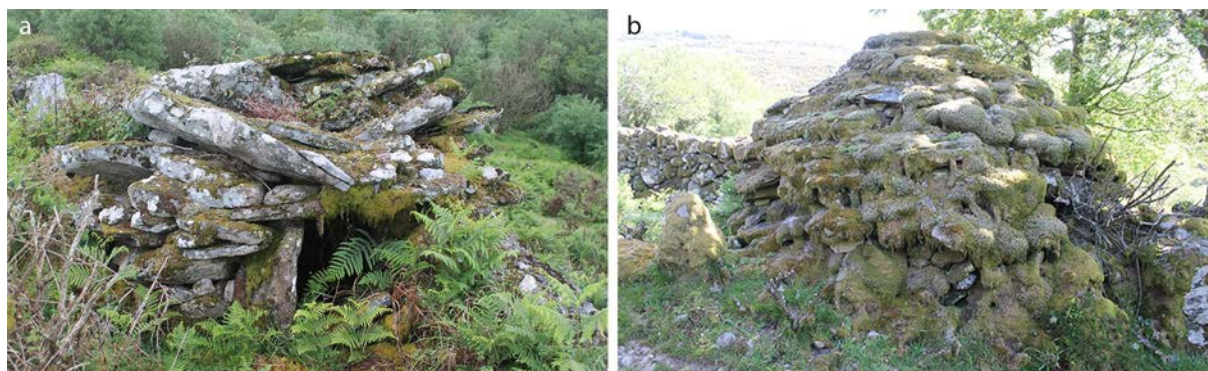
Figure 10 - Damage in corbelled dome structures: a - corbelled dome collapse (“*branda*” of Braçal); b - severe biological colonization due to lack of maintenance (“*branda*” of Gêmea) [4].

During the fieldwork survey, an accurate damage identification was performed and allowed to concluded that three different levels of damage and associated risk can be found. The collapse of the walls and of the domes, shown in Figure 10a, present the higher level of risk to this building's structural security [4].

Concerning the corbelled domes, three possible outcomes were identified: *i*) a simple collapse of isolated stone blocks, with reduce damage to the remaining structure, allowing it to be repaired; *ii*) corbelled dome full collapse, generally inwards, causing low level of damage to the walls, thus allowing the corbelled dome reconstruction; *iii*) full collapse of the corbelled and the masonry walls, generally outwards, leaving the building unrecoverable. Due to the structural system type, a load-bearing wall significant collapse ultimately leads to the corbelled dome full collapse, representing the higher level of risk for the buildings safety. Regarding biological colonization, see Figure 10b, small and medium size species colonization is overwhelming, although not posing an immediate risk. Large size species, like bushes and trees, pose a serious risk: *i*) by destroying farm walls (out-of-plane loads) and making roads unusable; *ii*) penetrating roots disaggregate buildings and corbelled domes masonry structures, leading to their collapse; *iii*) by making structures to disappear in the landscape, thus, from collective memory.
