1 **Influence of traditional earthquake-resistant techniques on the out-of-plane behaviour of**  
2 **stone masonry walls: experimental and numerical assessment**

10 **Abstract:** The main goal of the work is to assess the efficiency of traditional earthquake resistant  
11 solutions to improve the out-of-plane performance of stone masonry walls. Therefore, the present paper  
12 presents the results of an experimental campaign and numerical analysis performed on three stone  
13 masonry walls with a U-shaped plan configuration. Two of them were built with traditional earthquake-  
14 resistant techniques usually found in European Mediterranean area, namely steel ties and timber-laced  
15 reinforcements embedded at the corners of the walls. These techniques are specifically intended to  
16 enhance wall-to-wall connections and, thus, improve the out-of-plane behaviour of the walls. The  
17 experimental campaign included qualitative assessment procedures, non-destructive tests for the  
18 material characterization and a quasi-static test for the characterization of the out-of-plane response.

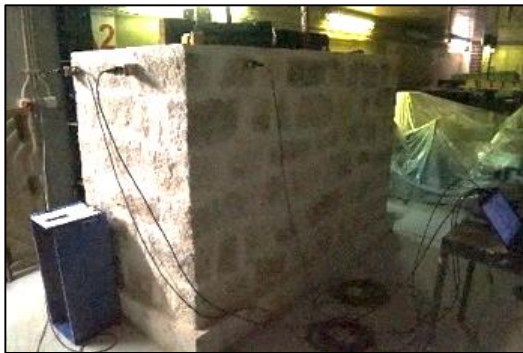
266 Figure 7 – Sensor placed during one setup (a); Artemis software axonometric scheme of the sensors  
267 location (b)

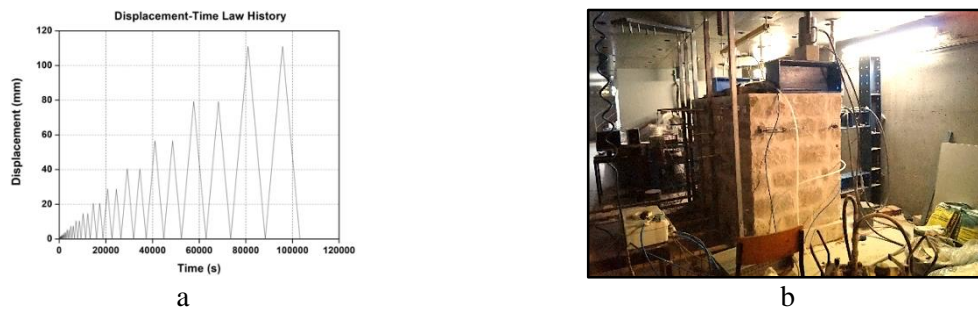
327 certain level of pressure that is enough to attain the imposed lateral displacement (Figure 11-b). Once  
328 the control displacement is reached, the air in the airbag is released until zero displacement in the early  
329 stages of the out-of-plane testing. When the non-linear response of the wall is activated, the unloading  
330 is only possible up to a residual displacement associated to the permanent deformation of the wall.

331 Figure 11 – Displacement-time law history (a); airbag pressure system (b)

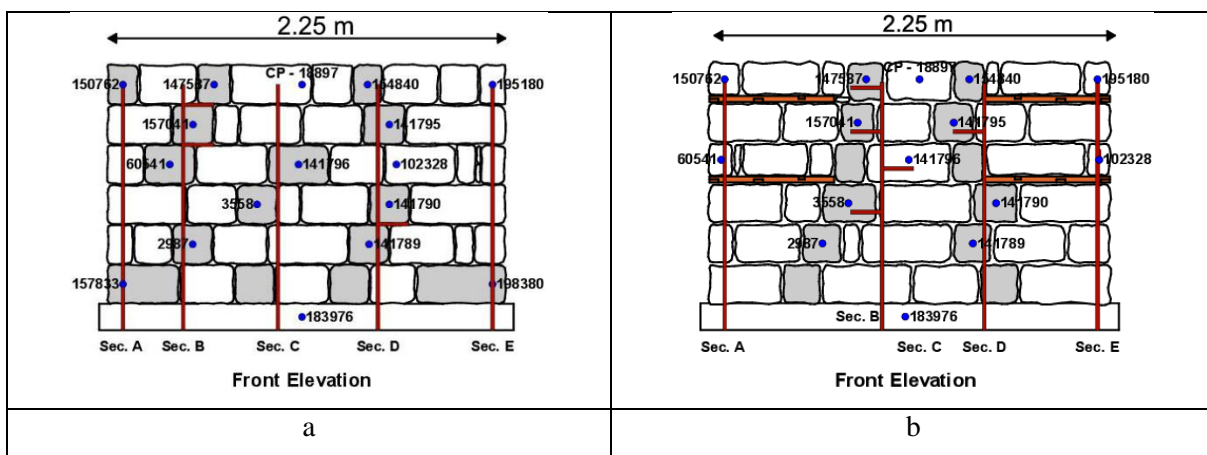
332 The monitoring of the displacements of the frontal wall during the out-of-plane test was carried out  
 333 using linear variable differential transducers (LVDTs). Figure 12 shows the LVDTs setup in Wall\_Stl  
 334 and Wall\_Tmb façade. Note that LVDTs are depicted using a blue dot and an identification number.  
 335 Sixteen monitoring points were set in the façade of the steel reinforced wall (Wall\_Stl), whereas 14  
 336 points were defined for Wall\_Tmb. Moreover, 2 displacement transducers were placed in the transversal  
 337 walls of the first reduced scale specimen (Wall\_Stl), in order to measure possible cracking and  
 338 detachment of the frontal walls with respect to the transversal walls. Due to the presence of timber  
 339 reinforcement, 4 displacement transducers were placed on the transversal walls of the specimen  
 340 Wall\_Tmb. They were intended to assess the performance of the timber elements, trying to detect

342 Figure 12 – Location of LVDTs at: Wall\_Stl façade (a) and Wall\_Tmb façade (b)

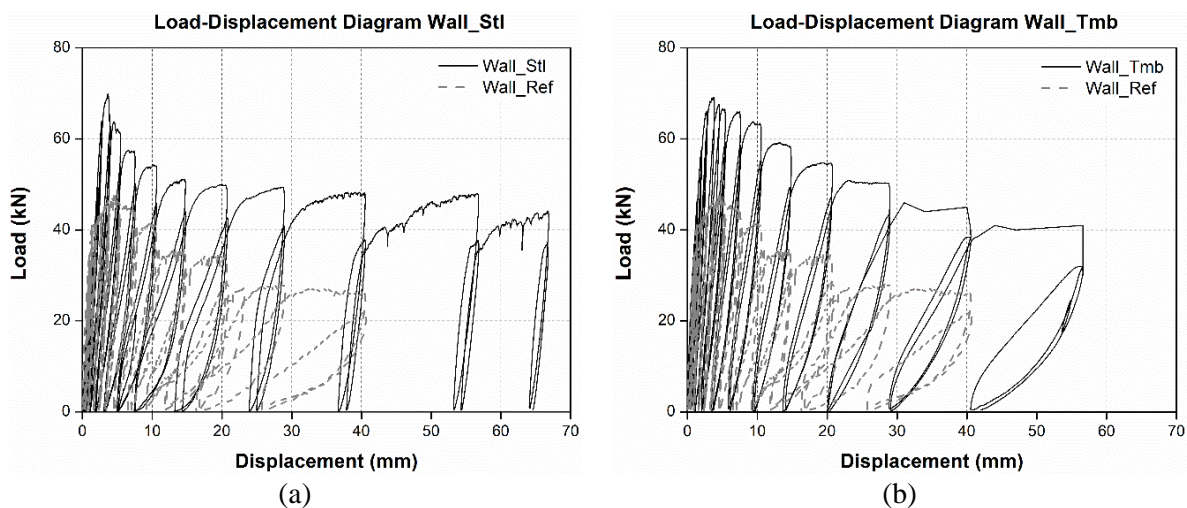
358 The load-displacement diagrams obtained from Wall\_Ref, Wall\_Stl and Wall\_Tmb are presented in  
359 Figure 13. The force represents the sum of the values recorded by the four load cells. The displacement  
360 is representative of the control point in the top mid span of the wall (CP-18897, see Figure 12). It can  
361 be observed that the out-of-plane behaviour of both reinforced walls (Wall\_Stl and Wall\_Tmb) is  
362 similar. Their response is characterized by a linear elastic regime that lasts almost until peak load, which  
363 is close in both specimens. The differences are more significant in the post peak cyclic response, in terms  
364 of permanent deformation. Nevertheless, they are characterized in both cases by a relatively smooth  
365 softening corresponding to the decrease of the force for increasing lateral displacements. In Wall\_Stl  
366 (steel reinforced experimental model), there is a more abrupt descending branch just after peak load, but

367 then the load almost stabilizes for increasing out-of-plane displacements. At the same time, the  
368 permanent deformations increase considerably after a displacement of 20 mm, which is due to the  
369 detachment of the upper area of the wall with progressive sliding along the horizontal crack developed

370 almost at mid height. This is also responsible for the stabilization of the lateral resistance, as damage  
371 localize in the top region of the wall. The softening branch recorded in Wall\_Tmb gradually decrease  
372 up to the maximum imposed displacement (Figure 13), meaning that the progression of damage is more  
373 spread in the wall.

379 Figure 13 – Load VS Displacement diagrams Wall\_Stl (a) and Wall\_Tmb (b)

374 With respect to the unreinforced wall (Wall\_Ref), a reduction of the initial stiffness is observed at around  
375 40 kN. After that point, the wall still reaches a maximum resisting load of 45.65 kN) but shows a notably  
376 higher rate of deformation. The post-peak branch highlights progressively decreasing loading levels,  
377 from the maximum force attained, reaching a stable trend for increasing lateral displacement until the  
378 end of the test, see Figure 13.

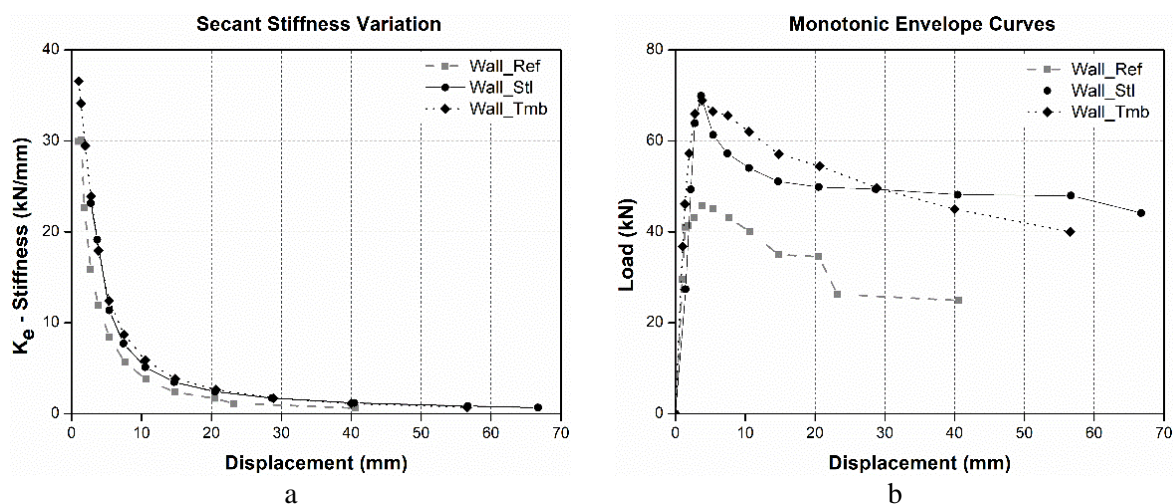
380 The secant stiffness is calculated as the ratio between the maximum load and the maximum displacement  
381 in each step in the linear branch of the envelope curve. It is equal to 29.90 kN/mm, 23.15 kN/mm and  
382 36.57 kN/mm in Wall\_Ref, Wall\_Stl and Wall\_Tmb respectively. The most significant stiffness  
383 reduction occurs at 45.65 kN (Wall\_Ref), at 61.32 kN (Wall\_Stl) and 66.51 kN (Wall\_Tmb). Even if  
384 both walls reach their maximum resisting load at around 70 kN, it is possible to notice a higher rate of  
385 deformation after the aforementioned stiffness decay thresholds (Figure 14-a). The maximum out-of-  
386 plane strength was 69.91 kN for the steel reinforced stone masonry wall and 68.91 kN for the timber  
387 reinforced stone masonry wall. Both techniques proved to be efficient enhancing the out-of-plane

388 strength, leading in average to an increase of about 52% in the lateral resistance with respect to the  
389 reference wall. Figure 14-b presents a comparison among the monotonic envelop curves obtained for  
390 the three walls. The tests were stopped, for the sake of safety of the test setup, after reaching an out-of-  
391 plane displacement of approximately 67 mm (Wall\_Stl) and 57 mm (Wall\_Tmb). Moreover, the out-of-  
392 plane response was considered completely characterized for a strength degradation of about 60%.

393 Figure 14 – Analysis of the force-displacement diagrams: Secant stiffness variation (a); Monotonic  
394 envelope curves (b)

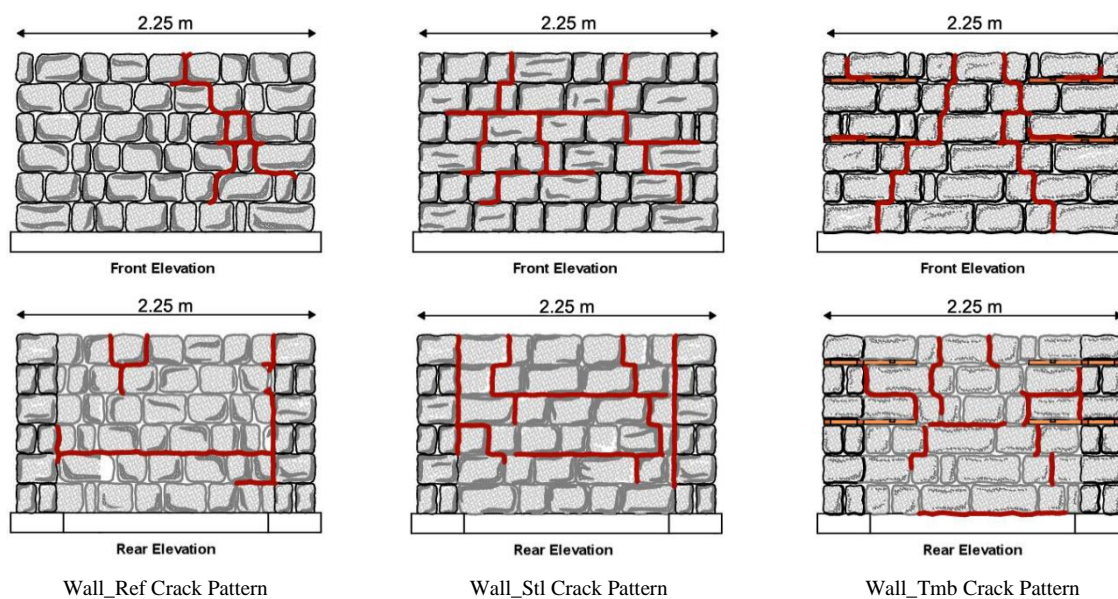
396 The final damage patterns observed at the end of the out-of-plane tests for the reference wall (Wall\_Ref)  
397 and reinforced walls (Wall\_Stl and Wall\_Tmb) can be seen in Figure 15. It should be noted that the  
398 cracking development at the rear surface of the frontal wall could not be followed due to the test setup  
399 configuration. Once the testing procedure finished and the airbag was removed, it was possible to record  
400 the final cracks at the back surface of the walls, see Figure 15.

401 In both reinforced walls, the cracks developed in an almost symmetric way. The damage pattern  
402 developed in Wall\_Stl is characterized by diagonal cracks extending from the top to the bottom of the  
403 front elevation. Moreover, a considerable horizontal crack occurred along the top of the 4<sup>th</sup> bed joint  
404 from the bottom base. The wall section delimited by the aforementioned cracks, consisting of the stone

405 units laying on the central part of the 4<sup>th</sup> and 5<sup>th</sup> course from the bottom base, experienced some sliding  
406 displacements combined with rotation movements with respect to the right side. This phenomenon can  
407 be considered a sort of local mechanism mainly due to the inhomogeneity of the stone masonry bond,  
408 which rules the permanent deformation measured by the control LVDT, according to what was already  
409 mentioned in the previous section regarding the post-peak permanent deformations.

410 Figure 15 – Crack patterns (Wall\_Ref, Wall\_Stl and Wall\_Tmb)

411 The damage pattern of wall Wall\_Tmb shows more symmetric diagonal cracks in the front elevation.  
412 Timber reinforcements appeared to improve the overall behaviour of the wall, showing more uniform  
413 displacement field when compared to the displacement field recorded in the steel reinforced  
414 experimental model. In the specimen Wall\_Ref, despite the arching mechanism developed, the out-of-  
415 plane resistance was controlled by the detachment of the frontal wall from the transversal walls  
416 according to what is shown in Figure 15.

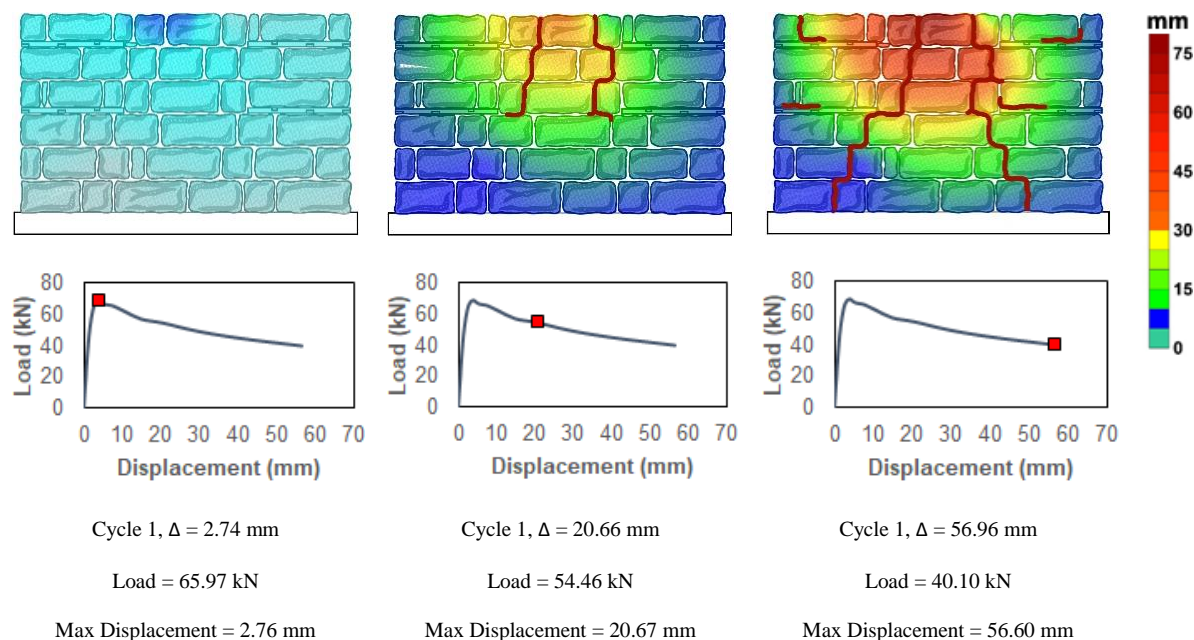
440 Figure 18 and Figure 19 present the crack development throughout the test in the front elevation of  
 441 Wall\_Stl and Wall\_Tmb respectively. Each crack pattern is drawn over the displacement fields obtained  
 442 from the mesh of LVDTs located in the wall (see Figure 12). The contour maps were obtained through  
 443 the measurements of all displacements at the frontal wall assuming a linear interpolation. The progress  
 444 of damage is also associated to a point of the monotonic force vs displacement curve for reference.

447 Figure 19 – Out-of-plane damage evolution in Wall\_Tmb

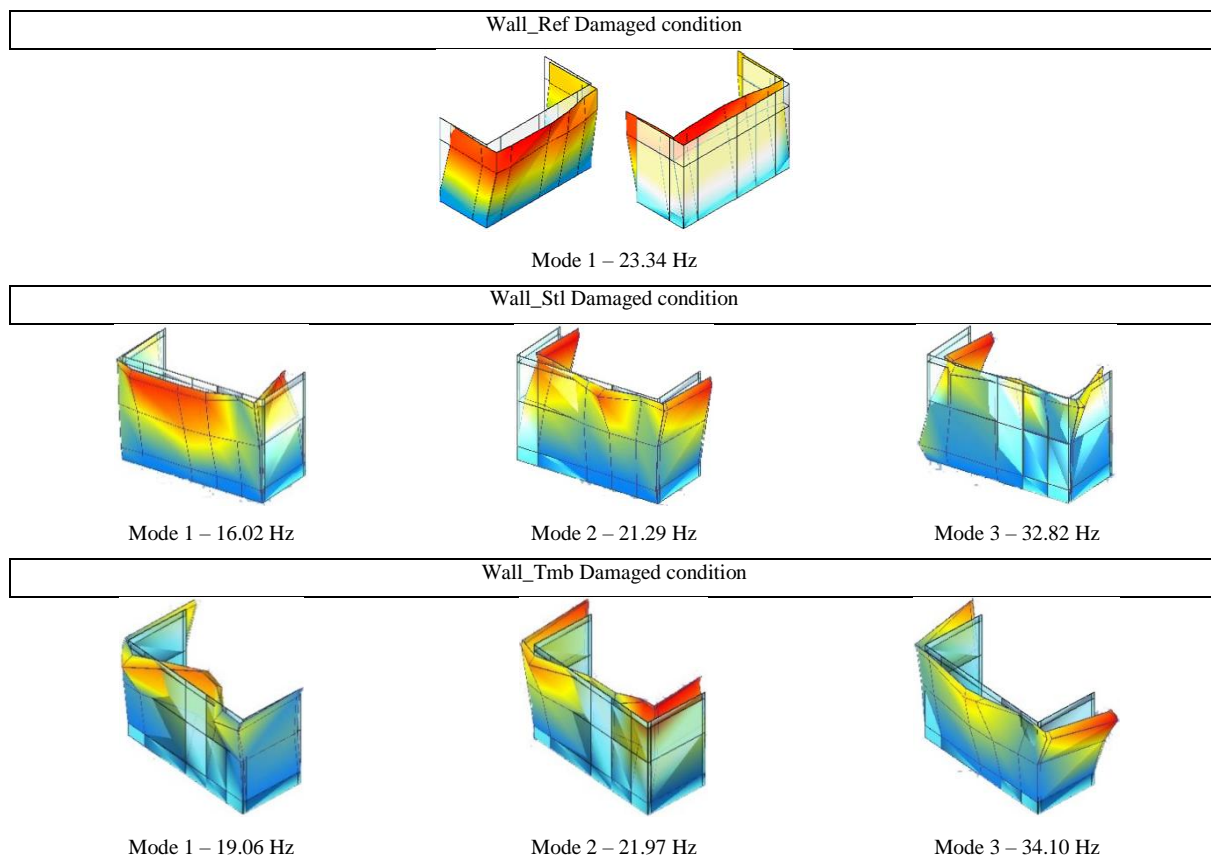
457 The final damage state of the walls was also assessed based on the variation of the frequencies and  
458 modes shapes obtained after the out-of-plane testing. With respect to the dynamic tests performed after  
459 the out-of-plane test, the first natural frequency experienced a reduction of 19.42% and 9.4% in Wall\_Stl  
460 and Wall\_Tmb, respectively. In the damaged condition, Wall\_Ref presents a reduction of about 12.5%  
461 on the first natural frequency when compared to the undamaged condition (Figure 20).

463 Figure 20 – Main mode shape and natural frequencies (damaged condition) in walls Wall\_Ref, Wall\_Stl  
464 and Wall\_Tmb

465 The mode shapes related to the damaged conditions are clearly affected by the crack distribution  
466 occurred after the out-of-plane test. The first mode in Wall\_Ref appears to maintain its original shape.

467 The out-of-plane displacement is more significant in the left portion of the façade, but it gradually  
468 decrease reaching the section of the wall where an extended crack occurred (Figure 20).

469 Similarly, both in specimens Wall\_Stl and in Wall\_Tmb, the out-of-plane displacement is mainly  
470 concentrated in those parts of the façade delimited by the biggest cracks. In Wall\_Stl, top and bottom  
471 corners show negligible displacement levels, whereas a considerable out-of-plane displacement  
472 characterizes the portion of façade, which experienced sliding phenomena during the airbag test. On the  
473 other hand, Wall\_Tmb crack pattern ideally divides the façade into three sections according to the cracks  
474 observed, resulting in a phased out-of-plane displacement of the central portion of the front wall  
475 delimited by the timber-laced elements with respect to its corners.

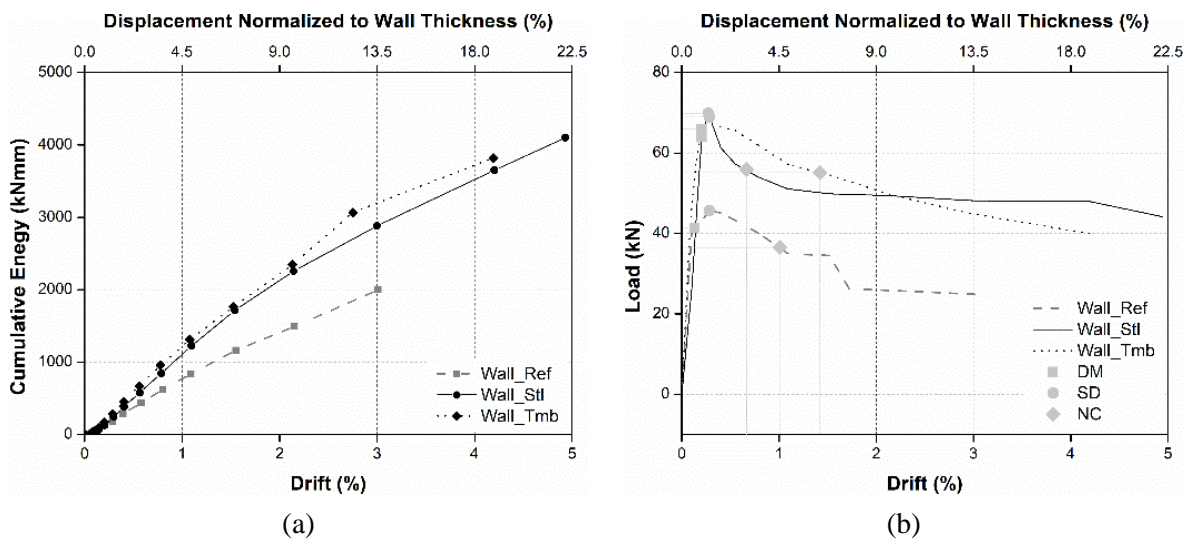
477 The positive influence of the two techniques in the out-of-plane response of stone masonry walls is  
478 further confirmed by the evolution of the hysteretic energy dissipated during the test (Figure 21a).  
479 Dissipated energy is represented by the area enclosed by hysteretic loops obtained from load-  
480 displacement response records in the reference LVDT (control point). It is seen that for the same drift  
481 demand, the energy dissipated by Wall\_Stl and Wall\_Tmb is significantly higher when compared with  
482 unreinforced masonry wall (Wall\_Ref). Looking at a drift level corresponding to 3%, the dissipated  
483 energy in Wall\_Ref is 1998 kNmm, whereas for the same drift level the dissipated energy is 2882 kNmm  
484 (44% increase) and 3068 kNmm (53% increase) in Wall\_Stl and Wall\_Tmb, respectively.

485 Figure 21 – Energy dissipation capacity in Wall\_Ref, Wall\_Stl and Wall\_Tmb (a); Limit states  
 486 identification in Wall\_Ref, Wall\_Stl and Wall\_Tmb (b)

487 Figure 21b provides information about the load and displacement corresponding to three damage levels  
 488 or limit states defined by Eurocode 8 [32]. Following this approach and based on previous data of  
 489 experimental campaigns on masonry buildings [33] [34], the different damage limit states were defined  
 490 for the two walls: (1) Damage Limitation state (DM), which is associated to the point where a change  
 491 of stiffness could be detected ( $H_{cr}$ ,  $d_{cr}$ ); (2) Severe Damage (SD) limit state, which is associated with the  
 492 drift corresponding to the maximum out-of-plane strength ( $H_{max}$ ,  $d_{Hmax}$ ); and (3) Near collapse limit state  
 493 (NC), which is associated to the lateral drift corresponding to a 20% decrease of the out-of-plane strength  
 494 ( $H_u$ ,  $d_{Hu}$ ).

495 The walls present a very stiff initial behaviour, leading to very low values of lateral drift corresponding  
 496 to the crack initiation (DM limit state). Due to the reduced nonlinearity before the peak load, relatively  
 497 low values of lateral drift corresponding to severe damage limit states (SD) are also observed. The lateral  
 498 drift corresponding to the NC damage limit state ranges between 0.66% and 1.42% for the steel  
 499 reinforced and timber laced reinforced wall, respectively, whereas in the reference wall (Wall\_Ref), the  
 500 lateral drift related to NC damage limit state is equal to 1.01%. The first test (Wall\_Stl) was stopped  
 501 before the collapse, when the walls presented a lateral drift of approximately 5%, whereas the second

502 test (Wall\_Tmb) stopped when a lateral drift of 4.19% was reached. Even though the aforementioned  
 503 limit states may be considered too conservative if applied to masonry walls under out-of-plane loading,  
 504 it is possible to observe that the overall behaviour of the reinforced prototypes improved the performance  
 505 of the walls in terms of the limit state corresponding to damage limitation (DM). The corresponding  
 506 lateral drift increases from 0.13% (Wall\_Ref) to 0.2% to reinforced walls (Table 5). The near collapse  
 507 limit state (NC) is also attained for a higher lateral drift in case of Wall\_Tmb. The lower lateral drift  
 508 found for specimen Wall\_Stl can be justified by the more sudden reduction of the lateral resistance after  
 509 the peak load. In both reinforced walls, the performance levels are clearly attained for higher values of  
 510 lateral resistance when compared to the reference wall.
