Title:
Crashworthiness Improvements to Automotive Sandwich Composites Using Tufting

Jamie William Hartley

September 2018

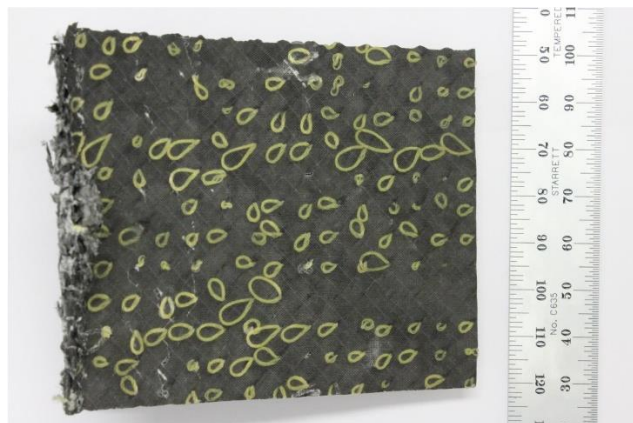
Figure 4-2: An example of loop variation visible on the surface of a cured sandwich panel.

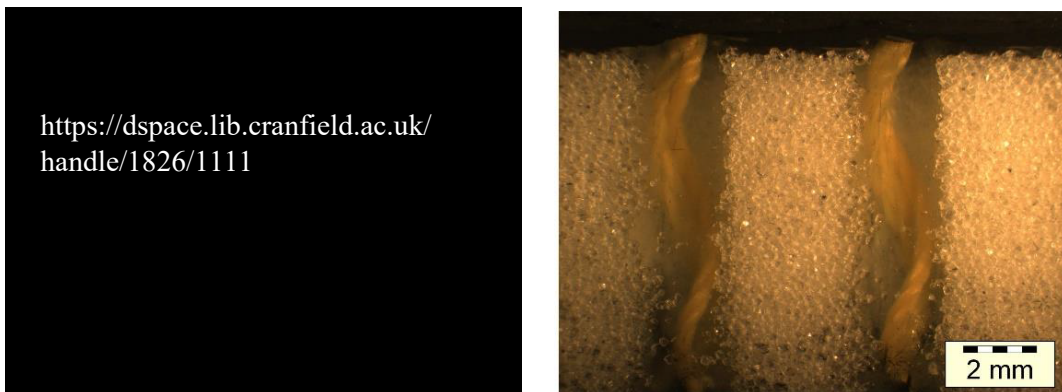
Figure 5-2: Differing reinforcement conditions within a foam core. Left: close fit between rigid pins and foam [84], Right: Substantial resin columns surrounding tufts.

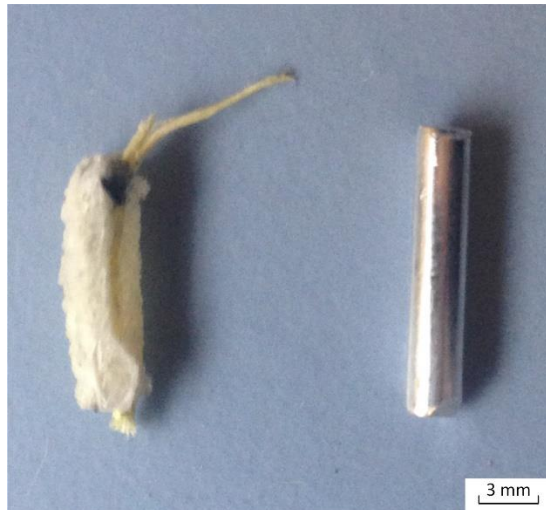
Figure 6-4: A comparison of a tufted resin column (left) and the steel pin used (right).

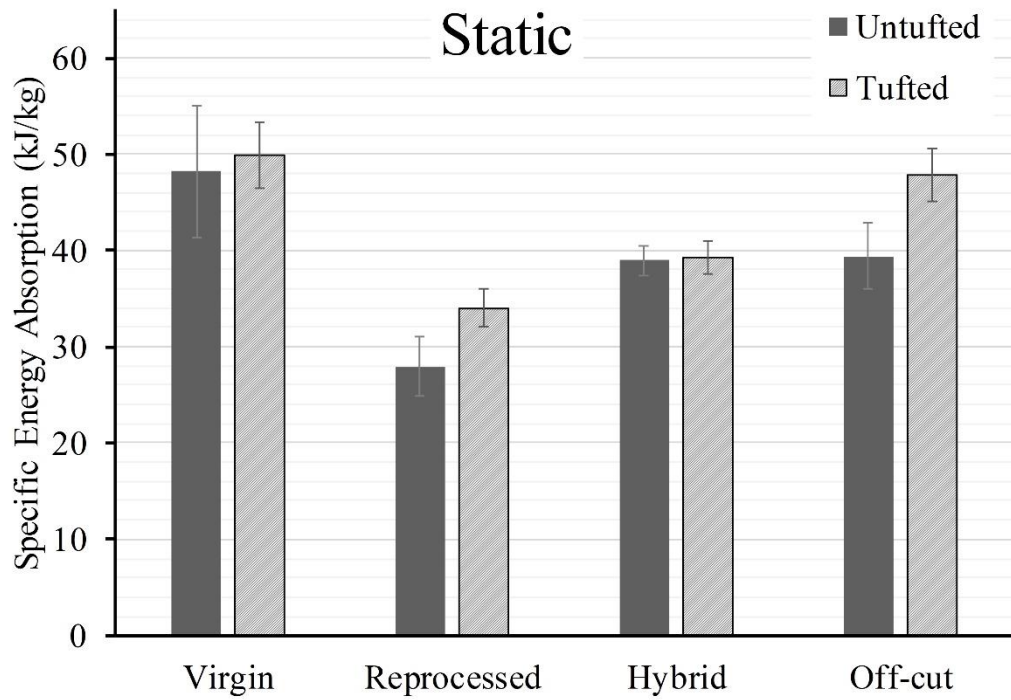
Figure 7-12: Averaged SEA results for static and dynamic tests.

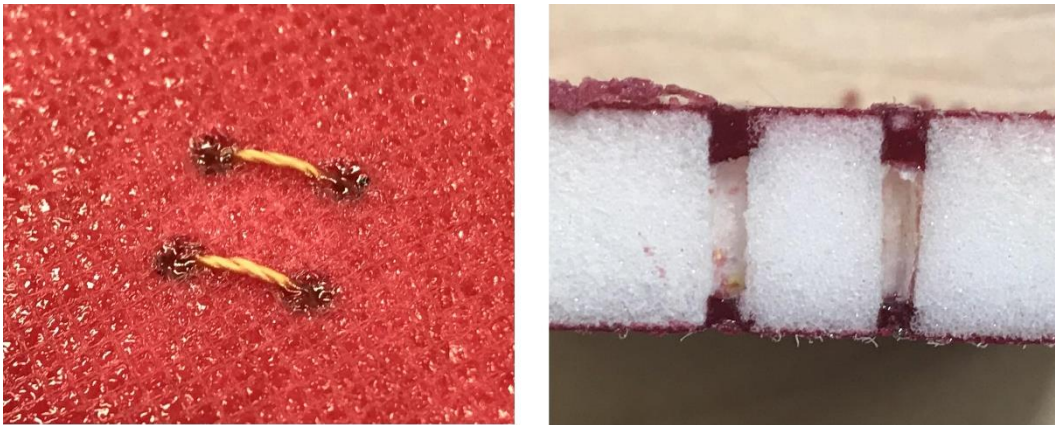
Figure 8-2: Example of lab-scale trials to ‘heal’ needle channel. Left, adhesive film sealing off tuft threads. Right, channel closed-off at top and bottom.

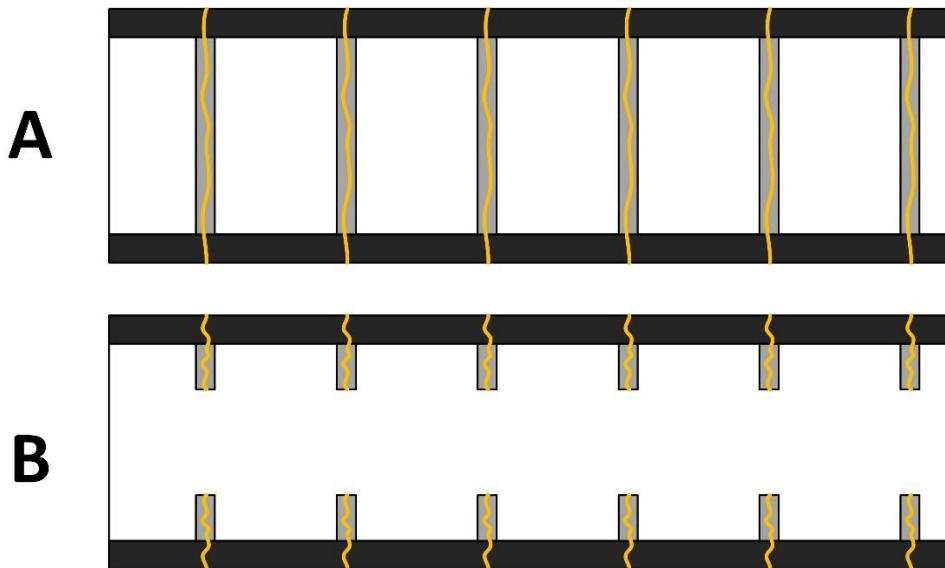
Figure 8-4: A proposed double-sided tufting method to reduce excess weight due to resin ingress. A) Traditional tufting method, B) Shortened tufts with insertion from both sides of the preform.
