Rebuilding the Architectural History of the Fort Vancouver Village

Meredith J. Mullaley

Master of Arts
in
Anthropology

Portland State University
©2011

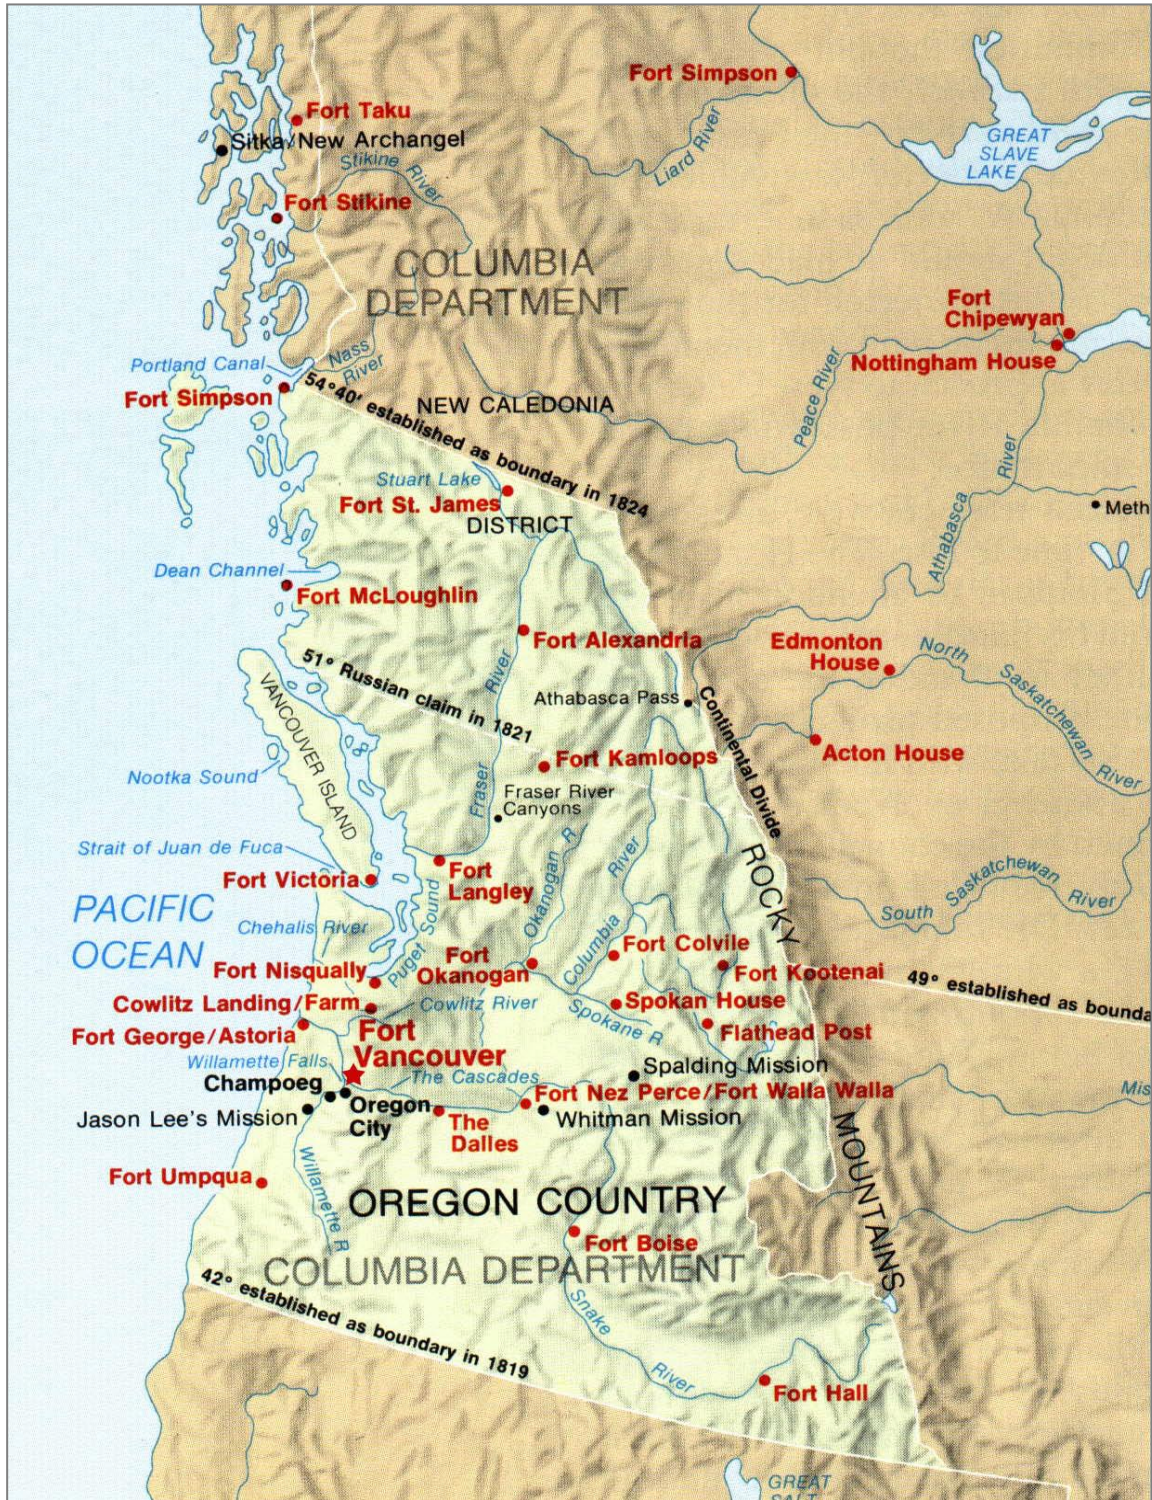
FIGURE 3. Hudson's Bay Company posts in the Columbia Department (yellow area) and other notable historic settlements and U.S. military posts. (Courtesy of Fort Vancouver National Historic Site.)

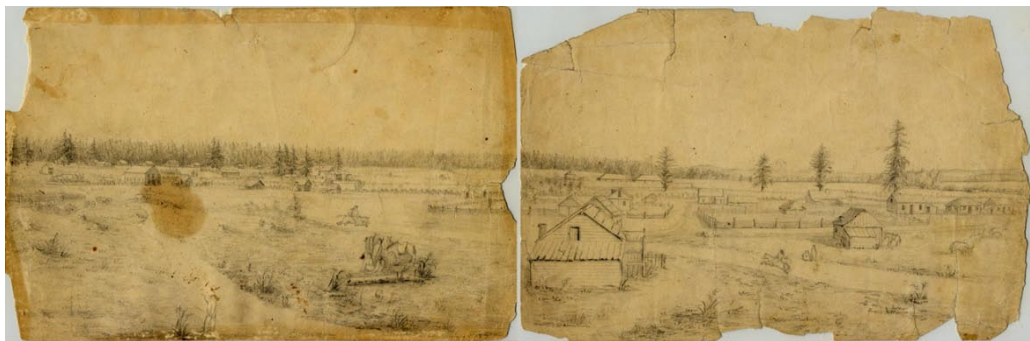
FIGURE 7a. Illustration of the Village by George Gibbs (1851), looking east, Stockade in distance. (Courtesy of Fort Vancouver National Historic Site.)

This description by Crate points to a few different construction methods and materials but also gives the impression that most were one-story high, one-room houses. If the illustrative record of the Village is accurate, many houses resemble the “Canadian style” wall construction. The variation Palmer spoke of might refer to differences in the types of hearths, roofing materials, and placement of structural elements like doors, windows, and side-sheds (Figures 7-9). The illustrative record is based on three circa-1850s drawings by George Gibbs (Figure 7a-c), Paul Kane (Figure 8), and Gustavus Sohon (Figure 9).

House 1 shares many similarities with a 1-½ story, side-gabled structure identified by NCRI staff as “House 1” in the 1851 George Gibbs illustration of the Village (Figures 7 and 37). This illustration was drawn near the end of House 1’s lifespan, likely after the modifications were completed. As an east-west oriented *pieux-en-terre* structure with *pièce-sur-pièce* walls and few windows, the House 1 interpretation is consistent with the illustration. (The alignment of House 1 was inferred based on the angle of the shed’s post features.) No shed is illustrated on the north wall, but it could be obscured by visual perspective. Nor does the illustration positively identify the roof type or the location of windows and doors on the other three walls. A fence appears to pass directly behind “House 1” in Gibbs’s drawing, giving weight to the interpretation a fence line to the east (Figure 34).

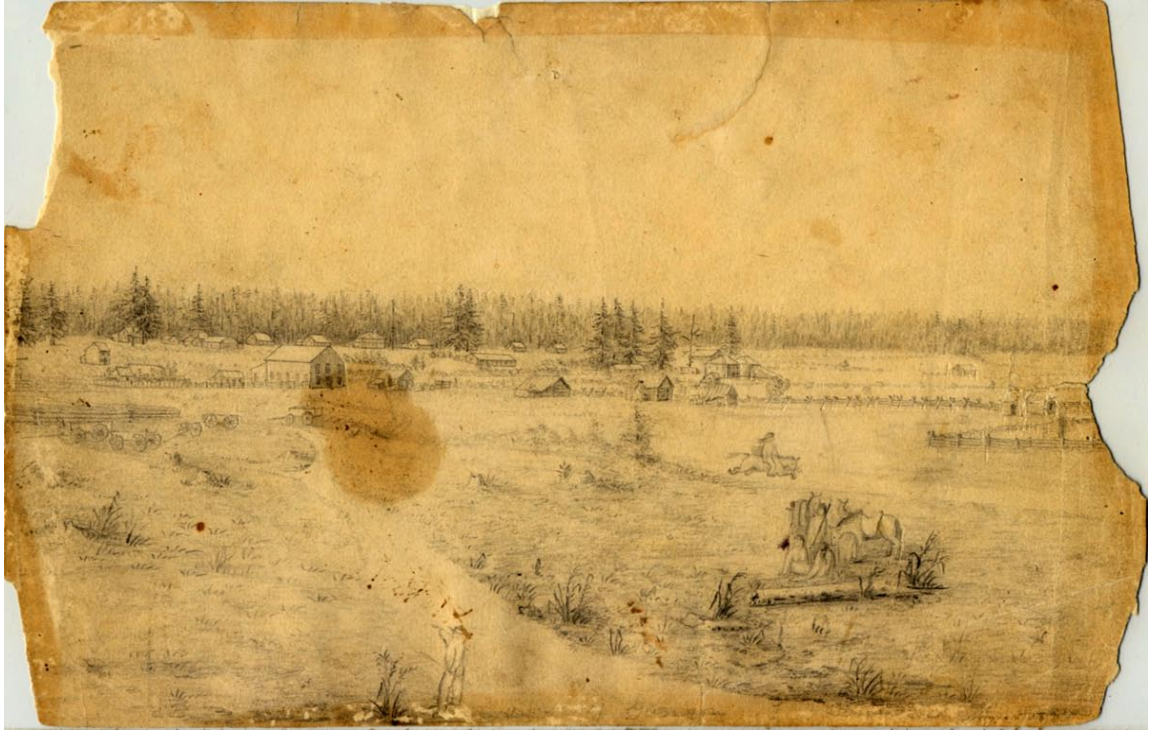
FIGURE 7b. Left half detail of the 1851 Gibbs sketch of the Village. (Courtesy of Fort Vancouver National Historic Site.)

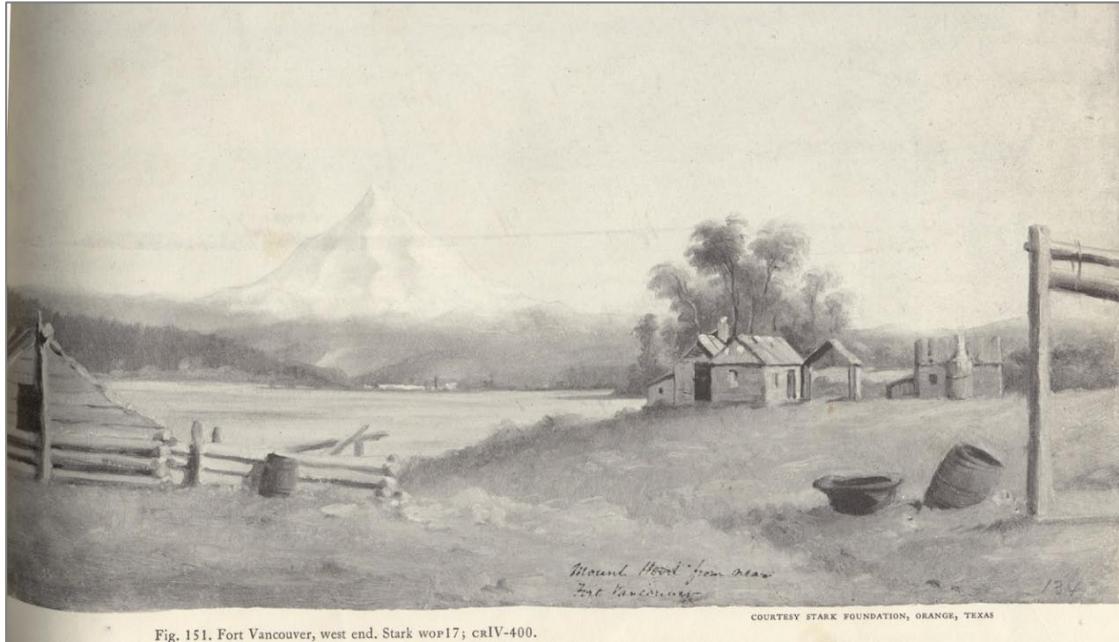
FIGURE 8. Paul Kane's sketch of the Village, looking east. (Courtesy of Fort Vancouver National Historic Site.)

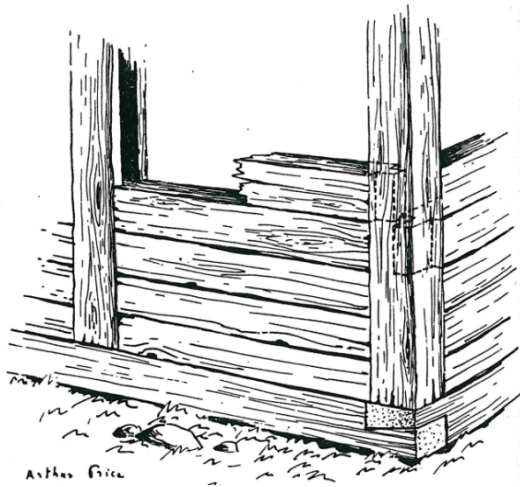
FIGURE 12. Examples of the *poteaux-sur-sole* construction style: (a) also shows the grooved wall construction method; (b) this structure is a reconstruction. In both examples, the wood sills lay directly on the ground surface, with upright wall posts placed at relatively even intervals (Barbeau 1945:10-11).

Poteaux-sur-sole (post on sill) construction refers to the wooden sills that support the vertical (upright) wall framing posts (Figure 12a,b). The *poteaux-sur-sole* structures in the Fort Vancouver stockade used wooden and brick footings to elevate the wooden sills, allowing for easier repair and replacement in the case of deterioration in the damp Pacific Northwest climate (Hussey 1957; Thomas and Hibbs 1984:46). This is consistent with French-Canadian and Métis structures from other regions that were commonly constructed using stone footings or foundations (Hébert 2007:28). The placement of wooden sills directly on the ground without an extra foundation layer is uncommon in the wider world of French-inspired architecture, but it appears to be the standard in the HBC employee communities, a decision made perhaps for the sake of time and efficiency. Louis Caywood’s (1955:10) excavation of multiple structures inside the Fort Vancouver stockade revealed wood footings (douglas fir) placed at 10 ft. intervals to support the

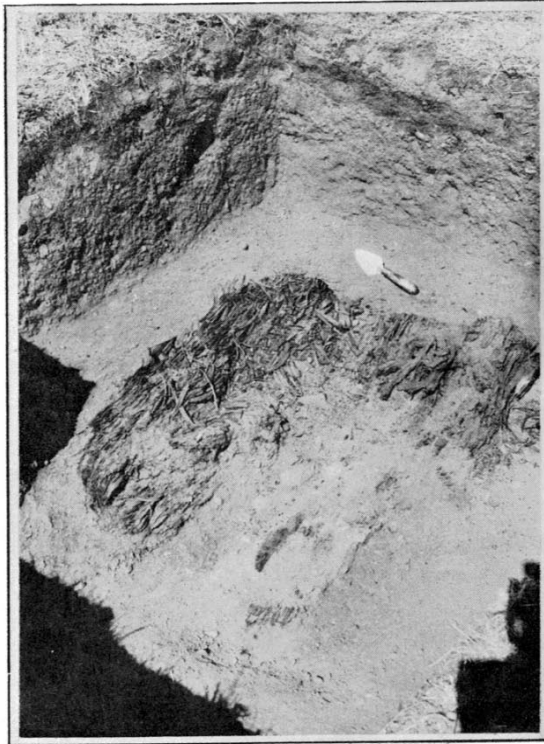
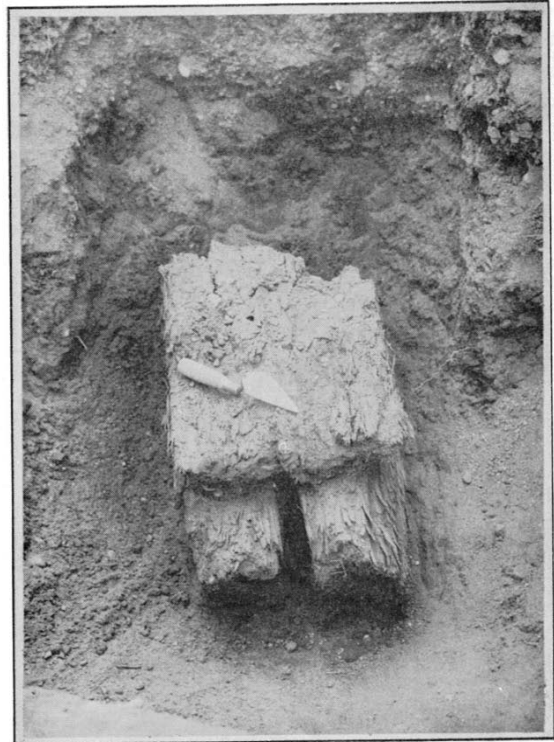
A. Typical slab footing found for most of the buildings.

B. Block footing found in northeast corner of Chief Factor's house.

FIGURE 13a. Photographs of Louis Caywood's 1952 excavations, showing two types of wood footings found in the stockade (Caywood 1955: Plate III).

foundation sills. The footings of the bakery (at Fort Vancouver) were approximately 76 x 30 cm (2.5 x 1 ft.) and 7.5 cm (3 in.) thick (Hoffman and Ross 1972:9). Figure 13a shows examples of the footings found by Caywood and Figure 13b shows the alignment of the bakery footings originally discovered by Caywood (1955:19) and mapped by Hoffman and Ross (1972:9). Three structures at the Fort Nisqually village were found with wooden sills placed directly on the ground, another two with the sills laid into trenches that were approximately 40-60 cm (16-24 in.) wide and 12-22 cm (5-9 in.) deep (Stilson 1991:18.10). These foundation sills measured 20-26 cm (8-10 in.) wide, but may have originally been as wide as 30 cm (12 in.) having “shrunk” from desiccation and deterioration in the ground.

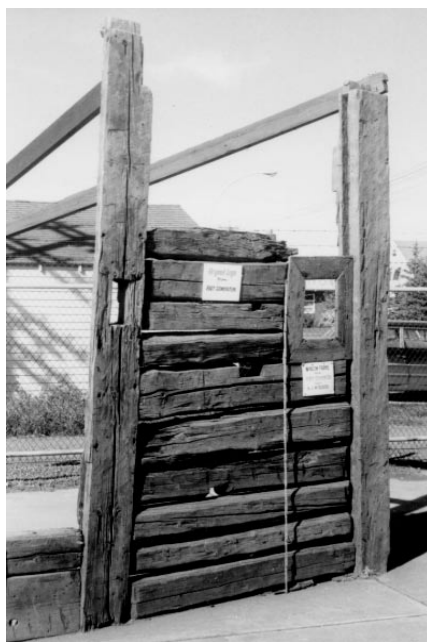
FIGURE 14. An example of a *pieux-en-terre* structure; a reconstruction from Fort Edmondton in Canada. This uses the same wall construction as *poteaux-sur-sole*, just lacking a sill support. (Courtesy of Fort Vancouver National Historic Site.)

Pieux-en-terre (pile in the ground) structures have no foundation or sill, but instead are built by setting the vertical wall framing posts into prepared holes or trenches (Figure 14). This method put the structure at greater risk for deterioration. *Pieux-en-terre* structures at Fort Vancouver differed from other regions, where round or unsquared timbers were placed side by side like a stockade wall and then insulated with chinking materials (Maygarden 2006:216; Hébert 2007:41,45). OP 14, excavated in 1980-1981, was interpreted as *pieux-en-terre* structure based on the rectangular arrangement of post features (Figure 15). Compared to the *poteaux-sur-sole* structures, this method was often used during “precarious economic times” in Canada, when an “expedient, low cost” structure outweighed the risk of deterioration (Hébert 2007:45). *Pieux-en-terre* structures may also have been the preferred construction style when the builders perceived theirs would be a short-term occupation. Earthfast construction was often considered “adequate” in the American South, where residents expected plantation crops to “play out” before their buildings deteriorated (Carson et al. 1981:141)

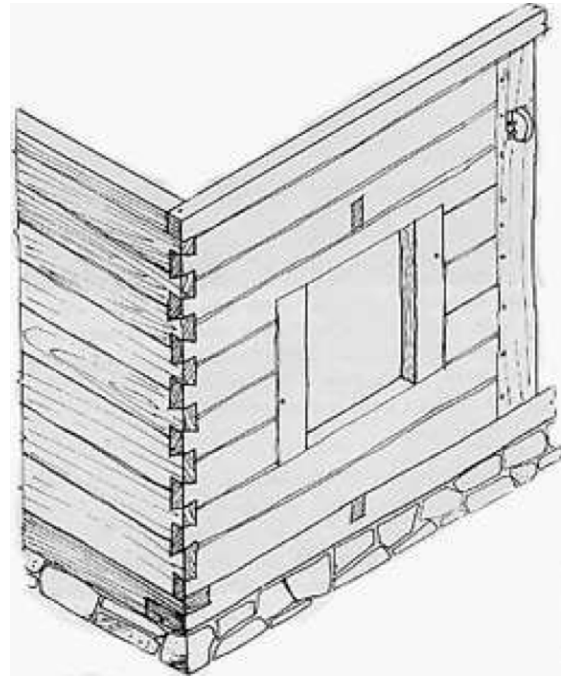
FIGURE 16. The *pièce-sur-pièce en queue d’aronde* wall style can be used with *poteaux-sur-sole* or *pieux-en-terre* foundations (Hébert 2007:40).

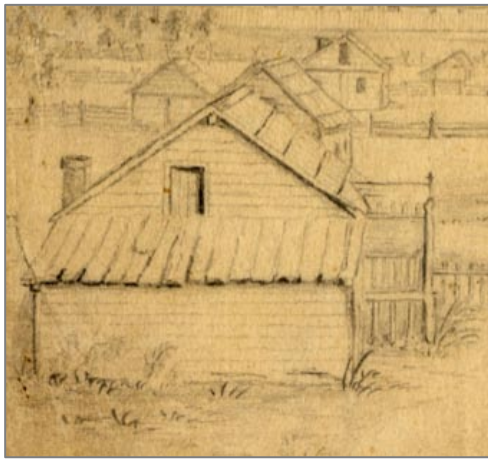
FIGURE 17. Detail of 1851 Gibbs drawing, showing a potential “balloon frame” shed attached to the side of this house, or at least what visitors may have thought was an “American style cottage” (Courtesy of Fort Vancouver National Historic Site.)

The “American cottage” style refers to another wall construction method and has no direct correlation with foundation type and wall construction. These “balloon frames” required more nails than their tongue-and-groove or log cabin counterparts because each board is nailed to the vertical framing posts (Chapman and Ozburn 2002:53). Presumably the upright wall posts would not be visible. The house in the foreground of Gibbs’s sketch includes a side shed with no visible vertical wall posts, just a wall of horizontal wood slabs or boards (Figure 17) (Thomas and Hibbs 1984:47). Balloon frame construction gained in popularity in the eastern United States in the 1830s, after mechanized sawmills and nail manufacturing lowered the cost of building materials

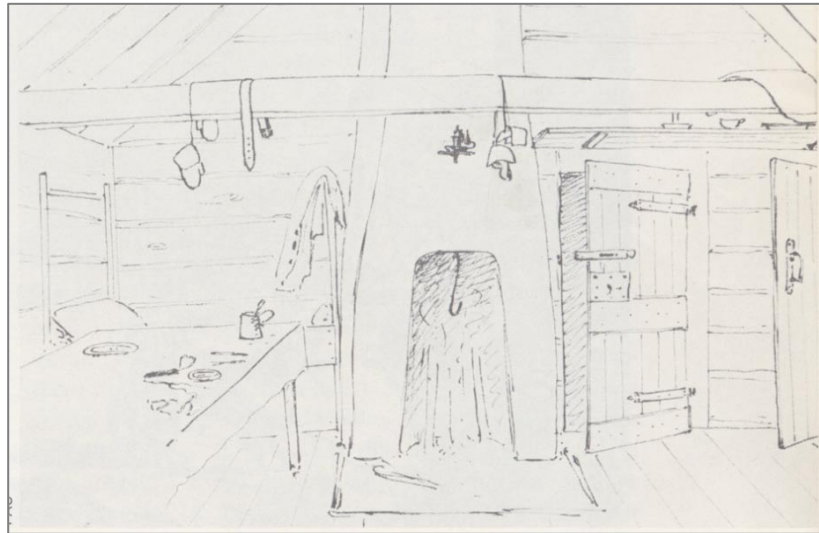
FIGURE 18. A sketch of a “Métis Interior” from Canada. Floorboards are drawn near the door, but the area around the hearth appears to without floorboards. Also note the rafter beam at the *top*. (Courtesy of Fort Vancouver National Historic Site.)

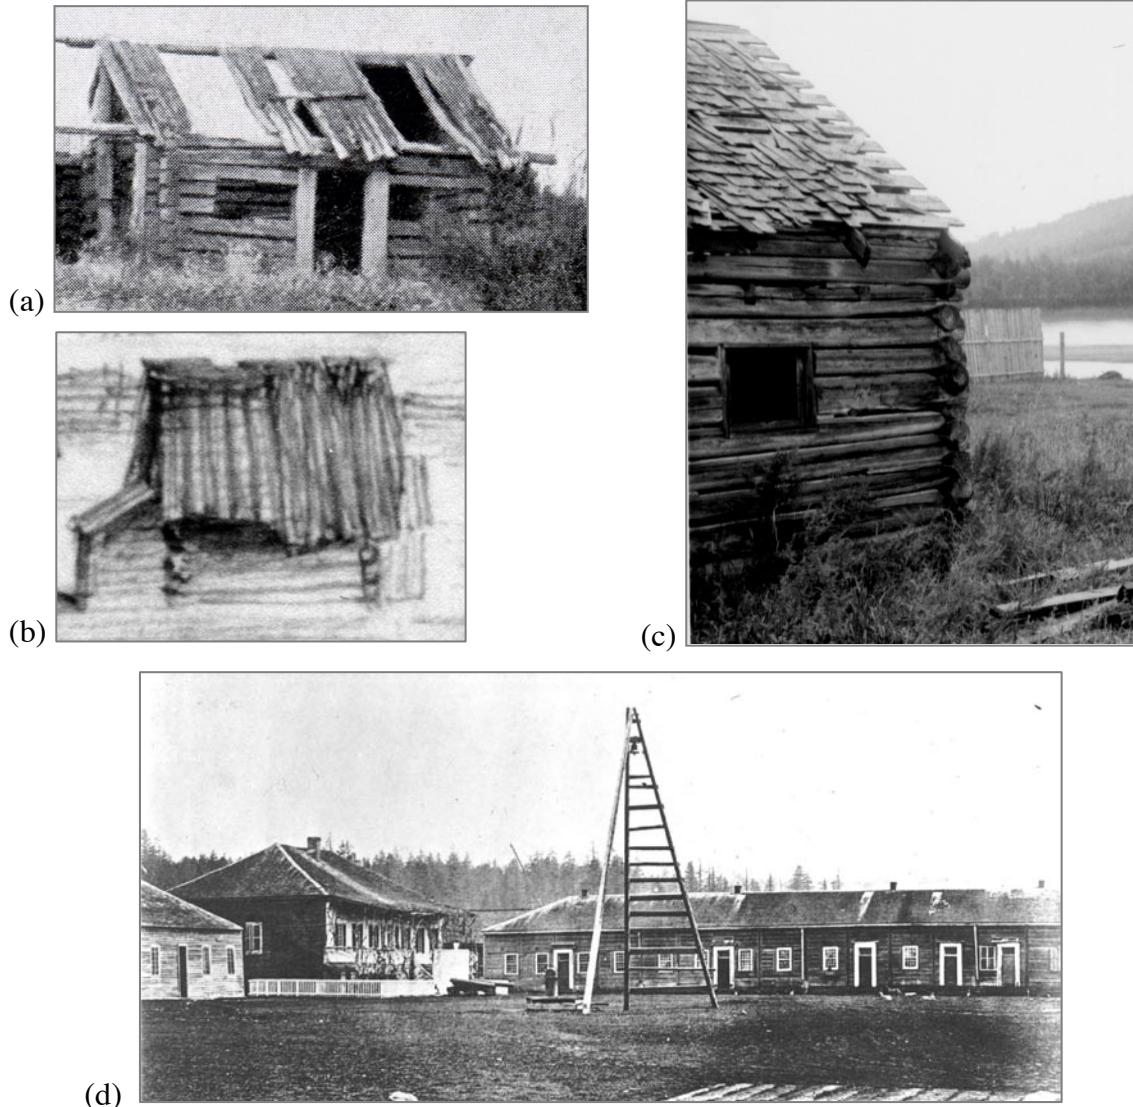
FIGURE 19. Roof examples: Some simple gable roofs were covered with long boards laid side by side, such as this (a) 1838 house from Fort Nascope (Barbeau 1945), and this (b) 1854 sketch Village house by Paul Kane. (c) shows a roof with smaller shingles from a cabin at Fort St. John. (d) shows hipped gables of Chief Factor's house and Bachelor's Quarters at Fort Vancouver. (Unless otherwise noted, images courtesy of Fort Vancouver National Historic Site).

Gibbs’s and Sohon’s sketches (Figures 7 and 9) show most Village structures with long boards laid side-by-side on the roof (Figure 19a-b). Within the stockade, rafters were fastened upon the top of the upright wall posts; presumably similar French-Canadian style houses built in the Village used the same roofing methods (Hussey 1957). During the 1820s and 1830s inside the Fort Vancouver Stockade roofs were simple gables covered with one-foot wide (30cm) sawed boards were the primary roofing material, but during the 1840s the sawed boards were replaced with shingles and shakes and the roofs on some of the important structures were changed to hip gables (Figure 19d) (Hussey 1957).

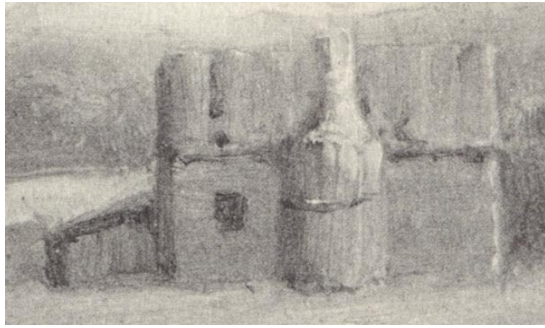
FIGURE 20. Chimney location: Some chimneys were placed on the exterior of Village structures (a) (Kane sketch), others inside the structure, appearing only through the roof (b) (Gibbs sketch). (Courtesy of Fort Vancouver National Historic Site.)

The hearth and chimney were likely centrally located on the exterior of the east wall, evidenced by the brick and rock concentrations (Feat. 2003-10) near to a bisque and charcoal concentration (Feat. 2002-12) on the east side of the study area. The widespread, low-density scatter of faunal remains did not aid in confirming the hearth location. The defining feature of House 3 during excavation was its brick and rock hearth remains, but the exterior of the chimney could have been constructed out of wood and clay, based on timbers strewn nearby, like those illustrated presented in Figures 20a and 21b.

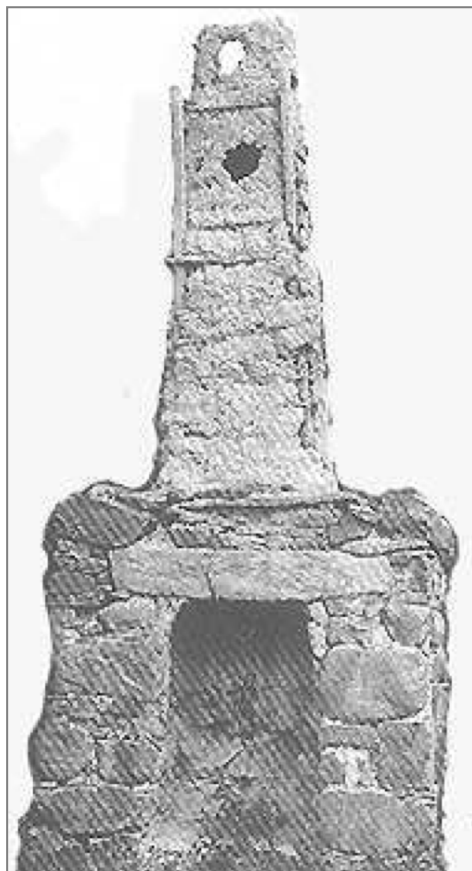
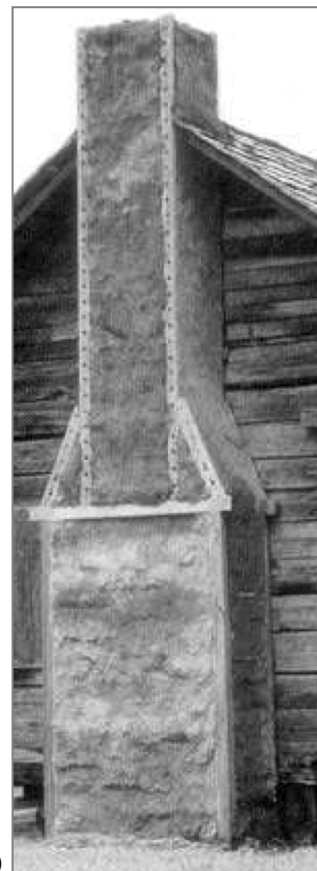
FIGURE 21. Hearth and chimney materials: Stone hearths and chimneys (a) were common in Canada, but clay and wood chimneys (b) were also reported in French Prairie (Hébert 2007:140-141).

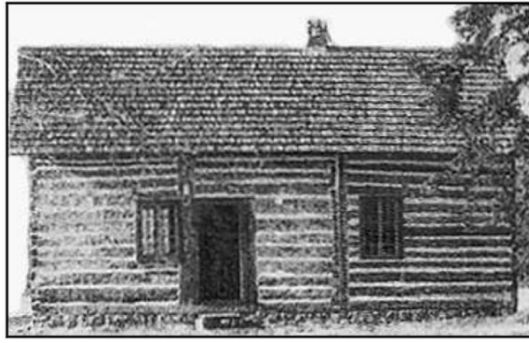
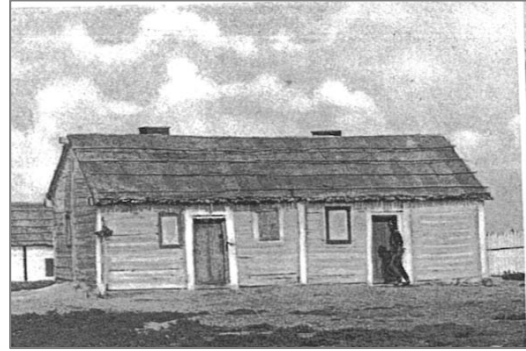
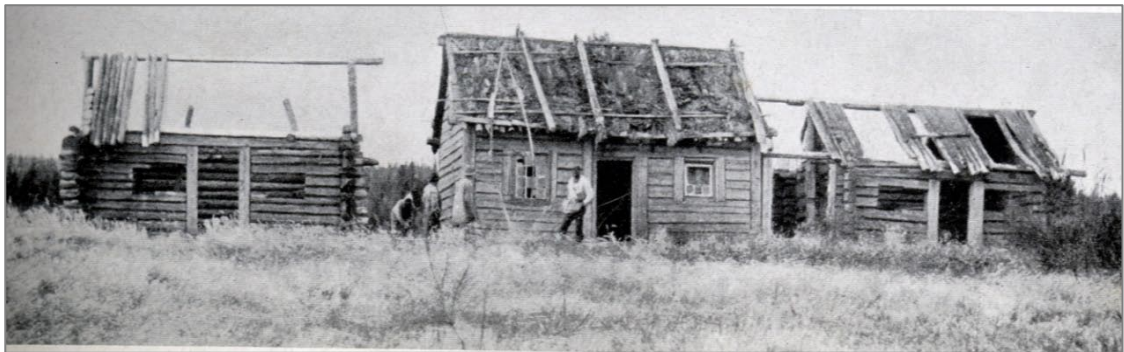
FIGURE 22. Windows and Doors. (a) 1805 house in Wisconsin (Hebert 2007:39), (b) Fort Good Hope, and (c) houses at Fort Nascopie, built in 1838 (Barbeau 1945:10)

Some Village structures were described as having “glazed windows” and “hinged doors” (BAJC 1865). Windows and doors were often placed next to a *coulisse* (upright wall post) and gaps would be made in the walls of horizontal timbers (Figures 22a-c) (Ross 1976:1346; Hébert 2007:57). To frame the door, a second upright *coulisse* would be placed two or three feet away from the primary support *coulisse*.

The location of a window is based only on the distribution of window glass and window-related hardware, such as latches or thin finishing nails. An area with a high concentration of large window glass fragments is a likely candidate for a window’s location (Willis 2008:21). Windows in the 1840s and 1850s were made of multiple panes, each 7 x 9 in. or 8 x 10 in. (Figure 10b) (Ross 1976:1346; Stilson 1990:32). There are some theories (Chance et al. 1982:307; Stilson 1991:18.14) that window glass was a luxury item and relative window density may indicate opulence. In other francophone communities, leather and oiled paper were used instead of window glass (Hébert 2007:60). Figure 22 shows additional examples of windows and doors from Canada.

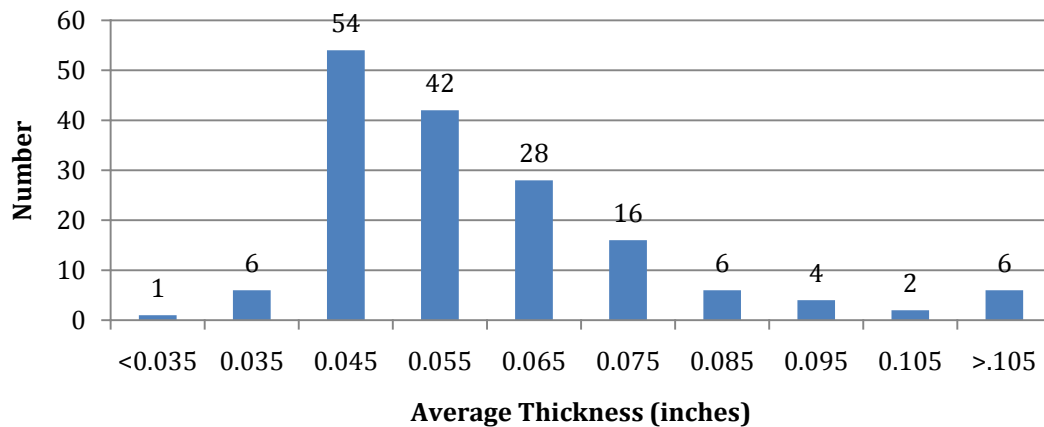
FIGURE 28: Overall flat glass average thickness for House 1. (Chart by author, 2011)

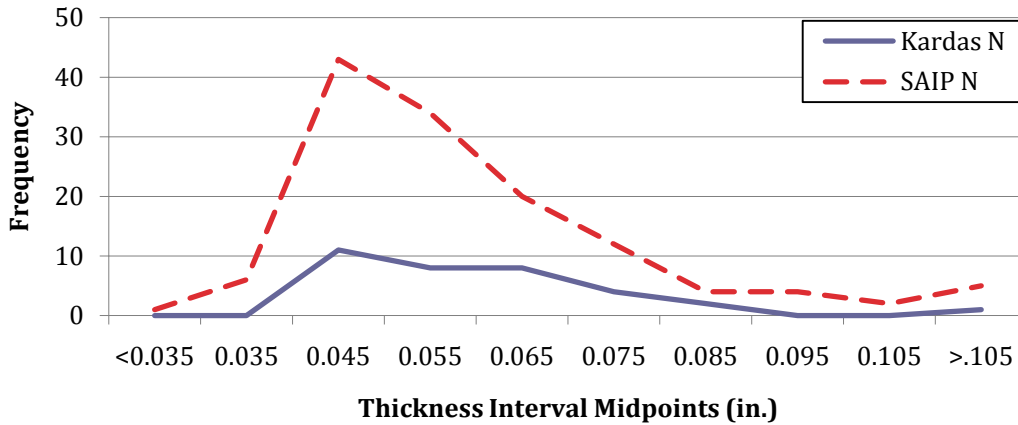
FIGURE 29: Comparing glass thickness modes by excavation. (Chart by author, 2011)

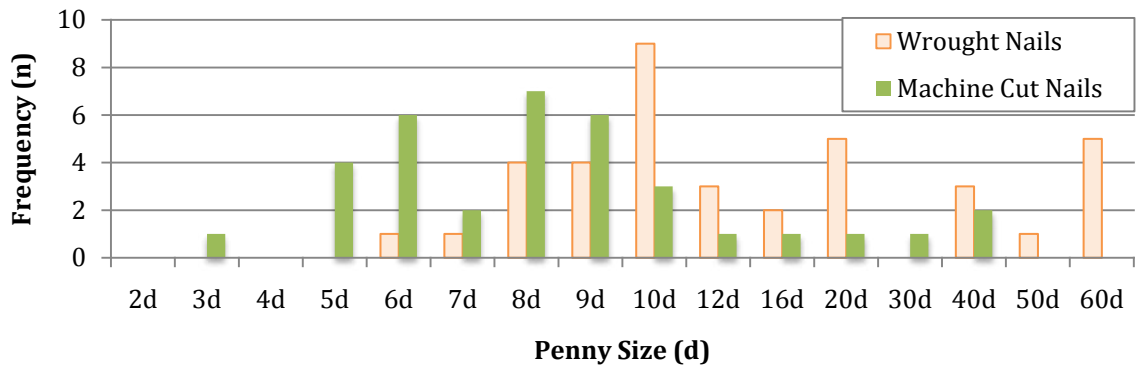
FIGURE 35. Penny size (d) distribution of wrought and machine cut nails from the House 1 assemblage (Chart by author, 2011).

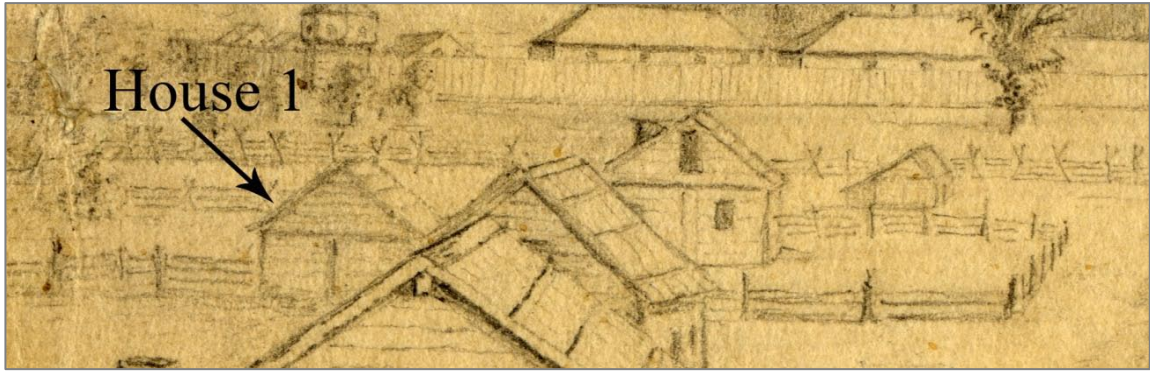
FIGURE 37. “House 1” as drawn by George Gibbs (detail of full 1851 illustration) (Courtesy of Fort Vancouver National Historic Site).

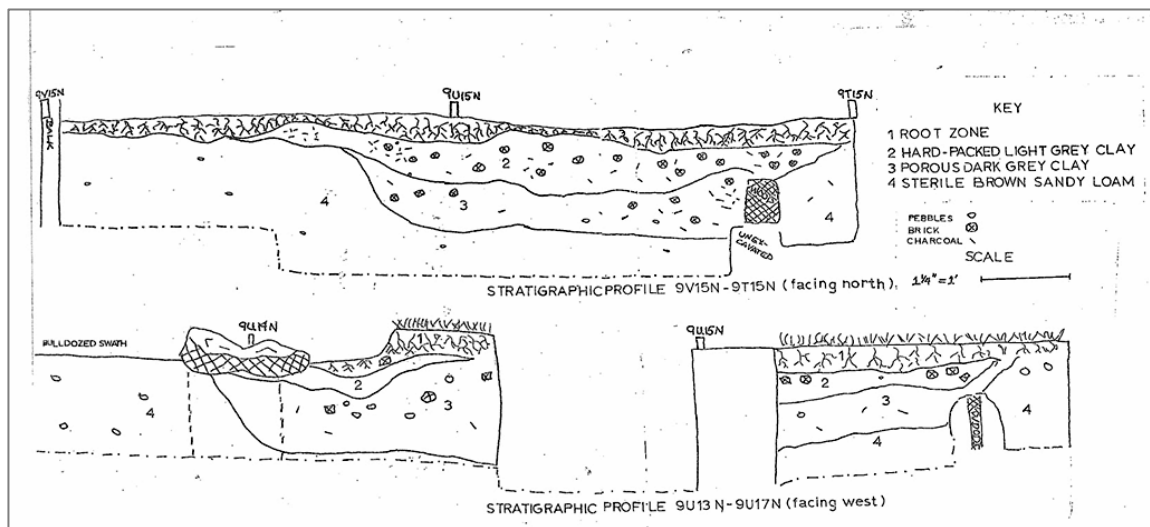
FIGURE 38. Stratigraphic profiles of select House 2 units (Kardas 1970:32-33).

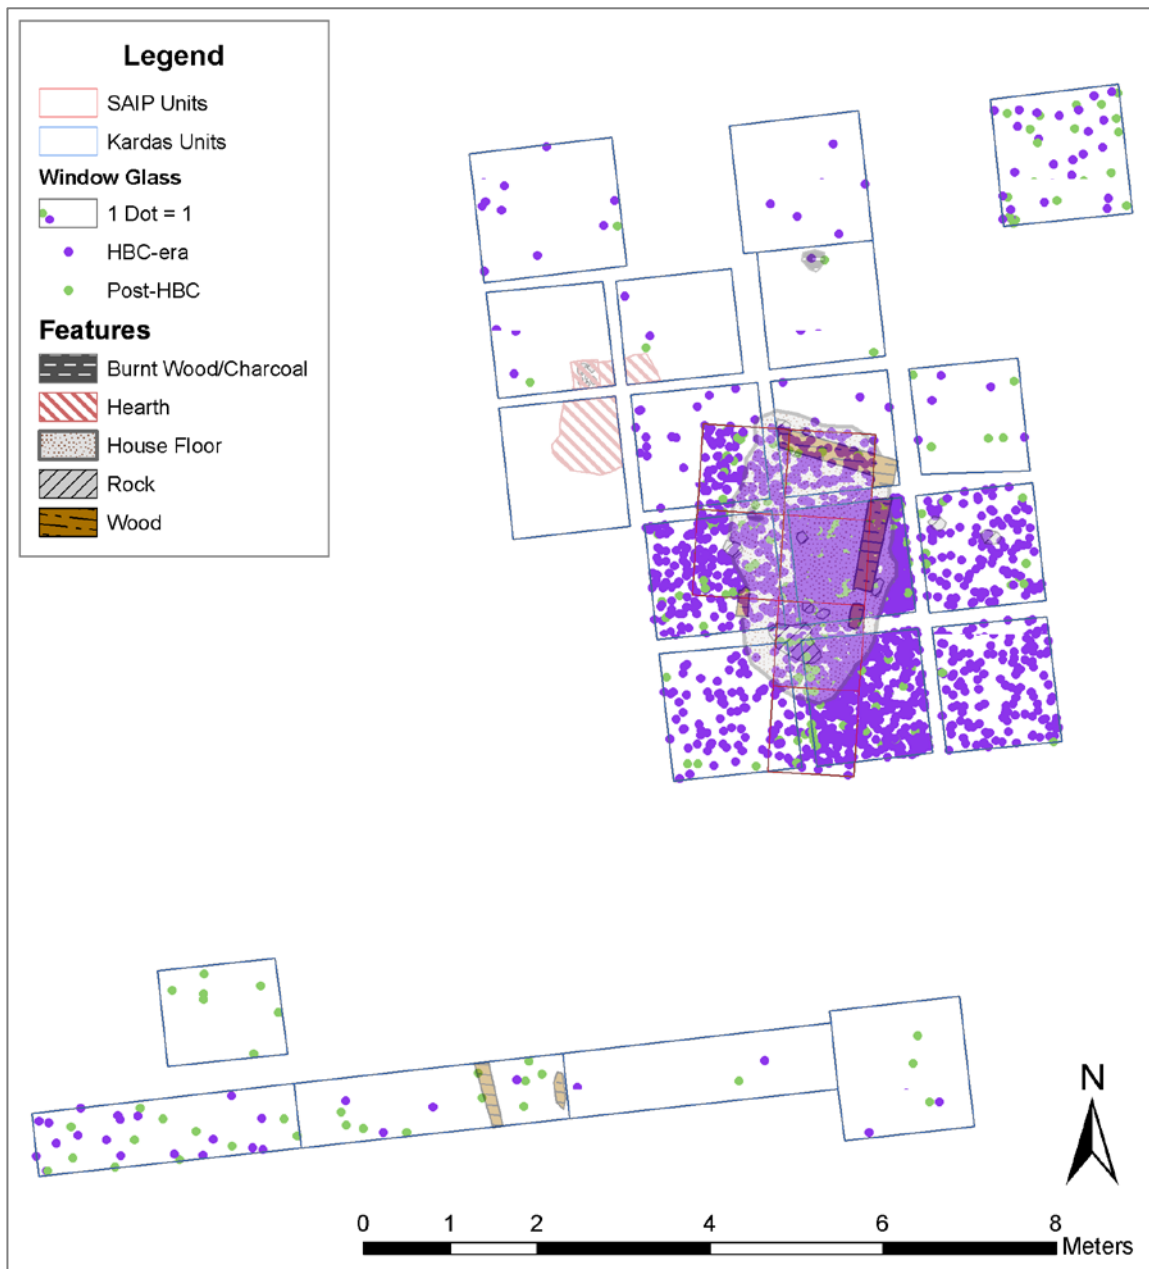
FIGURE 41. Window glass distribution in House 2 Study Area, showing HBC-era glass (purple) and post-HBC-era glass (green) (Map by author, 2011).

Window Glass. In total, 2888 window glass fragments were recovered from the House 2 study area (Figure 41). Such great quantities were recovered that the archaeologists did not list the total count of the House 2 window glass in the 1969 excavation report (Kardas 1970).

House 2 window glass thicknesses ranged from 0.062 mm (0.024 in.) to 3.34 mm (0.131 in.). For both the 1969 and SAIP assemblages, the overall primary thickness mode was 0.055 inches (1969 n=758; SAIP n=224), which correlates to the 1834-1845 date range (Figures 42 and 43) (Roenke 1982). The secondary mode is 0.065 inches, which dates to 1840-1850. Even though post-HBC window glass was present across the entire study area, HBC-era window glass dominated the units east and north of the house floor

(Figure 41). Post-HBC window glass outnumbered HBC-era window glass only in a few south wall and far northern units.

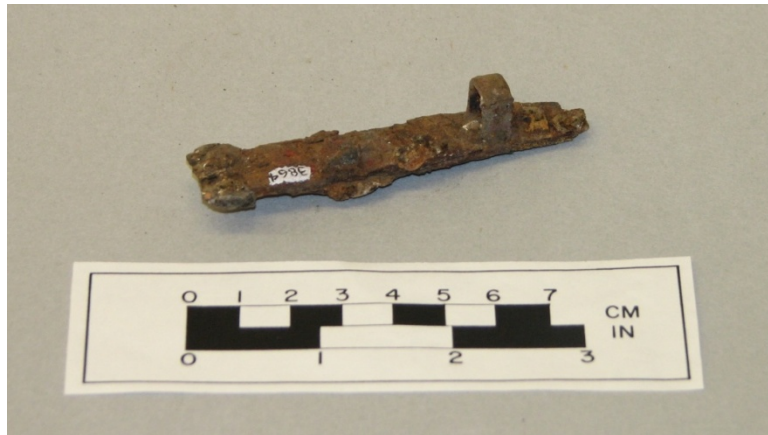
FIGURE 46. “Mortised lock fragment” Cat. No. 3864 (Photo by author, 2011).

Hardware. Three door- or window-related hardware artifacts were associated with House 2: two lock parts and one latch part (Figures 46-48). These are located near the

timber sills. The two lock parts were recovered units 9T14N-9T15N, 9T14N-9T16N. The latch part was collected from unit 9S15N-9S16N. The smaller of the mortised lock parts (fragmented, Catalog No. 3864) may have been for a window. No hinges or doorknobs were reported near House 2.

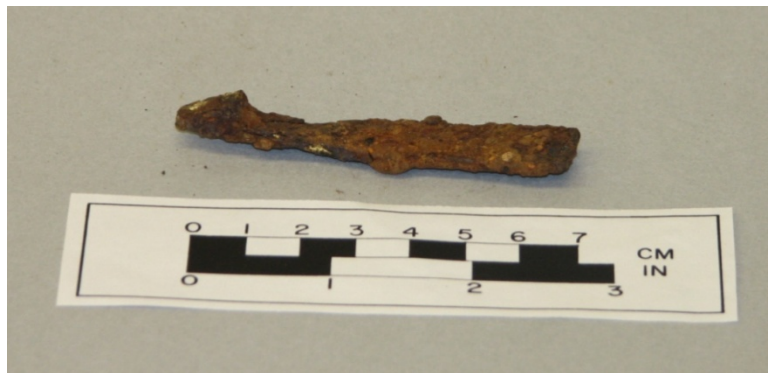
FIGURE 47. Cat. No. 4860 “Latch Part” fragment (Photo by author, 2011).

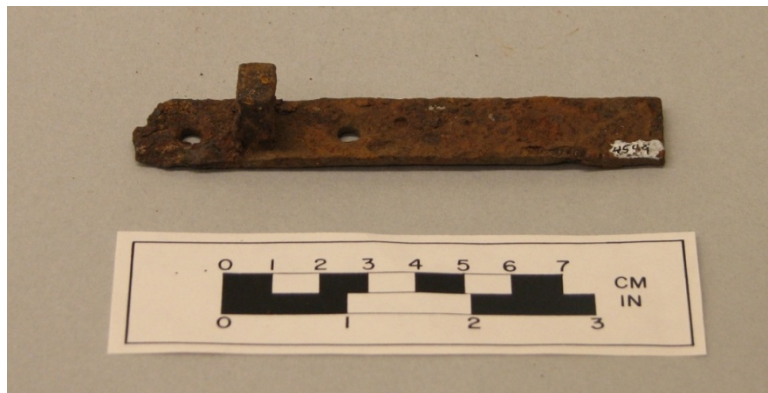
FIGURE 48. Cat. No. 157057 “mortised lock part” fragment (Photo by author, 2011).

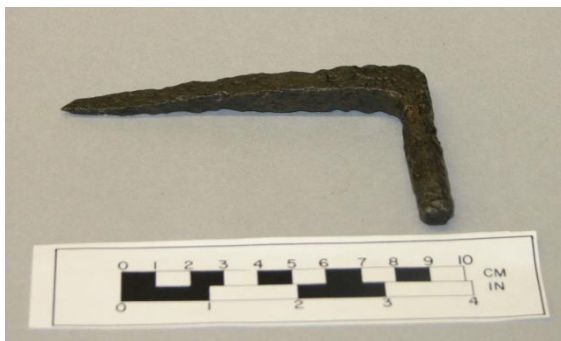
FIGURE 63a: Pintle hinge, Cat. no. 3611 (Photo by author, 2011).

Hardware. Five architectural hardware objects were collected from the House 3 study area in 1969, including two wrought iron hinge pintles, one door hook, a wrought key escutcheon, and a cupreous key and socket cock (Figures 63a-b and 64a-b). The last object may not be explicitly structural; perhaps it is more suitable for a chest or box. The broken hinge pintle (cat. no. 3319) was found in the East-West Trench, 20-21' in 1968. The other hinge pintle and the door hook were found in M4N-M5N, one of the units containing the Wood Lined Pit. These artifacts could (potentially) have served as hardware for a cellar door. Finally the key escutcheon and key cock and socket were recovered above the gray clay sediment layer in H3N-H4N and J3N-J4N, respectively.

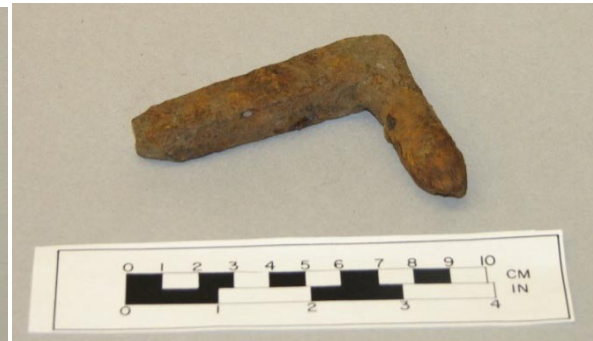
FIGURE 63b: Hinge pin[tile], Cat. no. 3319 (Photo by author, 2011).

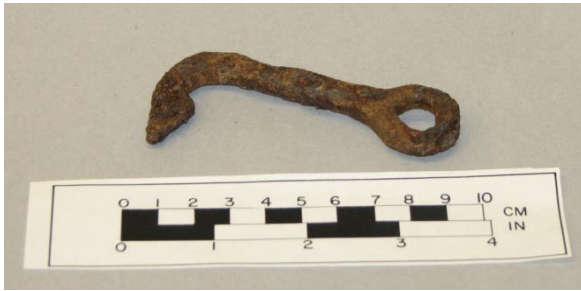
FIGURE 64a. Door hook, Cat. no. 3580
(Photo by author, 2011).

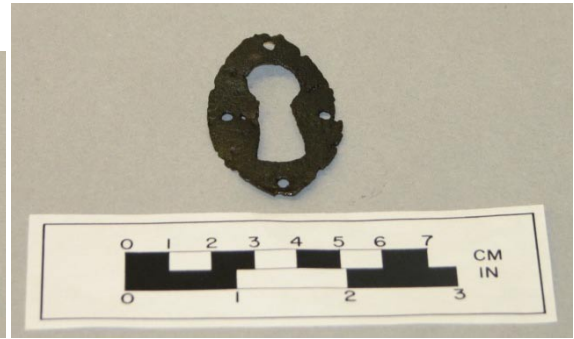
FIGURE 64b. Key escutcheon, Cat. no. 3544
(Photo by author, 2011).

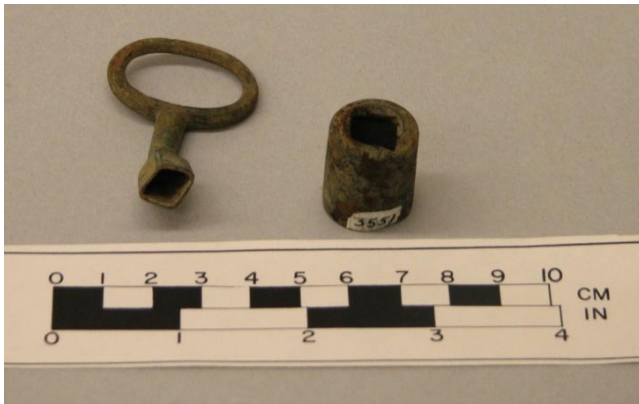
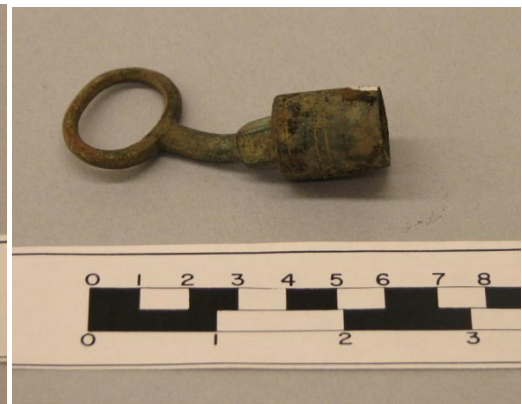
FIGURE 65. Key and socket cock, Cat. no. 3551. Cupreous socket has 3 incised lines around circumference (*right*) (Photos by author, 2011).

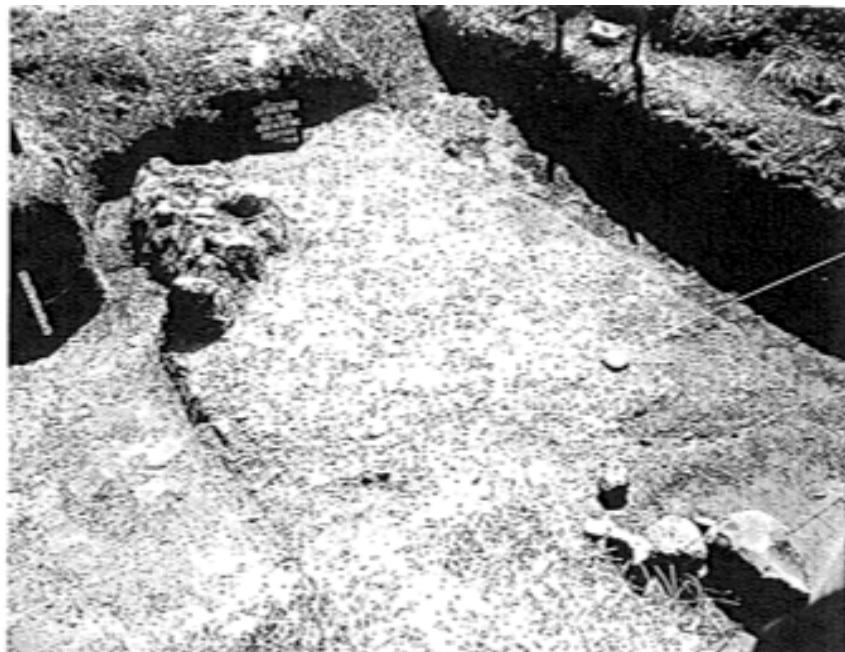
FIGURE 71: House 4 after excavation, showing clay floor and feature H4-02 in the center and H4-03 in the lower right, view to the southeast (Kardas 1970:66).

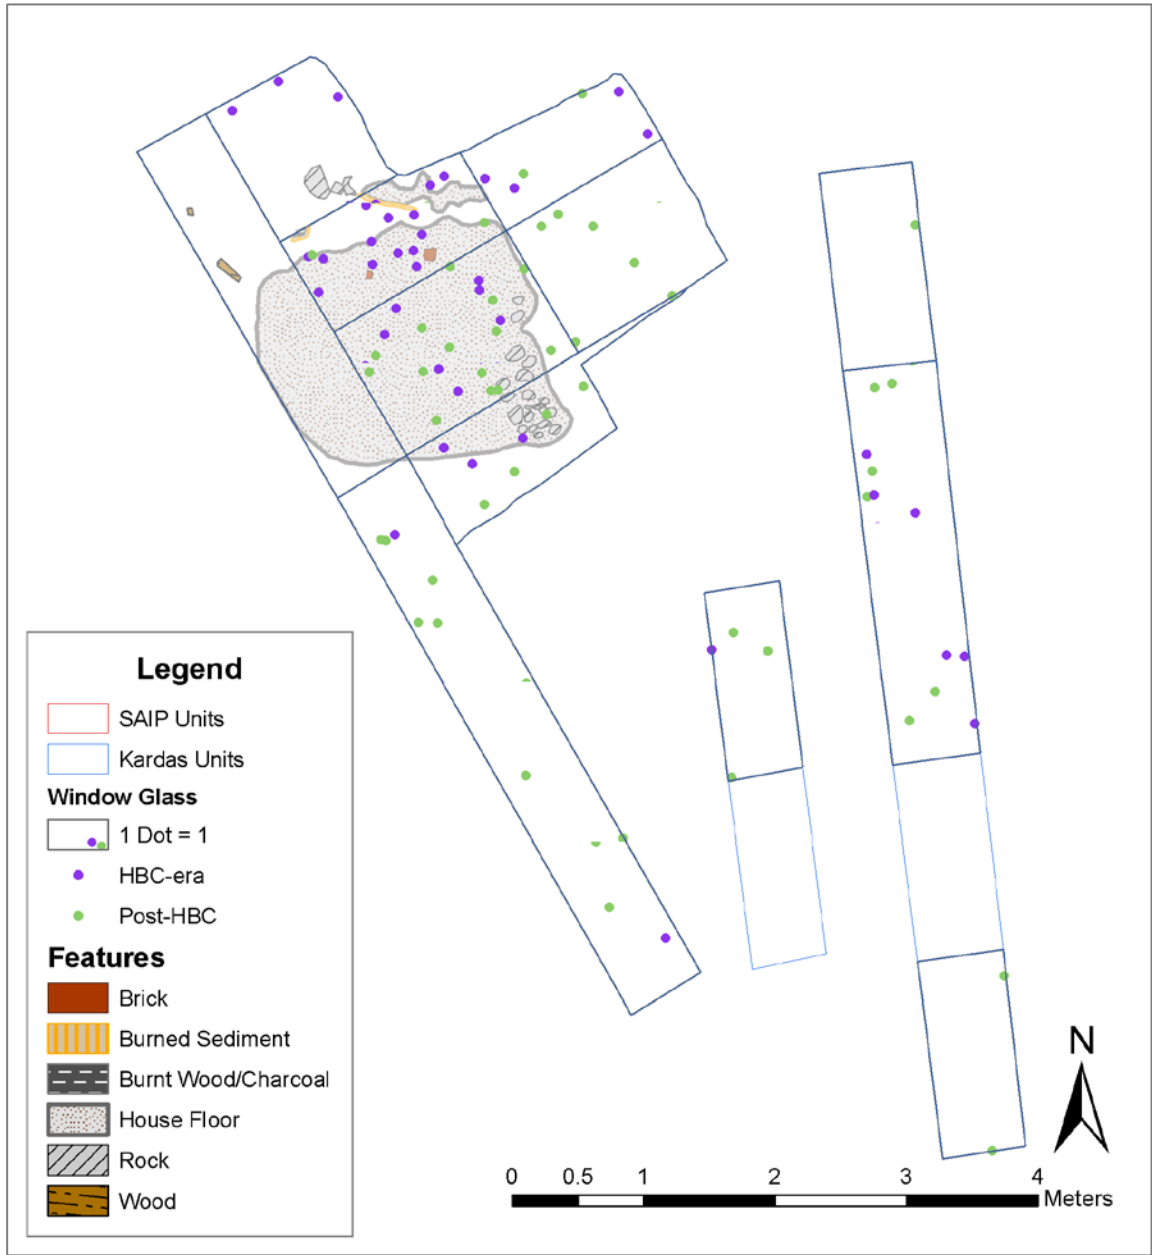
FIGURE 74. Window glass distribution in House 4 Study Area (Map by author, 2011)

The primary mode (0.085 in.) technically dates between 1855 and 1880, but for the most part glass of this thickness was imported and used by the U.S. Army, not the HBC. Within full the study area, 70% of the post-HBC era window glass (1860-1900) was concentrated in the southern and eastern units although a few of these later fragments were collected from the eastern edge of the house floor. The window glass associated with the HBC occupation (0.035-0.065 in.) is found predominately in the northern and western units, around the House 4 features (Figure 74). Although there is some early (pre-1830s) window glass, the House 4 feature area is equally dominated by 0.055 in. (n=15) and 0.045 in. (n=14) window glass (Figure 75). No unit had more than 4 fragments of any thickness interval.

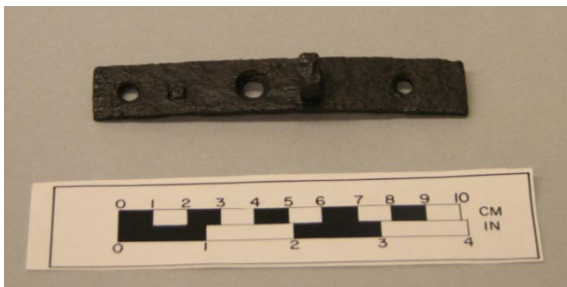
FIGURE 77a. Latch plate, (Cat no. 3694)
(Photo by author, 2011).

Hardware. Two architectural hardware artifacts were recovered from the House 4 area: a latch plate (Figure 77a) and a pintle hinge (Figure 77b). The pintle hinge, potentially suggestive of a door, was found in unit 34S 0-5. The latch plate (also door related) was found in DT 45-60, which was 4.5 m (15 ft.) long, so the exact location of the latch plate is not clear.

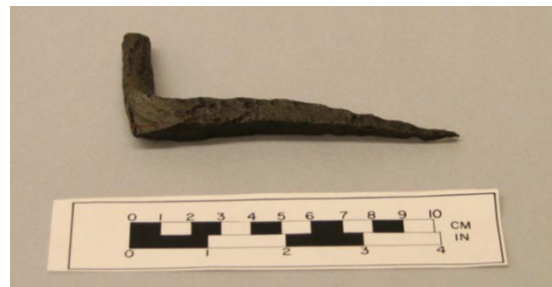
FIGURE 77b. Pintle Hinge, (Cat no. 3648)
(Photo by author, 2011).

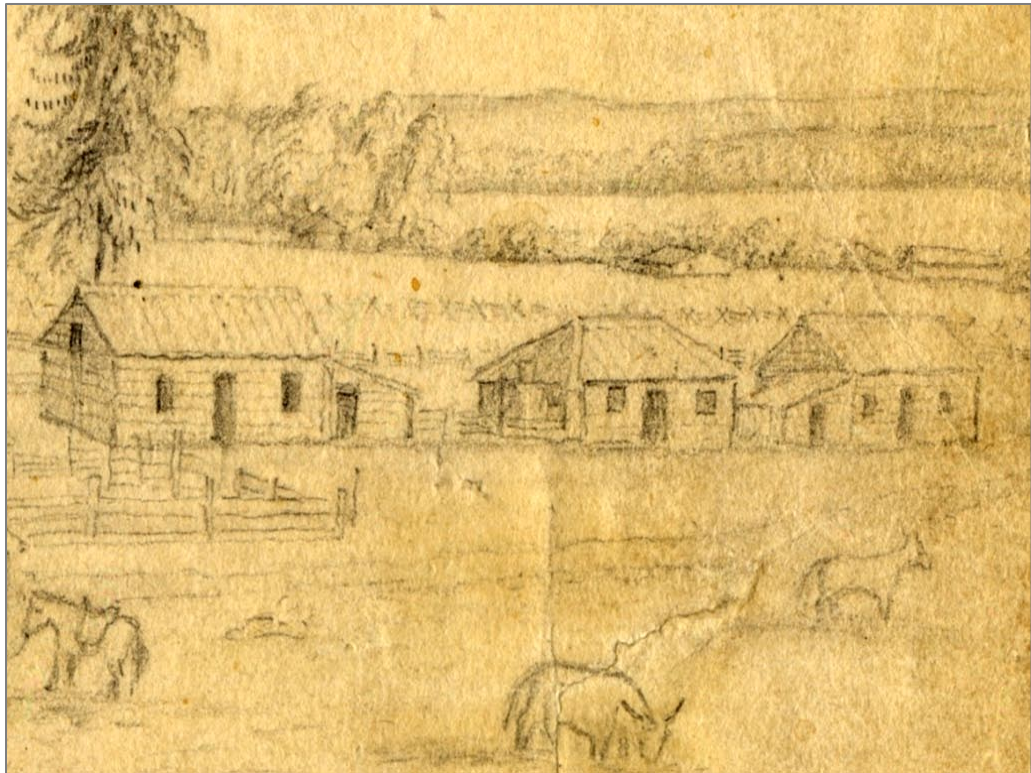
FIGURE 80. Houses shown in the inferred vicinity of House 4, as depicted in a portion of Gibbs's 1851 sketch (Courtesy of Fort Vancouver National Historic Site).

Based on the window glass-derived construction and demolition dates, it seems unlikely that House 4 was standing when Gibbs drew the Village in 1851, yet there is a cluster of structures where House 4 would be expected at the right side of the drawing (Figure 80). These structures likely represent the additional structures in the House 4 vicinity inferred based on artifact densities greater and more widespread than expected from a single house (Thomas 1994; Lynch 2009). Not enough architectural details are known about House 4 from the archaeology to determine if House 4 was represented in the sketch. The middle structure has a hipped gable roof, which became common within the stockade by 1846, possibly suggesting this middle structure was built around 1845.
