Rebuilding the Architectural History of the Fort Vancouver Village

Meredith J. Mullaley

Master of Arts
in
Anthropology

Portland State University
©2011

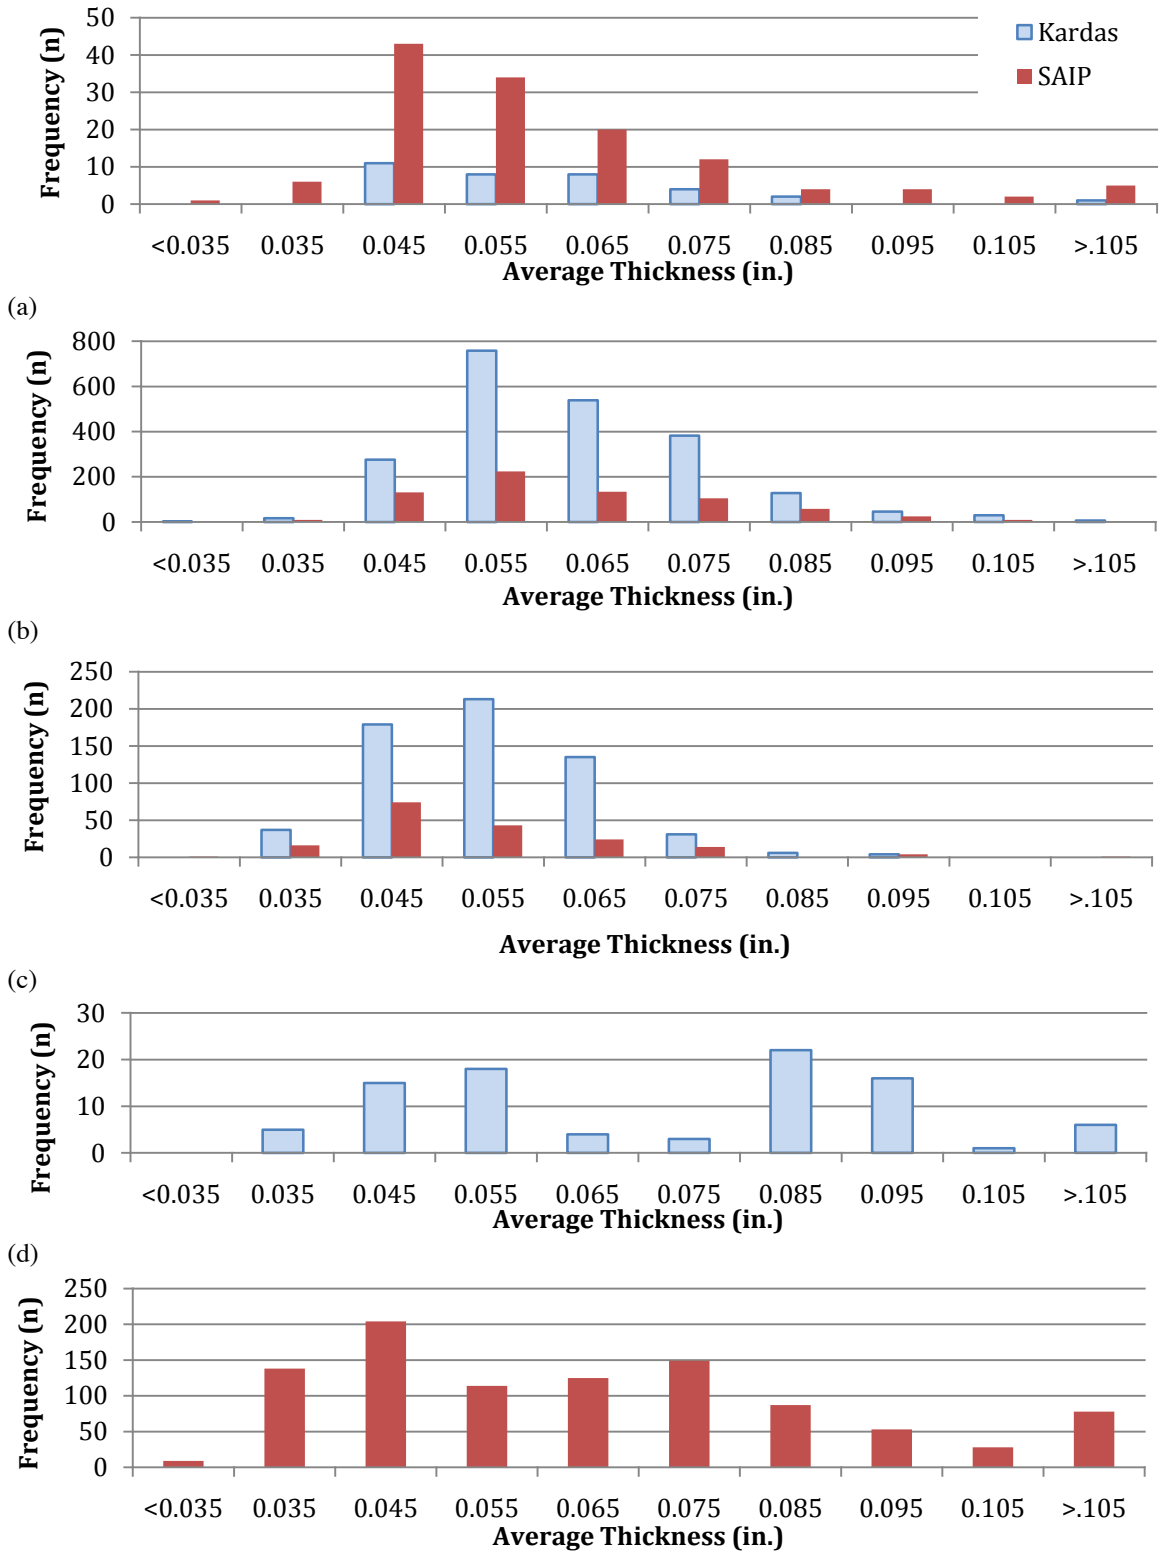
(e) FIGURE 92. Comparison of the window glass thickness distributions recovered from study areas of House 1 (a), House 2 (b), House 3 (c), House 4 (d), and House 5 (e), separated by excavation (Charts by author, 2011)

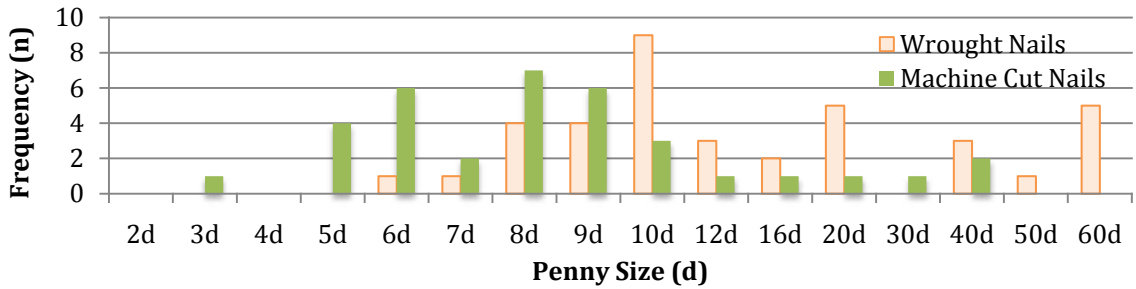
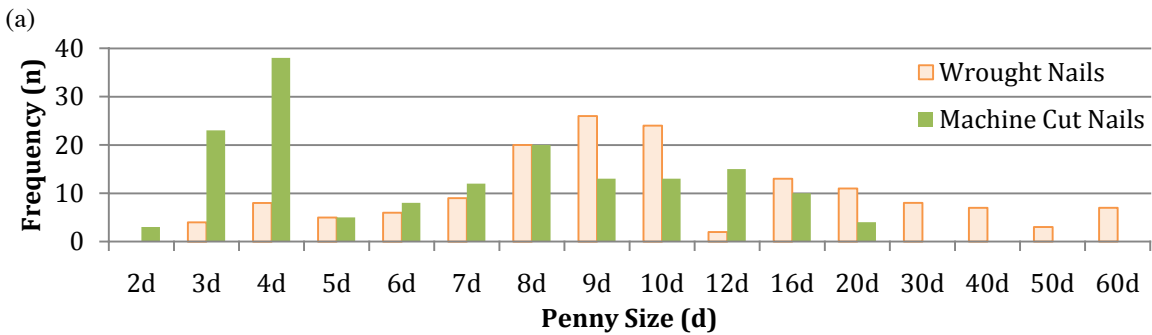
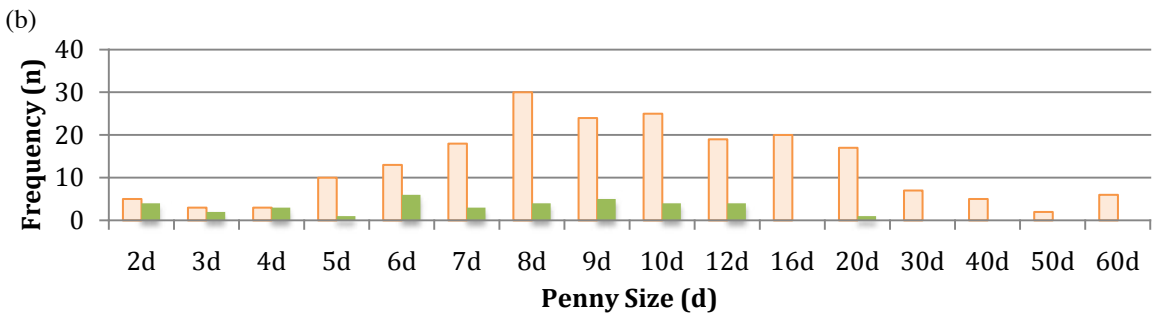
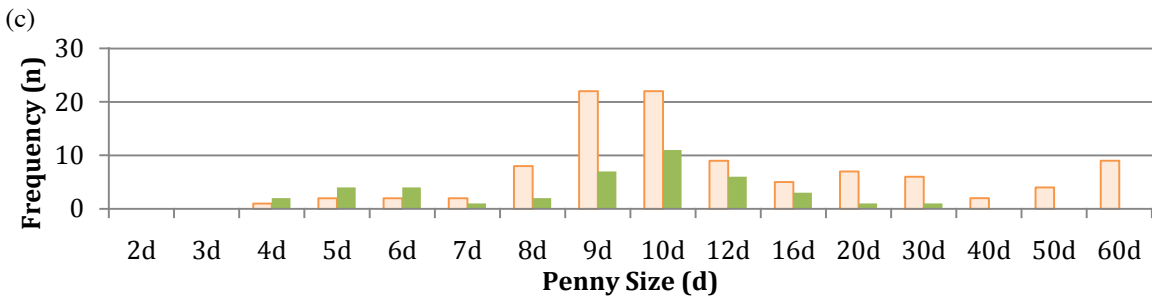
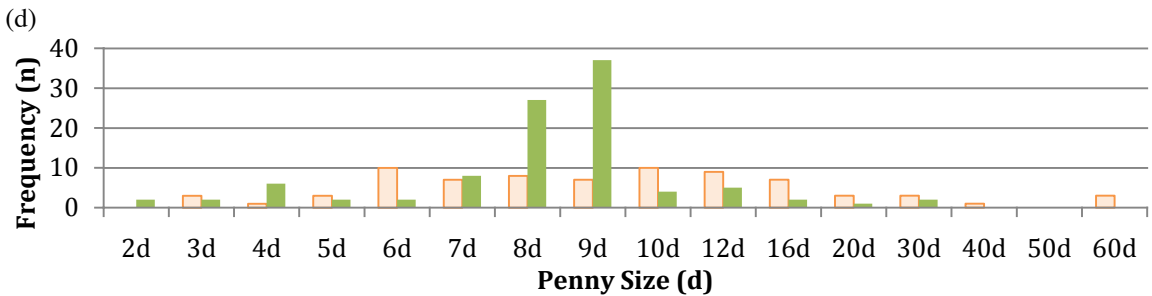
(e) FIGURE 93. Comparison of the nail penny size distributions recovered from study area of House 1 (a), House 2 (b), House 3 (c), House 4 (d), and House 5 (e), separated by manufacture type (Charts by author, 2011).

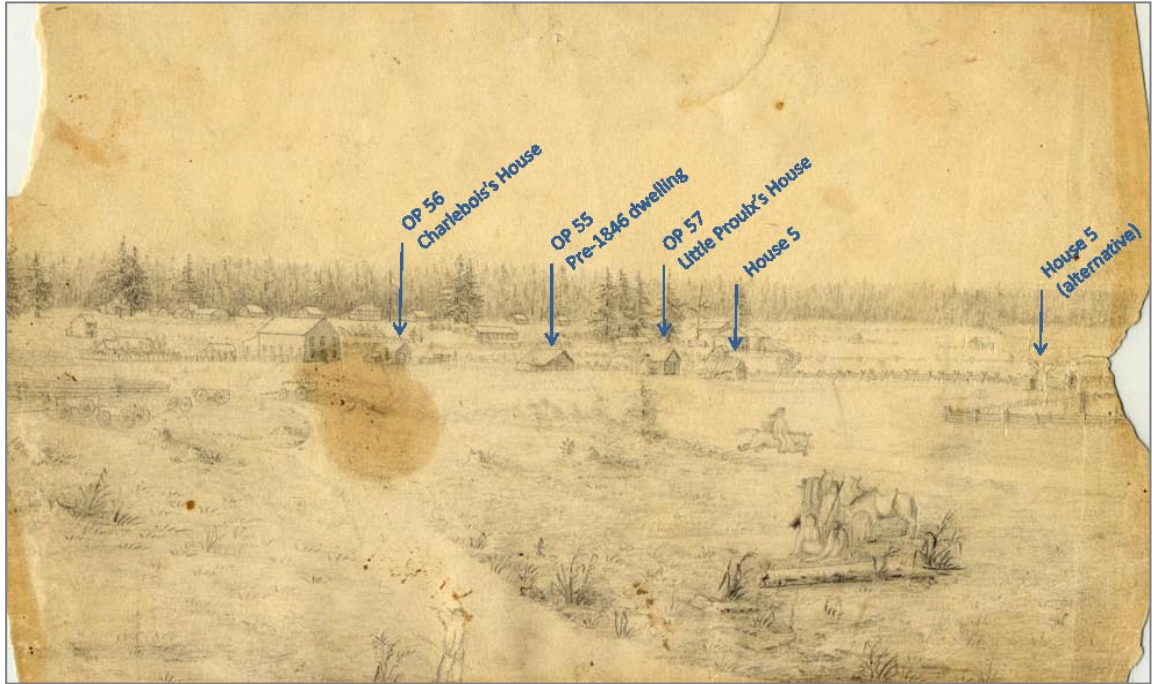
(Left half)

FIGURE 96. Inferred archaeological and cartographic identifications for the houses depicted by Gibbs in 1851. Identifications refer to location and do not necessarily confirm their physical appearance. (Courtesy of Fort Vancouver National Historic Site.)

The placement of houses, as evidenced in the historical literature and archaeological data, was used to understand the vernacular sense of landscape (Figure 96). A large part of the following discussion refers to Village house locations that were established by Thomas and Hibbs (1984). Based on their cartographic research and archaeological investigations, they postulated that between 1845-1860 (the date range of available maps and illustrations) the “village settlement pattern...remained remarkably stable,” intersected by a network of roads (Thomas and Hibbs 1984:722). Drawing on the life histories of Houses 1-5 and preliminary window glass-derived dates for other houses, a chronology has been applied to the accepted building locations to identify changes in the vernacular landscape over time. The occupation dates of the WSDOT houses in Table 51 are based on the 1984 excavation report only, and are meant to show the general trends of the landscape’s development. Some occupation dates estimated by Thomas and Hibbs (1984:719) were derived from window glass analysis (OP 6, OP 14, OP 20A, and OP 58), but other structures were assigned *terminus post quem* dates based on their presence in datable maps and illustrations (OP 55, OP 56, OP 57).

The five houses in this study occupy three different “sections” of the settlement (Figure 96 and 97). House 5 part of a house cluster in the northeast section, which also includes the structural features and domestic artifacts found at OP 55, OP 56, and OP 57. Houses 1, 2, and 3 follow a slight northwest-southwest orientation through the center of the Village on the north side of this east-west road, and House 4 is in the southern section of the Village.
