OSMB Final Report: Task 3. Containment Strategies for Eurasian Watermilfoil Infested Central OR Lakes

**OSMB Final Report:
Task 3.
Containment Strategies for Eurasian Watermilfoil
Infested Central OR Lakes**

**Final Report submitted by:
Vanessa Morgan and Mark Sytsma
for Oregon State Marine Board
funded by Aquatic Invasive Species grant
to the Aquatic Bioinvasions Research and Policy Institute
Portland State University**

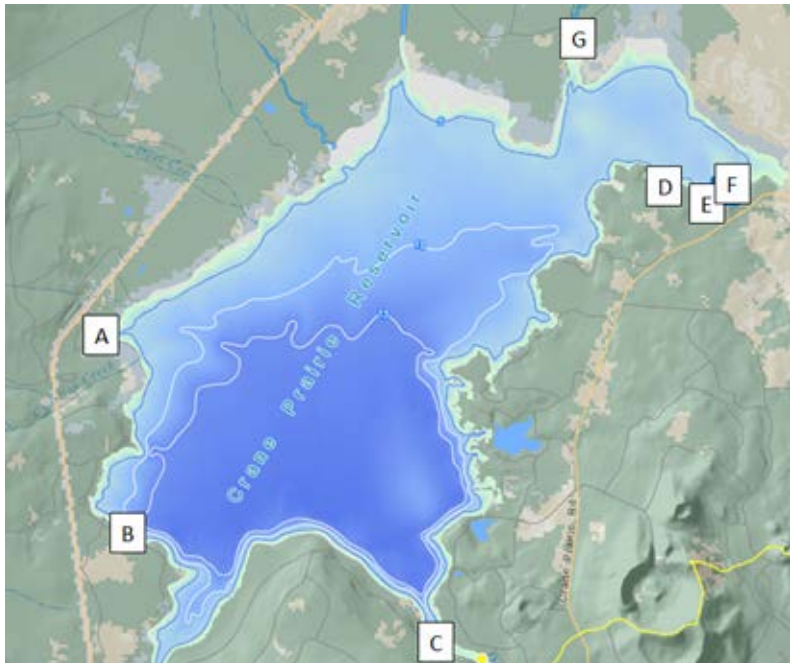
Figure 1. Map of Crane Prairie Reservoir (Deschutes County) showing bathymetry and surveyed access points including A) Quinn River Campground, B) Rock Creek Campground, C) Browns Mountain, D) CP Day Use Area, E) the CP Campground, and F) CP Resort and G) Cow Meadow (map adapted from Atlas of Oregon Lakes).

Crane Prairie Reservoir is a 4,167 acre irregularly-shaped impoundment on the upper reaches of the Deschutes River. Though managed primarily for irrigation purposes, it is also used heavily for fishing, camping and bird watching. Water flows into Crane Prairie primarily via the Deschutes River, but also Charlton Creek, Cutltus River, Cultus Creek, Deer Creek, Snow Creek and the Quinn River.

maximum depth of just 20 feet. Shallow areas are dotted with many dead, tall tree stumps, which deter boat traffic, but provide nesting areas for birds. Public access points around Crane Prairie Reservoir are numerous, including Quinn River, Rock Creek Campground, Browns Mountain, the Crane Prairie Day Use Area, Crane Prairie Campground, Crane Prairie Resort, and Cow Meadow (Figure 1); most of these ramps are managed by the U.S. Forest Service, with the exception of the resort which is under private management.

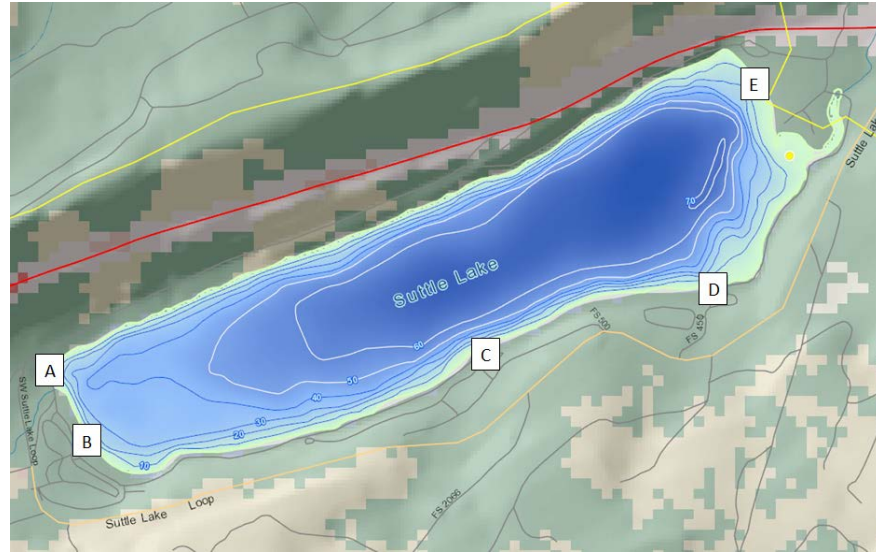
Figure 2. Map of Suttle Lake (Jefferson County) showing bathymetry and surveyed access points including A) Water Ski Area, B) Link Creek Campground, C) South Shore Campground, D) Blue Bay Campground, and E) Cinder Beach Day Use Area (map adapted from Atlas of Oregon Lakes).

Suttle is a long, narrow, and relatively small (253 acres) glacier-formed lake located close to the town of Sisters; it is popular for kokanee and brown trout fishing, boating, camping and other recreational activities (e.g., swimming, waterskiing, windsurfing). In Jefferson County, Suttle is second only to Lake Billy Chinook in its number of boater use days; over 2,309 trips reportedly made between October 1, 2006 and September 30, 2007 (OSMB 2008). Primary surface inflow is through Link Creek from Blue Lake just upstream, but subsurface flow from permeable volcanic rock contributes as well. Outflow is through Lake Creek, connecting downstream with the Metolius River and then flowing into Lake Billy Chinook. Suttle has a single deep basin and moderately steep sides; average summer depths are 44 feet and maximum depth is 75 feet. There are the five access points around the lake: the Water Ski Area, Link Creek Campground, South

Shore Campground, Blue Bay Campground, and the Cinder Beach Day Use Area (Figure 1). Transparency values indicate mesotrophic conditions, but the lake's high phosphorus levels and abundance of phytoplankton specify Suttle as a eutrophic waterbody (Johanson et al. 1985). Increased recreational activities and associated nutrient inputs are suggested for a possible decline in

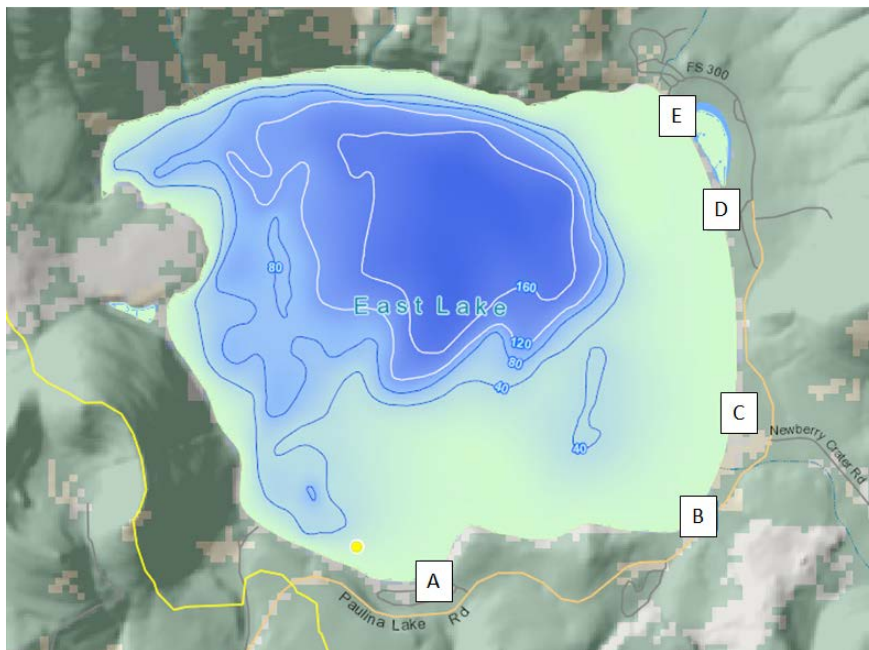
Figure 4. Map of East Lake (Deschutes County) showing bathymetry and access points including A) East Lake Campground, B) Hot Springs Ramp, C) East Lake Resort and D-E) Cinder Hill Campground (north and south) (map adapted from Atlas of Oregon Lakes).

Sitting within the Newberry volcano's caldera, just east of Paulina Lake is East Lake, a popular 1,044-acre lake known for its unique setting and productive trout fishing. Much of the northern portion of the lake is over 100 ft deep; the lake's maximum depth is 180 ft and its average depth 67-ft. Inflow into the lake is primarily through known hot springs near the lake's southeastern corner, other hot springs below the surface, and through seasonal snowmelt. Contributions from the springs yield high levels of conductivity and alkalinity, moderate phosphorus levels. Dense beds of macrophytes are reliably found near the springs, but the lake overall is considered at the lower end of mesotrophic. There is no surface outflow from East Lake, but waters slowly seeping through the underlying volcanic rock are thought to contribute to Paulina Lake which is 40-ft. lower. Multiple large Forest Service campgrounds are situated on the southern and eastern portions of the lake, along with a private resort; recreational activities include fishing, boating (motorized & non-motorized), swimming, and camping. Access points include: East Lake Campground, Hot Springs Ramp, East Lake Resort and Cinder Hill Campground (north and south) (Figure 4).

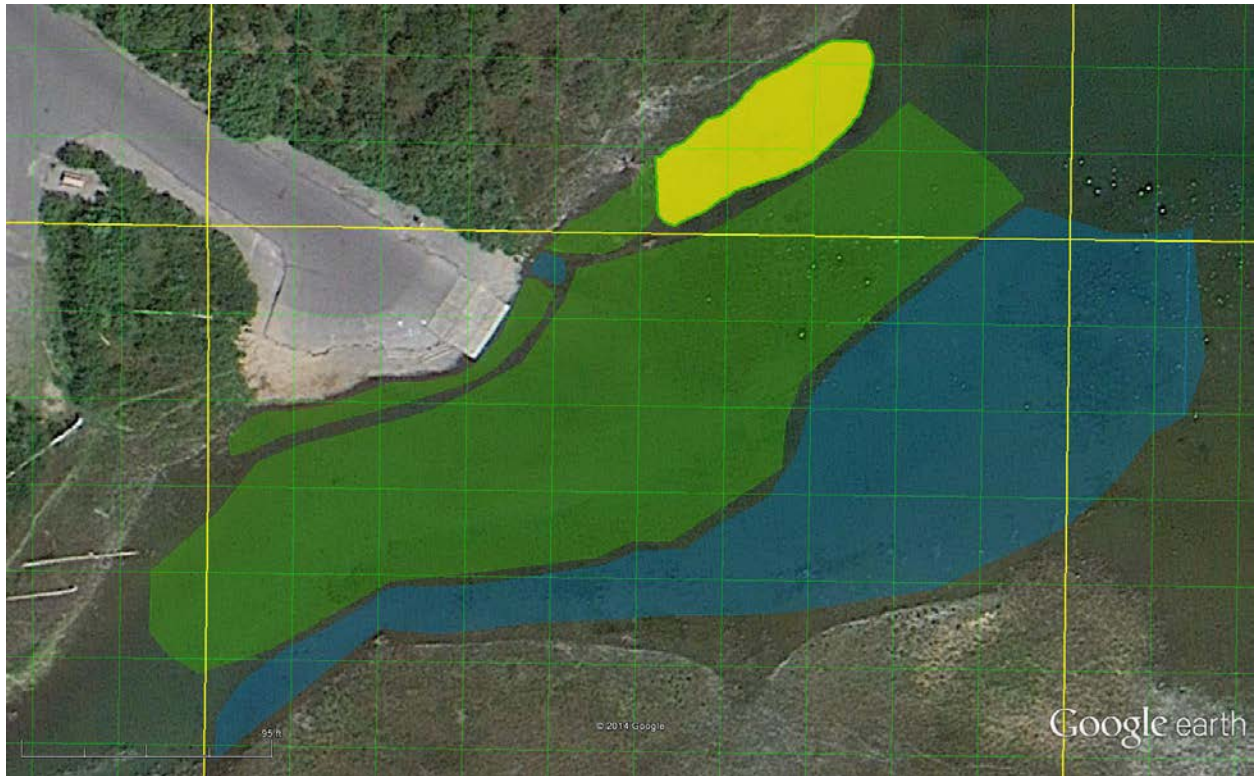
Figure 5. Aquatic plant beds at Quinn River Campground boat launch, Crane Prairie Reservoir; green polygons represent areas with sparse native plants; blue represents areas with sparse to moderate northern watermilfoil (*Myriophyllum sibiricum*); and the yellow polygon represents an area with moderately abundant Eurasian watermilfoil (*Myriophyllum spicatum*) mixed with native plants.

Six of the seven boating access points evaluated at Crane Prairie were free of rooted EWM (Table 1); however moderate populations were found near the Quinn River Campground (Figure 5). At this site, moderately abundant EWM was found in a single area just north of the boat ramp; plants were in shallow depths (0.1 to 0.5 m) intermixed with a variety of native plants including native northern watermilfoil (*Myriophyllum sibiricum*). Curlyleaf pondweed (*Potamogeton crispus*) was found growing at three other access points (most notably the boat docks at Crane Prairie Resort and the Crane Prairie Campground), but did not appear to be interfering with use of docks or launch sites since plants remained close to the sediment.

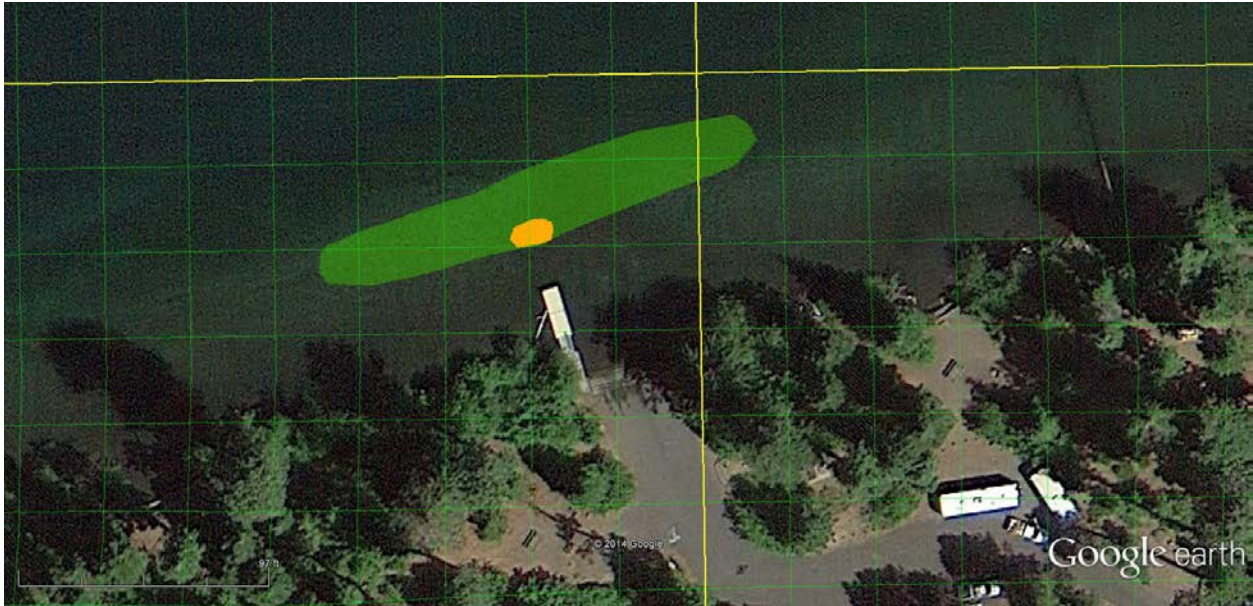
Figure 6. Aquatic plant beds at Blue Bay Campground, Suttle Lake; the green polygon represents an area of mixed native plants and orange represents Eurasian watermilfoil (*Myriophyllum spicatum*).

EWM was found rooted near two of Suttle Lake's boat ramps (Table 1), Blue Bay Campground and the Water Ski ramp. At Blue Bay campground, a single patch of EWM (approximately 3-m

diameter) was found straight off the dock in depths between 2.2 and 3.4 meters; surrounding areas had sparse to moderately abundant assemblages of native plants between depths of 2.2 to 5.5 meters (Figure 5). At the Water Ski Area ramp, moderate populations of native macrophytes and macro-algae were found towards the end of the dock between depths of 2.8 to 4.5 meters. Sparse EWM was found in a single rake sample taken directly off the north side of the deepest end of the dock (Figure 6). Visibility at this site was limited by wave action and suspended algae, but we estimate the patch at < 0.5 m diameter. Fragments of EWM were found floating near the Cinder Beach Day Use Area, but no EWM was found rooted in the area.

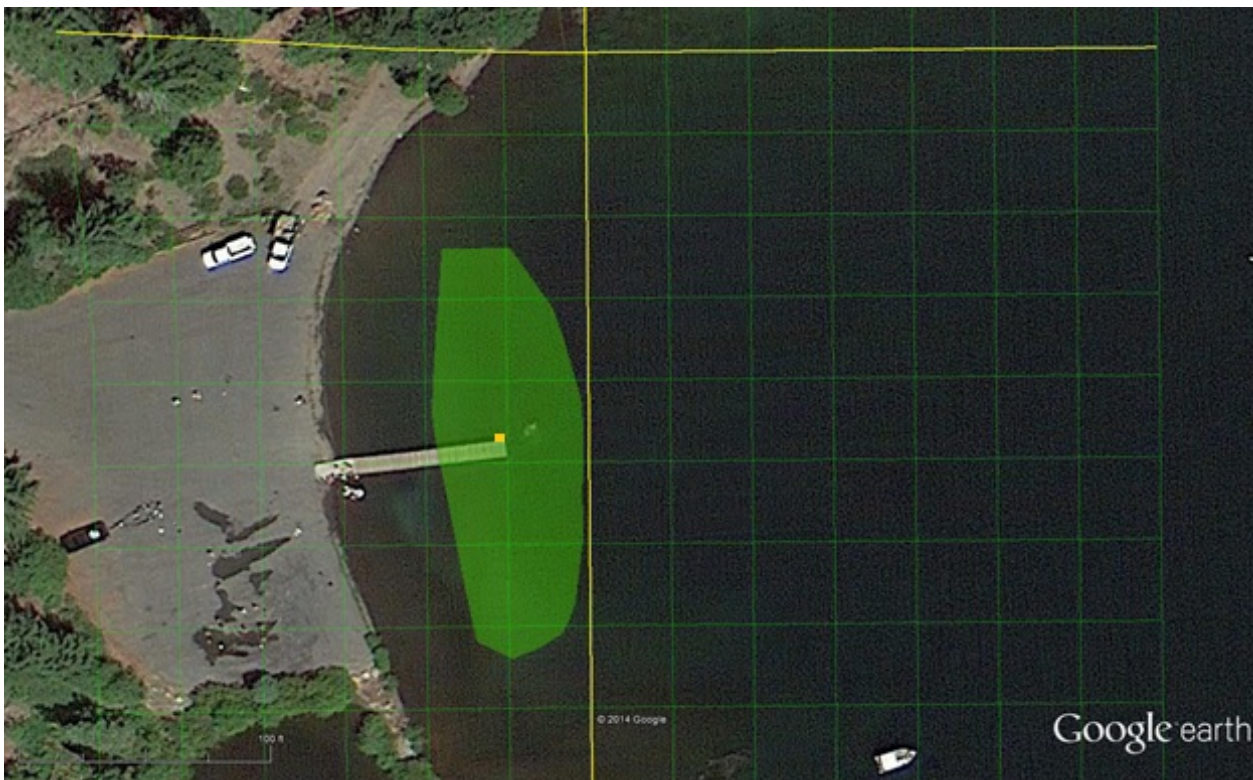
Figure 7. Aquatic plant beds near the Water Ski Area, Suttle Lake; the green polygon represents areas of mixed native plants and orange represents Eurasian watermilfoil (*Myriophyllum spicatum*).

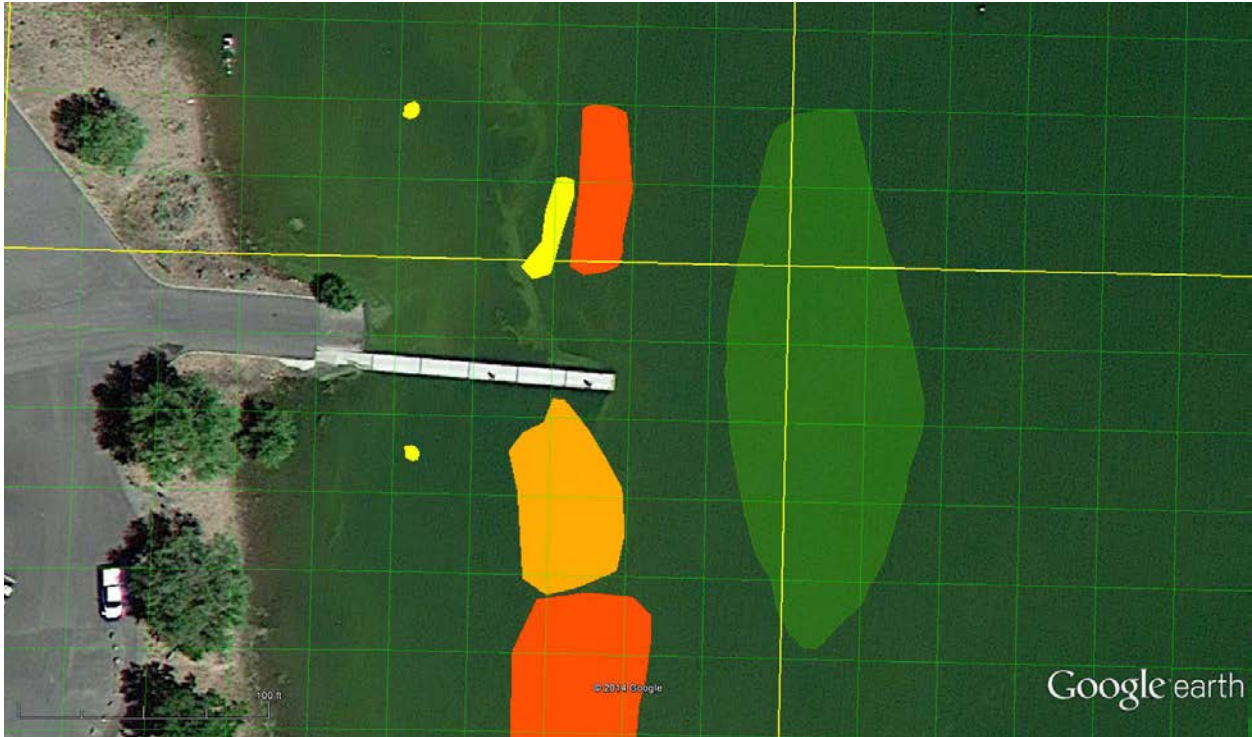
Figure 8. Aquatic plant beds near Haystack West boat launch, Haystack Reservoir; the green polygon represents general area with native coontail (*Ceratophyllum demersum*); Eurasian watermilfoil (*Myriophyllum spicatum*) is represented by yellow (sparse), orange (moderate), and red (dense) polygons.

Extensive beds of EWM were found rooted near both of Haystack Reservoirs' boat launches. At Haystack West (Figure 7), areas within 2 m of the dock appear clear of EWM and other plants, but large, moderate to dense beds of EWM lie both north and south of the dock in depths between 2.4 to 4.1 m; a native plant - coontail (*Ceratophyllum demersum*) - was found repeatedly in areas up to 5.4 m deep east of the dock. Piles of dried EWM were evident along sections of the shoreline and near the ramp. Similar to Haystack West, Haystack Campground, at the eastern edge of the reservoir, has moderate to dense beds of EWM at moderate depths and coontail in deeper regions.

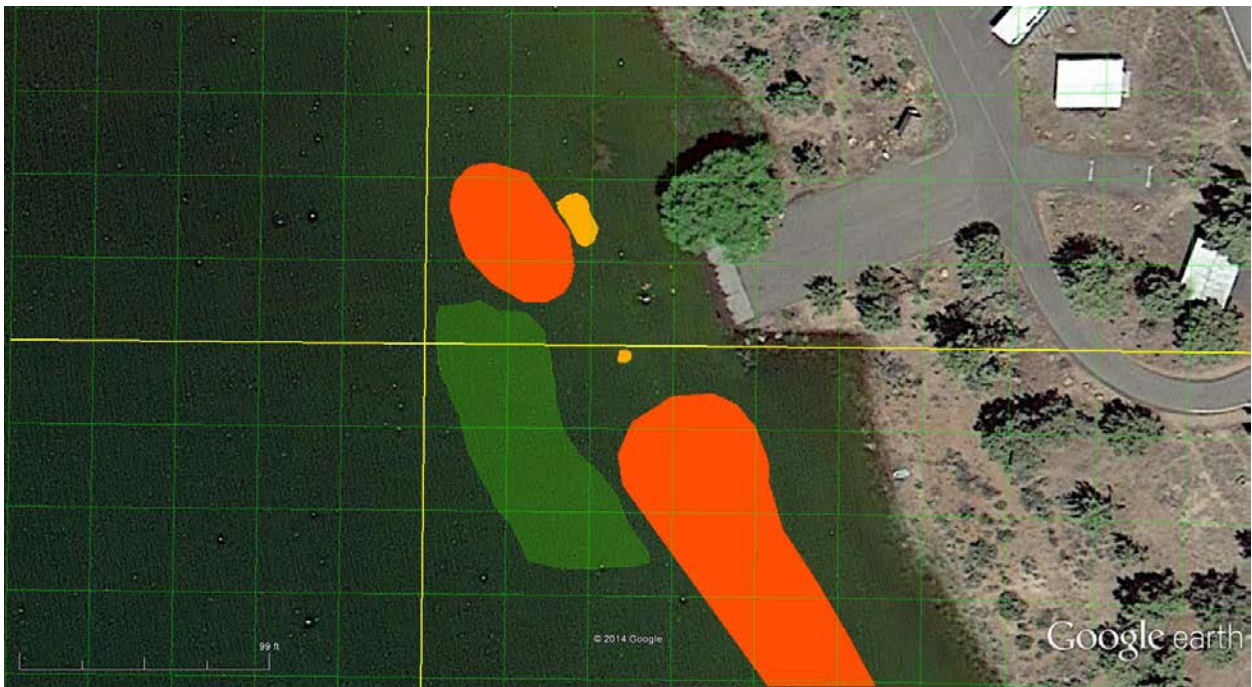
Figure 9. Aquatic plant beds at Haystack Campground boat launch, Haystack Reservoir; the green polygon represents an area of the native coontail (*Ceratophyllum demersum*); Eurasian watermilfoil (*Myriophyllum spicatum*) is represented by orange (moderate) and red (dense) polygons.

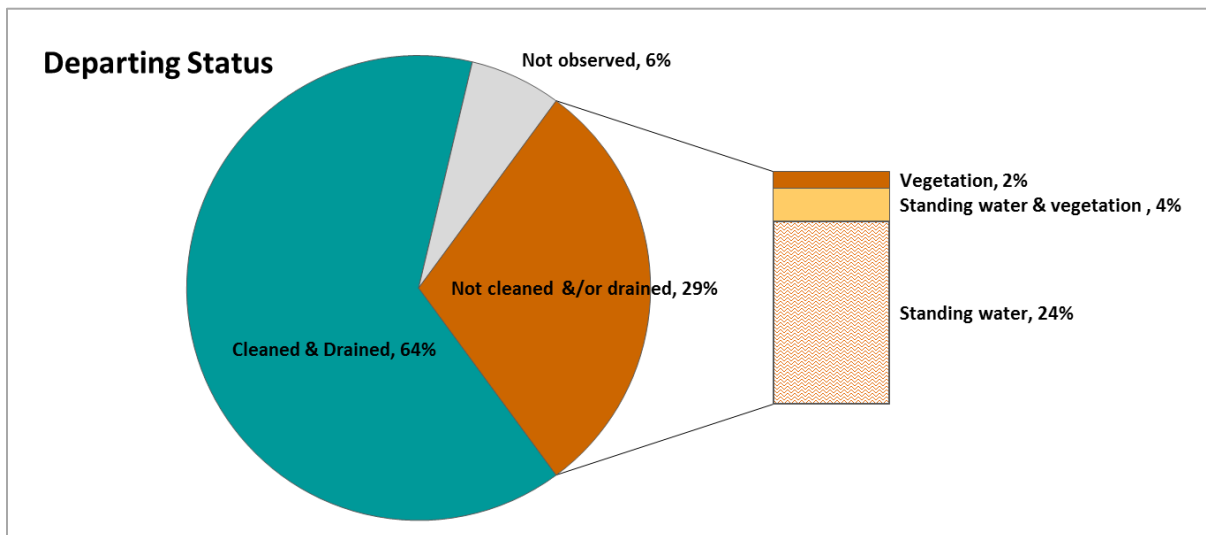
Figure 12. Status of departing watercraft at all lakes based upon whether boats and trailers were cleaned and/or drained; watercraft with standing water and/or vegetation were considered not cleaned, even if the owner suggested an intent to clean/drain them at home.

Nearly all completed surveys involved boats taking out of the water (n=44), and 25.5% of observations (n=12) included both launches and take-outs. Of the boats seen leaving the water, 31.8% were observed to have vegetation and/or mud on the hull, motor or trailer upon initially

exiting the water; subsequent inspection and cleaning by the users resulted in just three boats leaving the access point with vegetation still attached. Many boaters notably did not make any attempt to empty their bilges, live wells or other standing water in their boats, resulting in nearly 30% of observed watercraft departing with potential standing water potentially on board and/or aquatic plants attached (Figure 7). Five individuals stated their intent to clean, drain, and/or dry their boat at home, but since there was no way to verify subsequent actions, we categorized their boats as uncleaned.
