Sustainable resorts: learning from the 2004 tsunami

Renato Garcia, Stephen Siu-Yu Lau and K.W. Chau
*Faculty of Architecture, University of Hong Kong, Hong Kong,
People's Republic of China*

Purpose – Given the extensive destruction resulting from the devastating 2004 Indian Ocean tsunami that destroyed and damaged resort complexes in southern Thailand, the purpose of this research paper is to focus on the planning of architecture of resorts in two layers: the relationship of structures and land use to the natural environment, and the identification of specific design flaws that resulted in the loss of life.

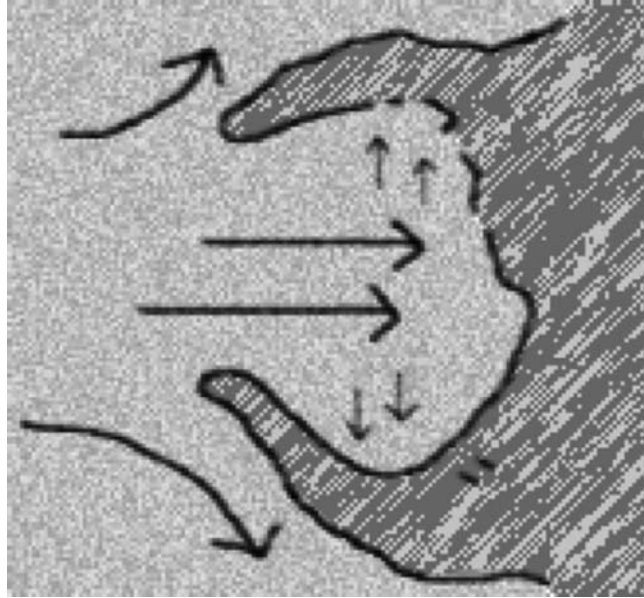
Figure 2.
Impact of the wave on
different positions of the
coast

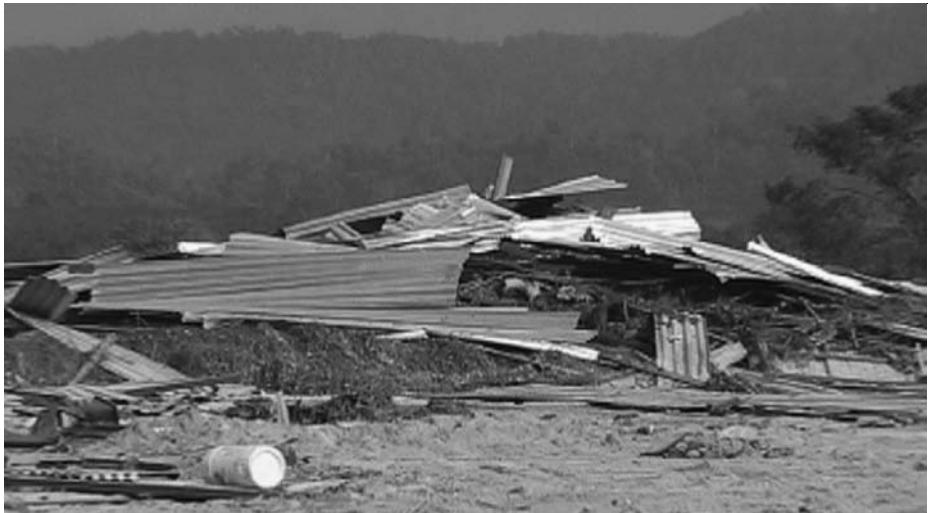
Plate 2.
Floating debris injured or
buried victims. Collapsed
sheet-metal walls and
roofing were lethal

Most of the deaths and injuries were sustained when people were hit by fast-moving debris or became trapped under the jetsam (Plate 2). The most lethal debris consisted of low-cost building materials, especially the corrugated sheet metal used to build shanties, as in Phi Phi’s Tonsai beach district. Instead of ramshackle construction in crowded quarters, small businesses such as shops, bars, and guesthouses, should be

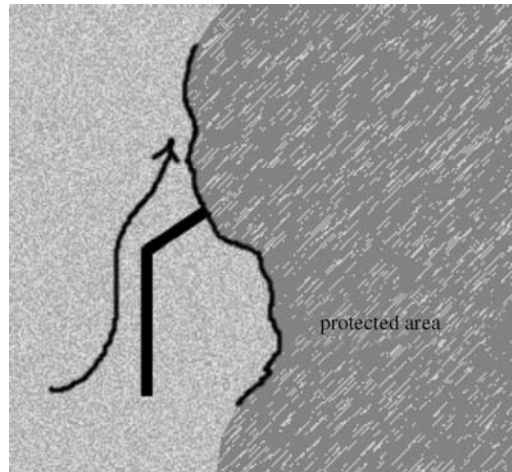
Figure 3.
Physical protection
coastline development

Apart from a suitable site location, it would also be useful to provide physical protection for the site. The use of offshore barriers or dykes and walls are options that

are appropriate and economically feasible for reducing the wave energy, and thus impact, on the structures (Figure 3).

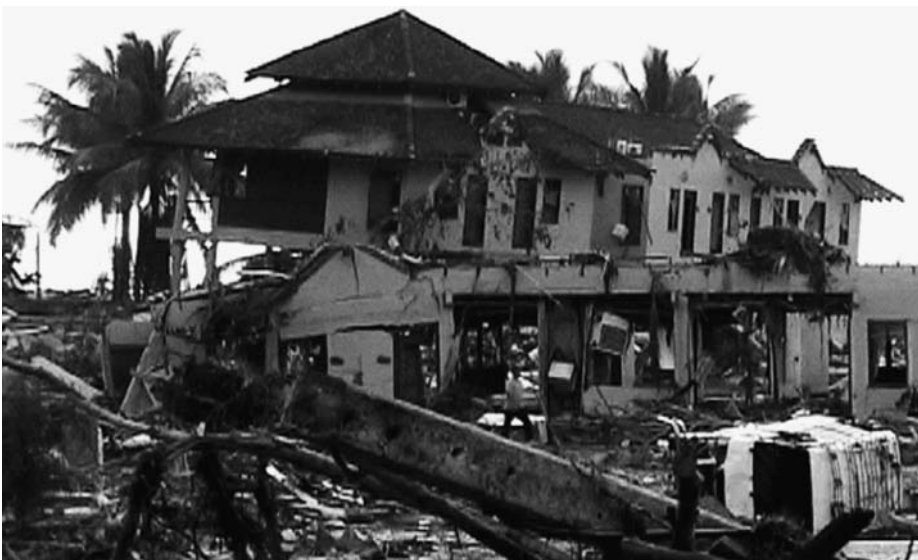
Plate 3.
Beachside hotels took the
full impact of the wave.
This Khao Lak hotel was
lifted off its foundations

Resorts and hotels were often built along the lowest-lying areas of the coast for the convenience of beach access. Nevertheless, such areas are the most prone to wave action and flooding. The low-density characteristic of sand was especially dangerous, due to its loosely packed foundation. In Patong-Phuket, Khao Lak, and KoPhi Phi, improper foundations led to the felling of resort buildings (Plate 3).

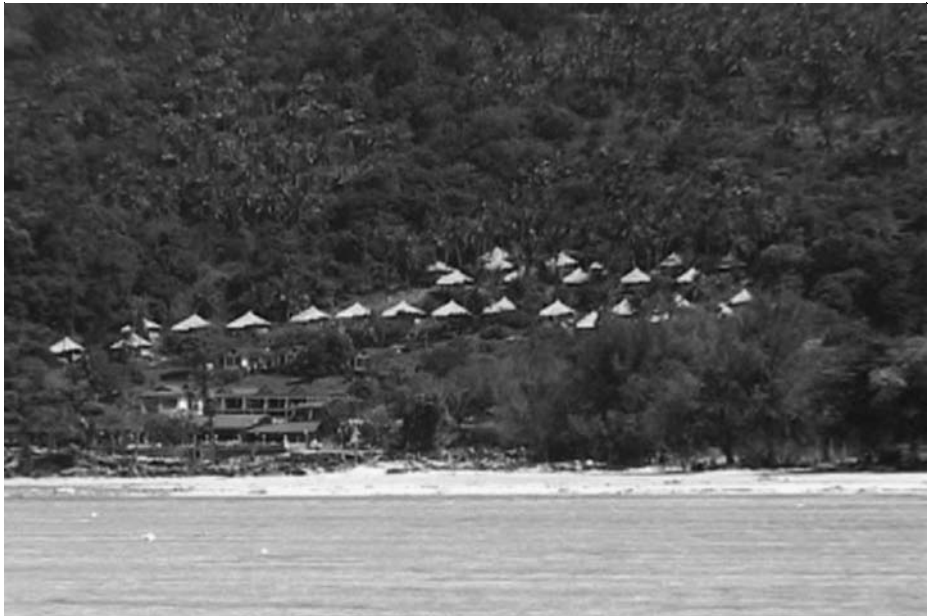
Plate 4.
A Phi Phi resort that survived was a few meters above sea level

On the contrary however, a group of Phi Phi resort buildings a few meters above sea level survived the disaster (Plate 4). It was obvious that an inland rock bed provided a firm foundation for these buildings to withstand great force. Zoning and land-use rules for resort districts in accordance with the contours of the land and tidal hydrodynamics should be developed. The creation of guidelines for land use will require further studies and extensive discussions by architects, building engineers, construction companies, hotel management, and government planners and regulators.

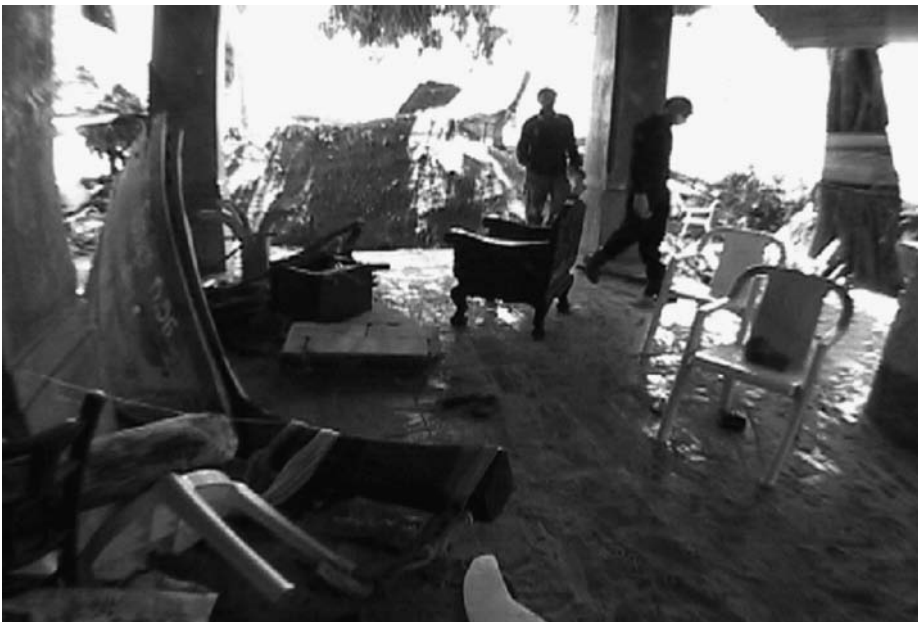
Plate 5.
The wooden posts of the
banyan tree lobby in Phi
Phi survived even after
being hit by a boat
because the ground floor
was open, allowing wide
and shallow flood flow

Structural damage to ferro-concrete structures and big wooden posts, especially in the larger hotels, was often not as devastating as the exaggerated news reports suggested. Many big hotels suffered only superficial structural damage, such as broken glass windows and interior damage, and could be renovated and reopened. Demolition was not necessary, especially in buildings where the ground floors were devoted to open-air facilities such as cafes and spas, which did not obstruct the floodwaters (Plate 5). "Wide and shallow" should be a ground rule for large structures, permitting floodwater to simply pass through unobstructed rather than constricting its flow and causing it to gain speed and rise higher.

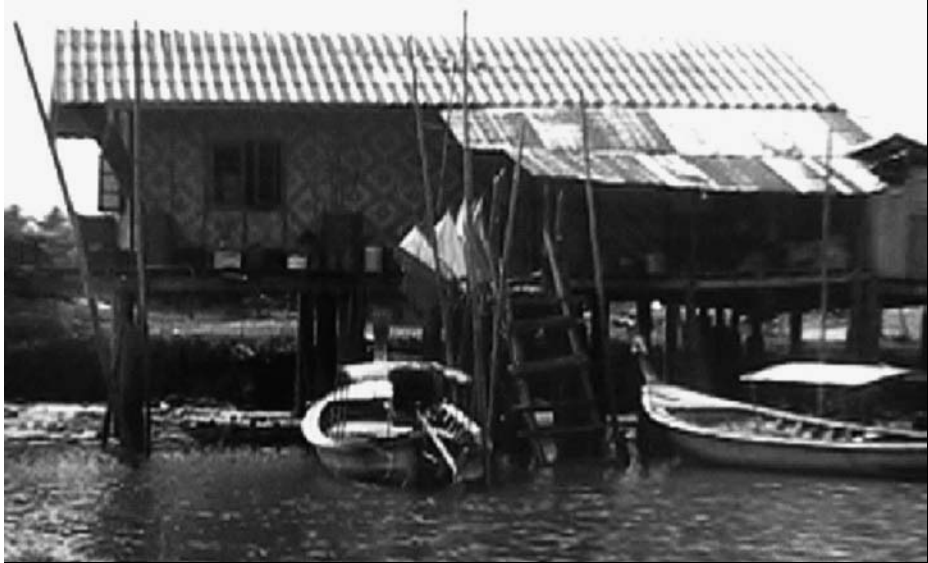
Plate 6.
Stilt houses and long-tail
boats survived waves
along rivers and
mangrove networks

On similar principles, traditional stilt houses of the indigenous Chao Le, or “sea gypsies” along waterways survived even great tide-driven waves (Plate 6). A large force of impact was prevented by their tiny pillars. Waves simply passed through without damaging the house itself. On the other hand, houses built directly on the ground received the full force of the wave when it struck and retreated. These houses were pulled off their foundations.

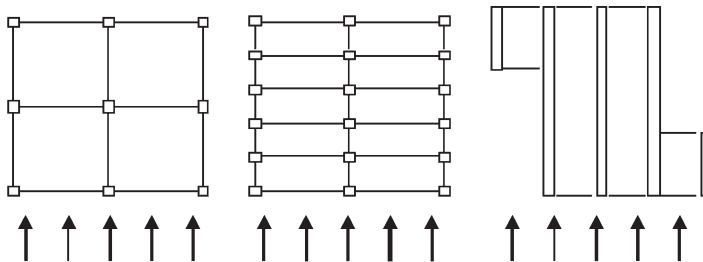
Note: Utilization of rigid frame or cantilever column action as lateral resistance system on exposed face reduces obstruction to flow while shear wall, bracing, and frame action all remain options along lines parallel to flow.

Figure 6.
Structural organization
allowing minimal
resistance to the flow of
water

To enjoy a full view of the waterfront, resorts are usually oriented with the wider side facing the sea. Unfortunately, this orientation makes buildings more collapsible. During the disaster, buildings that received less damage tended to have a smaller

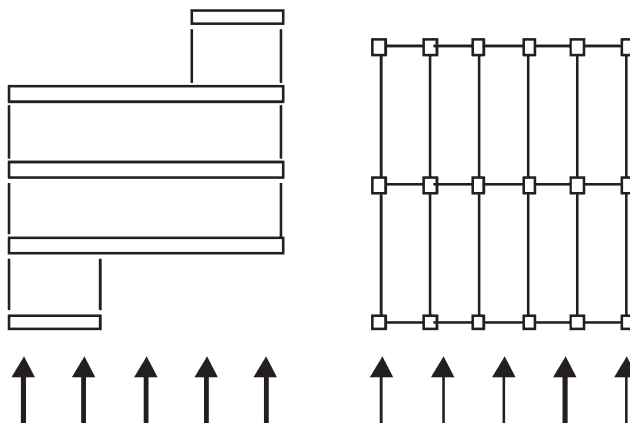
Figure 7.
Structural organization
resulting in greater
resistance to flow, which
resulting in greater impact
forces

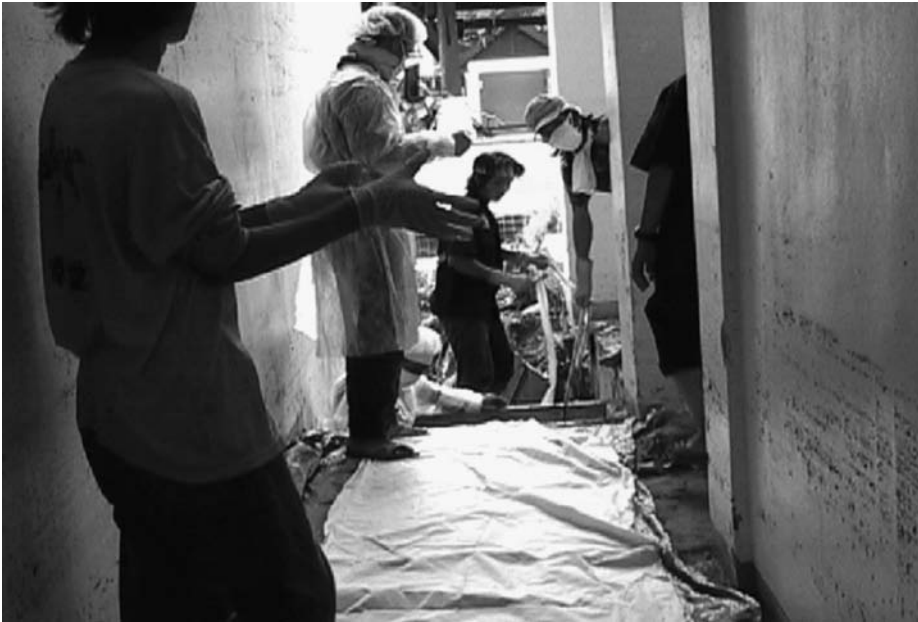
Plate 7.
Bodies were difficult to
remove due to built
obstacles such as the
crawl space below the
Sofitel Magic Lagoon
resort ground-floor
corridors

If a wider street or passageway had been provided in between buildings, the gap condition would have changed from semi-permeable to permeable. The mass of water would not have been intensified nor passed at such a high speed. Also, the work of emergency services would have been made easier, since debris would not have been stuck and piled high in narrow passageways (Plate 7 and Figure 9).

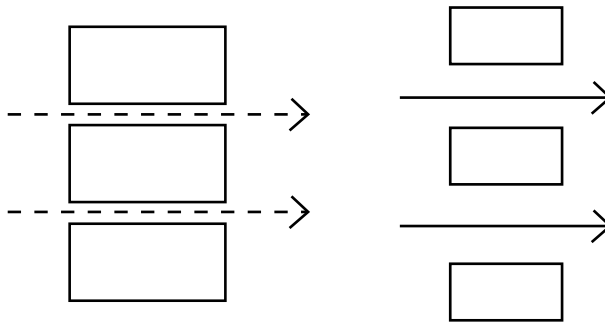
Figure 9.
Narrow gaps make spaces
between buildings
impermeable. Wider
spaces should be provided

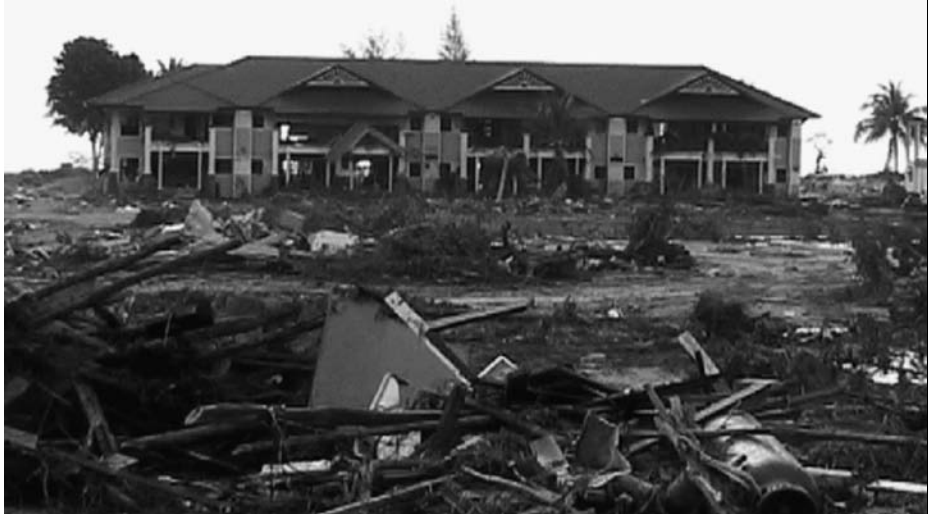
Plate 8.
Beachgoers were drowned because there were no escape routes to higher levels. This Khao Lak hotel lacked outdoor staircases to higher ground and upper-floor balconies that could have saved lives

The lack of escape routes to higher elevations was a major factor in the high death toll (Plate 8). Wherever beach-goers could rapidly access outdoor stairways to balconies, they had a good chance of surviving the flood, even in cases of very short notice or of being swept along by the wave. Tsunamis and strong tides can move very quickly, outpacing beachgoers, and reducing the odds of horizontal flight away from the waves. The best direction is upward.

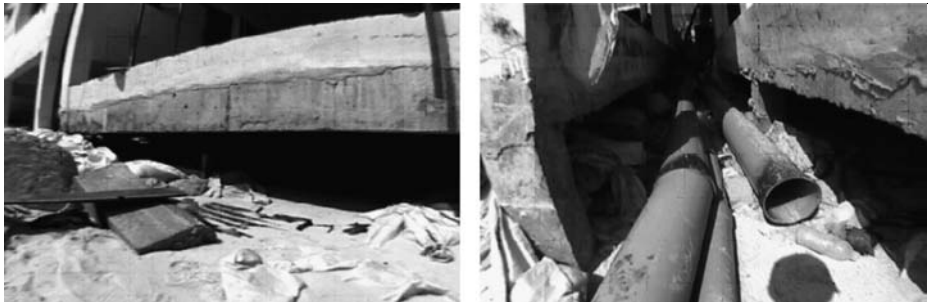
Figure 10.

Note: Left: narrow gap traps people. Middle: elevated gap allows people to pass through. Right: blocking gaps

Plate 9.
Narrow and low spaces trapped people underwater

Design flaws like narrow gaps between the ground and the base of buildings presented hidden dangers (Figure 10 and Plate 9). During the tsunami, many people were trapped or stuck between these gaps and died because they were unable to crawl out. Narrow or low inlets should be covered with metal grills to prevent the trapping of people or

objects in these spaces. Grills allow ventilation while providing safety. An alternative is to raise the gap between the ground and the base of buildings to allow water to pass under without trapping people or debris.

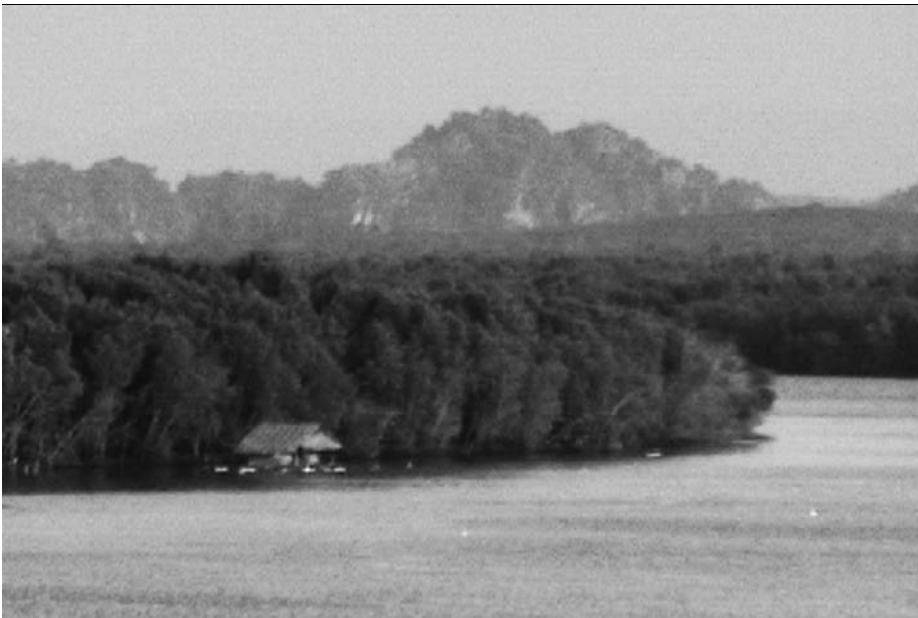
Plate 10.
What if the local fresh
water source has run dry?
Treat and recycle waste
water from hotels

To prevent the same situation from happening, it is necessary to restore the lagoons and waterways. Freshwater pressure reduces wave shock. Mangrove forests block and absorb floodwater. Fresh water should no longer be used for flushing. Recycled waste water should be considered as a source for non-drinking functions. A regional study of patterns of settlement by the indigenous Chao Le, and their use of mangrove forests as natural barriers, should be conducted to better understand the relationship between the natural and built environment.

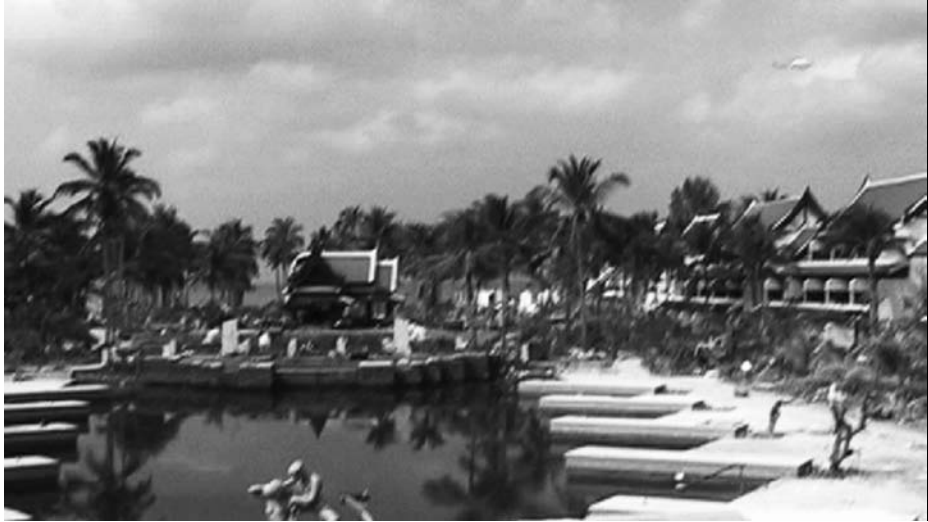
Plate 11.

Construction drained the lagoons, and fresh water was flushed from toilets and showers into the sea

The tourism industry contributed to the deaths of local fishermen and shopkeepers by literally flushing fresh water down the toilet. The massive waste of fresh water resources by hotels and restaurants has drained lagoons and creeks, thereby transforming the remaining lowlands into sites for building more houses and shops (Plates 10 and 11). In Khao Lak, the tsunami moved "like a snake" through dry creek beds and lagoons, demolishing everything in its path. In contrast, areas surrounded by healthy lagoons and rivers, like Krabi town, were protected by these natural features from the wave and sustained much less damage. Lagoons, creeks, klongs (manmade pools, canals), and other water channels need to be restored as a self-regulating system that can apply counter-pressure on floodwaters rushing in from the sea and absorb overflow from the sea or rivers.

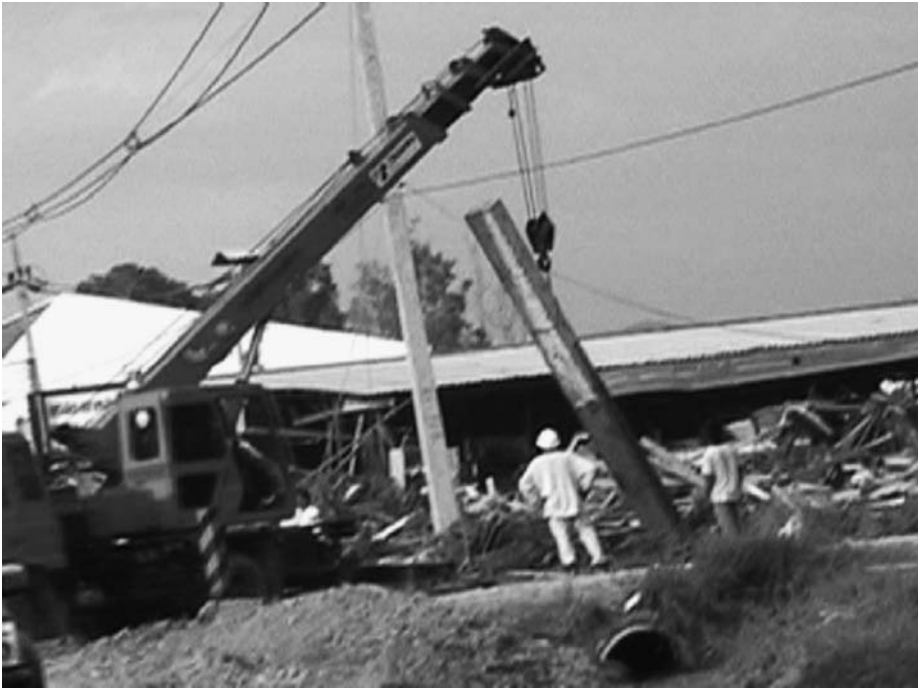
Plate 12.
A power outage led to
chaos and lawlessness.
Debris tore down power
lines

The major resort complexes lacked co-generation power plants on their grounds for generating electricity. When power lines were destroyed by the tsunami, the entire coast suffered a blackout of lighting and communications, adding to the chaos for at least one week (Plate 12).

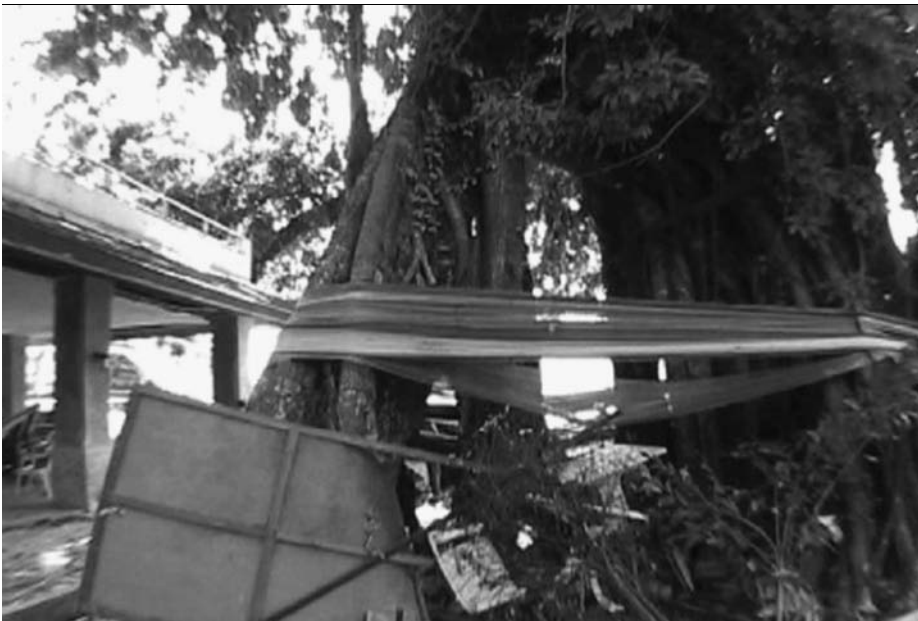
Plate 13.
Multi-branched trees with
aerial roots proved to be
better at saving people
than eye-catching palms

The occasional banyan, with its many trunks and aerial roots, saved many lives, allowing people to find support against the water flow and climb above danger (Plate 13). Palms, which are visually attractive, are harder to climb and have no branches. The planting of sturdy, branching hardwoods in resort areas is a “must-do.” Innovative tensile structures and flexible platforms on larger trees could be designed as a form of recreation to encourage people to climb, as well as a safety measure.

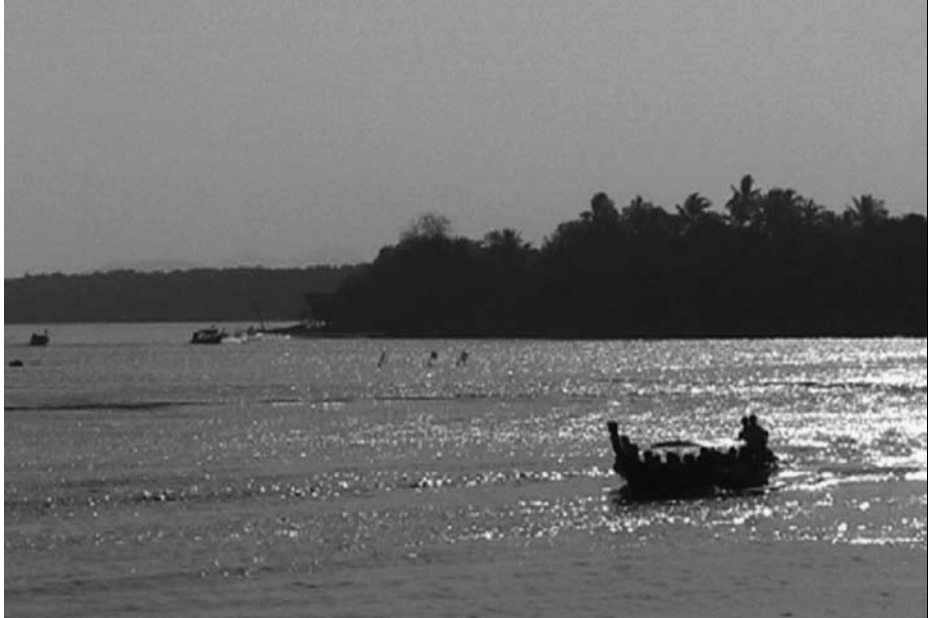
Plate 14.
Landscape design can be a
part of a built-in safety
system

Natural landscapes at higher levels can also provide safety platforms during tsunamis and floods. Landscape design should be incorporated as a safety feature in the master planning of resort development (Plate 14). It can help restore the balance between the natural and built environments.
