**The Distribution of Landslides on Lantau Island,
Hong Kong**

Bachelor of Arts Dissertation

Department of Geography and Geology
University of Hong Kong
2000

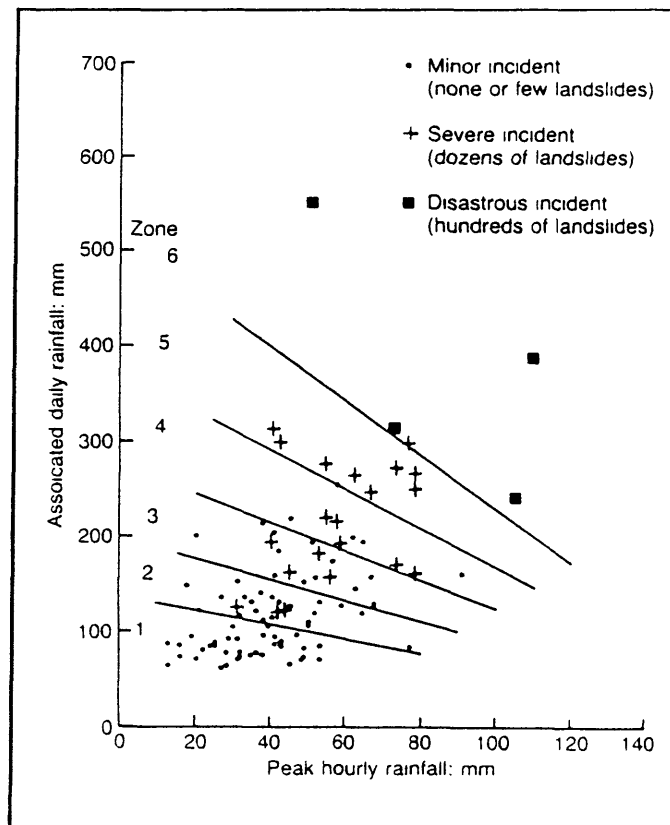
Figure 2.4. Rainfall-landslide relationship after Kay & Chen (1995)

More recent study on rainfall-landslide relationship in Hong Kong was taken by Kay & Chen (1995) which correlated the 1-hour rainfall and 24-hour rainfall with landslides occurrence based on 1984-1992 GEO data (Figure 2.4).

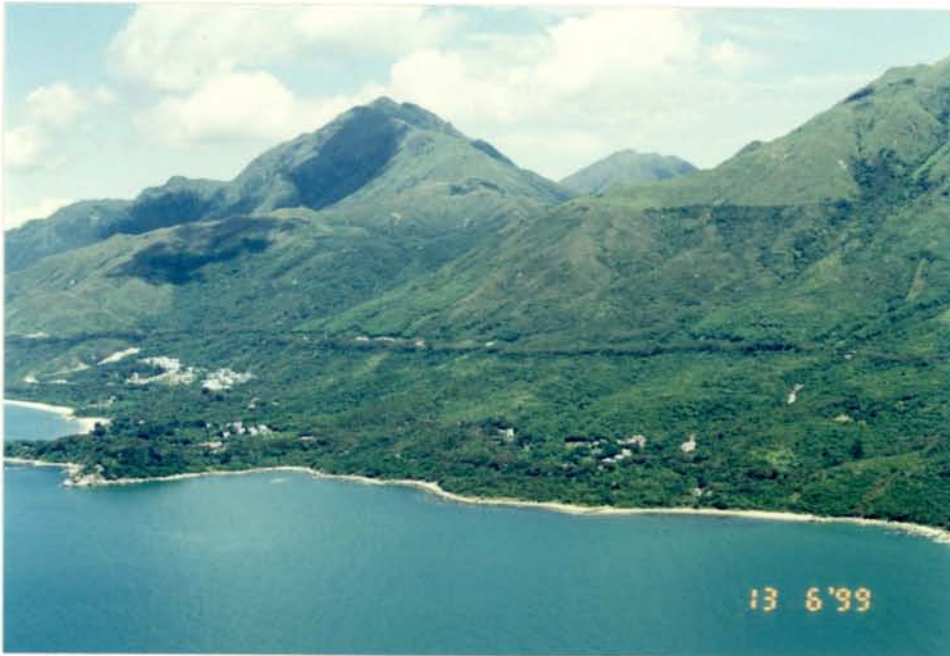
Plate 3.1. High relief with steep slopes at Central Lantau

Lantau Island is the largest island located in the Southwestern part of Hong Kong Territory (Figure 3.1). Most part of the island is unaffected by urban development and uninhabited because of the steep hilly terrain (Figure 3.2). The total land area is about 165 square kilometres (Langford, 1995), consisting 13.28% of the territory (GCO, 1989). The island is mountainous, dominated by east-northeast trending ridges with steep slopes. Highest relief is located in the central part of Lantau (Plate 3.1) where the second and third highest peaks of Hong Kong---Fung Wong Shan (Lantau Peak, 934 metres) and Tai Tung Shan (Sunset Peak, 869 metres) are located. Lowlands are limited, mainly found along the coastline which is indented by narrow deep bays (Langford, 1995) (Plate 3.2).

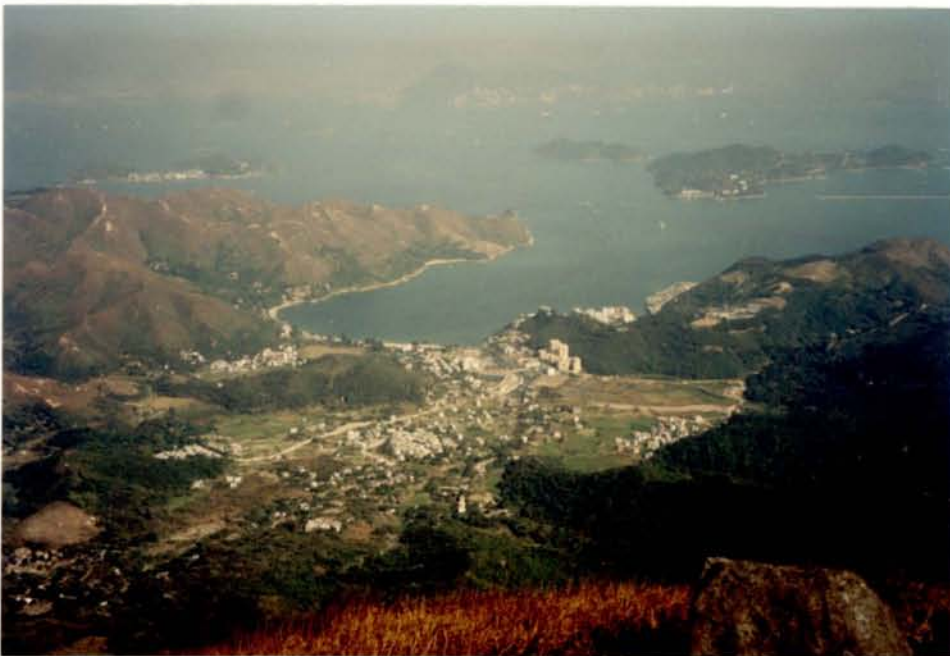
Plate 3.2. Flat low-lying alluvial plain at Mui Wo, East Lantau

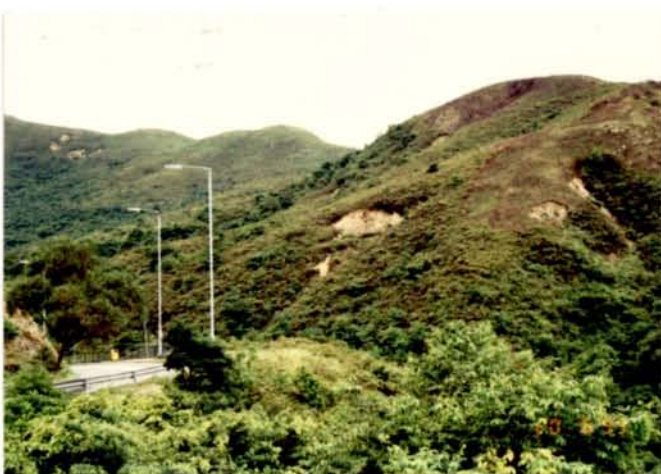
Plate 4.1. High landslide density at the junction of Sham Wat Road and Ngong Ping Road, Ngong Ping

Several areas had a much higher density of landslides (where there were high number of landslides within a small area), relative to other areas of the island. These areas included Ngong Ping (Area A) (Plate 4.1), eastern part of Shek Pik Reservoir (Area B), western part of Mui Wo (Area C) and eastern part of Tung Chung (Area D) (Plate 4.2) (Figure 4.2).

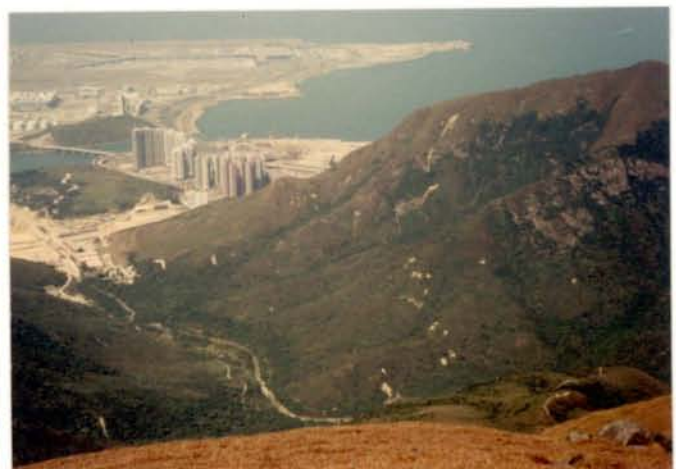
Plate 4.2. A number of small-sized landslides on volcanic hillslopes, near Tung Chung New Town

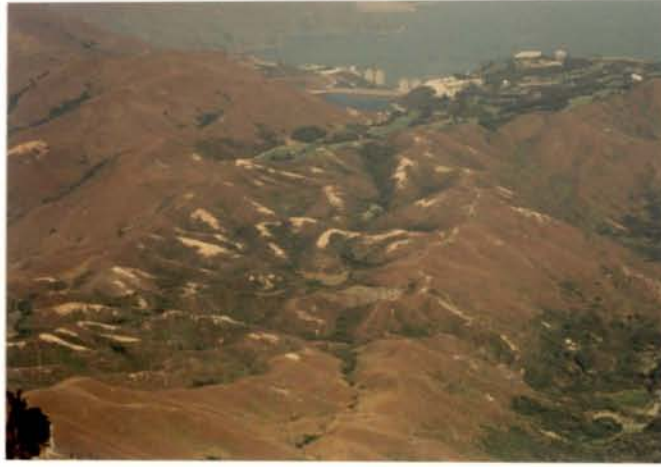
Plate 4.3. Severe soil erosion at ridgecrest of granitic terrain, East Lantau

Regarding to the shape, size and colour of landslides, the scars recognised had well-defined sliding plane and were mostly circular in shape and concave-upward. Some had elongated tongues, with slope debris extending out downslope from the base of the scar to a certain distance. Size of landslides on Lantau was small with shallow depth. Colour of most recent landslides was light reddish brown (deeply weathered soil) while dull in colour for the “older” ones that occurred in previous years. The landslide scars recognised were mostly bare of vegetation cover. Concluding from the above characteristics, landslides on Lantau could be classified as rotational slips or “earthflows” (Figure 4.5) which are commonly found on hillsides in humid areas (Tarbuck & Lutgens, 1993). Compared with landslides, badlands (Plate 4.3) (some mixed with landslides) on Lantau were in irregular-shaped and mostly found on the ridgecrest of granitic terrain.

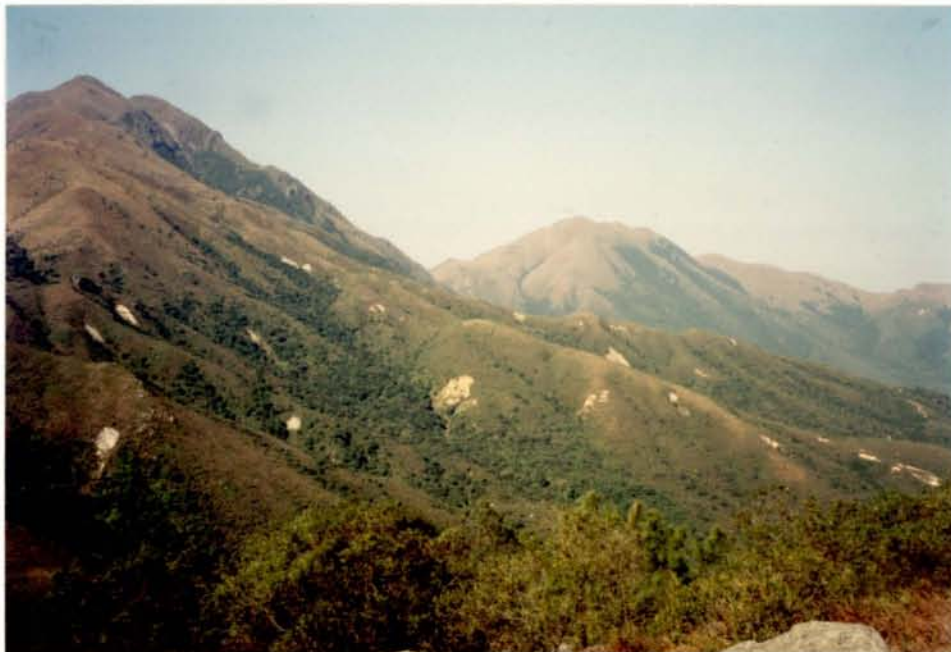
Landslides identified showed an “orientation”. The tongues of landslides mostly run at right angles to contours down the valley slopes in the direction of the valley floor to the upper part of streamlines (Plate 4.4) (Figure 4.6).

Plate 4.4. A number of small-sized landslides at upper hillslopes of Lantau Peak, showing orientation

In geographical location, most landslide scars were found at the upper part of valley slopes, just below the crest of the spurs (Plate 4.4). Also, most landslides occurred on natural hillslopes of the island -- areas without much human impact or development.

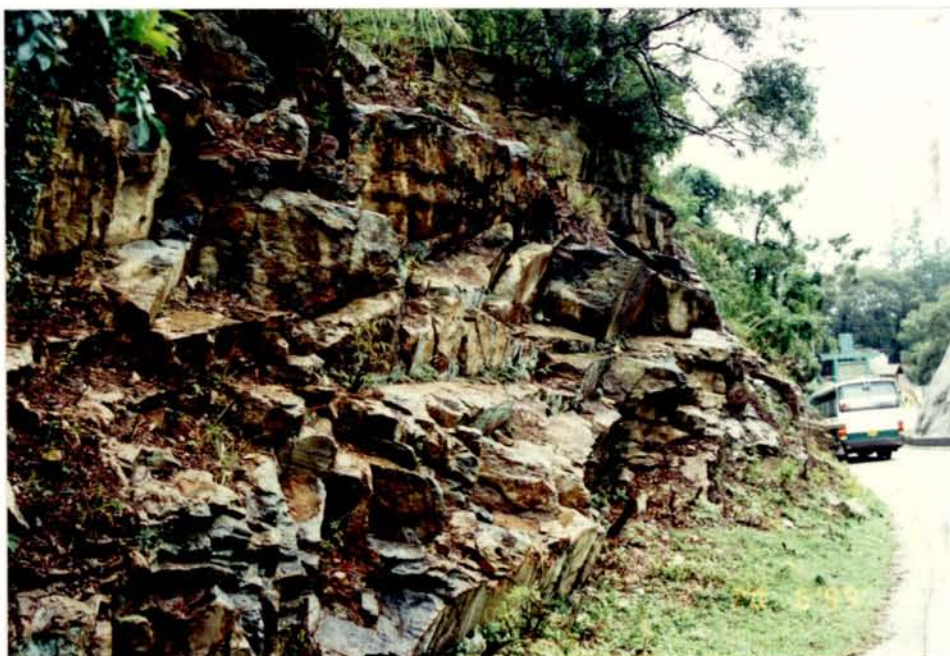
and lavas (Lands & Survey Dept., 1979; Langford, 1995). Some parts have been severely folded and metamorphosed as a result of granitic intrusion. Volcanics are well-jointed with joint-spacing varies from narrow to wide of less than 10 metres. Its weathering depth is about 8-10 metres, in which weathered materials are mainly clayey silt with minor sand (GEO, 1988a, 1988b).

Plate 5.1. Jointed volcanic rock exposed after roadcutting at Keung Shan Road

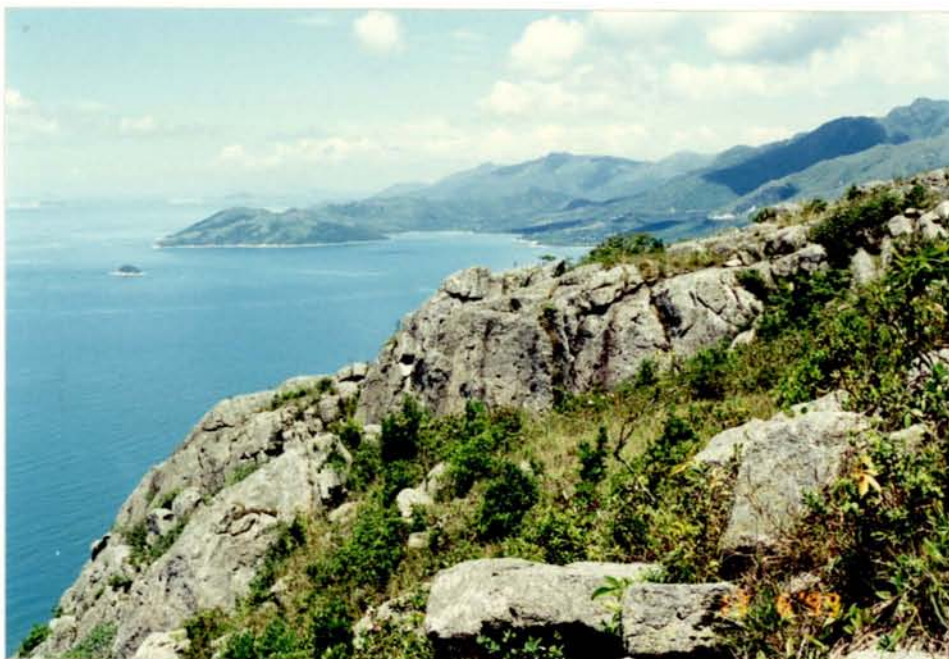
Granite is another major type of intrusive igneous rock found on Lantau, which is exposed extensively on the eastern part of the island (Plate 5.2), with isolated outcrops at the Northern coast west of Tung Chung and Southwest coast at Shui Hau and Fan Lau (Figure 5.1). Granites of Lantau Island are mostly classified as Cheung Chau Granite of Upper Jurassic age, characterised by its pinkish colour, porphyritic texture, with medium to coarse-grained size between 3-5mm (Lands & Survey Dept., 1979; GEO, 1988a, 1988b). Granites have medium to very widely-spaced sheeting and tectonic joints. Its

Plate 5.2. Well-jointed granite outcrops at Chi Ma Wan Peninsula

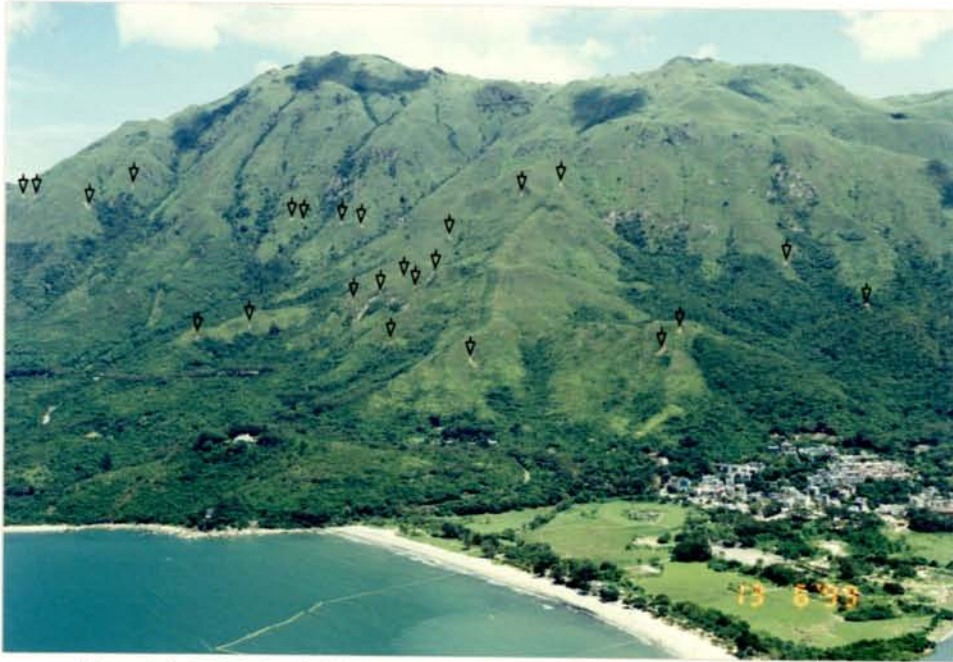
Plate 5.3. High landslide density on steep volcanic hillslopes, Pui O

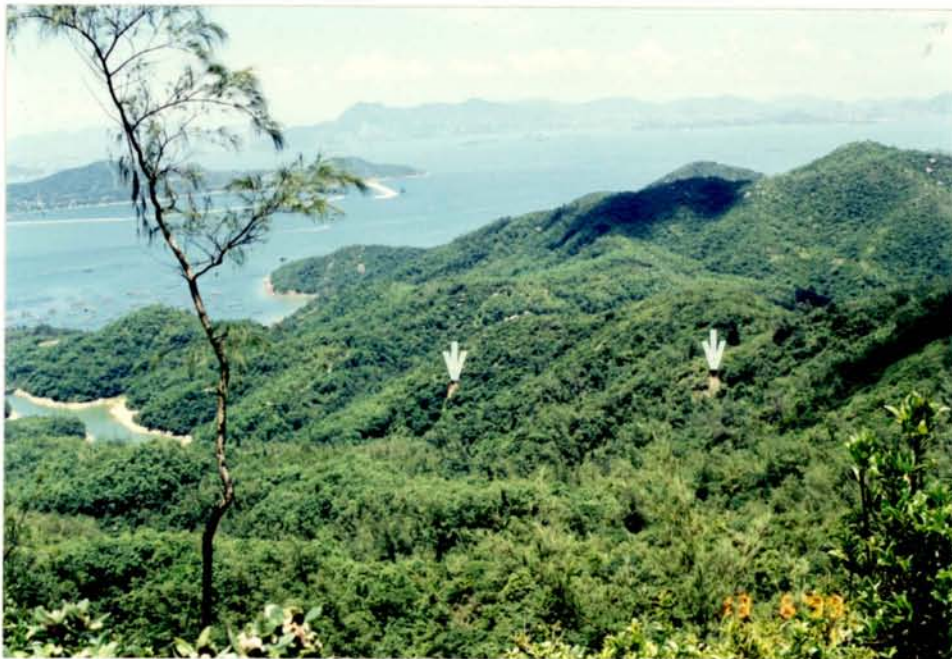
Plate 5.4. Low landslide density on gentle granitic hillslopes, Chi Ma Wan Peninsula

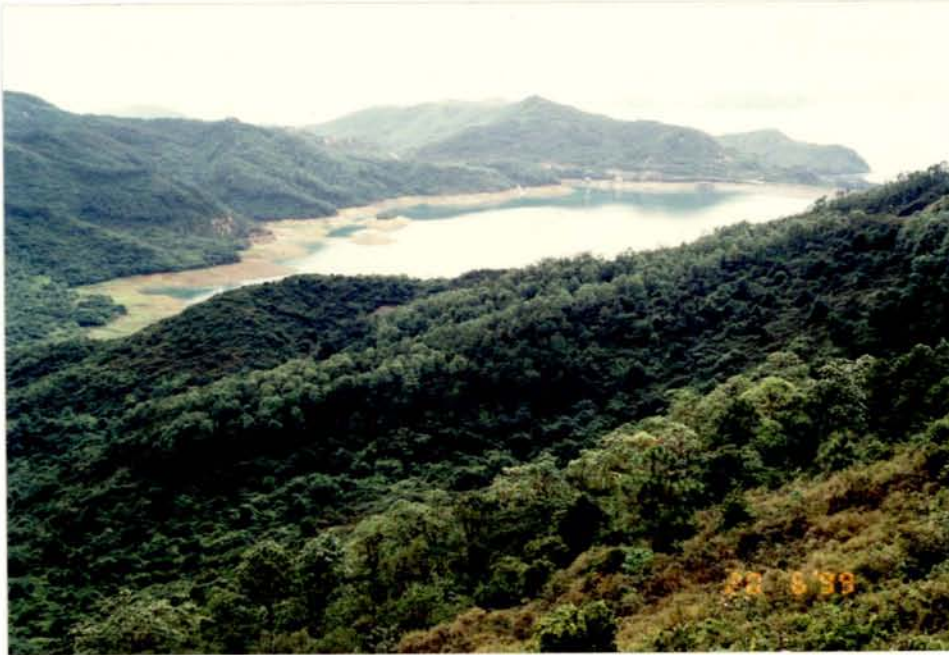
Plate 7.1. Luxuriant woodlands around Shek Pik Reservoir due to afforestation, for protecting water catchment

The spatial distribution of woodland over the island was not evenly distributed (Figure 7.1). Woodland was mainly found at Nam Shan and extensively covered Chi Ma Wan Peninsula (Southeast Lantau). Large woodland coverage was also found around Shek Pik Reservoir (Plate 7.1). They were mainly the result of the government's reforestation programmes since the 1950s, particularly during the 1960s and 1970s, for environmental conservation and preservation (Catt, 1986). As reported by GCO (1988a, 1988b), the natural vegetation of Lantau Island was largely modified by man.

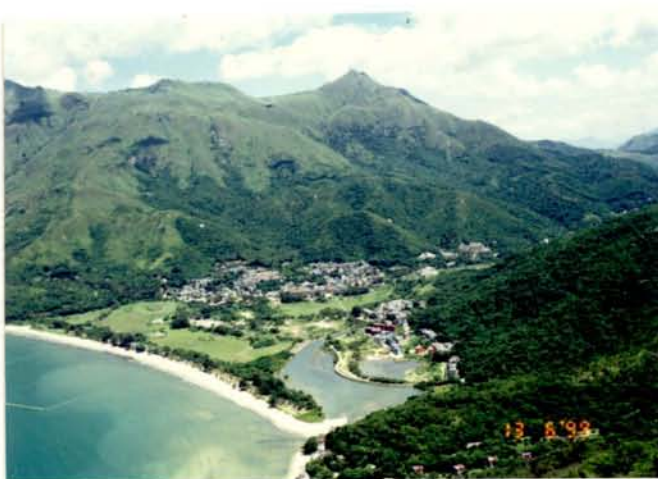
Plate 7.2. Woodland distribution pattern at low and mid-slopes, Pui O

Scattered vegetation pattern was shown in the Northern part (west of Tung Chung) and Northeast part of the island. By map (Survey & Mapping Office, 1996) and field observation (Plate 7.2, 7.3), it was noted that woodlands were usually most intensive at the lower and middle slopes of river drainage basin, extending “narrowly” to the upper slope near ridgecrest.

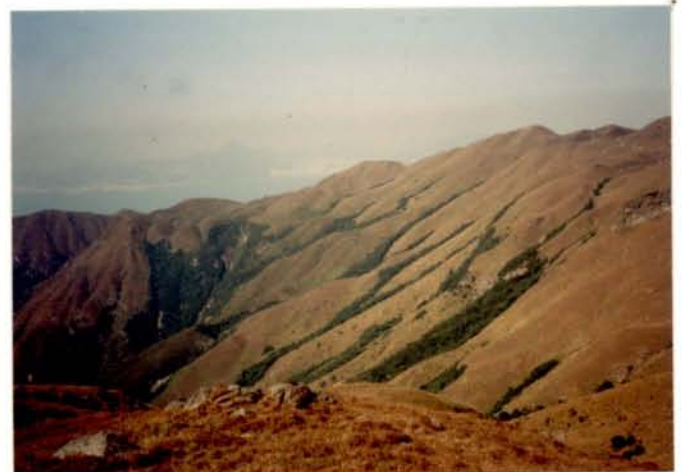
Plate 7.3. Woodlands follow drainage lines stretching upslope, Lin Fa Shan

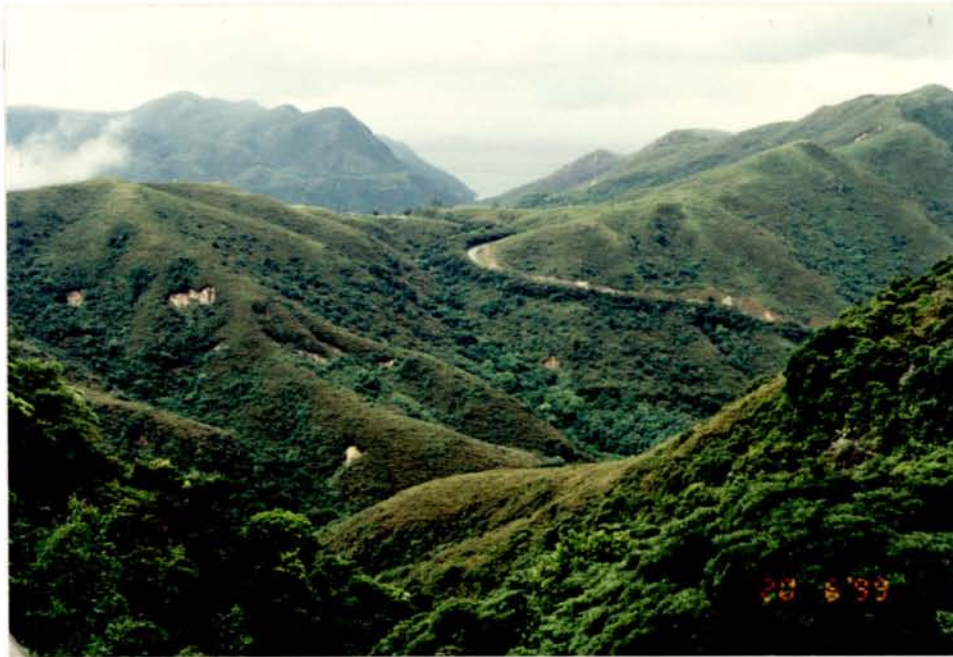
Plate 7.4. Most of Lantau Island is covered by grassland
(photo taken at Ngong Ping)

Non-woodland areas (85.2 % of Lantau) were mainly grasslands (observed from air photos of 1995 and during field visits) (Plate 7.4), usually found at the higher slopes and crest slopes. This was caused by the clearing of shrub and woodland by hillfires and strong prevailing winds (GCO, 1988b).

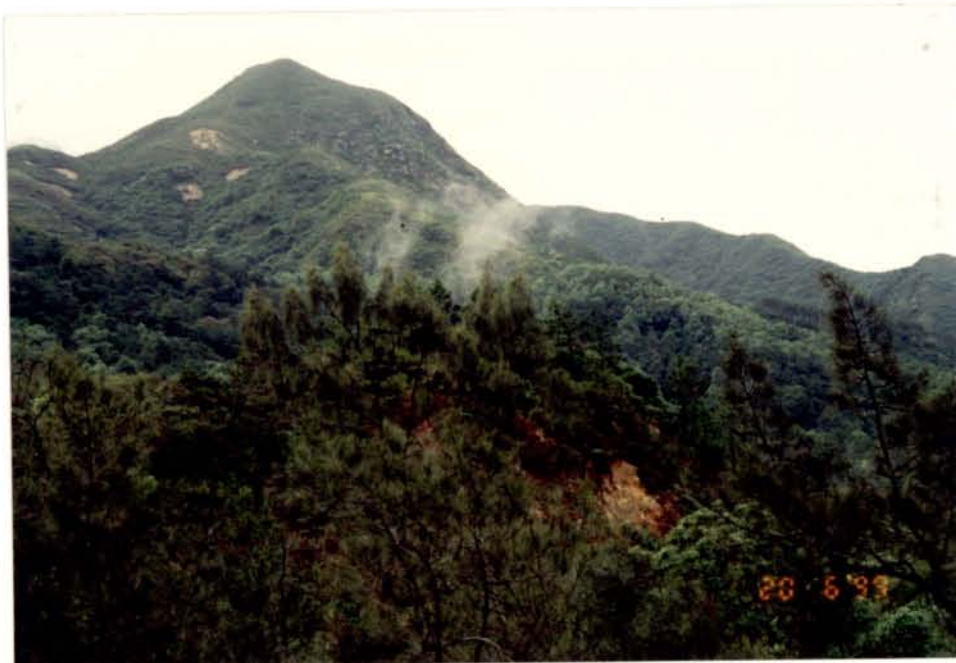
Plate 7.5. Landslides occurred on grassland upslope and woodland areas at foothill of Lantau Peak

= 0.98). This indicated that landslide occurrence had a slight tendency to concentrate on woodland areas. It was noted that 16.1% landslides occurred over the island took place at woodland area, which consisted 14.8% of Lantau Island. However, as the LQ of woodland and non-woodland areas (Plate 7.5, 7.6) was approximately near the value of 1, this indicated that the distribution of landslide on woodland and non-woodland areas was in equal proportion with their areal extent. In short, landslide distribution had insignificant relationship with woodland.

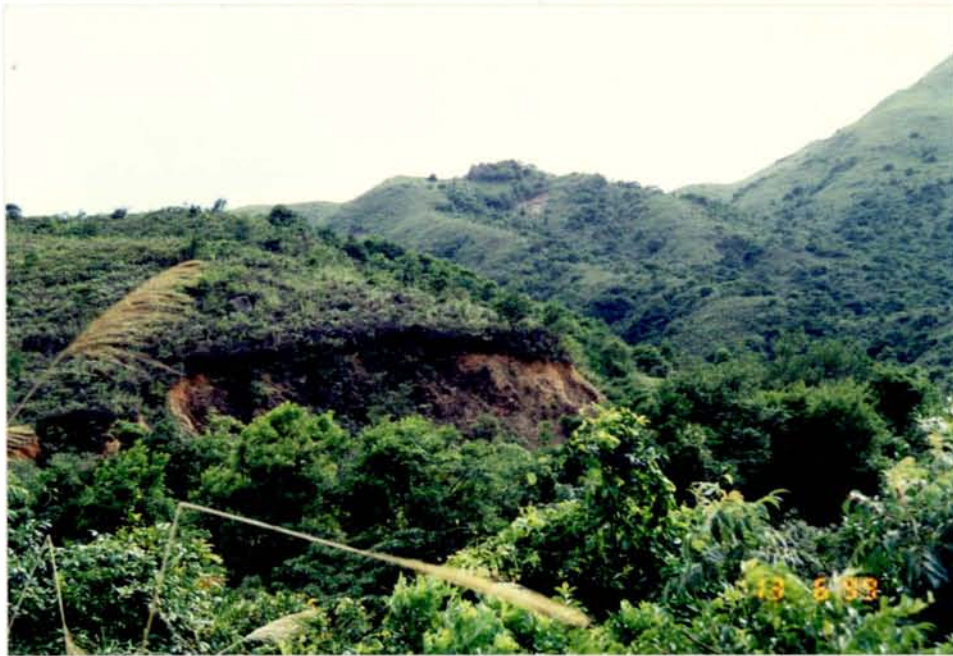
Plate 7.6. Landslide at shrubland under revegetation, the biggest landslide found beside Tung Chung Road

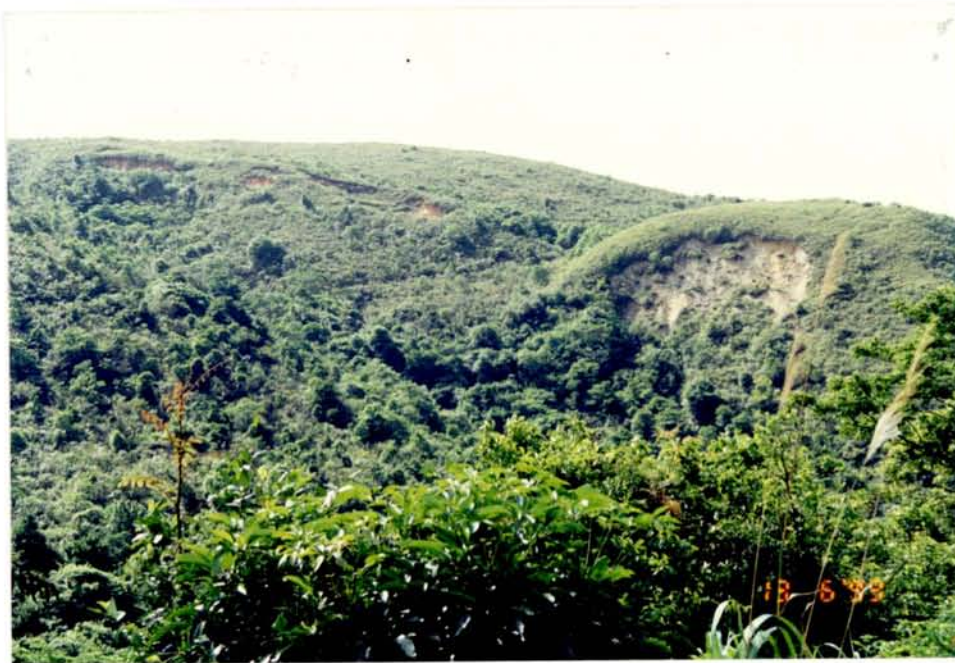
Plate 7.7. Landslide scar under revegetation on a steep slope beside Tung Chung Road

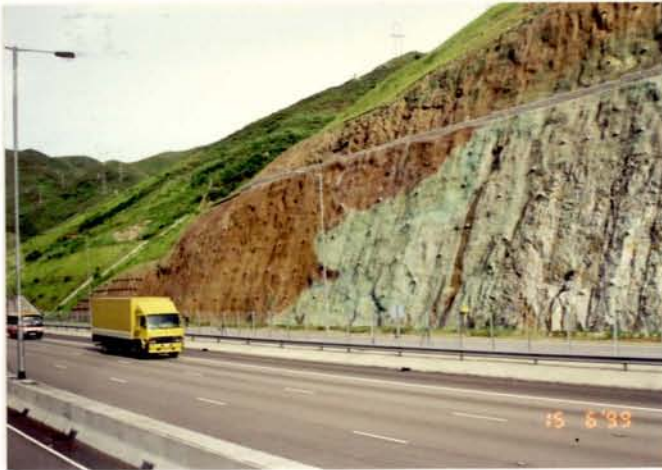
Plate 9.2. Steep roadcuts along the North Lantau Expressway

Another major human impact was noted at reclaimed land (consisted 2.54% of Lantau) (Figure 9.1). A long stretch of reclaimed land along the North coast of the island was caused by the construction of the North Lantau Expressway (Plate 9.2) and the

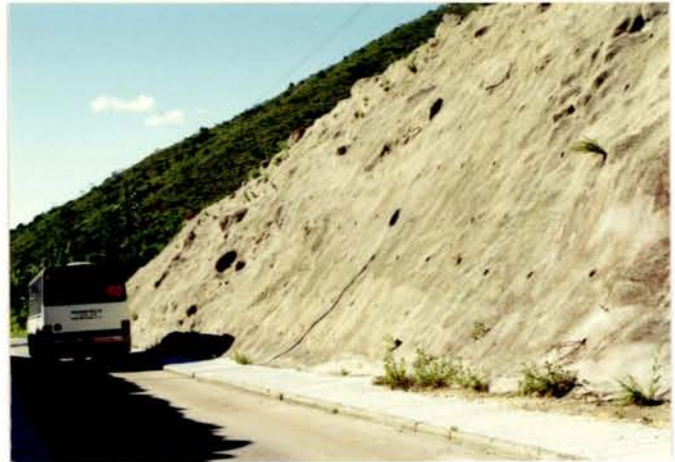
Plate 9.3. Roadcuts along Tung Chung Road

airport railway linked with the New International Airport. Reclaimed land was also found at the coast of Penny's Bay associated with a shipyard. Other human structures were less significant in areal terms, including roads, roadcuts (Plate 9.3) and reservoirs.

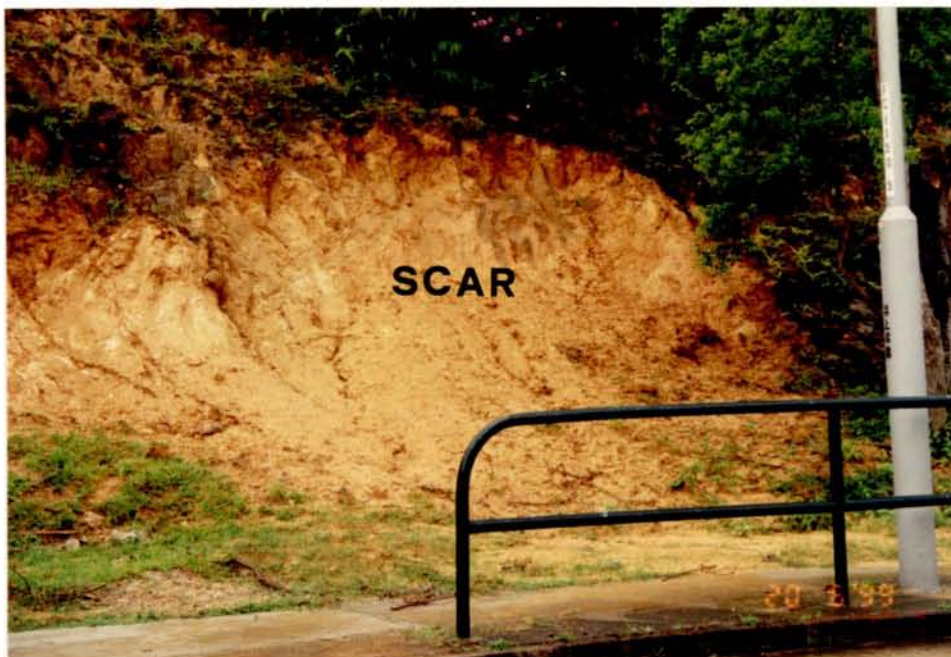
Plate 9.4. Landslide along a roadcut at South Lantau Road exposing deeply-weathered reddish-brown soil.

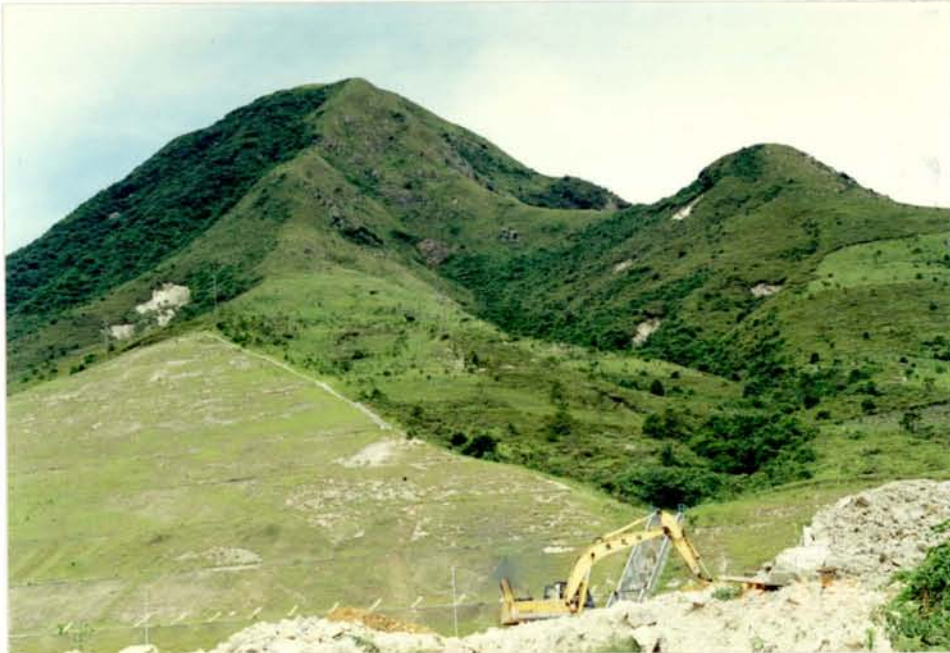
Plate 9.5. Landslides on natural hillslopes above a roadcut, Tung Chung

Regarding to the spatial distribution of landslides, it was noted that landslide distribution had very low correlation with human influenced areas. Majority of landslides did not occur on man-made features though many landslides located around those

features (Figure 9.1) (Plate 9.5). However, some high landslide density areas did locate near human settlements, such as Tung Chung (Plate 9.6) and Ngong Ping.

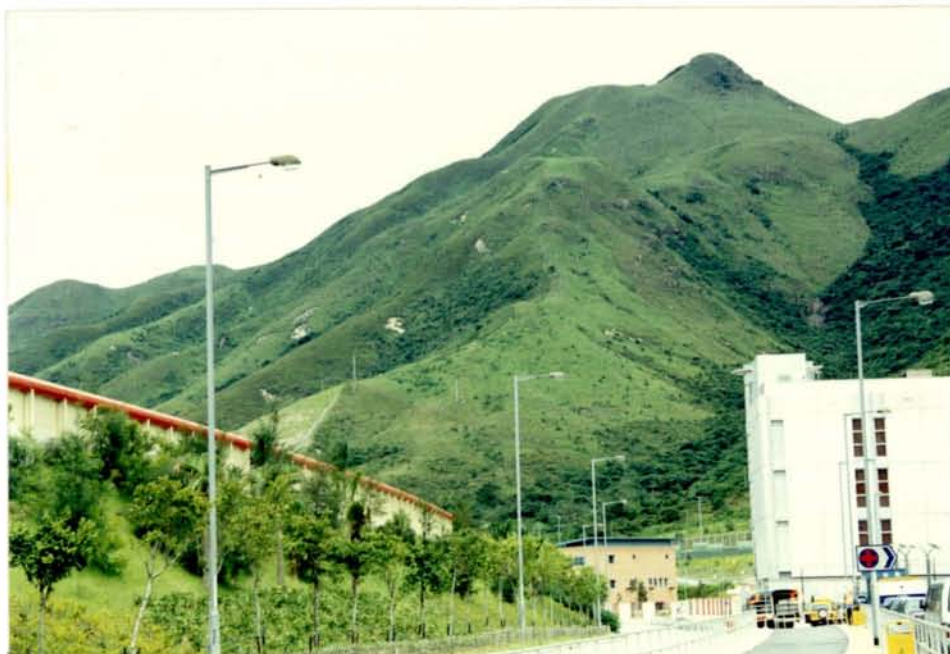
Plate 9.6. Hillslopes near Tung Chung New Town have high landslide density

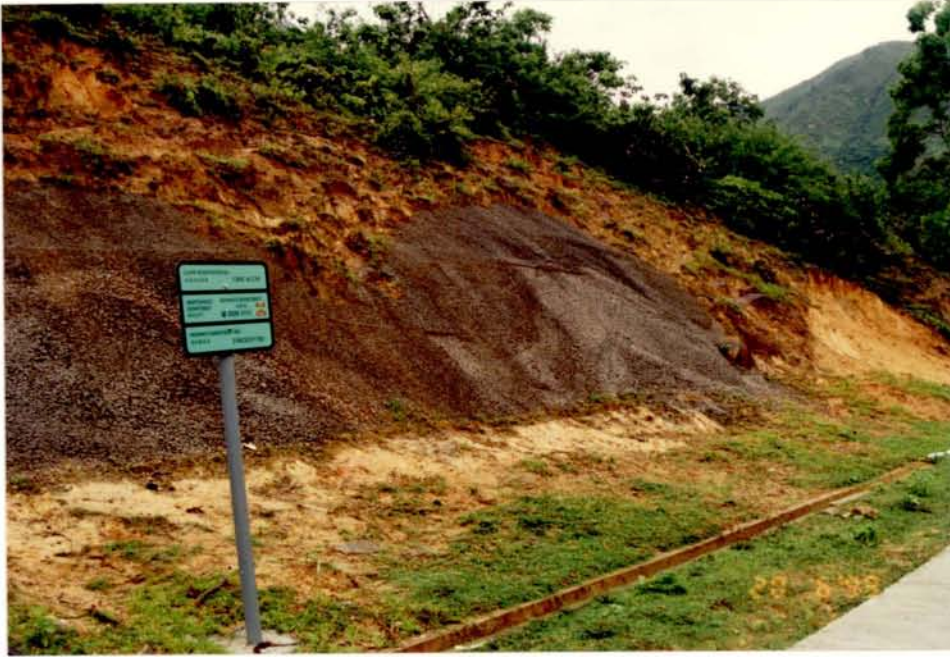
Plate 9.7. The roadcut slope was not properly protected by shotcrete, at South Lantau Road

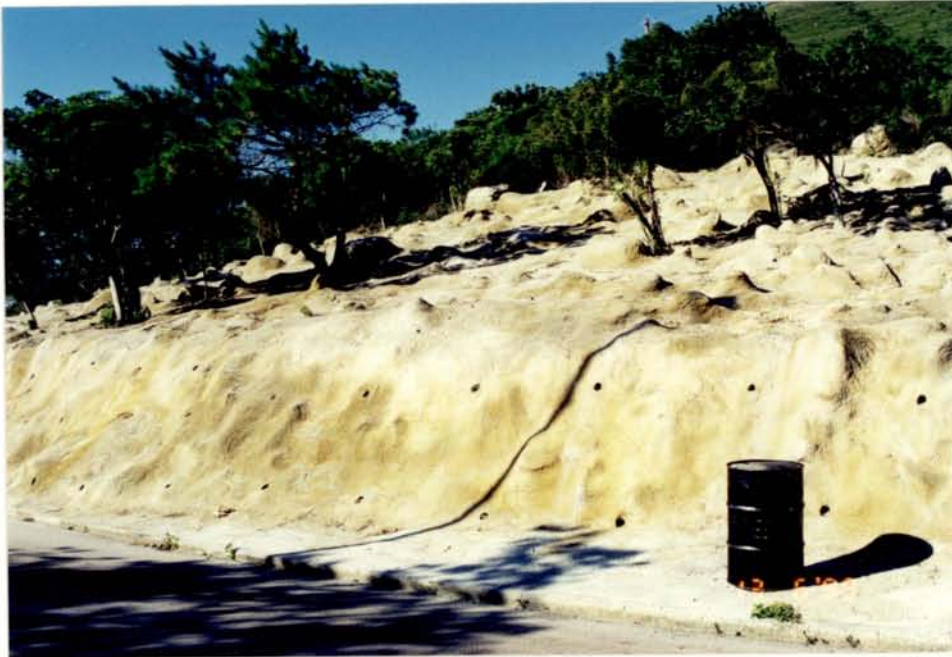
Plate 9.8. A newly-repaired roadcut slope with numerous surface drainage, at Tung Chung Road
