Monitoring Slope Failure at Kadoorie Agricultural Research Centre with a 3D Laser Scanner

Andrew Wong, Alan K. L. Kwong and Jacky Ng, Hong Kong SAR, China

Key words: Fill slope, soil nail, instrumentation, slope failure, movement monitoring, 3D laser scanner

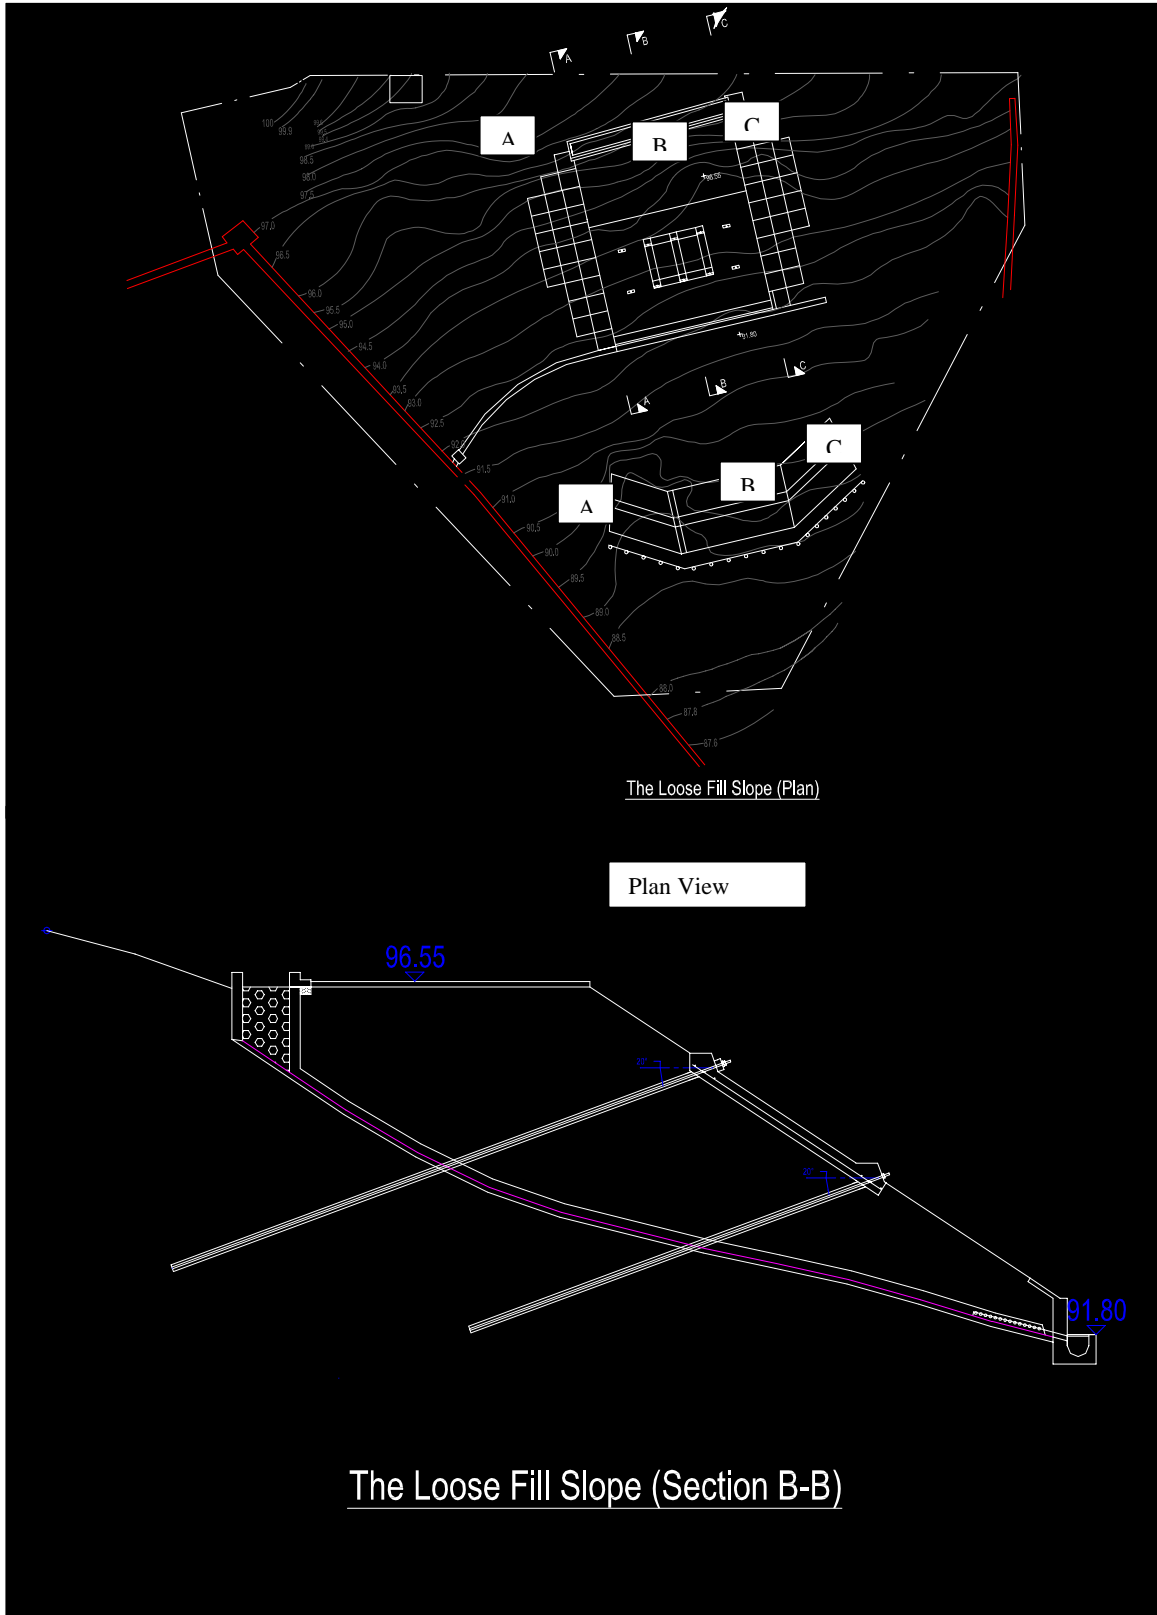
Figure 1 Plan and Section of Installed Soil Nails

Two rows of grouted nails were installed at a grid of 1.5 m x 1.5 m at an inclination of 20° from the horizontal. Holes of 100 mm diameter with two different lengths (8 m and 6 m) were drilled. A 25 mm diameter steel ribbed bar was inserted into each hole and the hole was filled with grout from the bottom up using a plastic hose. Figure 1 shows the plan and cross sectional view of the installed soil nails in the slope.

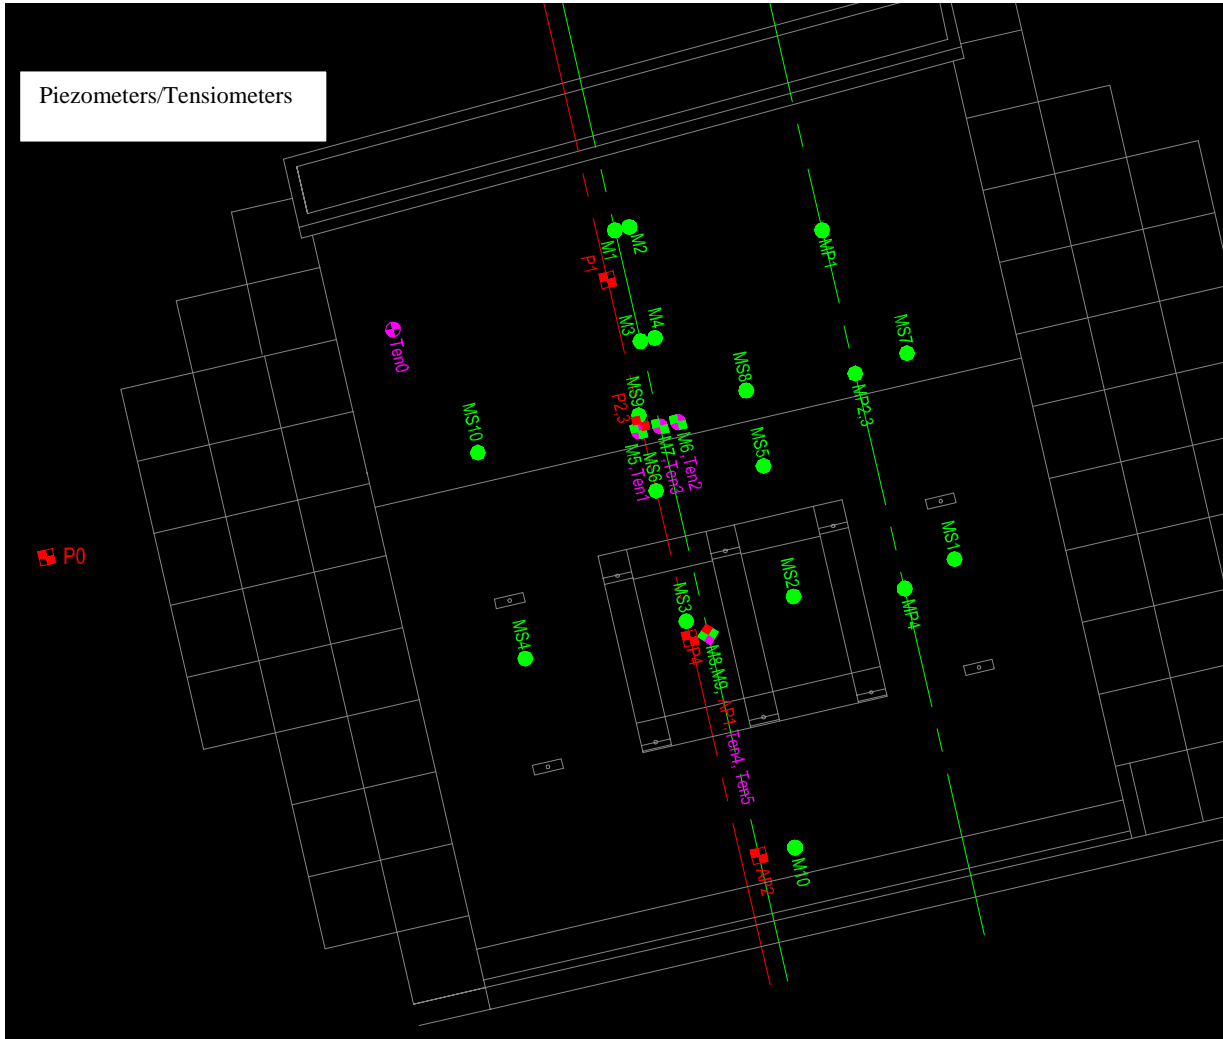
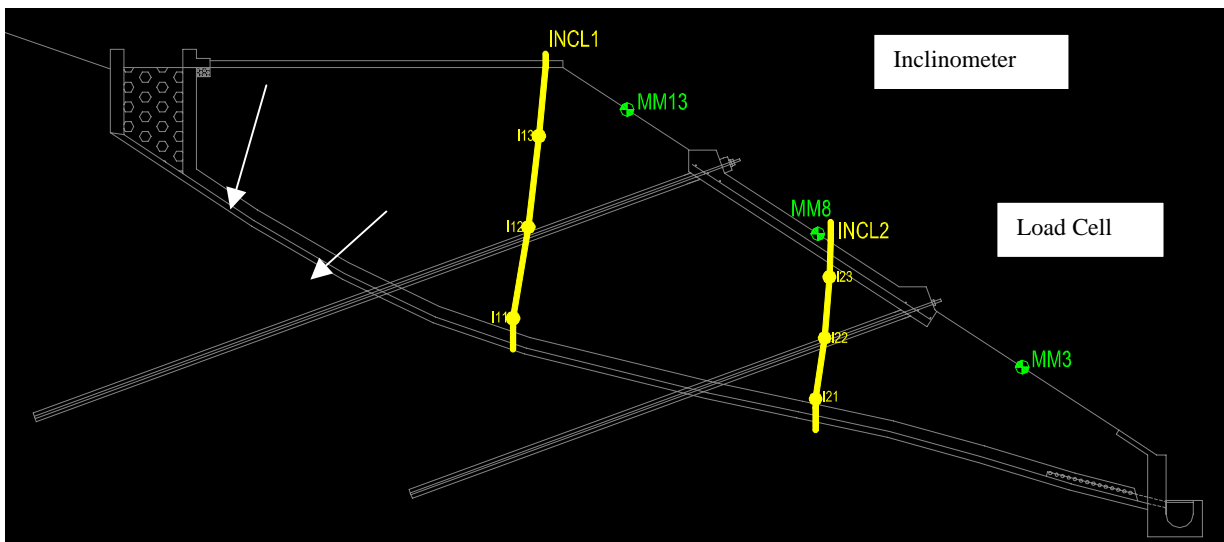
Figure 2 Instrumentation Details

Instrumentation comprised of 2 nos. of in-place inclinometer strings (a total of 6 measuring elements), 7 nos. of vibrating wire piezometers, 24 nos. of soil moisture probes and 6 nos. of tensiometers, 6 nos. of vibrating wire earth pressure cells, 2 nos. of load cells, 46 nos. of vibrating wire strain gauges, 12 nos. of flow meters and 2 nos. of automatic data loggers. Figure 2 shows the plan and cross sectional view of the instrumentations.

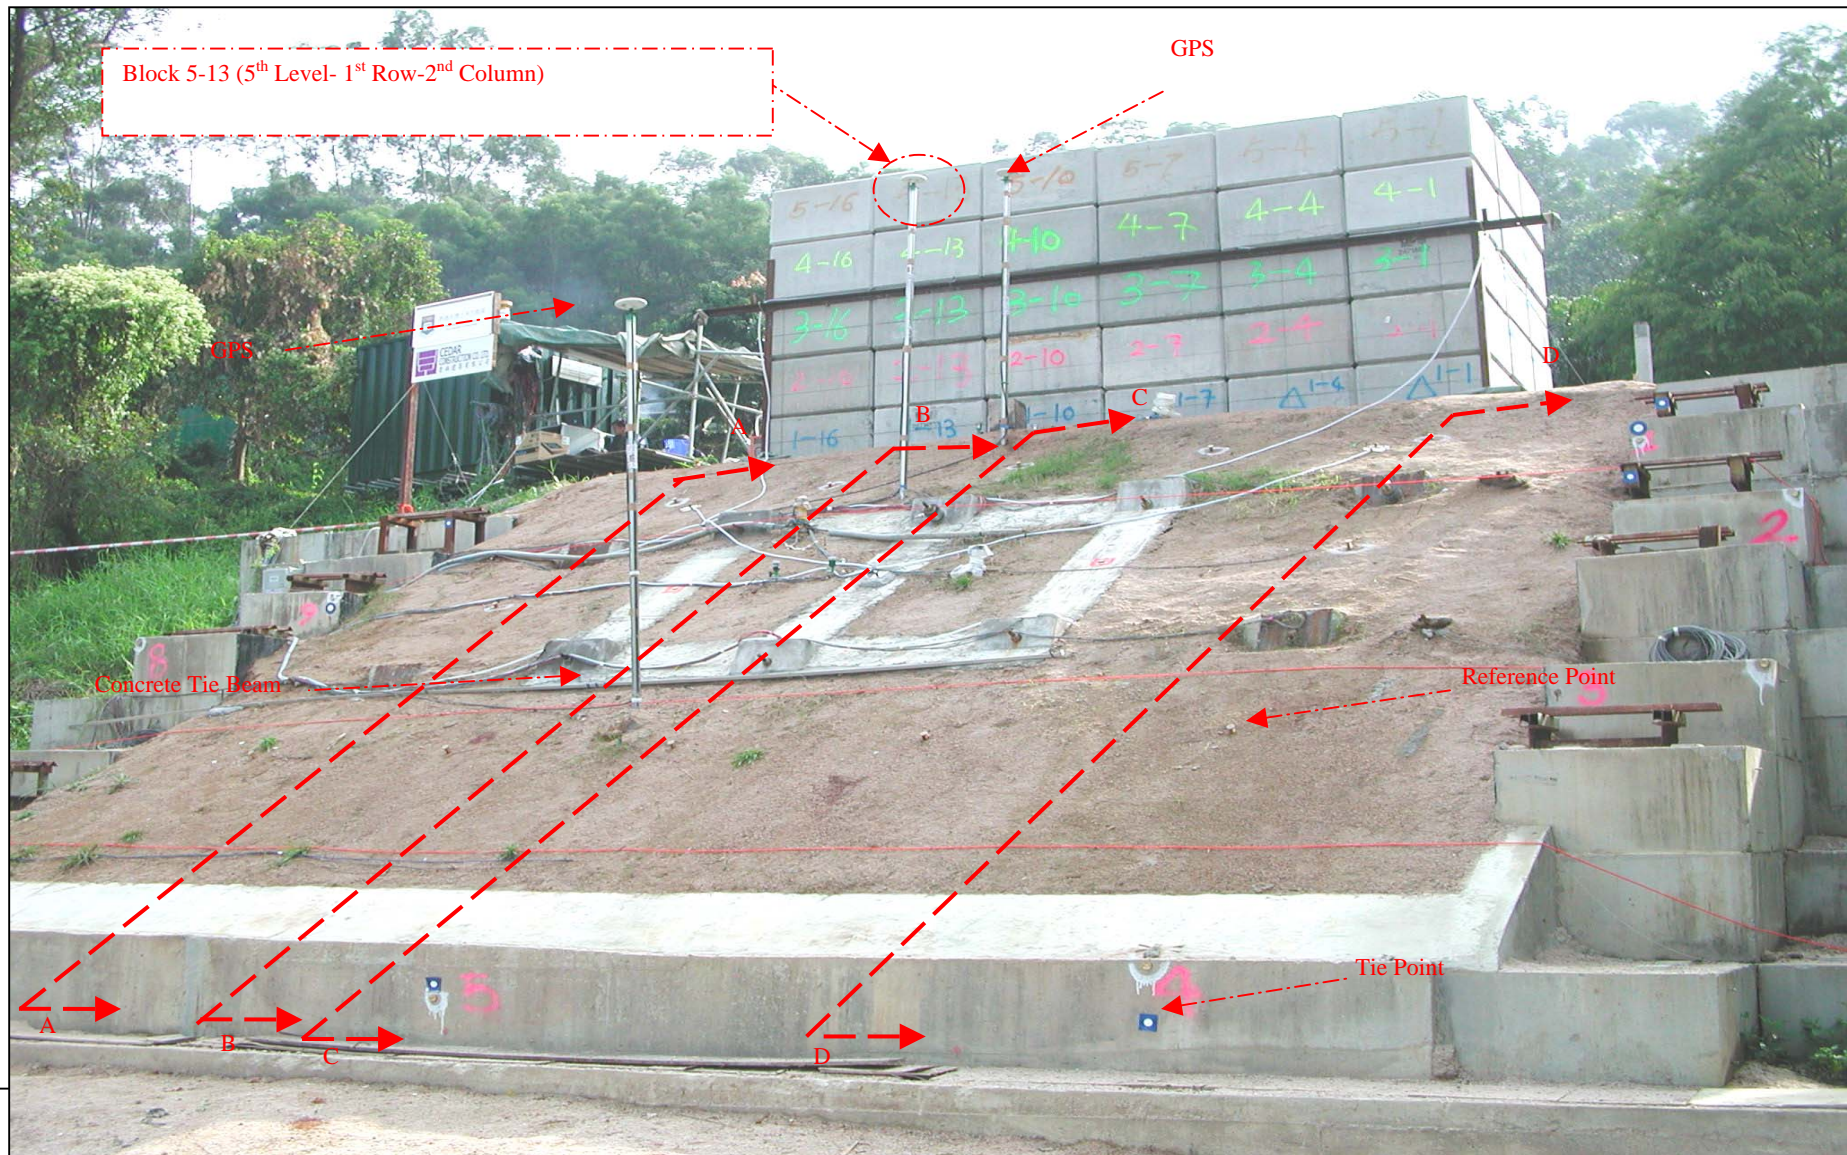
Figure 3 General Layout of Slope at Agricultural Research Centre with a 3D Laser Scanner

The general view of the slope surface is presented on Figure 3. In this figure, the location of GPS, concrete tie beam, settlement reference points, scanner tie points and reference cross sections are shown. Figure 4 shows the point cloud (3D scene) taken at 0930hr, 23 November 2002, before the groundwater table was raised and toppling of the surcharge blocks. Details of the surcharging and program of inducing rise in groundwater table and subsequent failure of the blocks can be found in Li (2003). In order to capture the surface movement with time during the induced rise in groundwater table, the slope surface was scanned at half an hour interval and each scan was referenced to the same tie points as those shown on Figures 3 and 4. Since the tie points were stationary and each scan was referenced to the same local coordinate system, therefore it was possible to record the change in point cloud positions with time. In this paper, only cross sectional profile A-A (with a close-up view of the point cloud on Figure 5) is presented to demonstrate that movement of 28 mm

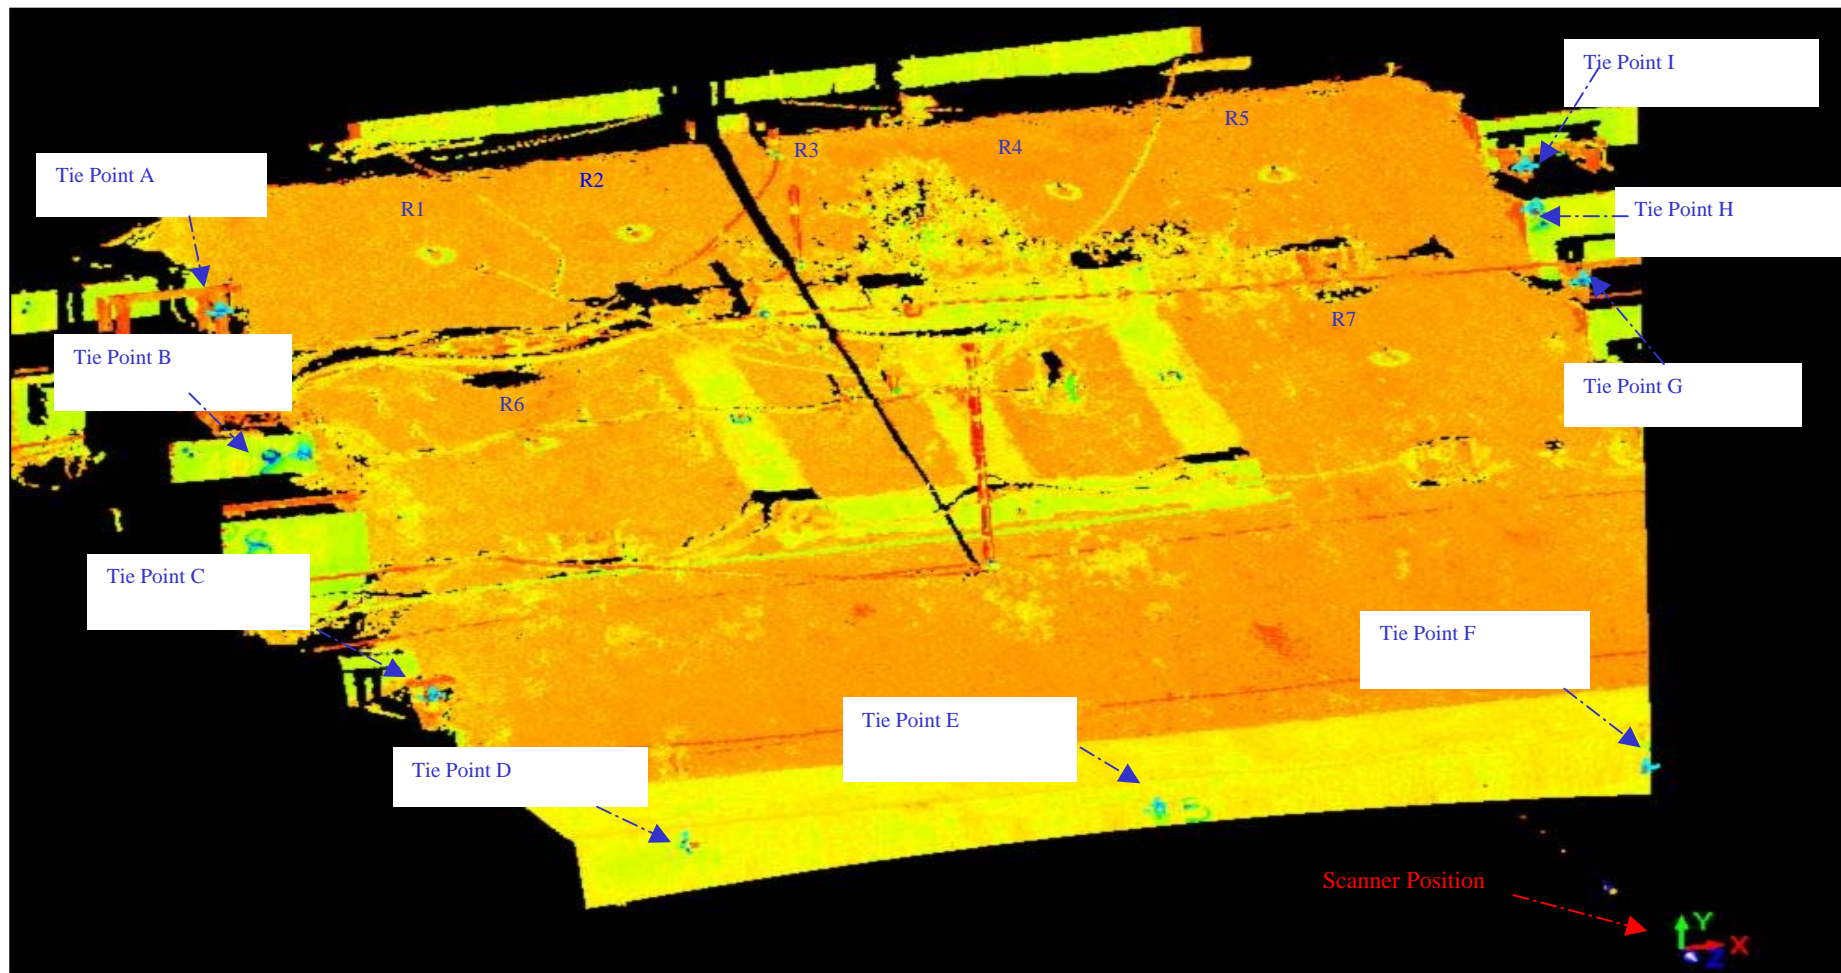
Figure 4 Overall View at 0930 hr, 23 November 2002

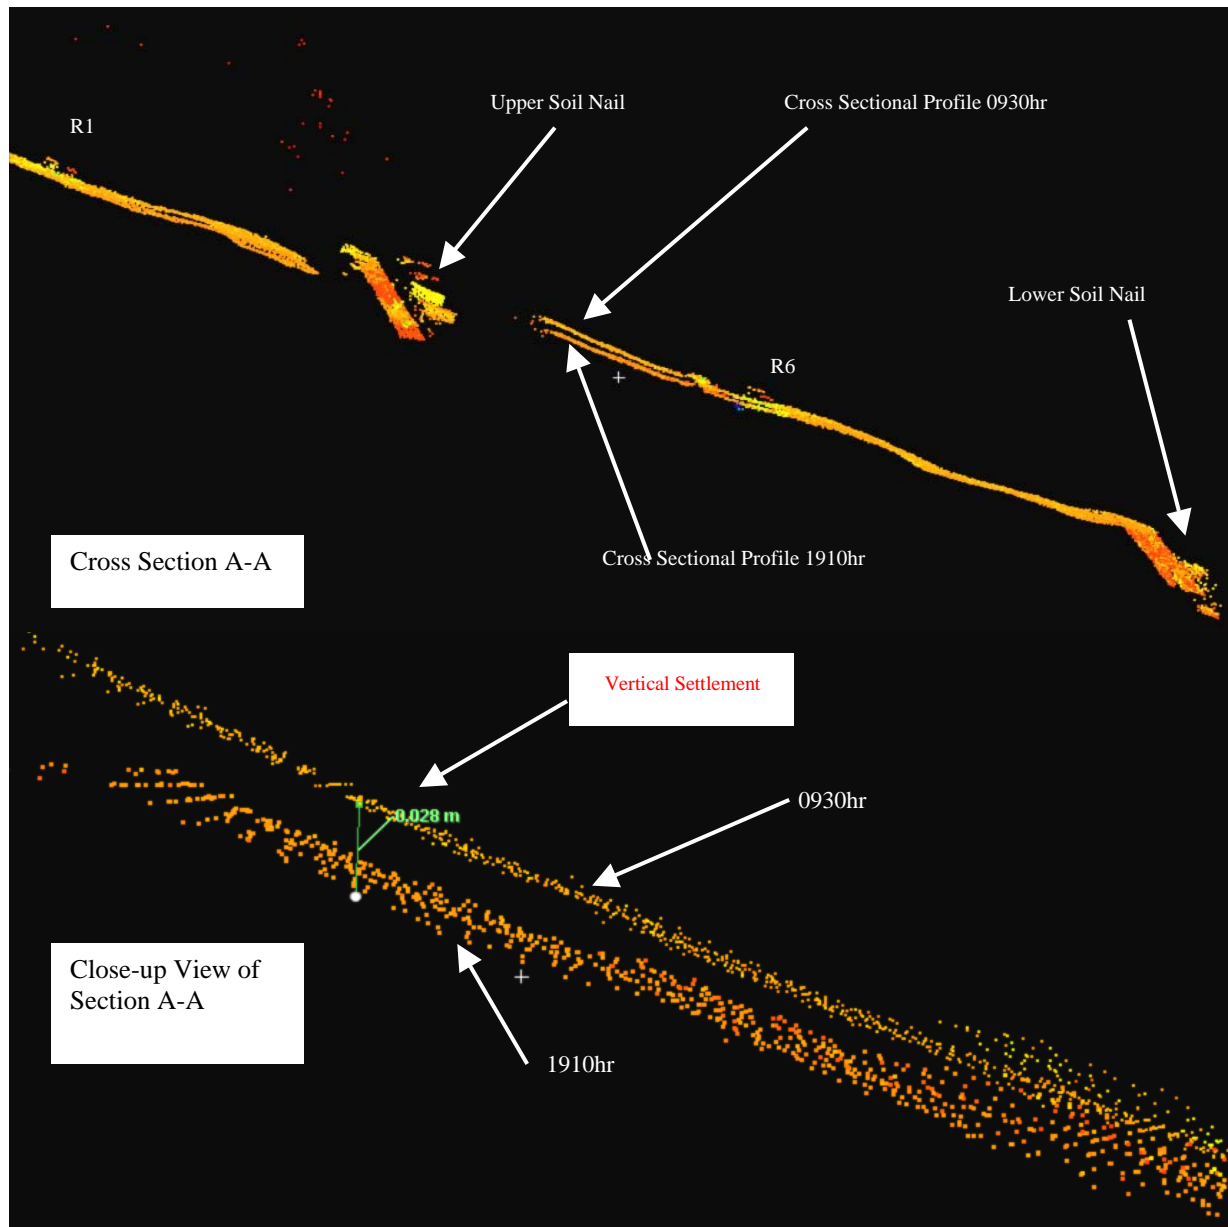
Figure 5 Point Cloud between Upper Soil Nail and R6

had occurred at the slope surface between 0930hr and 1910hr. The regression analysis shows that the positions of the tie points between each scan was less than 2 mm, thus indicating that high accuracy was achieved for the point cloud at each scan and that the recorded movement of 28 mm at this point was real movement of the slope surface between this time interval.

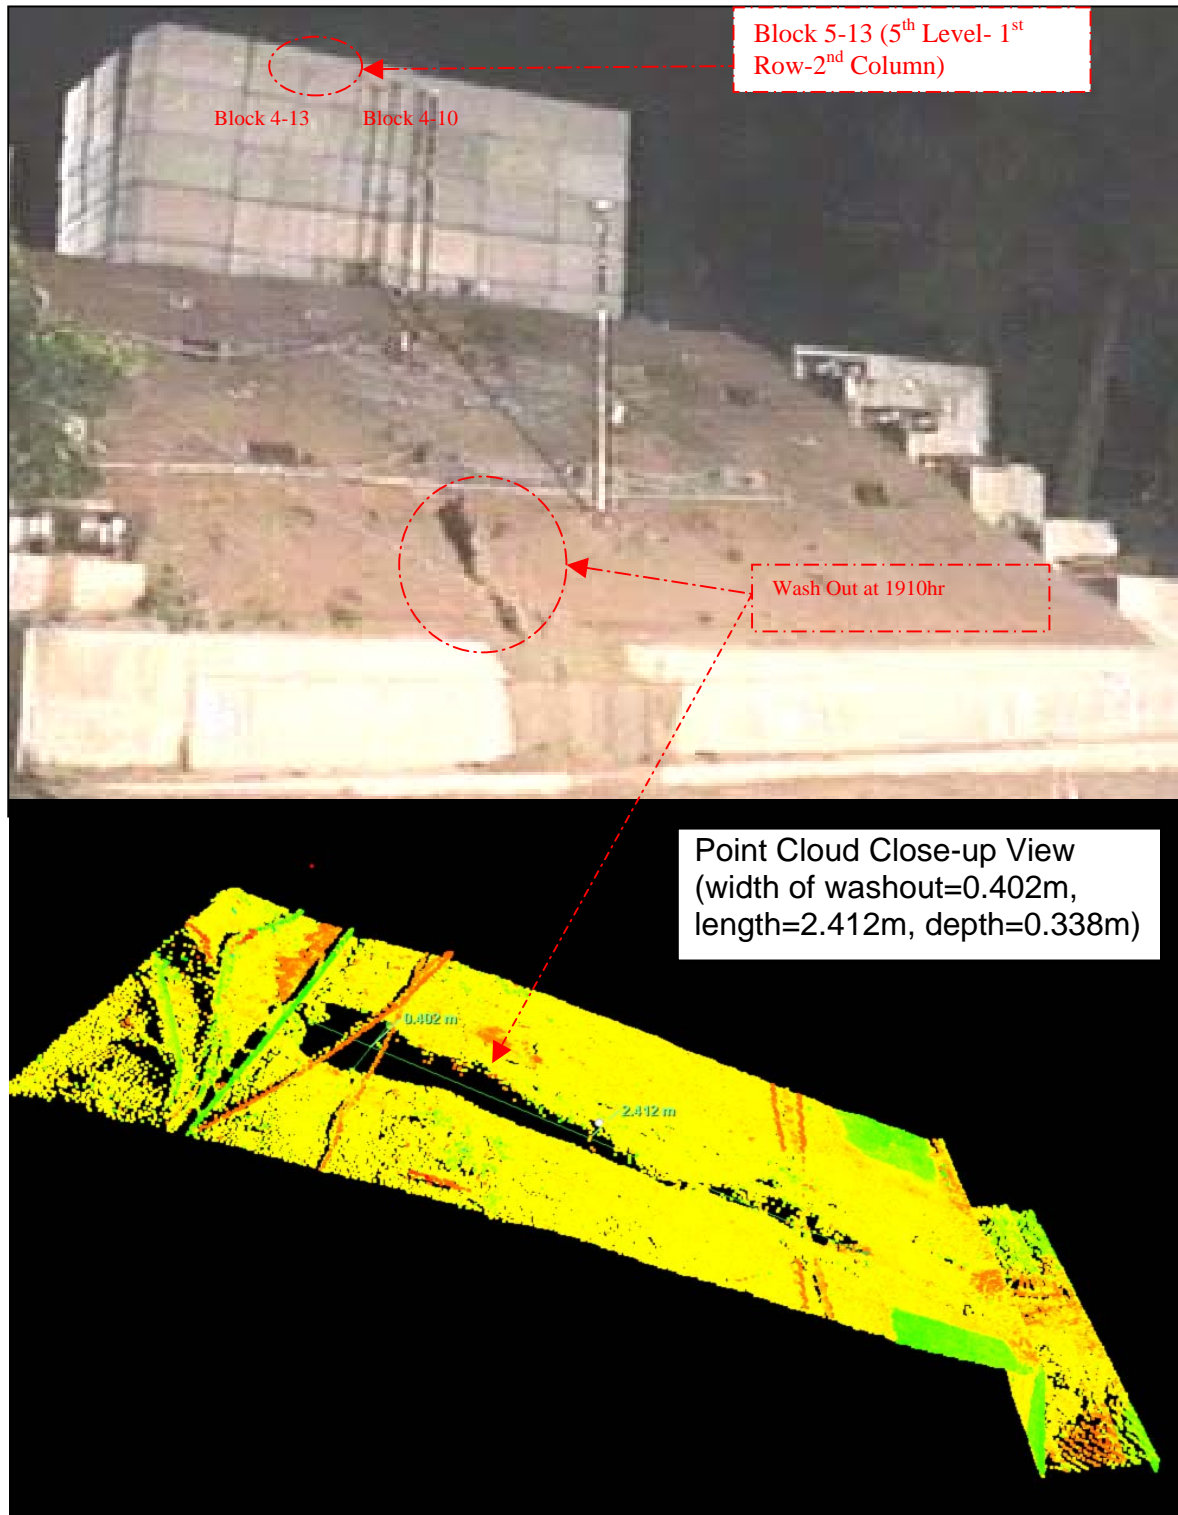
Figure 6 Washout observed at 1910hr, 23 November 2002

When the groundwater table was further increased and the sprinkler system was continuously stimulating rainfall infiltration to the slope, a large washout was observed and the scanner had safely captured the shape and dimension of this washout. Figure 6 shows the close-up view of the point cloud at 1910hr (23 November 2002) and the dimensions of the washout (maximum width=0.402 m, maximum length=2.412 m, maximum depth=0.338 m). The front row of the concrete surcharge blocks had started to move very slowly, showing signs of tilting at this time. The concrete blocks could have tumbled down the slope at any moment and manual measurement of the washout would have been too risky. This demonstrates that the use of remote scanning technique in capturing movement, position and depth of scouring/washout in an inaccessible and distressing slope has definite advantages over manual measurement.

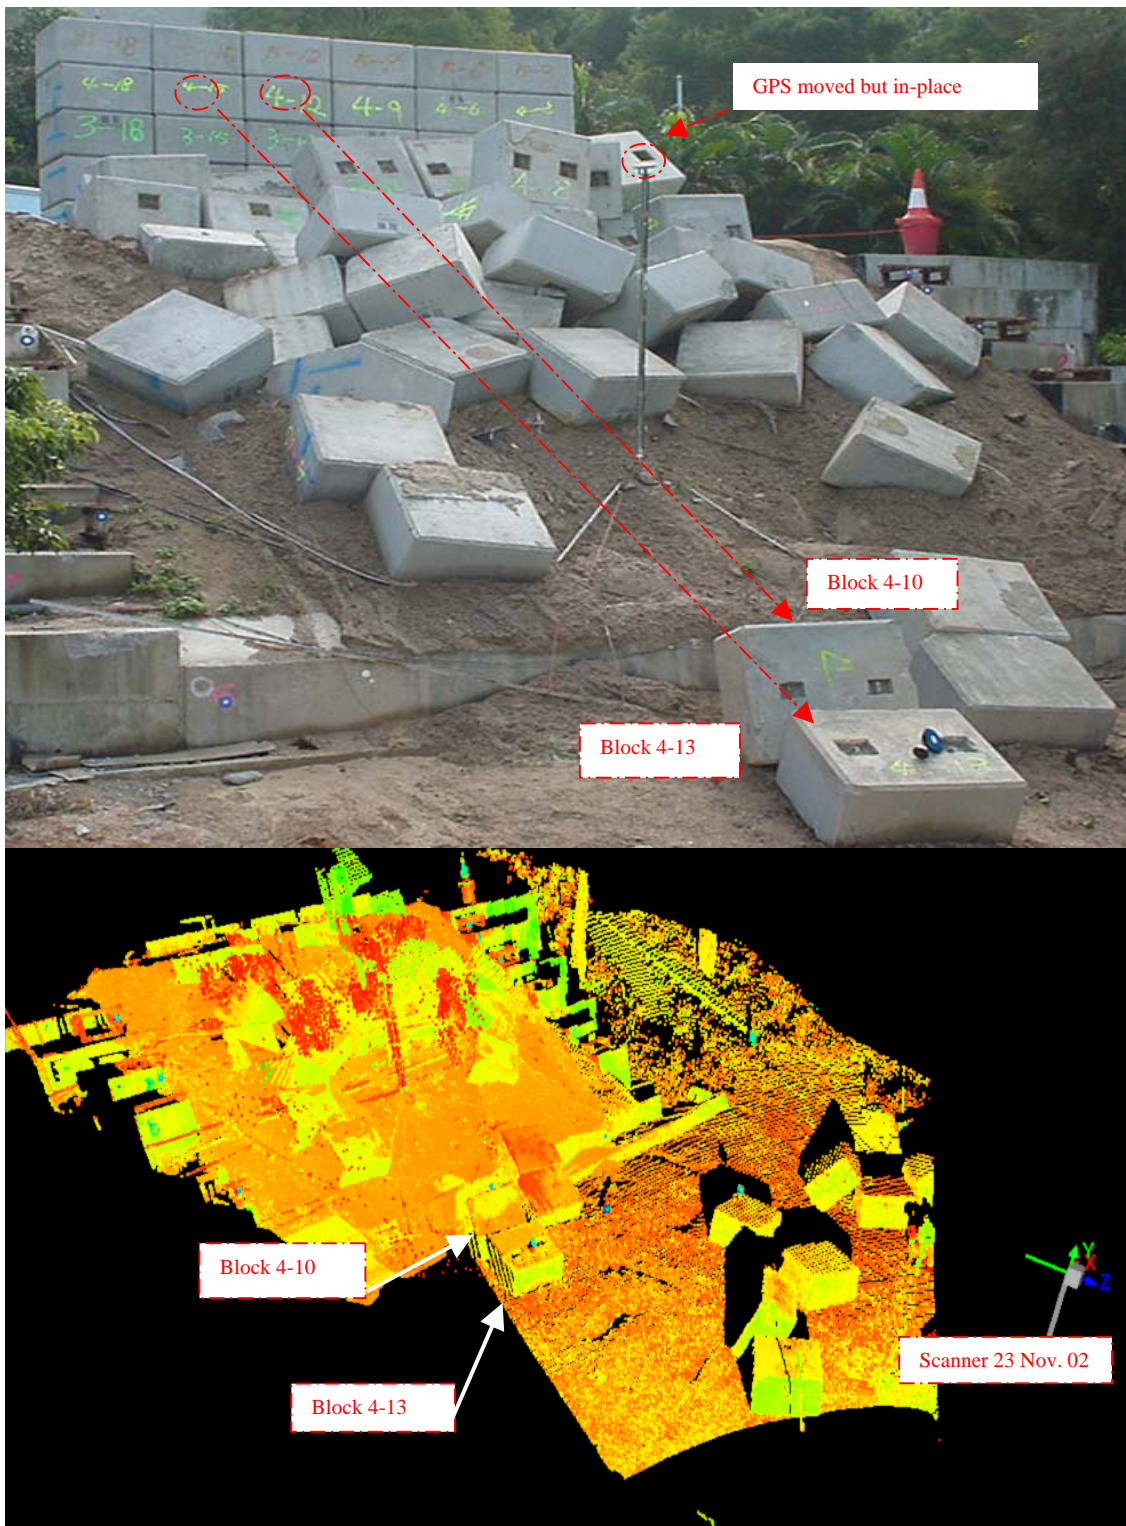
Figure 7 Blocks Topped at 1930hr and Point Cloud

Groundwater table continued to rise and the concrete blocks finally tumbled down the slope at 1930 hr (23 November 2002). Significant movement had now occurred on the slope and the GPS had displaced laterally due to the movement of the slope and the falling of the blocks. Figure 7 shows the locations of the blocks and the point cloud provides a clear identification of the positions of various blocks after failure. The vertical and horizontal travel distances of each individual blocks can be easily calculated by comparing the positions of the block corners before and after failure of the slope.

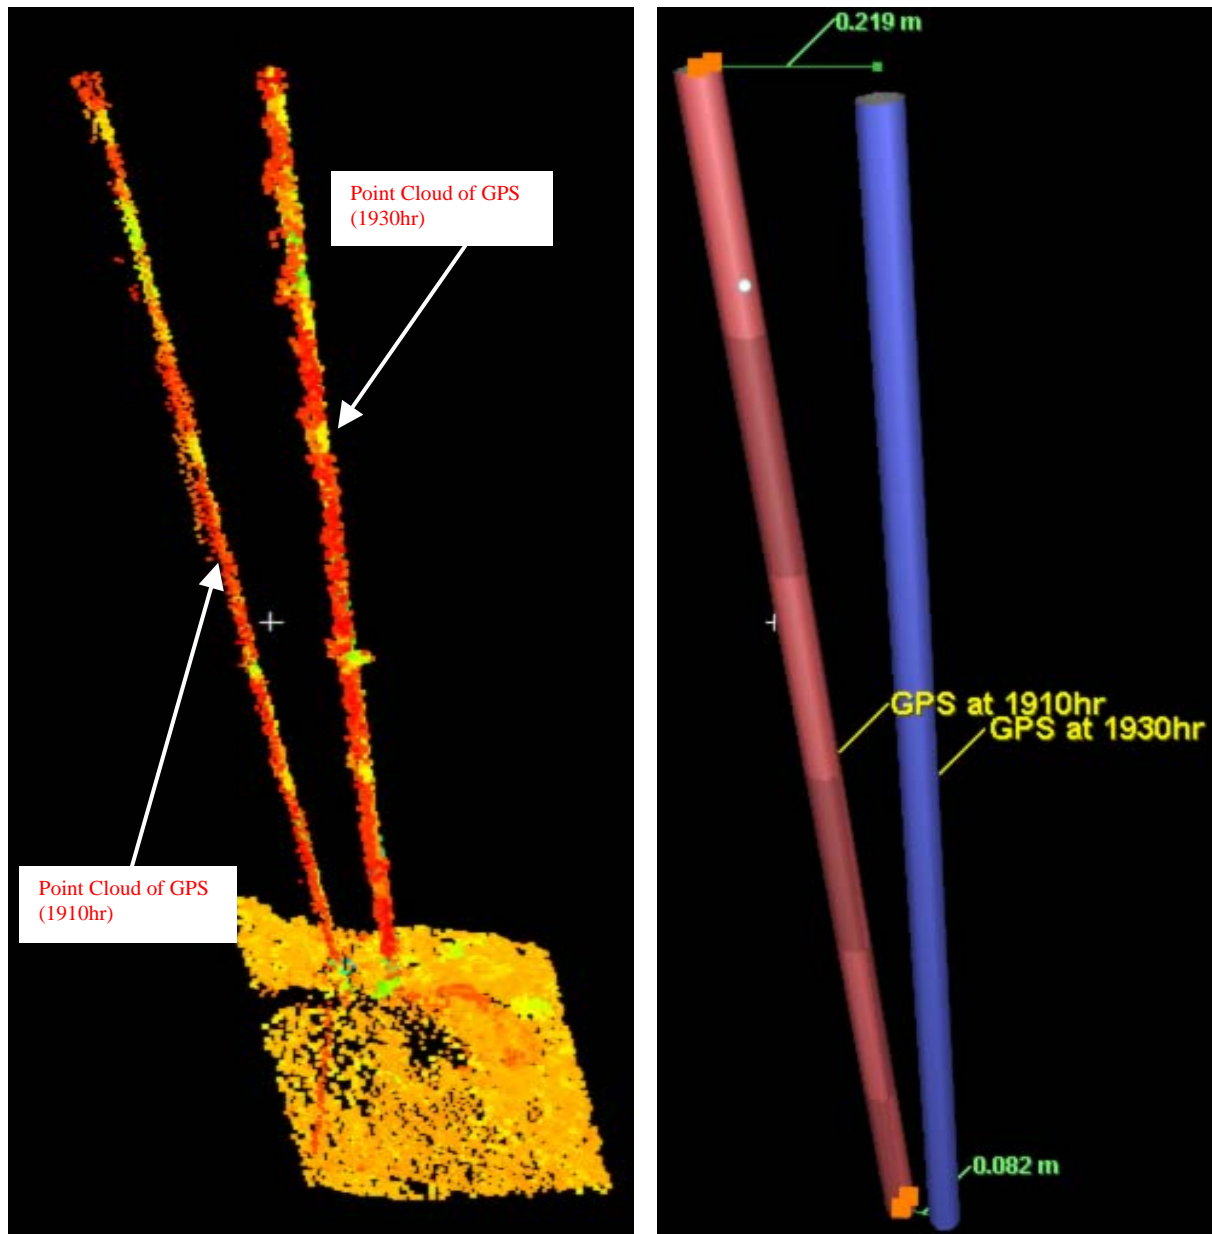
Figure 8 Modelling of GPS Positions

It is noted that the GPS position had moved significantly due to the falling of the blocks. Since the GPS pole has a cylindrical shape, therefore the point cloud of the GPS can be easily modeled into a cylinder, providing the best-fit geometry intersecting and representing all the points. This is illustrated on Figure 8, which compares the point clouds and the cylindrical models of the GPS at 1910hr (before blocks tumble) and 1930hr (after blocks tumble). It is clearly seen that the GPS had moved 0.219 m at the top and 0.082 m at the bottom between this time intervals. The advantage of the modeling is that the centerline of the GPS is used as the reference line for comparing the movement occurred.
