Title	Cutout of proximal femoral nail antirotation resulting from blocking of the gliding mechanism during fracture collapse
Author(s)	Cheung, JPY; Chan, CF
Citation	Journal of Orthopaedic Trauma, 2011, v. 25 n. 6, p. e51-e55
Issued Date	2011
URL	http://hdl.handle.net/10722/173999
Rights	This is a non-final version of an article published in final form in Journal of Orthopaedic Trauma, 2011, v. 25 n. 6, p. e51-e55

1 Cut-out of PFNA Due to Blocking of the Gliding Mechanism During Fracture 2 Collapse

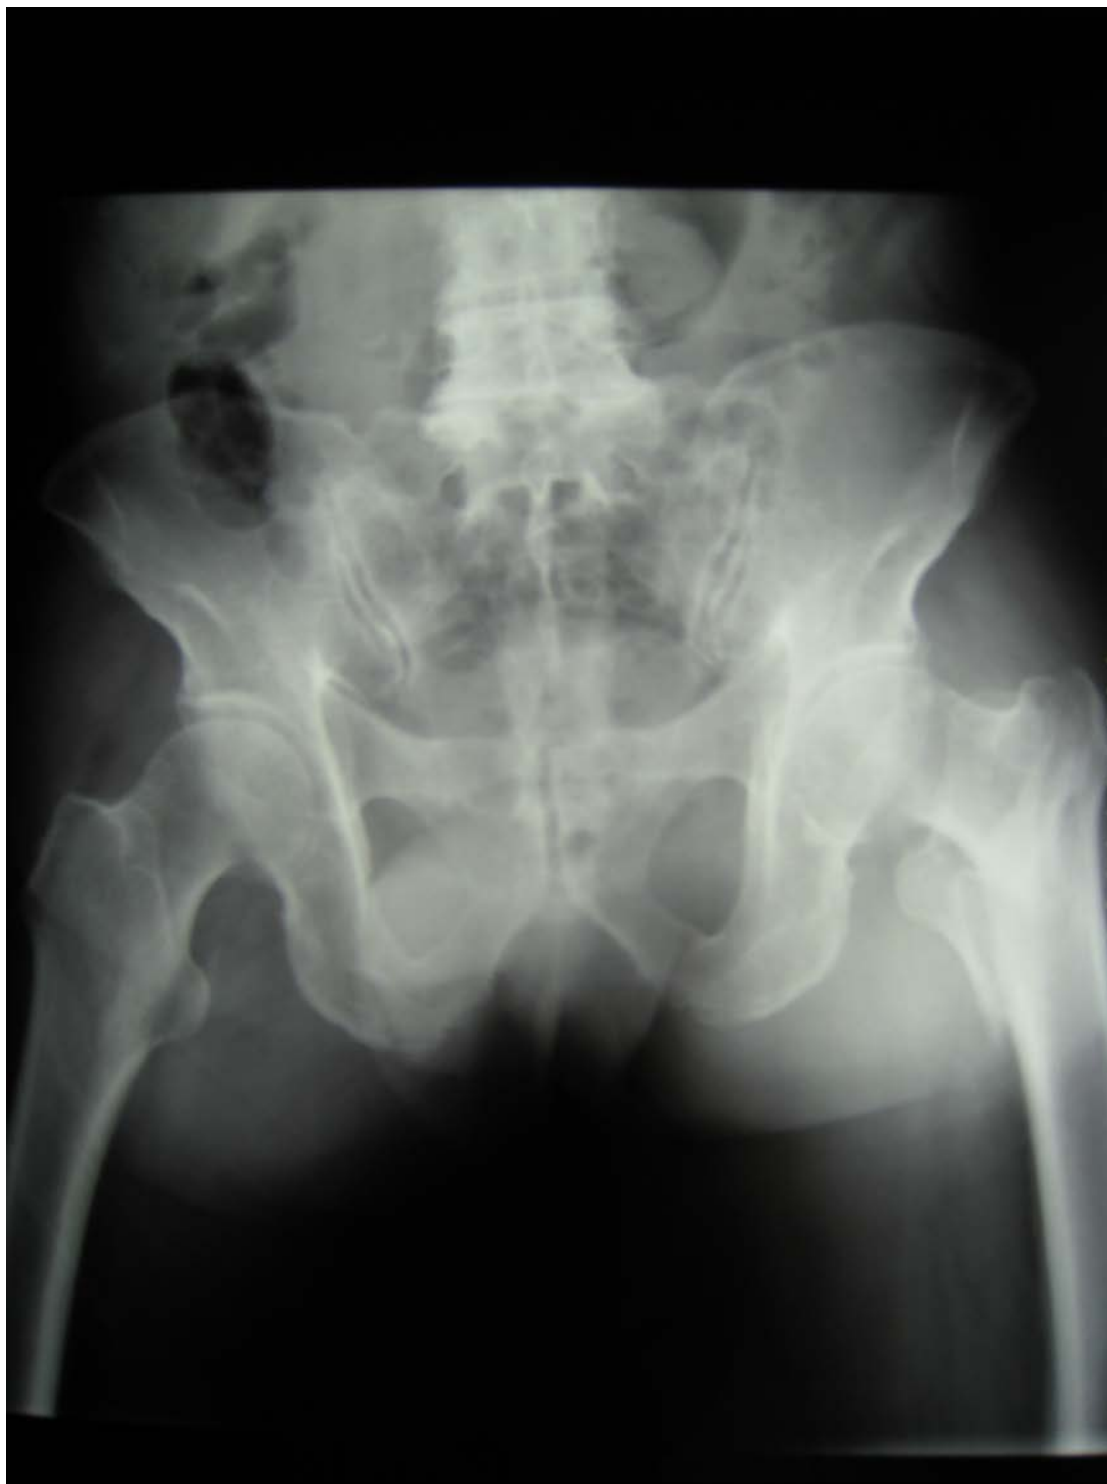
191 Figure 1a (Pelvis Injury Film)

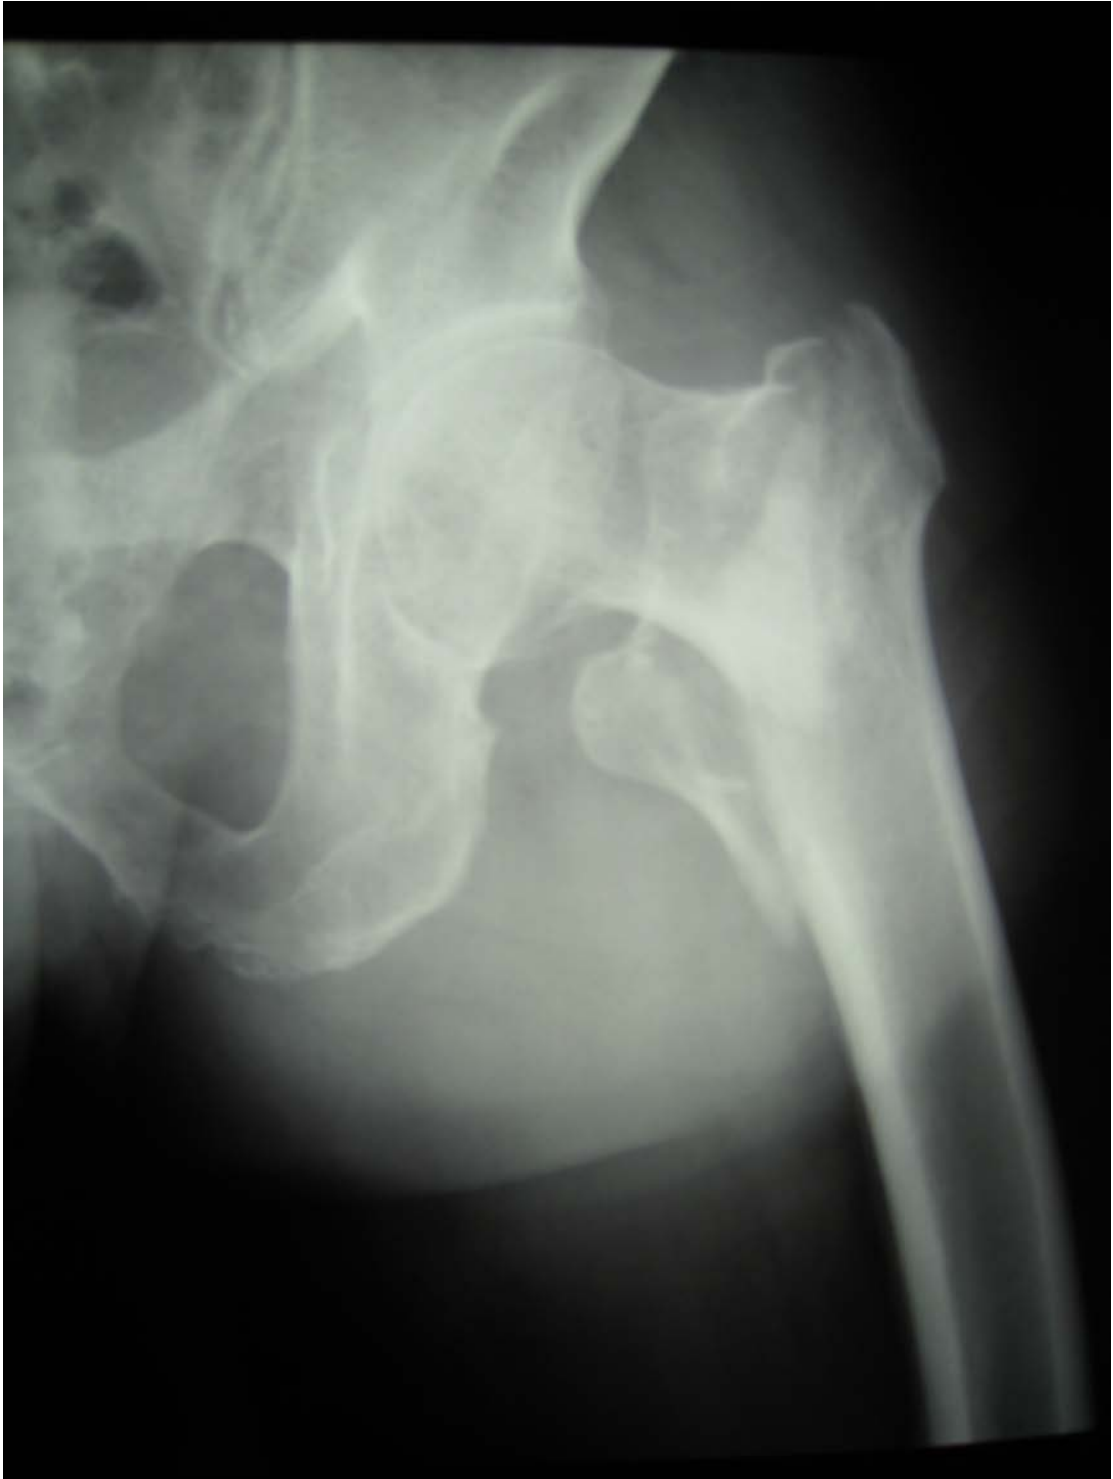
196 Figure 1b (AP Injury Film)

36 An 81 year-old man in good health and unaided ambulation was admitted to our
37 unit after a slip and fall resulting in an OTA 31A-2.2 trochanteric fracture of the left
38 hip (figures 1 and 2). An operation was performed on the first day after admission and

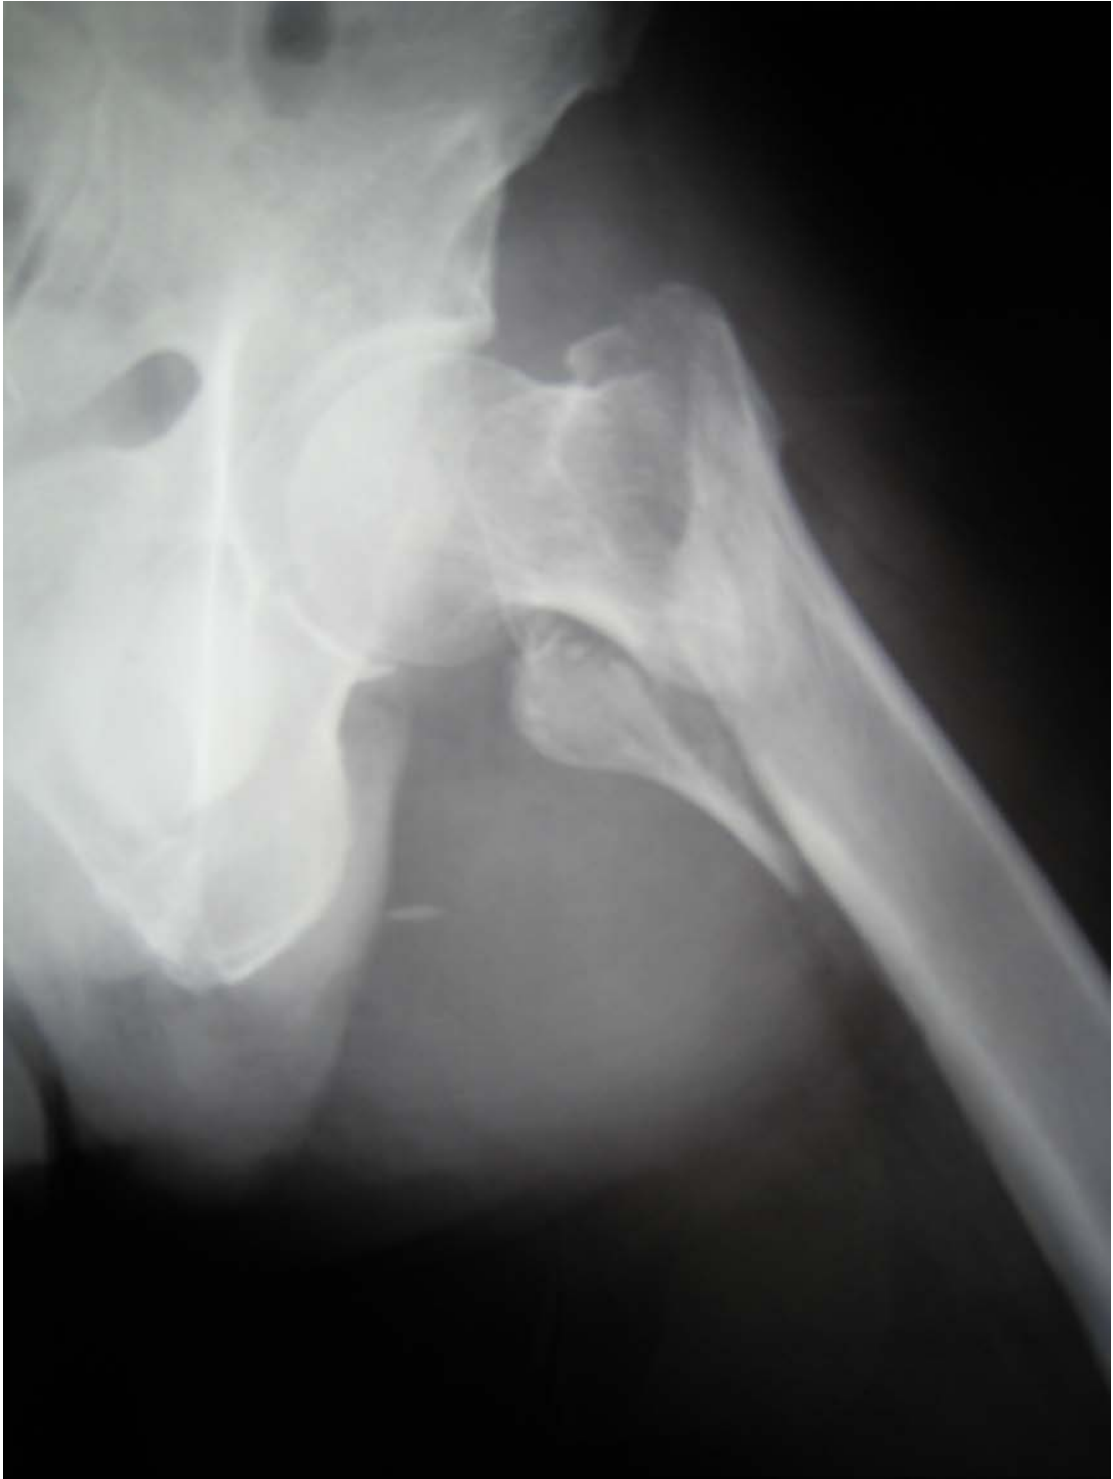
201 Figure 1c (Lateral Injury Film)

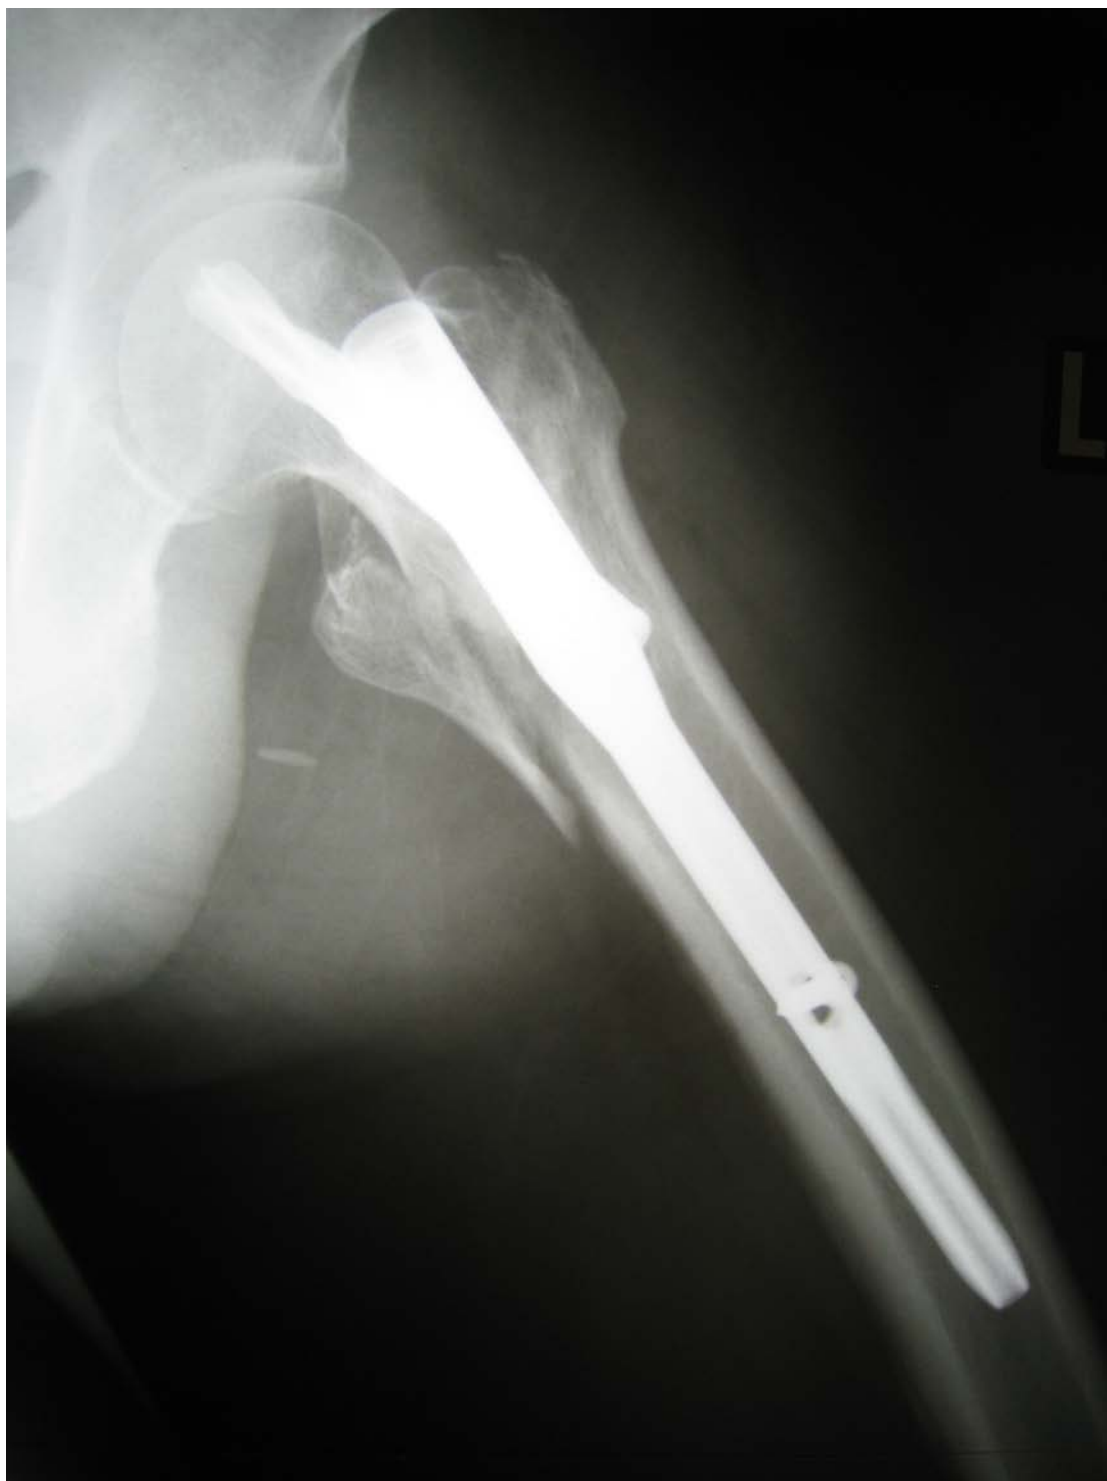
211 Figure 2b (Lateral Post-operative X-ray)

39 a PFNA was inserted due to the large postero-medial fragment. Postoperative x-ray
40 (figures 3 and 4) showed satisfactory alignment with a tip-apex distance of 16mm, a
41 neck-shaft angle (AP) of 128 degrees and Garden alignment index of 166 degrees in
42 the anterior-posterior (AP) view and 178 degrees in lateral view. The placement of the
43 helical blade was at the center of the femoral head in both the AP and lateral views.

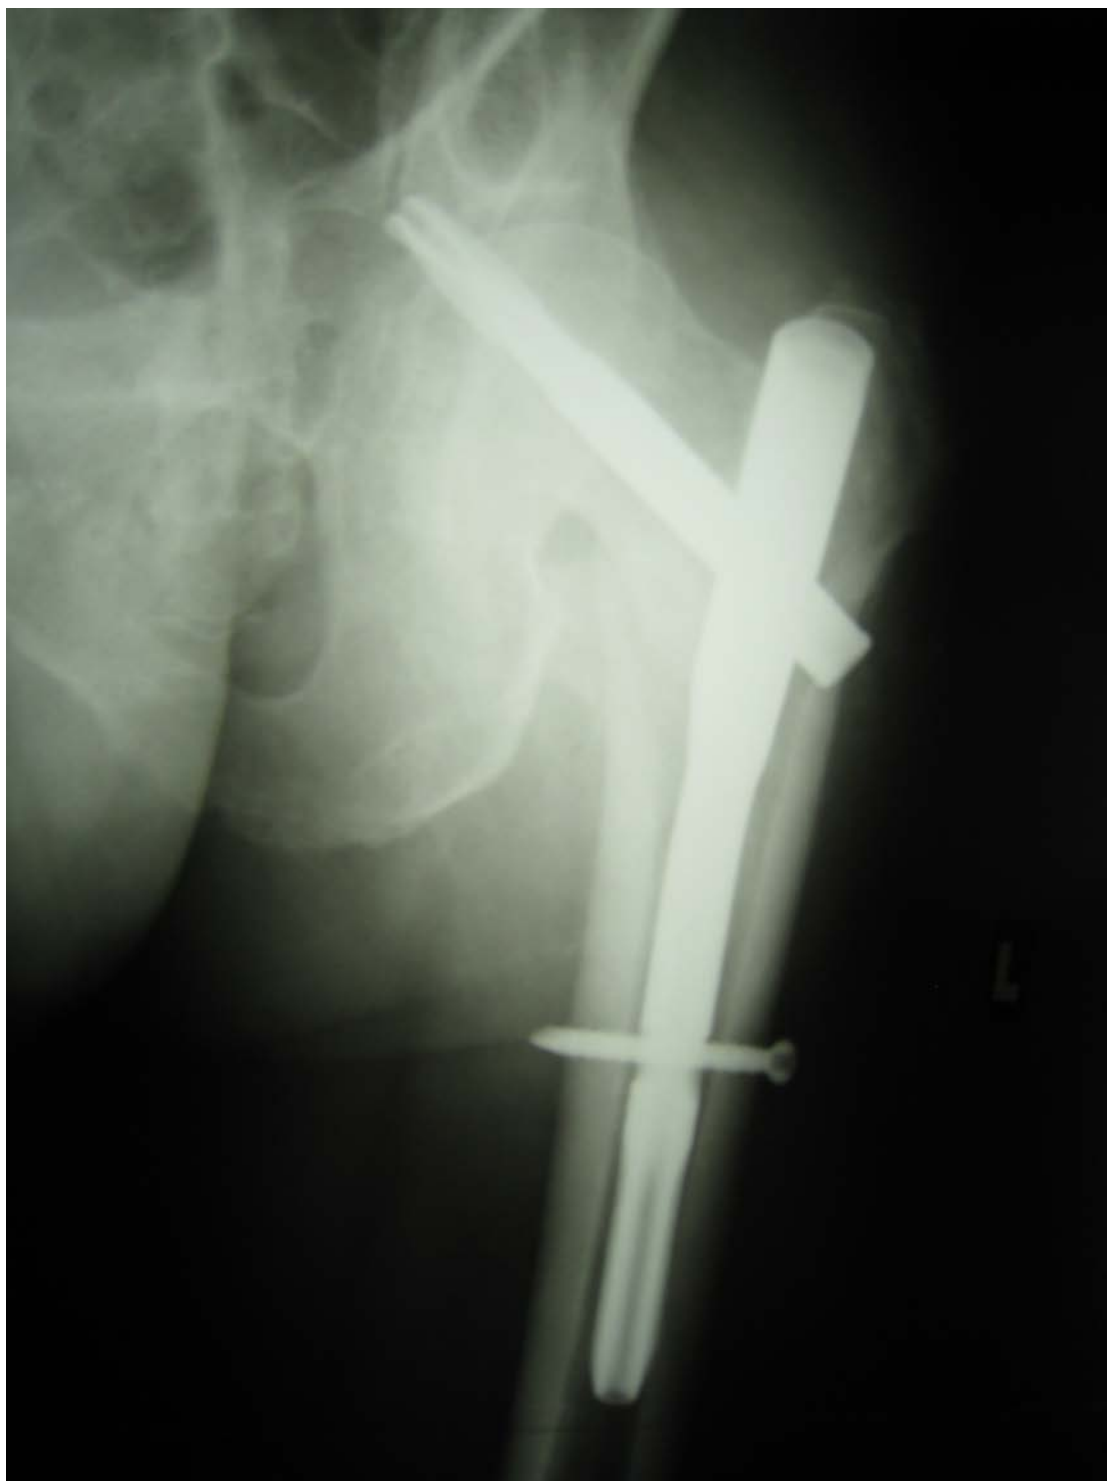
227 Figure 3b (AP Film Showing Cut-out Blade)

44 The patient was subsequently transferred to a rehabilitation center on
45 postoperative day 5 for further training. He was able to walk with a quad cane after
46 one month. The patient returned to our clinic two months after the operation
47 complaining of left hip pain. He was able to tolerate walking without aids and there
48 was no associated trauma or fever. Radiographs (figures 5 and 6) revealed protrusion
49 of the PFNA into the acetabulum.

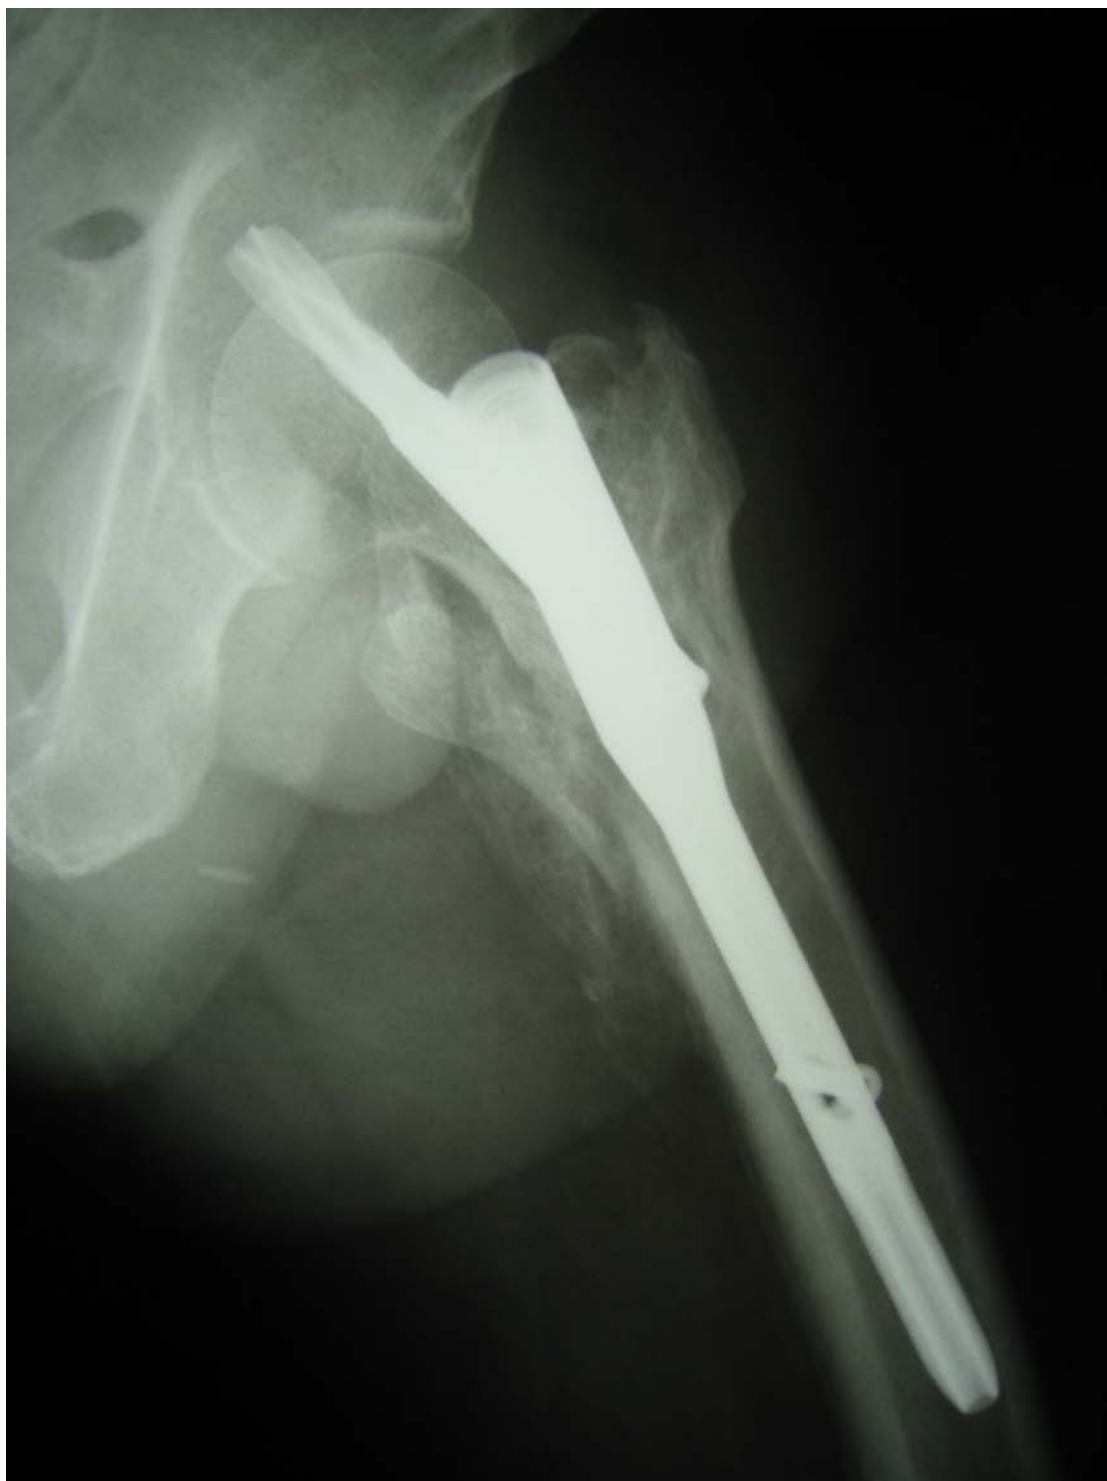
232 Figure 3c (Lateral Film Showing Cut-out Blade)

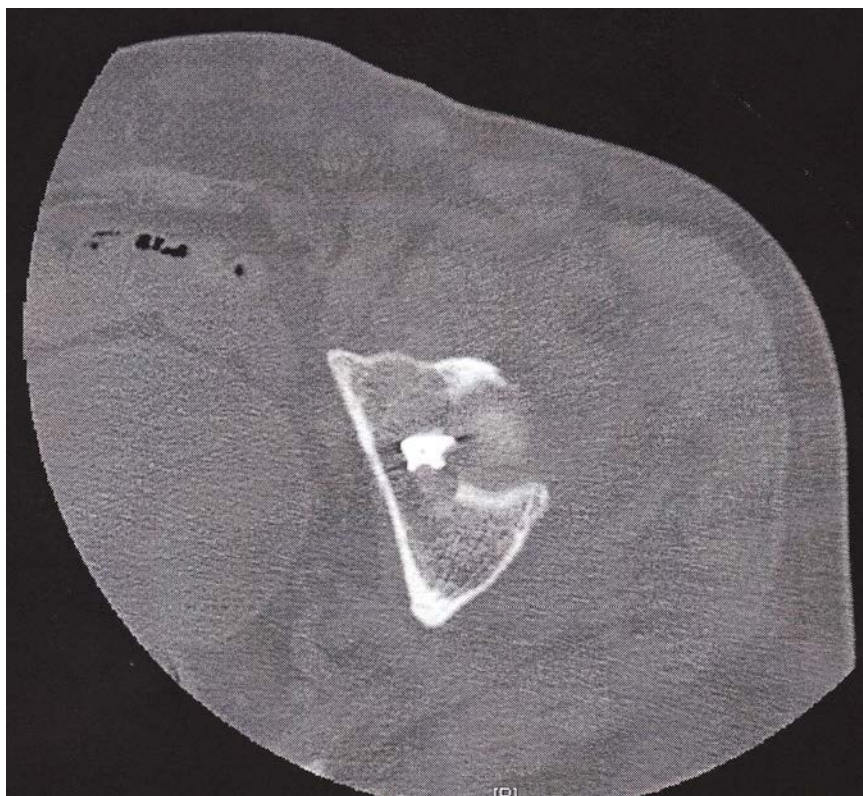
250 Figure 4b (Axial CT Scan Showing Cut-out Blade)

50 He was admitted into hospital for work-up and blood tests showed a normal
51 white cell count, erythrocyte sedimentation rate and C-reactive protein. Hip joint
52 aspiration was performed yielding no positive cultures. A CT scan was also performed
53 (figure 7) revealing a 2 cm blade cut-out into the acetabulum with a fracture that had
54 not healed. Thus, a cemented total hip arthroplasty was performed. Intra-operatively
55 (figures 8 and 9), there were no signs of infection and the lateral cortex was found to
56 be obstructing the blade entry site preventing it from gliding during fracture collapse.

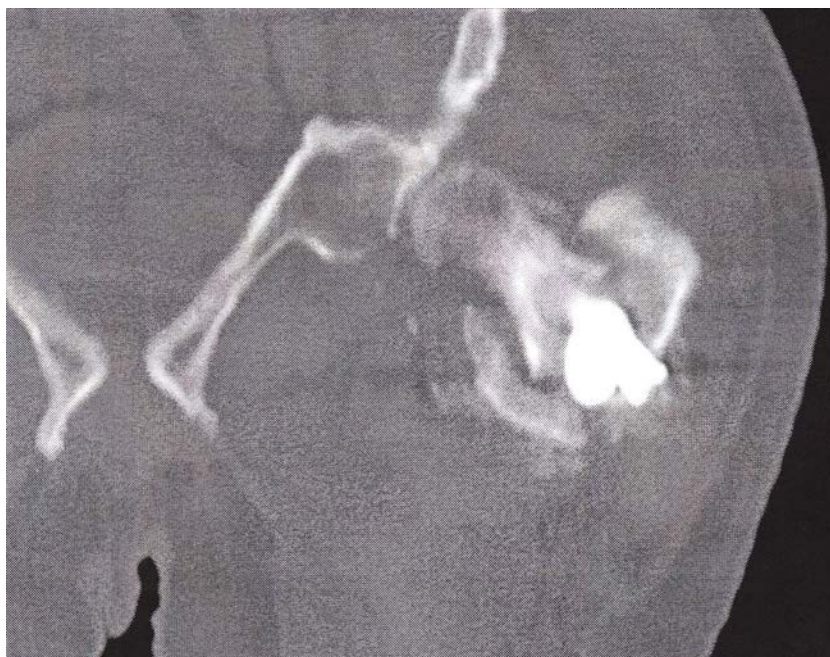
Figure 4c (Fracture Not Healed In Coronal CT Scan)

103 Some studies have advocated revision fixation for cut-out PFNA.(6, 8) We were
104 unable to apply this treatment option in our case because the trochanteric fracture had
105 not healed and there was significant protrusion into the acetabulum (2cm on CT scan).
106 Therefore revision fixation would have likely failed and we performed a cemented
107 total hip arthroplasty instead. Fortunately for our patient, the arthroplasty was
108 successful in treating the complication and he was able to return to walking without
109 pain.

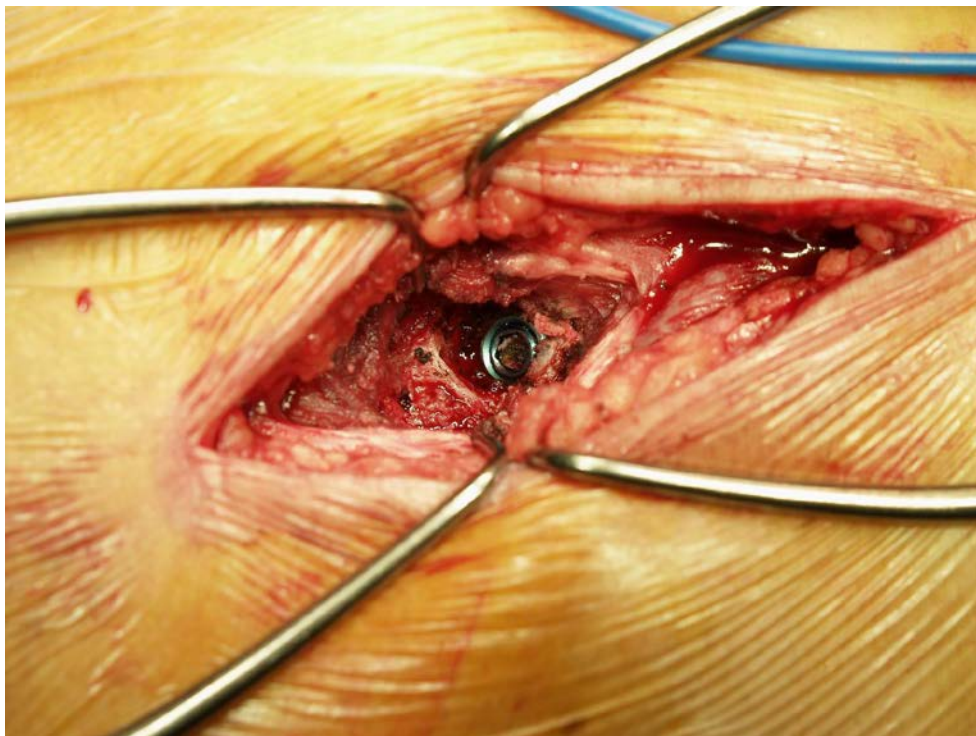
96 the lateral cortex (figure 2) after the initial operation. Thus, when the fracture
97 collapsed, the blade was only able to slide proximally through the femoral head into
98 the hip joint. For future reference, a longer length, with the helical blade protruding
99 from the lateral shaft would have probably been a better decision to prevent the lateral
100 cortex from blocking the gliding mechanism during fracture collapse. Unfortunately
101 this has the unwanted consequence of lateral thigh pain, especially when sleeping on
102 that side.

179 Figure 8: Intra-operative photo showing the lateral cortex abutting the helical blade;
180 fracture has collapsed without gliding of the blade

275 Figure 5a (Intra-operative Photo Showing Sunken Blade with Blocking by the Lateral
276 Cortex)

115 critical. Proper reduction of the fracture, insertion of the PFNA at the tip of the greater
116 trochanter and good placement of the helical blade are all vital to the success of the
117 implant. It is good practice to keep 2-3mm of the blade end protruded from the lateral
118 cortex to avoid a similar complication.

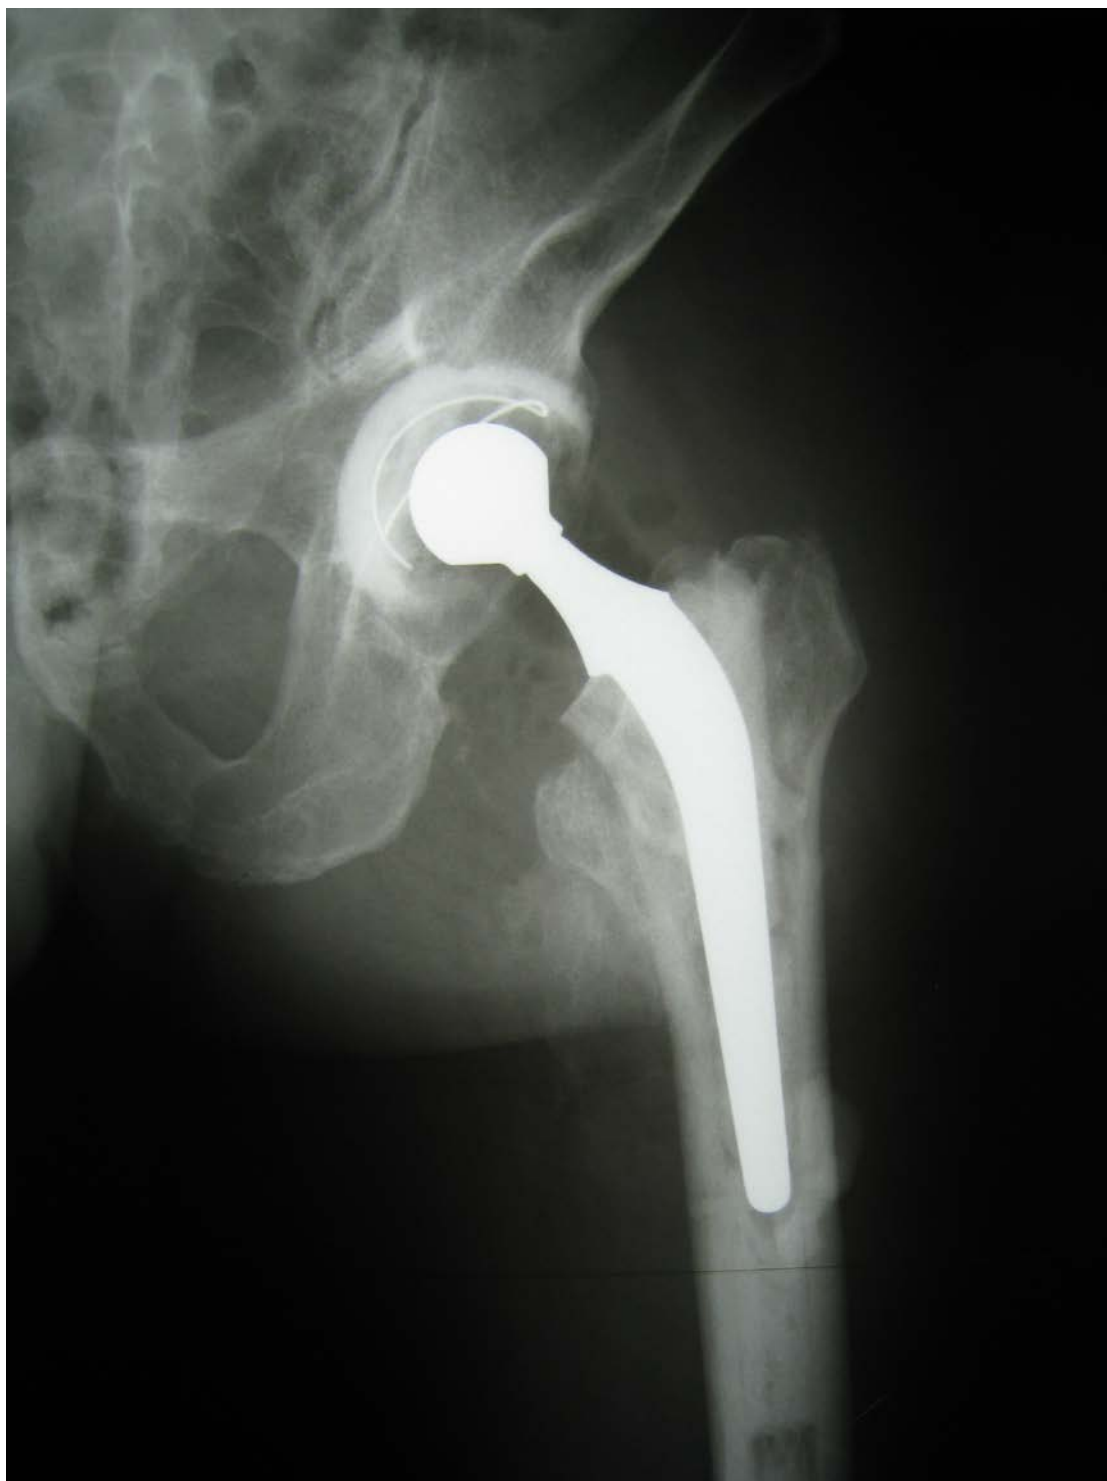
182 Figure 10: Post-operative film after cemented total hip arthroplasty

311 Figure 6a (Post-arthroplasty AP X-ray)

57 Postoperatively (figure 10), the patient recovered well. He was most recently
58 seen in follow-up 5 months after the operation with no more hip pain. He was able to
59 tolerate walking with a quad cane for 30 to 60 minutes and was very satisfied with the
60 final result.

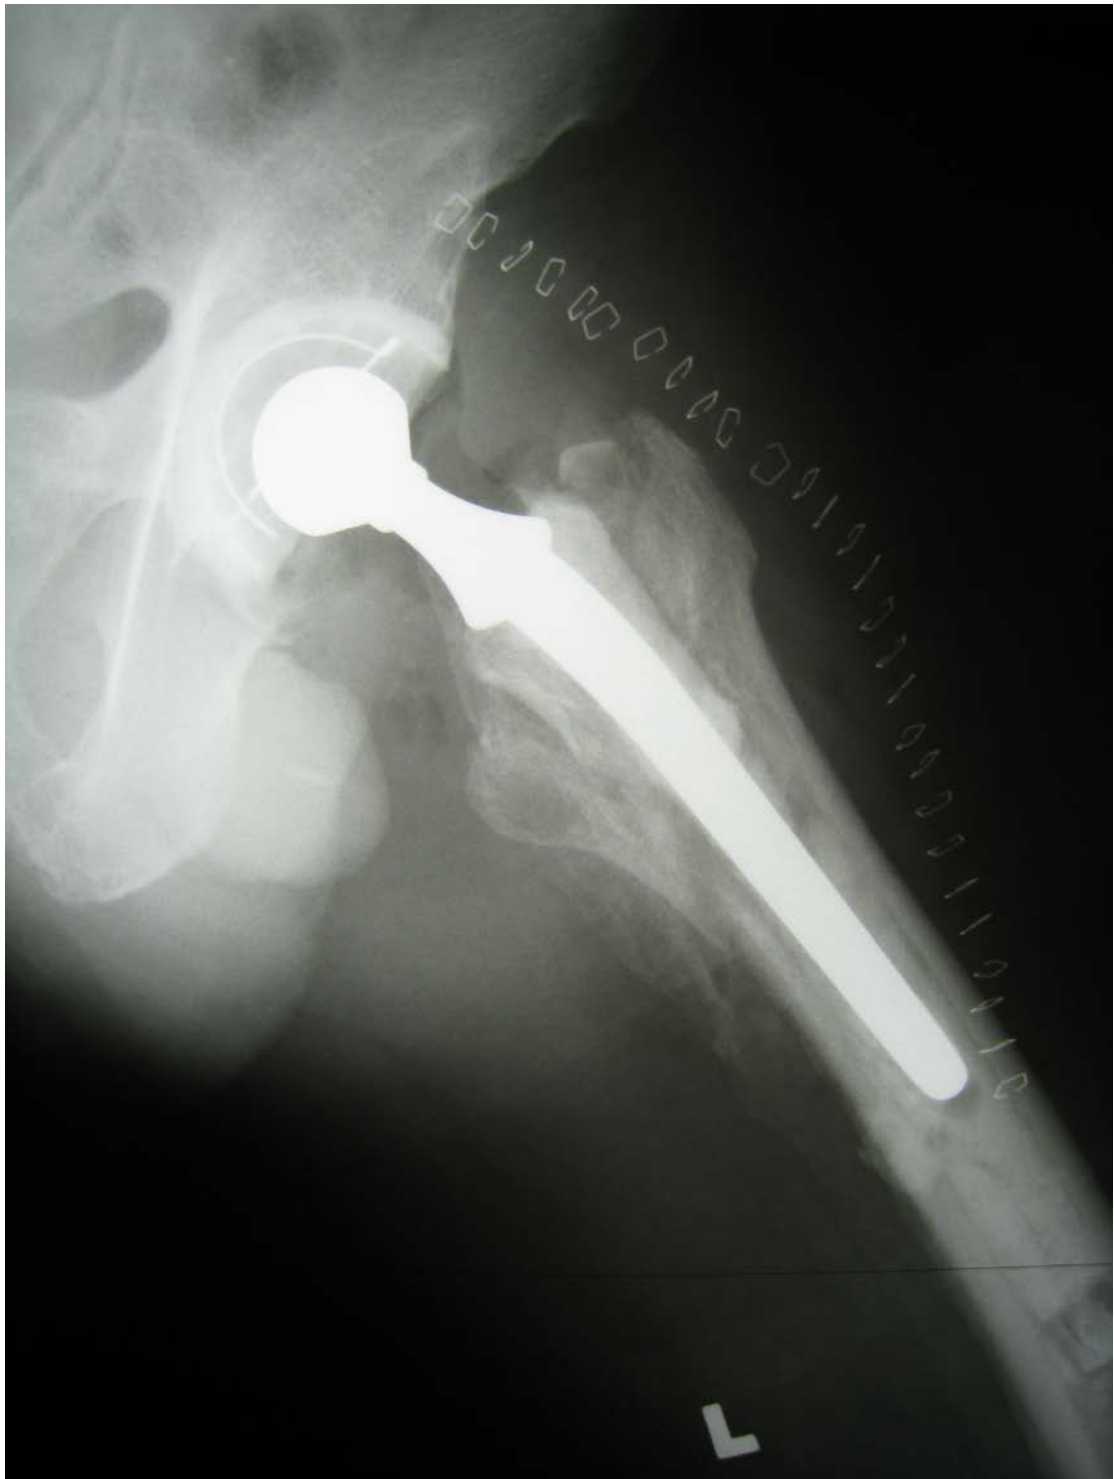
316 Figure 6b (Post-arthroplasty Lateral X-ray)
