Observations from the Folkestone, UK, earthquake of 28 April 2007

A compendium of observations from the Folkestone earthquake is presented here. This includes analysis of the first ‘strong’-motion record from a British earthquake, a description of the damage

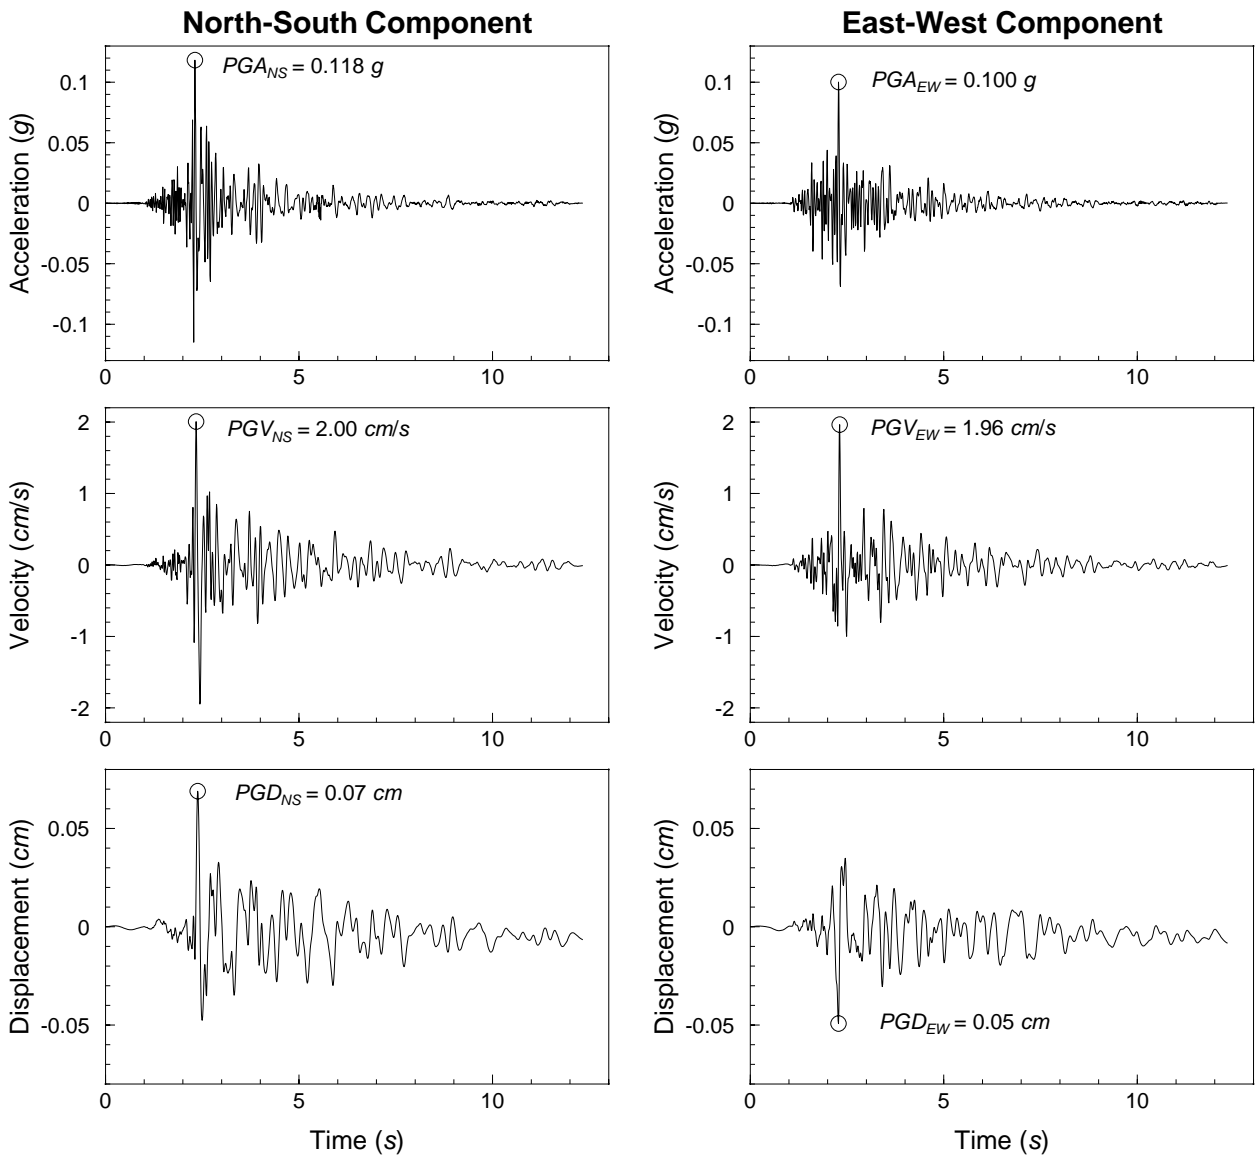
Figure 2. Horizontal acceleration, velocity and displacement time histories of the accelerogram recorded at station TFO.

One accelerogram of the Folkestone earthquake was recorded at station TFO (51.1135°N, 1.1409°E), just over 5 km north-northwest from the epicentre of the event (Figure 1c) and just under 4 km from the region of concentrated damage in Folkestone. The bedrock at the station is chalk and the superficial geology consists of sandy clay with flints. This information is taken from the bedrock and superficial geology maps of the area and is not based upon any site-specific investigation [although boreholes in the area suggest that superficial sediments are of the order of 2-18 m thick (Ottemöller *et al.*, 2008)]. The accelerograph is located in free-field conditions and is an

Integra 3JLA10 with a flat response to acceleration up to approximately 25 Hz and a sampling rate of 100 Hz. While the recording is not significant from a global strong-motion perspective, this recording is significant for the UK in that it captures the strongest acceleration ever recorded of 0.118 g on the north-south component. The horizontal acceleration, velocity and displacement time-histories for the accelerogram are shown in Figure 2 along with the annotated peak value corresponding to each trace. It is clear that the relatively strong peaks that may be observed in the acceleration and velocity traces are isolated spikes that are not overly representative of the overall strength of the shaking at the TFO site. A peak acceleration, velocity and displacement of 0.036 g, 0.53 cm/s and 0.02 cm respectively were observed on the vertical component. The instrumental recordings of the horizontal components may be used to infer an anticipated level of damage as quantified by a macroseismic intensity scale. Using the relationship of Wald et al. (1999), the peak ground accelerations suggest that Modified Mercalli intensities of around V-VI (5.6-5.9) should have been experienced in the vicinity of the TFO station. The proximity of the TFO station to both the located epicentre and the town of Folkestone further suggests that similar levels of intensity would be expected to occur in Folkestone itself.

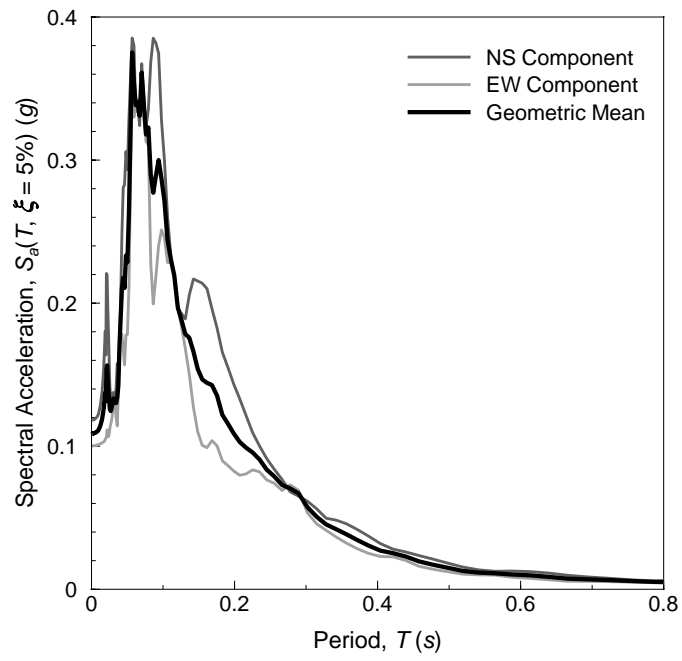
Figure 3. Elastic 5% damped acceleration response spectra for the Folkestone recording

Elastic acceleration response spectra for a damping ratio of 5% were calculated and are plotted in Figure 3. The spectra have peak amplitudes occurring at periods of roughly 0.1 seconds and have very weak spectral amplitudes at moderate to long periods, both attributes reflecting the dominance of high-frequency components expected in recordings of small earthquakes at short source-site distances. The amplitude of the geometric mean spectrum with respect to the spectra of the two orthogonal components also indicates that there is no strong polarization of the ground motion at the TFO site. Given the magnitude of the earthquake and the small rupture dimensions that are associated with such events, the lack of polarization is to be expected.

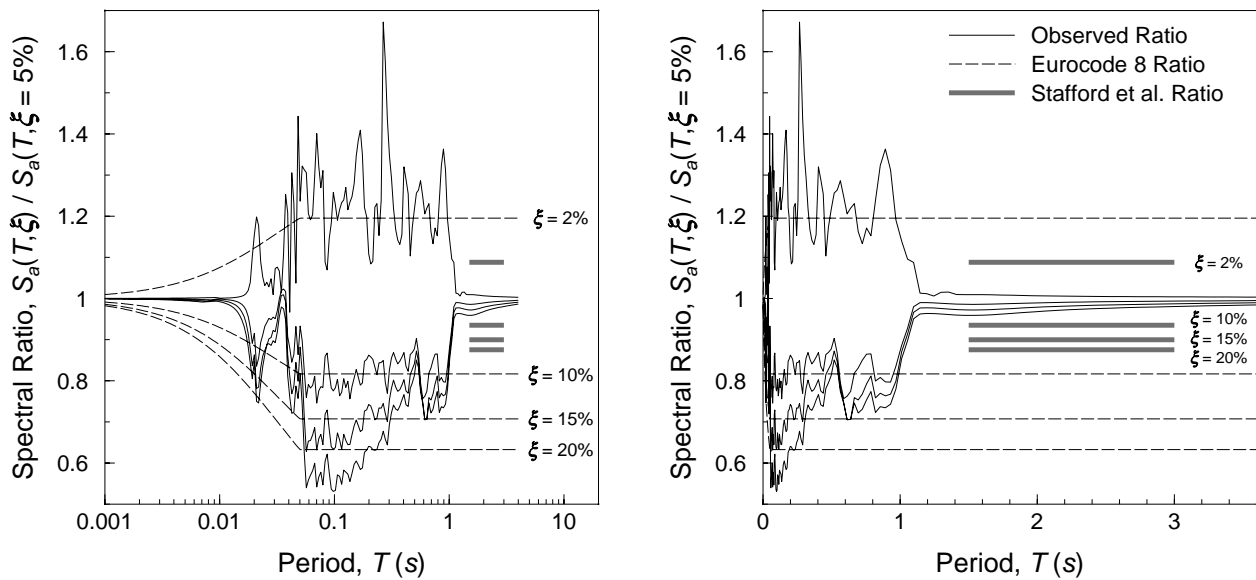
Figure 5. Comparison of the observed spectral ratios of the Folkestone recording with the damping correction factors specified in Eurocode 8 and the duration dependent ratios of Stafford et al. (2008) using the case of $D_{5-95\%}$. The Stafford et al. (2008) relations are derived using periods between 1.5 and 3 seconds.

When making these comparisons it must be kept in mind that both the EC8 and Stafford et al. (2008) proposals are being applied outside of the magnitude range for which they were derived as well as the fact that the comparison is being made with respect to a single observation. However, the comparisons do suggest that the influence of duration on damping correction factors is an

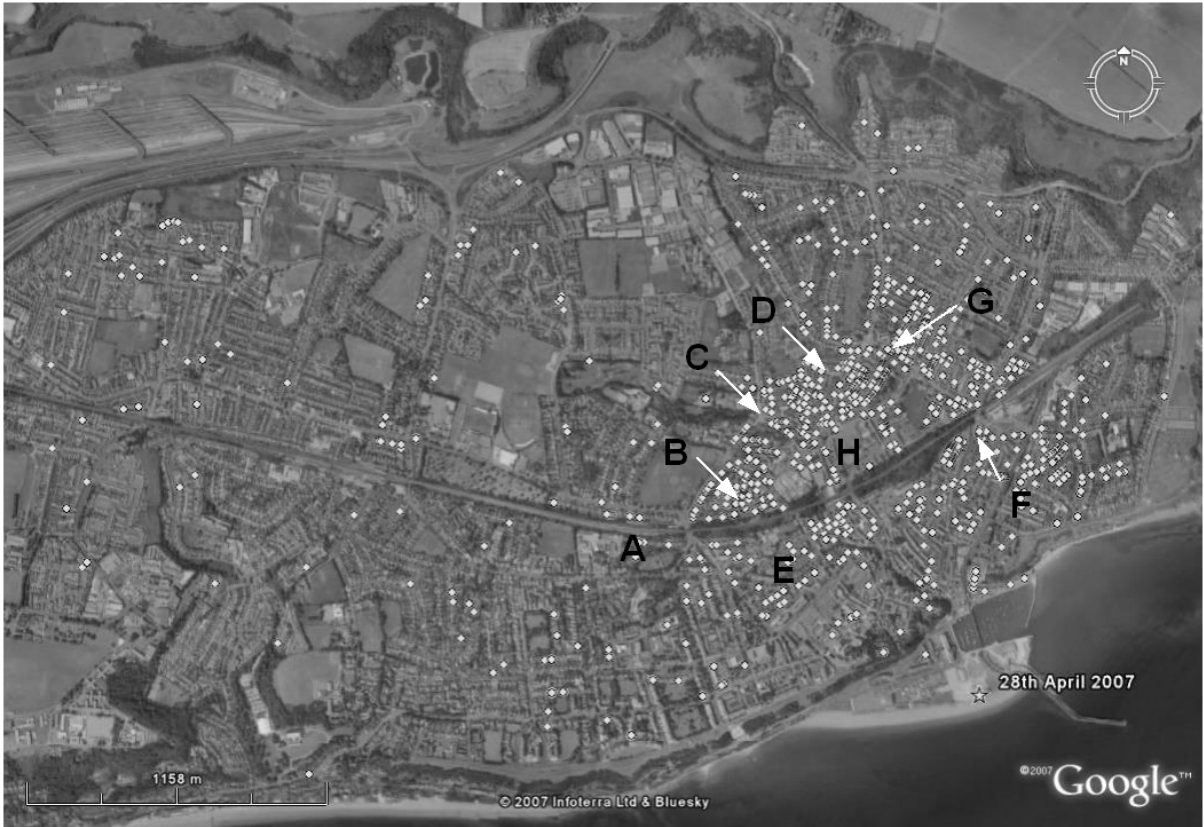
The main areas of damage in Folkestone are marked in Figure 6. This map is based on the damage lists maintained by Shepway District Council during their response to the earthquake and encompasses all but one or two sites visited by the reconnaissance teams. Shepway District Council's building control team assigned properties to one of five categories corresponding to the priority given to the need for action based on the level of risk posed to the public by the damage. Category 1 was defined as "Unoccupiable... posing high level of risk to the public. Immediate action required". 'Unoccupiable' here should not be read literally but should rather be interpreted within the context of the very stringent Health and Safety culture of the UK. Category 2 damage was similar to Category 1 but with a lower risk of collapse or injury. Category 3 covered reports of cracks. Category 4 indicated that the building had been assessed and made safe (it may have been assigned to Category 1 to start with), and Category 5 indicated an unconfirmed report of damage. To the best of our knowledge, this is the first occasion that any buildings in the UK have been so designated as a result of earthquake damage in order to implement a public Health and Safety based response.

Figure 6. Map of the main areas of damage in Folkestone. Lettered locations are referred to in the text.

To the west and south of Radnor Park (Figure 6 – Marker ‘A’), chimney pots were dislodged on isolated properties (1930s-style three-storey detached houses), but not fallen. Damage was more extensive in the region to the east of Radnor Park, an area characterised by two- and three-storey 1930s’ semi-detached housing. In these roads most properties exhibited chimney damage. In some cases this was principally in the form of dislodged bricks or extensively cracked chimney stacks. There were many properties, however, for which the chimney stack had collapsed, either partially or in its entirety above the roof level. Rather than chimneys fracturing at the roofline, the full body of the chimney stack fractured and disintegrated. For many of these houses, the impact of falling bricks was sufficient to dislodge and break tiles on both the property and its neighbour’s roof (Figure 7a), thus increasing the number of houses damaged. Cracks (2-4 mm wide) were evident in plasterwork and brickwork of exterior main walls on some of these properties (Figure 7b).

North of Pavilion Road and Radnor Park Road (Figure 6 – marker ‘D’) are smaller residential streets lined with terraced housing. Despite many reports of damage on these roads, it was less evident on the exterior of these buildings than in the semi-detached properties closer to Radnor Park. In this area, most of the chimney stacks remained intact though minor cracking was observed

in the exterior plasterwork. This style of terraced housing is typical of the region east of and parallel to Black Bull Road (Figure 6 – marker ‘E’). The density of damage was relatively high in this area with a large proportion of houses in these roads exhibiting chimney damage. Scaffolding had been erected on many of these properties and remedial action taken to prevent collapse of the chimney stack.

Larger roads lined by a mixture of residential and commercial properties and running southeast from the town centre to the harbour were also inspected. A three storey residential apartment building on Grace Hill (Figure 6 – marker ‘F’) suffered exterior damage in the form of a crack in the wall 10-15 mm wide extending through the roof line (Figure 7c). Towards the harbour, along Tontine Street and Tram Road (Figure 6 – marker ‘G’) there were few reports of damage, and none in the harbour itself. No damage was reported to the railway line or any associated viaducts and tunnels.

In the east of the town, along Dover Road (Figure 6 – marker ‘I’), the density of damaged buildings was not as great as in the roads to the west although there were isolated incidences of significant chimney damage. Isolated incidences of damage were also reported for properties in smaller roads connected to Dover Road. These were mainly in end-of terrace houses which had cracks in the gable end. Stuart Road, a small cul-de-sac of terraced housing (Figure 6 – marker ‘J’) suffered significant damage with nearly one third of the chimney stacks either partially or entirely collapsed to roof level (Figure 7d).

The streets around the junction between Black Bull Road, Radnor Park Road and Foord Road (Figure 6 – ‘N’) are characterised by late Victorian and early 20th Century residential terrace housing. Damage to chimney stacks was, again, mostly in the form of partial collapse with some

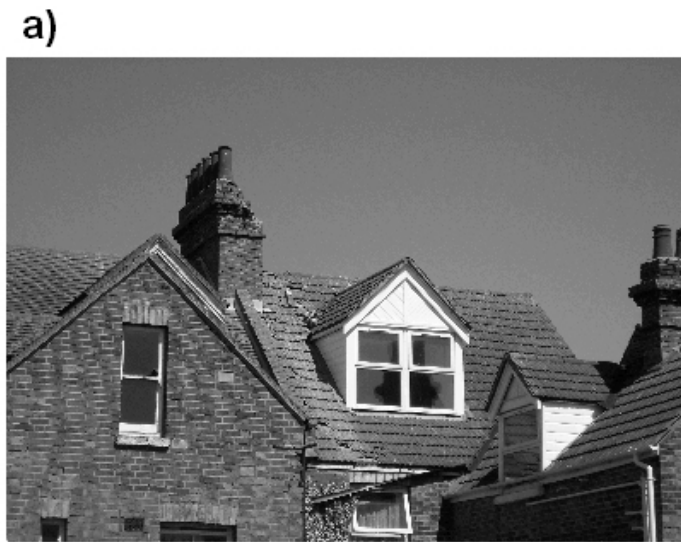
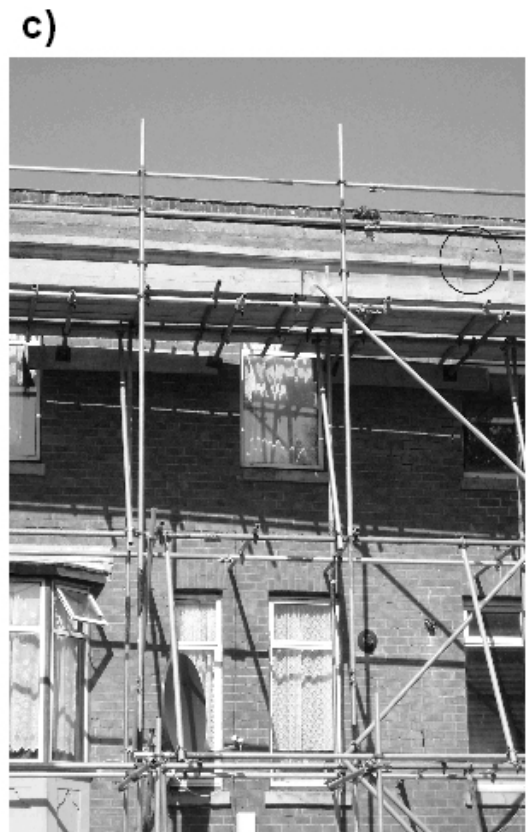
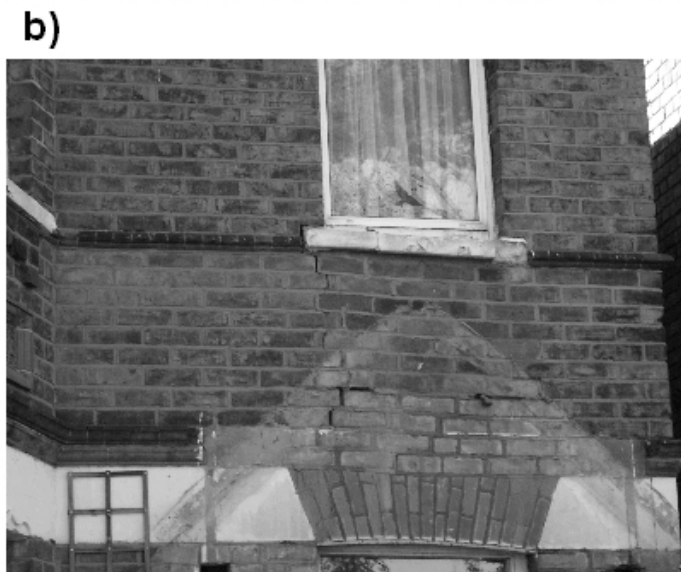
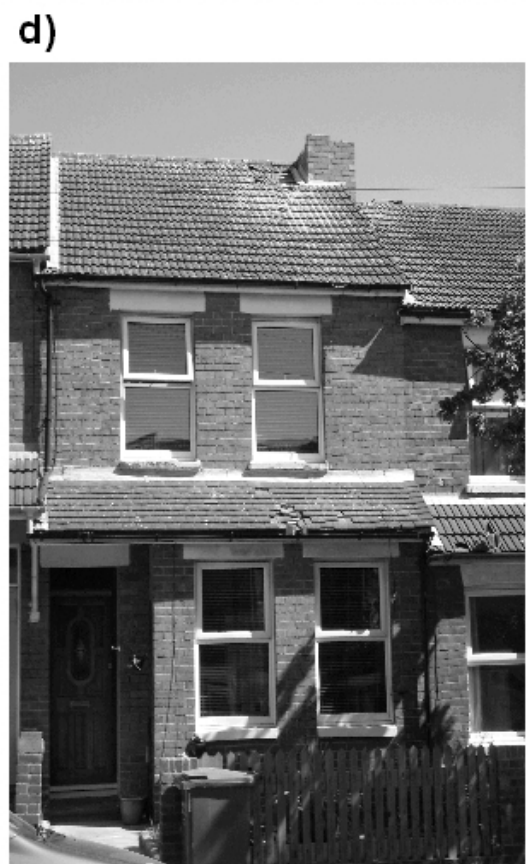
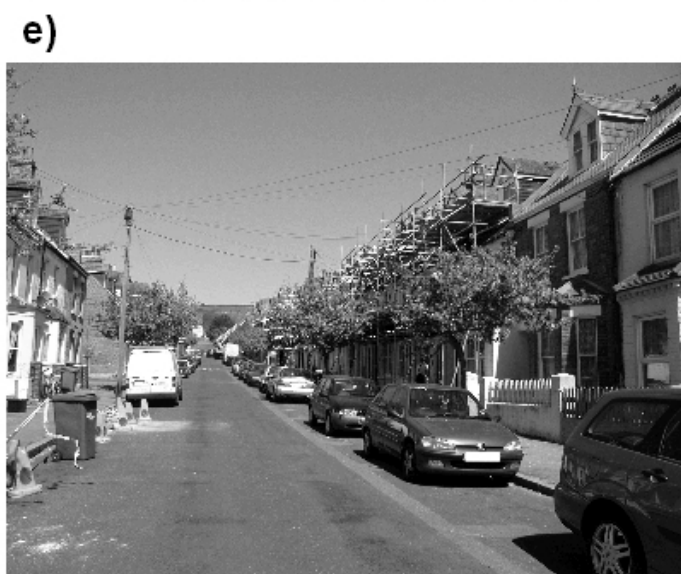
By far the most common form of damage observed was chimney damage ranging from moderate to partial collapse. In most roads chimney damage was observed in 10-20% of buildings (e.g., Black Bull Road), however in some roads (e.g., northern end of Marshall Street, Broadmead Road) this damage rate rose to 60-70%. The chimneys consist of brick stacks on which multiple cylindrical clay chimney pots are mounted with mortar. These heavy clay chimney pots were commonly seen to dislodge as a result of the ground shaking, often together with bricks in the chimney stacks. The

extent of chimney damage varied significantly among chimneys located in close proximity. The majority of damage seemed to occur in chimneys that had been poorly maintained and that had either lost mortar or had suffered some sulphur intrusion. However, this was not always the case. Some chimneys that had been re-pointed with cement mortar, which tends to be less flexible than the original lime-mortar, were also seen to be damaged. The failure of chimneys was also seen to cause secondary damage to roofs. In most cases this was limited to the removal of roof tiles (commonly seen in the lea of falling chimney pots) and in rare cases damage to the roof structure.

The highest density of damaged properties occurred in the region around Canterbury Road. Of particular note are the 1930s style terraced properties along Sidney Street and Marshall Street (Figure 7e), on which there were many (consistent with MSK and EMS macroseismic definitions of “many”) examples of partial and full collapse of chimney stacks. Vertical cracks tens of millimetres wide were observed in those chimney stacks that had not collapsed. In contrast to the terraced housing in the surrounding roads, Canterbury Road itself is characterised by semi-detached three- and four-storey 1930s style properties. Damage to these buildings was mostly a result of partial collapse of chimney stacks, affecting nearly half of the properties. Generally these buildings were in good condition at the time of the earthquake.

Figure 7. (a) Damaged chimneystack and secondary damage to roof tiles, (b) Cracks in brickwork (Radnor Park Road), (c) Cracks extending through the roof line of a building at Grace Hill, (d) Collapse of chimney stack to roof level and associated roof damage (Stuart Road), and (e) Marshall Street: 1930's style terraced houses with relatively high density damage.

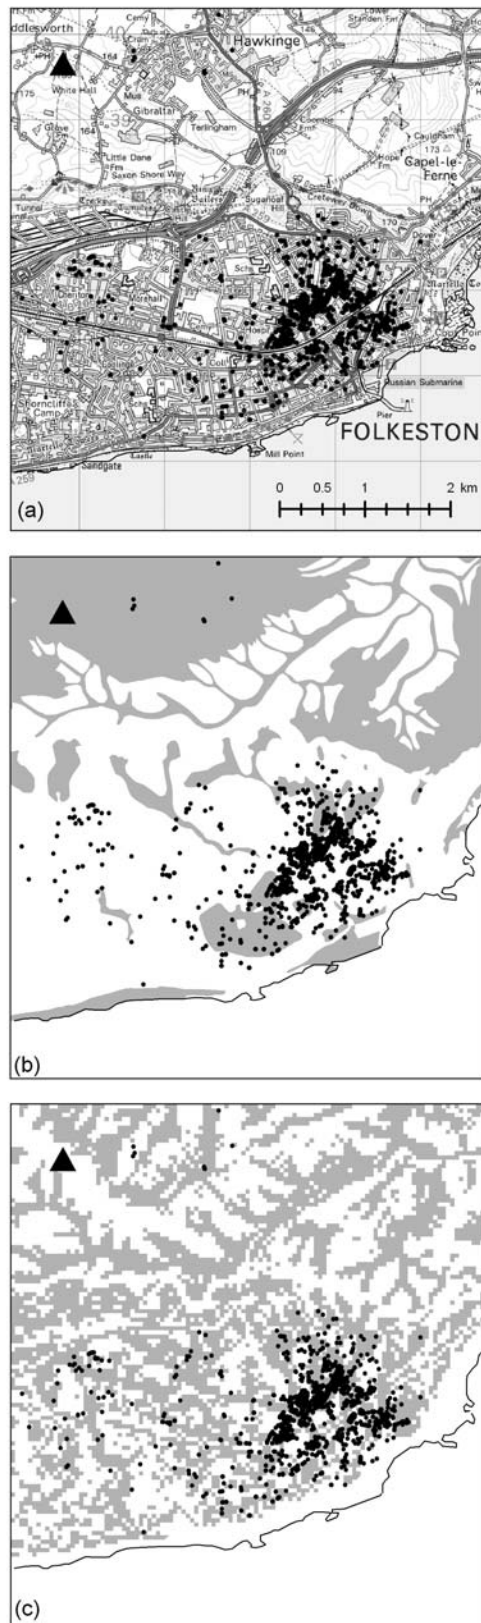
The possibility that superficial geology may have influenced the spatial distribution of damage in Folkestone was investigated. Figure 8a shows the distribution of all damaged properties reported to the local District Council. The current 1:50,000 scale geological map of the area (Figure 8b) indicates superficial deposits associated with the River Pent, which is now culverted extensively beneath Folkestone, partial infilling of minor tributary valleys and mantling of the areas between adjacent streams. Additional thin tracts of accumulated soil and hill wash material associated with

The accumulated material model was derived from the Nextmap Digital Terrain Model (NDTM; Intermap) for an area that covers the location of TFO and Folkestone (Figure 8c). Standard algorithms for calculating the surface, planform and profile curvatures (Zeverbergen and Thorne, 1987) were used. The planform curvature is the curvature of a hill measured along a height contour. The profile curvature is the amount of curvature as you move down slope (Shary et al., 2001). The NDTM has a nominal cell size of 5 m. Using bilinear resampling, the grid was resampled for cell sizes of 10 m, 25 m and 50 m. The resampling creates a smoothed and generalised land surface with reduced surface noise from trees and urban features. Creating surfaces for three different grid cell sizes allowed the effect of NDTM complexity on the overall results to be investigated. Planform curvature (pl_{curv}) and profile curvature (pr_{curv}) were determined from the NDTM from which the overall curvature (tot_{curv}) was obtained:

Figure 8. Damaged properties (black circles) plotted on (a) the Ordnance Survey map for Folkestone; (b) the 1:50 000 superficial geology map (mapped deposits shaded grey); (c) map showing the total curvature derived from the NDTM resampled at 50 m. Areas of potential accumulation (negative tot_{curv}) are shaded grey. The location of TFO is denoted by the black triangle.

The validity of each of the accumulated material models (i.e., 10 m, 25 m and 50 m) was assessed by comparing the results to the existing geological map (Figure 8b) and a limited number of geological boreholes in the Folkestone area. A qualitative judgement was also made as to whether

the geometries of the deposits in the model reflect a natural system. The 10-meter model (not shown) is characterised by an almost uniform distribution of potential accumulation sites across the Folkestone area and it is difficult to identify any features in common with the geological map. Furthermore, the results appear to be subject to data acquisition and processing artefacts with man-made structures such as the mainline railway, Channel Tunnel railway link and major roads and motorways causing edge-effects and false surface curvature. At 25 meters (also not shown), correlation with the mapped geology, although improved, remains relatively poor. There is some correlation with mapped deposits in the rural area north of Folkestone but the urban area is still affected by cultural and processing effects and the River Pent valley is poorly defined. The 50-meter model (Figure 8c) shows a strong visual correlation with the mapped geology north of Folkestone. In the town, the River Pent and its tributaries are clearly delineated. There is also a weak correlation between the modelled and mapped colluvial deposits around the north-eastern area of the town. However, the mainline railway remains a problematic feature.

The 50-meter model is preferred and indicates potential for a wider spread of unconsolidated accumulated material than suggested by the 50k geological map. In the absence of ground-truthing, this result must be considered preliminary. However, it is possible to compare the incidences of damage with the superficial geology map in Figure 8b and the map showing potential areas of sediment accumulation in Figure 8c. The results in Table 1 indicate that a higher proportion of the damaged properties may be underlain by unconsolidated accumulated deposits than indicated by the geological map (59% as opposed to 12%). However, it is also evident that whilst there may be some degree of correlation between the inferred presence of unconsolidated material and building damage, a significant number of properties must also be founded in bedrock or weathered bedrock. The significance of this correlation must be investigated using traditional ground-truthing techniques but the issue of building vulnerability must be addressed fully too.

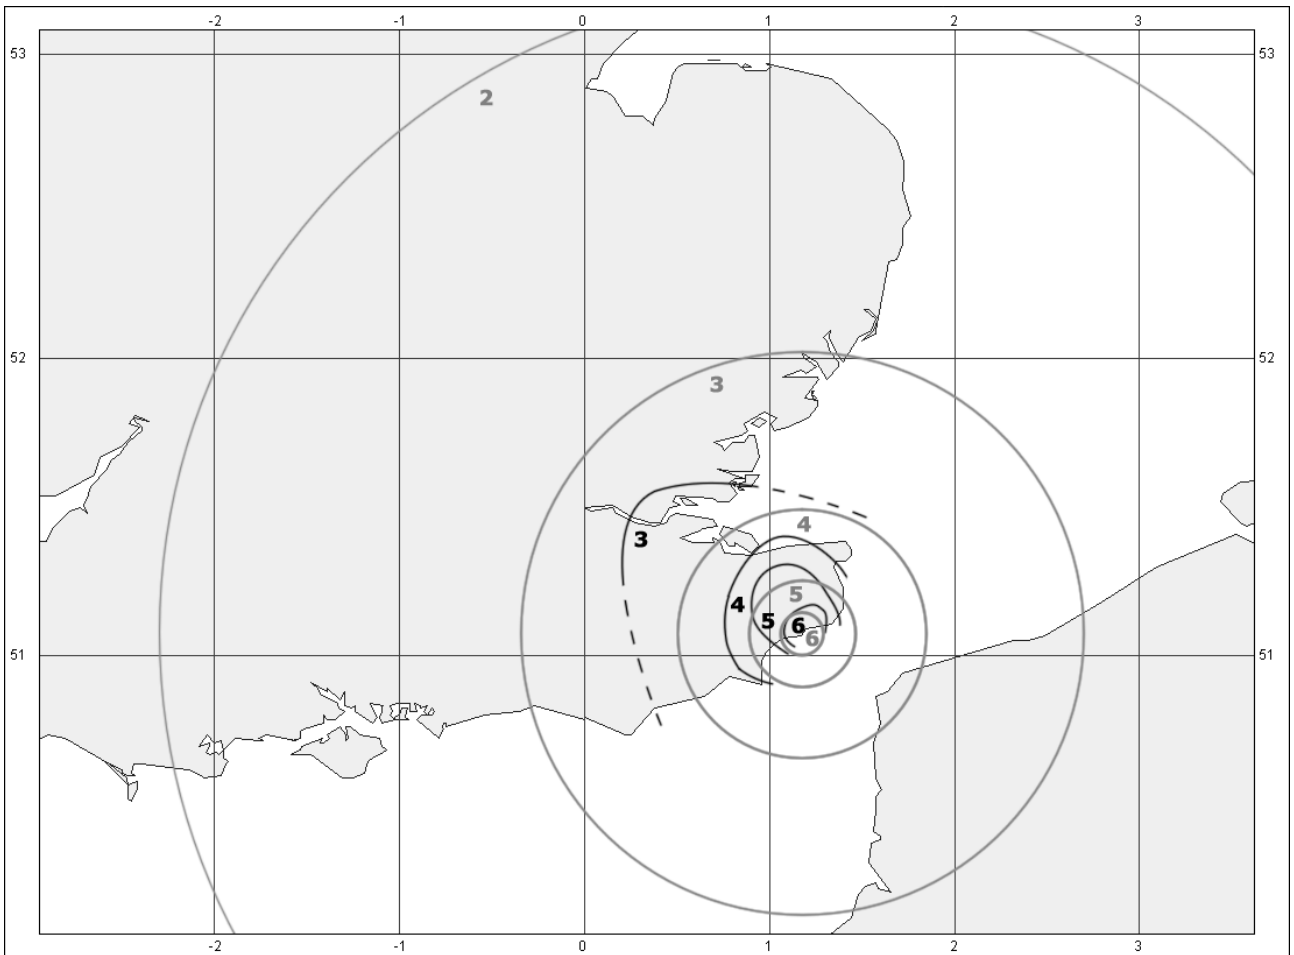
Figure 10. Observed (black lines) and modelled (grey lines) isoseismals for the Folkestone earthquake. Observed isoseismals are generated from the online macroseismic survey information presented in Figure 10 while the modelled isoseismals are obtained through the use of the Musson (2005) intensity attenuation model for the UK

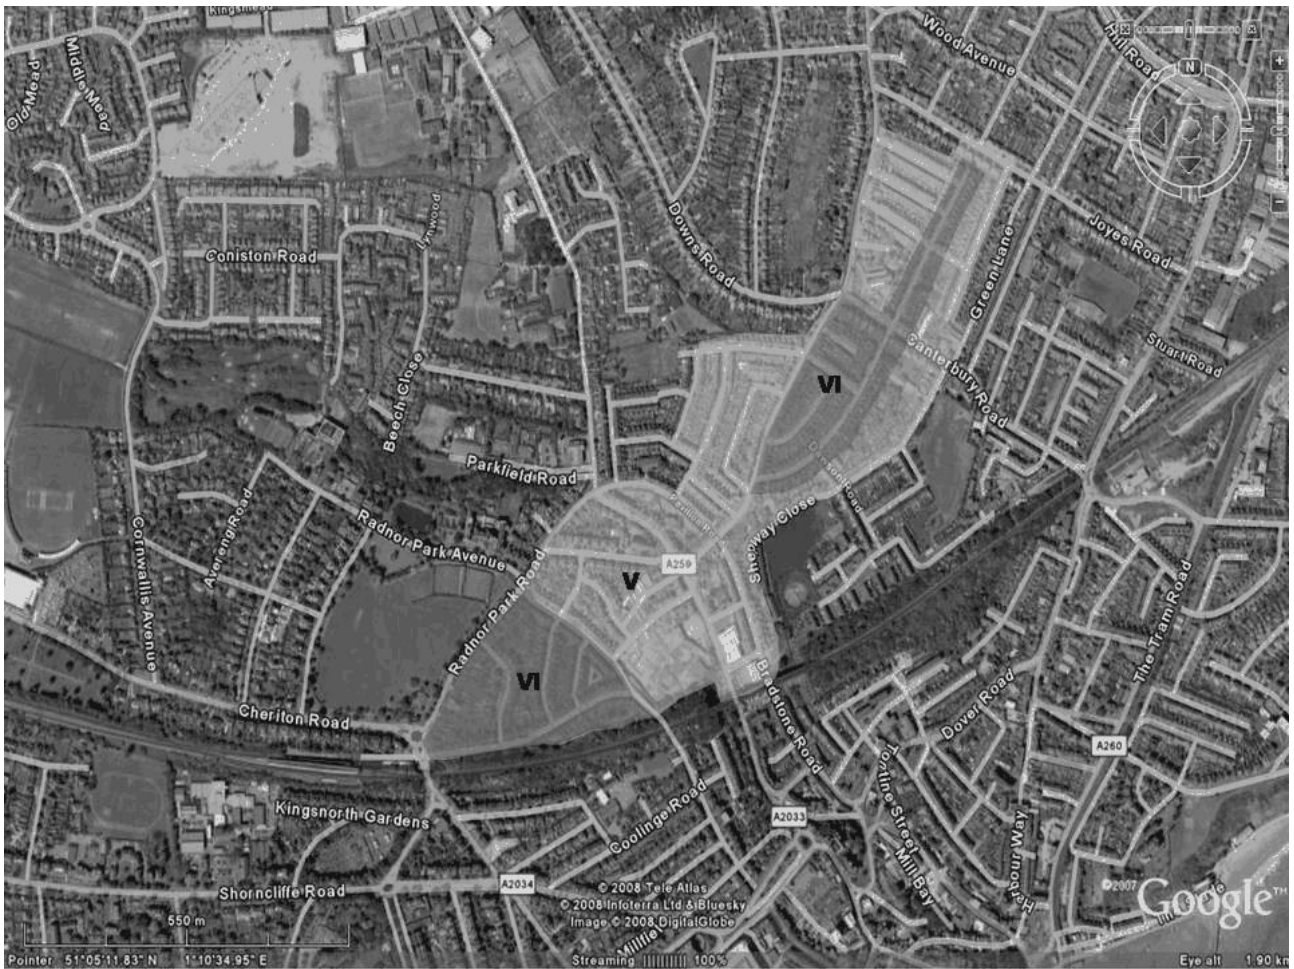
The field survey confirmed a maximum intensity of 6 EMS. Figure 11 shows the spatial extent of intensities 5 and 6 derived from the damage data when chimney damage is considered to be non-structural, which would soon attenuate to non-damaging intensities for the rest of Folkestone (Rossetto et al., 2008). The online macroseismic survey, as shown in Figure 9, depicts intensity 6 EMS over a rather larger area, into the villages around Folkestone itself. It should be noted that online questionnaire samples are self-selecting, and therefore likely to be biased towards respondents more affected as opposed to respondents less affected. This is a well-known problem in macroseismology and is likely to be the case with all questionnaire surveys, especially online ones, which are now the majority in many countries. Note also that questionnaires can only take a simplified approach to damage; in the case of the BGS algorithm, if the respondent records partial collapse of chimneys, this is automatically considered to be grade 2 damage to class B structures.

Figure 11. Map of Intensity V and VI in Folkestone derived from observations of structural damage only (assuming chimneys to be non-structural components). Intensities smaller than V are not plotted as these are mainly derived from observations of earthquake effects other than structural damage.
