Art Collections 2020, Safety Issue (ARCO 2020, SAFETY)

Digital survey for the structural analysis of the Verruca fortress

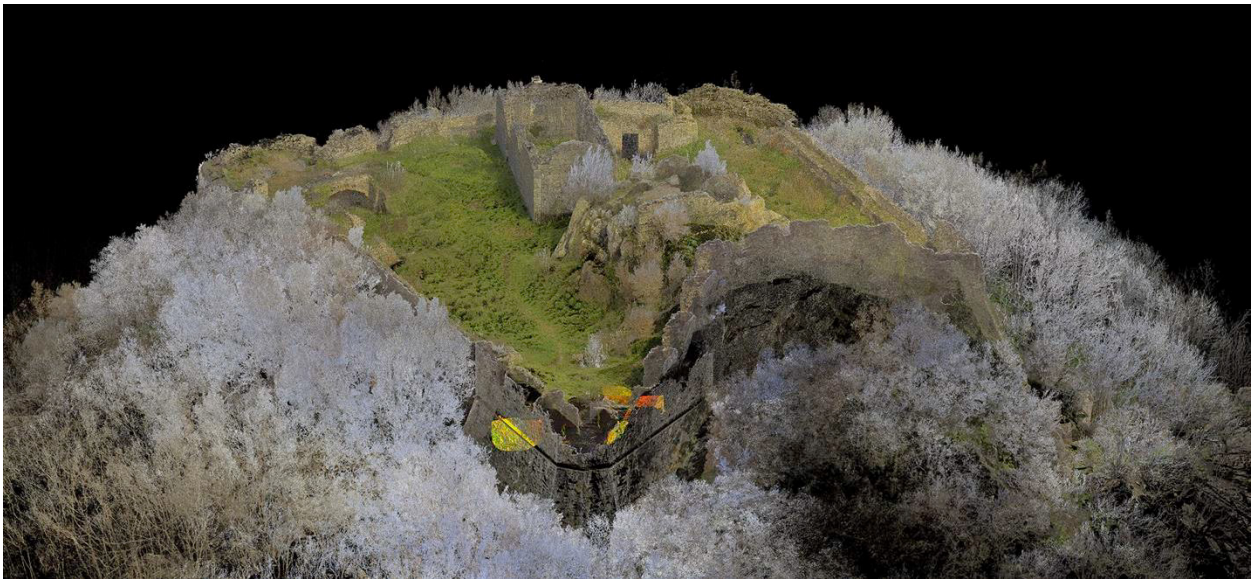
Fig. 1. General point cloud realized by laser scanner of the Verruca fortress.

The recent fires, which burned the top of Mount Verruca, have partly favored the creation of new measurement campaigns, using digital data acquisition systems: until now the fortress surveys have been carried out with older instruments such as total stations [Nicolosi 2012]. Three different acquisition campaigns were carried out: with laser scanner instruments to create a model that described the building's morphology, SfM photographic acquisitions from the ground to create three-dimensional models that describe the texture of the walls, and finally aerial photogrammetry with drone use, to create a mapped model of the whole complex [Volzone et al. 2018]. The data from different acquisition systems were used, integrating the information, to create the technical drawings according to the traditional system that provides for the extraction of geometries from the point clouds of the laser scanner, the materiality of the surfaces from the photographs and photogrammetric models: both databases were suitably subjected to data certification protocols, in order to verify the reliability of both the registration of the scans and the calibration of the

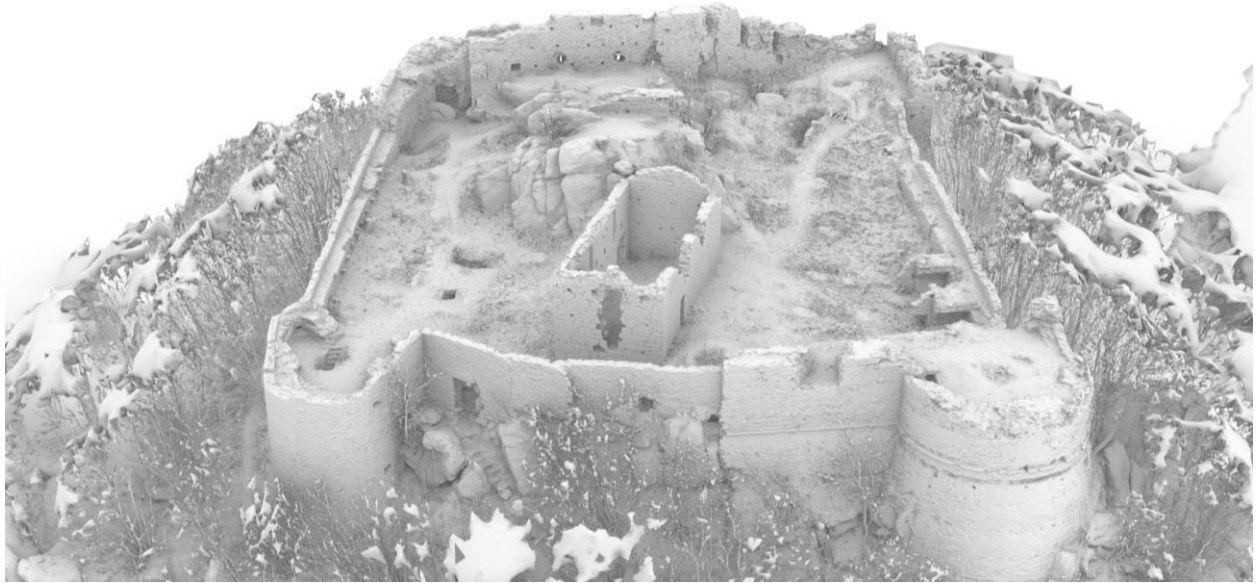
Fig. 2. 3D mesh model realized combining drone's pictures and laser scanner scan station.

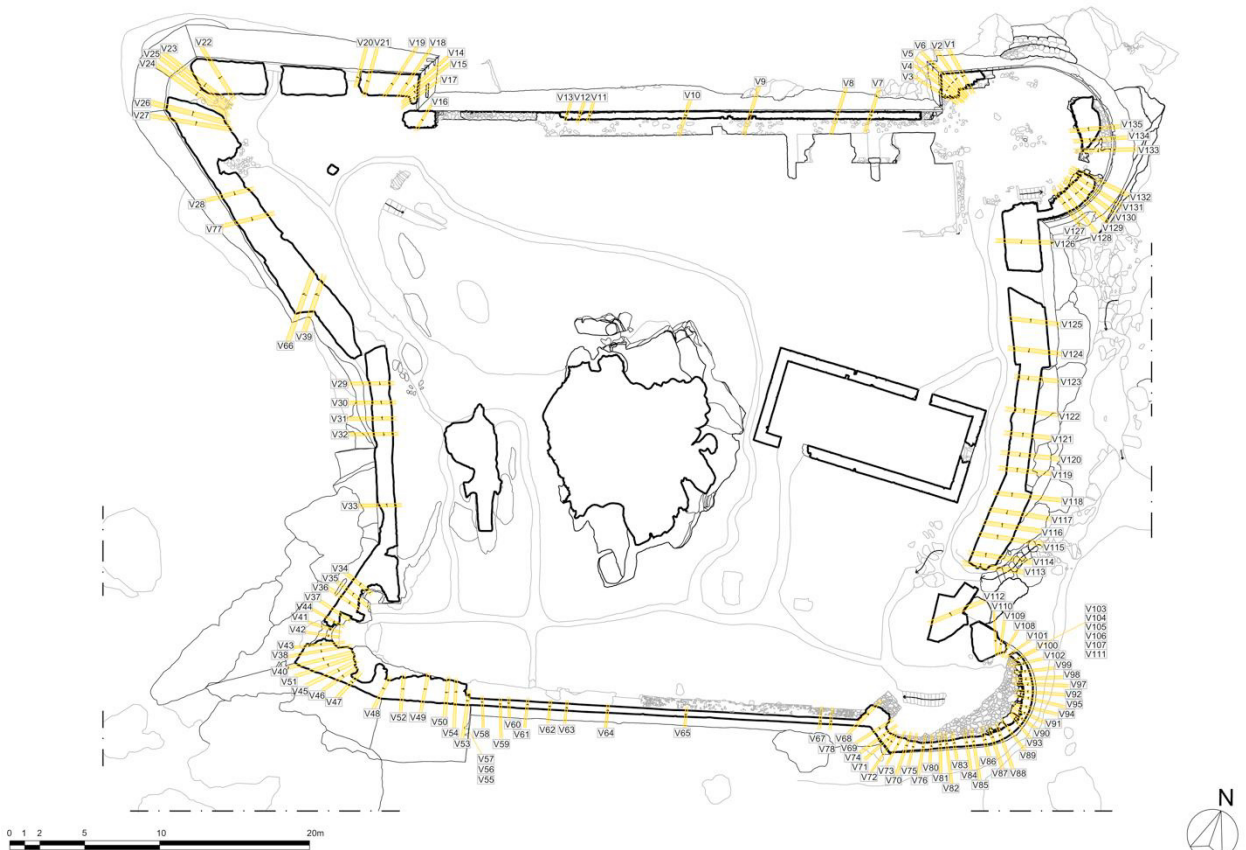
Fig. 3. Plan of the fortress with the drawing of the structural cracks on the walls.

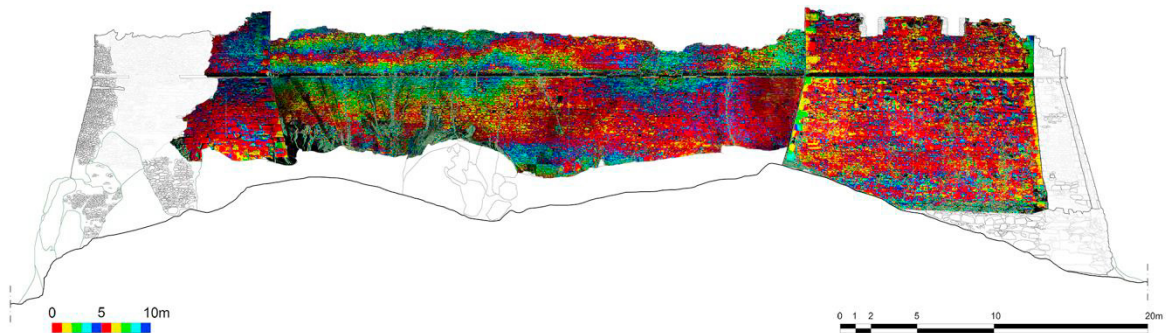
Fig. 5. Elevation map of the West façade, useful to understand the wall's deformation

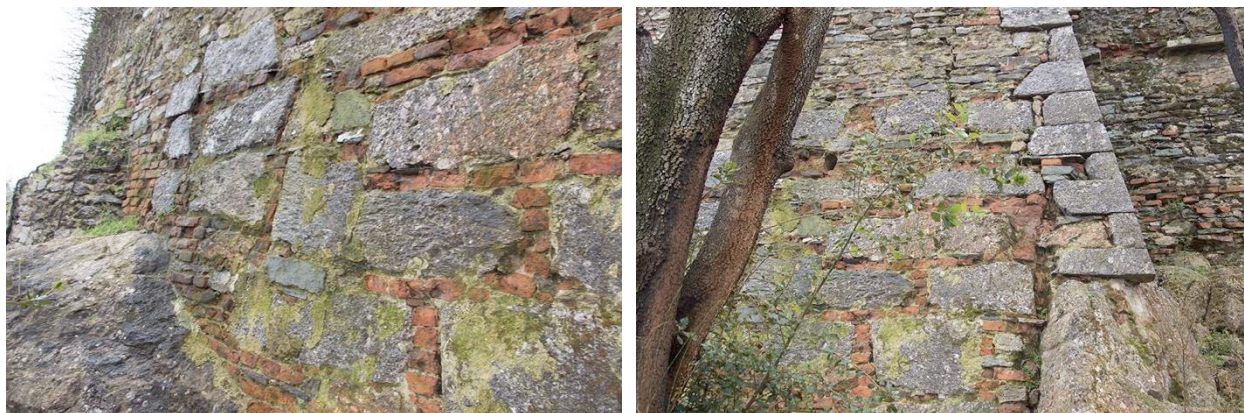
Fig. 6. Structural restoration, made using bricks, of the defensive walls of the fortress

The irregularity of the walls and the high usage of mortar is also due to the awareness of the purpose for which the enceinte were intended, or to the resistance to the bullets of the enemies: in case of a attack or siege these architectures, if they had been hit, would have required restoration interventions. From the point of view of the defensive system, the highlights of the defense would have been concentrated in the bastions and towers that have precisely more regular and elusive walls. The characteristic inclined scarp, which allowed the architectures to resist the blows of the firearms, appears regularly on the northern side and in the pentagonal bastions; there is no trace of it on the southern side, where the wall rises vertically, a rather strange shape considering the different development of the fortification which could suggest an intermediate phase in the construction. The signs of subsequent restorations are evident, with strong presence of brick elements that testify to the restoration of the enceinte and the circular tower; these interventions could explain the presence of the sign of a previous cordon. The presence of numerous signs of intervention shows that in a specific period the fortress has undergone an important renewal or consolidation. The use of brick elements, to fill the lack of the walls, indicates a construction phase that is incompatible with the late fifteenth century, since in the walls, even if mixed and unworked stones, there are no traces of brick elements, except in the consolidations. It is conceivable that the restoration interventions are directly linked to defensive needs following the continuous struggles to conquer the fortification. To understand the structural behavior of the fortress it was necessary to perform an accurate mapping of the damages: the structural lesions have been reported, distinguishing their direction and their vector. It was useless to differentiate between passing and non-passing lesions since the majority of the structures visible from the outside are not reflected on the internal face, because they are buried and placed against the ground on the filling performed in the modern age: the analysis of the fortification lesions provides in this case information on the construction phases, since the walls are oversized compared to those of civil construction and, unless there are problems of subsidence of the ground, they do not risk static problems. The same problems have already been addressed in the structural study of Porta Nuova in Verona, where the structural problems were the trace of the gradual dismantling of the walls [Parrinello 2018]. In the specific case of the Verruca, deformations hardly have been caused by subsidence of the foundations since the walls of the fortress rest directly on Verrucana rock, which is very resistant. The foundations may only have had some problems of cohesion between the rocky layer and the walls right at the ground attack, where in fact fillings with mortar and bricks are recurrent. Finally, the loss of most of the roofing structures has canceled the thrust on the structures, even in the event of seismic events, one of the main causes of
