**Application for ERS-1 AR Data in Flood
Hazard Assessment of Fluvial and Coastal
Environments**

Final Report

**APPLICATION OF ERS-1 SAR DATA
IN FLOOD HAZARD ASSESSMENT
OF FLUVIAL AND COASTAL ENVIRONMENTS**

EU-ASEAN PHILIPPINE PROJECT 2

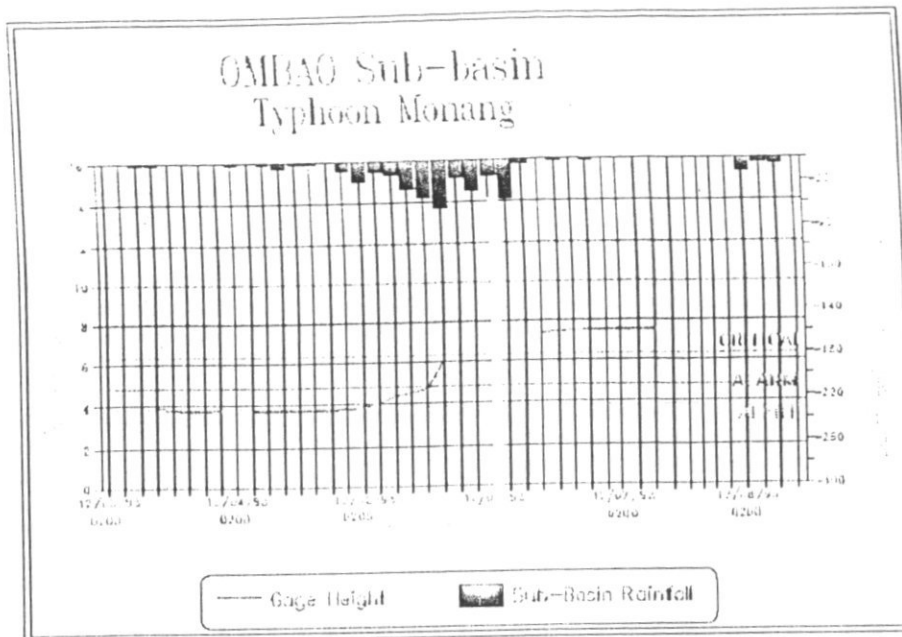
It can be noticed that from the flood hydrographs in Sipocot (Fig. 8) and Ombao (Fig. 9) that the flood peak coincided with the acquired ERS-1 SAR image for December (02:14:17). ERS-1 was able to image the basin in the morning of 01 November 1993 (02:11:18) where minor flooding was reported (Fig. 10 & 11). It can be resolved by studying both the images that the inundation observed both in November and December 1993 corresponds to the flood water level for developing relationship between water level/discharge and flood inundation.

Fig. 9. Flood hydrograph of Ombao River. Yellow vertical line indicate time of satellite pass.
December 1993

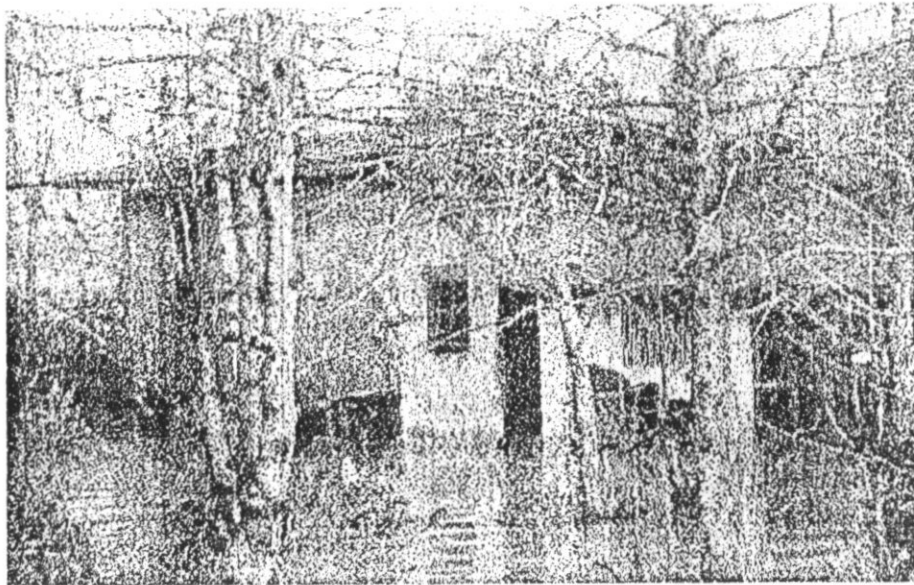
National Highway going to Milaor Camarines Sur

The place is basically a ricefield growing area associated with sparsely located residential houses. It was inundated by flood waters on Dec. 5, 1993 and was still under water during the Dec. 13, 1993 ground investigation and field survey.

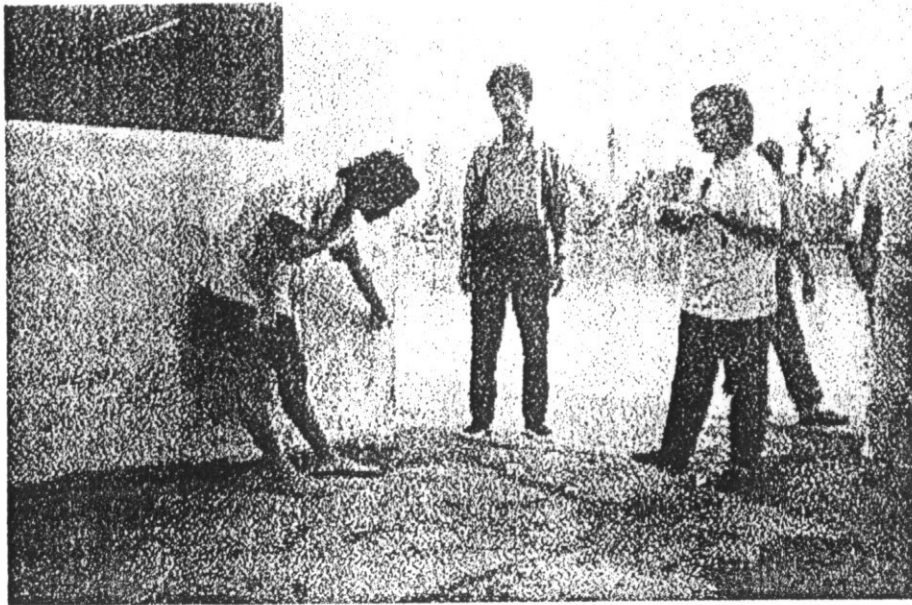
Brgy. Poblacion, Minalabac Camarines Sur

The banks of Bicol river located near the municipal hall of Minalabac. Residential houses comprise the area on one bank of the river, and coconuts and shrubs on the other. Accordingly, the flood waters started to rise slowly at 6:00 p.m. of Dec. 5, 1993 and by 10:00 p.m. the peak of the waterlevel reached a meter deep from the concrete floor of the river embankment. For 2 days, the flood water stayed on until the flood waters started to recede on Dec. 8, 1993. On Dec. 13, field work, the other bank of the river was still under water.

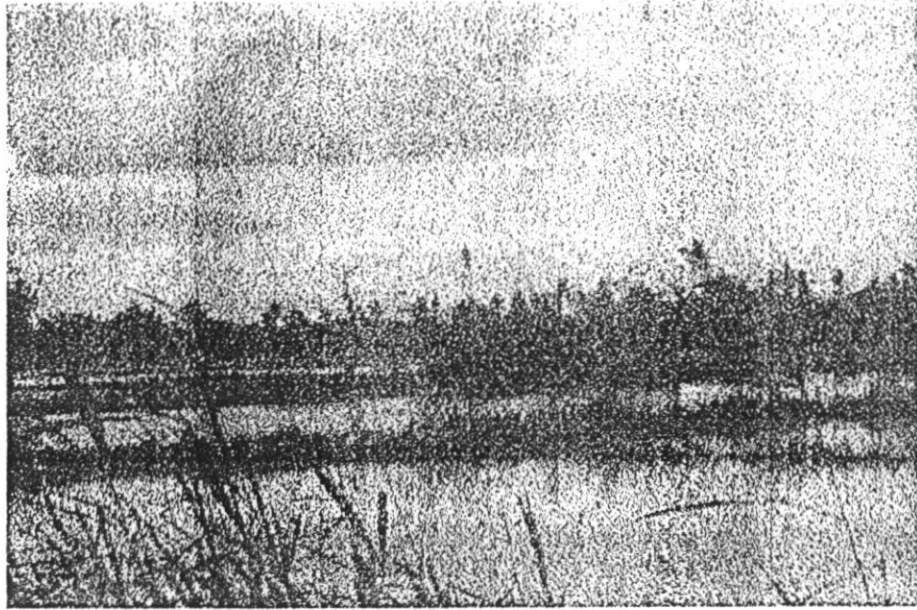
**2nd District of Gainza
Camarines Sur**

The place is basically a ricefield area.

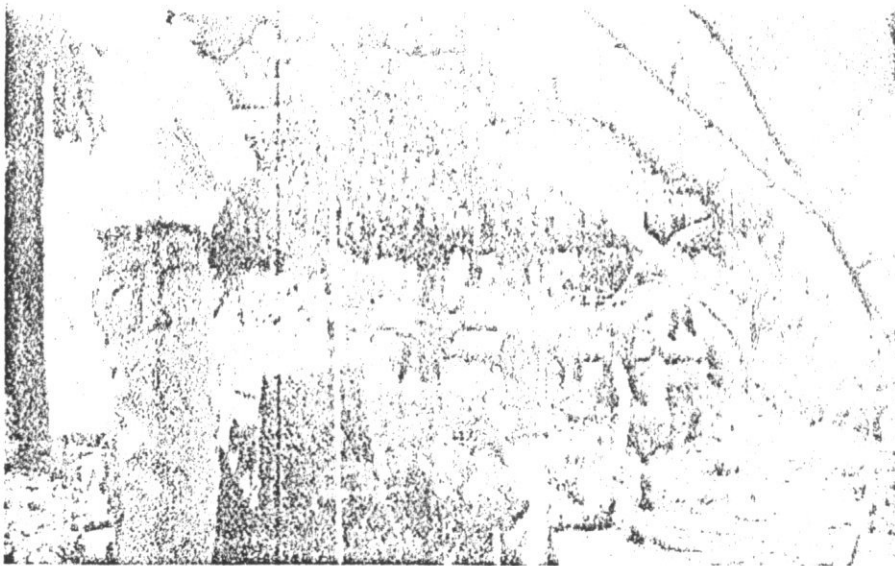
**Pawili River, Boundary of Brgy. Causip and Bagumbayan,
Bula, Camarines Sur**

Pawili river started to overflow at 6:00 p.m. of Dec. 5, 1993 and continued to rise until 3:00 p.m. the following day. Water level reached to about 0.8 meter above the natural ground line as indicated. The water then receded slowly for days until the river was back to normal flows on Dec. 12. During the Dec. 14 ground investigation and field survey the ground was still wet while in some regions, ponding of water was still evident.

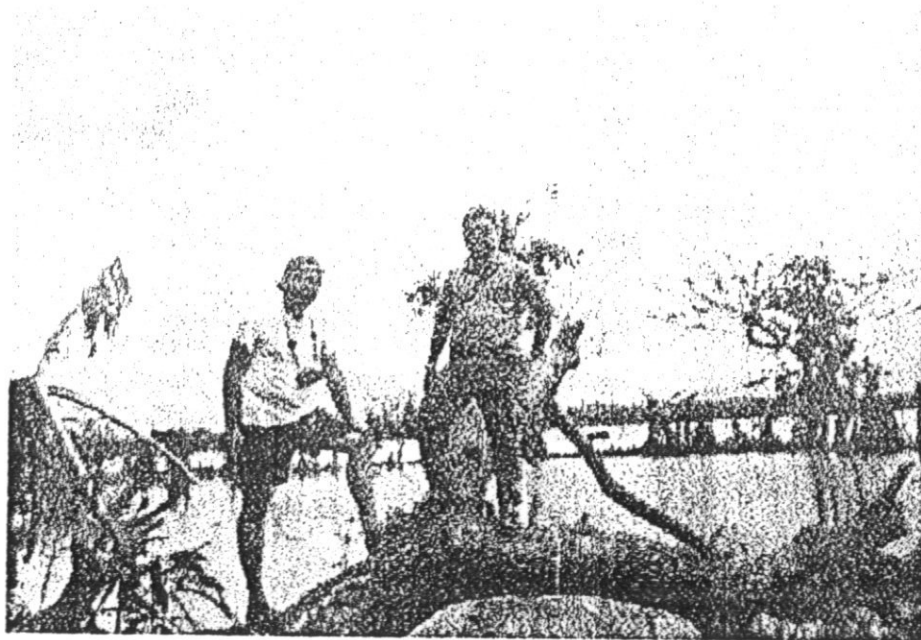
**Brgy. Madawon, Nabua
Camarines Sur**

This is an agriculture land utilized for rice, banana and coconut farming. Adjacent areas are still flooded on Dec. 14, 1993 field work. Accordingly, the flood waters started to inundate the area on Dec. 5 due to heavy rainfall spawned by typhoon "Monang" and peaked on Dec. 7 before it receded the following day. Flood waters inundated the area again on Dec. 9 due to heavy rainfall spawned by typhoon "Naning". The area is approximately 4.5 kms. north of Lake Bato.
