control: use of wastes on local engineering works in the coast of Gaza City

M.R. Al-Agha

Abstract Investment in the coastal resources of Gaza City is vital to various developmental issues and projects. Access to the coast and coastal erosion represent two major geo-environmental problems to the city. This paper describes local engineering works developed by the municipality and local people to overcome such problems. A cliff of calcareous sandstone – Kurkar as it is locally known – (up to 18 m high), is located at a distance of 20–50 m from the water–land contact. People who need to reach the beach must cross this Kurkar cliff. The engineering works used to facilitate access to the beach are: old automobile tires, white waste skeletons (refrigerators) and construction waste, where long stairs were designed using these materials. Meanwhile the engineering works which were used as erosion control measures include: rock gabions, concrete wastes, construction waste, concrete walls and shallow excavations. Such practices are commonly used in third world countries and are characterized by inexpensive transportation and implementation costs. The performance of these methods was evaluate

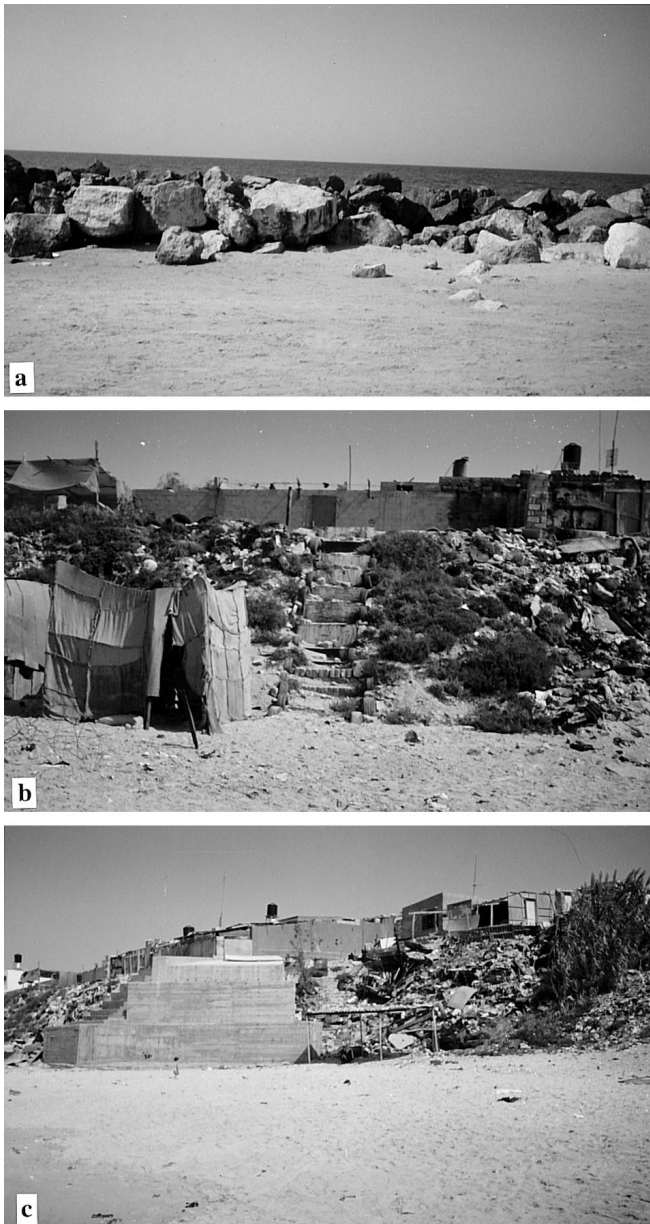
Fig. 2

a Rock gabions transported from the West Bank located in the sea water, white beach sand (*base of the photo*). The size of the largest block in the centre is about 1 m³. **b** White wastes (*refrigerators skeletons*) engineered in the form of stairs (*centre of the photo*), dumping of solid wastes along the Kurkar ridge, note the destruction of the coastal vegetation as a result of the dumping. The length of the skeleton is about 2 m. **c** Concrete walls with concrete stairs to the left of the photo, solid waste dumping to the *right of the photo*

White and non-cemented quartz grains are common along the coast of the Gaza Strip from the extreme north to the extreme south (Fig. 2a). Sand extends just from water–land contact to several meters and rarely tens of meters. It is normally about 1 m higher than the sea water level. Sand grains are mixed with shells and shell fragments with variable shapes and sizes.

Solid wastes of different types were dumped along the coast during the last few decades (Fig. 2b, c), during which no landfills were present in the Gaza Strip (Al-Agha 1997). Plastic, kitchen, metal, glass and paper are the main constituents of the domestic wastes dumped along the coast. The food wastes form about 70% of the total wastes in the Gaza Strip. This implies that the amount of leachate produced after the dumping will be quite high. This leachate finds its way either to the coastal Kurkar rocks, which form the main aquifer in the Gaza Strip, or to sea water.

Another type of engineering construction made to gain access to the coast of Gaza City is old refrigerator skeletons (Fig. 2b). These skeletons are placed in the same way as the tires mentioned above, where the slope is changed to be suitable for safe access. The skeletons are filled with sand and/or fine aggregates of construction wastes.

Large rock blocks were collected and transported from the West Bank, and placed along areas of active coastal erosion as barriers located at the water–land contact (Fig. 2a, 3b). Sometimes these rock gabions are placed in the contact line between the beach sand and the Kurkar ridge (Fig. 3a). They are formed of limestone rocks which are common in the West Bank. The unit volume of these blocks is generally about 1 m³. These barriers work as wave breakers, and thus stopping the advancement of waves to the Kurkar rocks. Transportation of these materials from the West Bank is one of the problems that makes this an expensive solution.

A few years ago, a 5-m high wall was constructed along the coast. The length of the wall is about 15 m. It is totally composed of concrete. Because of its high cost, such a measure was only constructed in one place along the coast. Stairs are associated with these walls and used for access (Fig. 2c).

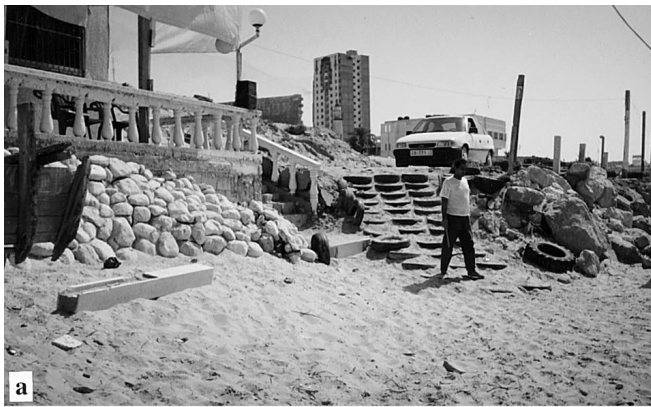
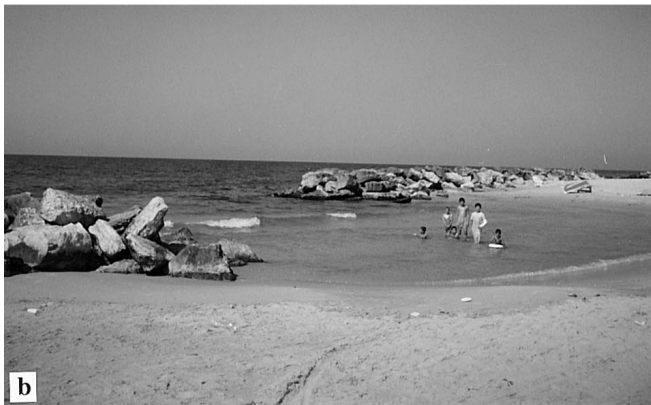
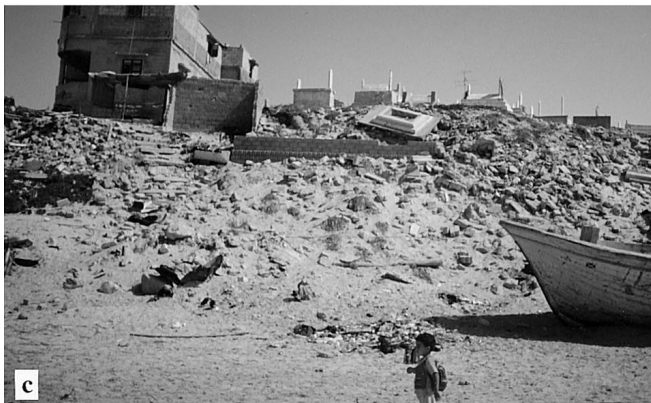
Fig. 3

a Use of old automobile tires for access to the coast (*centre of the photo*), rock gabions and construction wastes located along the Kurkar ridge (*right and left of the photo*), white beach sand (*base of the photo*). **b** Rock gabions located in the water to prevent the advancement of sea water towards the Kurkar ridge, an opening was left between two barriers of rock gabions where an excavation was designed, the excavation is used for playing and swimming of the children. **c** Collapse of the cemetery as a result of coastal erosion

Automobile tires made of synthetic rubber are used as stairs on the Kurkar cliffs along the Gaza City coast (Fig. 3a). Here the slope of the Kurkar ridge is modified

to 45–50°. This is made by the dumping of construction wastes on the Kurkar cliff until the slope is changed. This makes it easy for people of all ages to have easy access to the coast. Two or three tires are placed close together horizontally and filled with sand and/or fine aggregates of construction wastes.

In some parts along the coast of the Gaza Strip, coastal erosion is considered a threat to buildings, roads and other installations located directly on the coast. This is clearly seen along the coast of the city of Gaza, where an asphalt road and a cemetery partially collapsed during the last 5–6 decades as a result of coastal erosion (Fig. 3c).

In some other areas small aggregates and blocks of construction wastes were dumped along the coast to prevent the coastal erosion (Fig. 3a, c). This type of erosion control is commonly seen on the Kurkar cliff, and rarely in the water–land contact area.

In some areas shallow excavations were performed to absorb the waves, and consequently to prevent their arrival at Kurkar ridge (Fig. 3b). One of these excavations is located just in front of the main street of Gaza City (Omar Al-Mukhtar Street). The excavation was performed in both the beach sand and under the sea water along the coast. The area of such excavation is estimated to be a few hundreds of square m, while its depth is not more than one meter.
