# Fracture Tests to Study the Behaviour of Simulated Sub-Surface Flaws in a Reactor Pressure Vessel Steel

*a continuation of the NESC-IV project*

EUR 23970 EN - 2009

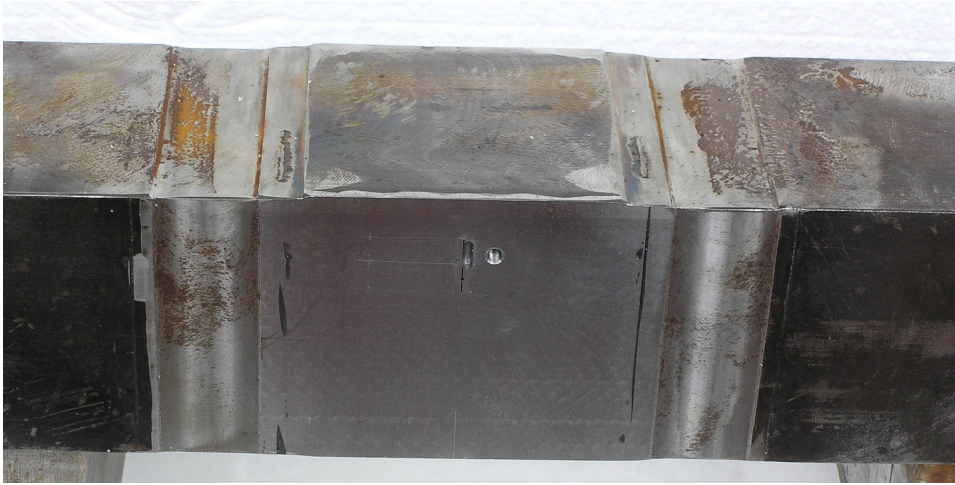
**Figure 5 The central section of specimen no. 1 prior to testing.**

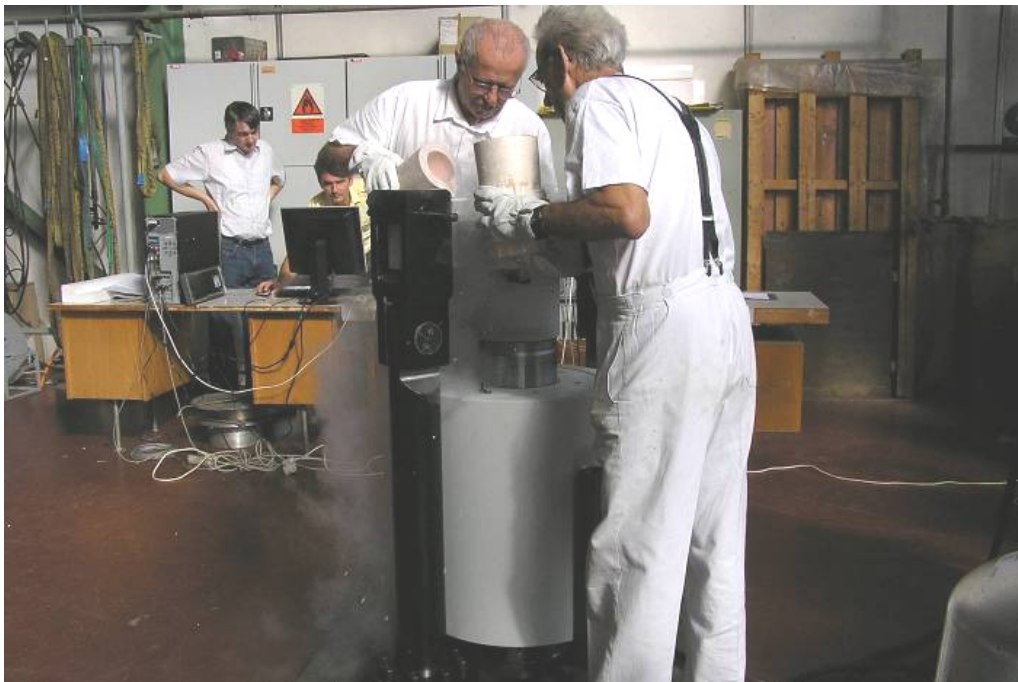
**Figure 7 System for cooling the test piece: a) the liquid nitrogen baths at either side of the beam; b) addition of liquid nitrogen for the cooling phase.**

Since the nominal test temperature was -95 °C, the test section was cooled by liquid nitrogen (see Figure 7). To calibrate the system, a mock-up was manufactured and instrumented with 8 thermocouples placed in the symmetry plane of the mock-up. Before the calibration test, the mock-up was loaded with about 10 kN to assure contact with the supporting mast. It was then cooled by pouring liquid nitrogen into four vessels attached to the specimen arms and one vessel cooling the top of the central mast. The temperature was reduced to about -140 °C and then allowed to increase. At about -90 °C liquid nitrogen was added again to decrease the temperature. This cycle was repeated four times. The resulting temperatures from the thermocouples are shown in Figure 8. The behaviour is similar in all four cycles.

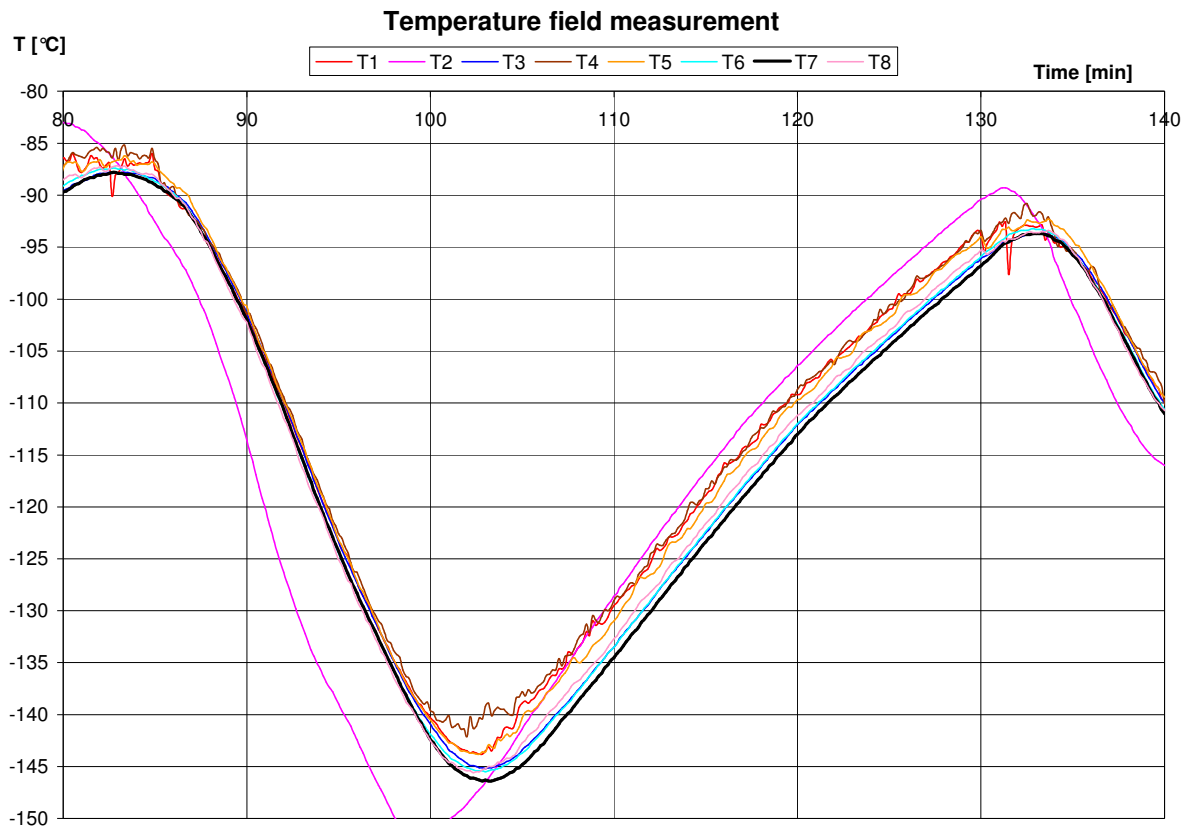
**Figure 9** Detail of the 2<sup>nd</sup> temperature cycle during the calibration. Thermocouple T1 is in the middle of the upper surface; T2 in the middle of the lower surface (in a notch to avoid being squeezed against the support plate); thermocouples T3 - T5 are at the upper crack tip; T6 and T8 are at the lower crack tip and T7 is in the drilled hole of the “real” specimen.

Figure 9 shows details of the second cooling and heating cycle. During the free heating phase the temperature field in the test section is almost equalised. The exception is thermocouple T2, which is influenced by the heat flux from the relatively warm and massive piston, but is

also well away from the crack tip position. It was therefore decided to apply only two cooling cycles for the actual tests and to fracture the specimen in the final stage of the second free heating phase. Thermocouple position T7 (in the drilled hole of the simulated flaw) was selected as reference because of its simple installation and very good agreement with the crack tip temperatures.

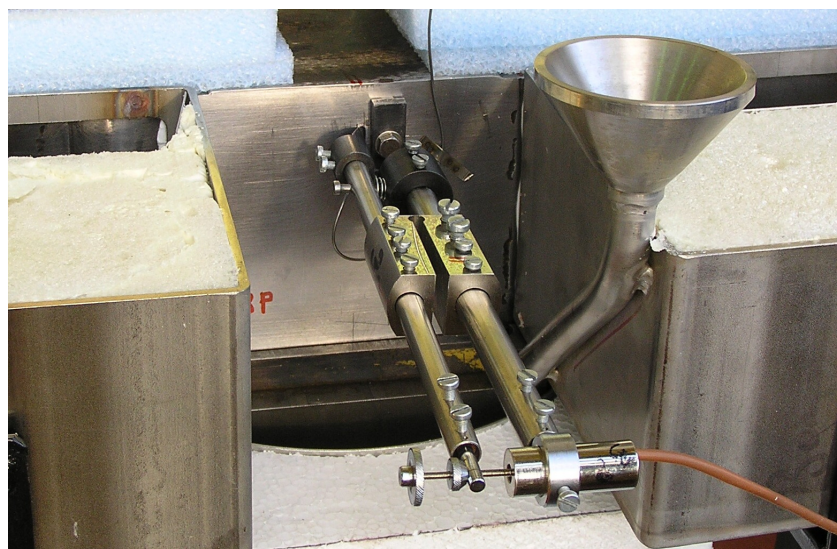
**Figure 10** The device for CMOD measurement mounted on the flank of a specimen.

Crack Mouth Opening Displacement (CMOD) measurements were made using clip gauges attached at either side of the specimen. Each CMOD gauge was calibrated separately using a Mitutoyo position transducer. One arm of the measuring device was fixed to the specimen by a screw, while the other arm was ended by an edge touching the specimen on the opposite crack face. To enable this touching, a small notch was machined on the flank surface of the specimen. The centre of the notch, i.e. the position where CMOD is measured, was located 21 mm below the specimen top, i.e. 8 mm above the centre of the drilled hole, about 2 mm above the crack centre. For specimen no. 1 and 5 measurements were performed on both specimen flanks; for the other specimens measurements were made at one side only to leave the other side free for the video recording of the crack tip. Figure 10 shows the device for CMOD measurement mounted on the flank of a specimen.

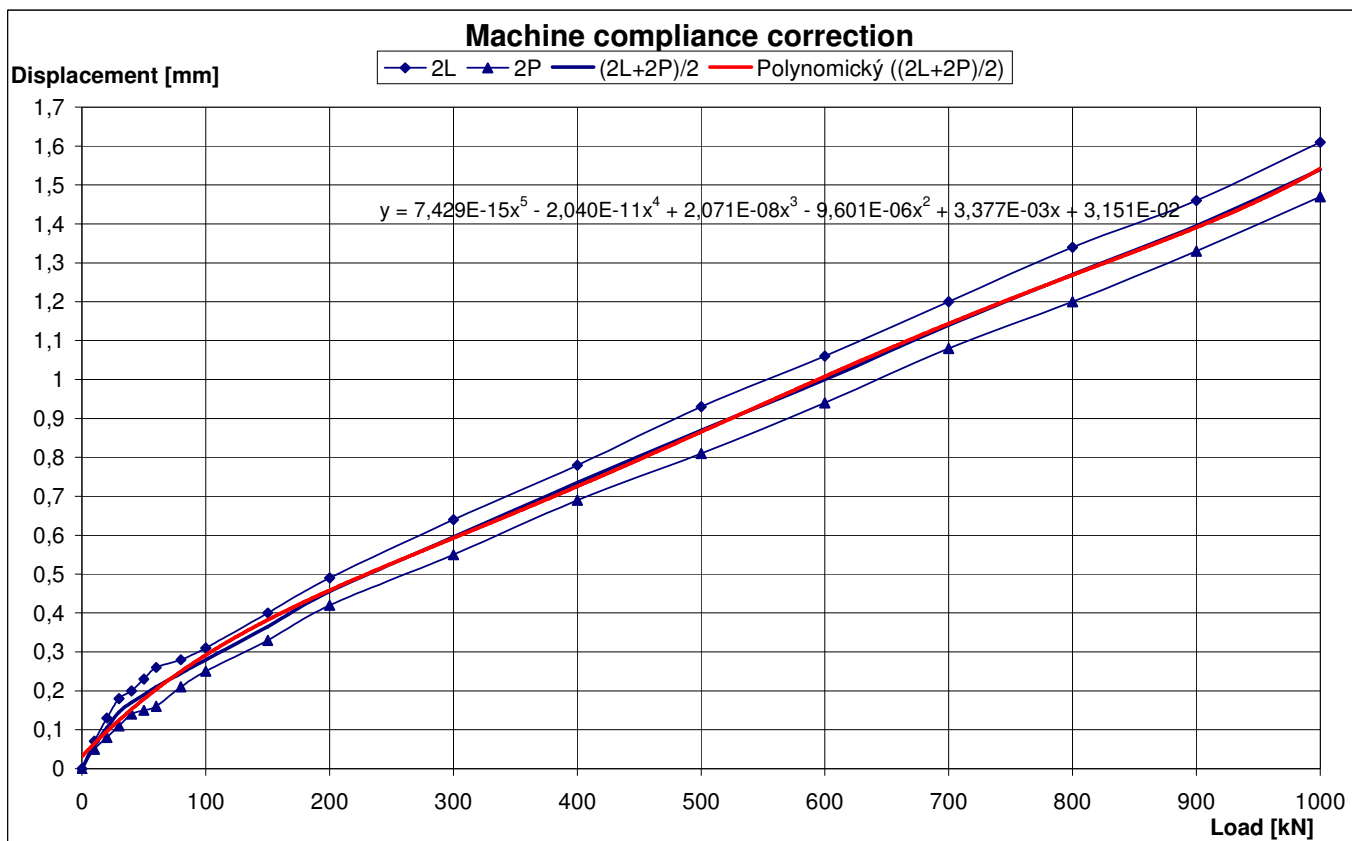
**Figure 11 Calibration to establish the compliance correction function for the LLD.**

The Load Line Displacement (LLD) was measured during the tests from the extension of the hydraulic ram piston relative to the piston body. This however needed to be compensated for machine compliance to convert it to the value on a test specimen. As a basis for this, a special series of compliance measurements was performed using a very thick mock-up specimen. These measurements were carried out for several load levels up to 1 MN. Details are given in the NRI test report [4]. The resulting correction  $\Delta LLD$  is shown as a function of applied load in Figure 11. The 5th order polynomial fit is as follows:

$$\Delta LLD = 7.429 \times 10^{-15} \cdot F^5 - 2.040 \times 10^{-11} \cdot F^4 + 2.071 \times 10^{-8} \cdot F^3 - 9.601 \times 10^{-6} \cdot F^2 + 3.377 \times 10^{-3} \cdot F + 3.151 \times 10^{-2}$$

where  $\Delta LLD$  is in mm and F is in kN. This amount is subtracted from the measured LLD to give a “true” value.

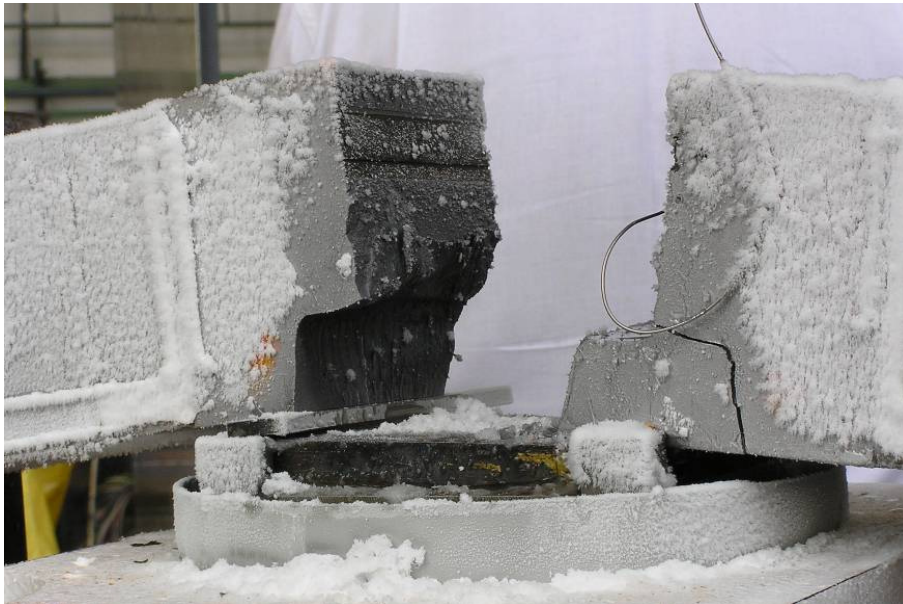
**Figure 13** Specimen no. 1 after fracture.

In total six specimens were tested. Specimen no. 1 was successfully tested at -95 °C in September 2006 as a pilot test. On the basis of this result, also the other specimens were fatigue sharpened at SVUM and the main testing schedule started in November 2006. The first four tests produced fracture at loads at the upper end of the expected range and as a result for the remaining tests it was decided to lower the temperature by approximately 10°C. Specimen no. 6, which was tested at -108 °C, failed prematurely in one of the electron beam welds connecting the extension arms with the insert (Figure 12). A repair weld was performed and the specimen was successfully retested in May 2007 to produce a fracture at the crack. For each test data of temperature at thermocouple no 7, of the force, LLD and CMOD were stored in an Excel file, which is available from the JRC. The values of the main parameters at fracture are summarised in Table 2. Concerning the CMOD measurements, in the first two test performed (numbers 1 and 5), two clip gauges were used, one on either side of the specimen. These produced almost identical readings and for the remaining tests only 1 clip gauge was used to allow better access for the video camera to the crack tip on one side. In the test on specimen 3, the CMOD readings were unfortunately lost shortly after the start of loading. All specimens failed directly after initiation of fracture, with the crack propagating downwards and then bifurcating at a position about 1/3 of specimen height (from its bottom). Further propagation occurred to some extent in horizontal direction to both sides. Figure 13 shows an example of such behaviour.

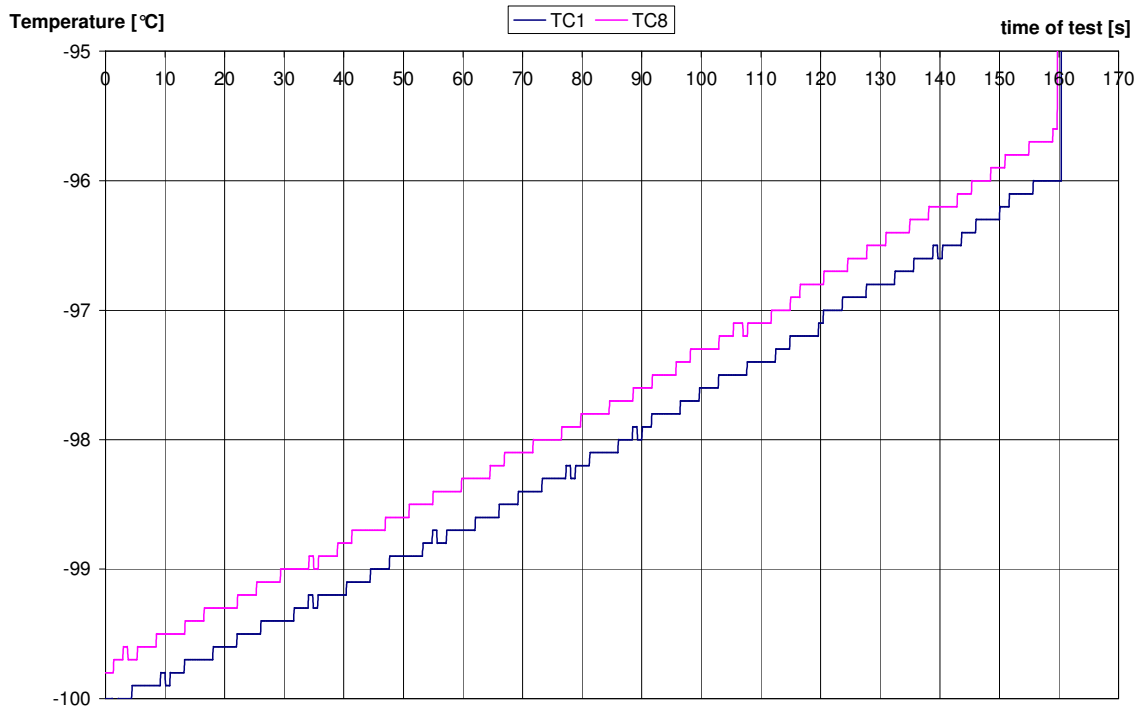
**Figure 14 Temperature variation during the test on specimen no. 1 for thermocouple 1 (top centre) and 8 (deep tip on the specimen flank).**

Figure 14 shows the temperature variation for thermocouples 1 (middle of upper clad surface) and 8 (specimen flank at deep crack tip) for the period of the fracture test and confirms the good degree of uniformity of the temperature field.

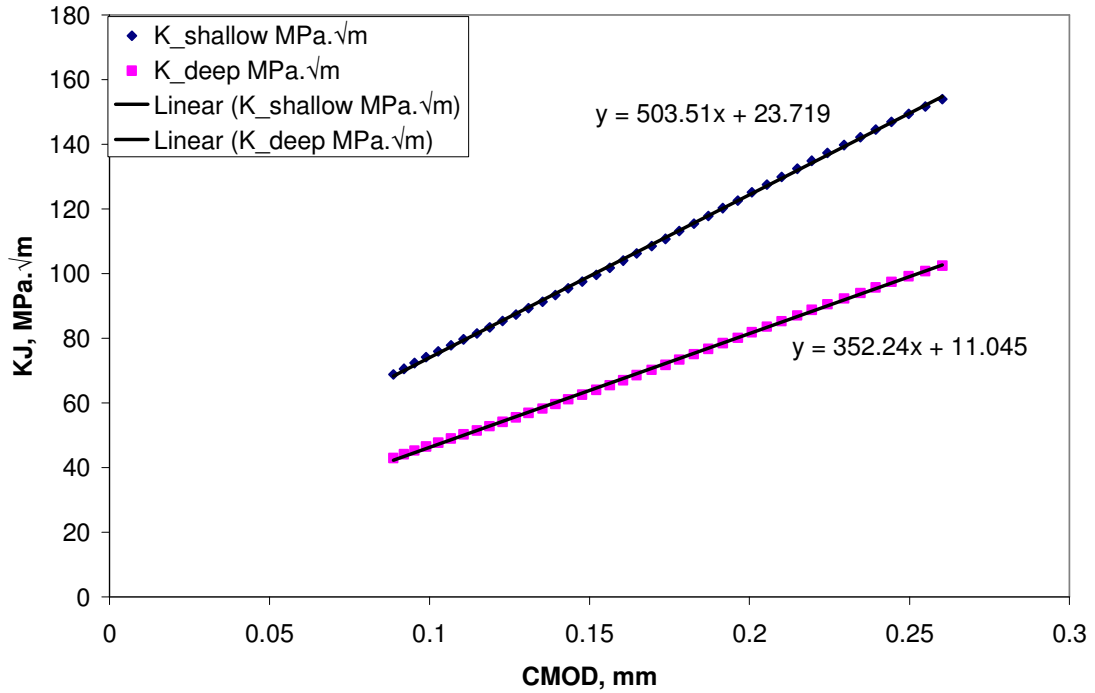
Figure 23 The  $K_J$  vs. CMOD relationships for the shallow and deep crack tips established from elastic-plastic FE simulations in the NESC-IV project.

The sub-surface crack configuration and the presence of the clad layer mean that standard K or J solutions are not strictly applicable. It had been hoped to directly use the solutions developed in the NESC-IV project to provide  $K_J$  estimates. However as noted above, the beams in the present series show slightly greater stiffness than the corresponding ORNL data, so ideally new cracked-body FE calculations should be performed with the exact geometry of the beams and the NRI test rig. For the purpose of this quick look analysis we have simply assumed that the CMOD -  $K_J$  relationships established in the NESC-IV tests (Figure 23) can be used to provide an estimate of  $K_J$  at fracture for the NRI specimens (both shallow and deep crack tips). These  $K_J$  estimates were first size-corrected to the standard Master Curve crack length of 25 mm using the relation:

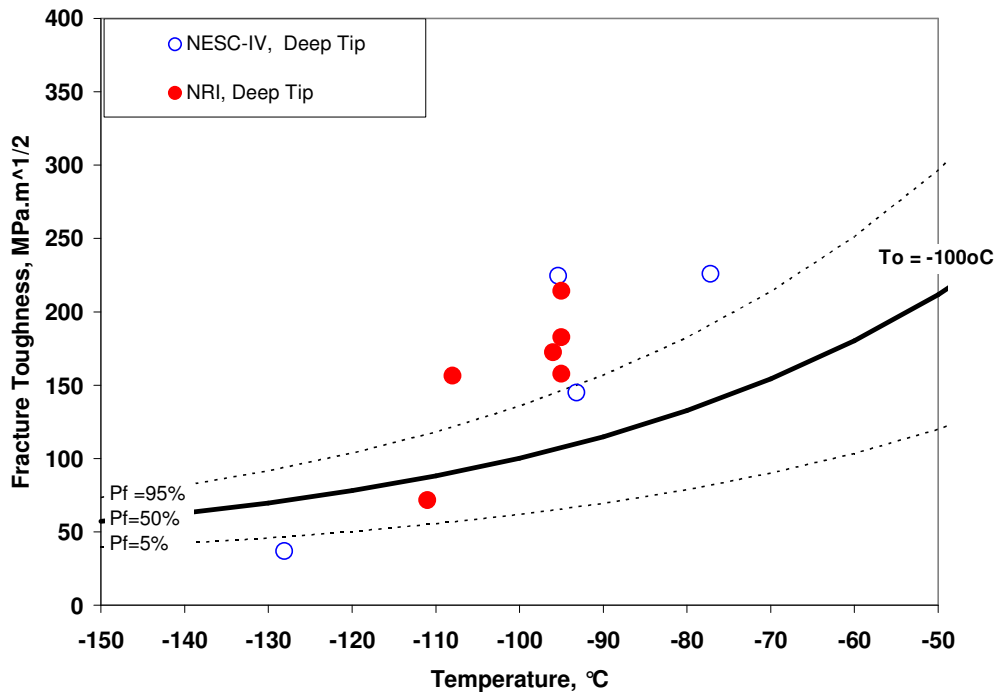
Figure 24 The Master Curve with  $T_0 = -100$  °C with experimental deep tip data for the PVRUF shell.

Figure 24 and 25 show the  $K_J$  data for the deep tip and the shallow tip, respectively, together with the NESC-IV data and the  $T_0 = -100^\circ\text{C}$  Master Curve. For the deep tip, the values from the tests performed around  $-95^\circ\text{C}$  lie above the Master Curve  $P_f = 95\%$  upper bounding line. For the same group of tests, the shallow tip  $K_J$  values are substantially above the Master Curve. The video camera evidence for specimen no. 5, which was in this group, suggests that the fast fracture event initiated at the deep tip. Hence the hypothesis is that at this temperature level the constraint loss effect at the shallow tip suppresses fracture initiation (even if though the  $K_J$  level is higher). Instead the fracture starts at the deep tip, and the fact that the  $K_J$  lie slightly above the Master Curve suggests that even this point may experience some constraint loss effect.

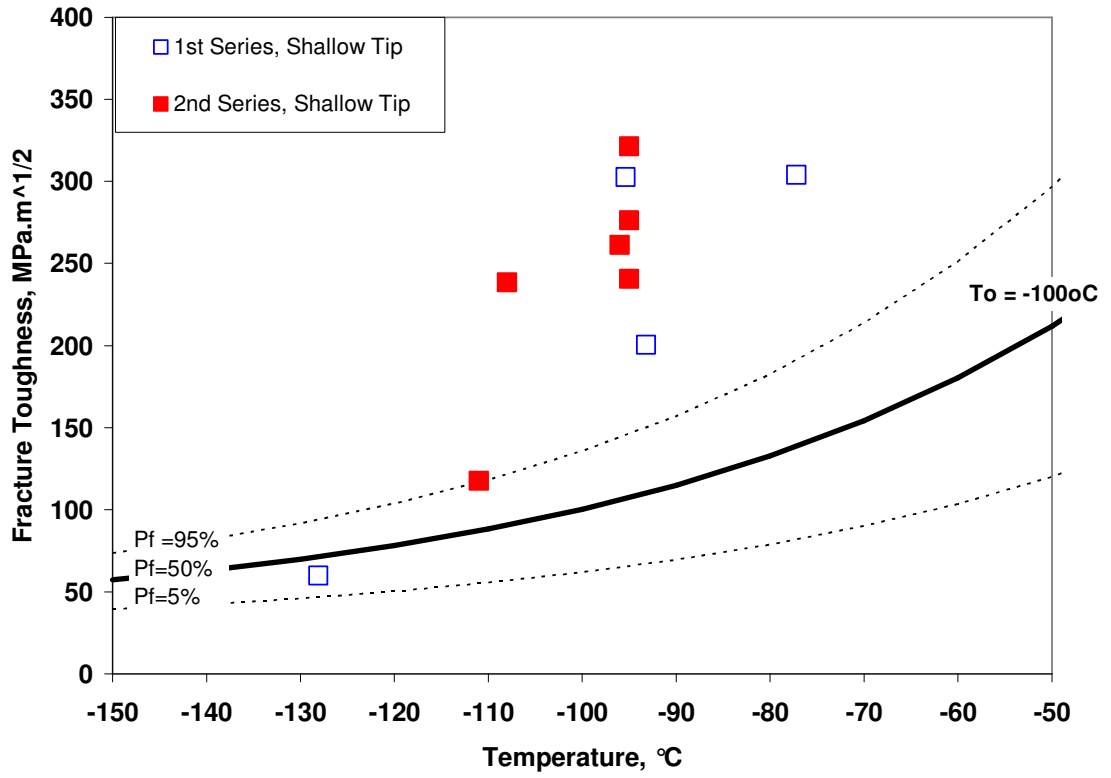
**Figure 25 Master Curve plots showing the present NRI data with data points from the NESC-IV test series for the shallow tip.**
