# Development of the Mandrel Test for Controlled Displacement of Zircaloy tubes

Summary of Initial Work 2007

K-F Nilsson, C. Chenel-Ramos, V. Vokál, J. Mendes and O. Martin

EUR 23283 EN - 2008

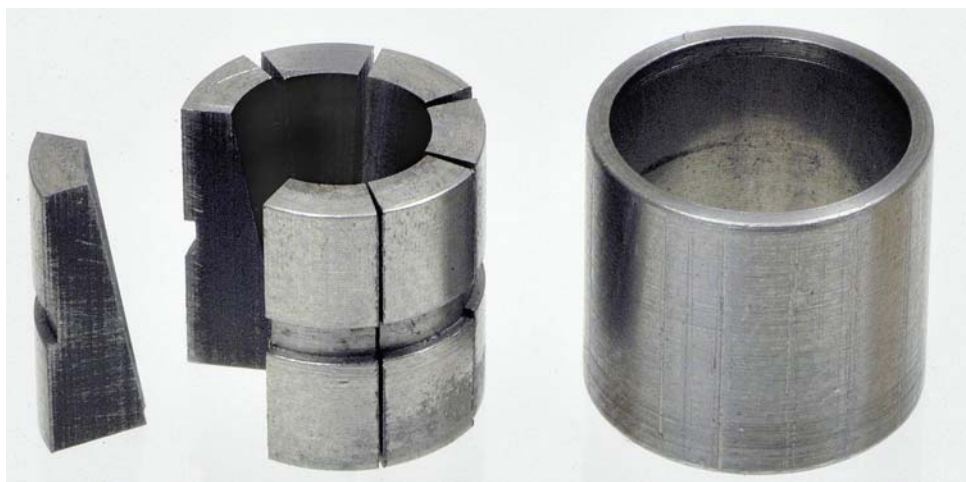
*Figure 4 Machined segments and zircaloy tube.*

The segments are made of Nimonic105. Two sets of segments were prepared for different tube geometries. The segments were machined from cylindrical pieces with diameters equal to the inner dimension of the tubes. A central hole was machined away in the cylinders to have a surface that matches the shape of the end section of the cone. A small slot was also machined from the outer part of the cylinder. The segments were subsequently cut into the eight nominally identical segments. The purpose of the slot is to accommodate a wire spring that should hold the assembly together. This element was however not employed during these trial tests. The cone, the segments and the inner surface of the cladding tube were covered with a lubricant to minimize friction between the parts.

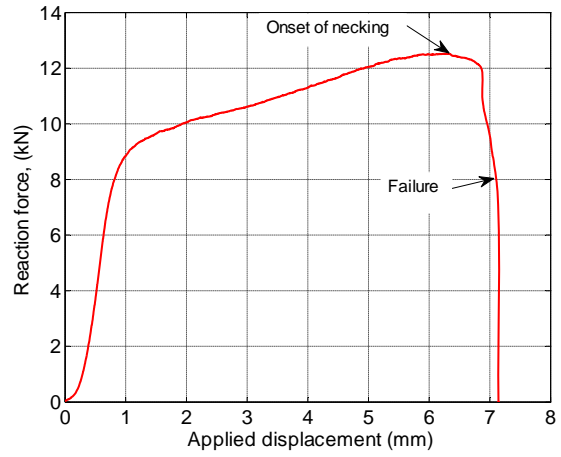
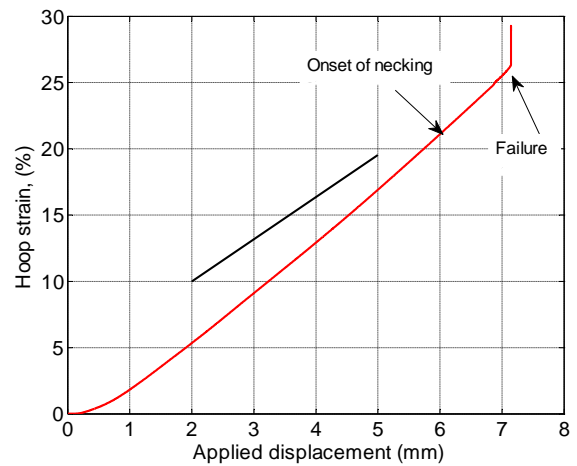
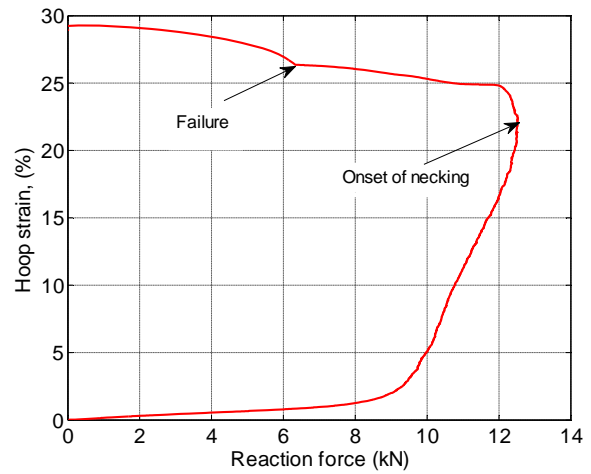
Figure 6 Test #2 a) and b) Measured reaction force vs. applied displacement c) and d) measured hoop strain versus applied displacement e) and f) measured hoop strain versus measured reaction force

Test # 2 was first loaded to a vertical displacement of 0.9 mm which resulted in 1.2% strain and then unloaded. According to the hoop strain formula above, the strain increment should be 3.5% per mm applied vertical displacement. For the loading part it is quite clear that the strain does not increase linearly with the load and the initial strain is lower than given by the formula. This could be caused by non-perfect alignment. The unloading is also quite complex. The reaction force first drops drastically from 8 kN to 1 kN as the applied displacement is lowered from 0.9 to 0.8 mm. When the load is further reduced there is some elastic unloading. The plastic residual strain is 0.6%. The load-strain curve for the second load cycle is shown in Figure 6b, d and f. A load maximum is achieved at about 27% strain. This load maximum indicated that there is a kind of “necking” behaviour with localized plastic deformation. The load then decreases as the strain is further increased and the tube cracks at about 33% strain. The onset of necking and the failure are indicated in the plots.

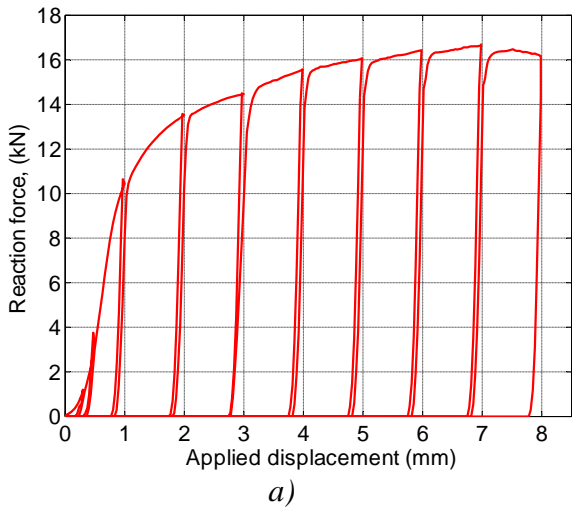
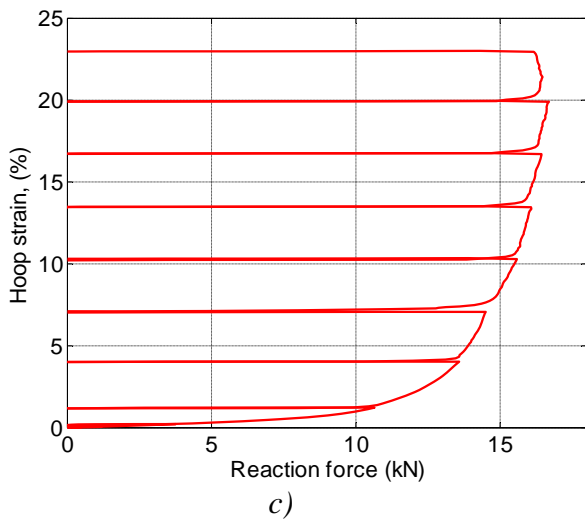
Figure 7 Test #3 a) Measured reaction force vs. applied displacement b) measured hoop strain versus applied displacement c) measured hoop strain versus measured reaction force

For the third trial test (Test #3), the tube was loaded and unloaded several times. The unloadings did not result in any measurable strain reduction. From the load-strain curve it appears that the unloadings did not affect the overall behaviour. It can be noted that Test # 3 had significantly more hardening than Test #2. For instance at 20% strain the force on the cone is about 16kN for Test #3 but only 12 kN for Test #2. The load maximum also occurs for 16 kN and the failure is at about 24% strain.

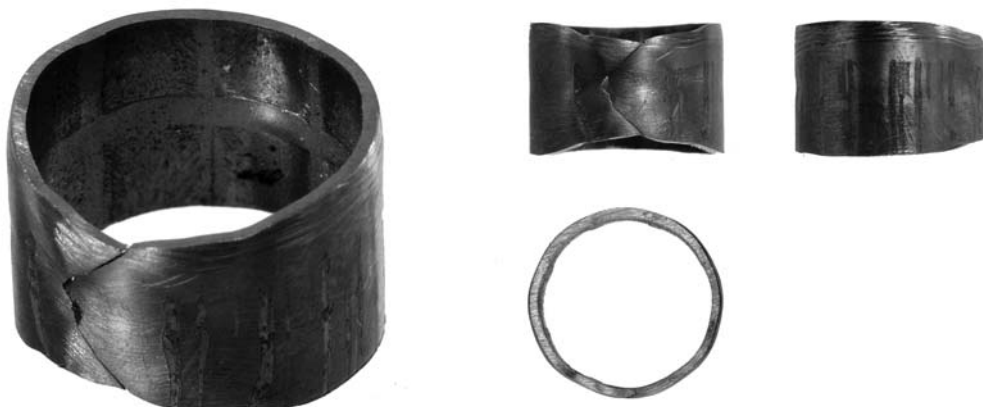
*Figure 10: 3D, front, left and top overview of tested Zyr4A specimen. Crack together with local deformation is present. Mandrel test device pattern is visible inside of specimen.*

As mentioned above the Mandrel test loading resulted in local thinning, necking and cracking as seen in Figure 10 and 22 for Test #2 and Test # 3 respectively. The cracking of the specimens was influenced by shear stress as expected and took preferential direction of 45° angle (Fig 10, 11, 22). Cross slip at the middle of the crack is also visible.

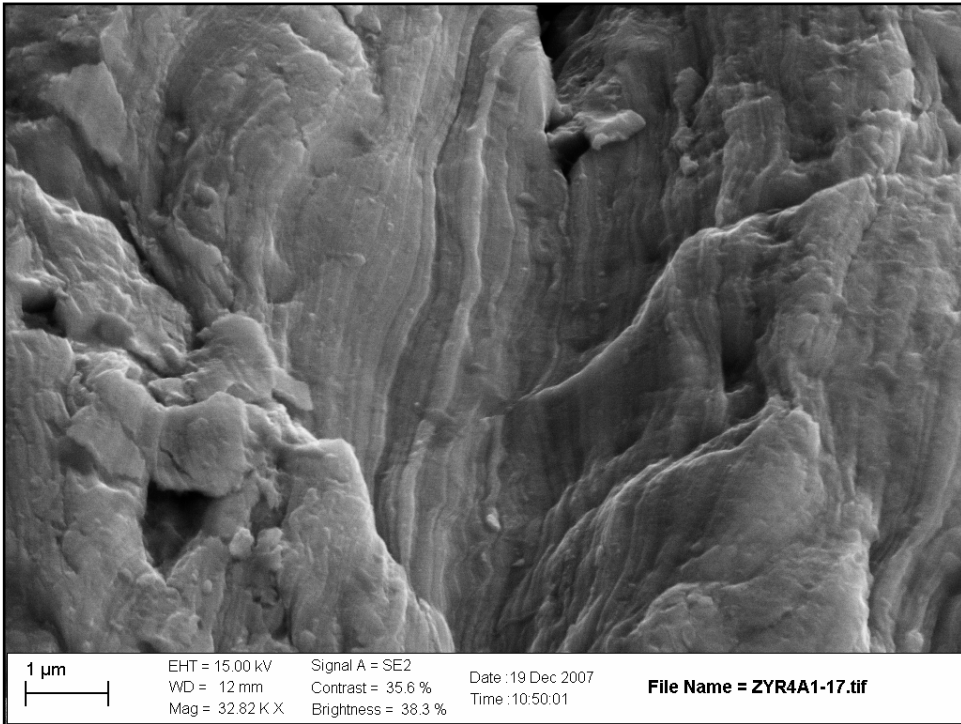
*Figure 17 One of the detailed views on the surface deformed zone – shear bands. Picture is presented on the same planes effecting from deformation of specimen.*

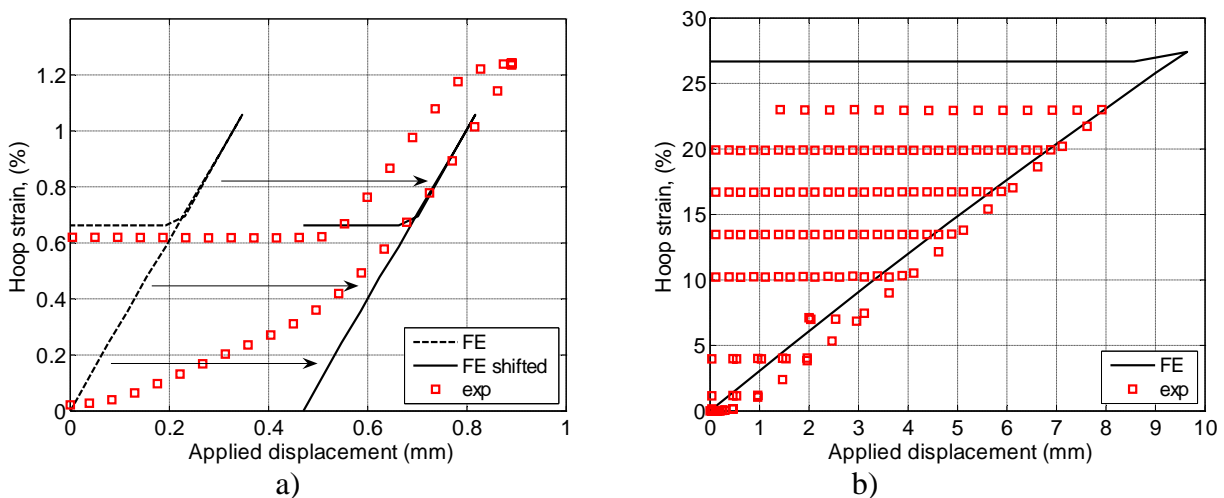
Figure 27: Hoop strain for applied radial displacement of a) 0.0611 mm experimental data from Test #2 and b) 1.7 mm and experimental data from Test #3.

Figure 27a and b show the computed hoop strain on outer edge of the tube at  $\varphi = 0$  for an applied radial displacement of  $U_R = 0.0611$  mm and  $U_R = 1.7$  mm respectively together with the measured values from Figure 6 and 7. The displacement corresponds to the axial displacement,  $U_z = U_R / \tan(\varphi/2)$ . The computed curves give of course a linear relationship for loading and the elastic unloading. As discussed in previous sections the measured strain does not increase linearly with the displacement for low loads, and for low loads the measured strain is smaller than the computed values. As already mentioned this is probably caused by a gap between the cone and the segment and non-perfect alignment of the cone and tube. By translating the applied displacement in the computed curve by 0.5 mm a better agreement with the measurements is attained as seen in Figure 27a. This indicates that the gap is  $0.5 \cdot \tan(\varphi/2) \approx 0.09$  mm.

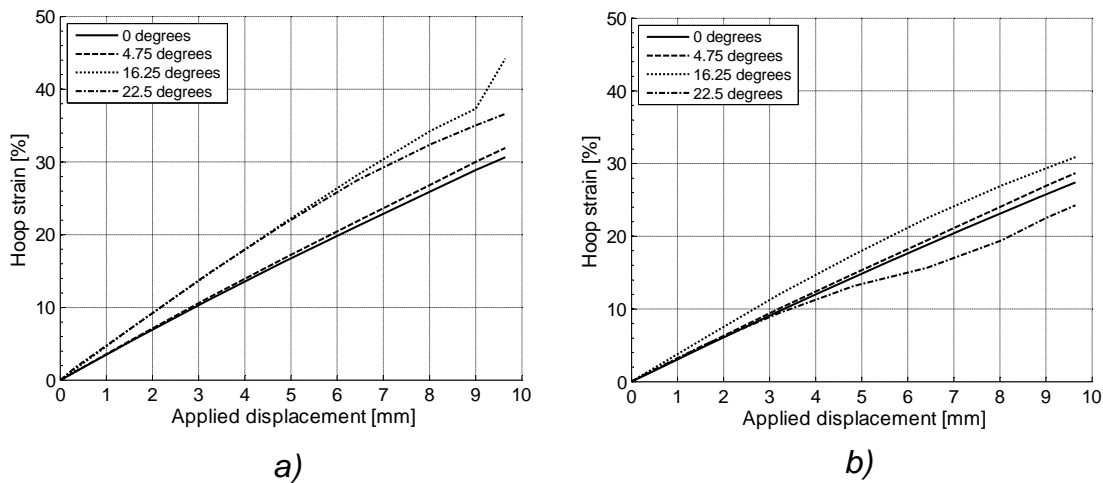
Figure 31: Hoop strain vs. applied vertical displacement at four locations along a) inner and b) outer edge.

Figure 30 shows the hoop strain vs. the position angle  $\varphi$  along the inner and outer edge of the tube for four different load levels whereas Figure 31 shows the hoop strains vs. the applied displacement at the four angle positions along the inner and the outer edge of the cladding tube. From Figure 31 we note that that the hoop strains have its largest value at  $\varphi = 16.25^\circ$ , which is approximately the position where the contraction is most pronounced at higher loads and where the local strains have their largest values. From Figure 32 we note that for the inner edge at the position,  $\varphi = 16.25^\circ$ , the hoop strain has a strong increase at an applied displacement of  $U_z = 9 \text{ mm}$ . This could be and indication for the onset of necking.
