Geology as a control on landslides on the Isle of Wight: an overview

G. O. Jenkins^{a*}, C. Foster^a & P. M. Hopson^a

Abstract

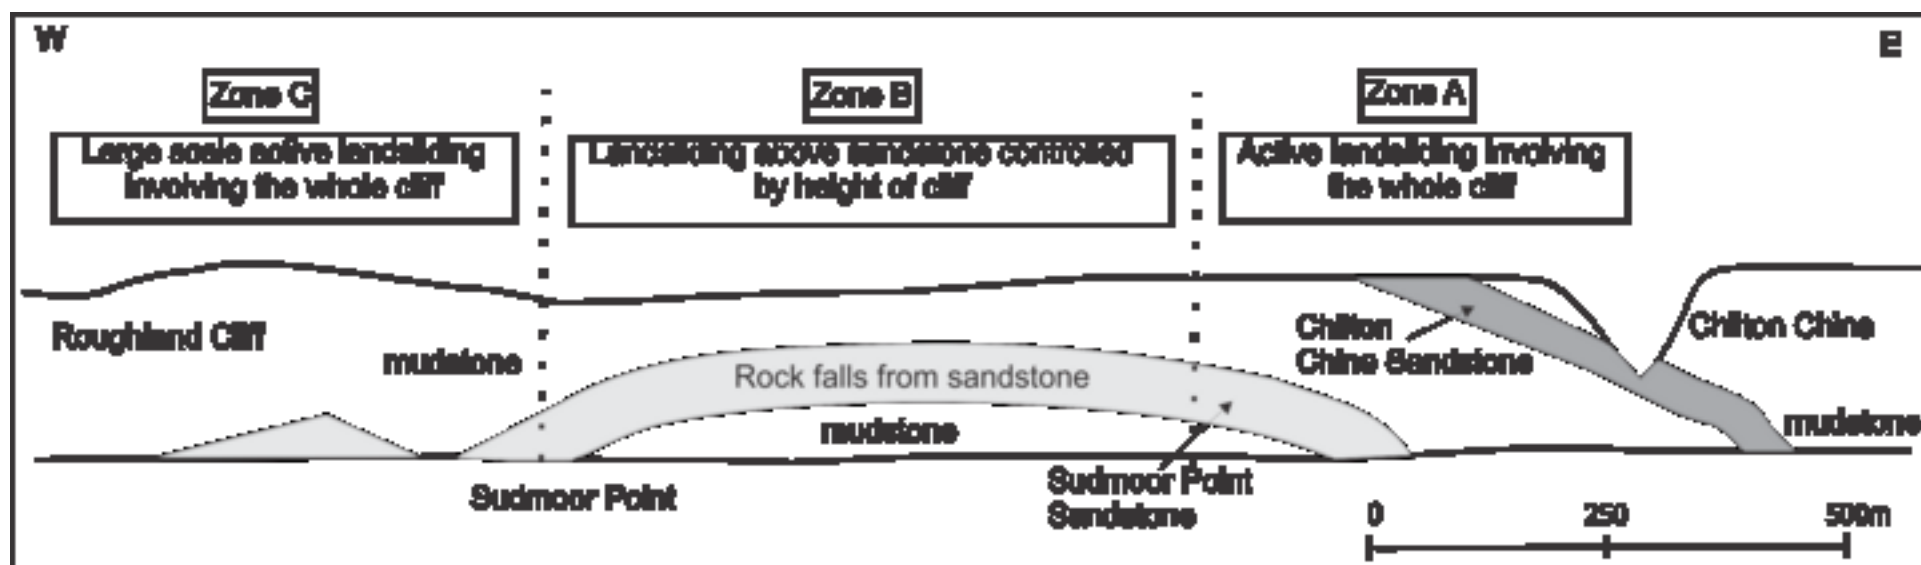
Figure 2
[Click here to download high resolution image](#)

22 The Wealden Group, consisting of interbedded mudstones and sandstones, can be
23 divided into the Wessex and Vectis formations (Table 1). The Wessex Formation is
24 composed of a non-marine sequence comprising multicoloured, predominantly red,
25 mudstones with subordinate sandstones. The Vectis Formation is principally
26 composed of dark grey siltstones and mudstones which are thought to have been
27 deposited in a shallow lagoonal environment. It is subdivided into three members:
28 Cowleaze Chine, Barnes High Sandstone and Shepherd's Chine Members (Daley &
29 Stewart, 1979). Both formations are highly susceptible to landslide failures,
30 particularly where they are exposed to storms on the southwest coast. The character of
31 the failure is determined by the presence and thickness of sandstone units within both
32 the Wessex and Vectis formations. This is illustrated in Fig. 2 using an example from

33 the Wessex Formation along the Brook Undercliff. Here three basic types of failure
34 can be identified (Zones A to C) associated with both formations. These are illustrated
35 in Figs. 2 to 5.

41 Zone A represents whole cliff activity, with thinner sandstones being incorporated
42 into landslides as rotated blocks and where the sandstones only act to limit failure
43 when outcropping at beach level and the cliff above is relatively low (Fig. 3). Zone B
44 represents cliffs where a thick competent sandstone acts as a natural revetment behind
45 the beach or as a reinforcement to the cliff when above the beach level. The degree
46 and inland extent of failure of the units above the competent sandstone is determined
47 by the remaining height of the cliff. Failure of the sandstone leads to debris cones of
48 material spilling onto the beach and abutting the sandstone unit (Fig. 4). In general,
49 clay-rich units, when exposed below the competent sandstone, retain a steeper profile
50 as they are frequently removed during storm events. In this scenario the sandstone
51 generally fails by undercutting and block-failure. Zone C is illustrative of the cliff

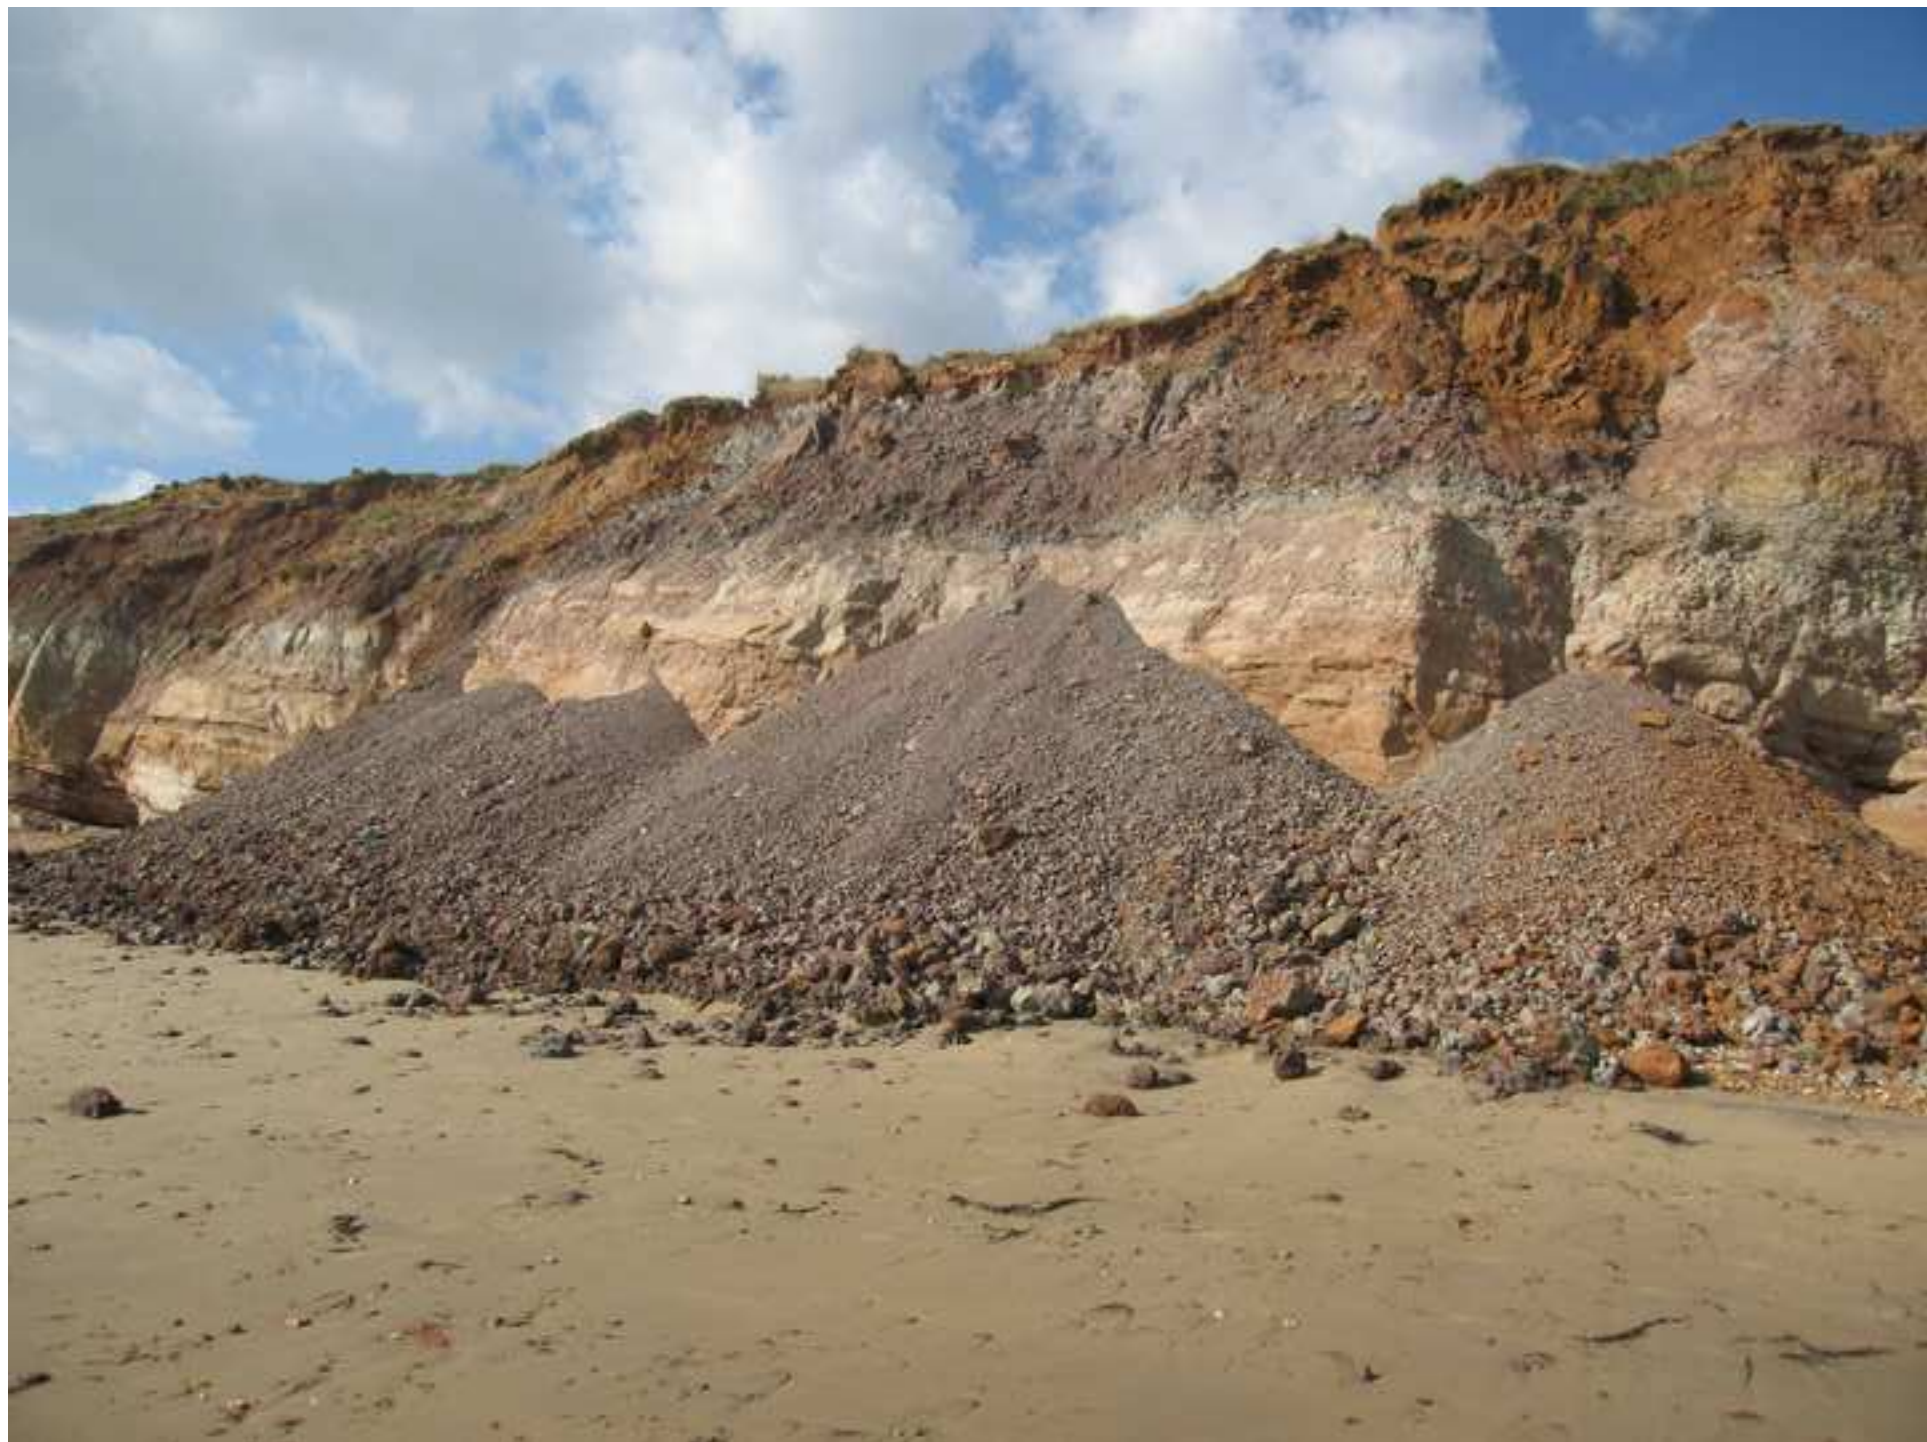
Figure 4
[Click here to download high resolution image](#)

15
16 Fig. 4. Presence of debris cones below a massive sandstone bed in the cliff at
17 Sudmoor Undercliff (Fig. 2, Zone B). P769944.
18

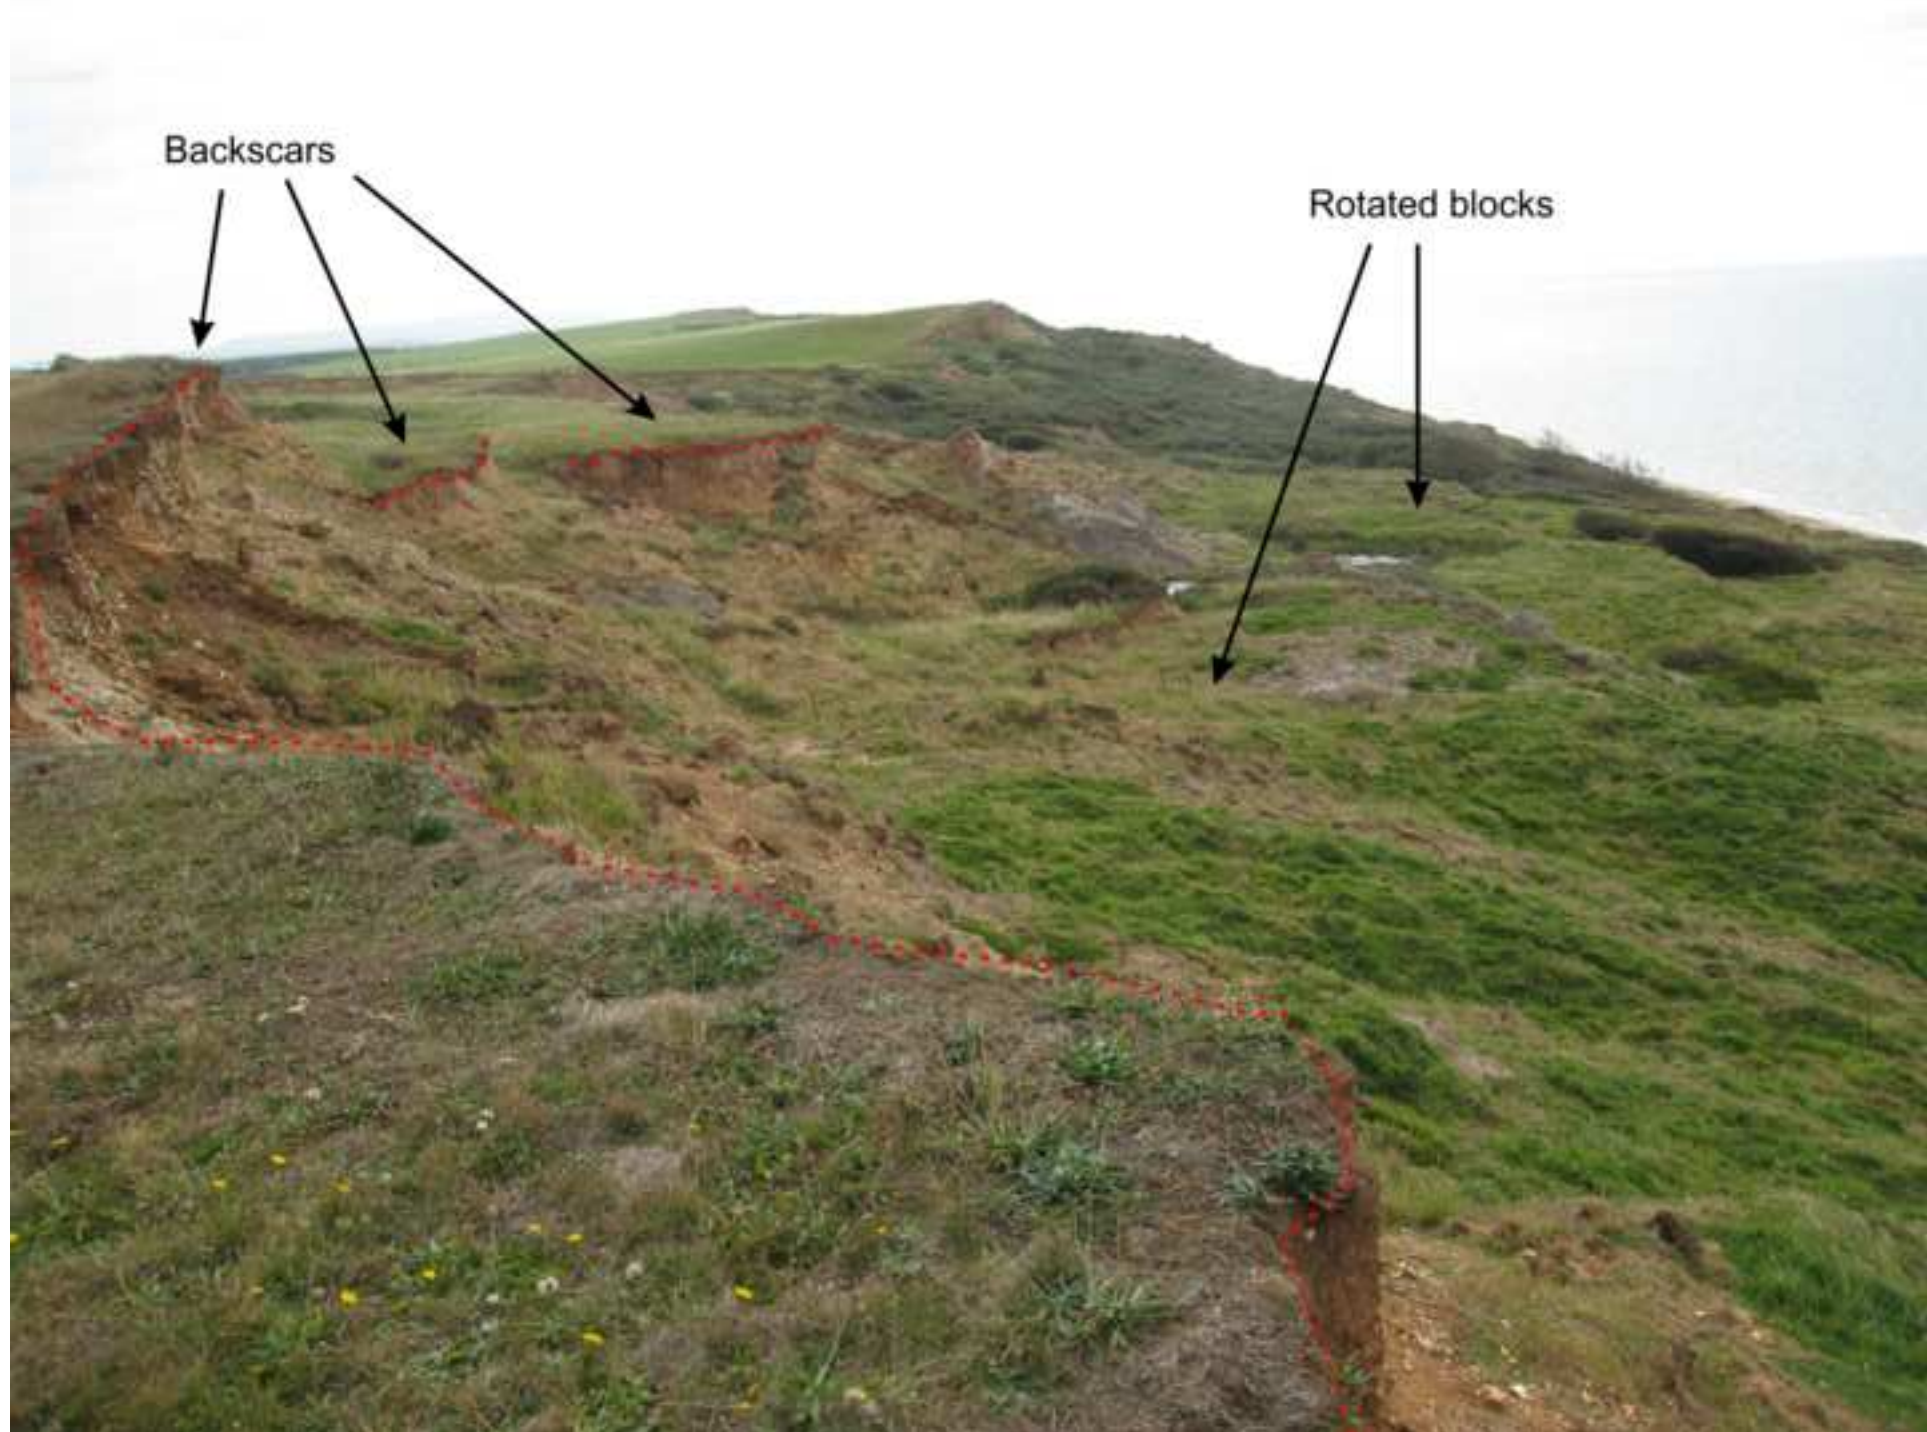
Figure 5
[Click here to download high resolution image](#)

52 where no significant sandstone reinforcement is present and the whole cliff is active
53 even where cliffs are low (Fig. 5). General observations indicate that the retreat of the
54 cliffline is different within each of the zones; there is an increase of activity from
55 Zone B into Zone A and the most severe retreat is associated with Zone C.

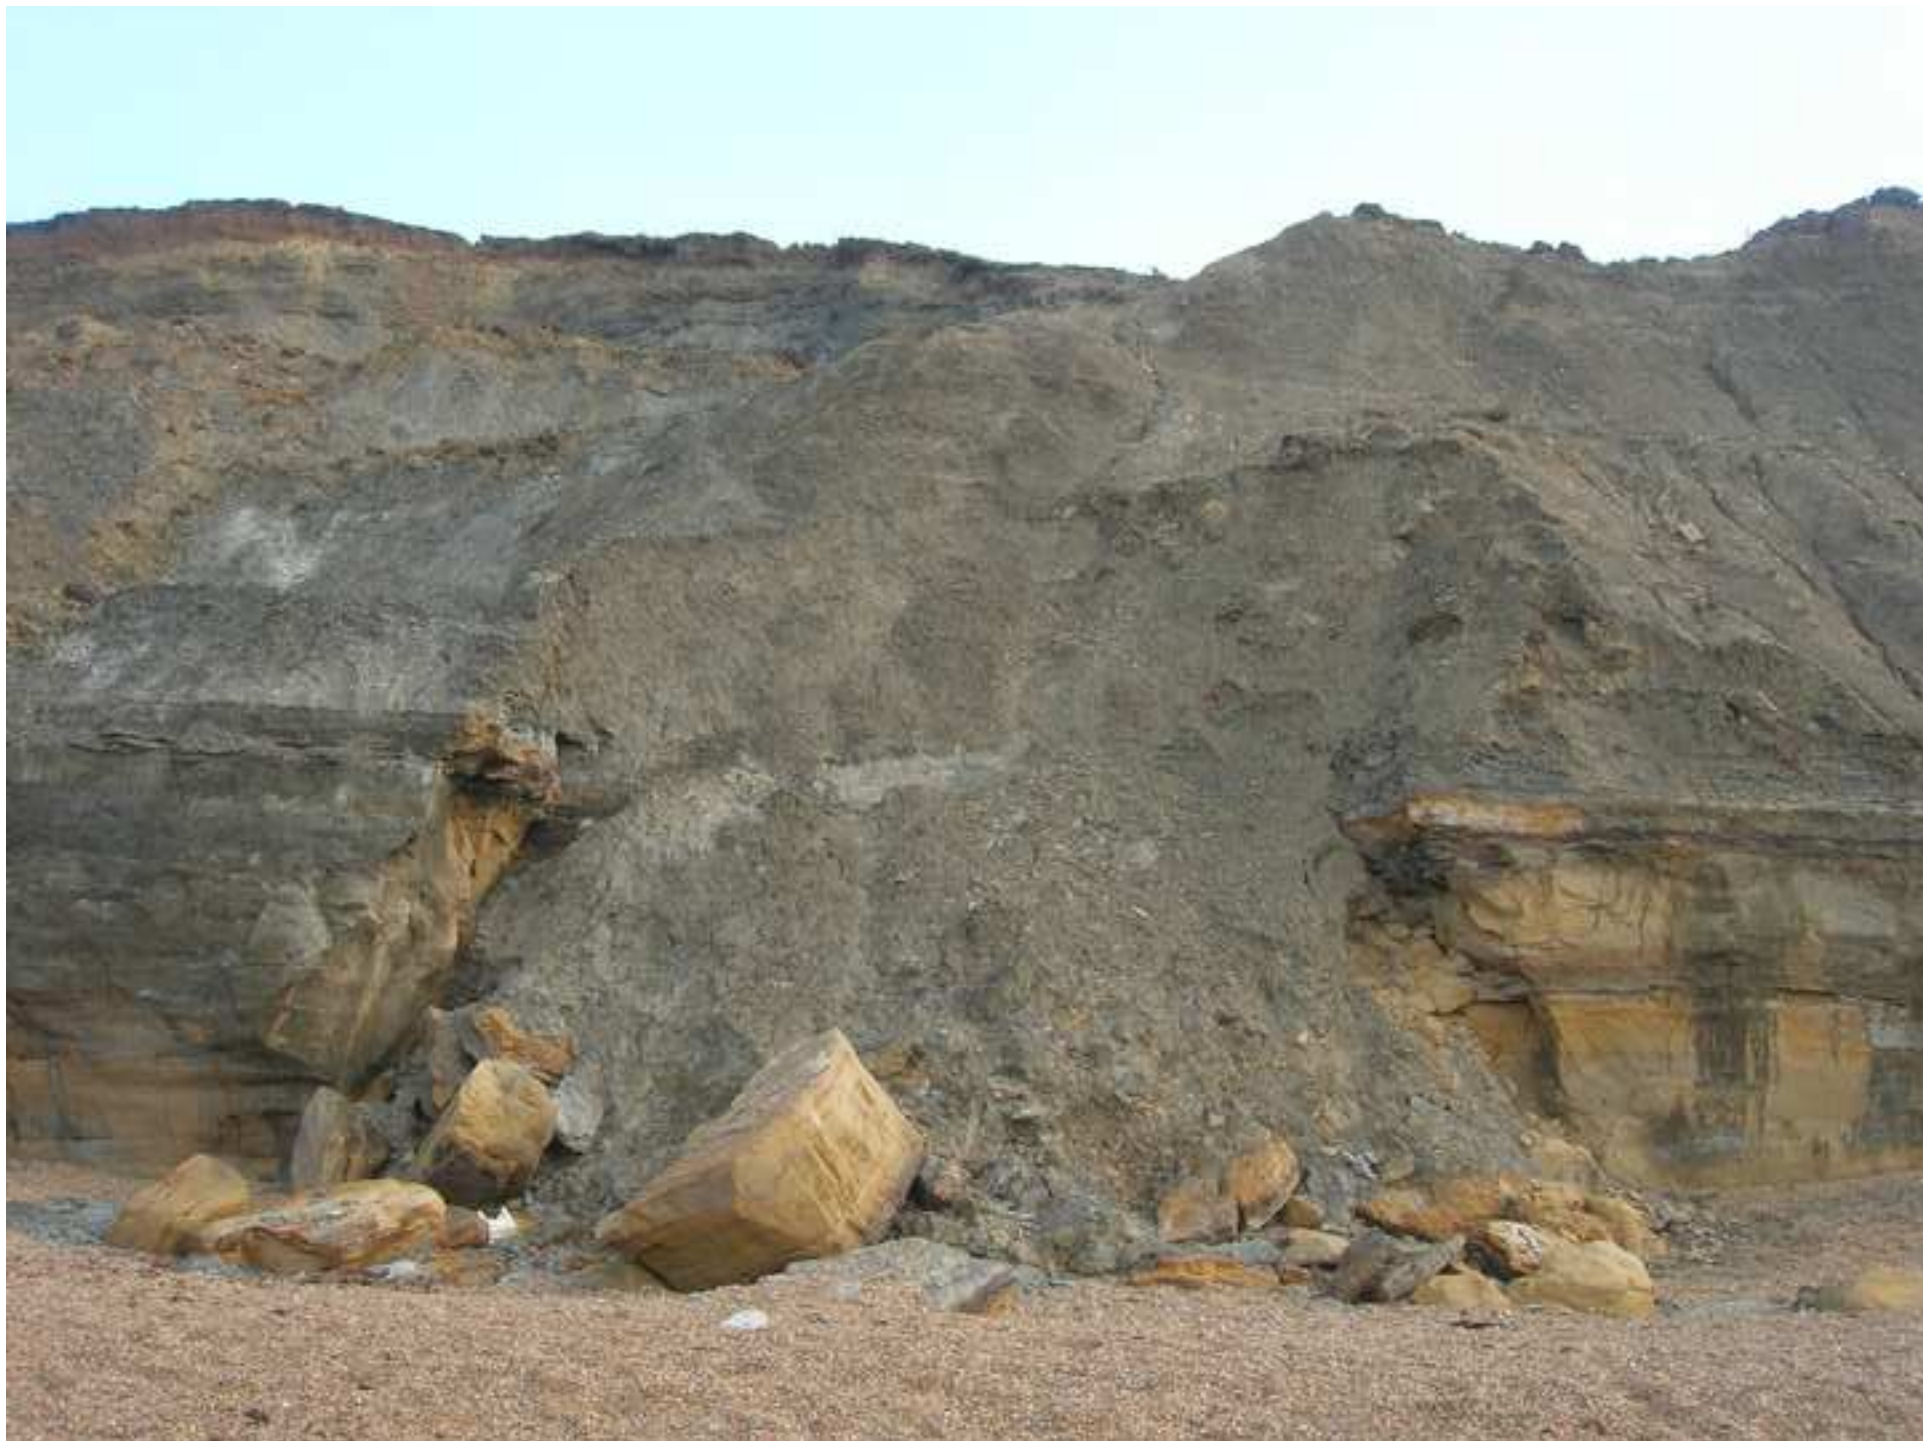
Figure 6
[Click here to download high resolution image](#)

22
23 Fig. 6. Failures in the Vectis Formation of the Wealden Group. P769946.
24

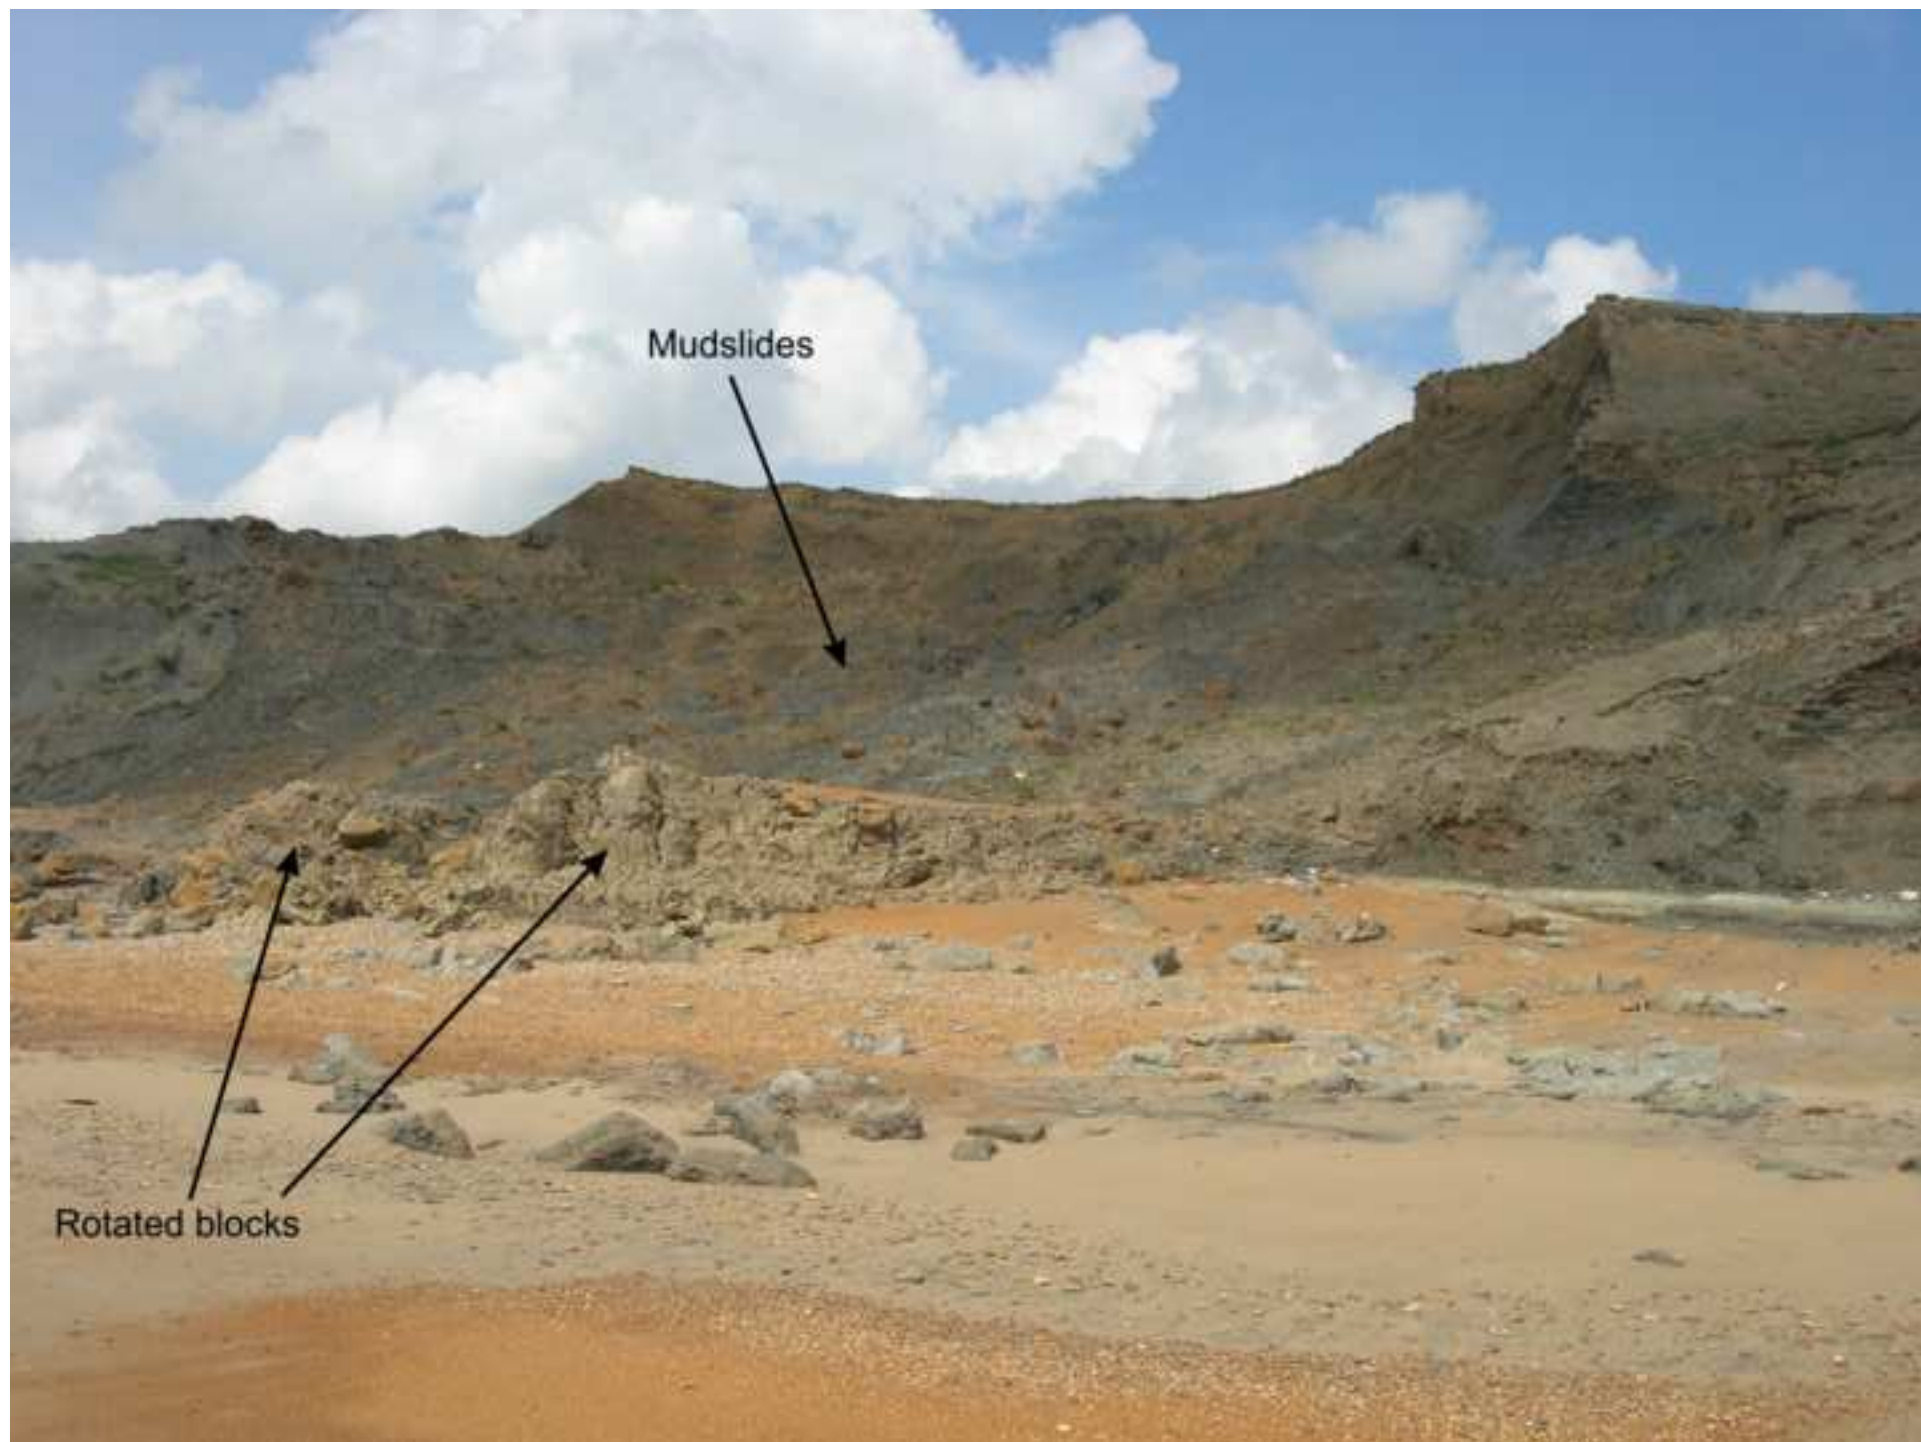
Figure 7
[Click here to download high resolution image](#)

25 Fig. 7. Failures in the Shepherds Chine Member, Vectis Formation, east of Shepherds
26 Chine. P760858.
27

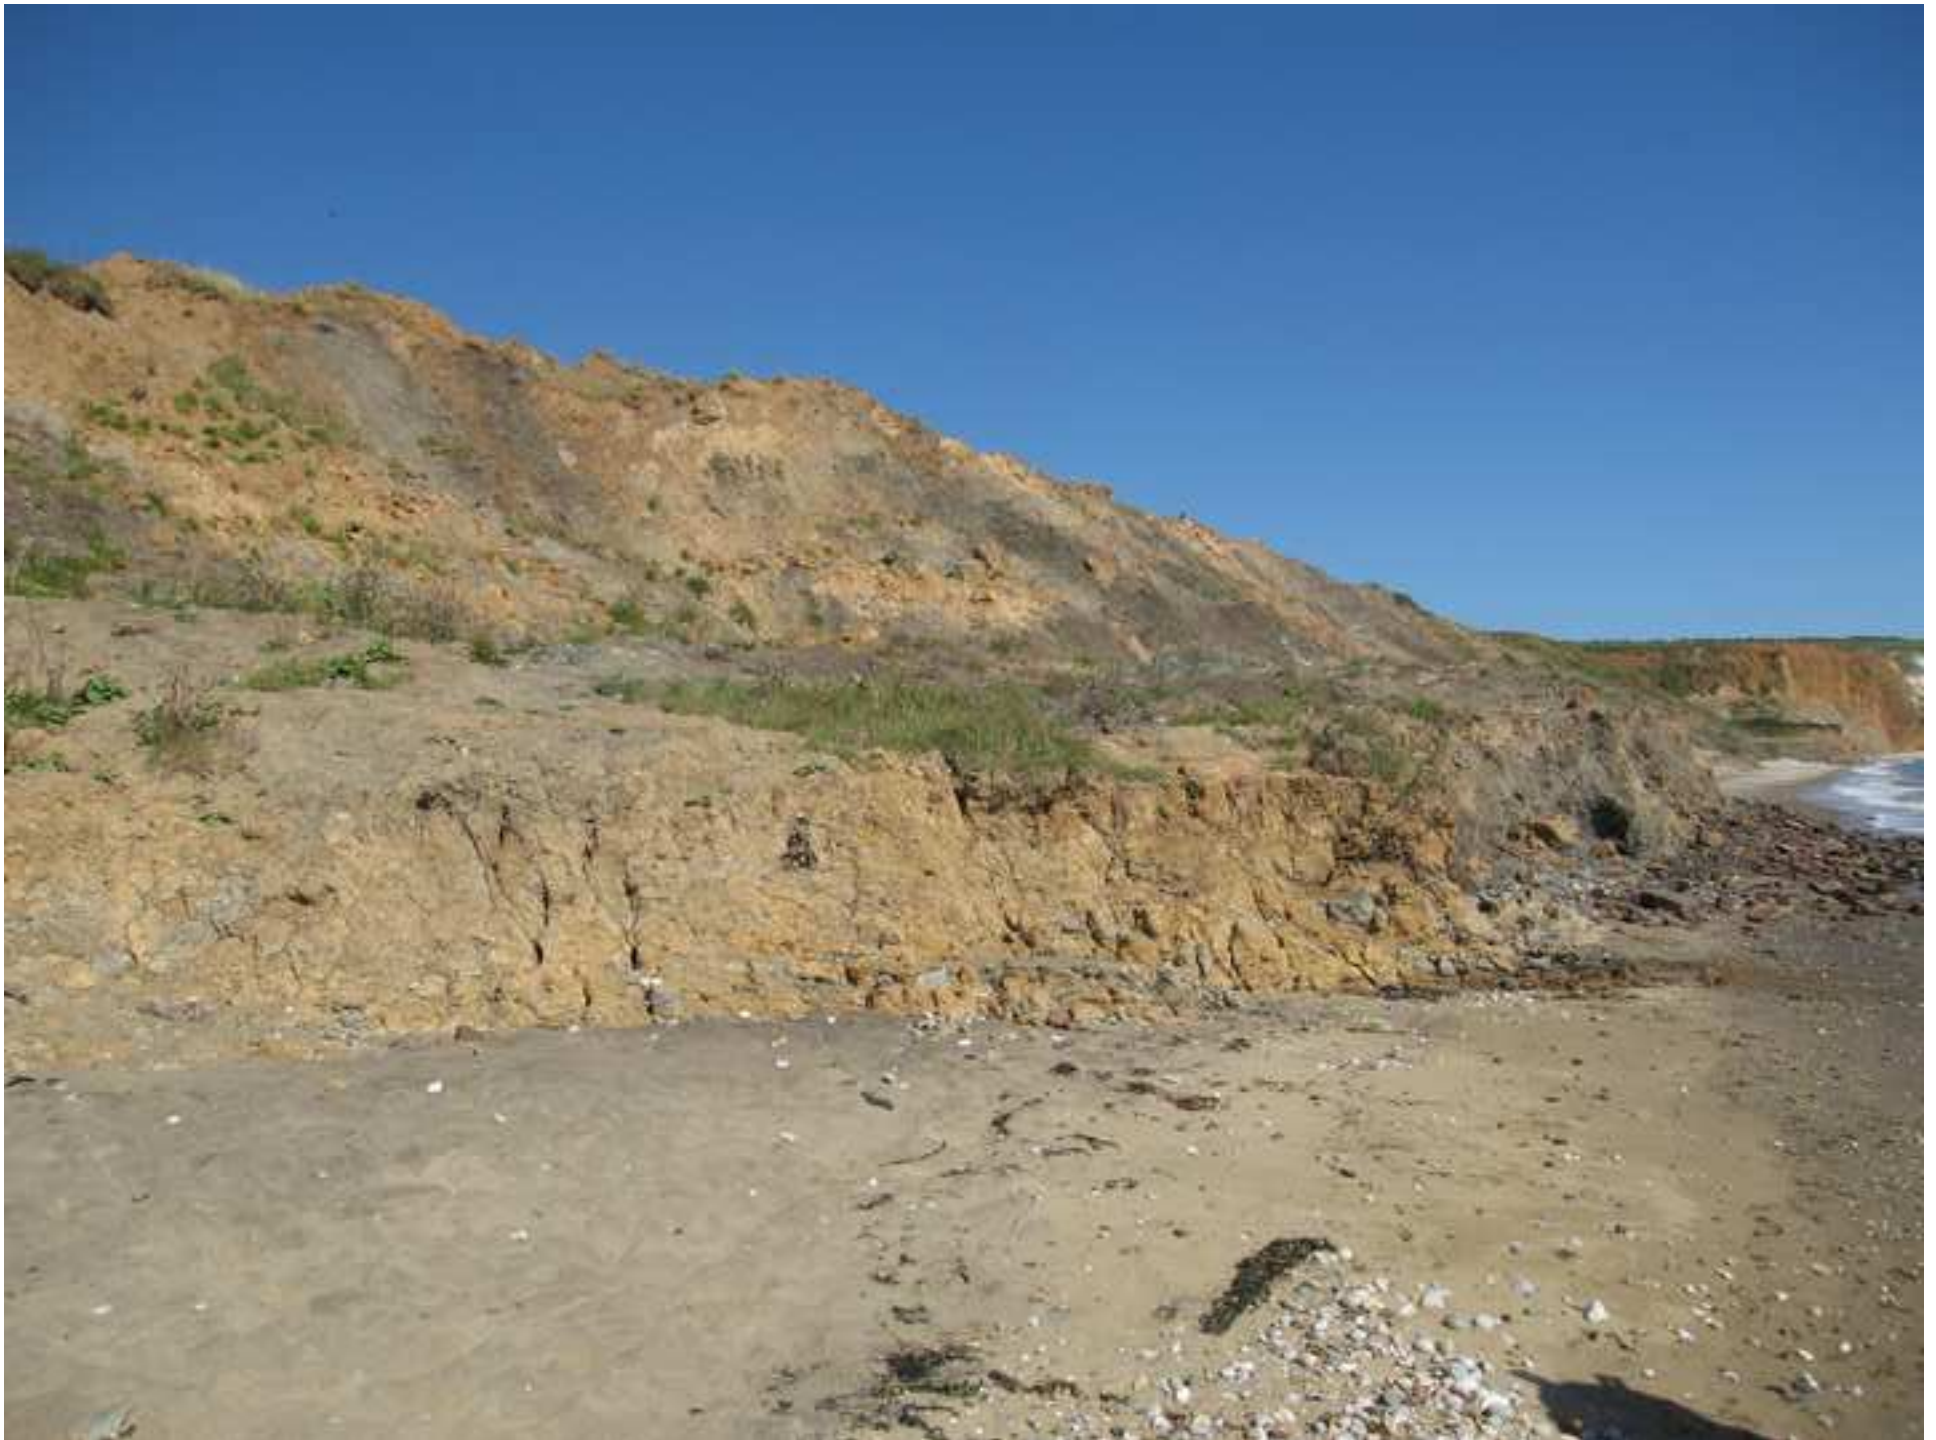
Figure 8
[Click here to download high resolution image](#)

28
29 Fig. 8. Landsliding at Red Cliff, Sandown Bay. P769942.
30

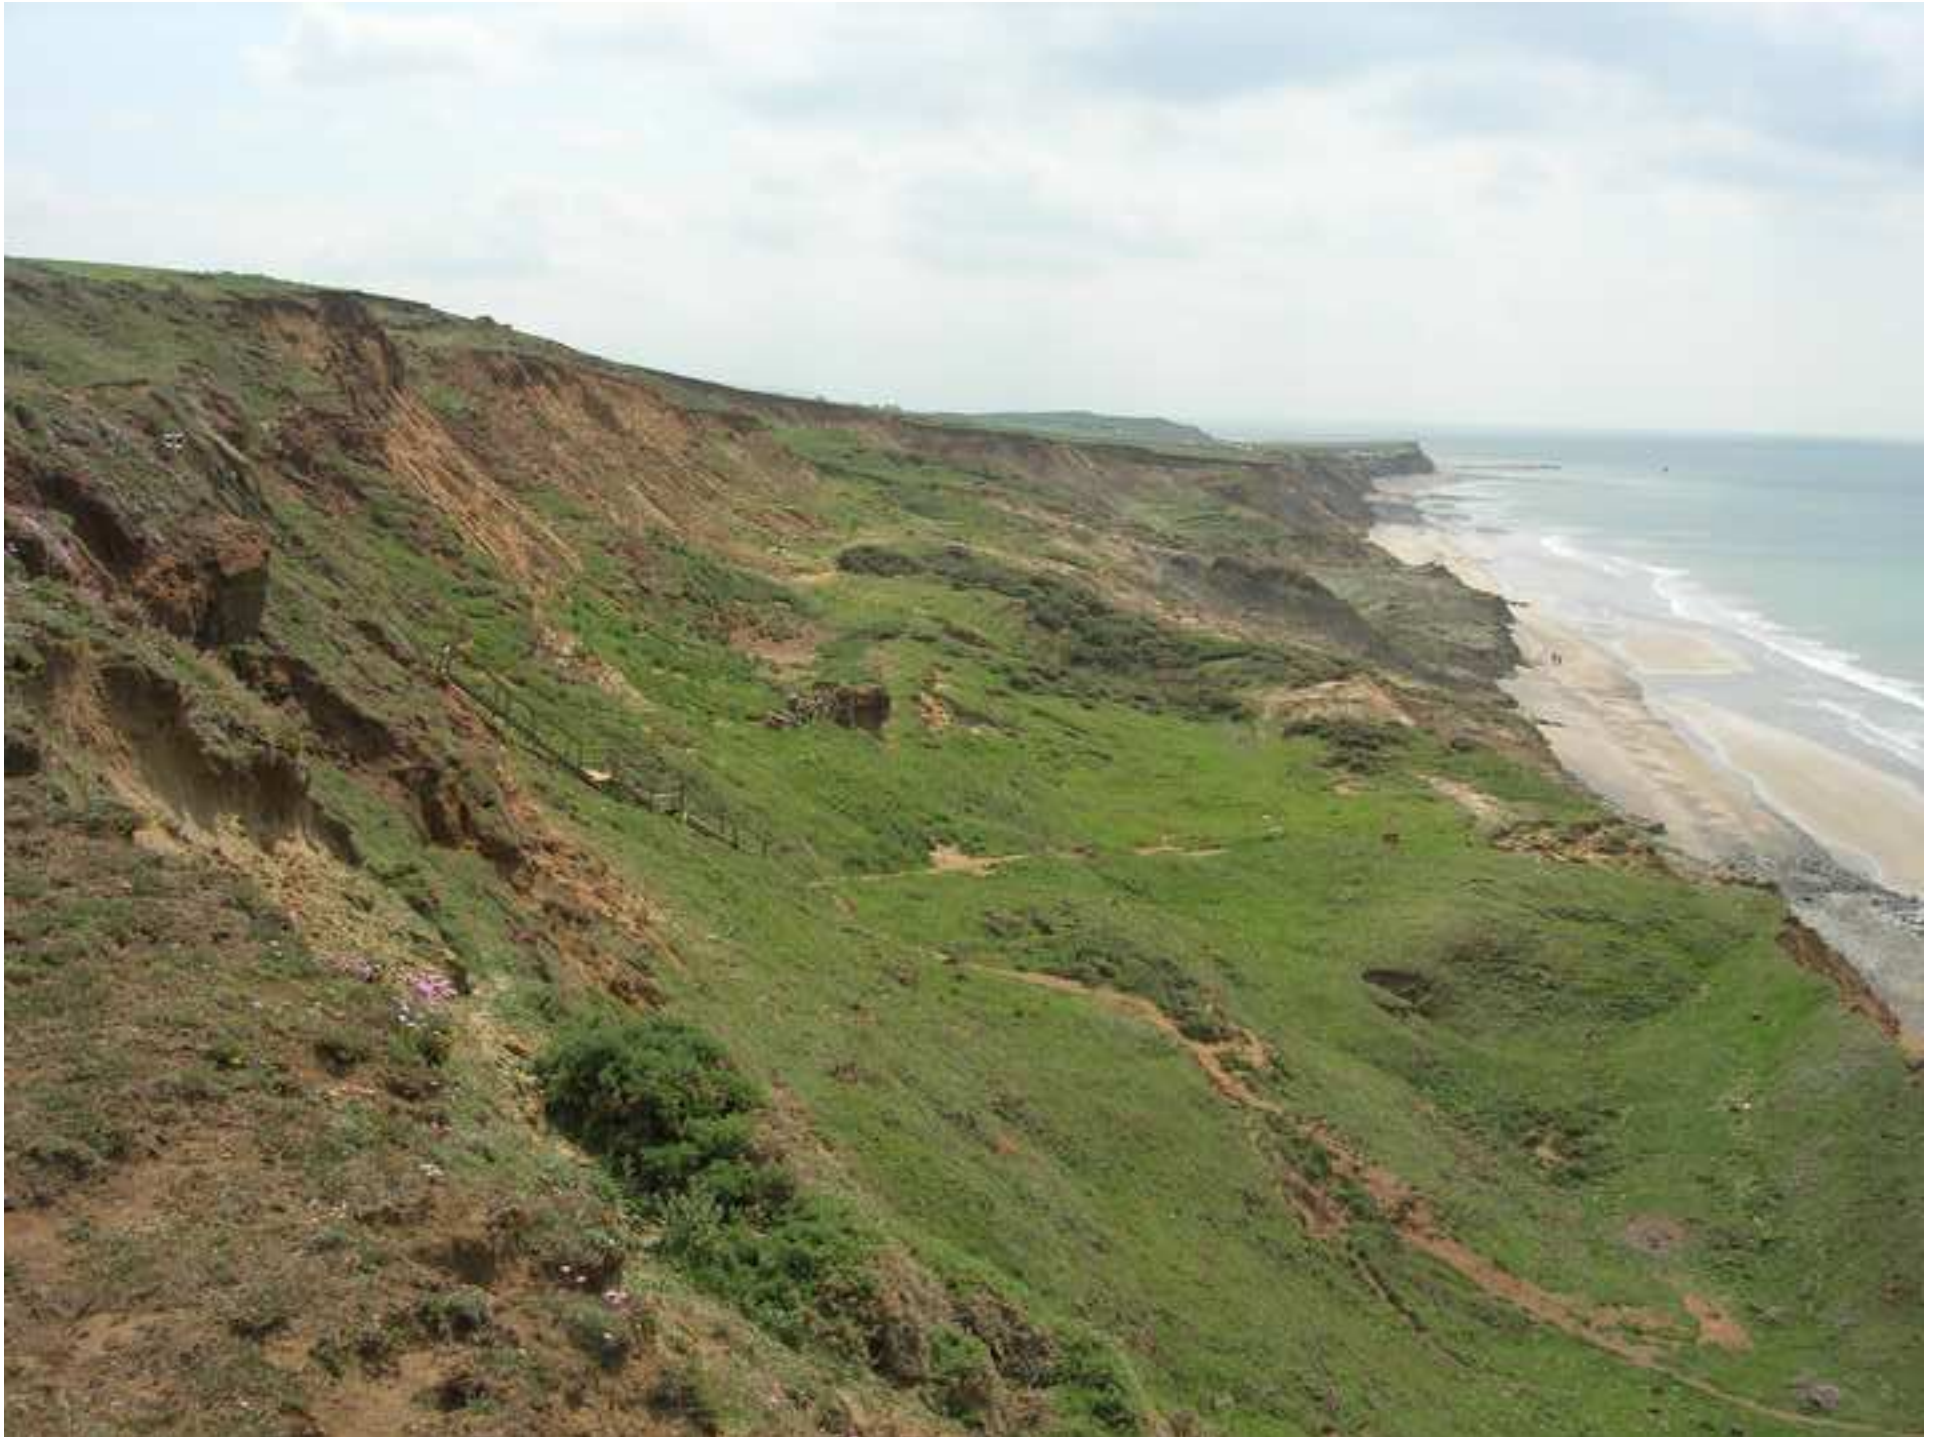
Figure 9
[Click here to download high resolution image](#)

31 Fig. 9. View across the large landslide complex in Compton Bay. P760901.
32

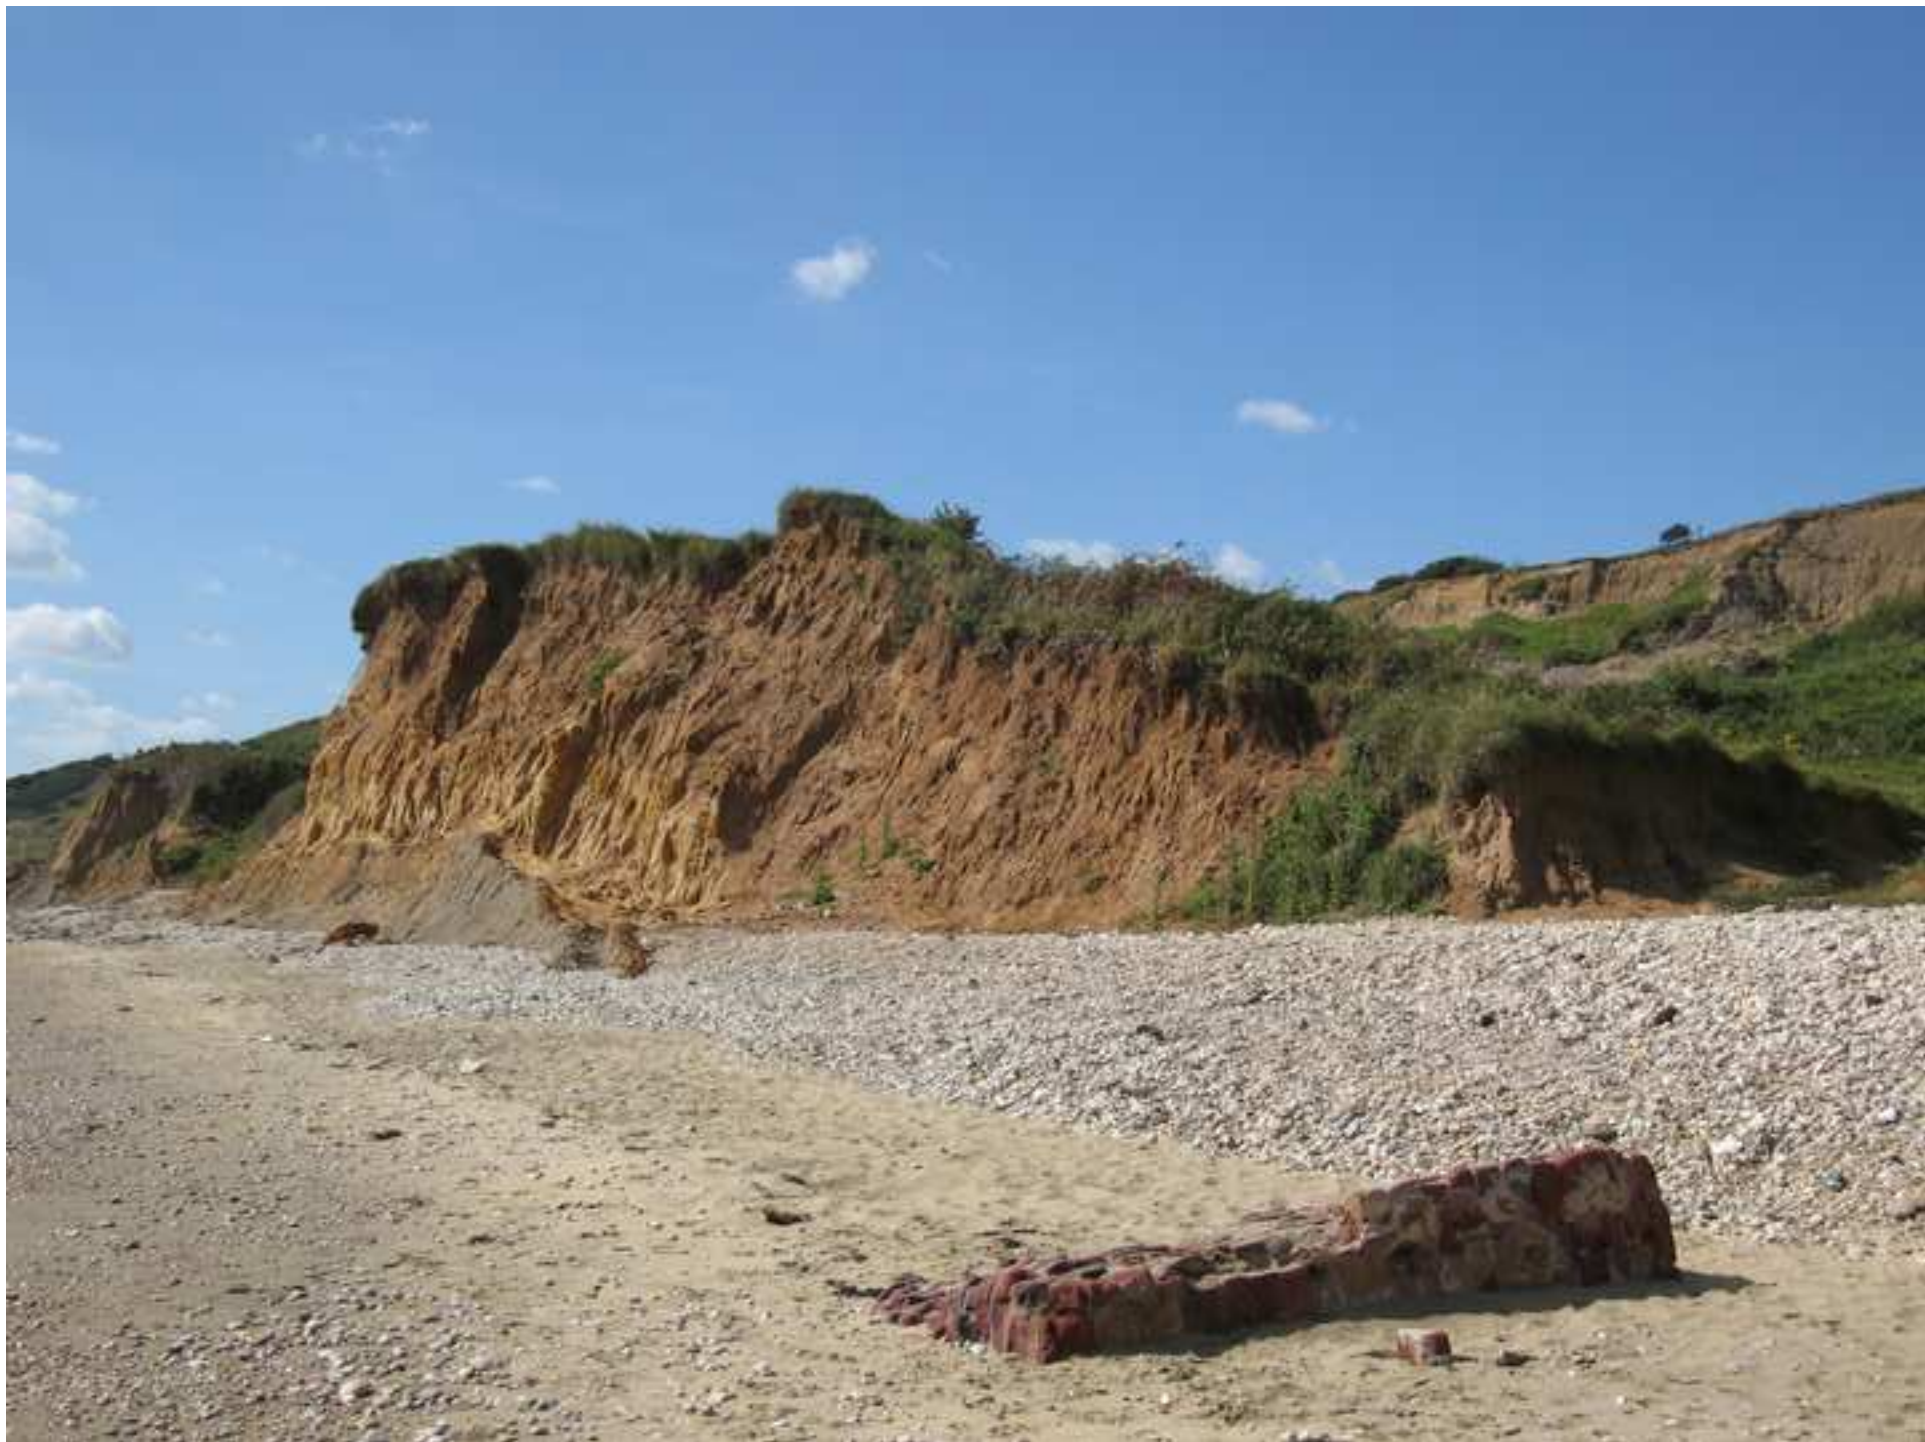
Figure 10
[Click here to download high resolution image](#)

33
34 Fig. 10. Rotated block (Ferruginous Sands Formation) in the beach at Yaverland.
35 P769933.
36
