Geology as a control on landslides on the Isle of Wight: an overview

G. O. Jenkins^{a*}, C. Foster^a & P. M. Hopson^a

Abstract

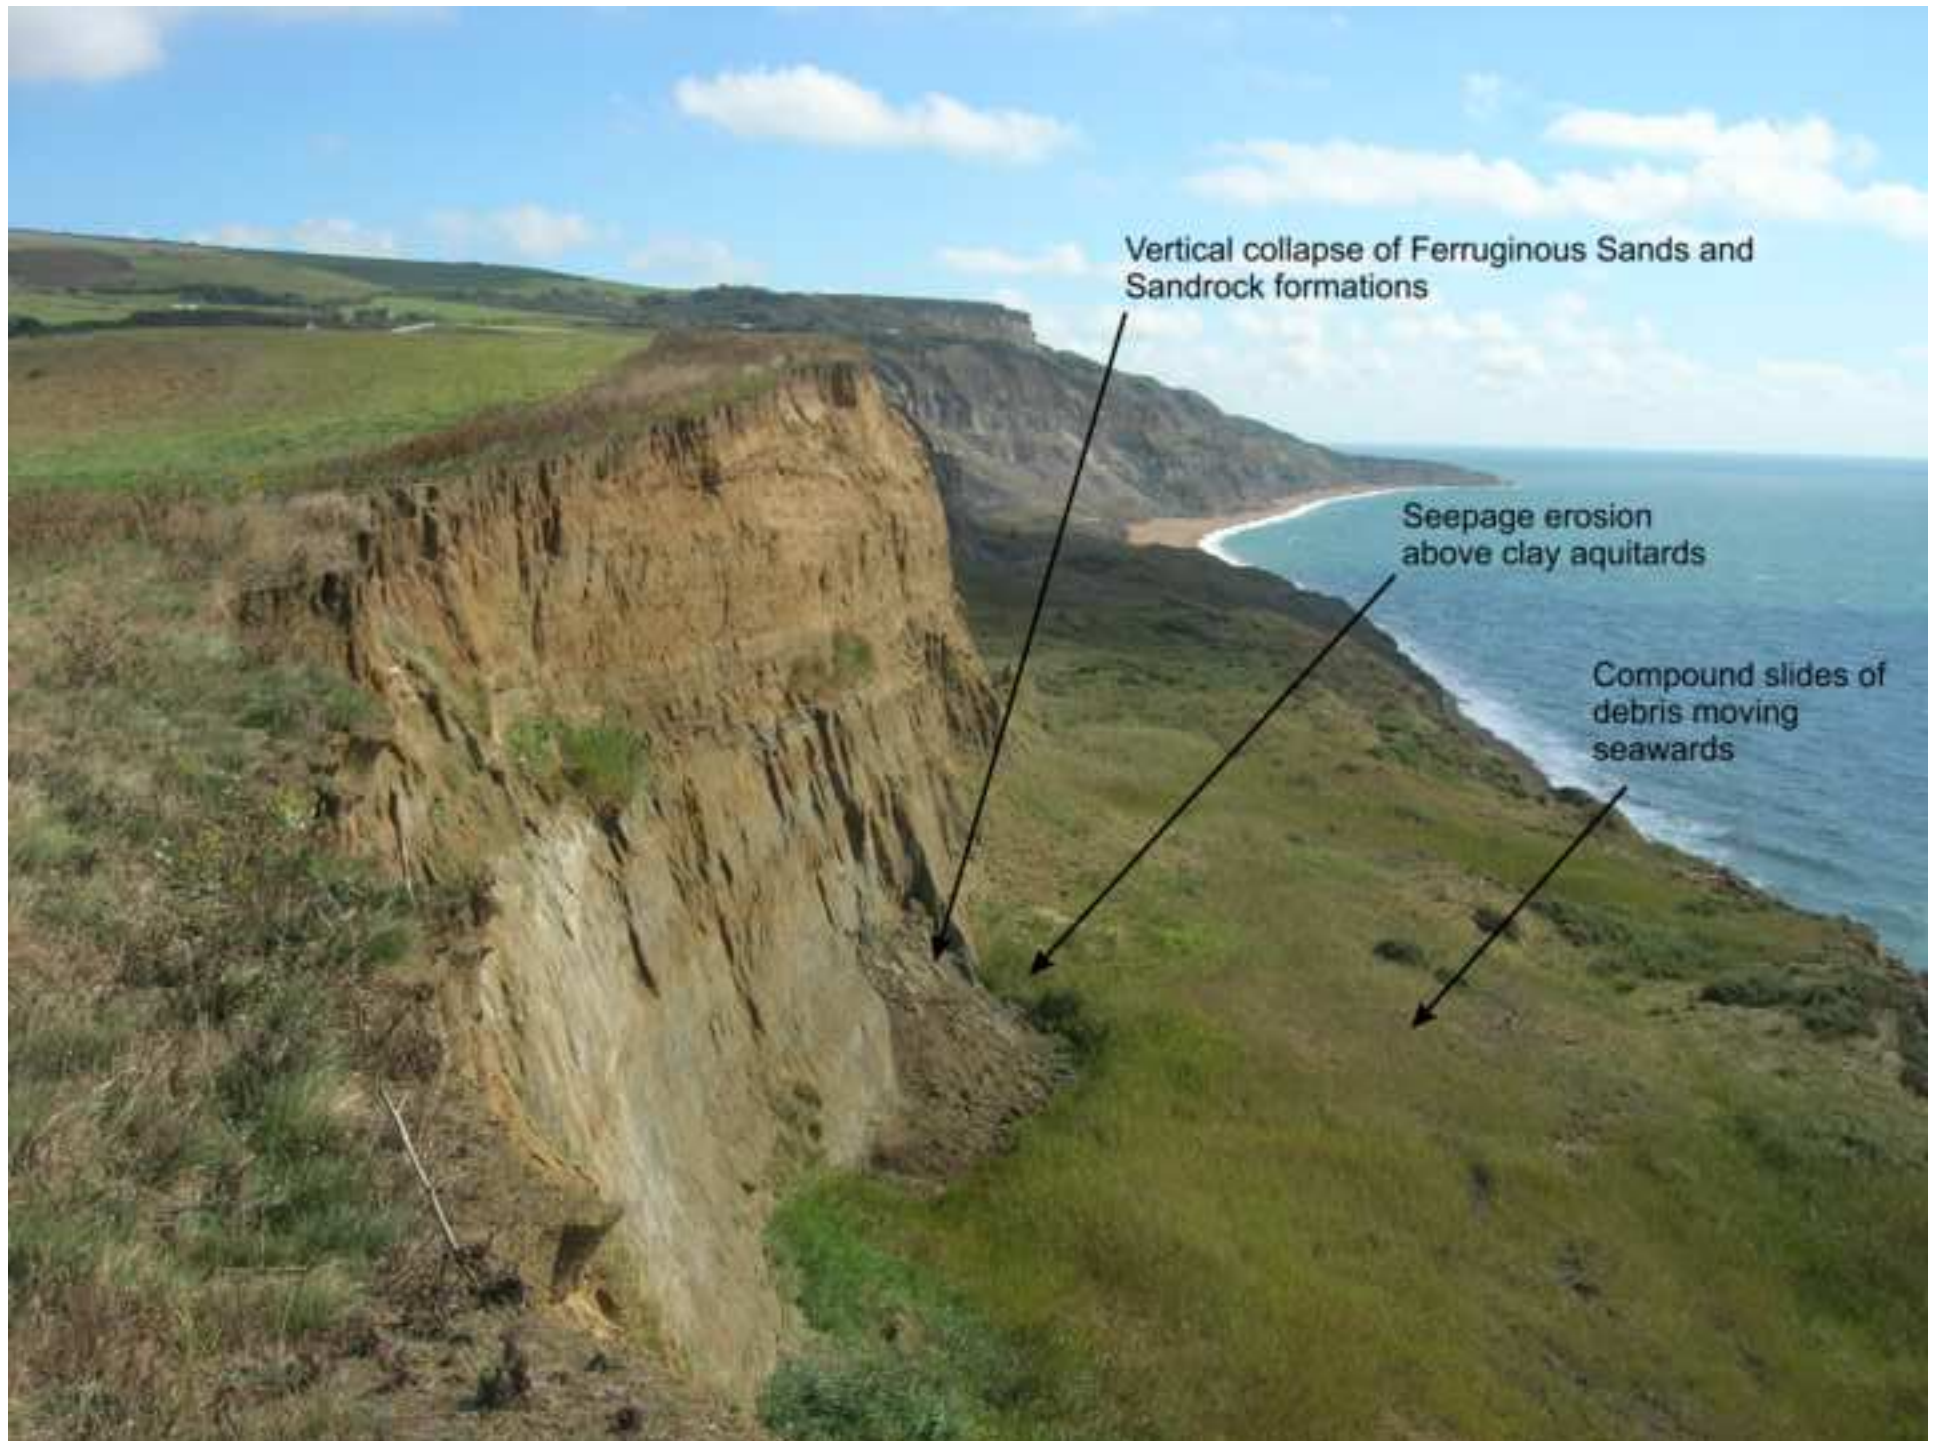
Figure 11
[Click here to download high resolution image](#)

14 Considerably more complex failures occur within the Lower Greensand Group on the
15 coast at Chale Bay from Blackgang Chine [48400 76800] to Walpen Chine [46800
16 78200]. Here a bench has developed mid way up the cliff in the Ferruginous Sands
17 and Sandrock formations. Seepage erosion is taking place because of the presence of
18 clay aquitards within the sequence. Water movement along the top of the aquitards
19 leads to the undermining of material, leading to rock falls. Once on the bench the
20 landslide debris fails in a series of compound slides moving seaward. This process
21 produces a cliff top retreat rate that is more rapid than the marine erosion at the base
22 of the cliff, leading to the formation of the bench feature (Fig. 11) (Insole et al.,
23 1998).
24
25
26
27

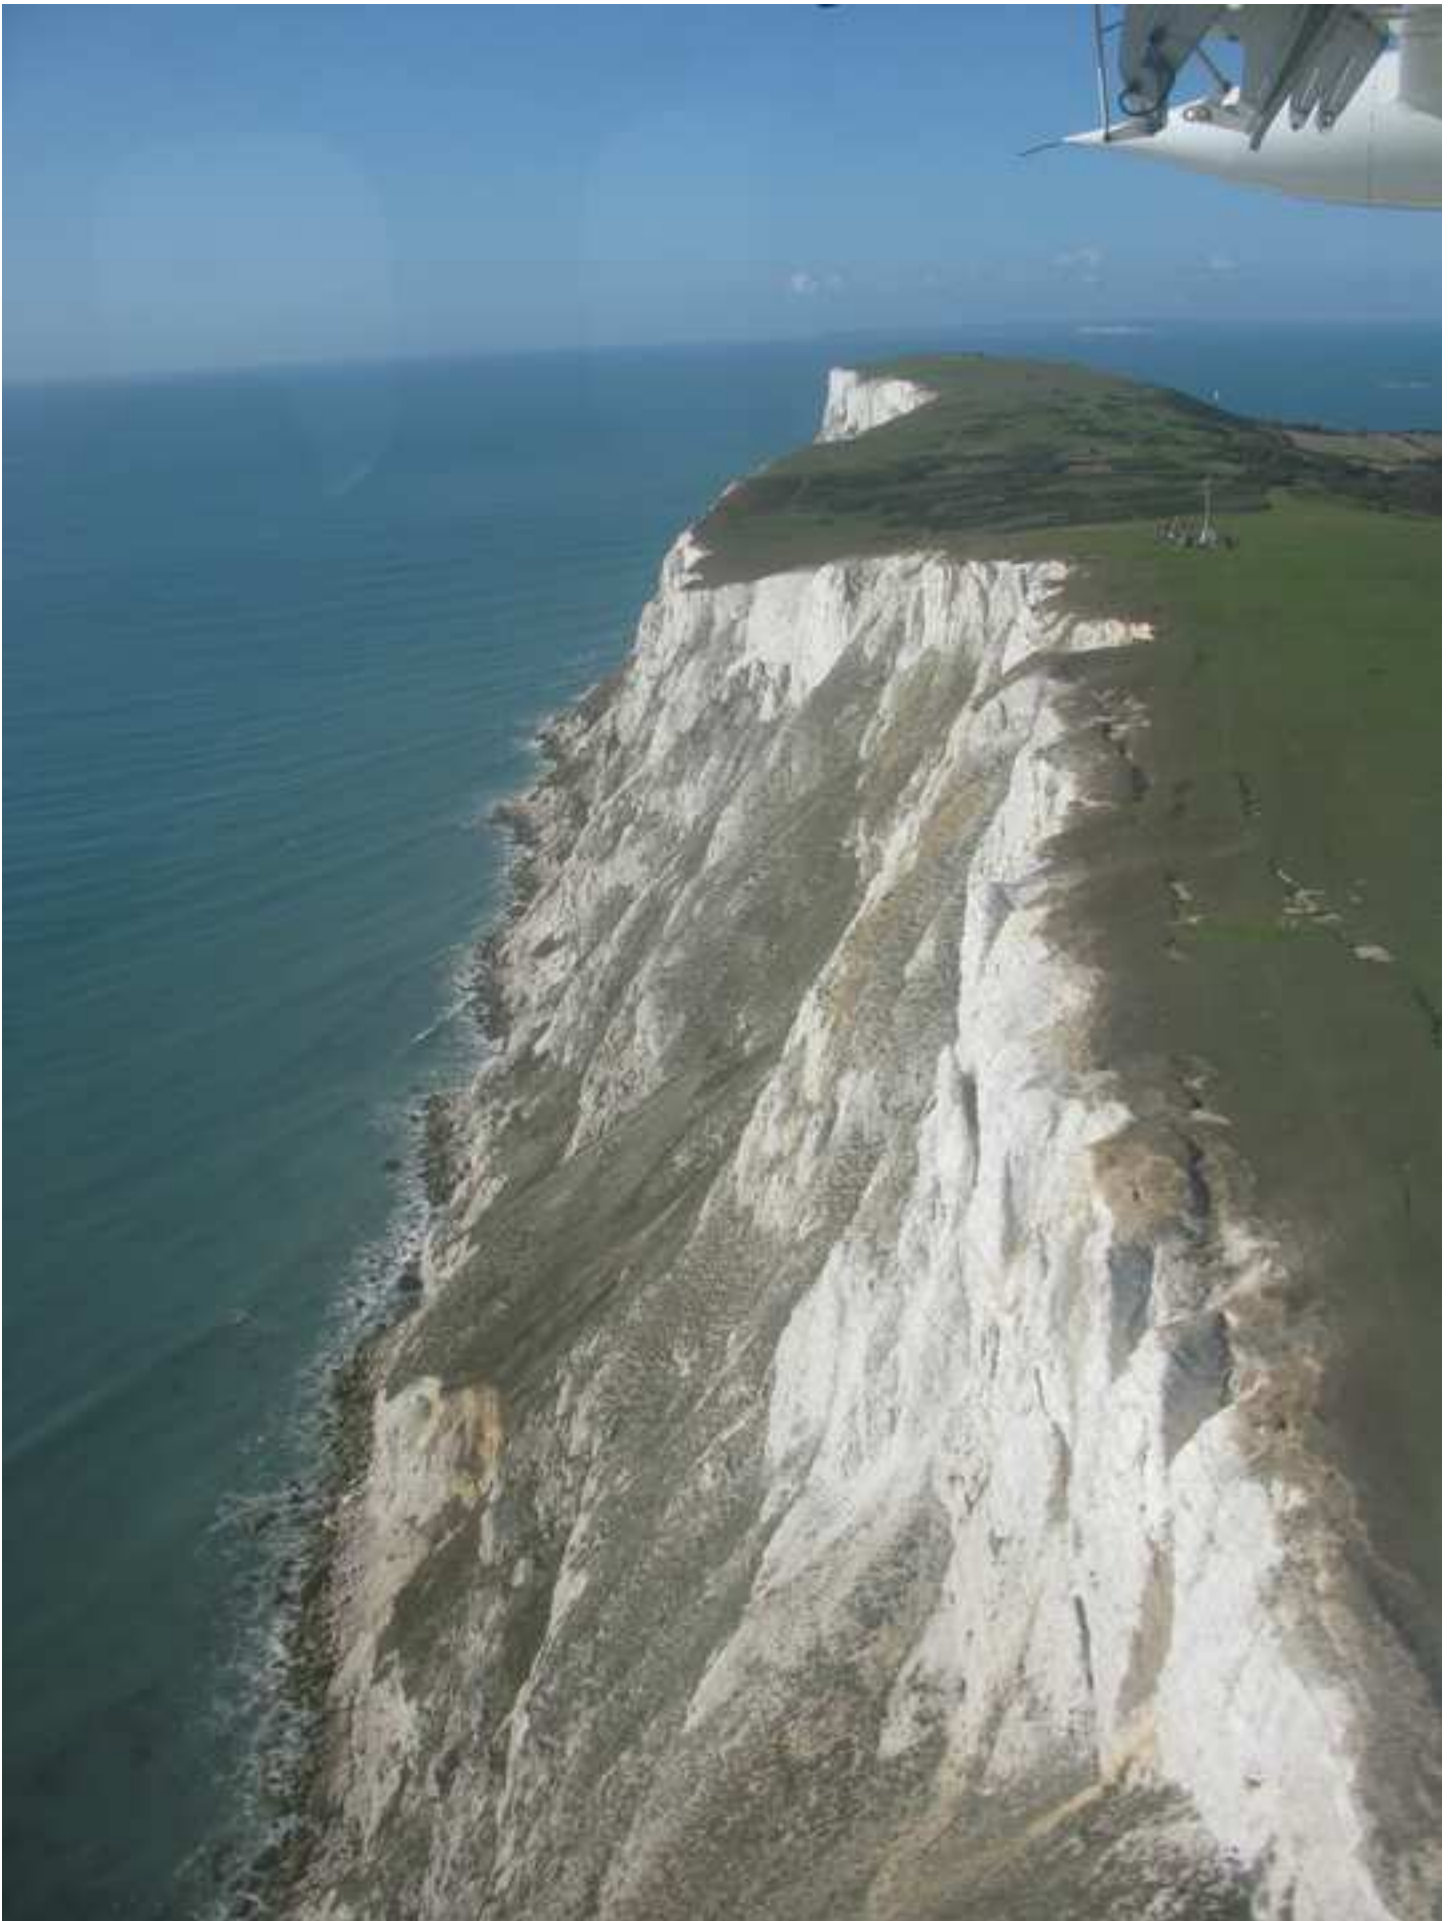
Figure 14

45 Fig. 14. Tension cracks above Tennyson Down which could lead to large scale
46 failures. P769938.
47

1 Marine erosion at the site is also a significant factor leading to undercutting of the
2 cliff and failure of material by falling. Similar fissure-like features are found on the
3 southern margins of Culver Cliff where it abuts Sandown Bay [6350 8550], although
4 the fissuring does not appear to be as advanced. Little work has been conducted at this
5 site as it does not directly affect any infrastructure. Photographs collected during an
6 airborne geophysics survey by the BGS in September 2008 reveal the presence of
7 large tension cracks above Tennyson Down at the western end of the island,
8 suggesting that further failures along this section are also likely (Fig.14).
9

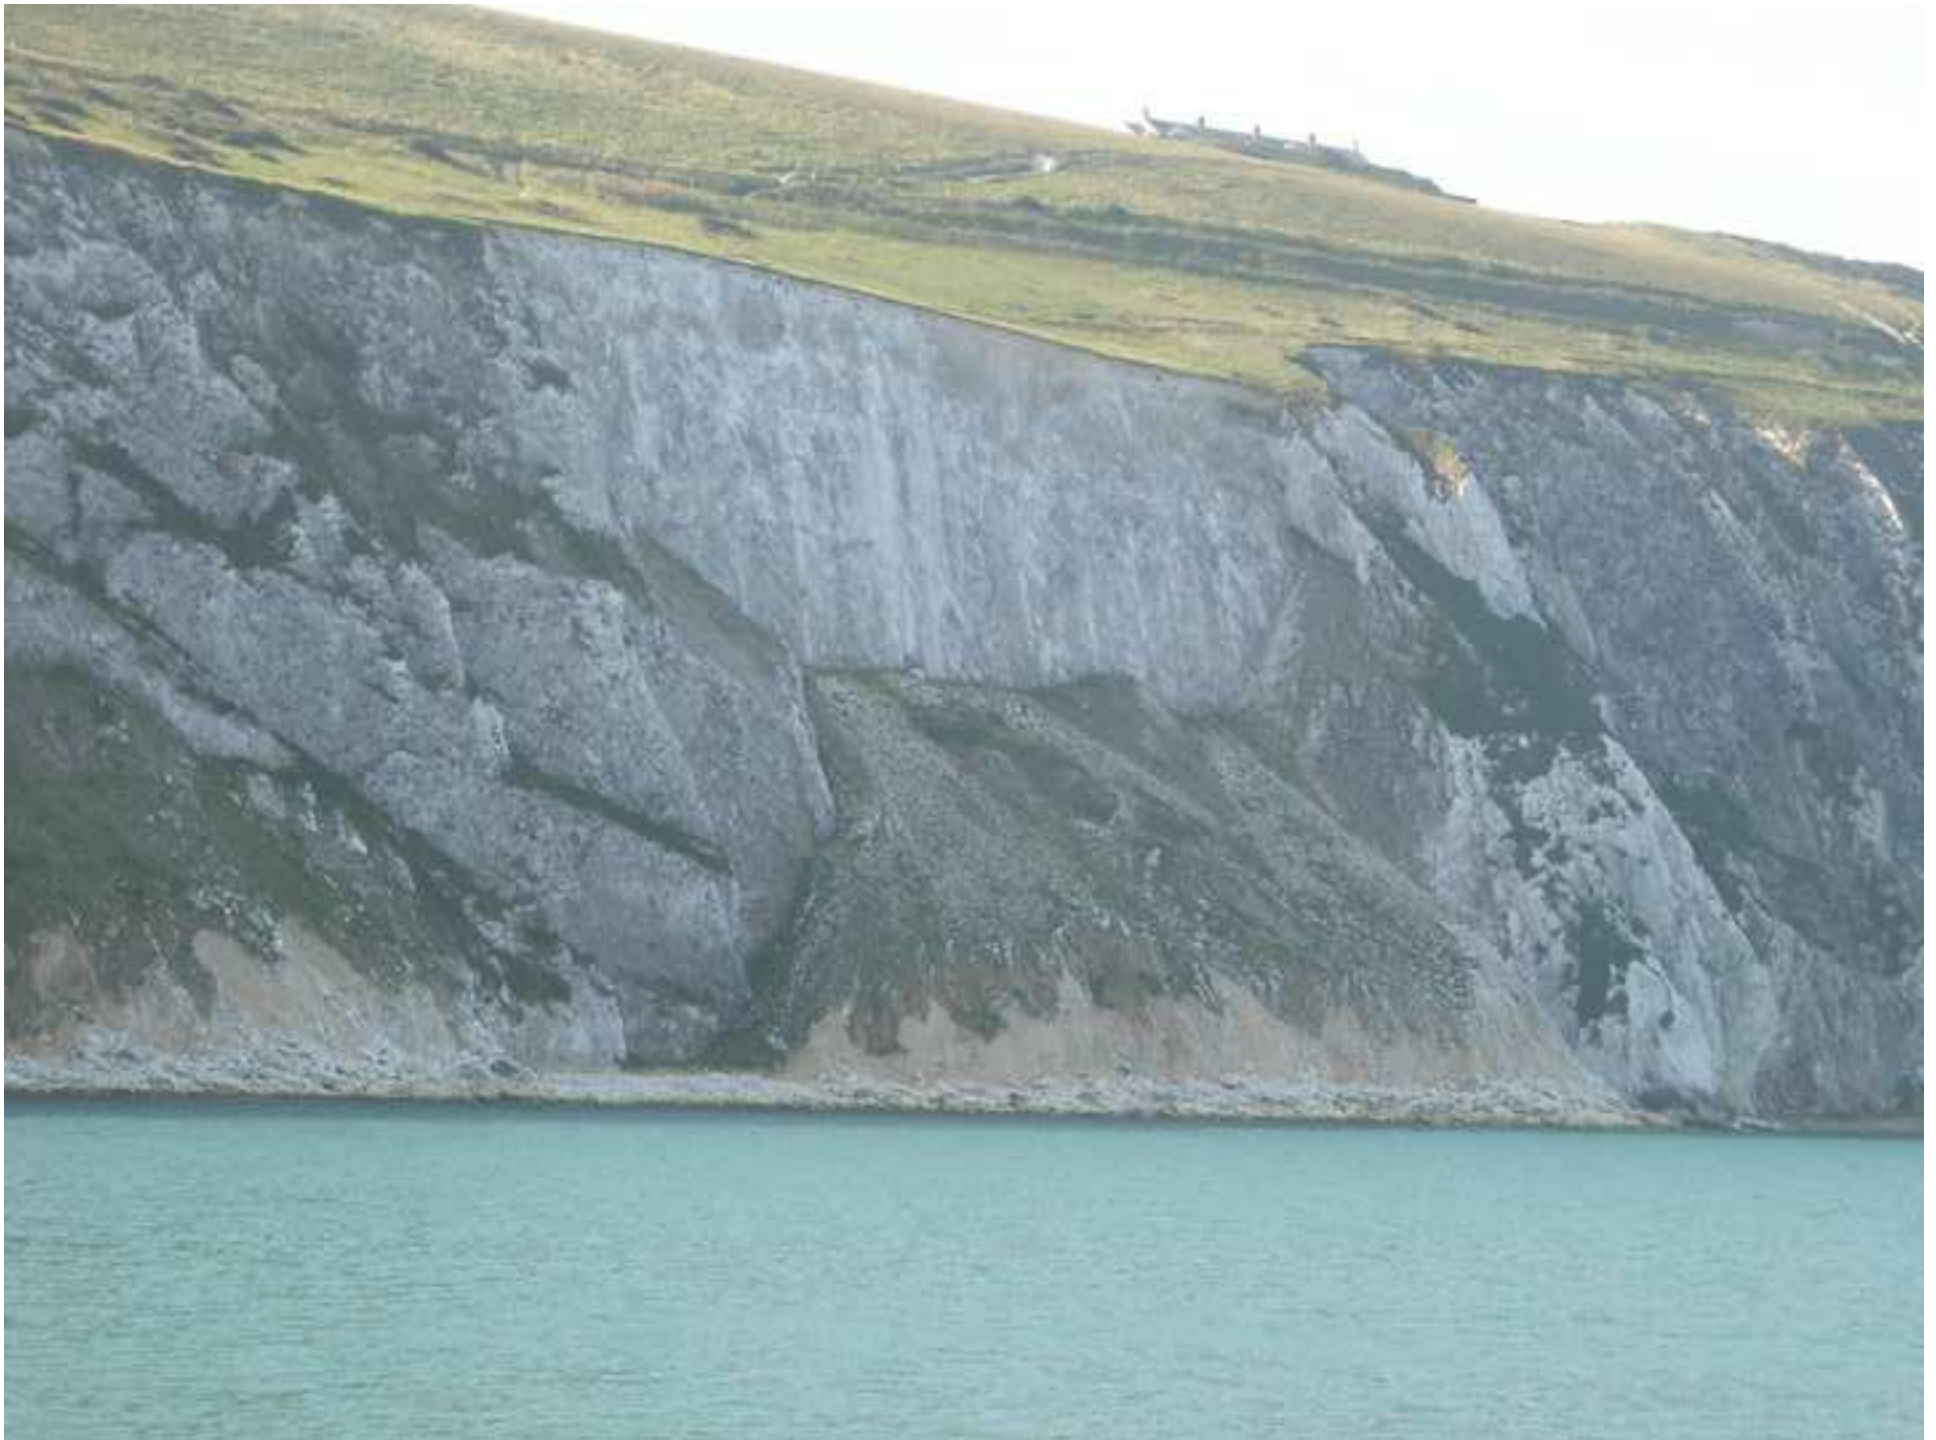
Figure 15
[Click here to download high resolution image](#)

48
49 Fig. 15. Failure in steep chalk cliffs at White Cliffs, Alum Bay. P769937.
50

10 The chalk that forms the headland in the south of Alum Bay [30000 85000] has a
11 steep northerly dip into the bay with bedding planes being commonly undercut by
12 wave-action. This difference in orientation (e.g. compared to Afton Down) results in
13 failure on bedding planes rather than along joints. Typically, rock slides occur where
14 the dip of the beds is approximately parallel to the topographic slope. In Alum Bay
15 the chalk dips between 70-75° to the north, whilst the cliff slopes at about 60° to the
16 north. It is possible that the movement includes both translational movement and
17 falling (Fig.15).
18
19
20
21

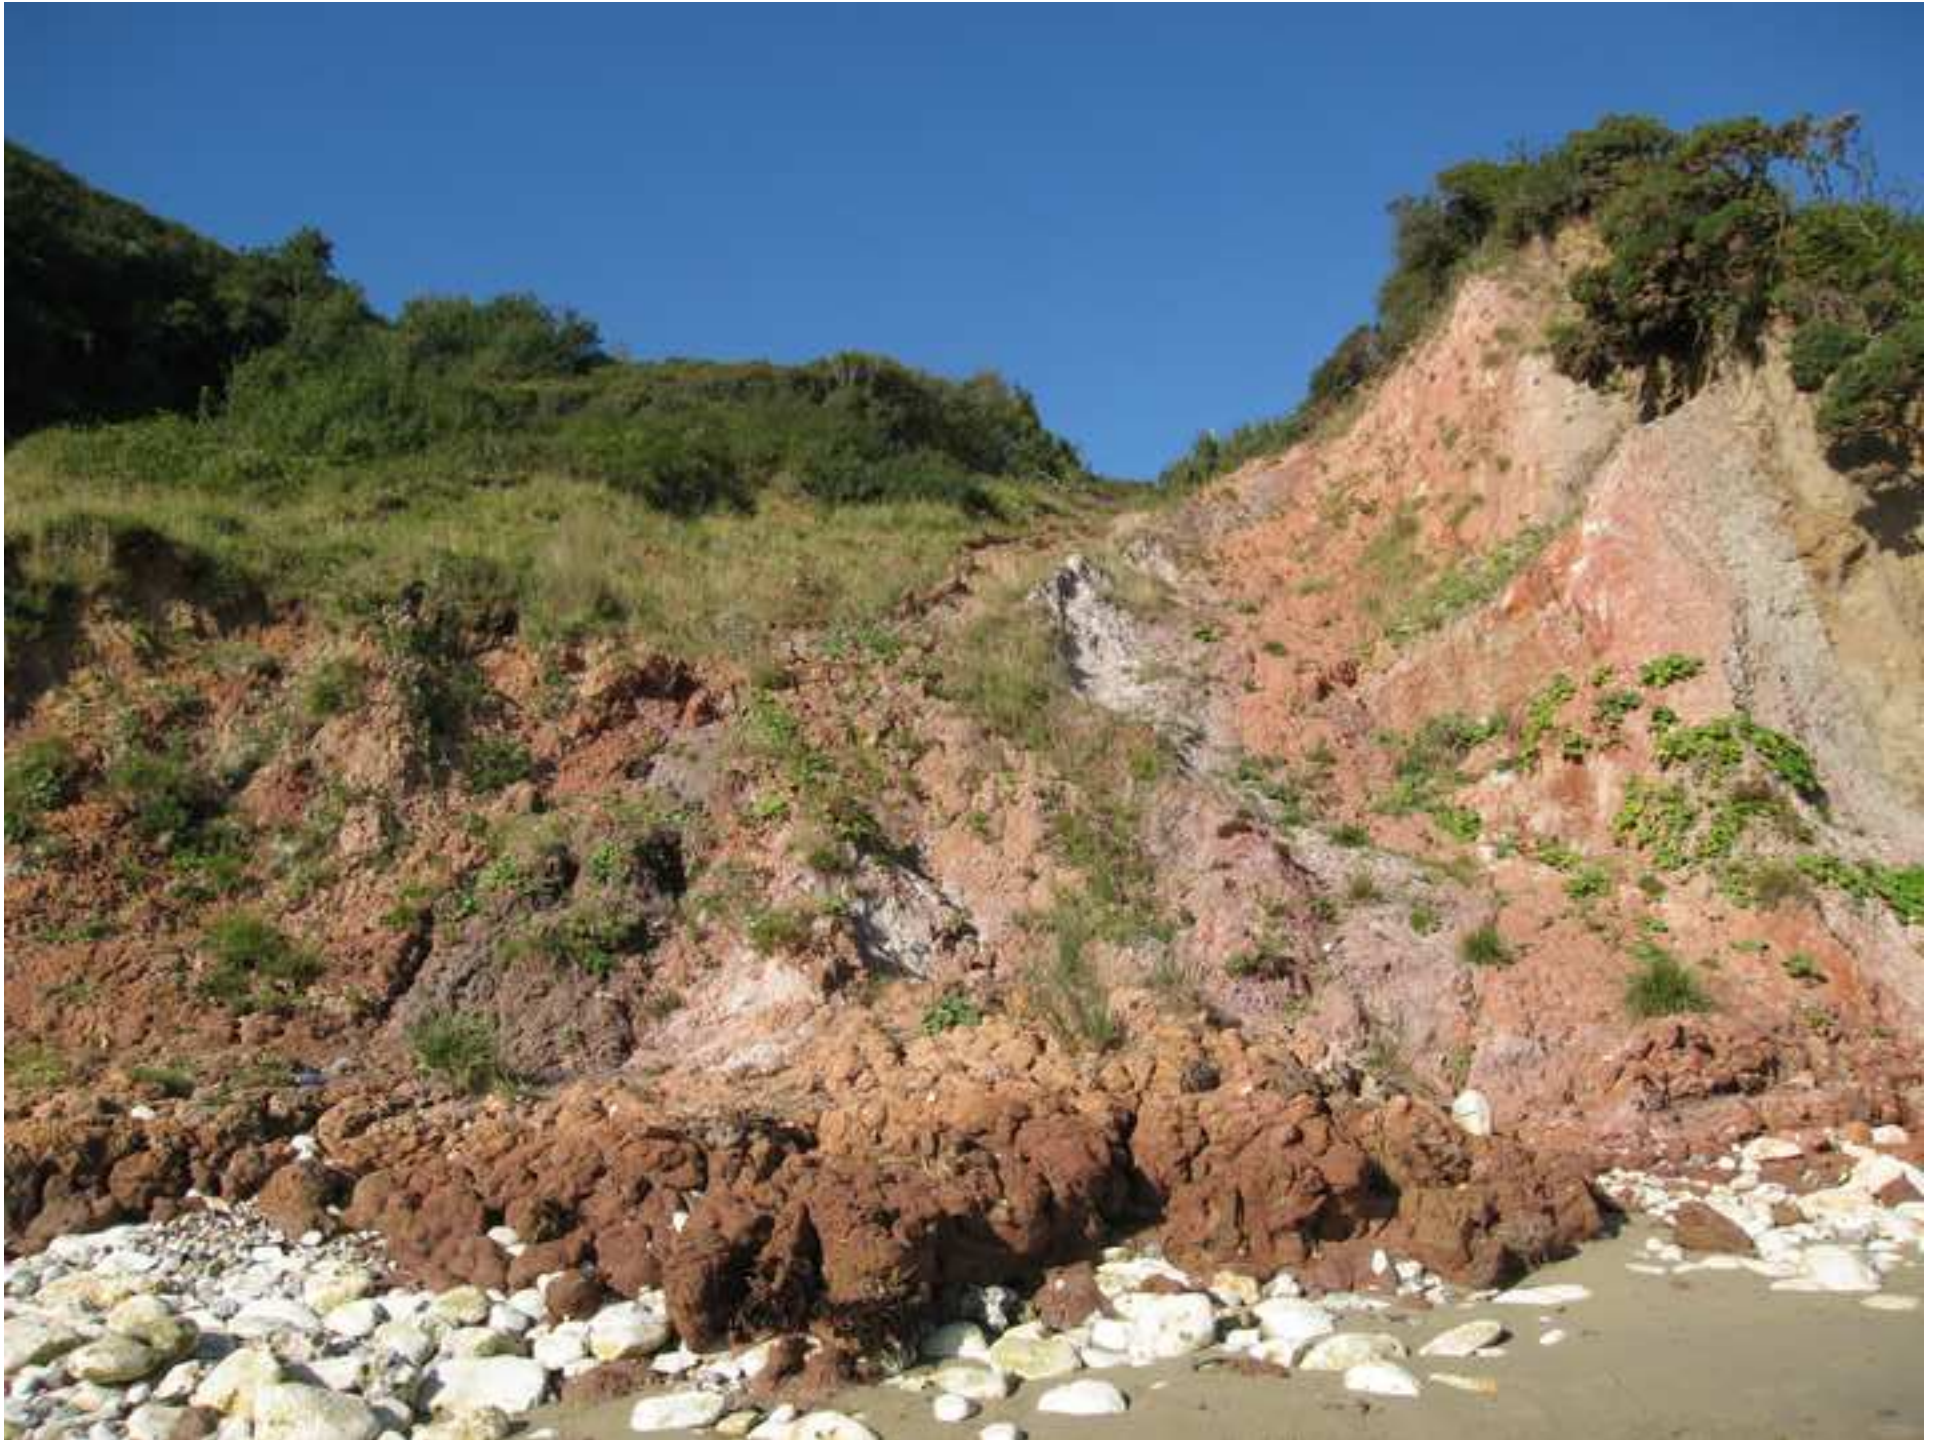
Figure 16
[Click here to download high resolution image](#)

51 Fig. 16. Mudslide in the Reading Formation, Whitecliff Bay. P769939.
52

24 The Reading Formation (Lambeth Group) is composed of predominantly mottled red
25 and purple clays with a basal conglomerate and sand. It outcrops in the west at Alum
26 Bay and in the east at Whitecliff Bay [463975 85830]. In both areas bedding is
27 vertical and the entire formation is subject to mudsliding (Fig. 16). The landslide in
28 Alum Bay is reported to have originally formed around the turn of the 20th Century
29 (Bromhead, 1979) and is most active between winter and early spring when the steep
30 slopes at its head become saturated due to higher rainfall levels. This causes the slope
31 to become unstable and fail as a mudslide, resulting in the formation of lobate toes
32 extending onto the beach (Bromhead, 1979). The toe area of the mudslide is subject to
33 marine erosion and is often eroded back to the cliff line during summer months, when
34 rainfall levels are generally lower and the slide is less active.

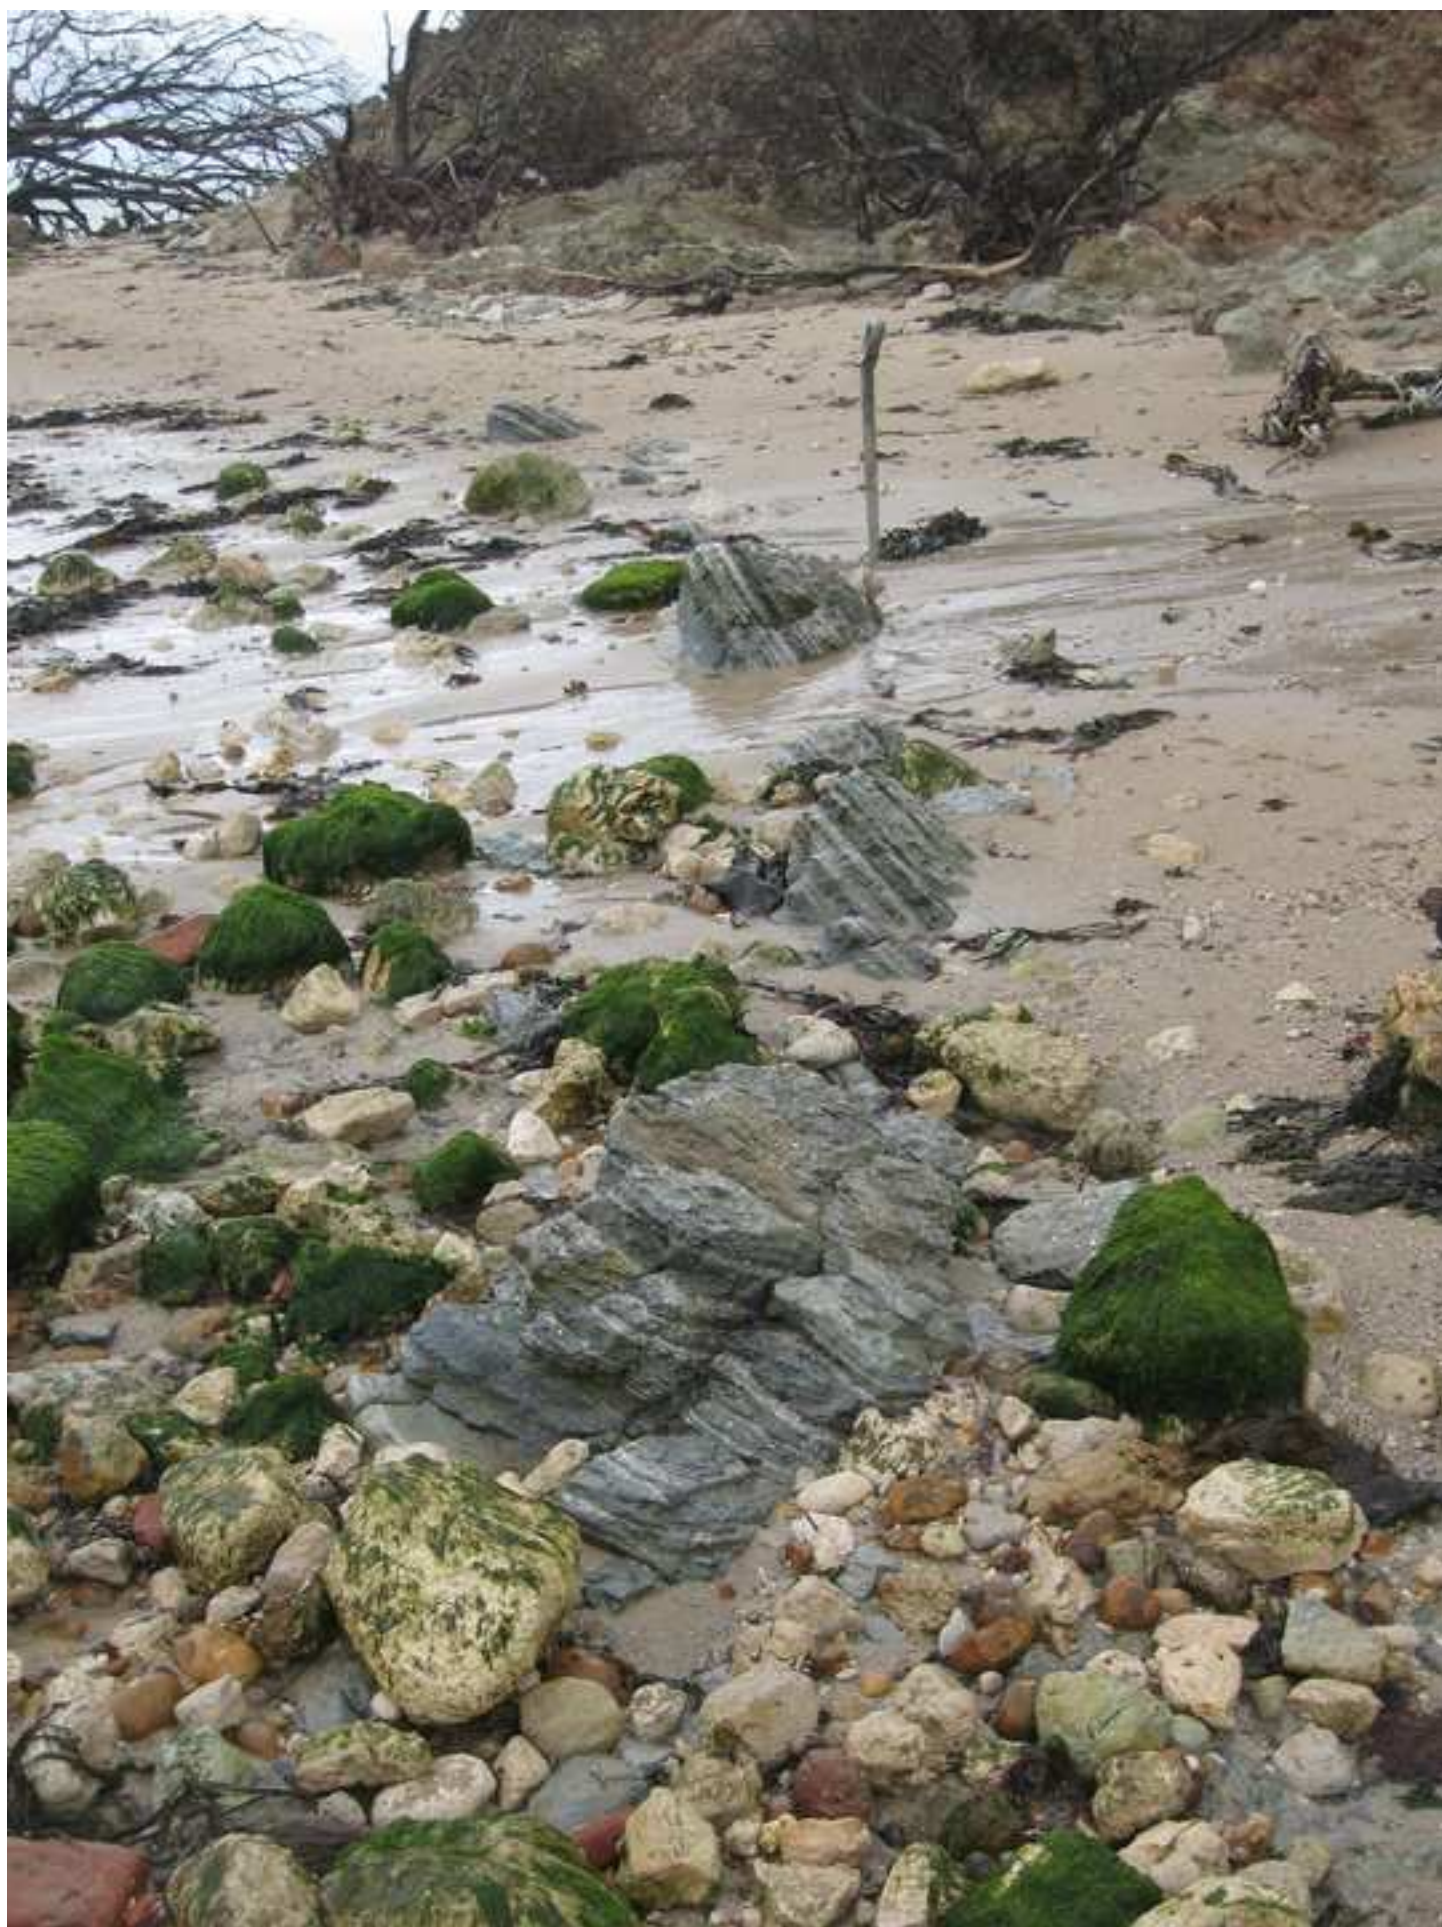
Figure 18

56
57 Fig. 18. Steeply dipping bedded raft of Headon Hill Formation embedded in the beach
58 at Fort Victoria. P769941.
59
60
61
62
63
64
65

Within the wooded areas of Fort Victoria Country Park [33630 89580] there is a conspicuous landslide topography of degraded hummocks and ridges. These relict features indicate that there has previously been a more pervasive period of landsliding along this section of coastline and that it was more advanced than the shallow failures that are currently active within the cliff. It is likely that these ancient landslides formed when sea level was lower (Lambeck, 1997) than the present day, and their slip planes are thought to propagate beneath current beach level. Evidence for this larger-scale ancient activity is present in the beach in front of the cliff. The Fishbourne Beds and Osbourne Member of the Headon Hill Formation, seen as horizontally-bedded units in the mid-cliff section, are also found on the beach platform as steeply-dipping rotated, back-tilted blocks (Fig. 18) indicating a buried slip plane at depth. Hutchinson and Bromhead (2002) also described a raft of Headon Hill Formation with vertical strata near to this site at Bouldnor Cliff [38810 90955].
