**DEVELOPMENT, ANALYSIS, AND CASE STUDIES OF IMPACT RESISTANT
STEEL SETS FOR UNDERGROUND ROOF FALL REHABILITATIONS**

**Thesis submitted to the Benjamin Statler College of
Engineering and Mineral Resources at West Virginia University
in partial fulfillment of the requirements
for the degree of**

**Master of Science
in
Mining Engineering**

Keywords: Mining, Ground Control, Roof Fall Rehabilitation, Steel Set

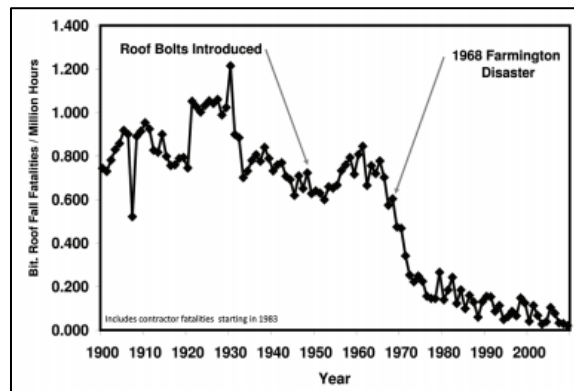
Figure 1.1 - Historical overview of roof fall fatality rates for underground bituminous coal mines (BOM,MSHA 1900-2009).

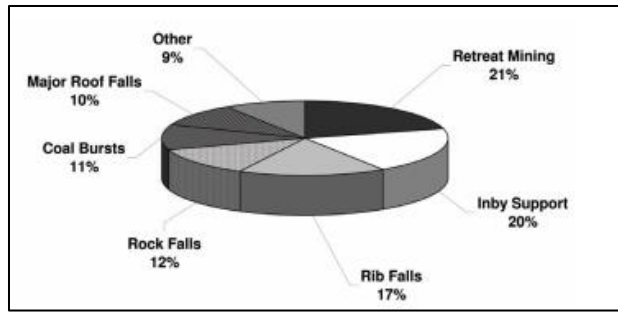
Figure 1.2 – Classification of ground fatalities from 1995-2009 (MSHA, NIOSH 1995-2009).

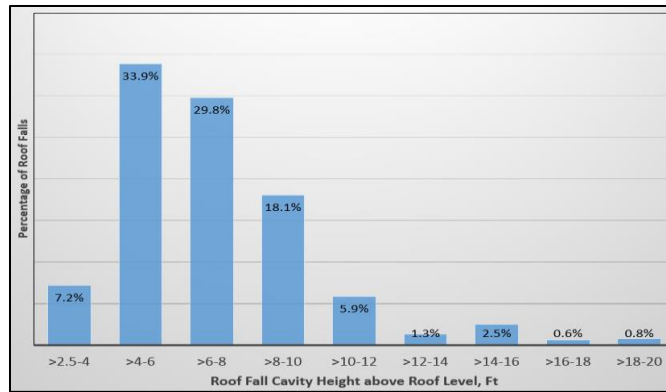
Figure 1.4 – Roof fall cavity height above roof level.

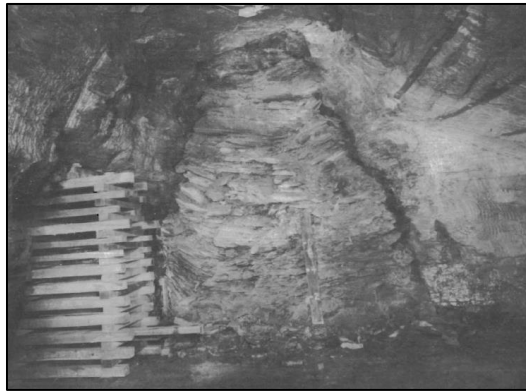
Figure 1.5 – Conventional re-support of a roof fall (Allwes, 1987).

such as a steel arch canopy. The conventional approach to re-support was to install standing support with cribbing, roof bolts and steel straps, Figure 1.5. This process was conducted in incremental steps with installing supports and removing debris. In massive roof fall areas cribbing, Figure 1.6, or multi-tiered steel sets may have been used.

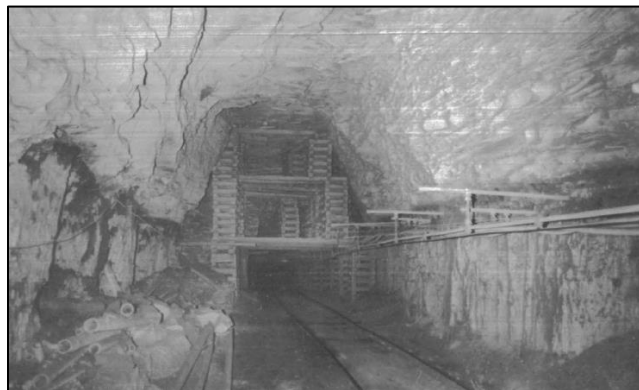
Figure 1.6 – Re-support of a roof fall using multi-tiered cribbing (Allwes, 1987).

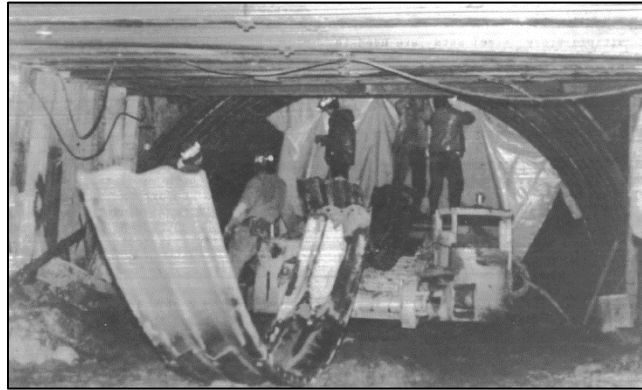
Figure 1.7 – Linear plate style arch support (Allwes, 1987).

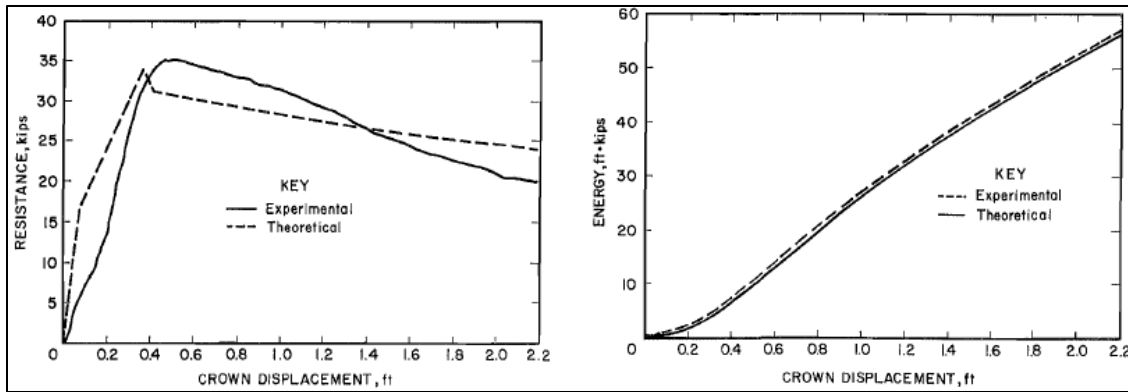
Figure 1.8 – Comparison of experimental and theoretical resistance and strain energy curves (Allwes, 1992).

Later, to evaluate the suitability of steel-set arches and tri-sets for use in roof-fall areas, the USBM conducted structural analyses and full-scale physical tests on these structures (Allwes and Mangelsdorf, 1992). The dynamic tests demonstrated that the previously developed arch canopy design procedure is appropriate and that it yields conservative designs for both steel-set arches and tri-sets Figure 1.8. However, the design procedure relies on the elastic and plastic strain energy absorbing capability of the steel structure to resist the impact load of the falling rock. Such a design concept is theoretically sound; however, from an engineering design perspective, the design concept tends not to be conservative if the plastic deformation of the steel-set is permitted in actual practice. Also, the design procedure is complicated and hard to implement. It will be difficult to calculate the strain energy from a static load-displacement diagram for every possible steel-set design. This is because the strain energy capacity of the structure differs between designs depending on the type and size of the steel member used. Most importantly, the design procedure ignores the adequacy of the wood lagging, which is likely the weak link of the entire impact-resistant steel-set system. Thus, steel-set and impact-resistant lagging panel designs have previously been by trial-and-error based on field experience.

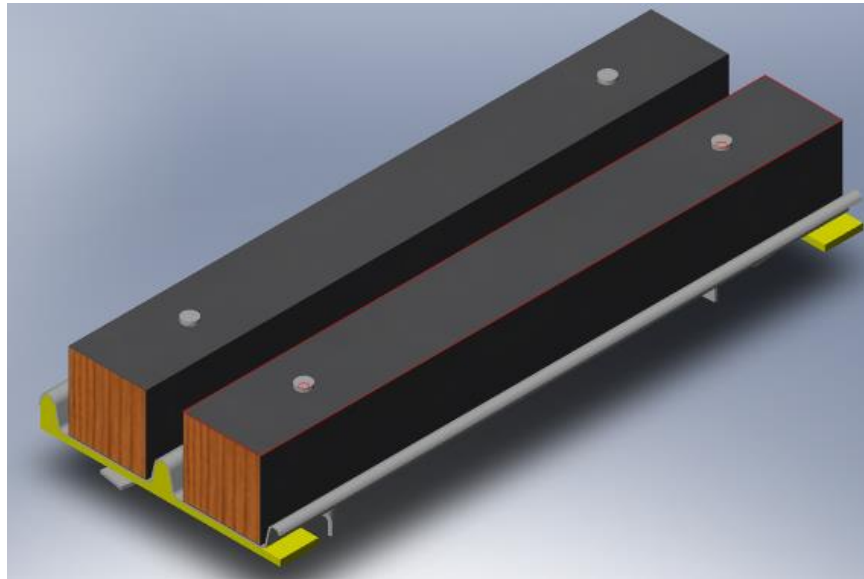
Figure 2.1 - Impact Resistant Lagging Panel

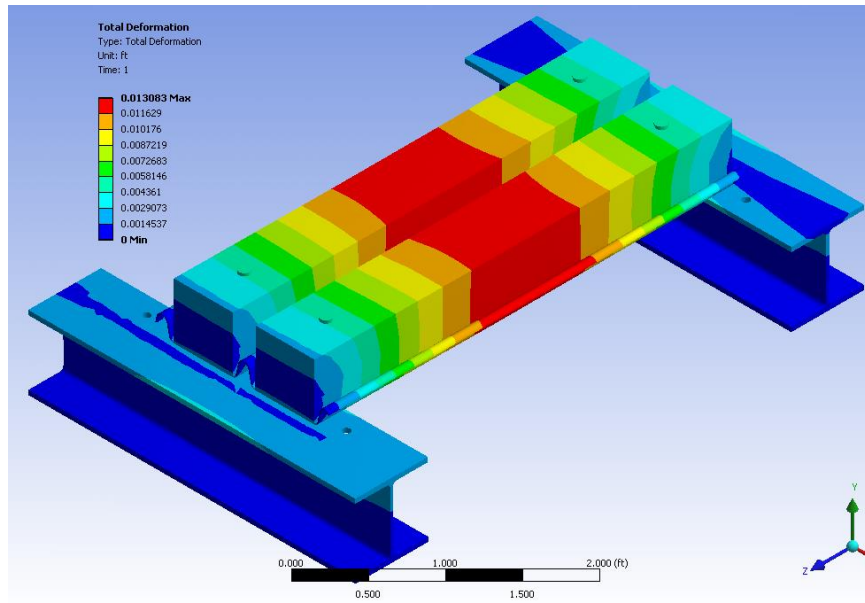
Figure 2.2 - Vertical deformation of the lagging panel.

The dynamic load support capacity of the IR lagging panel was evaluated using computer modeling technique. To determine the impact support capacity of the lagging panel, 3-D dynamic numerical modeling was conducted using the ANSYS program. The panel is supported over a 4 ft span by W8 x 31 beams on both ends. Figures 2.2 and 2.3 show the vertical deformation and safety factor distribution on the impact-resistant lagging panel at a given impact load.

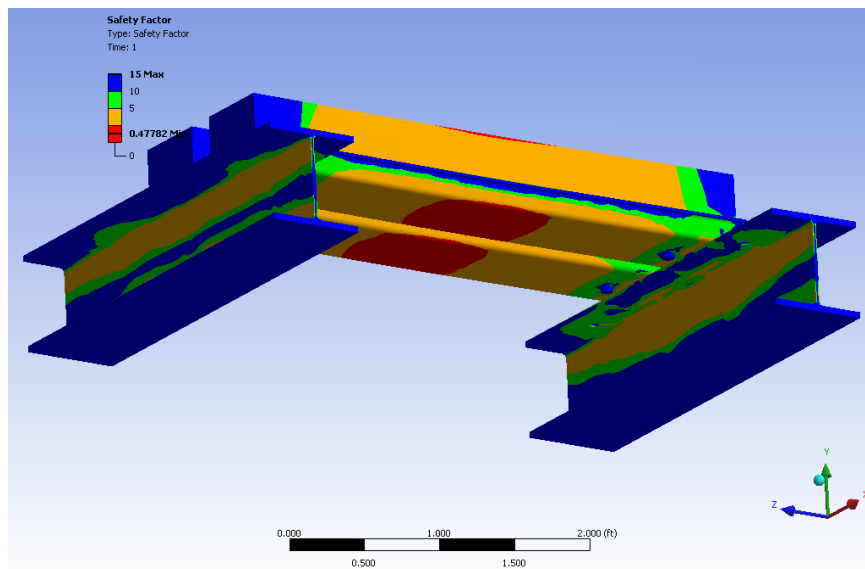
Figure 2.3 - Safety factor distribution.

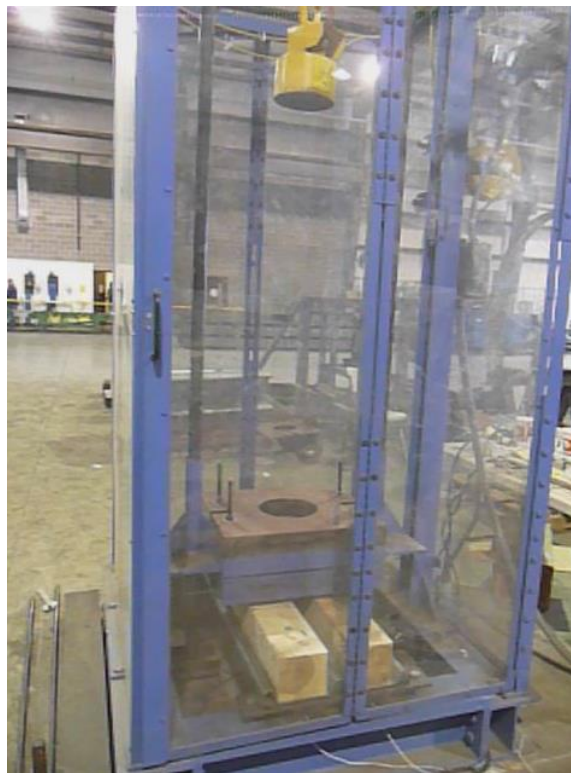
Figure 2.4 - Impact tester.

A full-scale laboratory test of the impact-resistant lagging panels was conducted with the Jenmar Impact Drop Tester shown in Figure 2.4. To simulate the actual loading condition, a steel block (600–1550 lbs) drops freely from a height of approximately 63 inches above the lagging panel assembly. An accelerometer is mounted on the steel block and a computerized data acquisition system records the steel block acceleration and duration of impact.

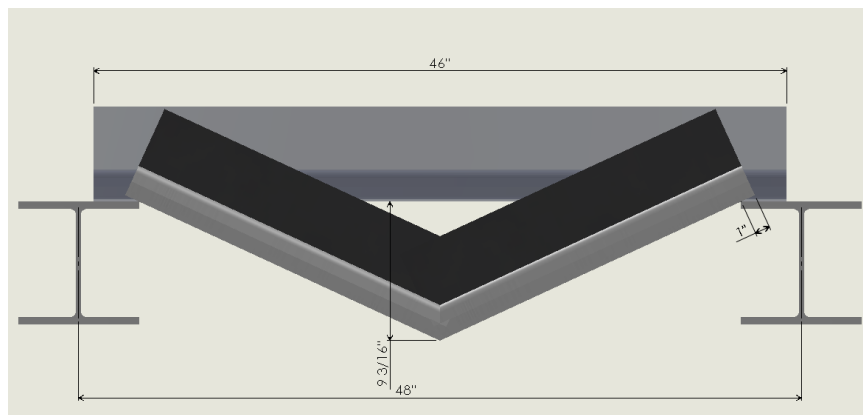
Figure 2.5 - Maximum deflection of the IR lagging panel at mid-span

From a serviceability perspective, it is considered that the IR lagging panel will serve its engineering purpose as long as the lagging assembly still remains on the steel set after being impacted by falling rock. To determine maximum allowable deflection, it is assumed that, upon a localized impact at mid-span, the IR lagging shall yield and deform to the extent that at least 1 inch of the lagging will remain on the W-beam flange on either end. With this assumption, it is determined that the maximum mid-span deflection is 9.187 in (Figure 2.5). However, to be conservative, a safety factor of 1.5 is applied and an allowable mid-span deflection of 6.125 in is considered as the testing criteria during the new laboratory drop tests. This assumption is considered reasonable while still conservative given the acceptable 8 inches of deflection measured in the field.

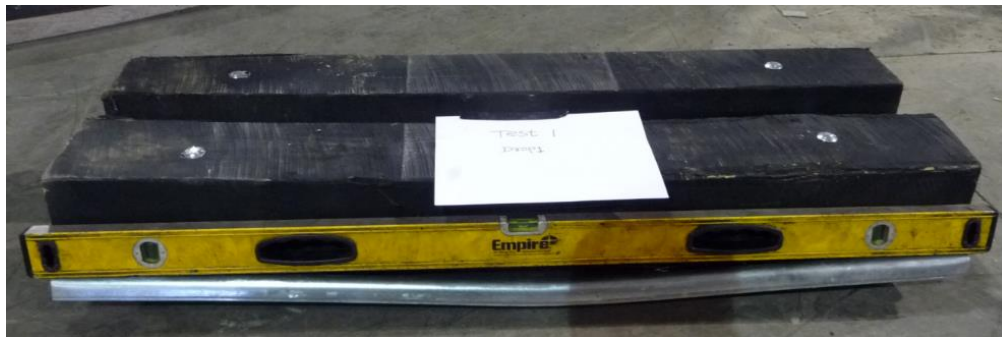
Figure 2.6 - Intact specimen after impact.

Figure 2.6 shows a typical drop test specimen that did not reach the 6.125" mid-span deflection failure state. To identify the maximum support capacity of the impact-resistant lagging panel, a series of drop tests were conducted by gradually increasing drop weight whereas the drop height was maintained constant. Permanent deflections of the V-deck panel and SLB were manually measured at mid-span with a straight edge.

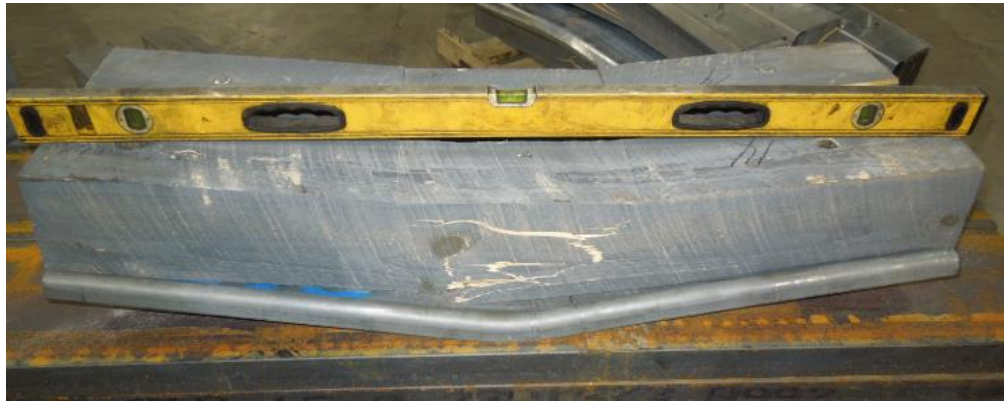
Figure 2.7 - Deformed specimen after impact.

Figure 2.7 shows the sample #14 after the impact. Upon a free drop impact at mid-span by a 1541.5 lb weight falling from 63 in high, the metal V-deck panel at the bottom experienced permanent deformation and the Special Lagging Block (SLB) fractured at the bottom but still maintained acceptable integrity.

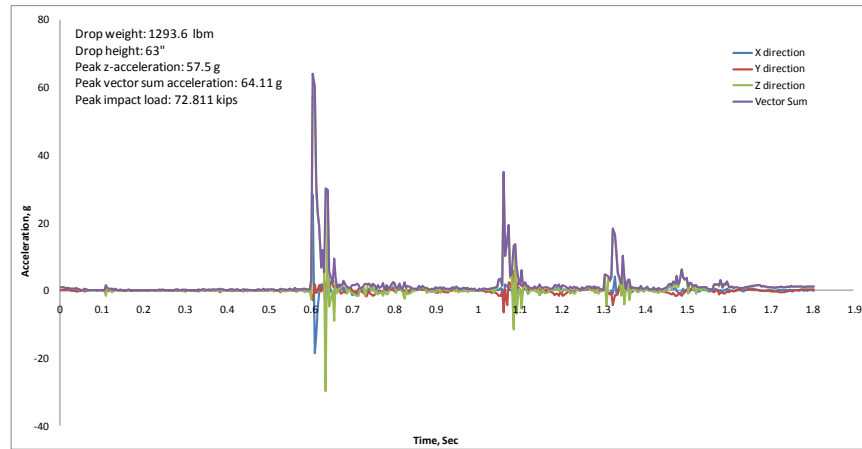
Figure 2.8 - Acceleration vs. time curve of impact testing – Test #1.

Figures 2.8 and 2.9 show the acceleration vs. time curves recorded for two typical impact tests. The weight block bounces up and down 5 – 6 times before the impact energy attenuates. Due to the spring effect of the panel, the steel block bounced up and down several times in each test. As a result, the IR lagging was actually subjected to 4 - 6 mini-impacts. As shown in Figure 2.9, impact duration of the first and second mini-impacts ranged approximately 0.03 - 0.05 seconds, and total duration of the impact was approximately 0.702 seconds. The instantaneous impact load peaks at 77 kips. In this case, the V-deck panel deflected 1.75 - 3.375 inches at mid-span and some deformation and/or fractures occurred to the SLB's.

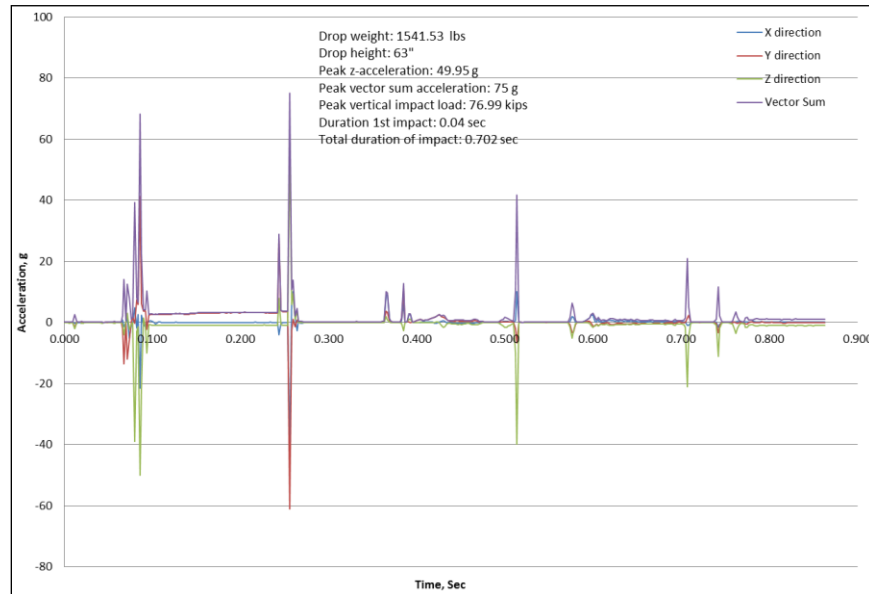
Figure 2.9 - Acceleration vs. time curve of impact testing – Test #15.

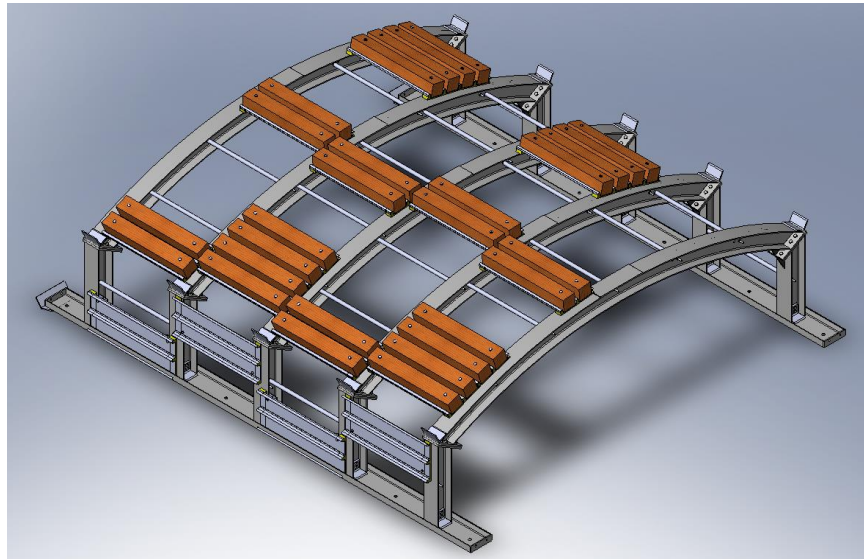
Figure 3.1 - Typical IR arch set canopy

An IR steel set canopy usually consists of multiple courses of single steel set (square or arch) that are spaced a few feet (typical 4 ft center to center), interconnected with each other with tie rods and spacer tube, assembled with runner channels with sled tips at the front, and totally covered with IR lagging panels on the top and v-deck panels on the sides. Shown in Figures 3.1 and 3.2 are typical 20 ft long IR arch set canopies. Note that coverage of IR lagging on the canopy shown in the figure is partial for demonstrational purpose only.

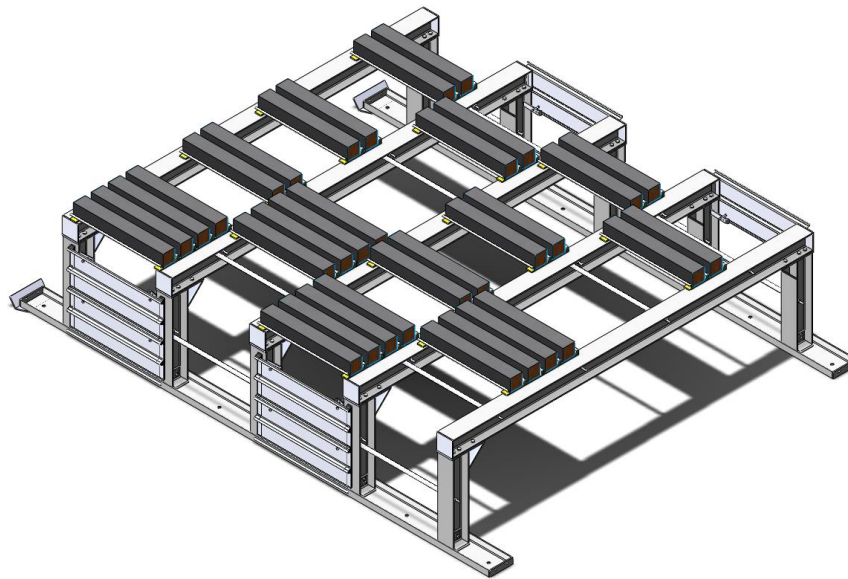
Figure 3.2 - Typical IR square set canopy

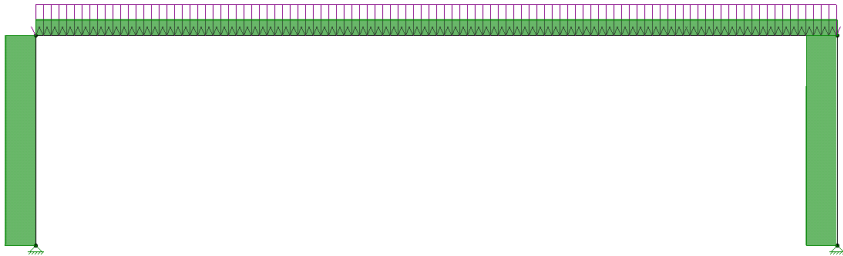
Figure 4.2 – Load and axial stress diagram

density of fractured rock. Shown in Figures 4.2, 4.3, and 4.4 are the load, axial stress, shear stress, and moment diagrams.

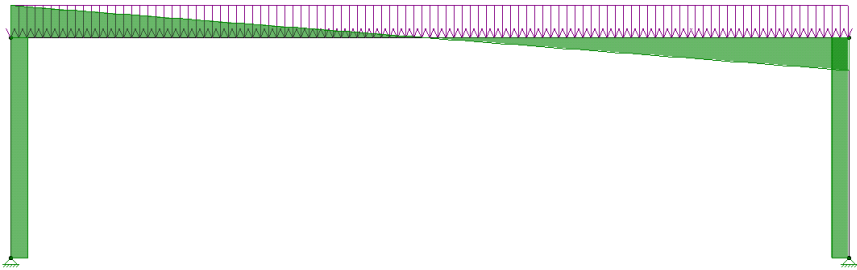
Figure 4.3 – Load and shear stress diagram

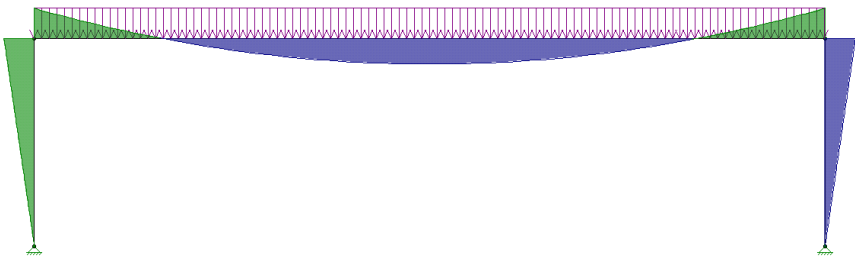
Figure 4.4 – Load and moment diagram

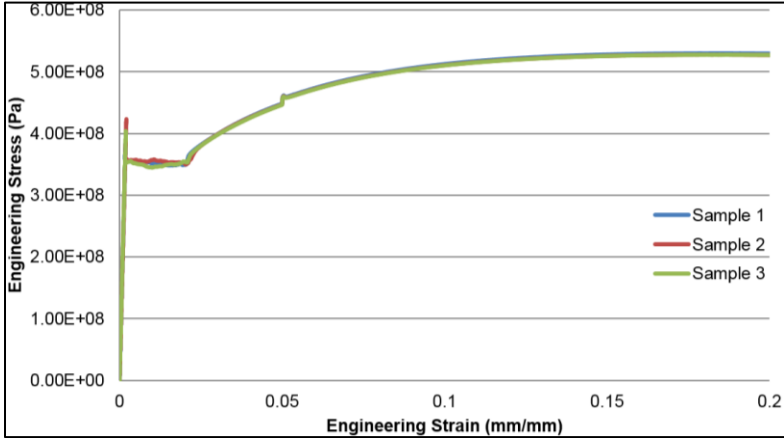
Figure 4.5 - Stress vs. strain of A36 steel

load in elastic design. However, in reality, most structural steel (A36, A992, A325, etc) exhibit a strain hardening characteristic, as shown in Figure 4.5.

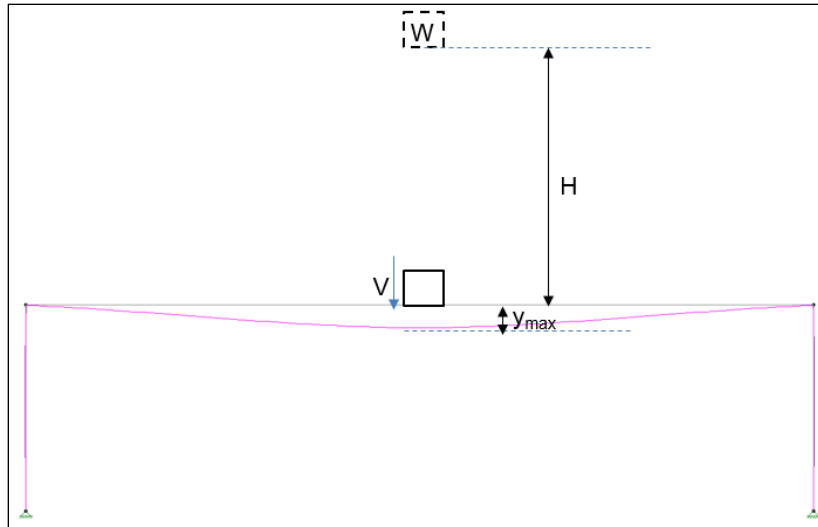
Figure 4.6 - Conceptual impact model

To evaluate impact resistant capacity, an elasto-plastic steel analysis was conducted for the W8 x 31 square set under an impact by a block with a weight (W) (mass x gravity) and a falling height (H) as shown in Figure 4.6.

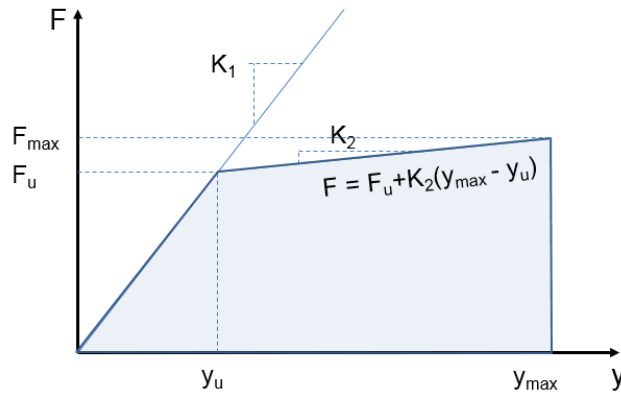
Figure 4.7 - Conceptual load vs. deflection curve

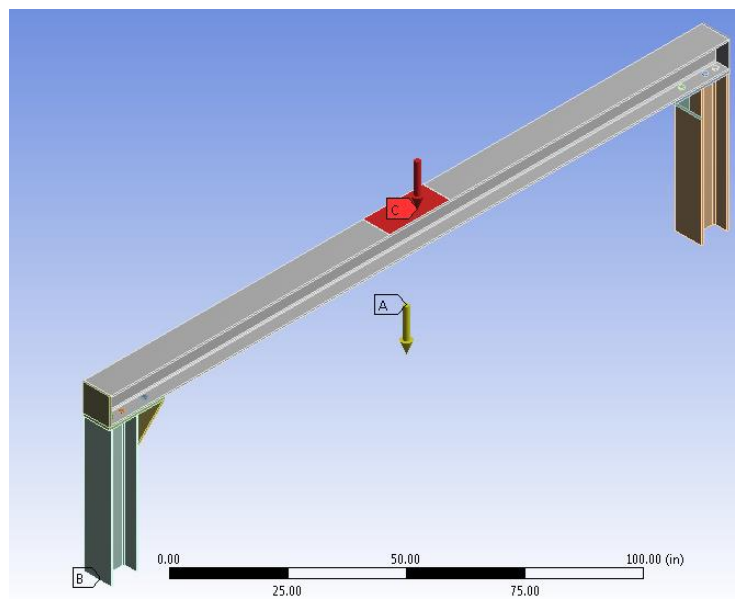
Figure 4.8 - Numerical model of W8 x 31 square set

In this evaluation, a 3D elasto-plastic finite element analysis was conducted to determine the parameters F_u , y_u , and K_2 . The W8 x 31 square set (Figure 4.8) was virtually tested and numerically analyzed to assess the yielding and deformation and to determine the relationship between mid-span deflection and the load applied. Listed in Table 4.1 are the material properties of the steel members used in the model. The stress-strain relationship for steel members was modeled using a multi-linear strain hardening constitutive model similar to the curve shown in Figure 4.5.

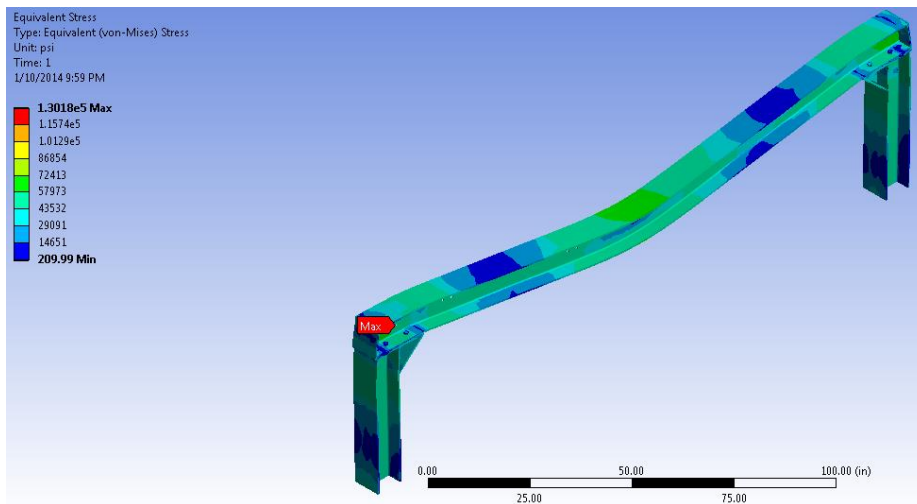
Figure 4.9 - Equivalent stress distribution

An isotropic strain hardening rule with Von Mises yield criteria was applied for simulating non-linear behavior of the steel member after yielding. Shown in Figure 4.9 is the equivalent stress (Von-Mises) distribution of the deflected W8 x 31 square set due to localized impact load at mid-span.

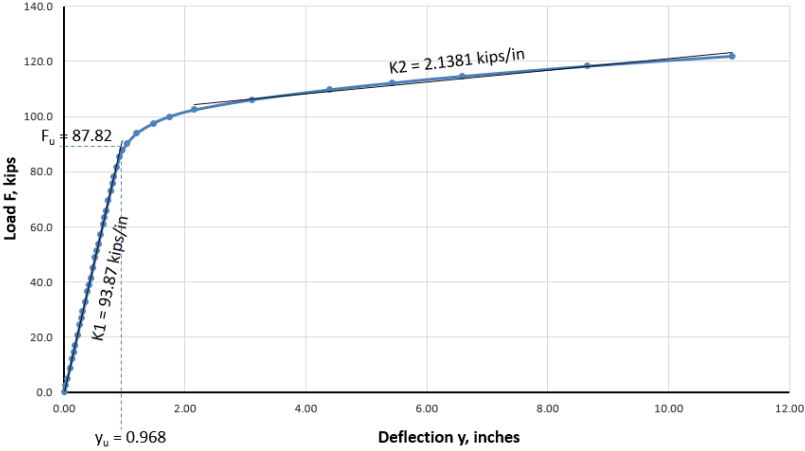
Figure 4.10 - Load vs. deflection of W8 x 31 square set

plastic yielding and deformation when the load exceeds $F_u = 87.82$ kips and the mid-span deflection is greater than $y_u = 0.968$ ".

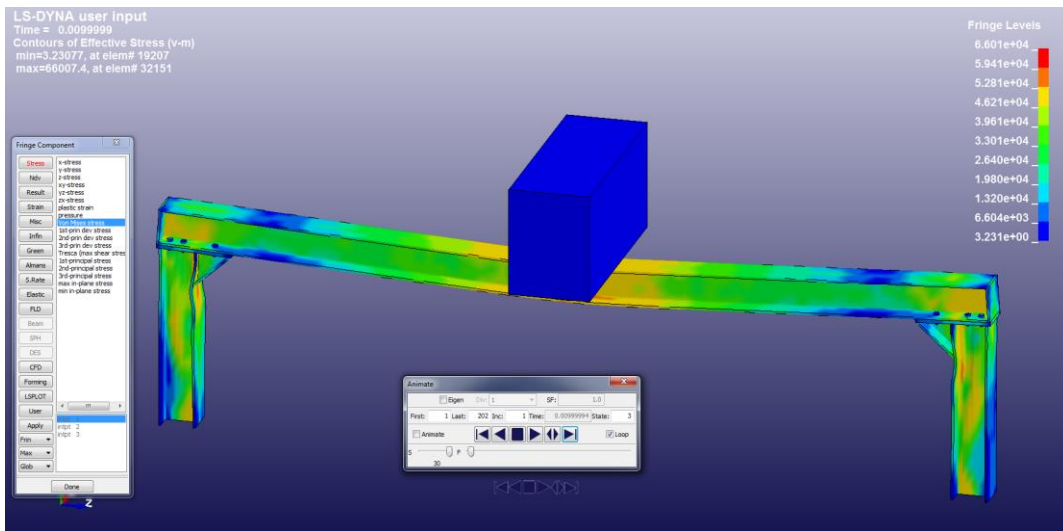
Figure 4.11 – Von-Mises stress distribution upon impact

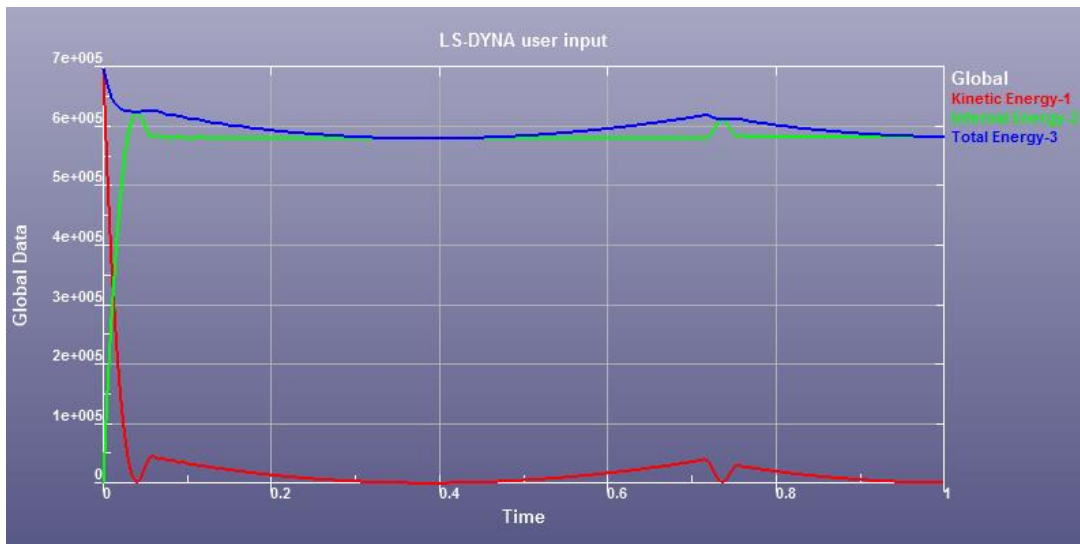
Figure 4.12 – Energy vs time

4.12 shows energy variation vs time. Analysis indicates that the kinetic energy carried by the weight block was absorbed as internal energy through cross beam deflection and deformation of the structure. The mid-span deflection of the cross member is approximately 8.25 inches (Figure 4.13) after the weight block becomes stationary. The results match well with the elasto-plastic analysis results, and it is concluded that the W8 x 31 square set meets design requirements.

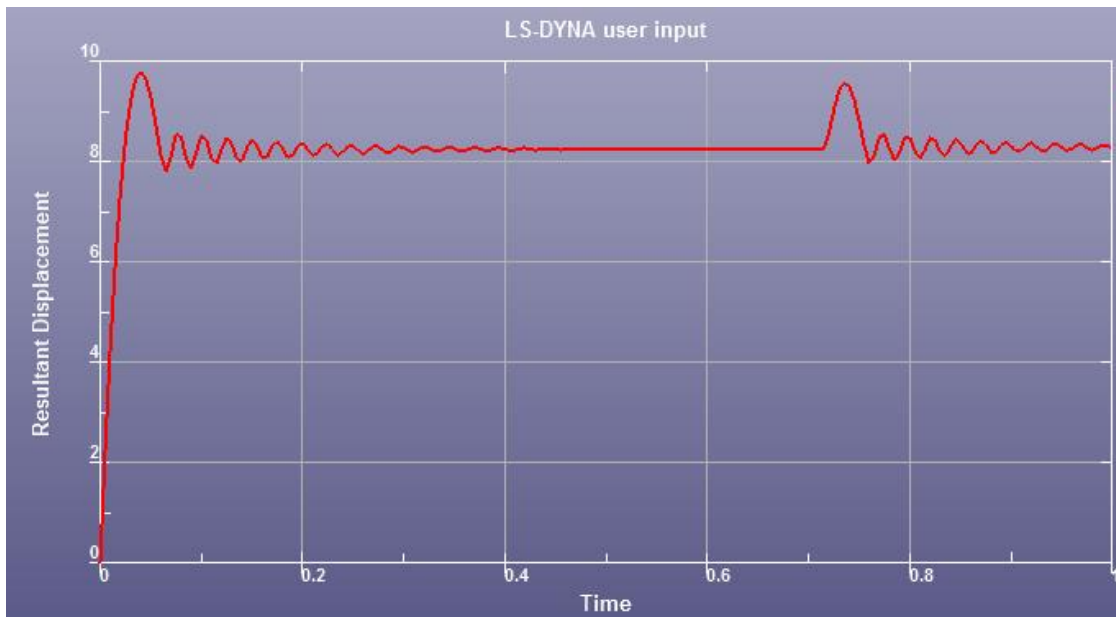
Figure 4.13 – Mid-span deflection vs time

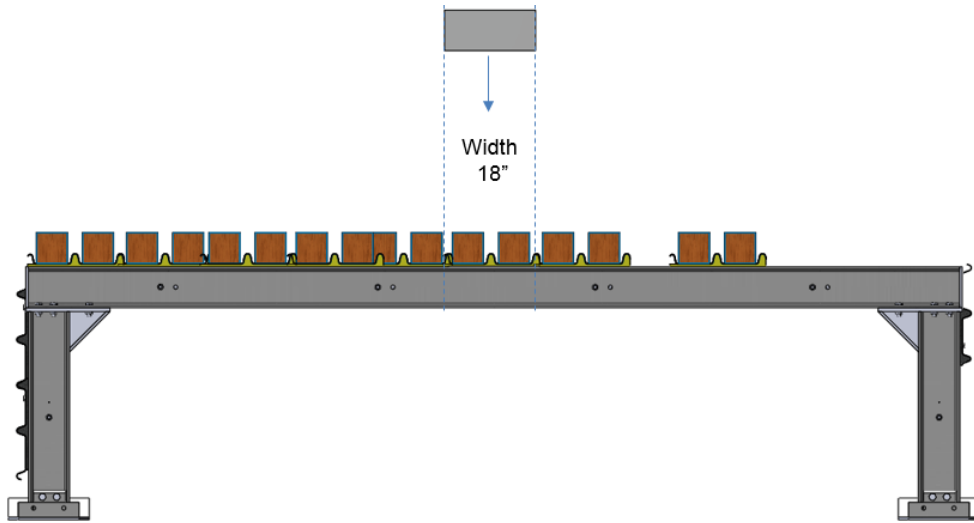
Figure 4.14 - Worst impact loading condition on steel set

For a steel set, a localized impact loading at mid-span (Figure 4.14) represents the worst case loading condition. Considering the fact that the impact load will be distributed to the steel beam through the 18 inches wide IR lagging panel, the rock slab thickness is evaluated on a unit basis (18 inches wide). Impact load by a rock slab that is greater than 18 inches wide is assumed to be shared by adjacent lagging panels.

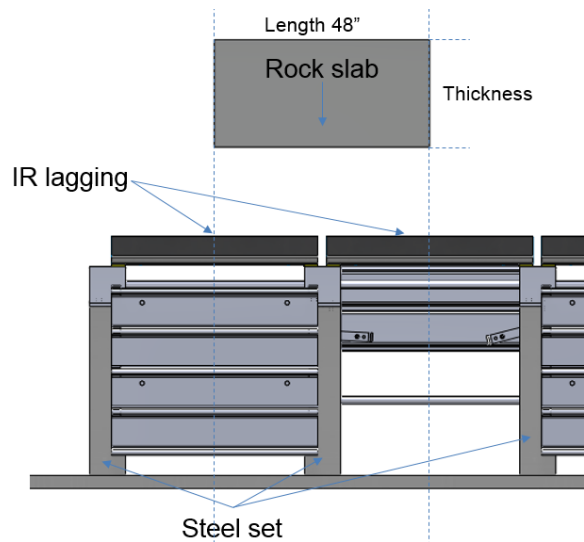
Figure 4.15 - Impact above steel set

The majority of the impact load will be undertaken and absorbed by the steel set if the impact contact point and center of gravity of a falling rock slab are above and through the cross beam of the steel set (Figure 4.15). If the rock slab is long, it may span over multiple steel cross beams. It is reasonable to assume that impact load by a rock slab longer than the steel set spacing will be shared by adjacent steel cross beams. With this assumption, the maximum allowable thickness of the falling rock slab that each steel set can sustain is estimated on a unit basis (4 ft long or set spacing x 18 in wide) using the maximum weight values in Table 4.2. Listed in third column of Table 4.3 are maximum rock slab thicknesses that each W8 x 31 square set can sustain for different falling heights.

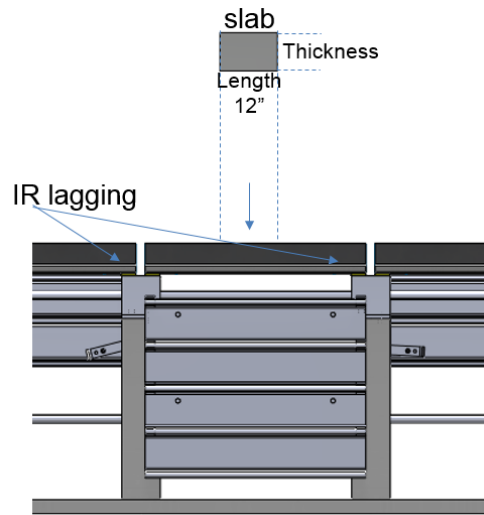
Figure 4.16 - Impact at mid-span of IR lagging

If the contact point and center of gravity of a falling rock slab are above and through the mid-span of the IR lagging (Figure 4.16), part of the rock fall kinetic energy will be absorbed by the IR lagging by means of SLB yielding, deformation of the cushion pad, and plastic deflection of the V-deck. Similarly, the maximum allowable thickness as listed in column 2 of the Table 4.3 of the falling rock slab that each IR lagging can sustain is estimated on a unit basis (12 inches long x 18 inches wide) using the maximum values in Table 2.2.

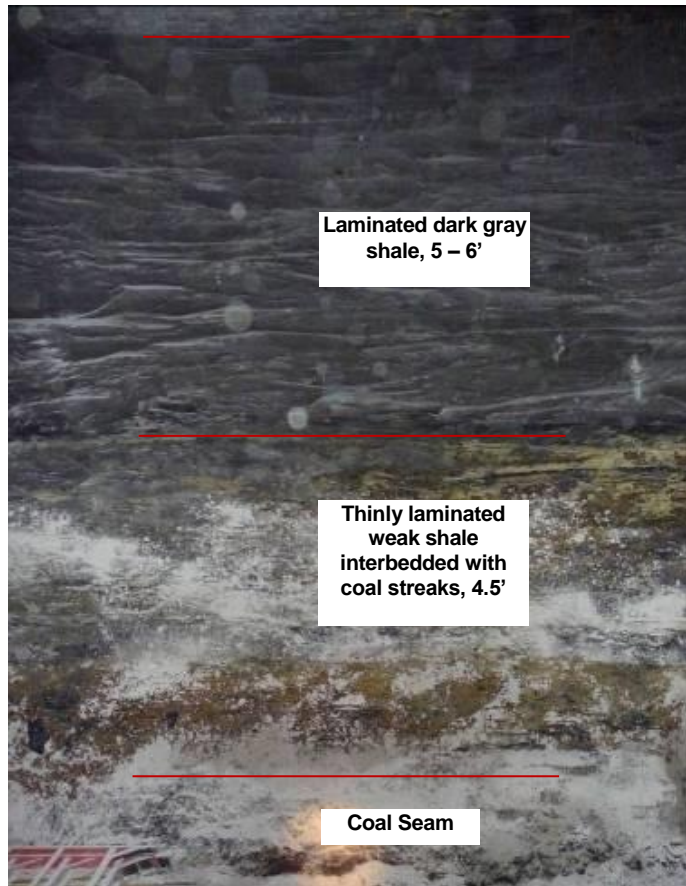
Figure 5.2. Exposed roof cross section

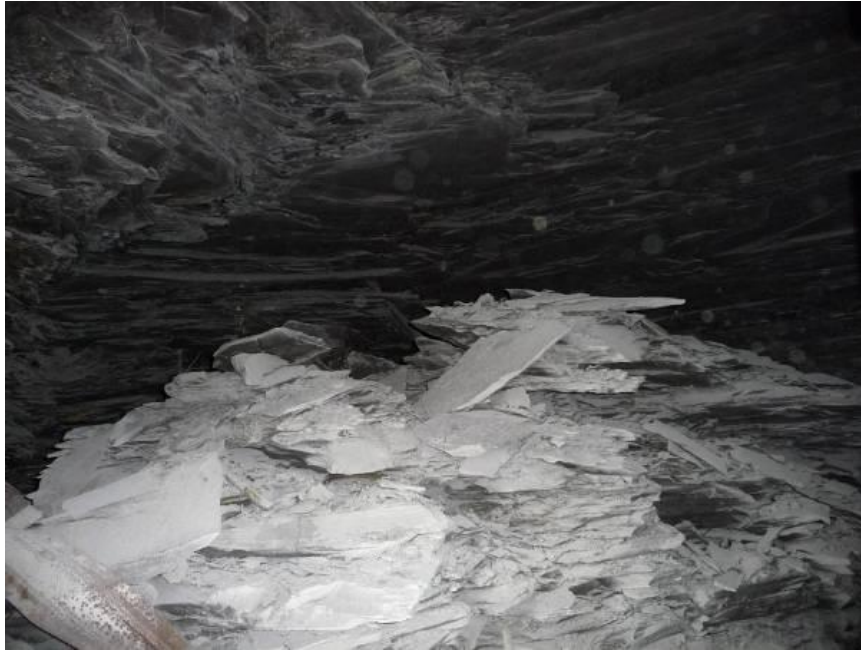
Figure 5.3. Caved roof

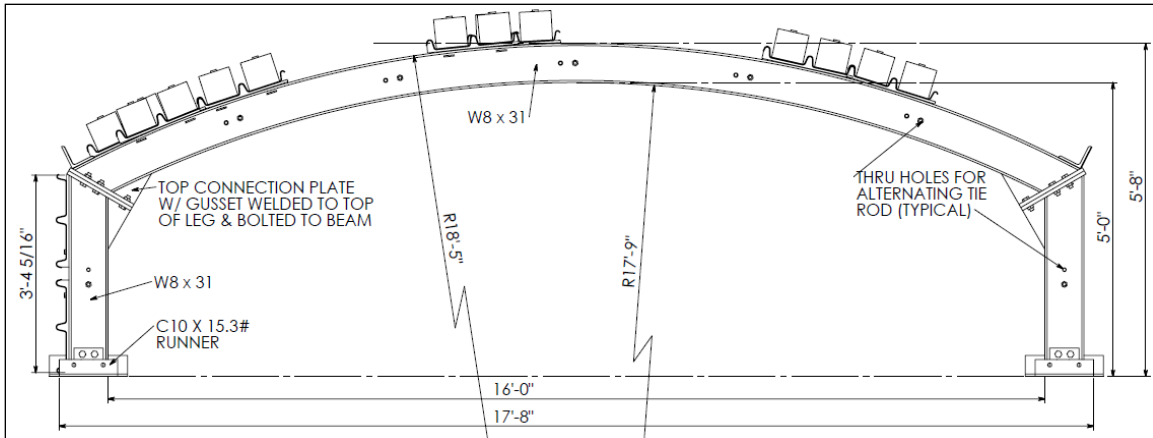
Figure 5.4 – W8x 31 IR arch set

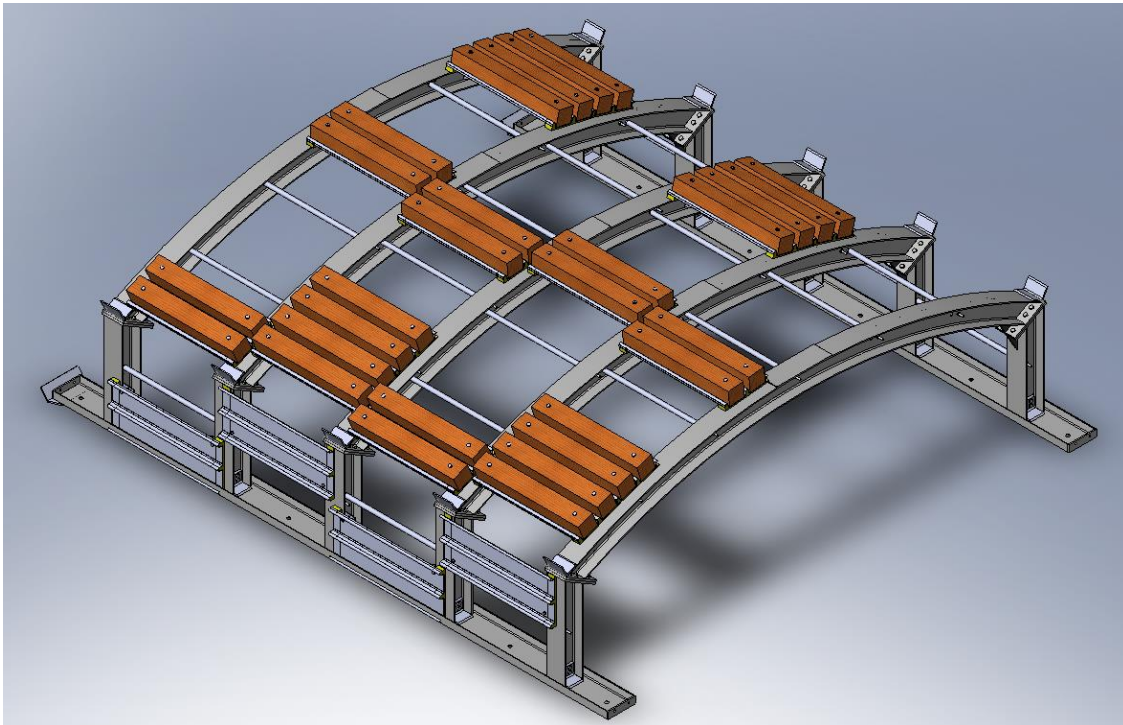
Figure 5.5. 3D view of the five-set unit

To reduce the weight of the structure while maintaining a higher support capacity, mine management decided to use a long radius impact-resistant arch set in lieu of a square set. Structural analysis following the AISC national standard indicated that a three-piece, W8 x 31 (W200 x 46) long radius arch set will meet the design requirements. Figure 5.5 shows a three-dimensional view of the same design as a five-set unit.

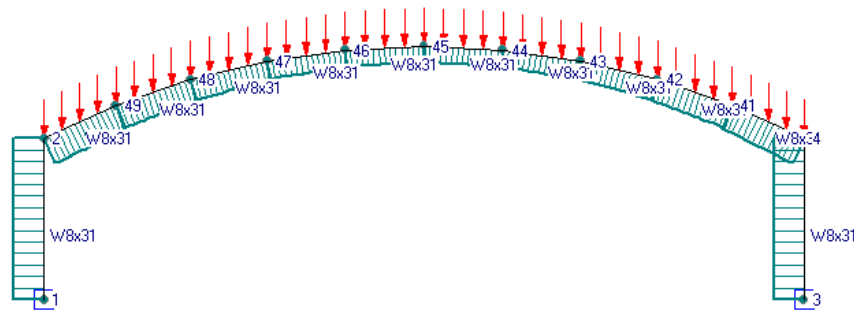
Figure 5.6 – Load and axial diagram

Figure 5.6 shows the loading and axial stress diagrams. Figure 5.7 shows the shear stress and bending moment diagram.

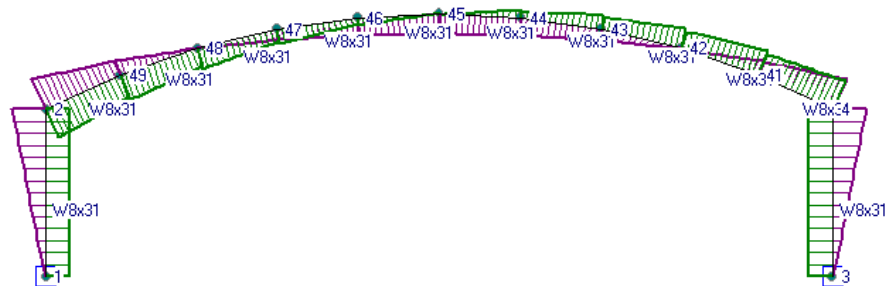
Figure 5.7 – Shear and moment diagram

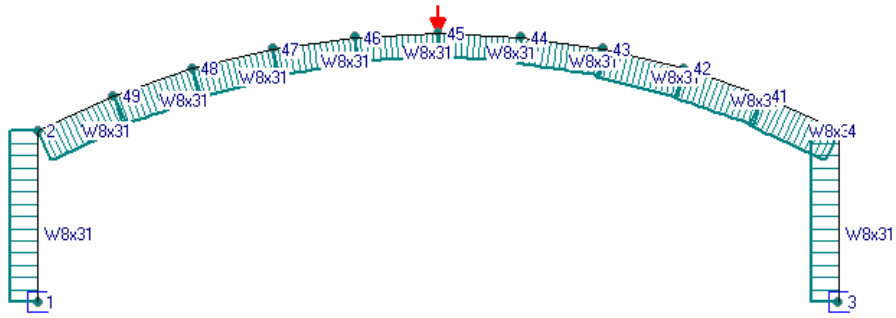
Figure 5.8 - Axial stress diagram

The proposed long radius arch can sustain a maximum of 31.9 tons (28.9 tonnes) localized dynamic load at mid-span. Figures 5.8 – 5.10 present the axial, shear, and moment diagrams.

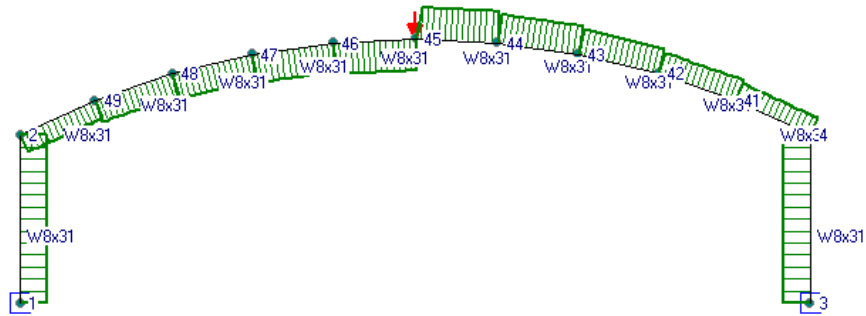
Figure 5.9 - Shear stress diagram

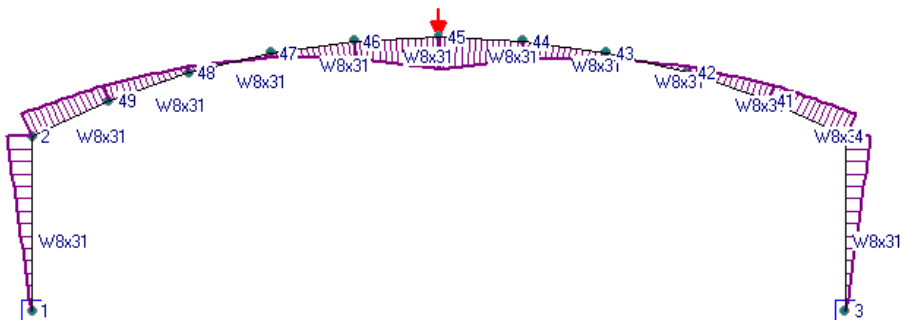
Figure 5.10 - Bending moment diagram

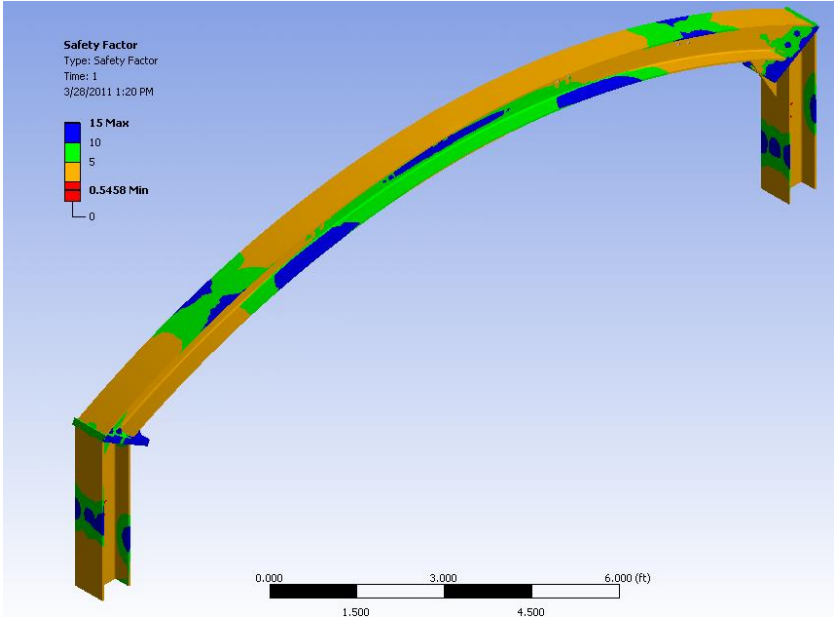
Figure 5.11 - Safety factor distribution (static uniform load)

surface on the cross-member. Since the yielding only occurs on the beam surface, it can be concluded that the structure has the expected impact load support capacity.

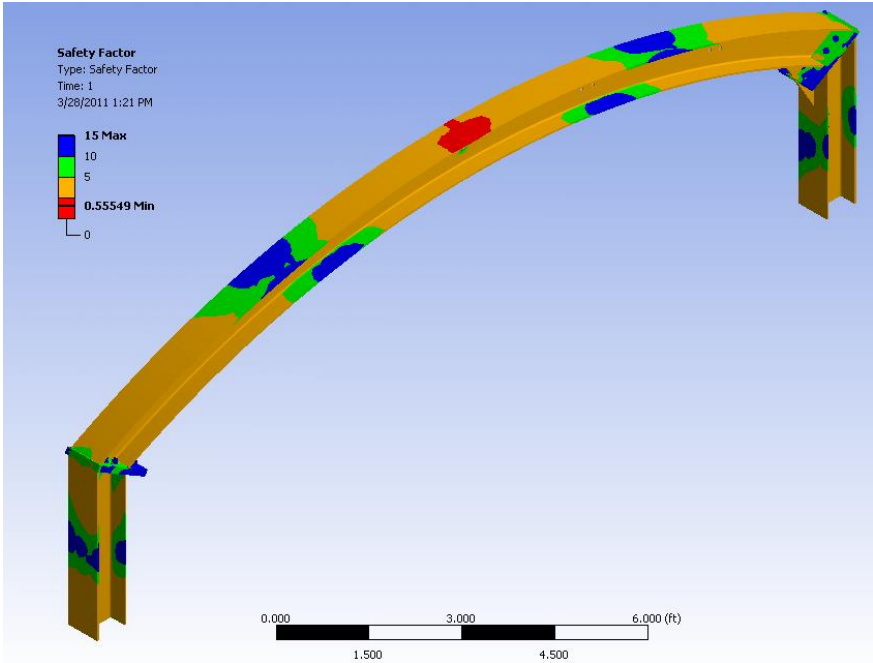
Figure 5.12 - Safety factor (localized impact load)

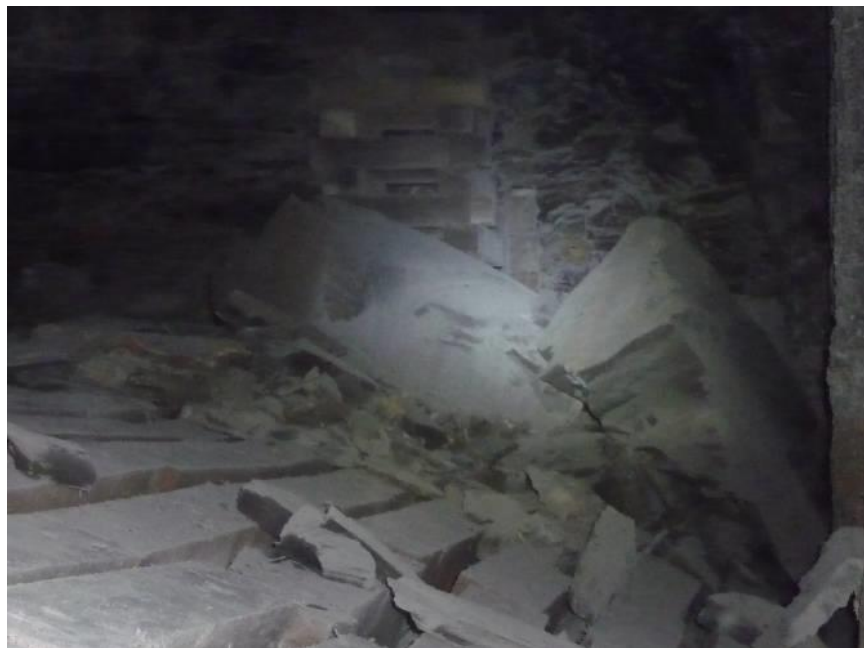
Figure 5.13 - Secondary roof fall

At the belt entry roof fall site, the overburden strata stabilized; only a few small rock pieces (<1 ft³) fell on the canopy over the last 19 months, and the impact-resistant arch sets remained intact. At another roof fall site, a small scale, secondary roof fall (Figure 5.13), composed of approximately 7–9 tons (6.4-8.2 tonnes) of rock fell off the 6 ft (1.8 m) high rib sometime in early 2010. Field investigation indicates that the impact-resistant arch sets performed very well and there was no apparent structural deformation or lagging panel failure. Figure 5.14 shows the inside of the arch set and lagging where the rocks fell. Only one of the impact-resistant lagging panels was deflected by less than 3/4 in (19 mm) at mid-span.

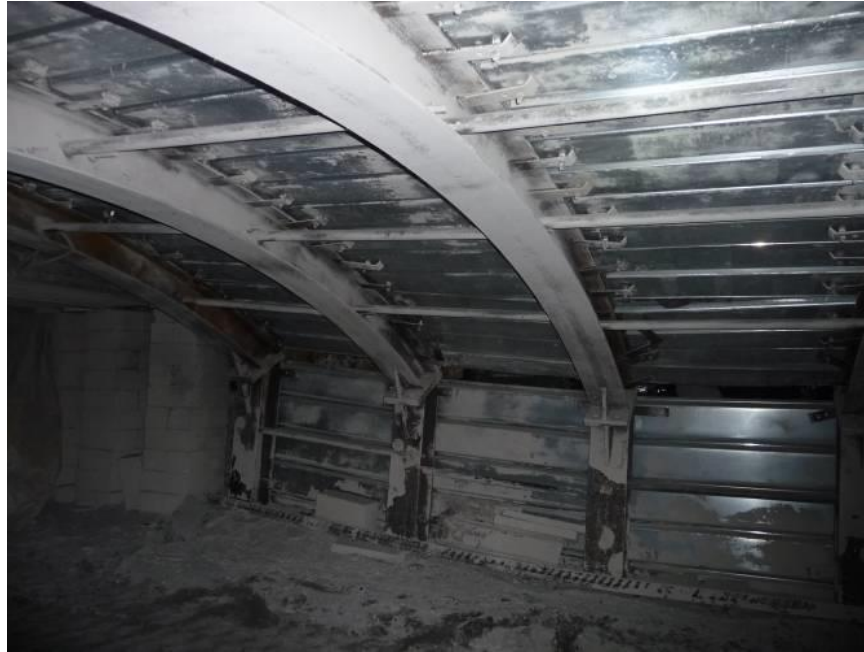
Figure 5.14 - Arch set and lagging impacted by roof fall
