**DEVELOPMENT, ANALYSIS, AND CASE STUDIES OF IMPACT RESISTANT
STEEL SETS FOR UNDERGROUND ROOF FALL REHABILITATIONS**

**Thesis submitted to the Benjamin Statler College of
Engineering and Mineral Resources at West Virginia University
in partial fulfillment of the requirements
for the degree of**

**Master of Science
in
Mining Engineering**

Keywords: Mining, Ground Control, Roof Fall Rehabilitation, Steel Set

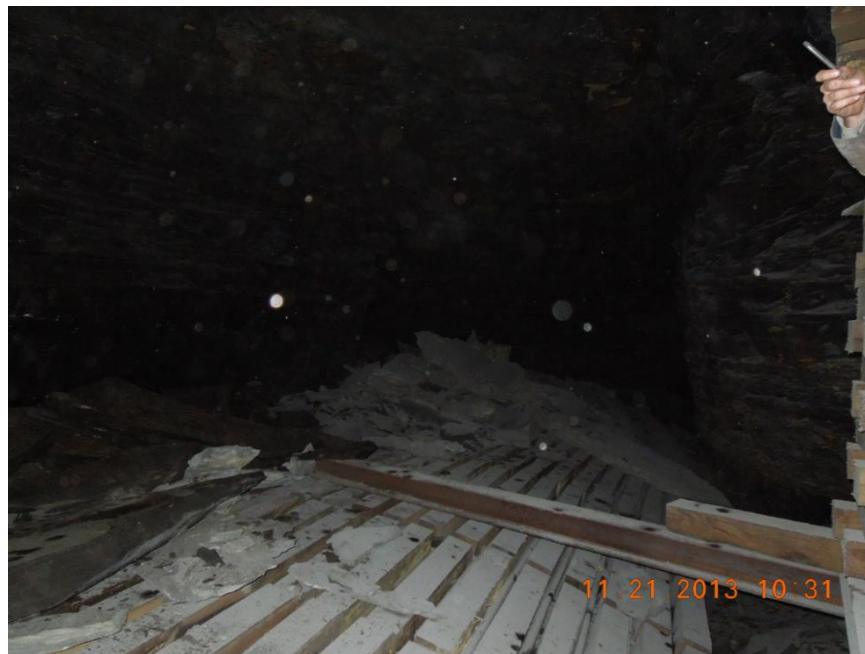
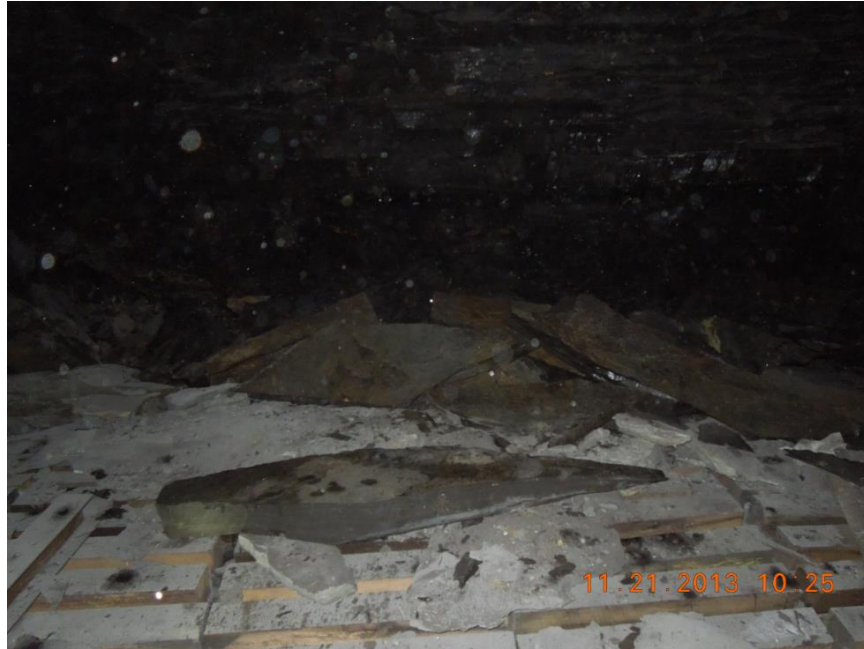
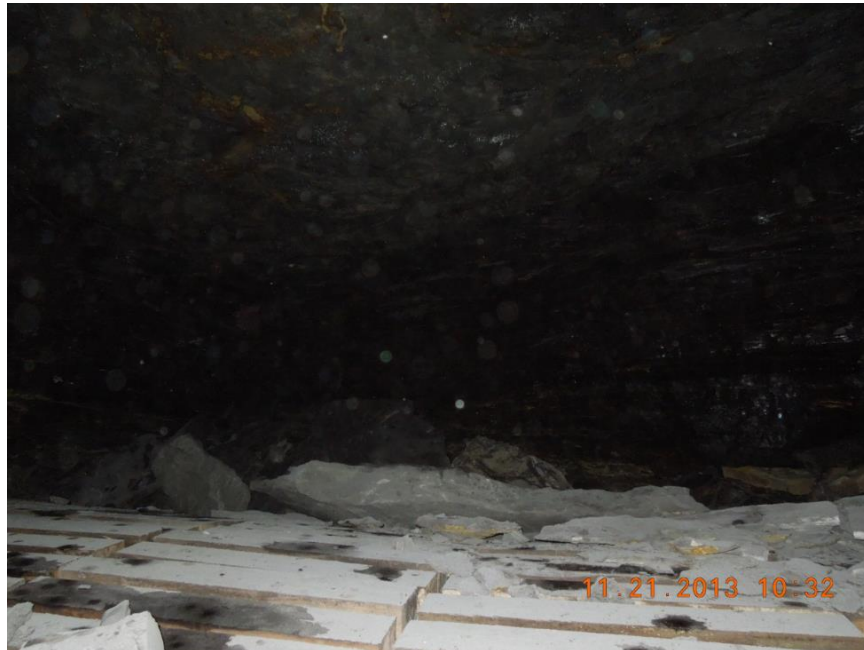
Figure 5.15 - Secondary roof fall

Figure 5.16 - Secondary roof fall

Figure 5.17 - Secondary roof fall

Underground examination of the steel set, lagging panel, and SLBs indicate that the installed W8 x 31 IR arch set performed very well during the last 56 month period. No lagging panels or SLBs were knocked off from the W-beam, and the steel set did not exhibit any measurable deflection (Figure 5.18 and 5.19) at the area where impacted by secondary roof falls.

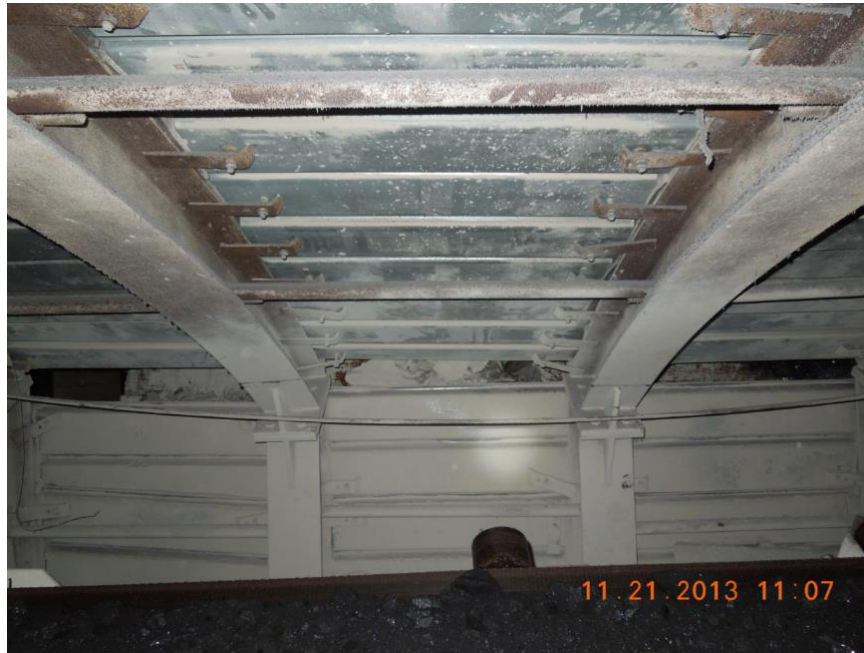
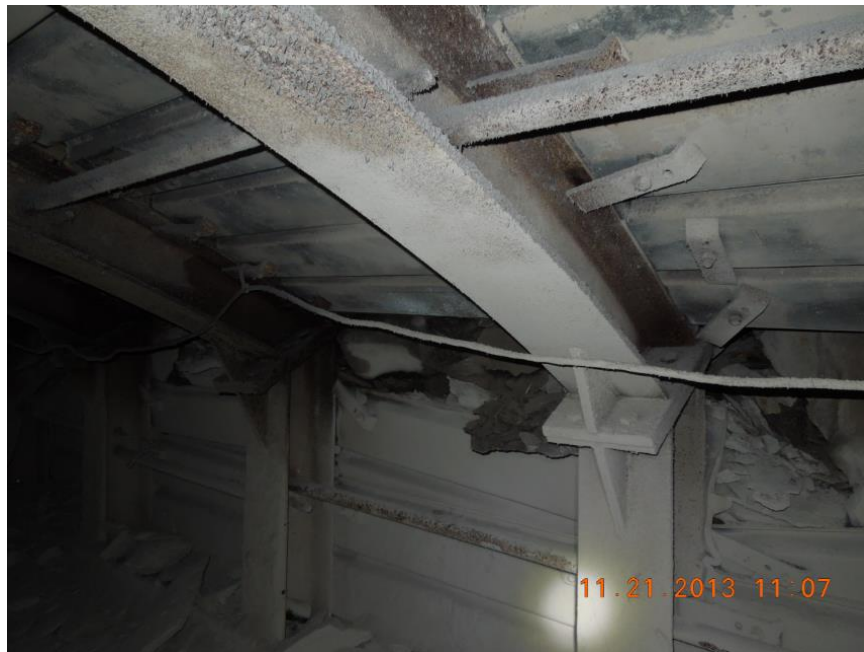
Figure 5.18 - Steel sets under the secondary roof fall area

Figure 5.19 - Steel sets under the secondary roof fall area

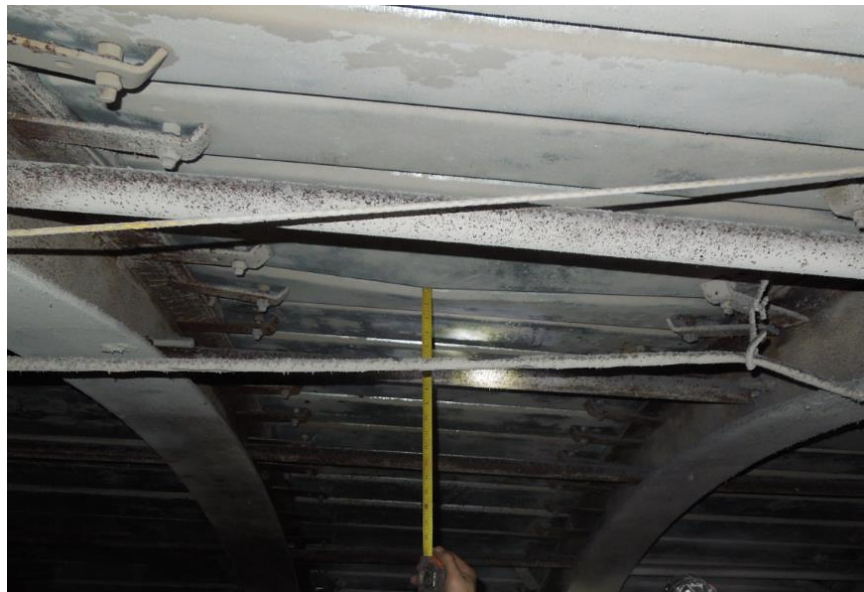
Figure 5.20 - Minor lagging deflection (0.25") due to rock impact

are a few lagging panels with 0.25 in, 3.5 in, and 8 in of permanent deflection at mid-span. At 3.5 in to 8 in deflection, the SLB fractures but the IR lagging still remains on the steel set still functioning. One of the IR lagging (Figure 5.23) panels was slightly knocked off the W-beam on one end due to improper installation and/or untightened clips. The problem is considered insignificant since the SLB is still intact and the lagging assembly is supported by the tie rods and spacer tubes.

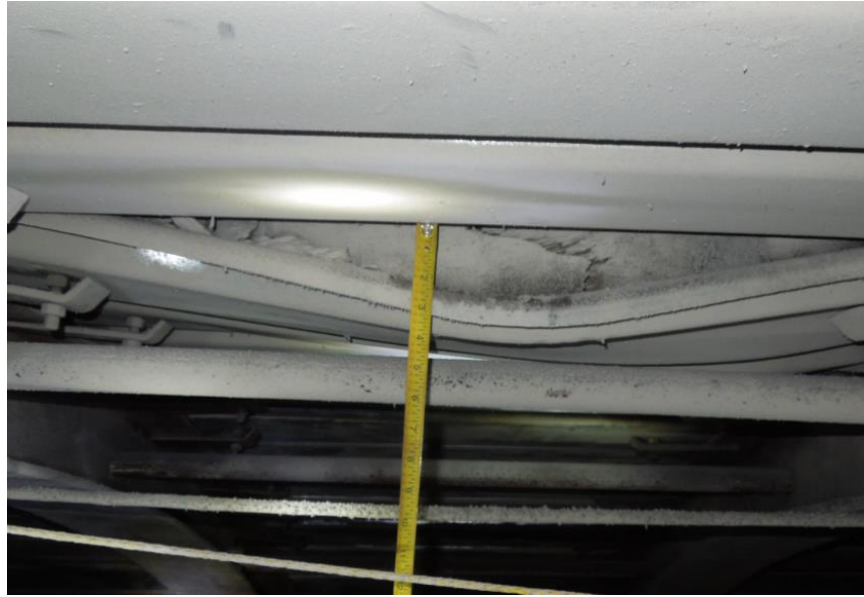
Figure 5.21 - Medium lagging deflection (3.5") due to rock impact

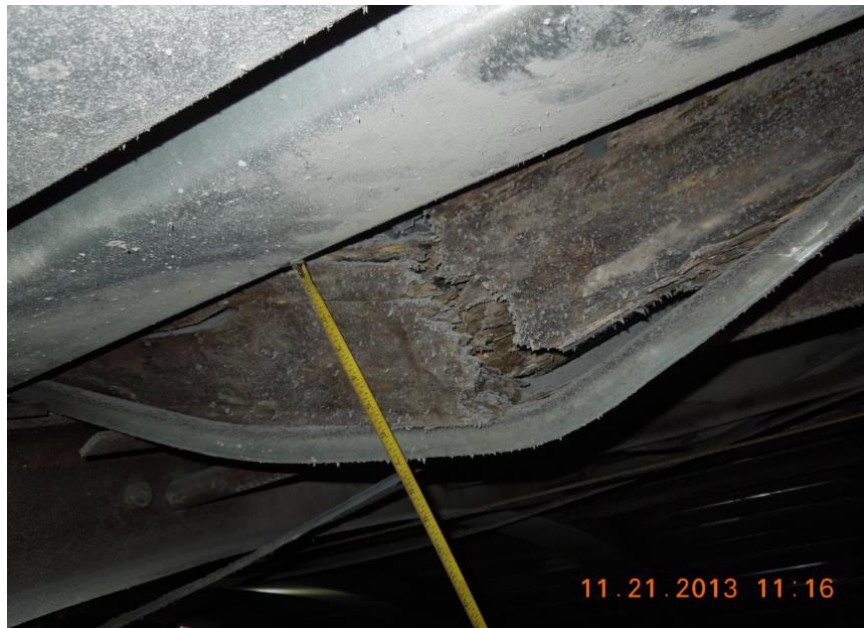
Figure 5.22 - Large lagging deflection (8") due to a pointed impact

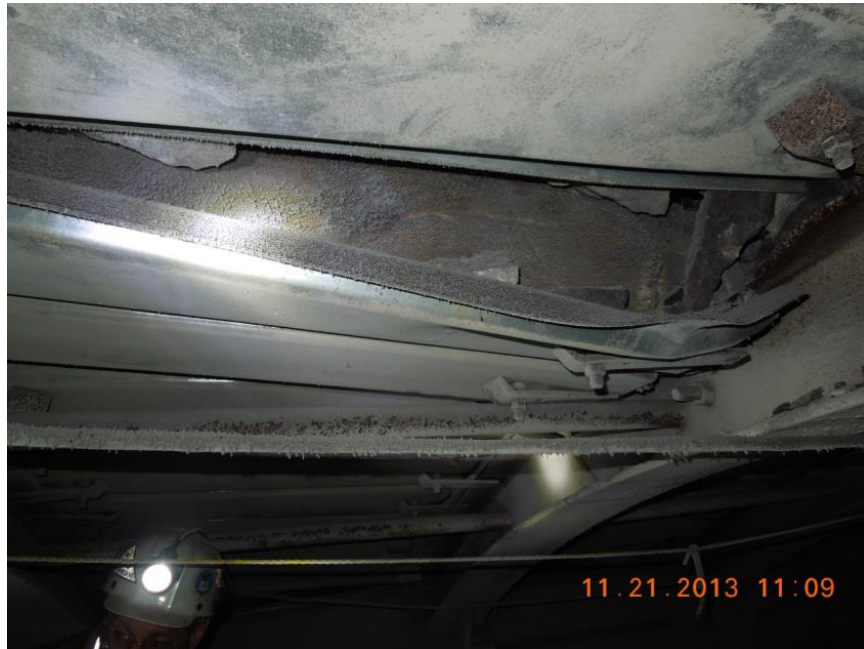
Figure 5.23 - Improperly installed lagging

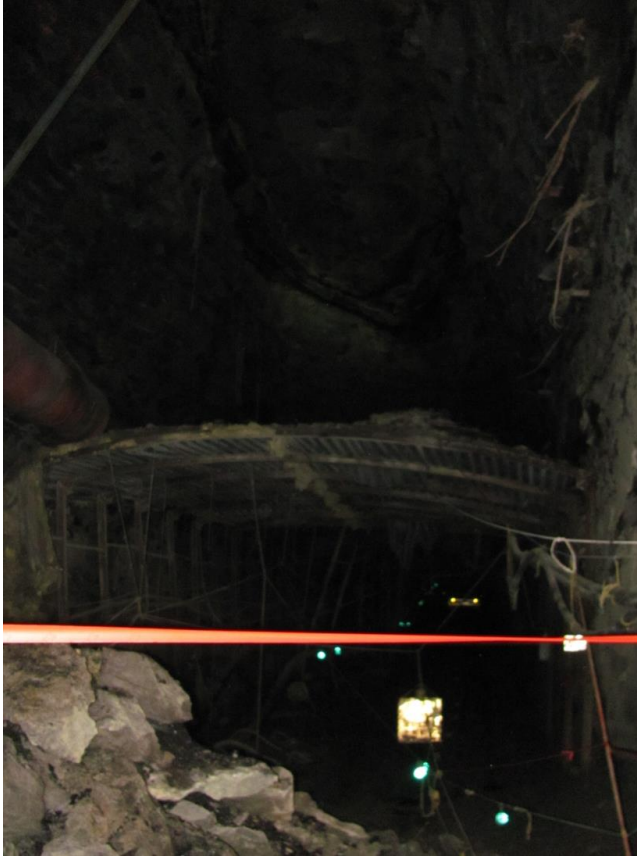
Figure 6.2. Large roof fall cavity

The overburden consists of thinly laminated, weak stack rock, including black shale, coal streaks with boney layers, coal bands, dark gray fireclay, dark gray shale, and interbands. Field investigation indicated that the roof fall was the result of a gradual separation of the laminated dark gray shale from the overlaying gray massive sandstone due to the existence of weak coal bands. The roof fall height was approximately 40 ft (12.2 m). Figure 6.2 depicts the large roof fall cavity.

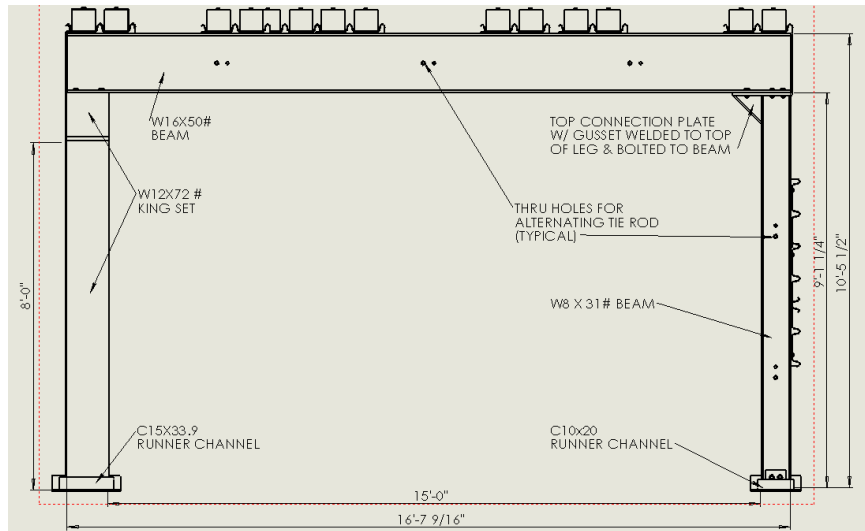
Figure 6.3. 2D engineering drawing – front view

Based on the field evaluation and engineering requirements, the steel canopy must have an inside dimension of 15 ft (4.6 m) wide and 10 ft (3 m) high. The structure has to have enough clearance to enable a rubber tire mine trip car (119 in (3 m) wide x 335 in (8.5 m) long) to pass through into the left travel entry. The structure must be capable of sustaining the impact generated by 1 ft³ (.02 m³) of rock falling from a height of 30 ft (9.14 m). The structure must also be able to support more than 30 ft (9.14 m) of backfill grout. Structural analysis and steel structure design indicate that a steel canopy consisting of seven one-leg square sets (W16 x 50 (W410 x 74) cross-member and W8 x 31 (W200 x 46) leg) and a W12 x 72 (W12 x 107) king beam set will satisfy these requirements. Figure 6.3 shows the two-dimensional engineering drawing showing the front view of the structure. Figure 6.4 shows the three-dimensional view of the entire canopy unit.

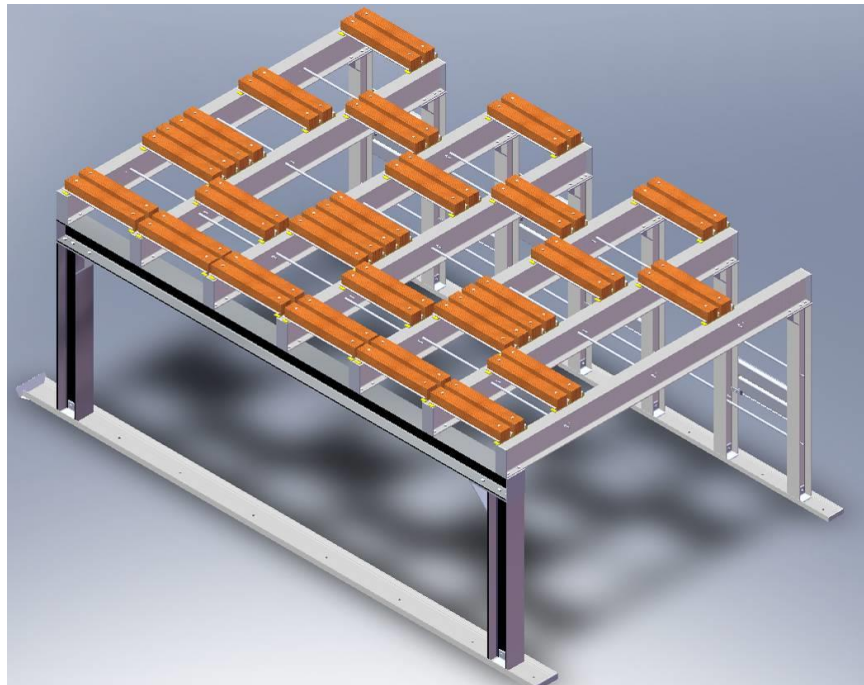
Figure 6.4. 3D view of the canopy set

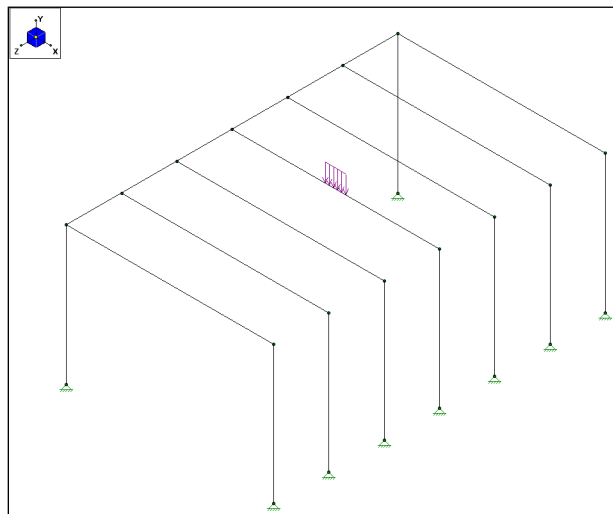
Figure 6.5. Load diagram

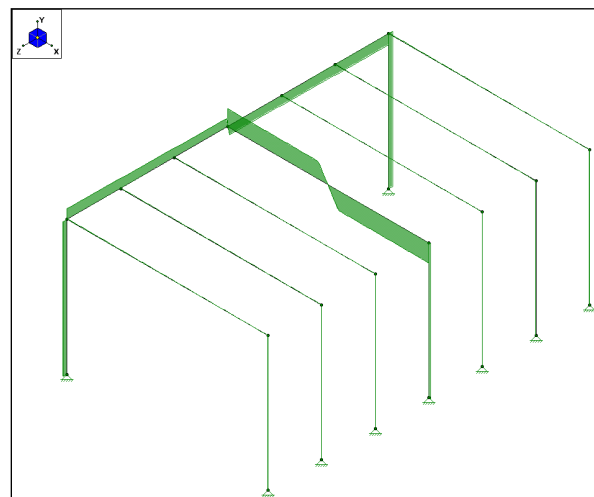
Figure 6.6. Shear stress diagram

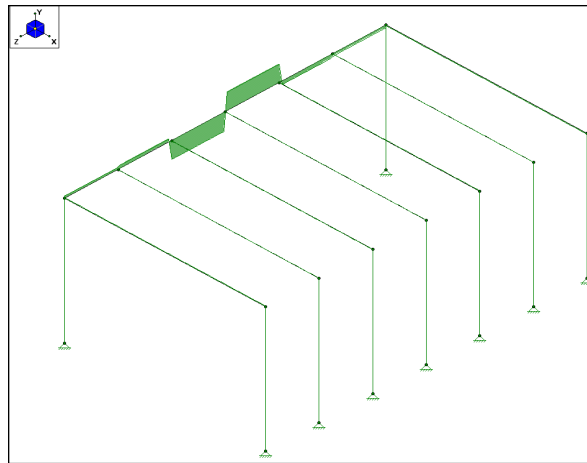
Figure 6.7. Torque diagram

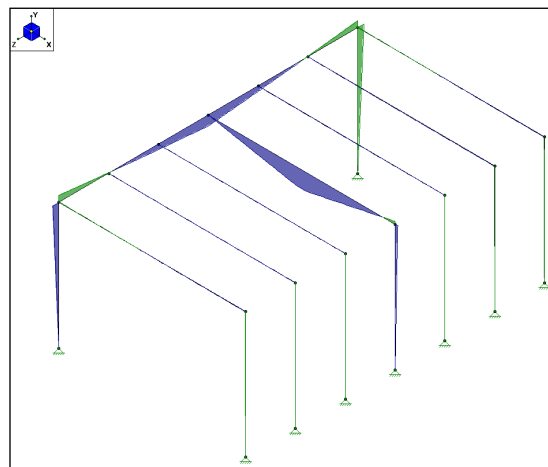
Figure 6.8. Bending moment diagram

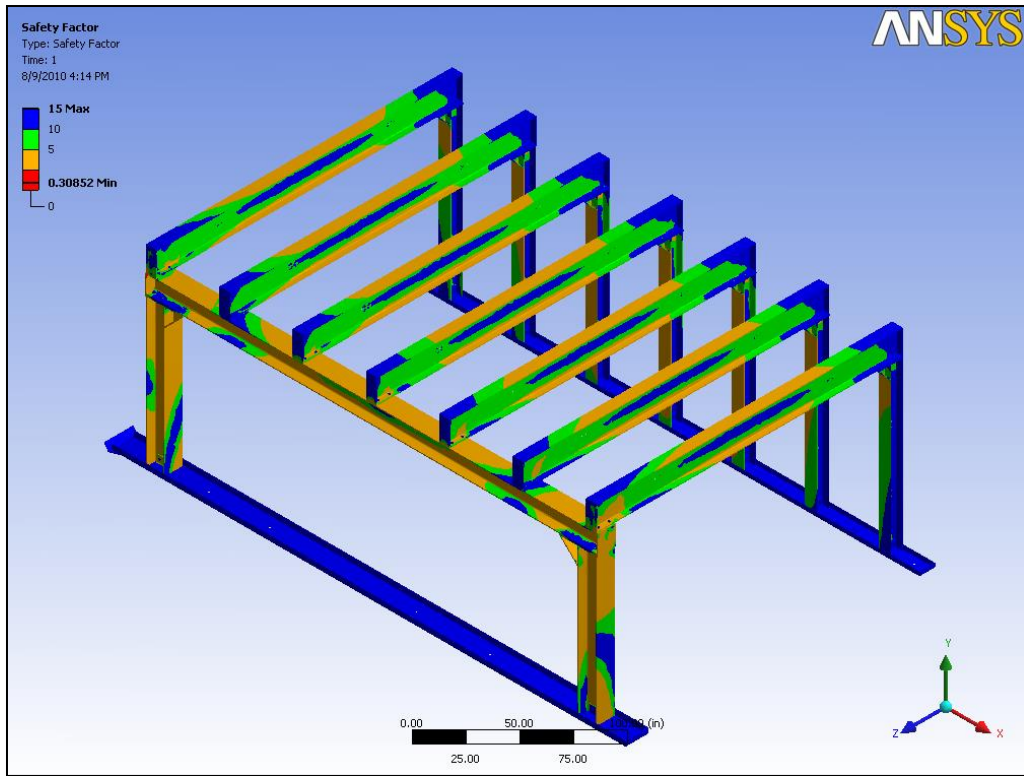
Figure 6.9. Safe factor (static uniform load)

A 3D computer model was developed to evaluate the steel canopy set performance under maximum support capacity loading conditions. Figures 6.9 and 6.10 show the safety factor distribution when the structure is subjected to a static uniform load and dynamic localized impact load, respectively. The structure does not have any apparent major material yielding. Therefore, it is concluded that the steel-set and connections have the expected support capacity.

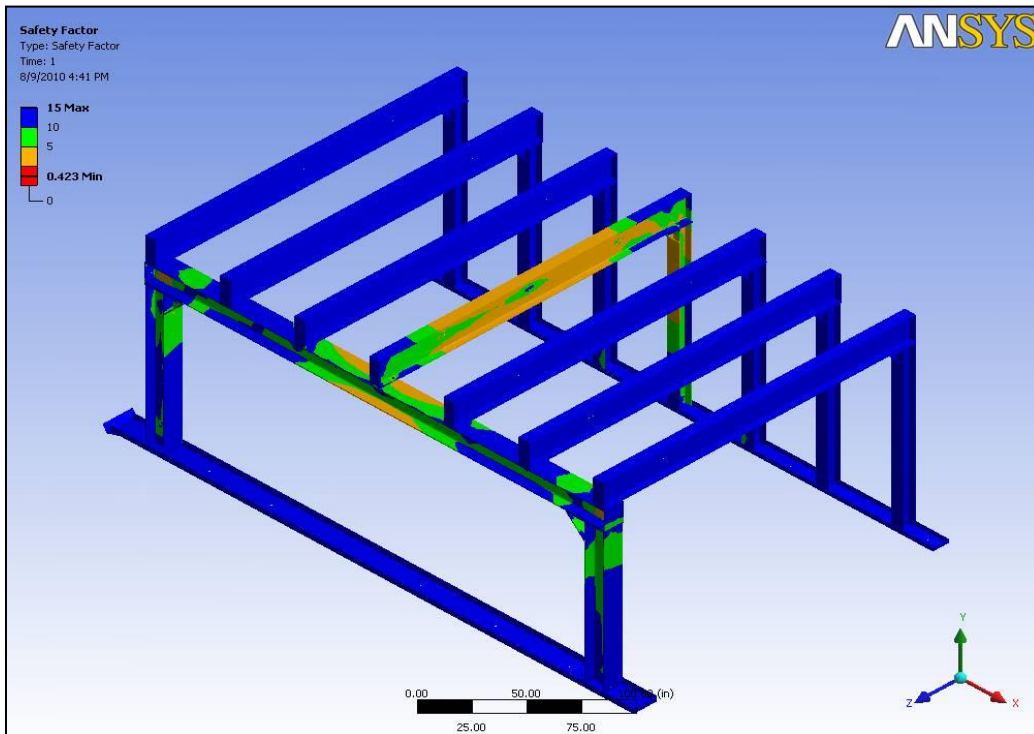
Figure 6.10. Safety factor (dynamic impact load)

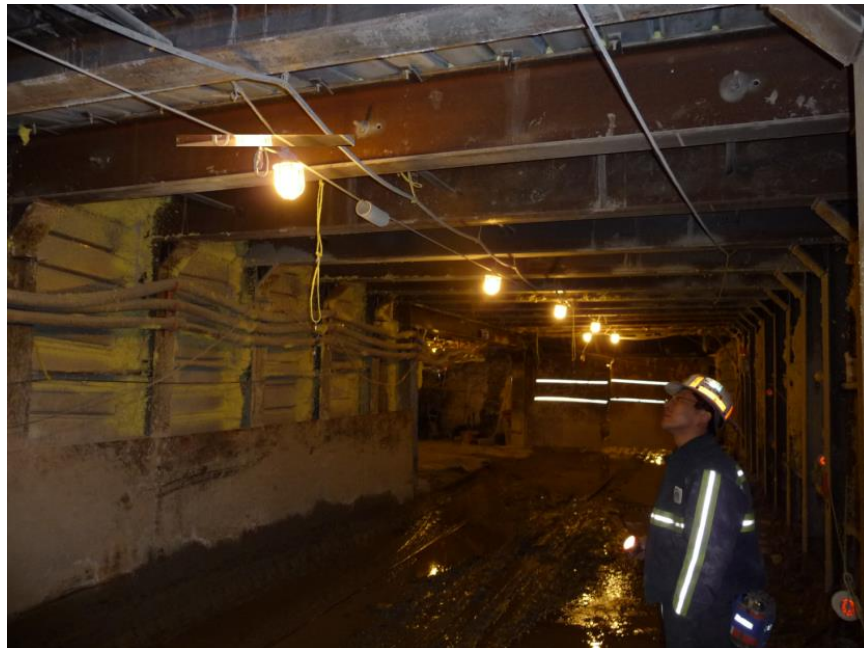
Figure 6.11. Rehabilitated slope bottom

The roof fall rehabilitation plan developed by the mine was based on the designed impact-resistant square set and was reviewed and approved by the MSHA district office. The roof fall area was quickly rehabilitated in a safe manner with no personnel injuries or equipment damage during the process. Figure 6.11 shows the rehabilitated slope bottom. The mine operator commented that the impact-resistant steel-sets gave “peace of mind” to the miners and acted as an important protection canopy. The mine was able to resume operations within a few weeks after the roof fall with no reported problems to date.
