## Understanding Corrosion in Modular Acetabular Tapers: Retrieval Analysis, In Vitro Testing and Cell-Material Interactions

UNDERSTANDING CORROSION IN MODULAR ACETABULAR TAPERS:  
RETRIEVAL ANALYSIS, IN VITRO TESTING AND  
CELL-MATERIAL INTERACTIONS

A Dissertation  
Presented to  
the Graduate School of  
Clemson University

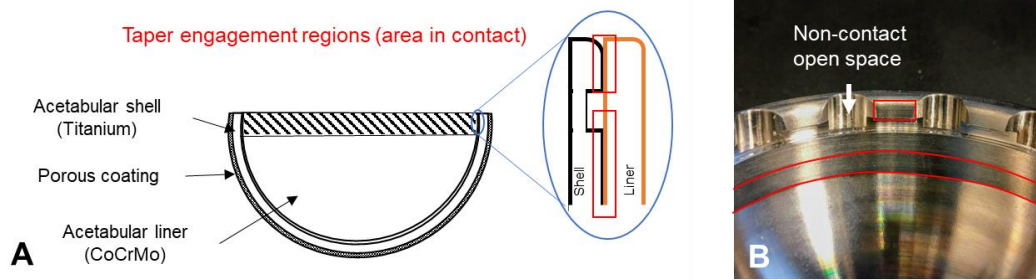
Figure 1: (a) Schematic showing the engagement region formed between an acetabular shell-liner couple (b) Picture showing an acetabular shell taper that could interface with the liners examined here. Note the antirotation tabs and the lower engagement region (marked in red) and the non-contact region between the tabs (white arrow). Figure adapted from Shenoy et al. [13]

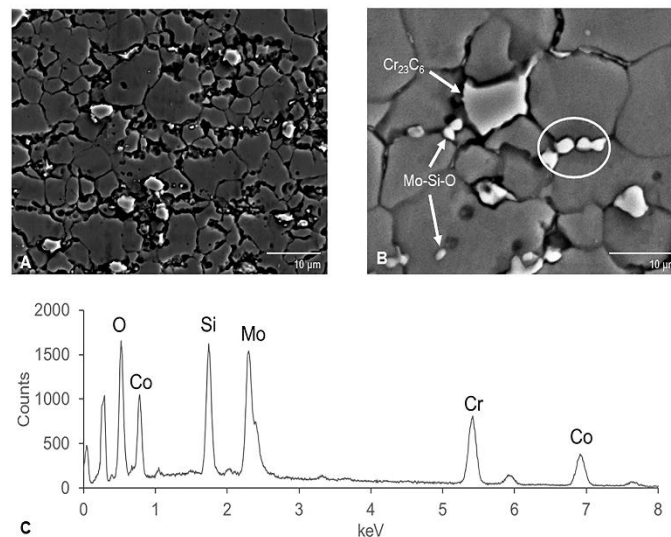
Figure 3: Scanning electron micrographs showing typical microstructure of the wrought CoCrMo alloy. (a) Lower magnification image shows distribution of the secondary phase

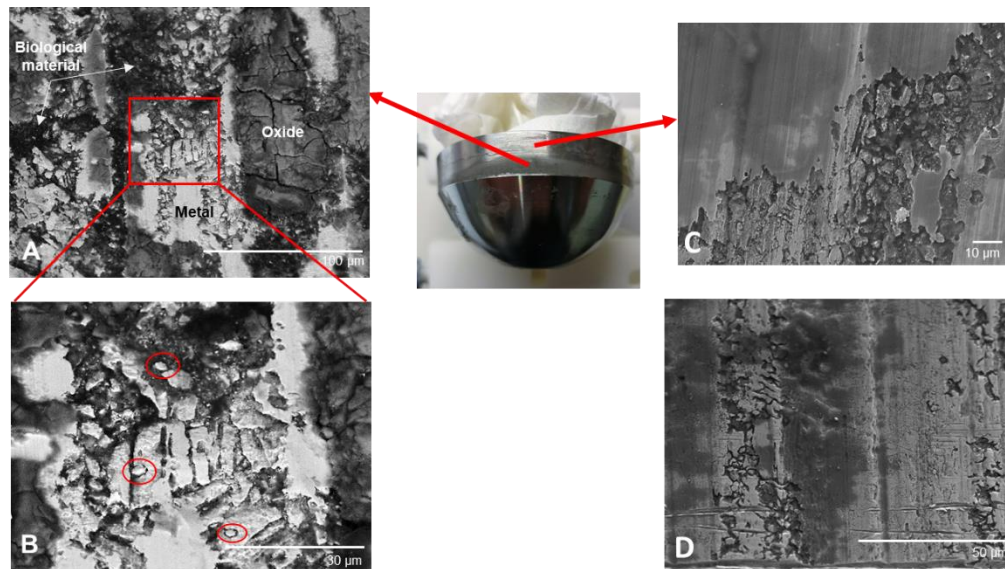
Figure 4: Schematic showing different types of damage seen within the taper region of one sample. Evidence of intergranular corrosion (IGC) clearly visible on the taper surface (a) Backscattered electron image of corrosion damage seen within the engagement region, with biological material (carbon-rich, dark regions), oxide deposits (grey regions) and metal alloy (light grey region) seen side-by-side (b) High magnification image of the area within the red square from (a). Linear etched lines ( $> 10 \mu\text{m}$  length, red arrow) of material loss across multiple grains (red circles,  $\sim 2\text{-}5 \mu\text{m}$  size) can be seen surrounded by nanoscale Mo-Si-O particles. (c) Secondary electron image of IGC observed in the non-engagement region directly above the lower engagement region. Bands of similar IGC were seen moving further upwards from the lower engagement region (d) Evidence of bands of IGC seen in non-engagement region. Scratches seen here are due to disengagement during revision.

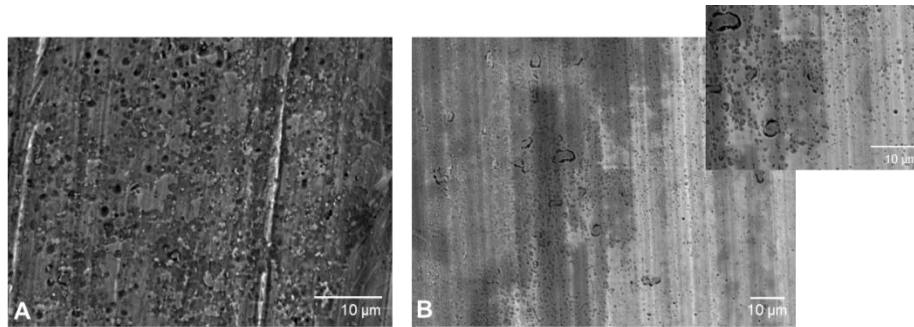
Figure 5: (a) Severe pitting attack, seen in non-engagement region of a sample (secondary mode) (b) Pitting attack in a different sample, overlapping with phase boundary dissolution (notice larger carbides and smaller Mo-Si particles with material loss around their boundaries). Pits are on the same size scale as the Mo-Si-O particles ( $< 2$  microns). Inset shows a higher magnification micrograph.

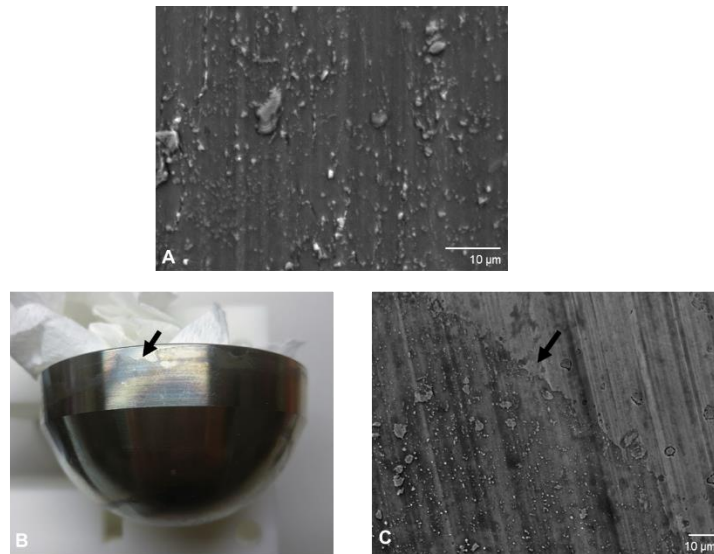
Figure 6: (a) Mo-Si particles and carbides (hard phases) are arranged along the grain boundaries in a linear orientation and have been exposed by material loss from the surface (b) Retrieved liner with discolored region extending outside the engagement region (black arrow) (c) Secondary mode SEM image of the area marked by the black arrow showing phase boundary dissolution in the discolored area, and a less severe form outside the discolored area.

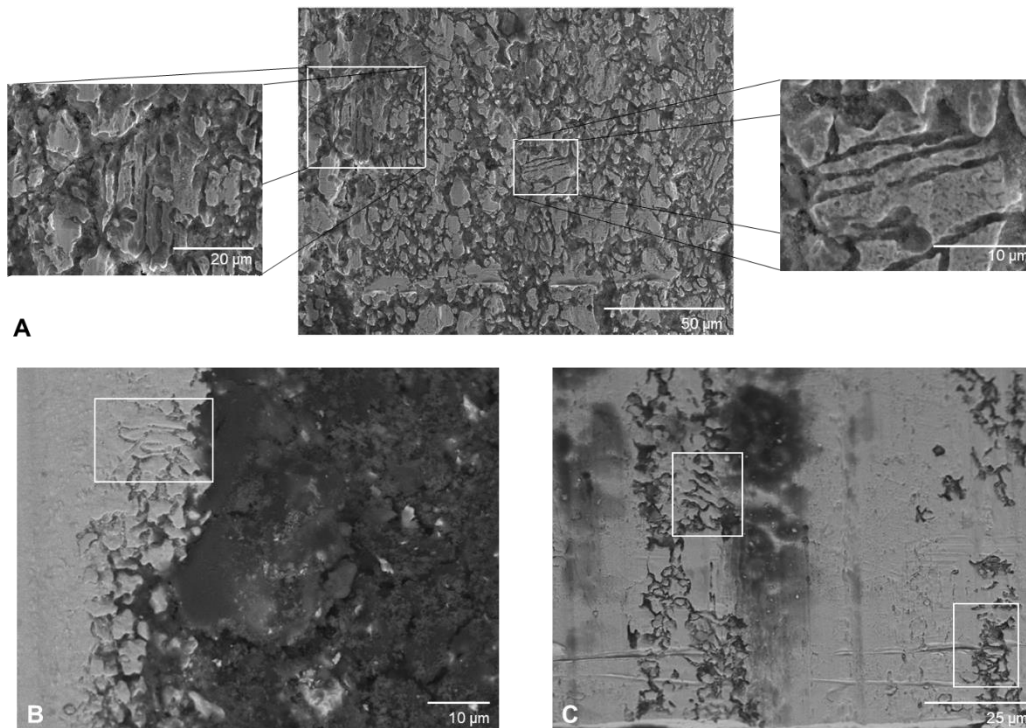
Figure 7: (a) Transgranular corrosion lines in a single sample, within a region of intergranular corrosion. Higher magnification insets show specific regions in close-up, displaying the parallel lines traversing multiple grains (~2-10 microns in size). Note the differences in orientation between the two etch-corrosion regions shown here, which eliminates the possibility of these lines being mechanically caused. (b) & (c) Backscattered electron micrographs of a sample showing early stages of intergranular

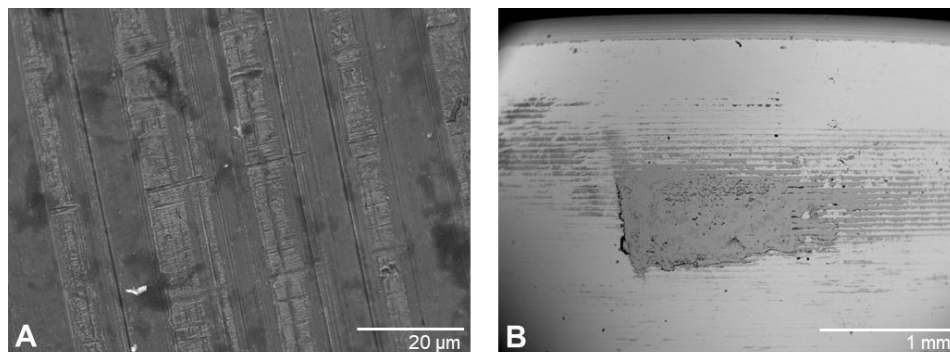
Figure 8: (a) Fretting scars seen in an examined sample. Actual contact area is minimal, and the abrasion did not lead to severe corrosion. (b) A backscatter electron micrograph

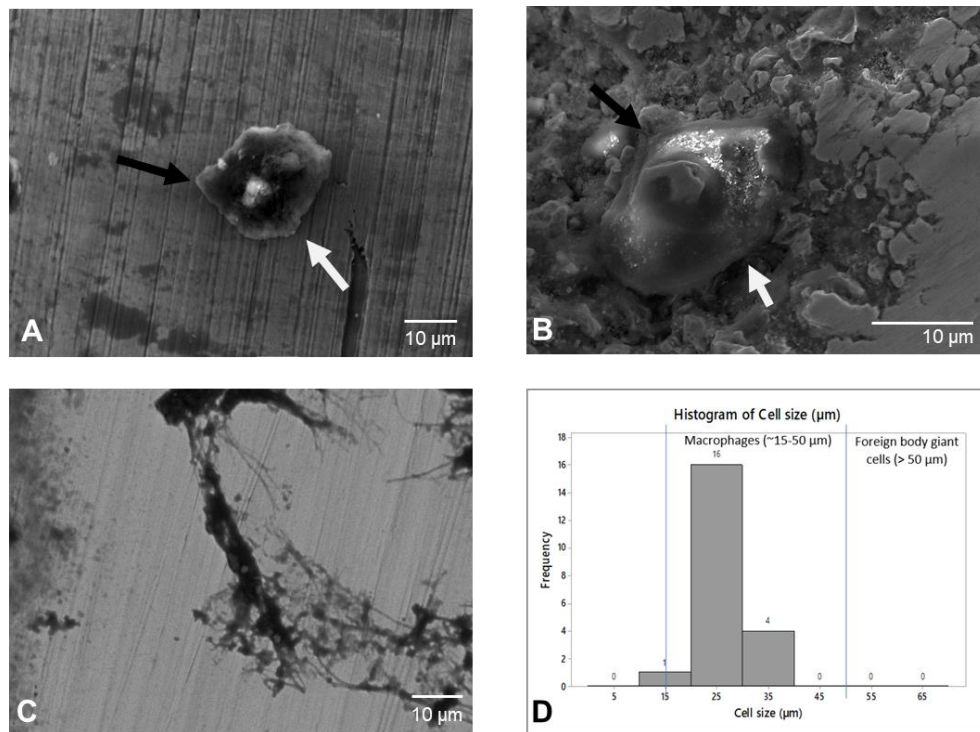
Figure 9: (a) Secondary electron image of a single cell-like feature with characteristic morphology, with an angular edge (black arrow), and a fluttered edge (white arrow) seen in similar features across all samples (b) Secondary electron image of another such biological feature with similar morphology seen within a severely corroded part of the

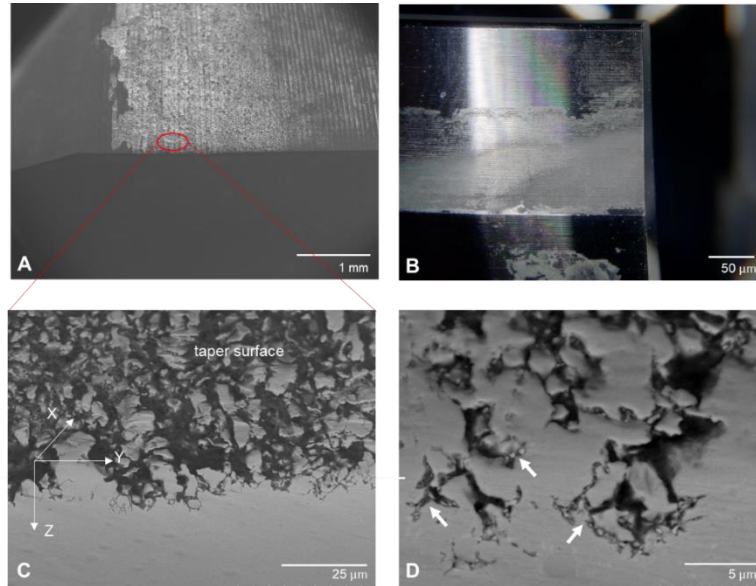
Figure 10: (a) Low magnification secondary electron image of the sectioned liner showing macroscale IGC on the taper surface. (b) Photograph of the sectioned liner showing grey burnished area (rotated 90 degrees anticlockwise from (a)) (c) High magnification backscattered electron image of the area marked in red from 10a. White line denotes the section edge. Note the biological material (dark regions) embedded within the IGC damage on the taper surface and penetrating into the bulk. (d) High magnification backscattered image showing the sectioned surface. The channels are formed by penetrating corrosion damage, and contain biological matter as well as Mo-Si-O particles (white arrows)

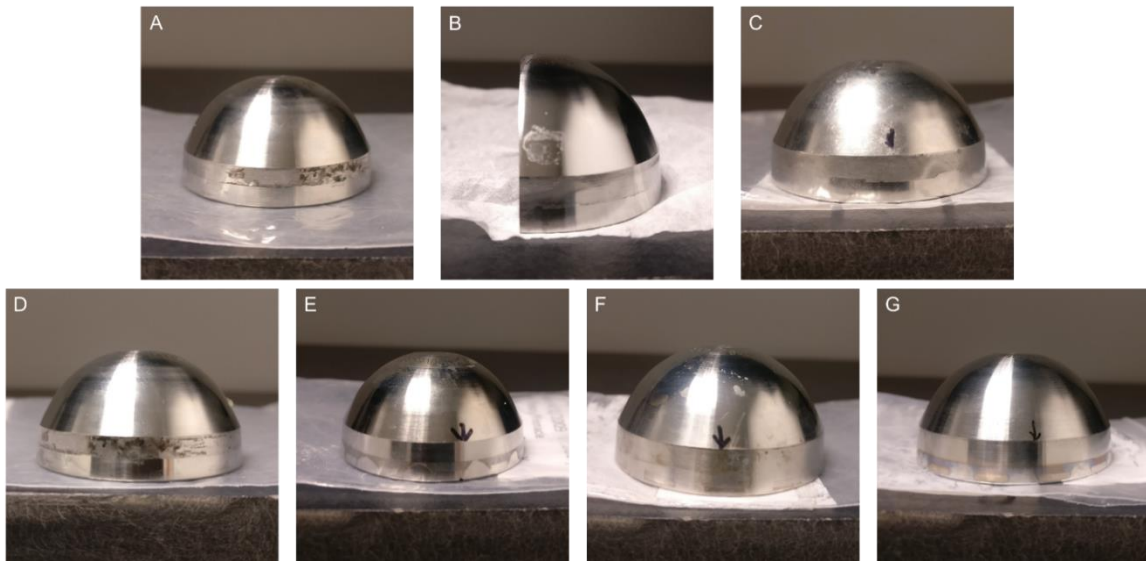
Figure 1: Test samples for: (A) IGC1 (grey burnished region visible in lower taper engagement region) (B) IGC2 (grey burnished area close to the edge of the sectioning plane in the lower taper engagement region) (C) IGC3 (grey burnished region visible in lower taper engagement region) (D) Oxides (dark deposits visible in the lower taper engagement region) (E) PBC1 (curved edge of the discolored region in the upper taper region) (F) PBC2 (brownish deposits in the lower taper engagement region) (G) PBC3 (curved edge of the discolored region in the upper taper region)

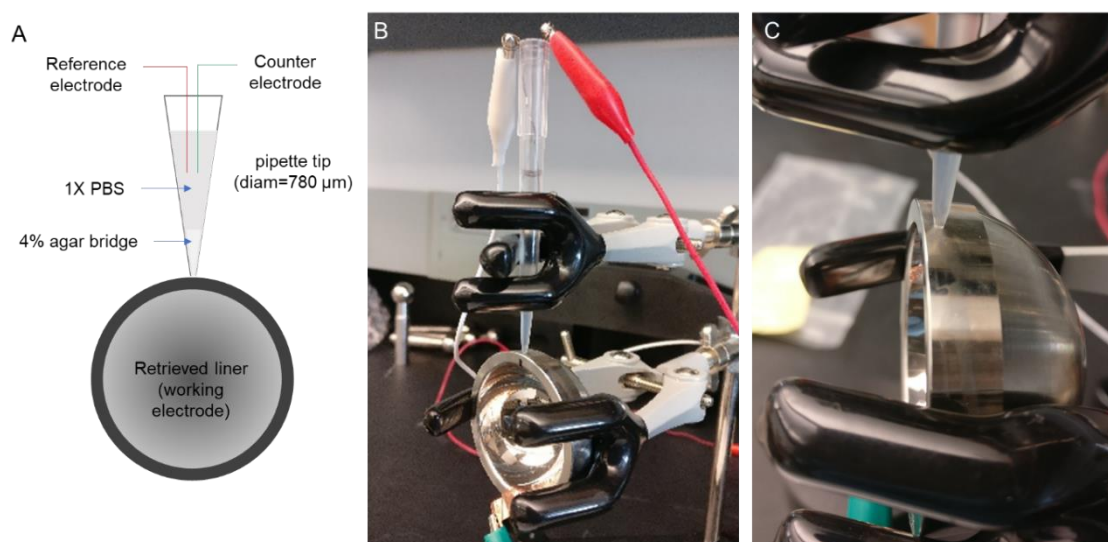
Figure 2: (A) Schematic for test setup featuring the microelectrode for the NEIS measurement, with 4% agar bridge (B) Photograph of the actual setup with a sample (C) Close-up of the device surface-tip interface showing that the surrounding area remained dry, and the only region acting as working electrode is the region directly corresponding to the tip area.

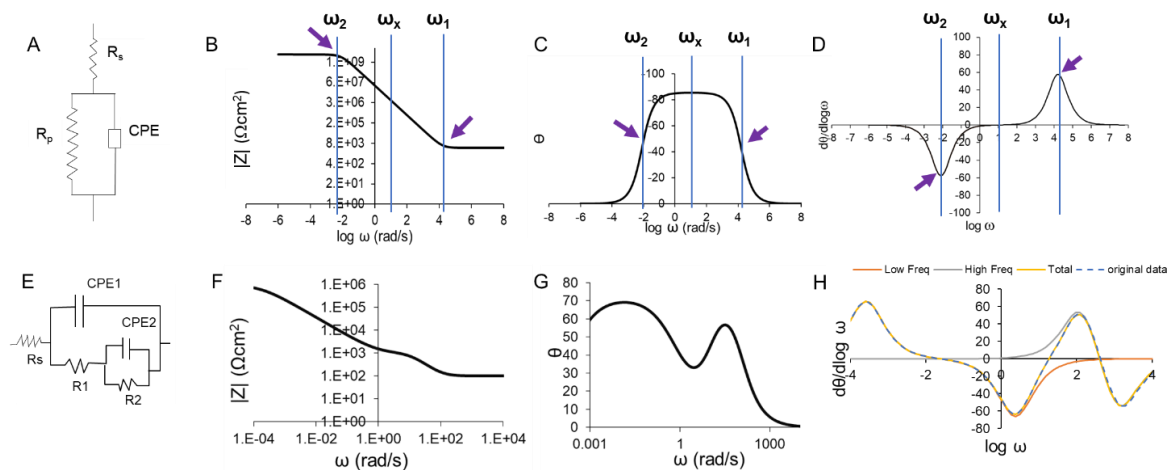
Figure 3: (A) Randle's circuit with constant phase element (CPE) in place of capacitor (Bode plot for a Randle's circuit response for  $\log |Z|$ , indicative of characteristic frequencies three characteristic frequencies marked on the figure ( $\omega_1$ ,  $\omega_x$ ,  $\omega_2$ )).  $\omega_1$  and  $\omega_2$

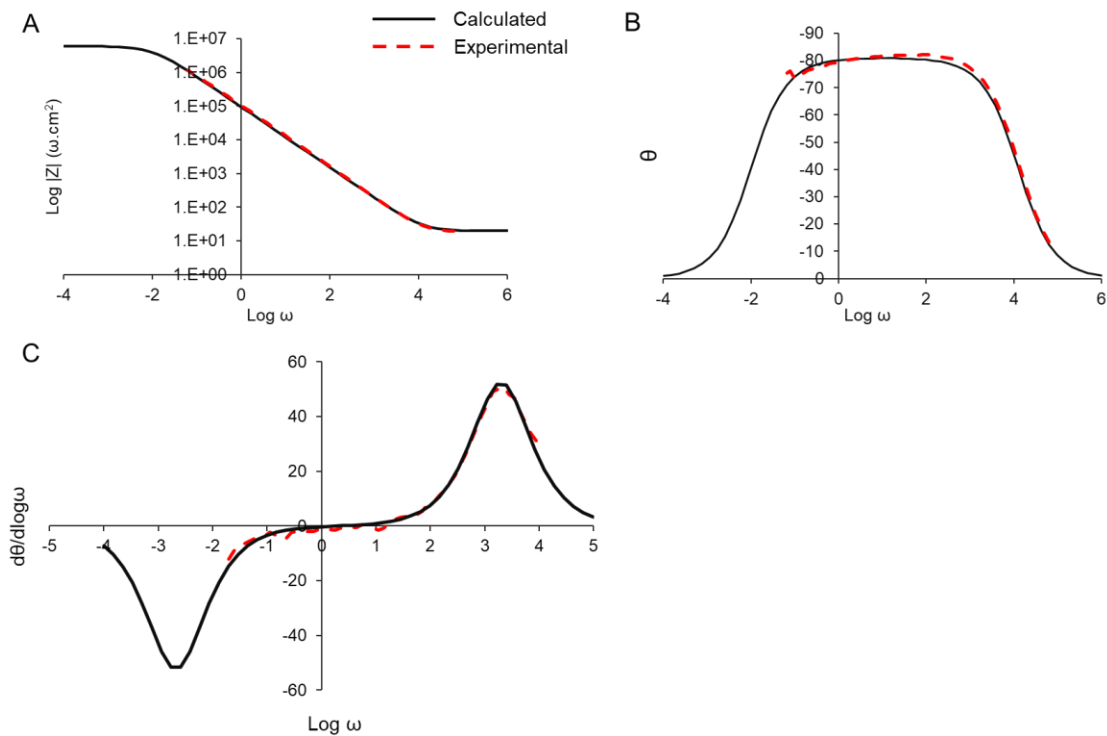
Figure 4: (A) Bode plot showing  $|Z|$  vs log frequency for a polished CoCrMo disk surface (B) Bode plot showing phase angle,  $\theta$ , plotted against log frequency (C) Derivative of phase angle,  $\theta$ , against log frequency ( $d\theta/d\log \omega$ ), showing the symmetry of the phase angle response with respect to the crossover frequency ( $\omega_x$ ), which in this case equals to 0.3 approximately on the X axis (D) Calculated values for Q,  $R_p$ ,  $R_s$  and  $\alpha$  for this experiment

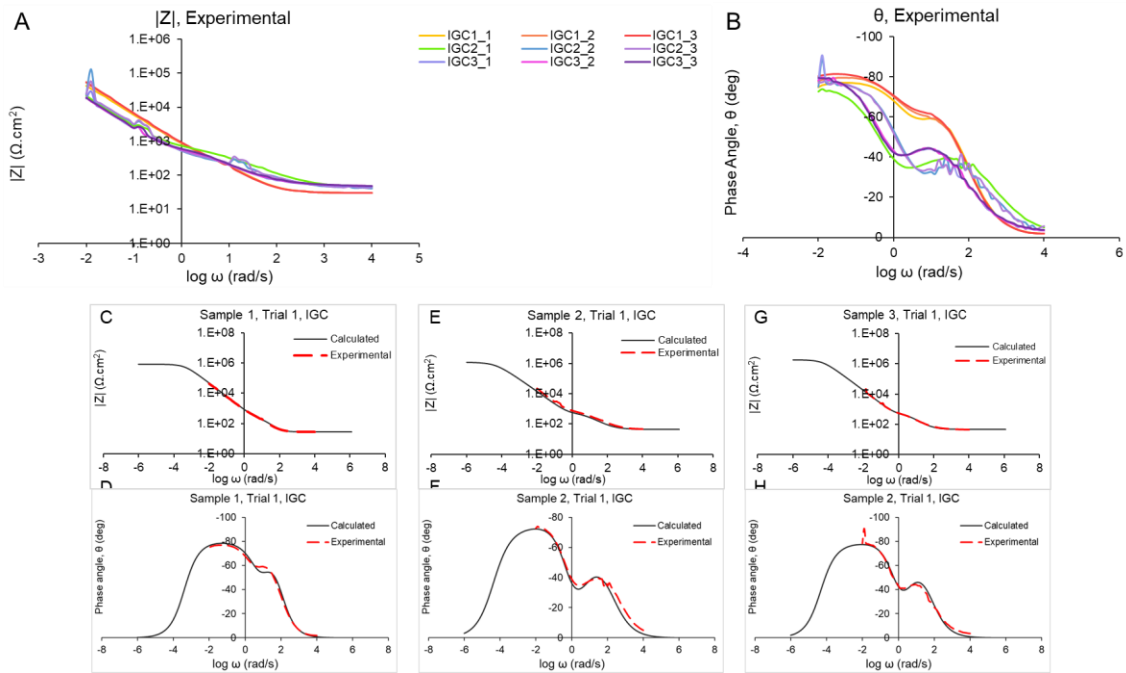
Figure 5: (A) Experimental  $|Z|$  Bode plots for all IGC samples, three trials each. Note the subtle differences in shape, IGC1 plots with a slight plateau mid-slope; IGC2 rising above IGC1 with the plateau mid-slope; IGC3 with a lower slope and prolonged high frequency elbow region (B) Experimental phase angle Bode plots showing pronounced differences among IGC samples: IGC1 with higher initial plateau; IGC2 with the lowest initial plateau and slightly wider phase angle plots; IGC3 with intermediate behavior between IGC1 and IGC3 (c-h) Individual Bode plots of calculated and experimental  $|Z|$  and  $\theta$  for one trial for each IGC sample displaying accuracy of the model used

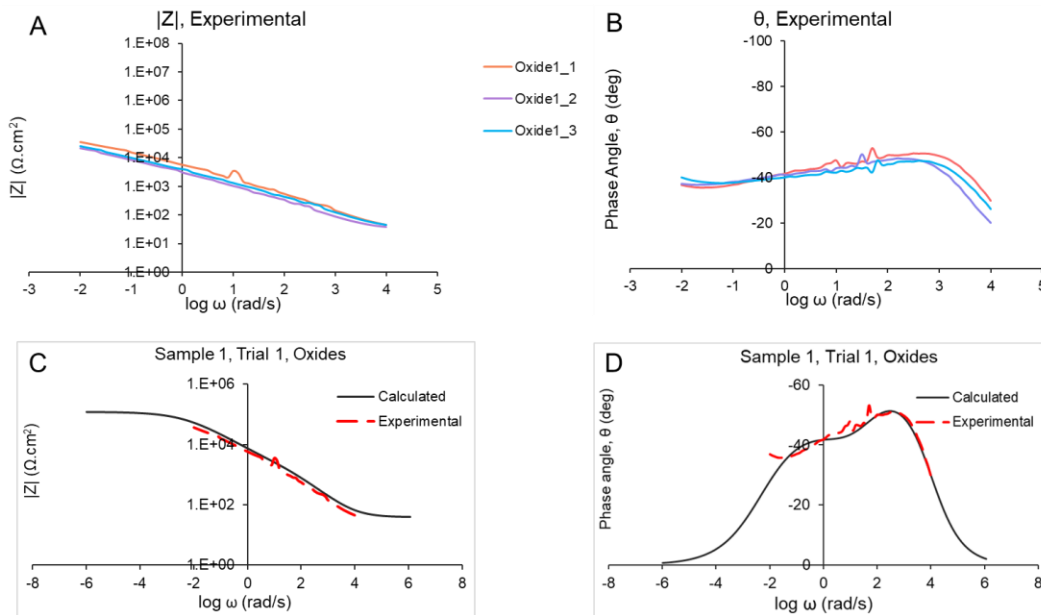
Figure 6: (A) Experimental  $|Z|$  Bode plots for oxide deposits sample. Note the almost absent initial plateau at high frequency and the curved shape of the plots (B) Experimental  $\theta$ , phase angle Bode plots showing the double plateau shape, which differs

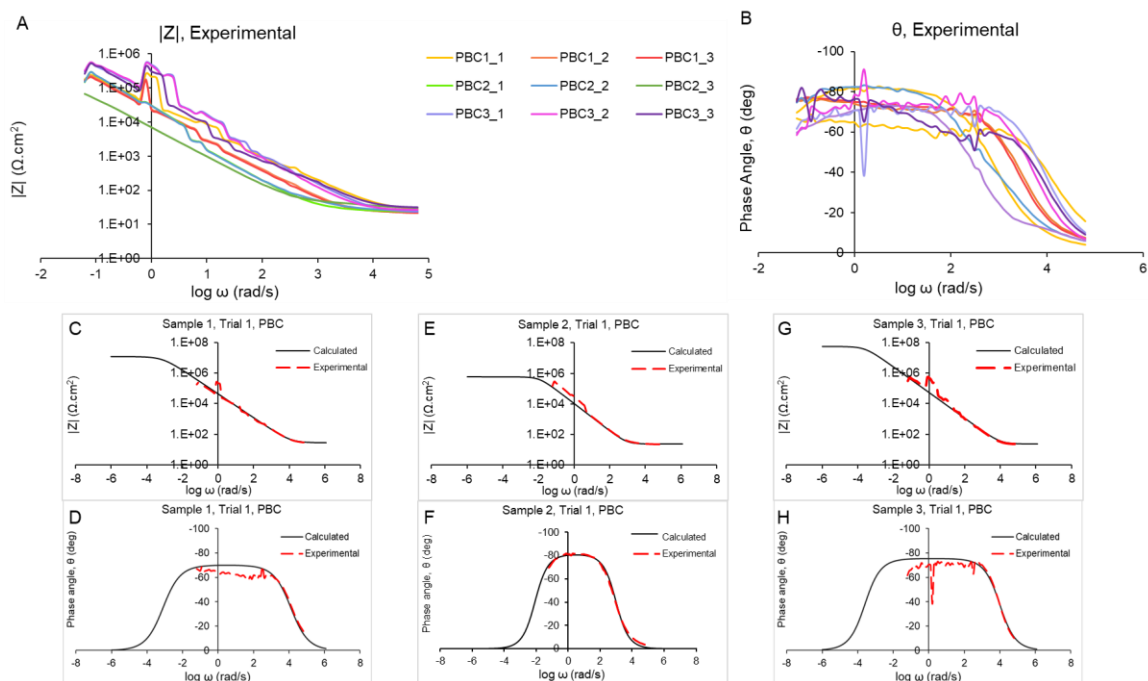
Figure 7: (A) Experimental Log  $|Z|$  Bode plots for all PBC samples, three trials each. Note the shift in the high frequency elbow region while the slopes remain more or less equal (B) Experimental phase angle Bode plots with a generally single plateau shape with differences in width and height (c-h) Individual Bode plots of calculated and experimental Log  $|Z|$  and  $\theta$  for one trial for each PBC sample displaying accuracy of the CPE-Randle's circuit model used.

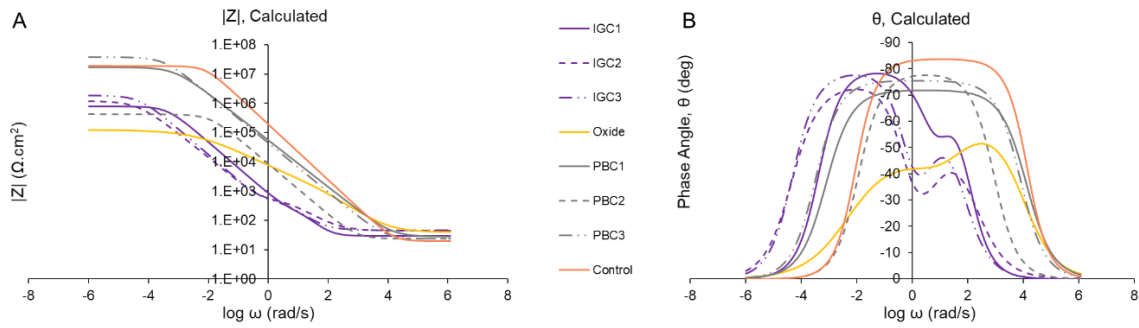
Figure 8: Calculated (A)  $|Z|$  and (B)  $\theta$  Bode plots, one trial from each sample of IGC, oxides and PBC, respectively. Note the differences in shape with each corrosion type having consistent and distinct impedance responses, with PBC exhibiting behavior close to a pristine CoCrMo surface but with lower slope in  $|Z|$  and phase angle maximum, IGC and oxides showing the double plateau coated model behavior, while remaining distinct from one another.

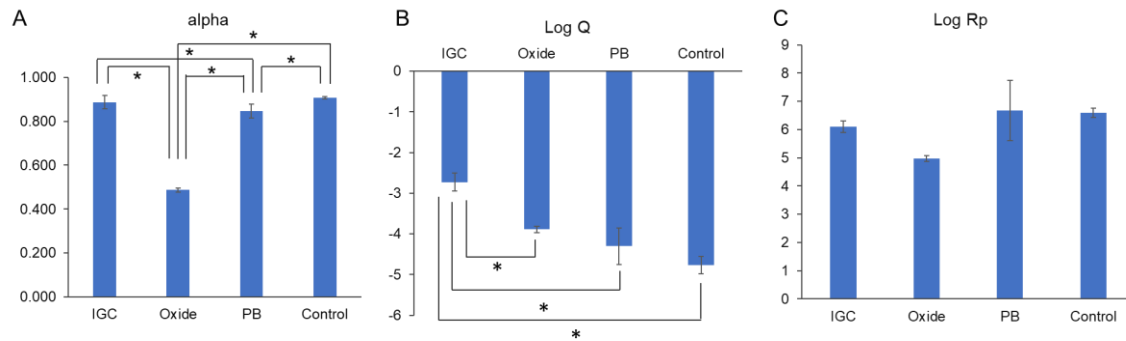
Figure 9: (A) Average  $\alpha$  across the three damage modes, with IGC and PBC displaying comparable values (confirmed by Tukey's post-hoc analysis) and oxides showing lower value ( $p < 0.05$ ) (B) Average Q across the three damage modes, with PBC exhibiting highest value, and IGC the lowest ( $p < 0.05$ ) (C) Average R across three damage modes, with PBC exhibiting the highest R and oxides showing the lowest ( $p > 0.05$ ). Asterisk represents statistically significant difference between indicated groups

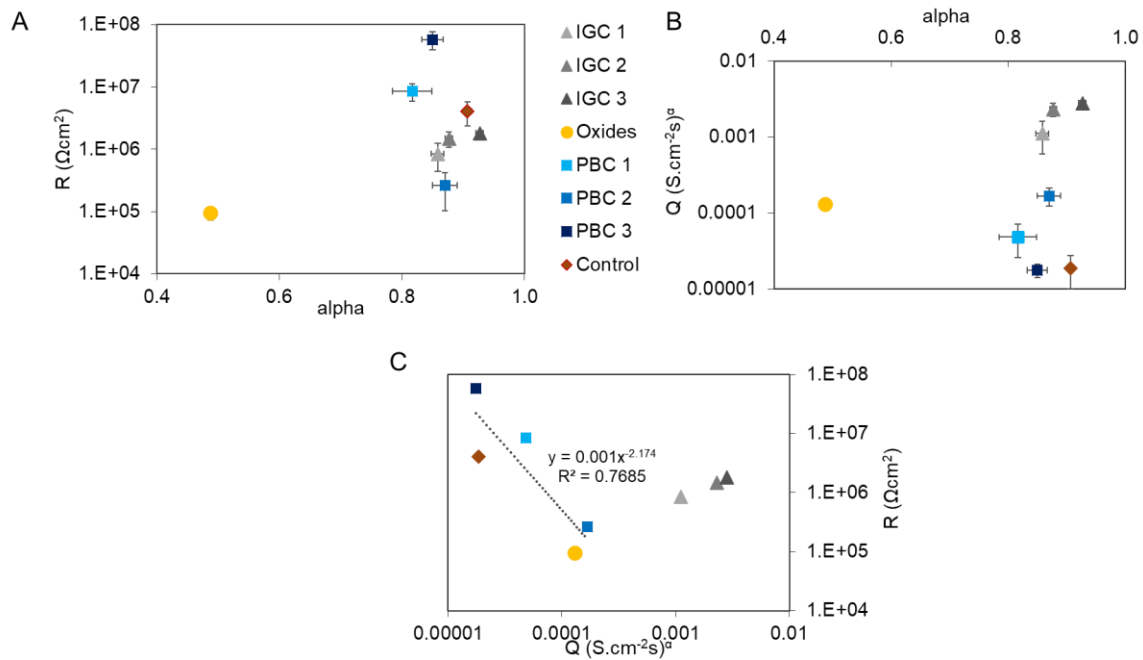
Figure 10: (A) Average R vs  $\alpha$  where oxides exhibit lowest R and  $\alpha$  values. PBC has the highest R values, with PBC2 lower than IGC samples (B) Average Q vs  $\alpha$  showing that the different types of surface damage separate themselves according to the surface features. Note that PBC2 is intermediate between IGC and other PBC samples, which are clustered with the control sample (C) Average R vs Q showing oxides have the lowest R and Q compared to PBC and IGC samples. Axes have been adjusted to illustrate differences among individual samples and error bars indicate standard deviation (n=3 for IGC and PBC and n=1 for oxide and control)

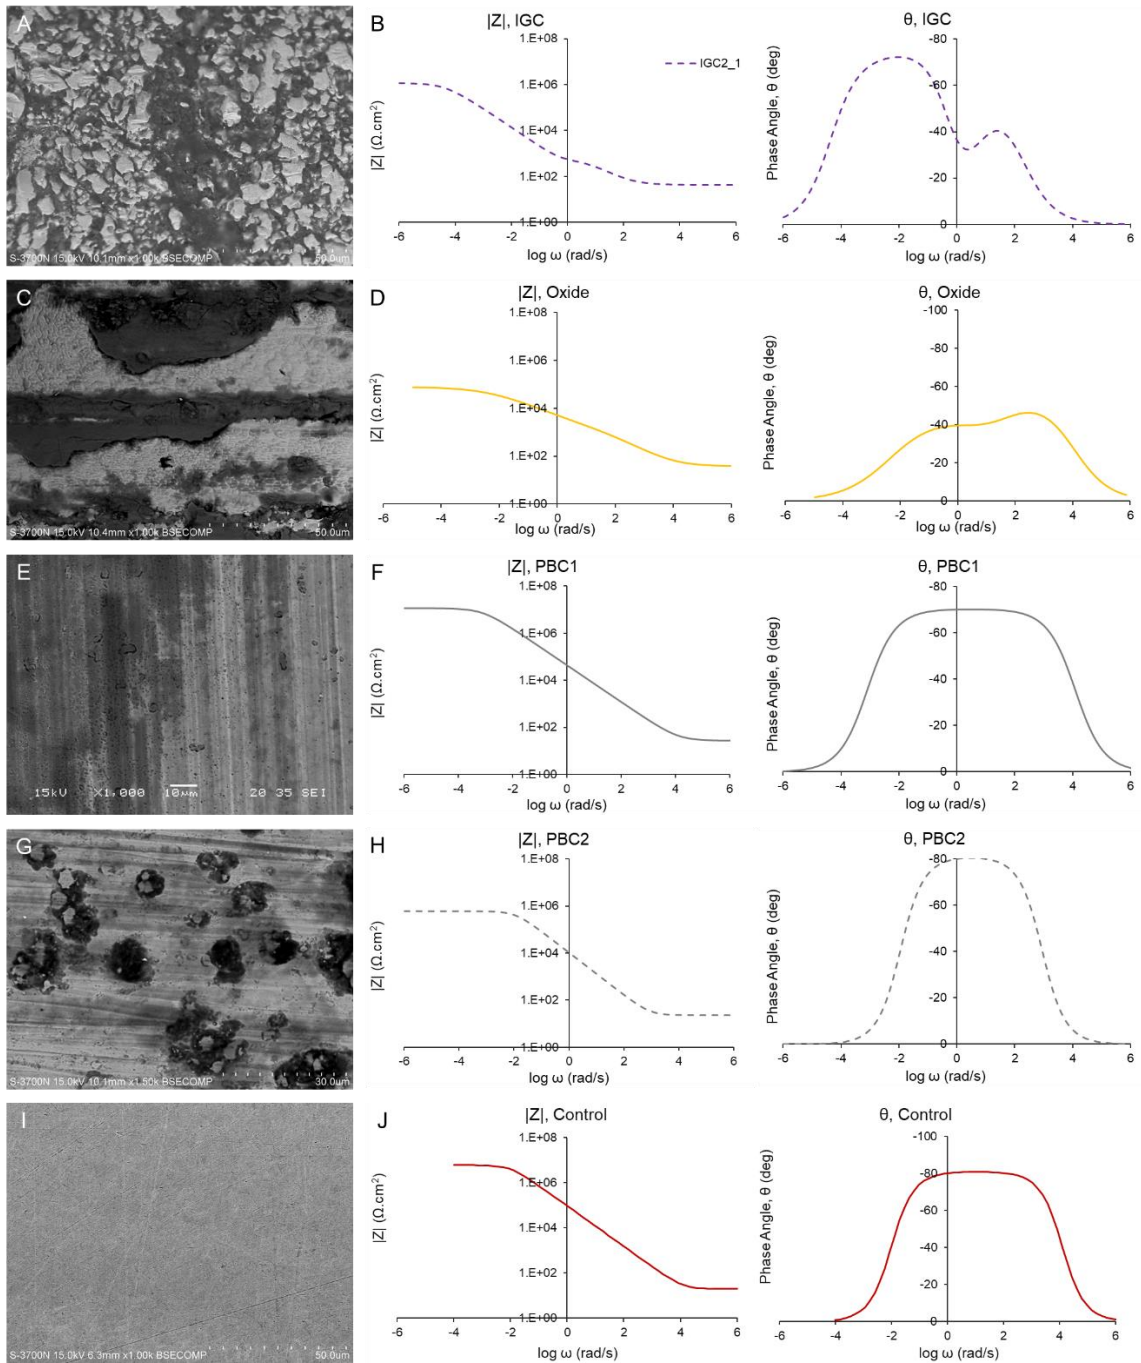
Figure 11: (A) Backscattered electron micrograph of IGC test surface. Note the extensive material loss and presence of biological material (dark contrast region) (B) Bode plots for  $\log |Z|$  and theta vs log frequency for IGC region shown in (A). The double hump in theta corresponds to the change in slope in  $|Z|$ , which denote a compromised surface with

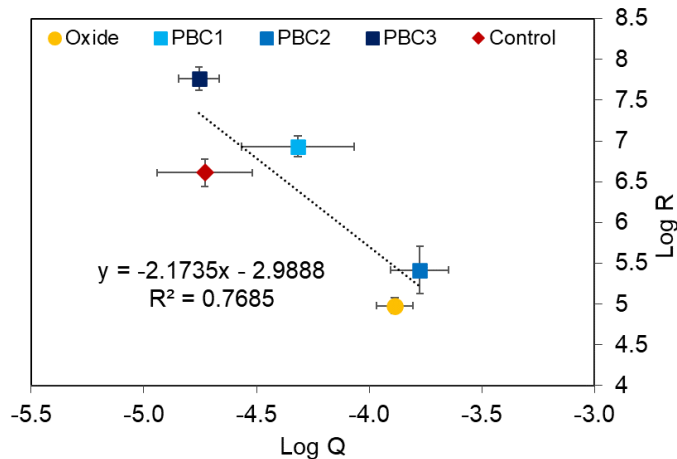
Figure 12: Log  $R_p$  vs Log  $Q$  plot showing linear correlation between the  $R_p$  and  $Q$  values for PBC, oxide deposits and control surfaces

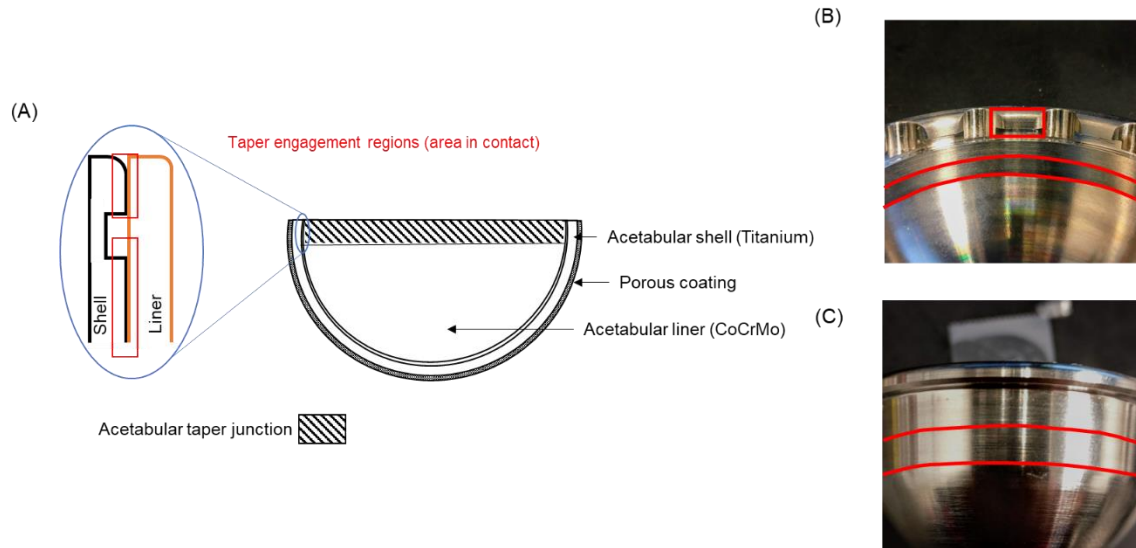
Figure 1: (A) Schematic showing the acetabular shell-liner junction with (inset) showing the actual geometry in the taper and the distinct areas of contact. (B) Titanium shell taper junction with the tabs and cylindrical engagement region in red (C) CoCrMo liner taper with the lower engagement region in red.

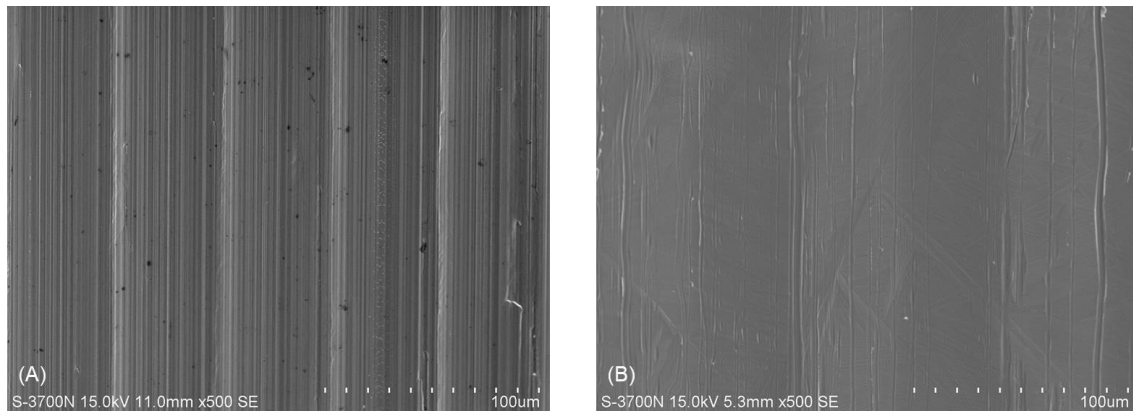
Figure 2: Scanning electron micrographs showing (a) the liner taper surface and (b) the shell taper surface. Note the ridges seen in the liner taper, spaced about 40  $\mu\text{m}$  apart. The height of these ridges was under 5  $\mu\text{m}$  (not shown), showing a low roughness surface. The shell taper has a ground surface finish, which appears as a mostly flat topography.

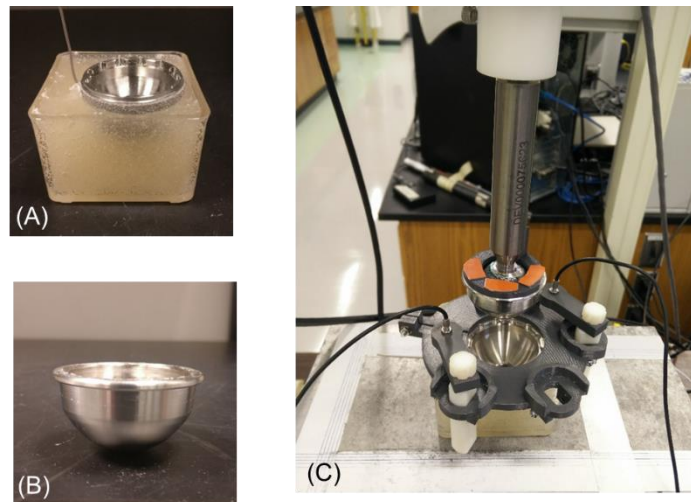
Figure 3: (a) Potted titanium shell with a titanium wire for electrical connectivity (b) Metal liner (full-lipped design) (c) Experimental setup for displacement measurement during assembly of the shell-liner construct. The orange parts correspond to the aluminum targets for the non-contact DVRTs which are threaded into the grey arms on the ring.

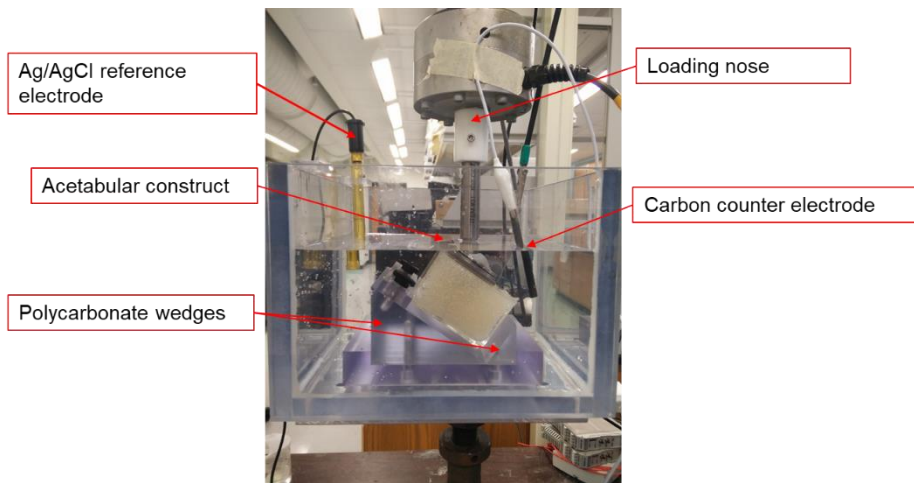
Figure 4: Experimental setup showing the three-electrode system for the short-term ICFC test with the construct held at a joint-force-cup-orientation angle of  $55^\circ$ . This reflects at  $45^\circ$  physiological inclination angle and a joint force orientation of  $10^\circ$ . The loading nose was electrically isolated from the acetabular components and it applied the cyclic load according to the program executed by Instron WaveMatrix software.

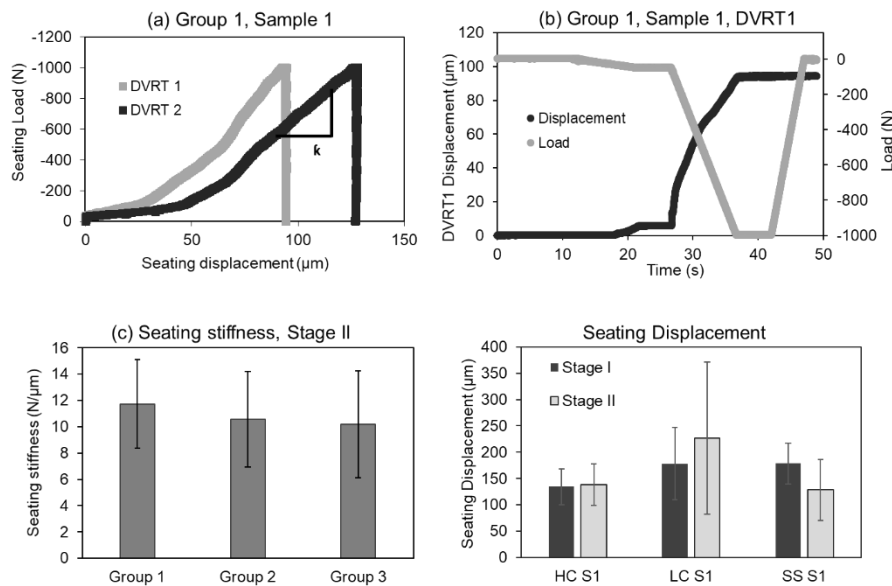
Figure 5: Representative plots of (a) seating load (N) vs seating displacement ( $\mu\text{m}$ ) (b) seating displacement ( $\mu\text{m}$ ) and seating load (N) vs time for DVRT1 data. Note the correlation between applied load and measured displacement. (c) Seating stiffness ( $\text{N}/\mu\text{m}$ ),  $k$ , across all three groups shows no significant difference with material combination ( $p > 0.05$ ,  $n = 5$ ). (d) Summary of the average seating displacement for each group.

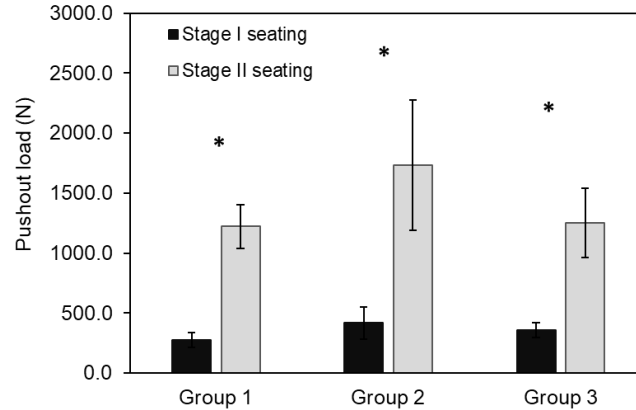
Figure 6: Average push-out load, for Stage I and II testing. No significant difference across groups ( $p > 0.05$ ,  $n = 5$ ). The asterisk denotes statistically significant difference between Stage I & II push-out loads ( $p < 0.05$ ).

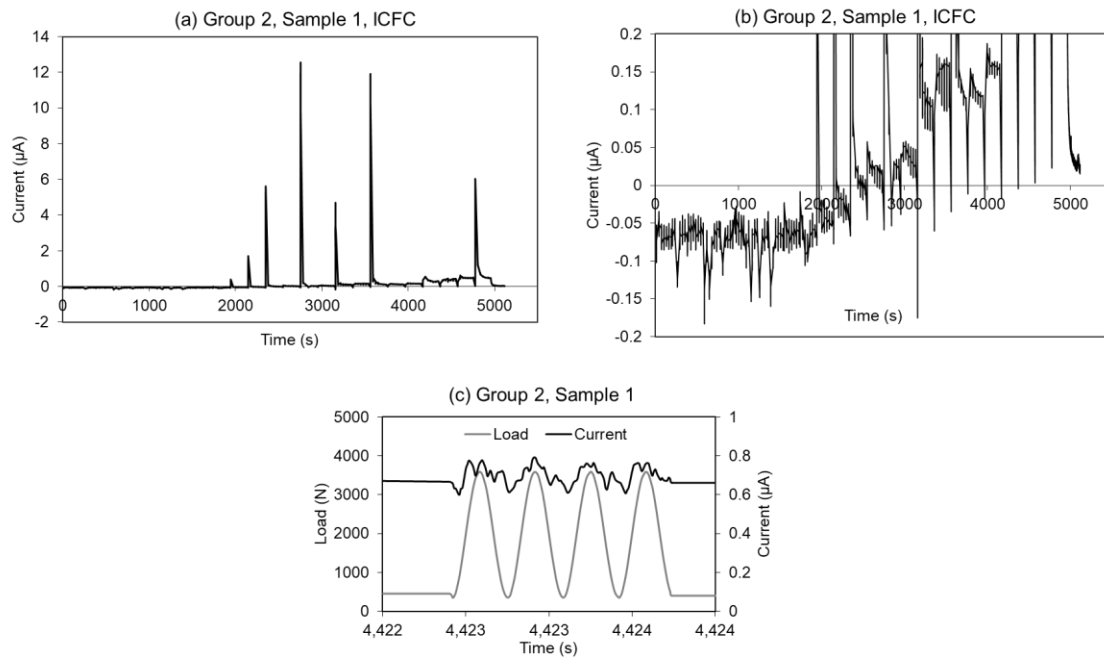
Figure 7: Plots showing raw data for (a) raw fretting current data in its entirety showing high current transients (b) fretting current ( $\mu\text{A}$ ) over the entire test duration with the vertical axis expanded to show the fretting current response, and (c) fretting current ( $\mu\text{A}$ ) and load applied (N) over 1 second, for Group 1, Sample 1, Stage I seating. Each upward spike in (a) denotes the start of a fretting cycle with a large current transient and quick recovery soon after. The more steady-state current measurements can be seen in (b). Note the correlation of current over time with the loading and unloading cycles, indicating a biphasic relationship between current and load applied.

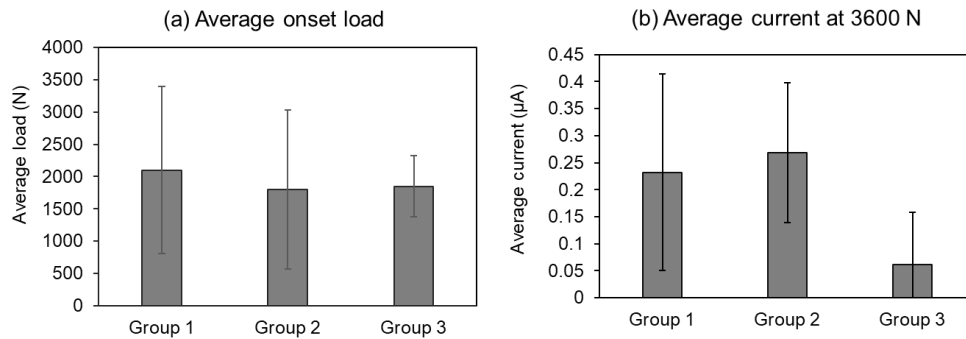
Figure 8: (a) Average onset load (N) for each material group. (b) Average current at 3600 N across all three groups tested ( $n = 5$ ). There were no statistically significant differences between groups seen.

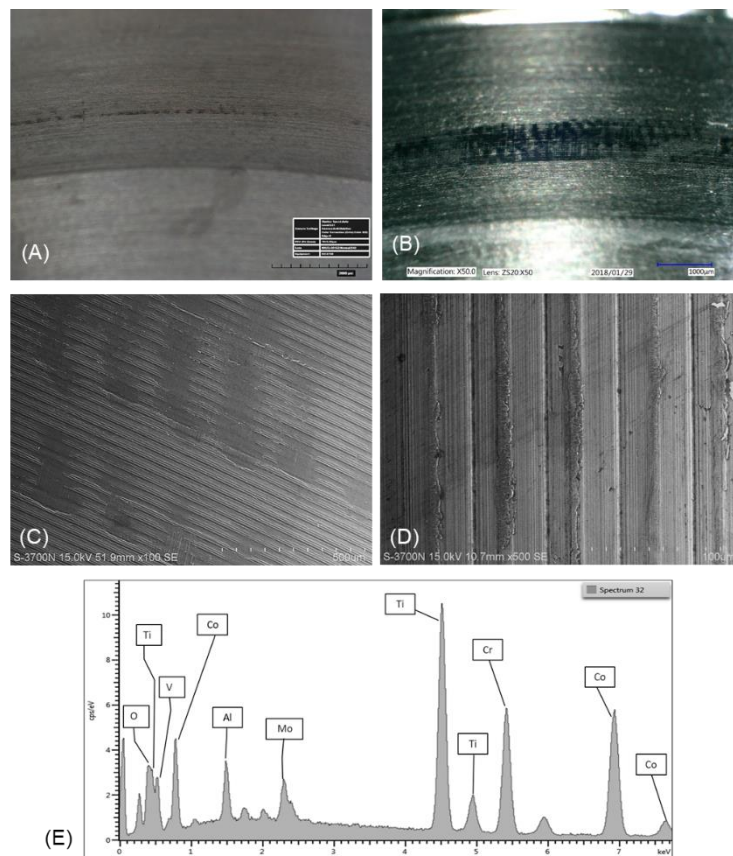
Figure 9: Digital optical microscopy (DOM) images of Ti shell taper for Group 2 (LC-CoCrMo) (a) pre-ICFC, (b) post-ICFC showing further scarring after ICFC testing. Scanning electron microscopy (SEM) images of the same sample (c) shell and (d) liner after ICFC testing showing deformation of the machining lines but limited corrosion damage (e) EDS spectrum for the region marked in white on 9d. Notice the titanium peaks on the CoCrMo surface.

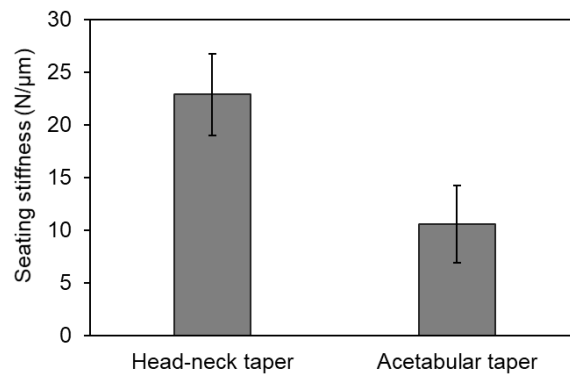
Figure 10: Seating stiffness ( $\text{N}/\mu\text{m}$ ) of head-neck taper (head-neck data from Ouellette et al, 2017, [15]) vs acetabular taper, with material combination and seating protocol remaining the same ( $n = 5$ )

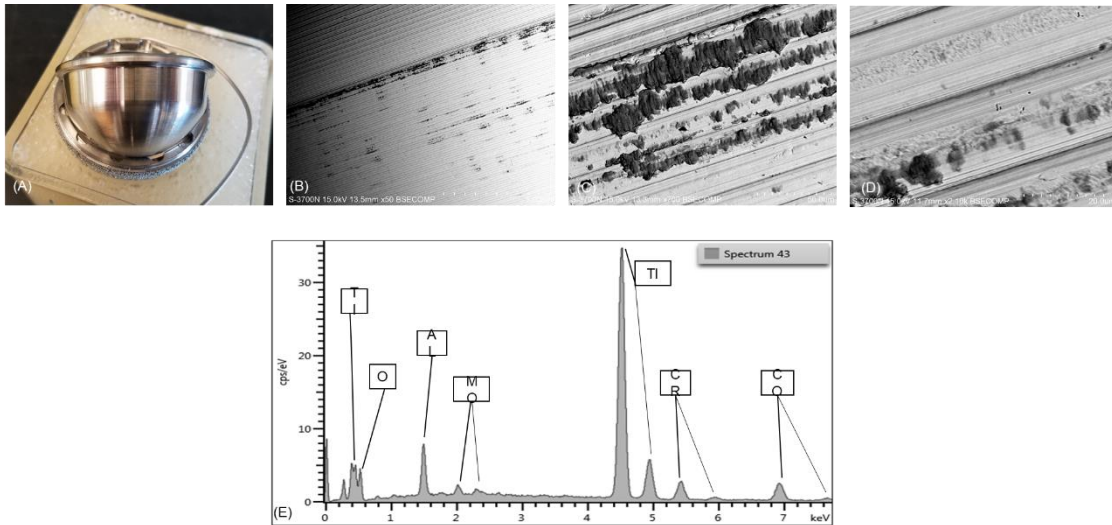
Figure 11: (a) Image showing the taper surface from sample 4, group 2 (low carbon CoCrMo) liner examined for surface damage. Note the lack of visible damage here. (b) Backscatter scanning electron micrograph of taper surface shown in 10a. Note the relatively sparse dark regions indicative of contact and resulting material transfer, compared to the non-contact regions. (c) Higher magnification image of surface from 10b. (d) Fretting scars seen in the same taper engagement region. Note the small amplitude of fretting (2-5  $\mu\text{m}$ ) (e) EDS spectra of the dark material in (c) indicating the material transferred is predominantly titanium oxide.

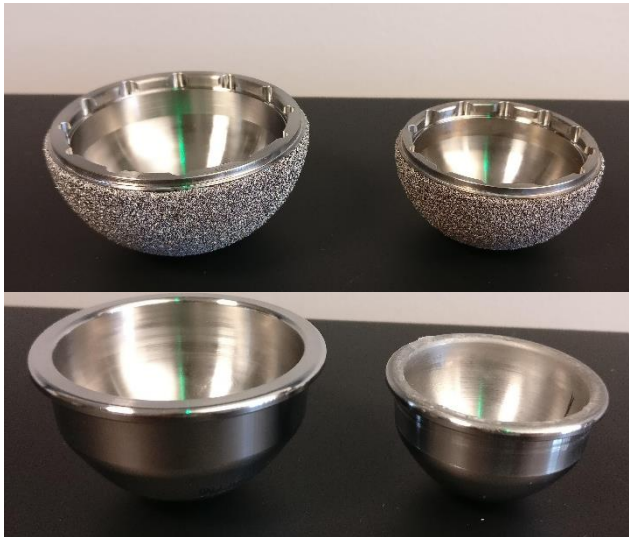
Figure 1: (a) Acetabular shells, 62 mm and 50 mm respectively (b) Acetabular shells, size 62/50 and 50/38 respectively. These are the CoCrMo HC liners, but the LC and SS liners were identical in design

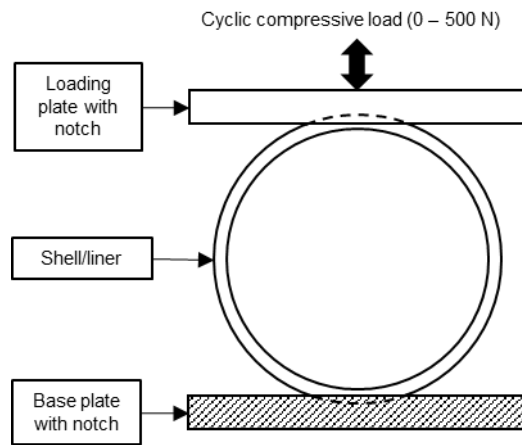
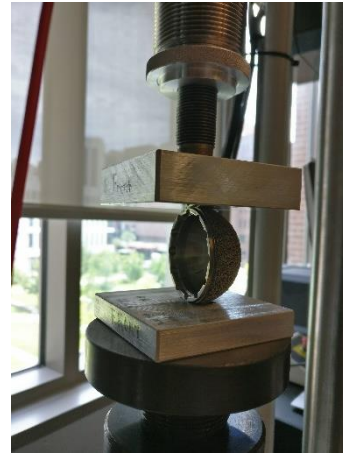
Figure 2: (a) Schematic showing the test method setup, with the dotted arcs representing the grooves cut into the plates to hold each device in place (b) Test setup with a device held in place by the plates

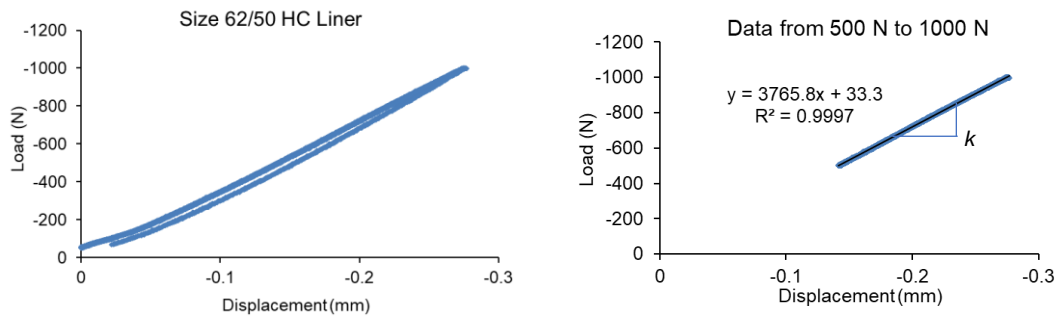
Figure 3: Representative plot showing (a) load-deflection data obtained from a single compression test on a size 62/50 HC liner. Note the short initial toe region and the constant slope beyond the toe region. (b) Data for the same test, condensed to include only those data points between 500 N to 1000 N to capture the true linear portion of the loading curve. A linear data fit provides the  $k$  value, which is the slope of the line (3765.8 N/mm in this case)
