## Understanding Corrosion in Modular Acetabular Tapers: Retrieval Analysis, In Vitro Testing and Cell-Material Interactions

UNDERSTANDING CORROSION IN MODULAR ACETABULAR TAPERS:  
RETRIEVAL ANALYSIS, IN VITRO TESTING AND  
CELL-MATERIAL INTERACTIONS

A Dissertation  
Presented to  
the Graduate School of  
Clemson University

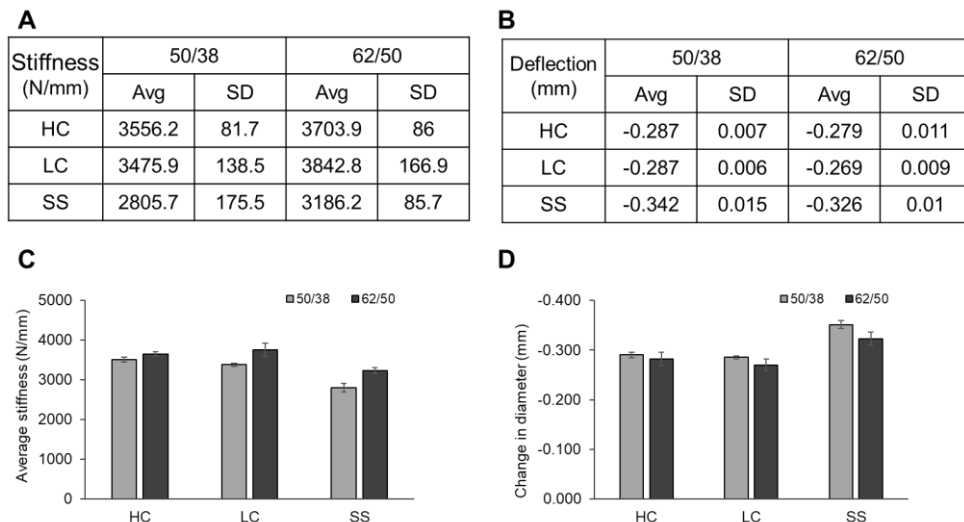
Figure 4: Summarized data for all tested liners across materials and sizes. (a) Average stiffness calculated values for all tested liners (b) Average deflection values measured for

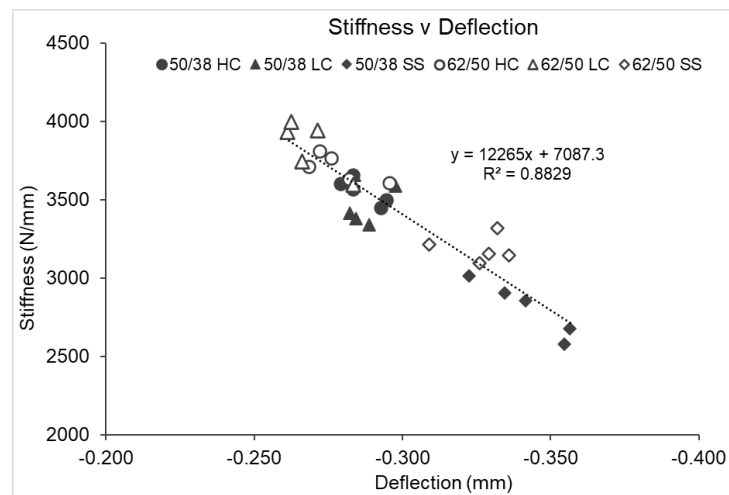
Figure 5: Stiffness-deflection plot showing the overall differences between the liners of different sizes and materials. The HC and LC CoCrMo liners are clustered towards the higher stiffness, higher deflection end of the linear fit, and SS liners are clustered towards the lower end

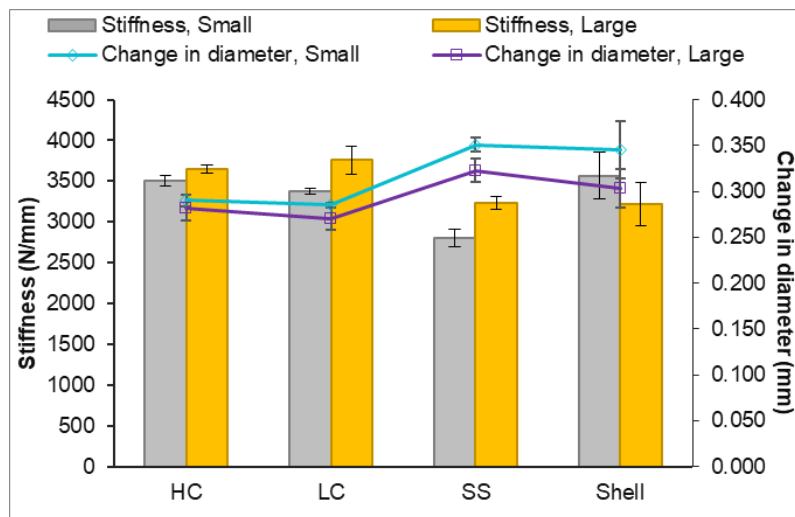
Figure 6: Average stiffness (bars) for each tested group: HC, LC, SS liners and titanium shells of small (50 mm) and large (62 mm) diameter, in combination with average change in diameter (lines) for each of the aforementioned groups

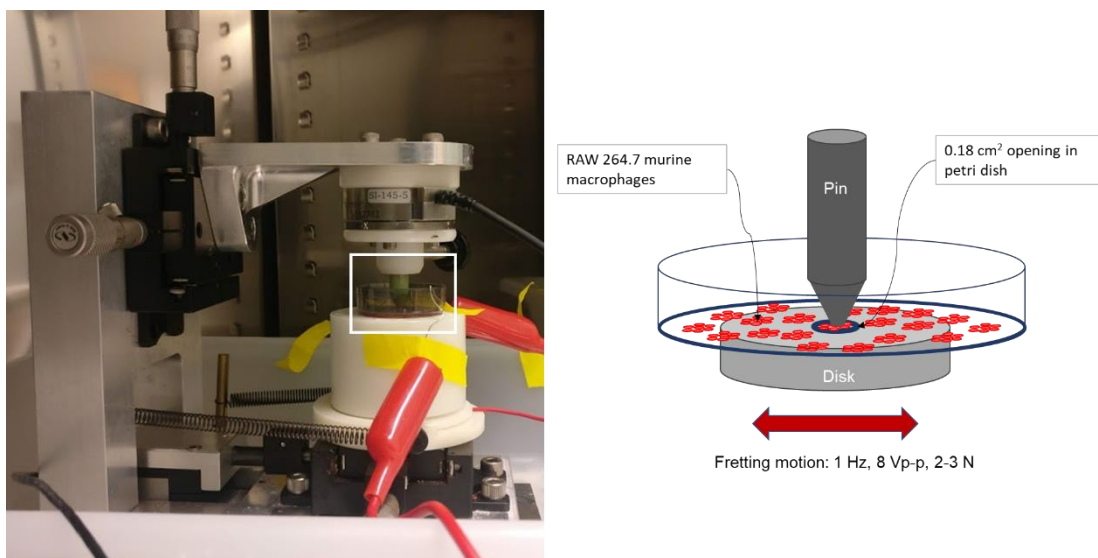
Figure 1: Photograph showing the custom-designed pin-on-disk system. A 6-axis load cell is used to apply a normal load of 2-3 N between the pin and the disk, and also measure loads along X, Y and Z axes. A piezo-actuator modulated stage applies the sliding motion to the sample holder into which the disk-petri dish construct is set. Schematic illustrates the pin-disk-petri dish set up with cells. Fretting motion was applied to the disk at 1 Hz, with sliding distance up to 100  $\mu\text{m}$ , while the pin remains stationary. Detailed description can be found in Liu et al. [118].

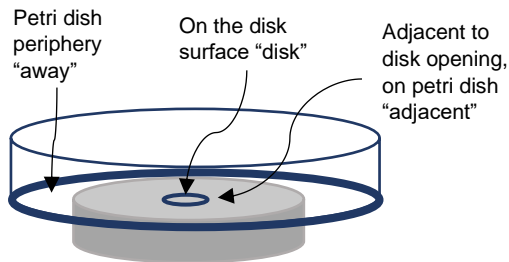
Figure 2: Locations where live/dead fluorescent images were captured

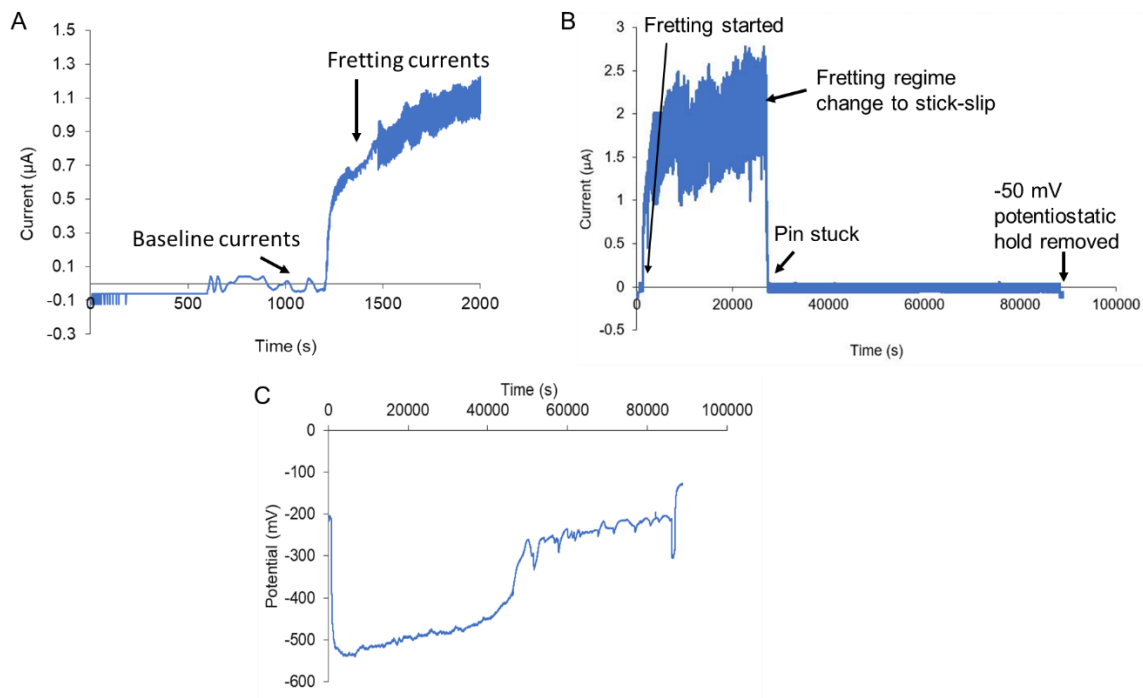
Figure 3: (a) Representative plot showing fretting corrosion onset and distinction from baseline currents prior to fretting (b) Example of a full 24-hour fretting test raw currents. Note that the full slip regime changed to stick-slip or full stick around 25000 s, leading to a drop in fretting currents (c) Variation in potential over a 24 h test for an OCP test. Transition to a sticking condition occurred around 40000 s. Reported values represent average current density and error bars refer to standard deviation across three trials per group

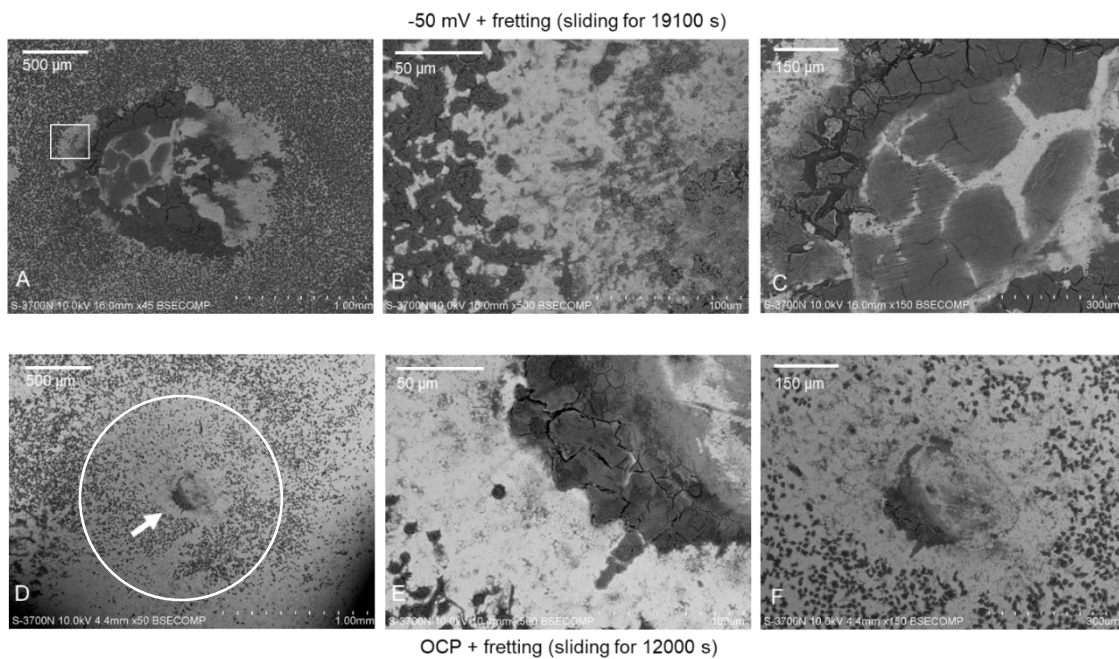
Figure 4: (a) Backscattered electron micrograph showing fretting contact area surrounded by oxide debris (dark contrast region, confirmed by EDS, data not shown) from group 1, -50 mV + fretting (b) A relatively cells-free ‘dead zone’ formed at the edge of the accumulated debris (inset in (a)). The actual cells are covered in proteins on the left,

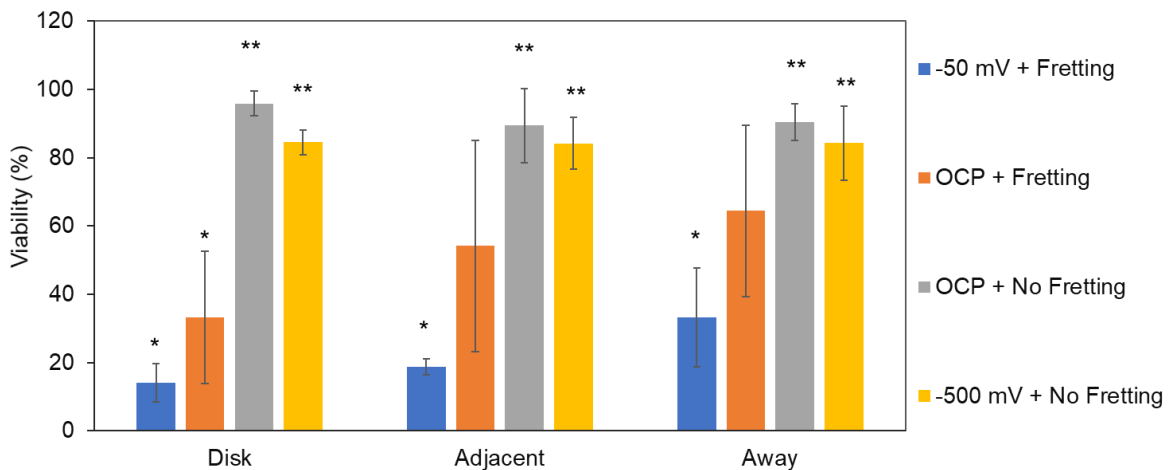
Figure 5: Summarized viability results for all test conditions and locations within the test chamber. Columns represent average viability calculated as percentage of live cells among total number of cells counted per image field. Error bars represent standard deviation across three trials. Single asterisk is statistically similar and statistically different from double asterisk columns. Average viability for OCP + fretting at adjacent and away locations lay intermediate between -50 mV + fretting and the other two groups

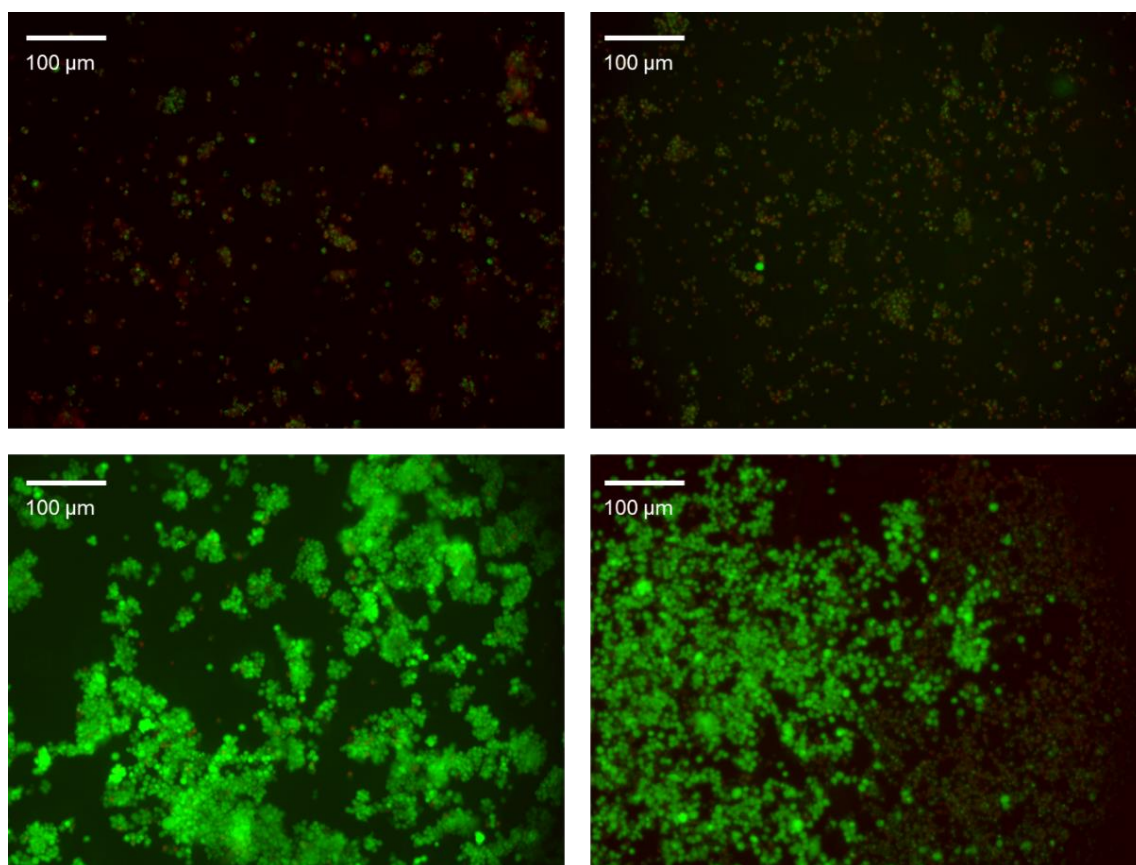
Figure 6: Live/dead fluorescence images for (a) -50 mV + fretting (b) OCP + fretting (c) OCP + no fretting (d) -500 mV + no fretting. All images are acquired from the metal disk substrate. Note the overlap in red stained dead cells and green stained live cells in (b)

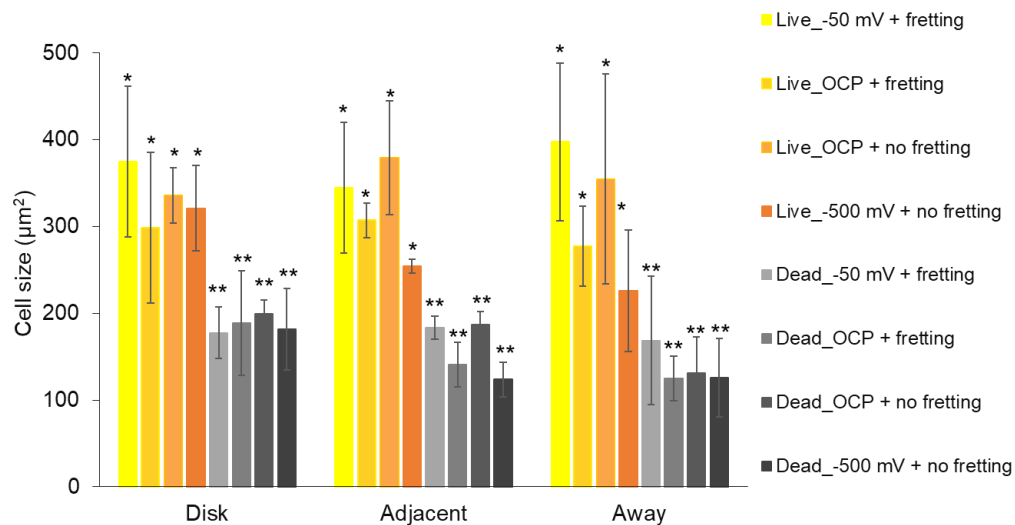
Figure 7: Average cell size ( $\mu\text{m}^2$ ) calculated from live and dead cells across all four groups, representing projected cell area calculated from fluorescent images ( $n=5$ ). Live cells within individual categories were significantly larger than dead cells, and cell sizes did not vary with differences in testing conditions. Single asterisk columns are similar to one another and statistically different than double asterisk columns.

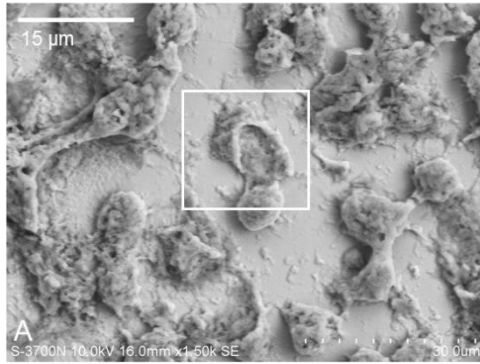
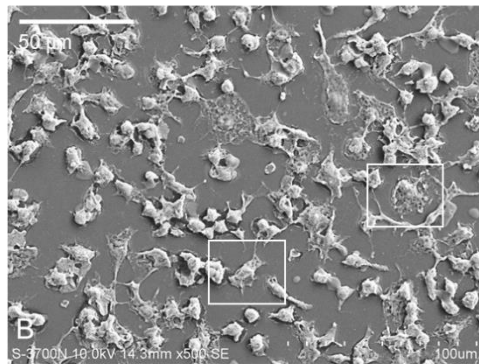
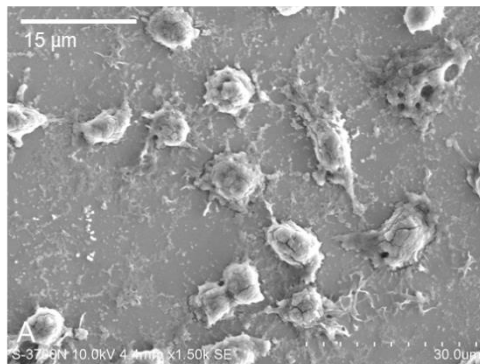
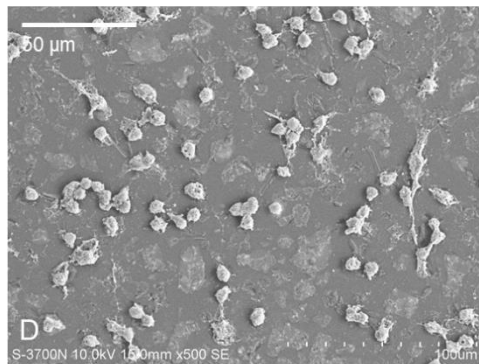
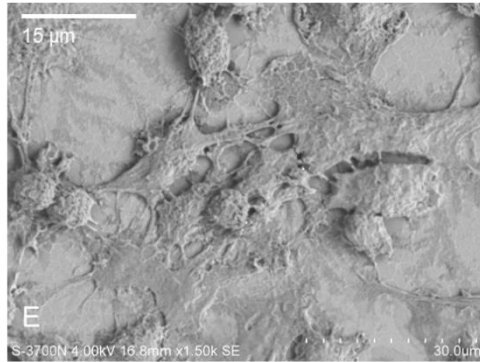
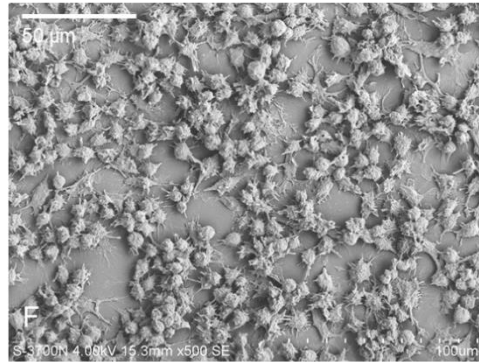
Figure 8: Secondary electron micrographs for (a) -50 mV + fretting, disk (b) -50 mV + fretting, petri dish. White insets show ruptured cells, with intercellular contents spilled around them. Other cells appear more rounded basally attached to the substrate (c) OCP + fretting, disk (d) OCP + fretting, petri dish. Note the balled-up appearance of the cells, with fewer focal adhesion points compared to 8a and 8b, with protrusions and general debris in their vicinity (e) OCP + no fretting, disk (f) OCP + no fretting, petri dish. Note the well spread out and attached cells in 8e. Comparatively, in 8f, cells appear to be more rounded, likely because of crowding (g) -500 mV + no fretting, disk (h) -500 mV + no fretting, petri dish. Cells are either spread out (white inset), cell membranes are beginning to contract (red inset) or cells are rounded and balled up (black inset)

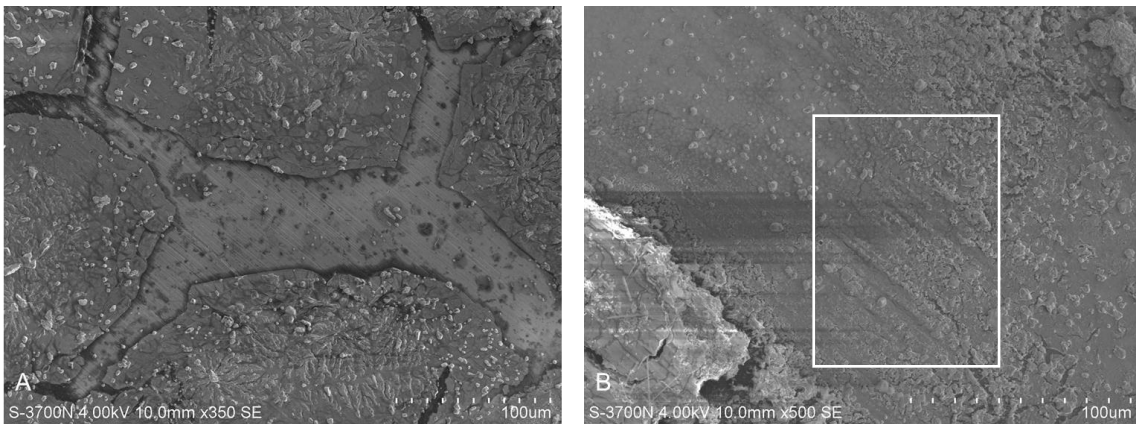
Figure 9: (a) Secondary electron micrograph showing a tribochemical layer rich in carbon, oxygen, chromium and phosphorus (EDS data not shown) formed atop the disk surface which shows the fretting scars (b) Secondary electron image showing the smeared accumulated debris which has protected the underlying disk surface and prevented oxide abrasion.

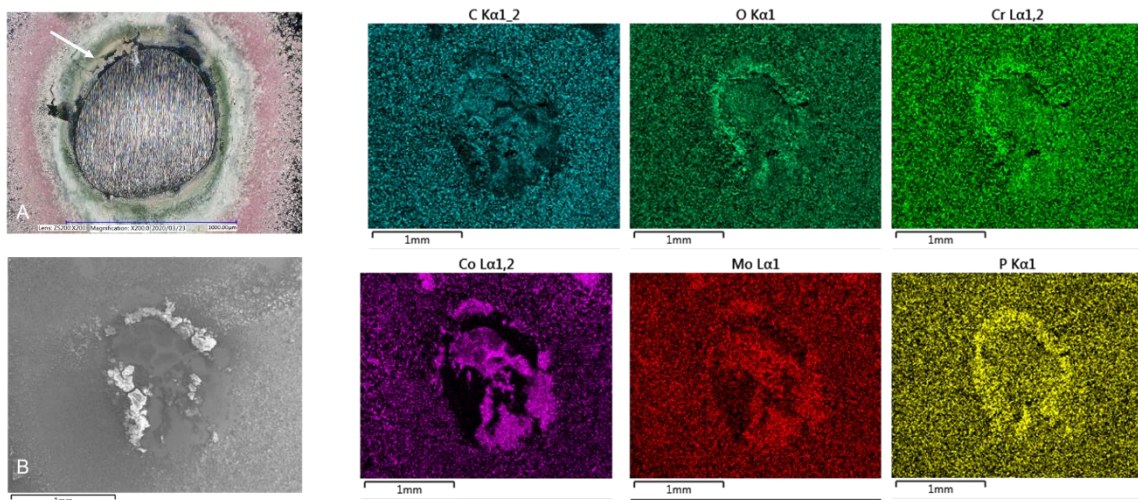
Figure 10: (a) Optical micrograph from a test condition without cells, showing the green deposits (white arrow) found to be rich in chromium, oxygen and phosphorus (b) Electron micrograph image of the fretting site from the -50 mV + fretting condition (with cells). Note the absence of cells seen through the carbon-nil regions in the first color plot. Debris detected here is mostly rich in chromium, oxygen, and phosphorus according to EDS analysis (color maps showing oxygen, chromium, phosphorus, molybdenum, and cobalt presence in clockwise direction)

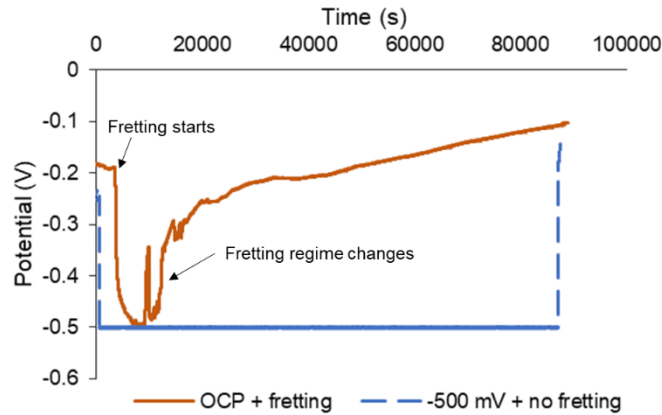
Figure 11: Graph showing differences in surface potential over time in groups 2 and 4. Note the anodic shift in recorded potential for group 2, OCP + fretting, over time, compared with the constant, externally applied potentiostatic hold in group 4
