## Burnham Cemetery Report

# **Burnham Cemetery Report**

Maria Meza  
April 26, 2017  
ANT4949

Project Name: CCAMP  
 Cemetery Name: Burnham Family Cemetery FMSF Site Number: 8BR2352  
 Date of Survey: March 20, 2017 Surveyor: Maria Meza

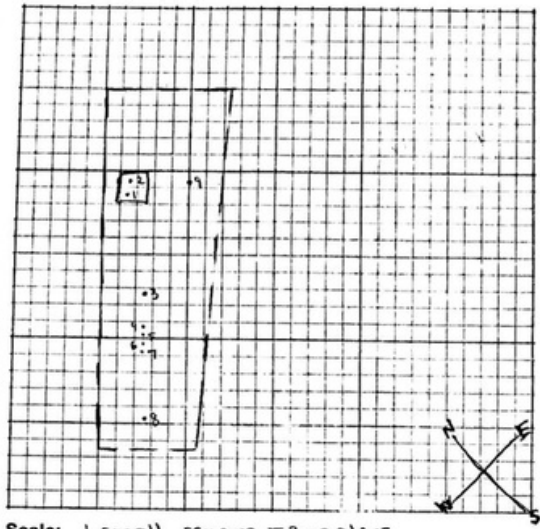
**Planview Map of Plot**

1. Grave #1
2. Grave #2
3. Grave #3
4. Grave #4
5. Grave #5
6. Grave #6
7. Grave #7
8. Grave #8
9. Grave #9
10. \_\_\_\_\_
11. \_\_\_\_\_
12. \_\_\_\_\_

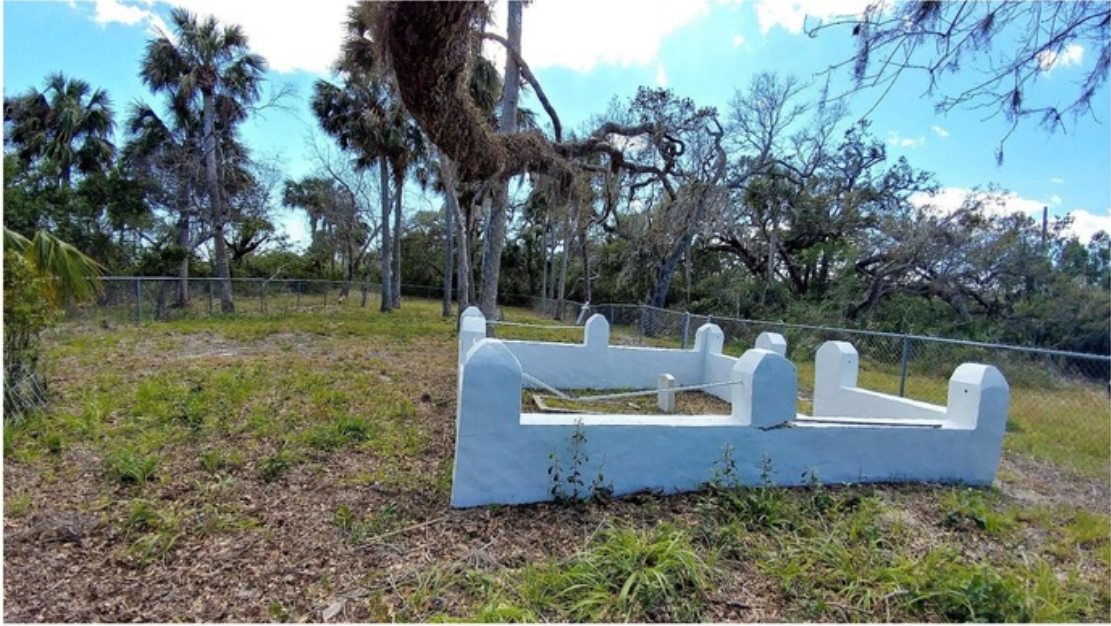
Burnham cemetery

The cemetery is enclosed by a cham link fence that is slightly uneven of each side. Inside, there are nine graves, eight of them are marked, and the last one is unmarked. The cemetery is in pretty good shape, it has been maintained, and there are signs of repairs. Two of the graves (grave 1 & 2) are enclosed in a ~~low~~ concrete fence that is partially broken on the north east wall.

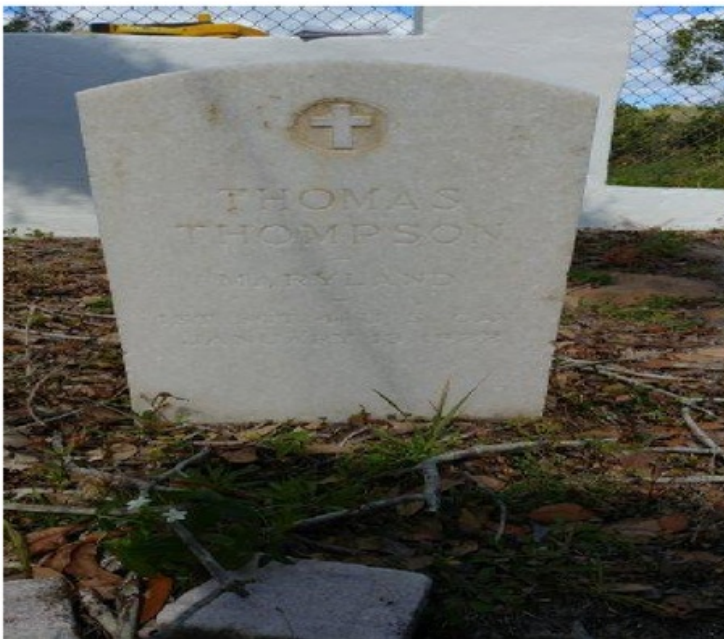
Grave #1: Thomas Thompson

Grave number one is the grave of Thomas Thomson. The grave is within a masonry enclosure that is inside the cemetery, this concrete fencing measuring 4.6 m x 4.5 m. during the mapping process, this enclosure was used as datum point. Grave number one and number two are in this enclosure. The grave has a concrete bordering that measures 1.8 m in length and .80 m wide. The Headstone is a military issued headstone, with a semicircular arch to it, and it is

made out of marble. The headstone's dimensions are 54 cm high, 36 cm wide, and 14 cm in thickness. The epitaph on the graves reads:

The condition of the inscription is sharp, tooling is evident and it's in good condition. Coping.../ there is no visible markers mark on the headstone or any grave good around the grave.

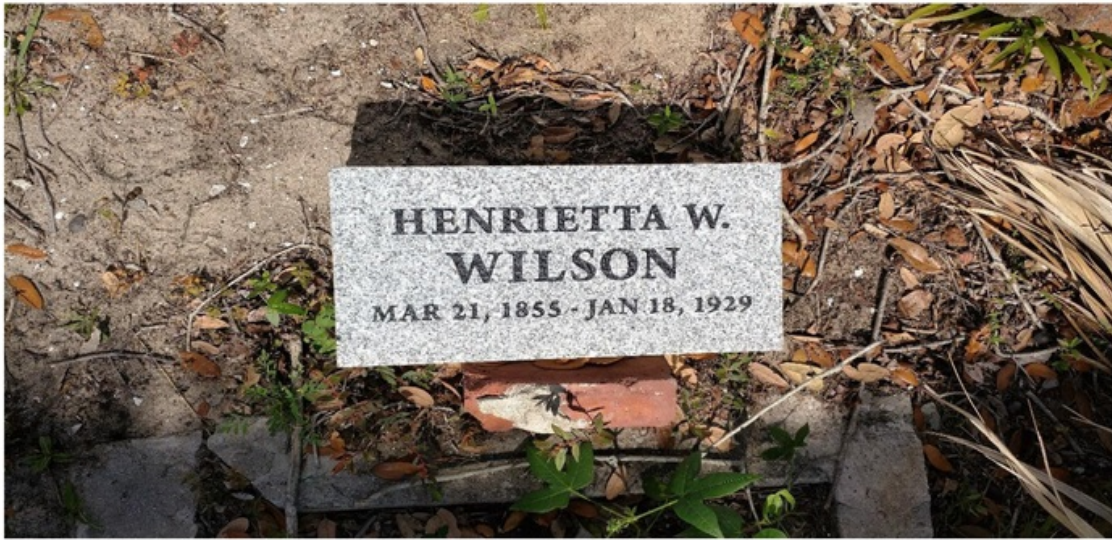
Grave #2: Henrietta W. Wilson (Marker)

Grave number two is the grave of Henrietta W. Wilson, granddaughter to Mills and Mary Burnham, Daughter to Henry and Frances Wilson, wife to Thomas Thompson (who was her second husband), which is why they are grouped together in the concrete enclosure. This grave also has a brick border around it, and it measures 2.10 m in length and its .80 m wide. The headstone is made out of granite and it is a plaque marker, and its dimensions are 23 cm in length, 44 cm wide, and 12 cm thick. This headstone is one of the newer headstones that were put in place in 2016. The epitaph reads:

The Headstone is in great condition, and the inscription is as well. There is no visible markers mark and there are no grave goods around the grave.

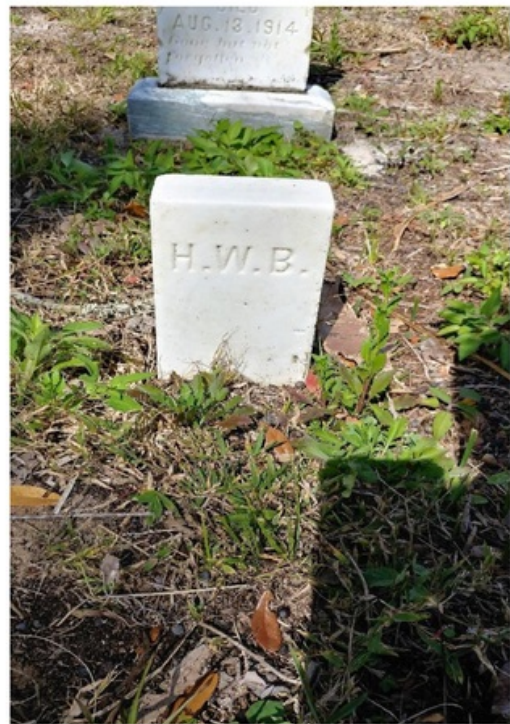
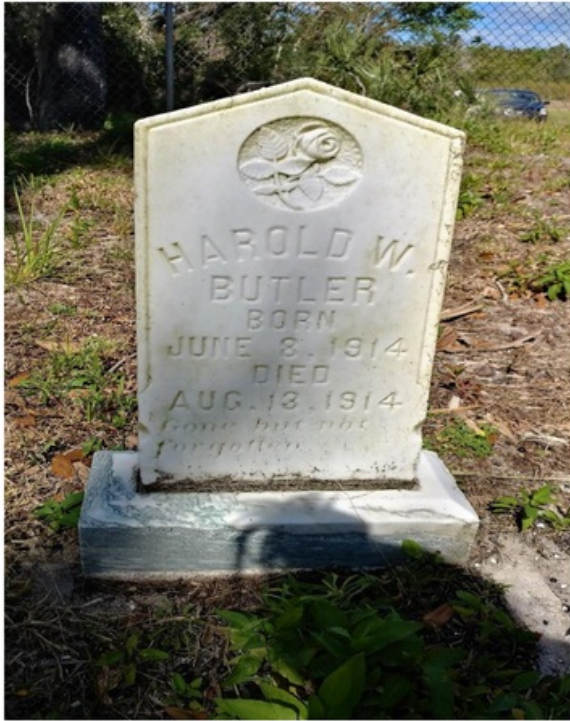
Grave #3: Harold W. Butler (Marker & Footstone)

Grave number three is the grave of Harold W. Butler. This grave is no part of a grave cluster, and is a noticeably small grave, this being because is the grave of an infant. Harold W. Butler was the son of the lighthouse assistant (Boyton 2015). The grave is 80 cm in length, and

40 cm wide; the headstone is die in base headstone and made out of marble, with the dimension of 50 cm high, 28 cm wide, and it is 10 cm thick. this is one of the graves that has a footstone, with the dimensions of 22 cm high, 16 cm wide, and 10 cm in thickness. the epitaph reads:

The Headstone is in good shape, but it is a bit weathered and has a couple of cracks and missing chunks. The Inscription is in good condition and the tooling is evident. There are no visible makers mark or any grave goods.

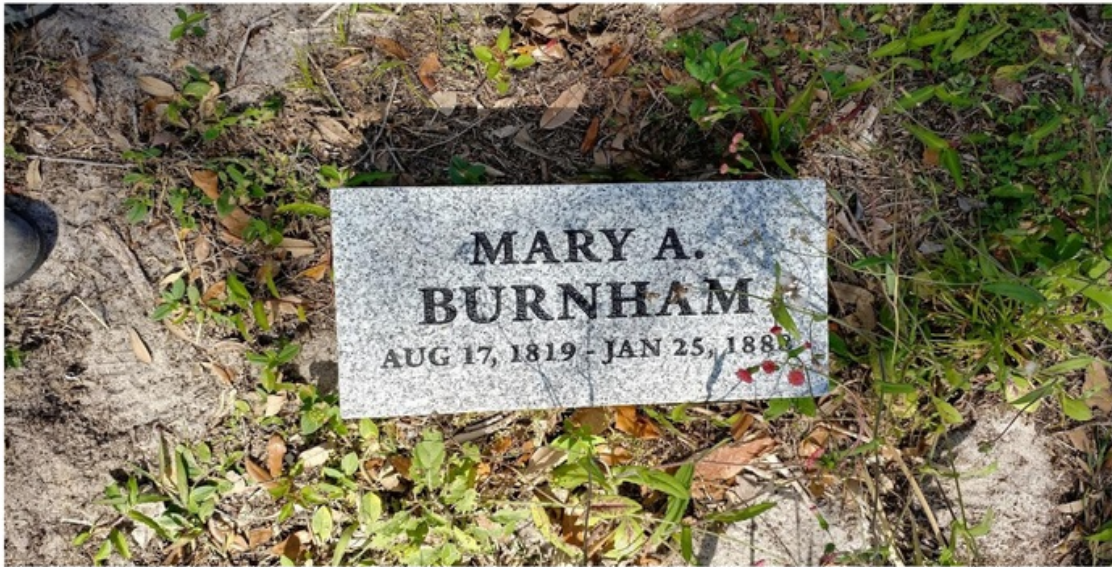
Grave #4: Mary A. Burnham (Marker)

Grave four belongs to Mary A. Burnham, wife to Mills O. Burnham. The grave is located of the western part of the cemetery, and it is grouped with three other graves. the grave length and width cannot be determined from the surface since there is an absence of a footstone or another indicator to tell how big the grave is. The headstone is plaque marker made out of granite, with dimensions of 24 cm in length, 44 cm wide, and 12 cm thick. The epitaph reads:

The headstone is one of the newer headstones as well, so it is in great condition. The inscription condition is sharp, and tooling is evident. There was no visible makers mark or any grave goods around the marker.

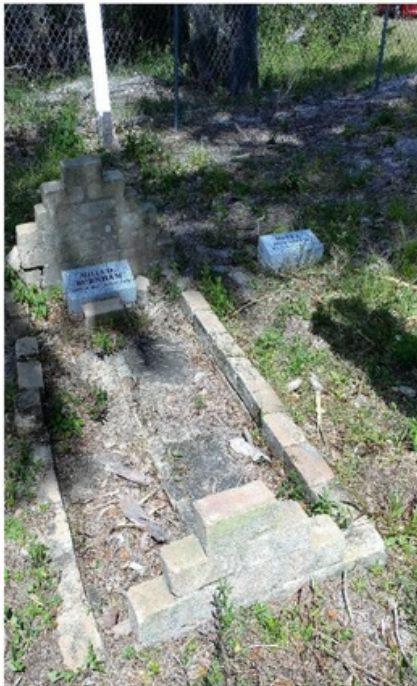
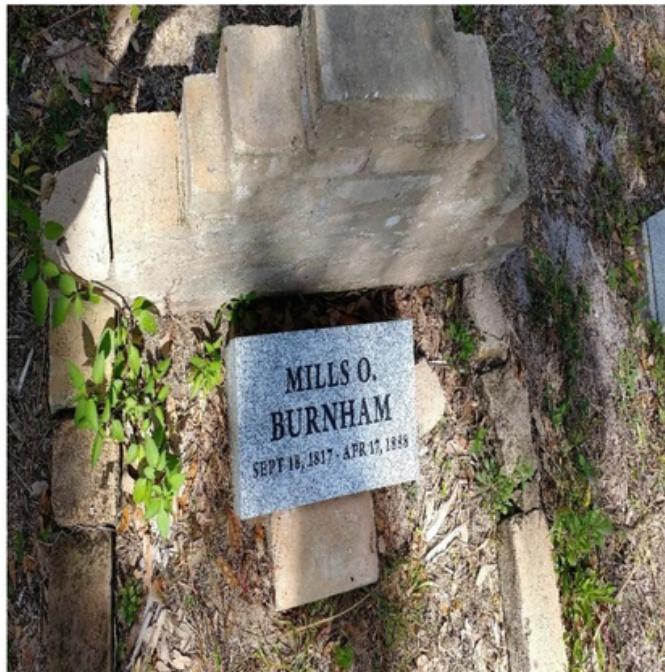
Grave #5: Mills O. Burnham (Marker & Coping)

Grave number 5 belongs to Mills O. Burnham, first permanent light house keeper, first Anglo-settler in Cape Canaveral, and one of the first to plant citrus groves in Cape Canaveral. His grave is located on the Western side of the cemetery, and it is grouped with three other graves, with the one of Mary A. Burnham, Mills Burnham's wife, to its right. The grave has its own individual fencing made out of brick, measuring 2.4 m in length and 1.1 m wide. It also has a 1.1 m high head board like structure also made out of brick right behind the headstone. The Headstone itself is a plaque marker and its dimensions are 24 cm in length, 44 cm wide, and 12 cm thick. The grave also has a brick footstone measuring 30 cm in length, the top brick 27 cm wide, and the base measuring 75 cm wide. The epitaph reads

This headstone is also one of the newer headstones, so it is in good condition. The inscription located on top of the marker is sharp, and tooling is evident, and it is in good condition. There are no visible signs of a maker's mark or any grave goods around the grave.

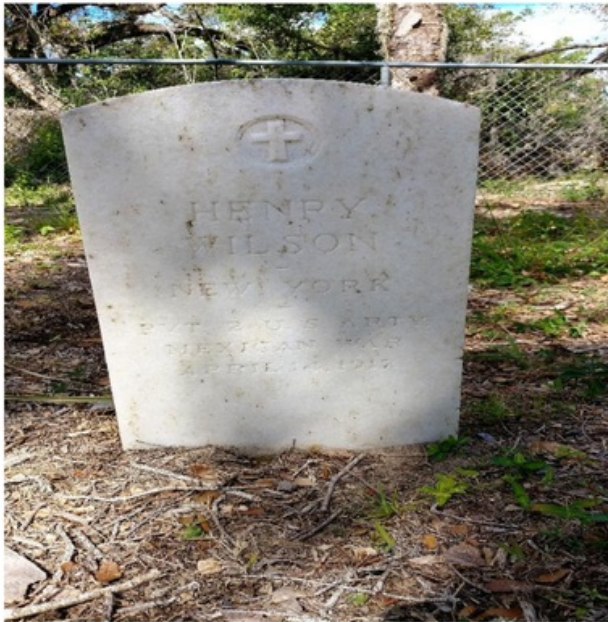
Grave #6: Henry Wilson (Marker)

Grave number six belongs to Henry Wilson. The grave is located on the west side of the enclosure, and it is grouped with grave numbers 4, 5, and 7. the grave does not have a footstone or another indicator to know the dimensions of the grave from the surface. The Headstone is Military issued marker, made out of granite, and the dimensions of the headstone are 62 cm in length, 36 cm wide, and 13 cm thick. The epitaph reads:

The headstone is in good condition...the inscription is sharp and tooling is evident, and the technique used on the inscription is carving. There is no visible markers mark and there are no greave goods around the grave or marker.

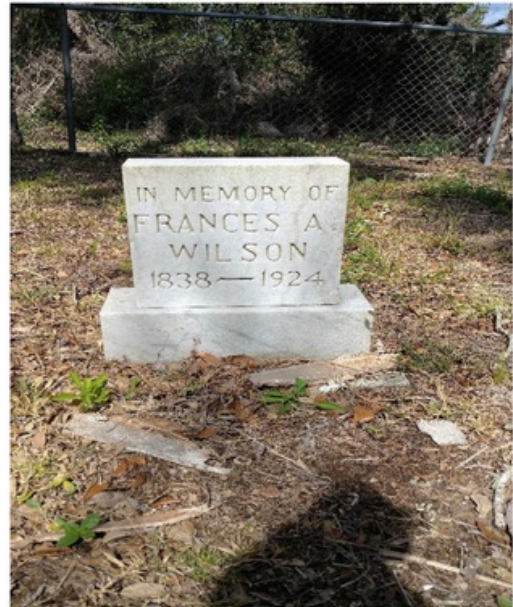
Grave #7: Frances A. Wilson (Marker)

Grave number seven belongs to Frances A. Wilson. This grave is located on the west side of the cemetery, and is grouped with graves 4, 5, and 6. Frances Wilson was wife to Henry Wilson, and the eldest daughter of Mill and Mary Burnham. The grave does not have a footstone or another indicator to know the exact dimensions of the grave from the surface. The headstone is a die on base, made out of granite, and the dimensions are 47 cm in length, 44 cm wide, and 19 cm thick. The epitaph reads:

The inscription on the headstone is located on the font of the marker, the inscription is sharp and tooling is evident, and the technique used for the inscription was carved onto the headstone. There is no visible markers mark and there are no grave goods around the grave or marker.

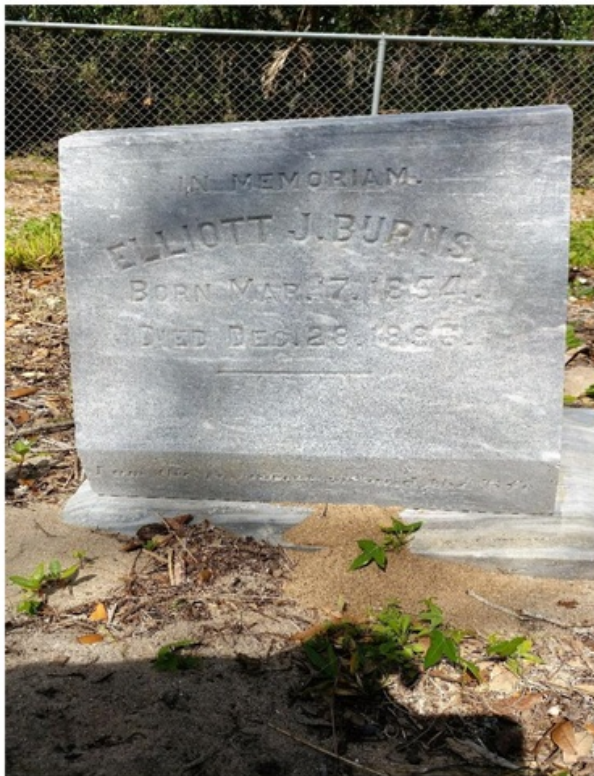
Grave #8: Elliot J. Burns (Marker)

The last of the marked graves is grave number nine and it belongs to Elliot J. Burns. Elliot Burns was the person who purchased the home of Mills and Mary Burnham (Boyton 2015:34). The grave does not have a footstone or another indicator to know the dimensions of the grave from the surface. The headstone is unique in that no other headstone in the cemetery is like it, and is made out of a gray stone. The marker is a little sunken on its right side. The dimension of the headstone 44 cm in length, 44 cm wide, and 22 cm thick at the base and 10 cm thick at the top. The epitaph reads:

The inscription is located in the front of the marker, and it is sharp and tooling is evident. The bottom of the inscription is clear, but slightly worn, and the technique that was used to get the inscription on the marker was carving. There are no visible maker's marks or any grave good around the marker or grave.

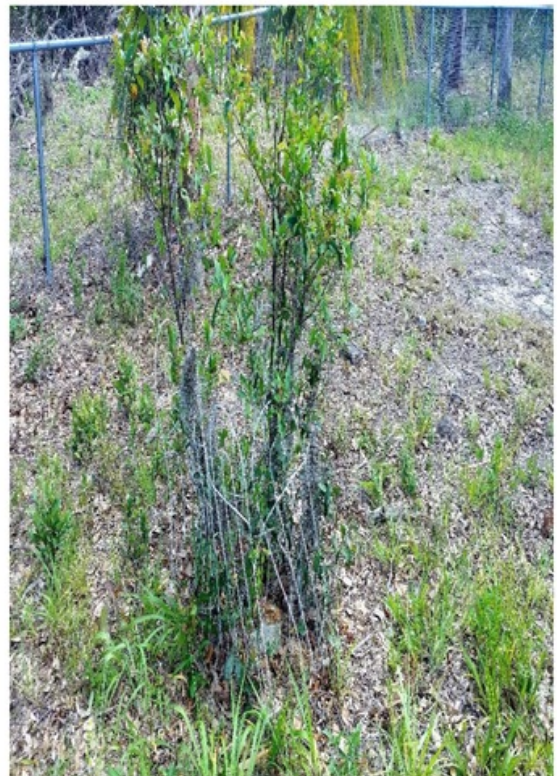
Grave #9: Unmarked Grave

The last grave in the cemetery is a grave without a marker. The grave is marked by small shrub that is within a white fence that is 1.0 m long and .55 m wide. The grave does not have any grave goods around it.
