NATURAL AND ARTIFICIAL INFLUENCES ON COASTAL EROSION AT SIDMOUTH, DEVON, UK

R. W. GALLOIS

Gallois, R.W. 2011. Natural and artificial influences on coastal erosion at Sidmouth, Devon, UK. *Geoscience in South-West England*, **12**, 304-312.

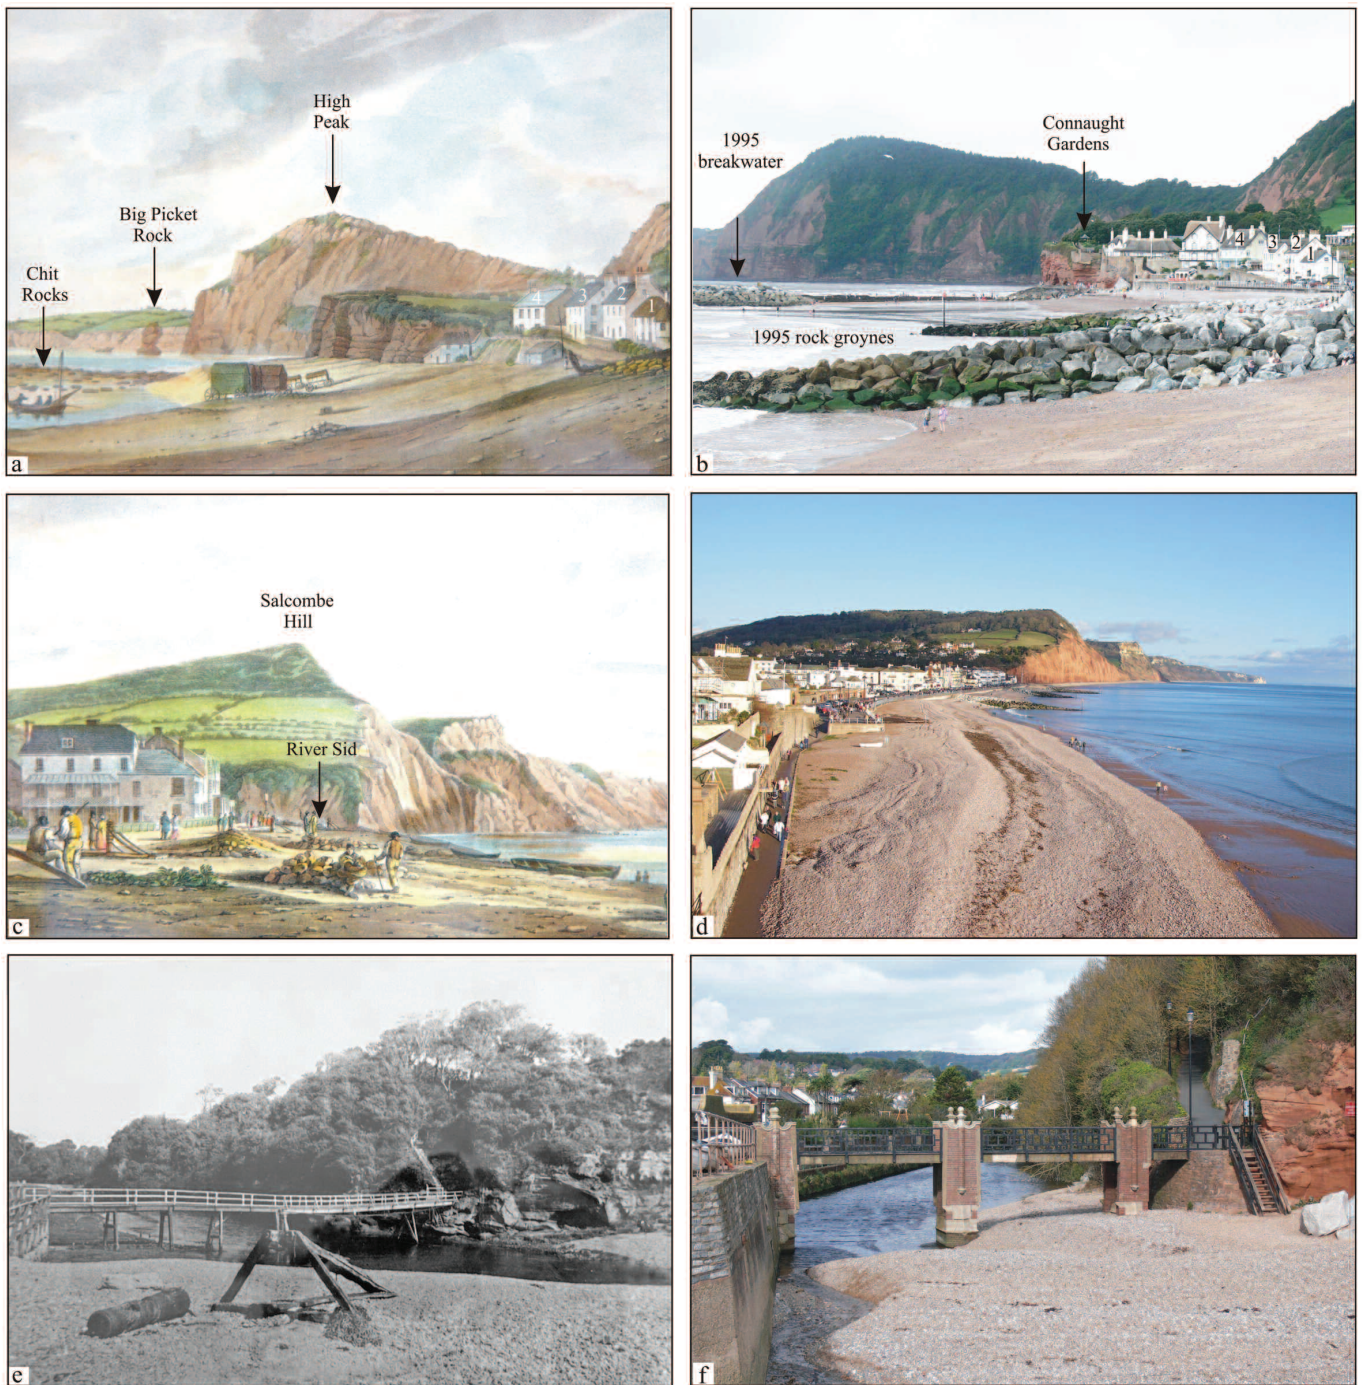
Figure 2. (a) View west of the western part of Sidmouth beach in 1815. An unbroken, wide shingle beach extends from Sidmouth to below Peak Hill. Part of a panorama of Sidmouth sea front by John Wallis Junior (Wallis, 1815). (b) View west, January 2005. The shingle beach is confined to areas between the rock groynes and between the most westerly groyne and the rock armour that protects the sea wall at the foot of Connaught Gardens Cliff. The cottages on the beach in (a) were destroyed in a storm in 1824. Houses 1 to 4 are still in place and now protected by a sea wall. (c) View east in 1815: part of the same panorama as (a). (d) View east from Connaught Gardens, December 2006. Most of the imported gravel that was emplaced evenly along the full length of the beach in 1995 migrated westwards during south easterly storms in the winter of 1995-96 and is now trapped in the quiet-water area between the sea wall and the offshore breakwaters. (e) The original (1855) Alma Bridge in 1890. Downstream from the 38-m long bridge the mouth of the River Sid was c. 100 m wide and blocked by beach gravels. Photograph courtesy Sidmouth Museum. (f) The replacement (1900) Alma Bridge, which consisted of four brick pillars supporting three spans, was c. 35 m long. It was reduced to two spans in 1921 when the river wall (left) was extended. Photographed in October 2011 at a time when the beach level was high.

were built not only on the higher ground of the valley sides, but also along the top of the gravel beach. Access to the beach-front properties was initially via a paved way along the top of the ridge (Figures 2a and 2c), but this did not protect them from storm waves.

In 1855 the Alma Bridge (named after the battle of 1854) was opened to allow a shorter foot access between the town and Salcombe Regis. The first bridge, 38 m long (Figure 2e), was replaced by a brick-and-wood structure in 1900 (Figure 2f). The eastern end of the sea wall was extended in 1870 to allow a gas works (1874) to be built on part of the former Port Royal area. The sea wall was extended again in 1921 over what remained of the former harbour to provide a turning area for traffic and hard standing for fishing-boats. The river wall was

extended at the same time with the result that the outfall of the river, now entrained between the river wall and the Otter Sandstone cliff, was reduced to 25 m at its mouth (Figure 2f).

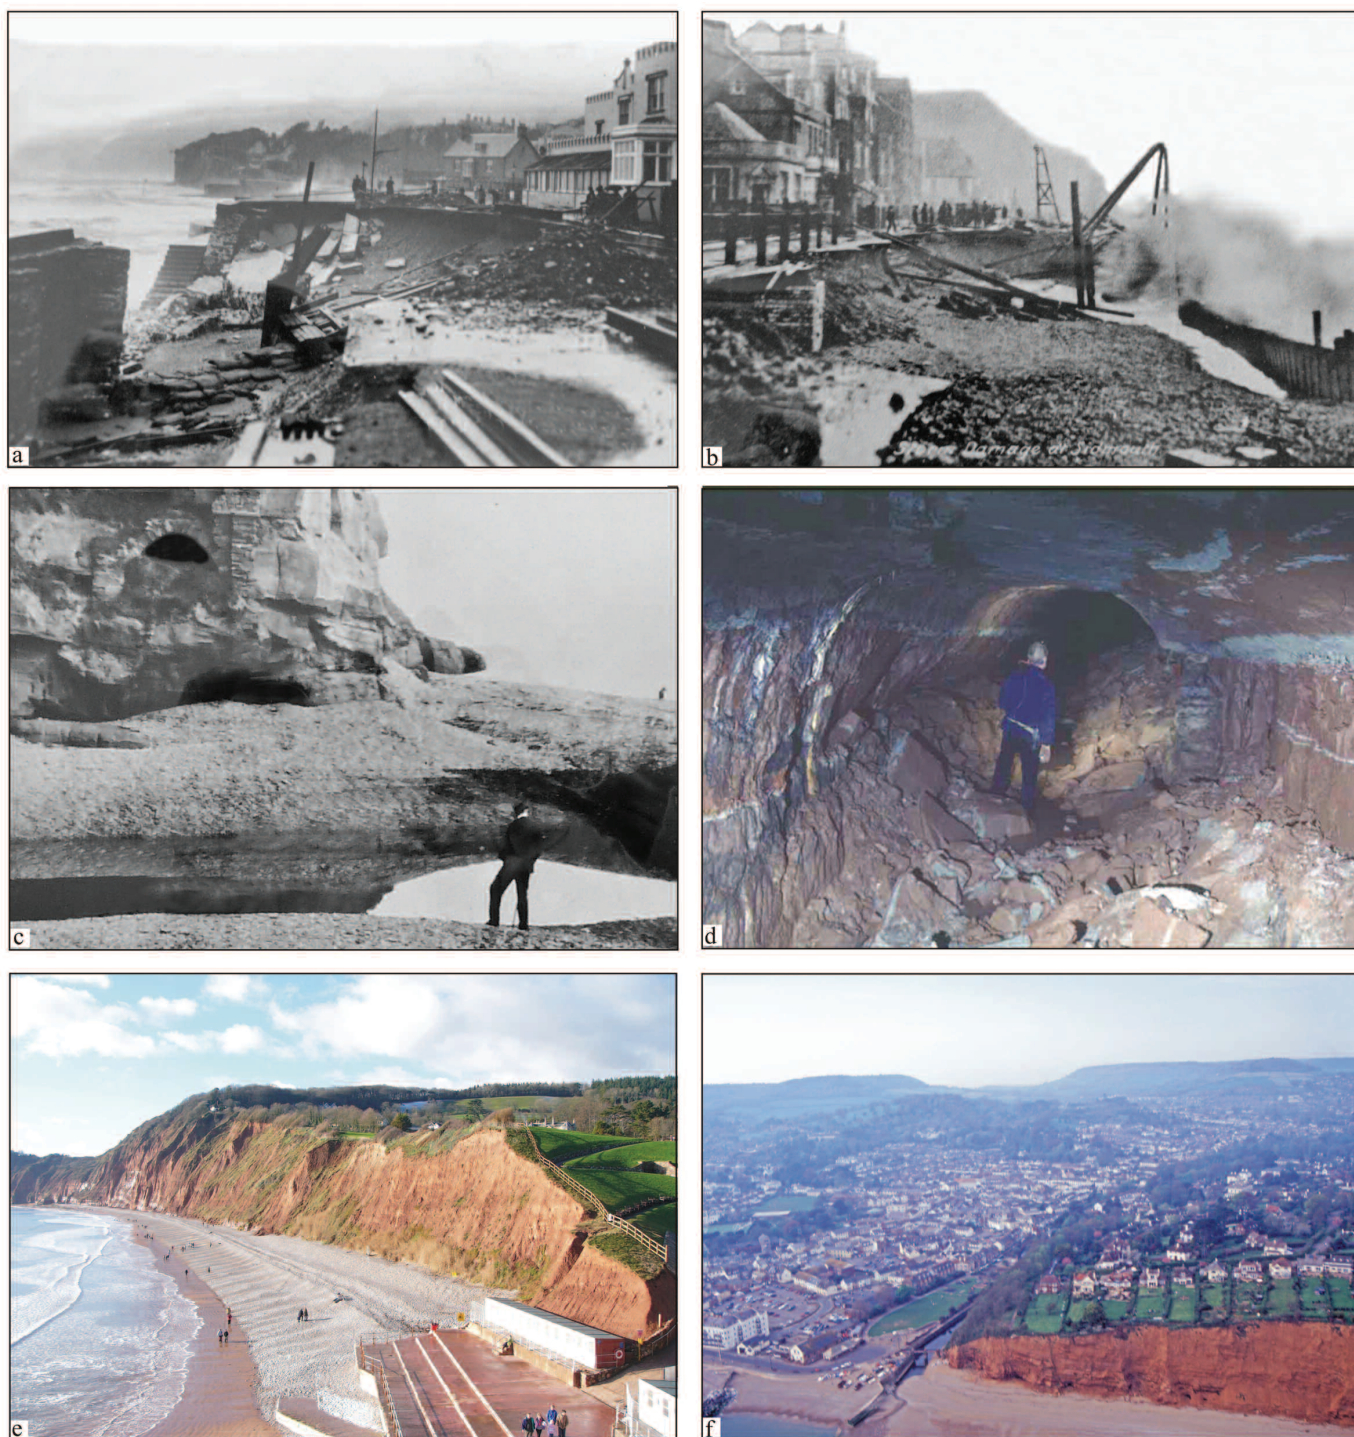
Figure 3. (a) Storm damage to the sea wall and the Esplanade in January 1925, view west. The western pier (The Hump) and Connaught Gardens Cliff are visible in the background. (b) Storm damage in January 1925, view east. The storms persisted for several days. Emergency repairs including the installation of sheet piling (bottom right) were carried out at times of low tide. (c) The western end of the railway tunnel in 1910. The River Sid percolated out through the beach gravels, as it did in October 2011. (d) View east inside the tunnel in February 2004 about halfway along its original length. The tunnel is in the lowest part of the Sidmouth Mudstone Formation at this point. Parts of the rounded arch shape of the tunnel are still well preserved. Almost all the roof falls are joint-bounded rock-block failures in thickly and thinly bedded mudstones. Photograph by and courtesy of Peter Glanwill. (e) View west towards Peak Hill from the top of Jacob's Ladder, December 2004. Beach gravels, almost all chert and flint derived from the Upper Greensand and Clay-with-flints, are banked up against the 1934 esplanade. (f) Oblique aerial view of the outfall of the River Sid, May 2005. Low tide at a time when the level of the beach gravels east of the river was high. Photographs a, b and c courtesy Sidmouth Museum.

long section of the sea wall and a 5 m deep section of the esplanade and road (Figures 3a and 3b). The cost of the damage was estimated at £30,000 (c. £ 1.3 million at current prices) (British Pathe News) and although the low-lying part of the town was not flooded, it was clearly at risk. A new sea wall was constructed at a cost of £100,000, and opened on March 20th, 1926 (*Sidmouth Observer*, March 24th, 1926).

The western entrance to the tunnel (Figure 3c) was visible in the cliff until the 1950s when it was eroded away. The eastern end of the tunnel, at that time c. 400 m ENE of the river outfall, collapsed in a cliff fall in 2001. About 150 m of tunnel remain including a ventilation adit halfway along its preserved length that allows access from the beach. Much of what remains is now blocked by roof falls (Figure 3d) and part of it is flooded (Glanvil, P. www.darkanddeep.co.uk). A landslide in 2010 revealed the western end of the tunnel, 120 m ENE of the River Sid outfall. Andrews and Davin (2009) concluded that the tunnel did not present any increased risk to the coastal footpath that runs adjacent to its eastern part. It appears, however, to have contributed to several landslides in that area in the past 20 years.

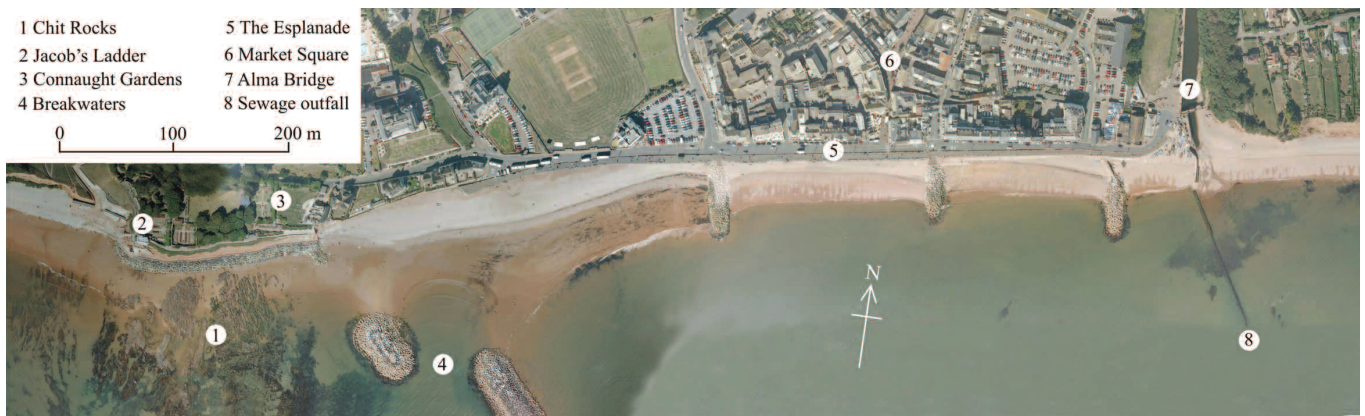
Figure 4. Composite aerial view of Sidmouth seafront showing the principal localities referred to in the text. Based on parts of Channel Coast Observatory (CCO) frames SY 11 86 NE, 12 86 NW, 12 87 SW, 12 87 SE, and 13 87 SW, 2nd June 2008. Reproduced courtesy and copyright of the CCO.

the sea wall was breached in February 1990. A new sea wall was completed in 1991, but beach levels remained low. Construction work was carried out in 1994-1995 to replenish the beach and protect it from future erosion at a cost of £6.5 m (1995 prices). The wooden groynes were replaced by three large rock groynes, and two rock breakwaters were constructed adjacent to Chit Rocks to prevent the beach being eroded

during south westerly gales (Figure 4). Ninety thousand tonnes of granite in blocks up to 12 tonnes in weight were imported by sea for the groynes and breakwaters, and 165,000 tonnes of Budleigh Salterton Pebble Beds were imported by road from quarries at Black Hill, Woodbury (Simm and Cruickshank, 1998).

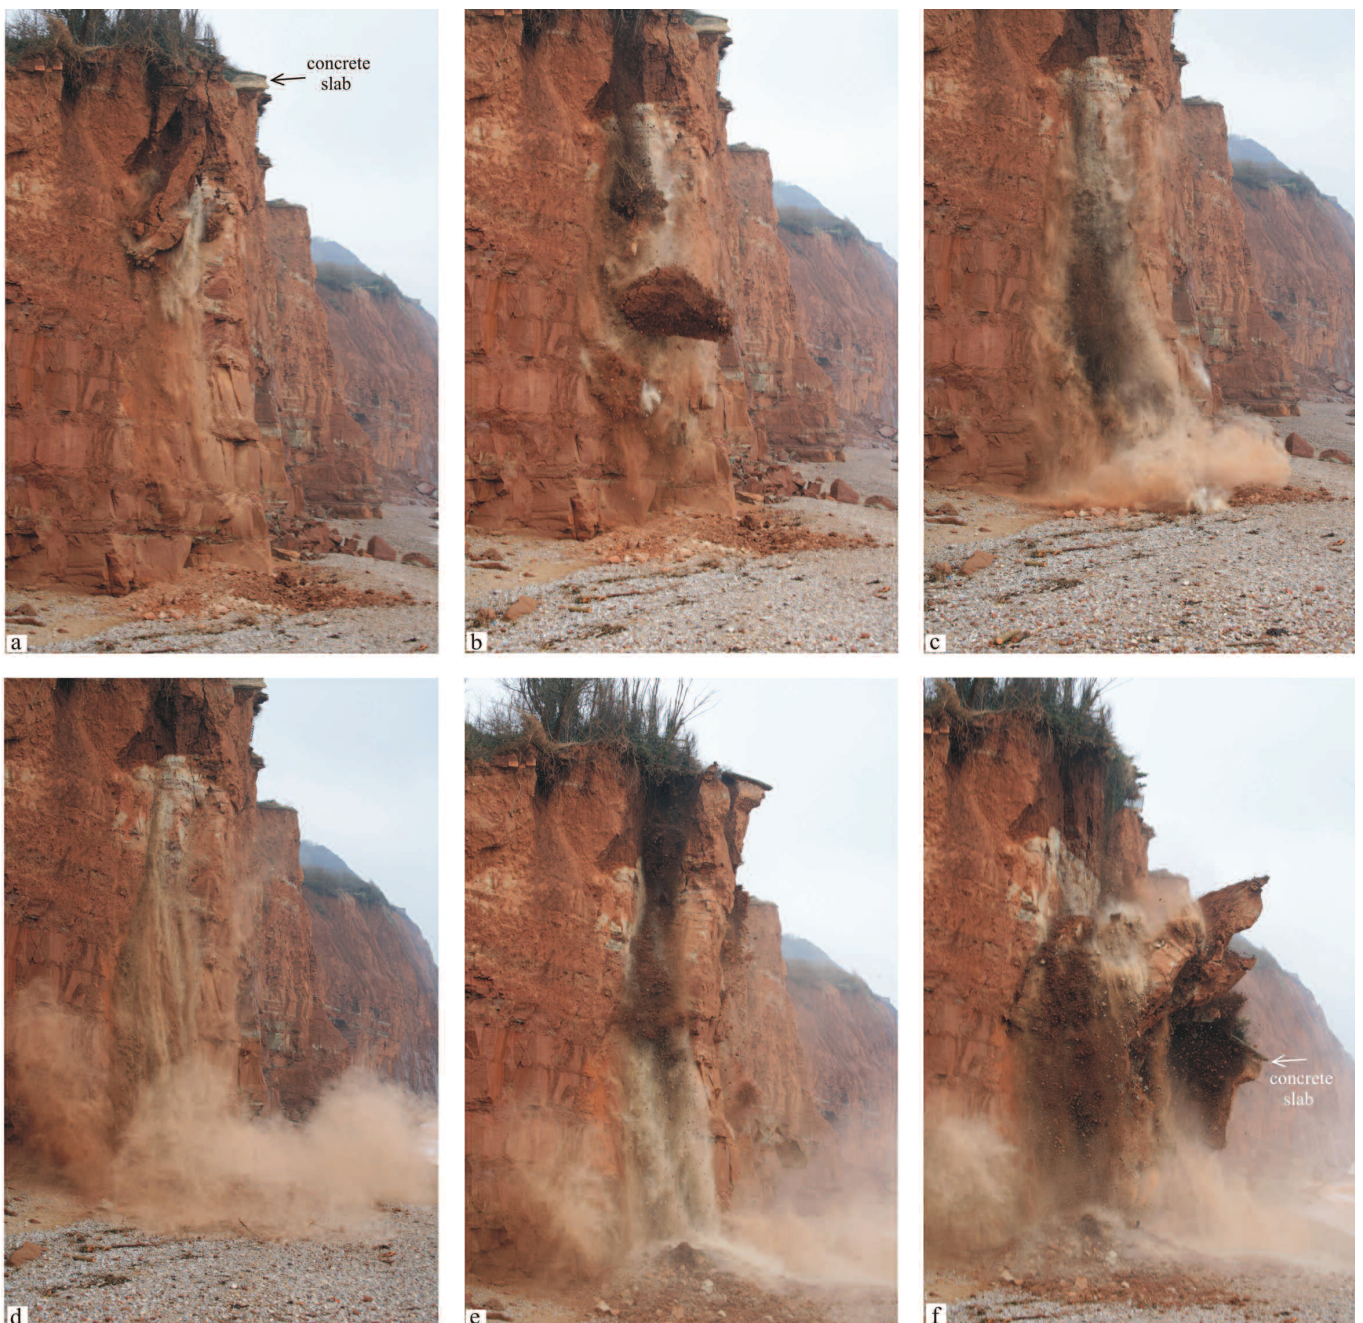
Figure 6. Landslide shown in Figure 5 photographed over a period of one minute by Eve Mathews. Small debris falls continued to occur over the next 10 minutes. Reproduced courtesy and copyright of Eve Mathews.

in the Pennington Point Member (Figures 5 and 6a). This dislodged some of the underlying sandstones and mudstones in the middle part of the cliff (Figures 6b to 6d), but the lower part of the cliff remained largely undisturbed. At the top of the cliff, the failure in the Head deposits and weathered mudstones progressed eastwards as a series of toppling failures and dislodgements (Figures 6e and 6f). This included a large concrete slab (a former viewing platform at the edge of the coastal path) that had been overhanging the beach for several years (Figure 6f). Debris and small blocks of material continued to fall from the cliff for ten minutes after the initial event. The same 'top-down' mechanism was inferred for a larger landslide (several thousand tonnes) that occurred in the Sidmouth Mudstone 420 m ENE of the river outfall in October 2001 (Gallois, 2001). In both examples, the well-jointed nature of the Triassic rocks in the middle and lower parts of the cliff was an important factor in their collapse.

adjacent to Pennington Point has retreated faster than the base, and some parts of the bottom and the top have experienced little or no movement. For example, the sandstones at the foot of the western end of the cliff have not been eroded during that time, and the concrete slab shown in Figure 6 projected out from the top of the cliff for at least 7 years before it fell in February 2009.

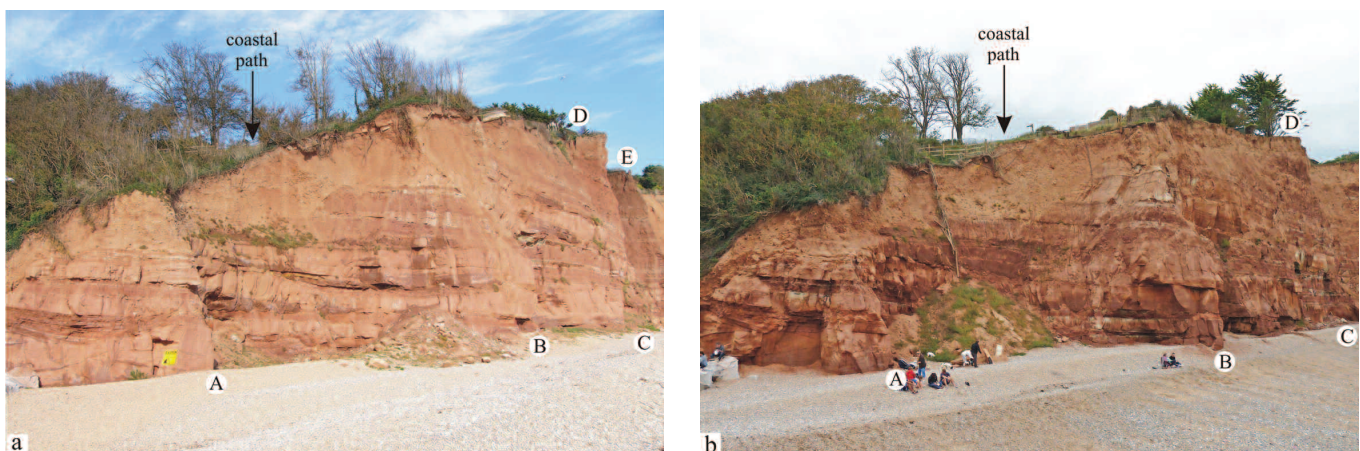
Figure 8. The western end of the cliff adjacent to the outfall of the River Sid at times of high beach level viewed from the river wall (a) 7th January 2004 and (b) 30th August 2011. There has been little change in the lower part of the cliff in the outcrops A, B and C of the sandstones and mudstones in the Pennington Point Member. In contrast, the collapse of Head Deposits and weathered mudstones in the upper part of the cliff adjacent to the coastal path (in 2008, 2009 and 2010), between there and the promontory D (in February 2009) and at promontory E have resulted in the local retreat of the cliff top by up to 2 m.

Most of the landslides in recent years have been relatively frequent (one or more per year) collapses in thick drift deposits in the highest part of the western end of the cliff close to the river and adjacent to the coastal footpath (Figure 8). These have been visible from the Esplanade and, as a consequence, have attracted much publicity.
