# Evaluation of Orange Pavement Striping for Use in Work Zones

Report Number: KTC-21-03/FRT-227-1F

**Evaluation of Orange Pavement Striping for Use in Work Zones**

February 2021

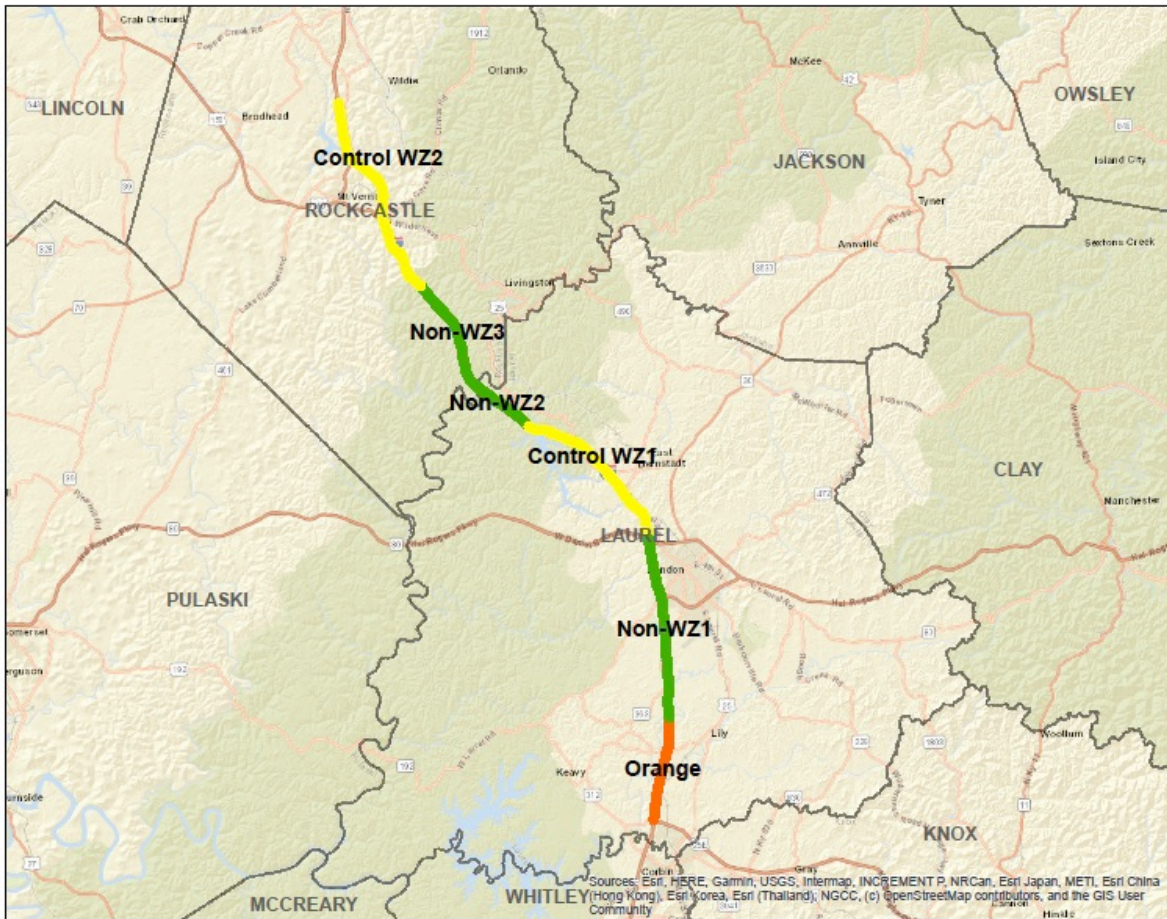
The orange pavement markings testbed is within an established construction project on I-75. The Kentucky Transportation Cabinet (KYTC) has a construction contract to widen the interstate and provide additional travel lanes on I-75 in Laurel and Rockcastle Counties. Both of the counties fall under the jurisdiction of KYTC's Highway District 11. The construction project is divided into a northern segment and southern segment and these segments were let at different times, meaning different work zones would be created throughout the span of this widening project. There are three work zones, one of which is the orange paint work zone while the other two serve as control work zones. There are also three non-work zone segments along the study corridor and they serve as a baseline for interstate traffic characteristics. The map in Figure 3.1 shows each section on the study corridor.

Figure 3.1 Map of Work Zones Within Interstate Widening Project

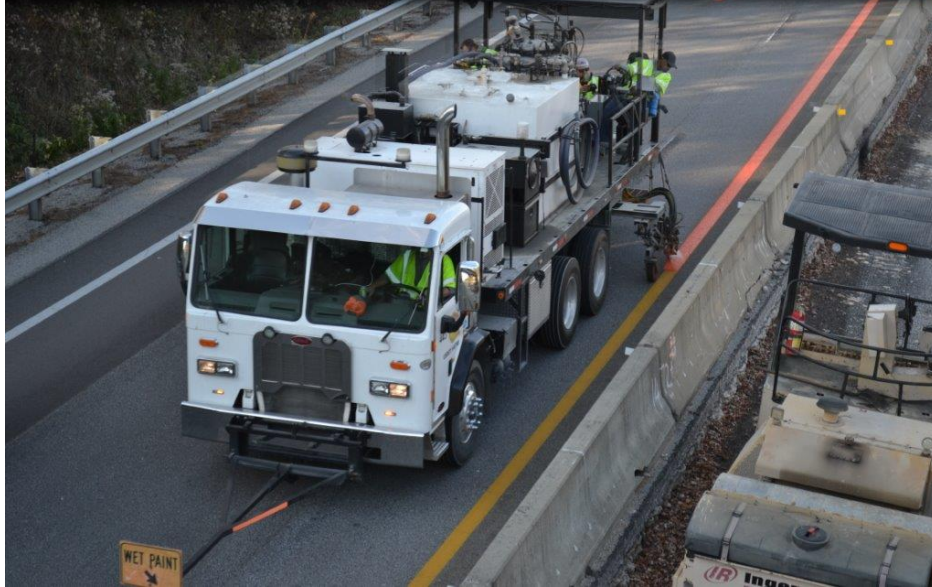
Waterborne orange paint was installed on November 7, 2019 on I-75 between mile points 28.9 and 33.2. Supplier Ennis Flint and subcontractor Central Seal developed the color by combining existing formulas for Kentucky’s yellow and white paint and mixing that with the orange paint that Wal-Mart uses for their parking lots. This combination became known as “Wal-Mart orange.” A basic package of Ultra blend glass beads was applied with the paint. The waterborne paint was applied as 6-inch markings at a 15-mil thickness. It was put down at a rate of approximately 16.5 gallons per mile. In total, about 115,000 linear feet of paint was installed through the work zone. Installation of the orange paint is shown in Figure 4.1.

**Figure 4.1** Initial Installation of Orange Paint

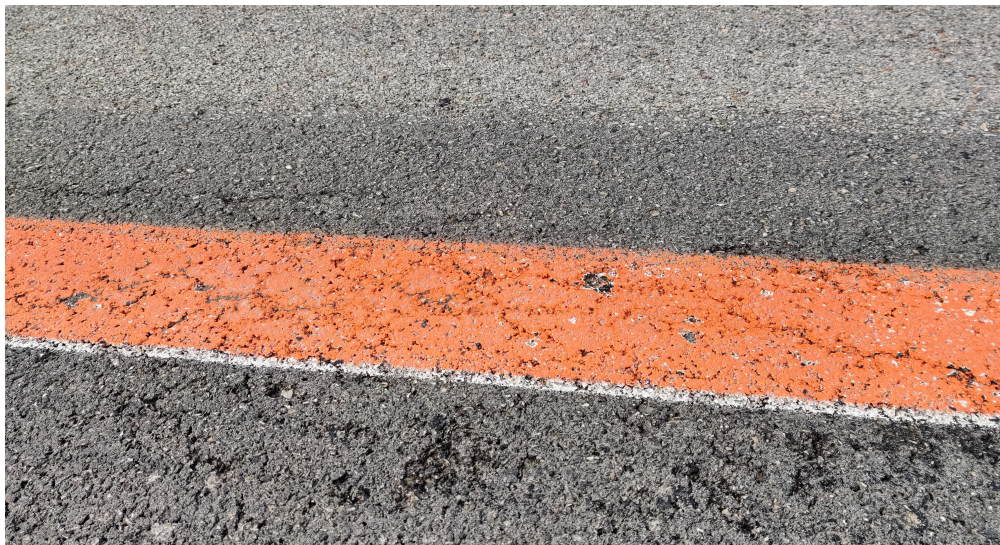
A second inspection on February 19<sup>th</sup> showed that the quality decreased significantly over the winter. (Laurel County received 1.5 inches of snow throughout the season [NOAA, 2020].) The waterborne paint was very worn; in some places the original white line was clearly visible underneath the orange paint, as shown in Figure 4.2. The average retroreflectometer reading on waterborne paint at this time was 51.6  $\text{mcd/lx/m}^2$ .

**Figure 4.2** Waterborne Orange Paint After 100 Days

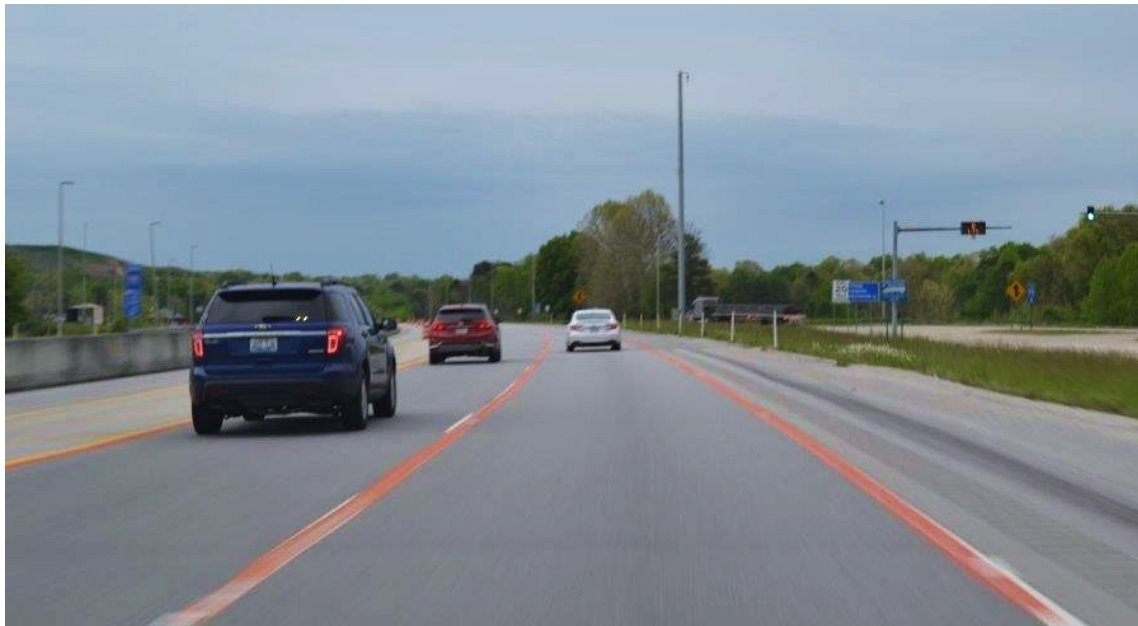
amount of data points and offered more opportunity for analysis. The mobile unit was first used on July 15, 2020. At this time, the waterborne paint had almost completely worn off since its first installation in November 2019, as shown in Figure 4.3.

**Figure 4.3** Waterborne Orange Paint After 250 Days

However, by measuring the right edge line of the northbound segment, which was originally waterborne paint and had sporadic spray thermoplastic patching, data collectors could get some rudimentary information about the remaining waterborne paint. The average retroreflectivity of the right edge line was 50.6 mcd/lx/m<sup>2</sup>. Again, it is important to consider that this value averages both original waterborne and spray thermoplastic patching, which were applied at different times. 31 percent of the total measurements taken on the right edge were zero; the research team inferred that most of these zero-retroreflectivity points were likely from the waterborne paint since visual inspections had concluded that most of the waterborne paint was completely worn off.

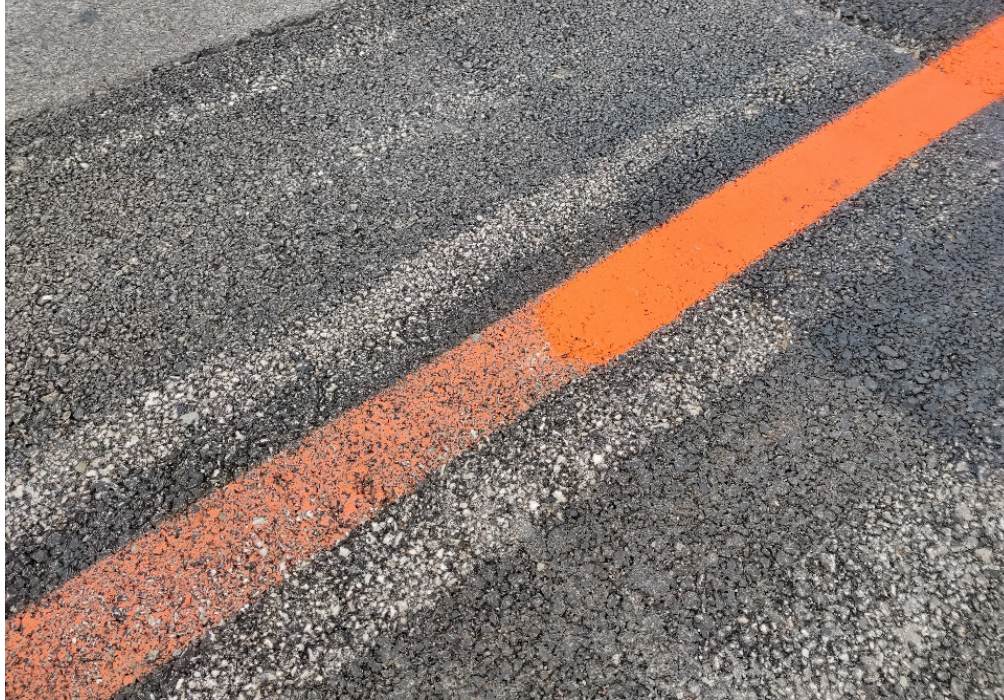
During the February 19<sup>th</sup> inspection, some locations had thermoplastic patching. At those locations, the readings averaged 135.5 mcd/lx/m<sup>2</sup>. The thermoplastic looked much brighter and more durable than the waterborne paint. Figure 4.4 shows the difference between waterborne paint (on the right) and spray thermoplastic (on the left.)

**Figure 4.4** Waterborne Paint and Spray Thermoplastic Side-By-Side

Retroreflectivity measurements were taken in July. The thermoplastic patches had been installed at various times so they were between 75 and 150 days old at the time of measurement. Their average retroreflectivity was 80.3 mcd/lx/m<sup>2</sup>. The same thermoplastic patching was measured in September (300 to 375 days old at the time) and had an average retroreflectivity value of 74.8 mcd/lx/m<sup>2</sup>. None of the spray thermoplastic met the established thresholds for yellow markings of any age.

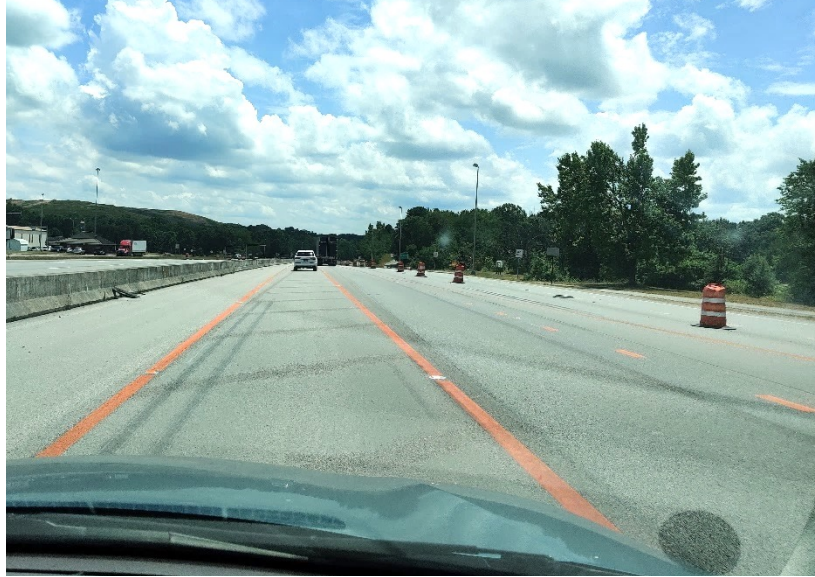
The third material that was tested was a high-build waterborne paint. The paint does not contain HD21 resin, a typical indicator of high-build; instead it is waterborne paint applied at a high-build rate of about 30 mils, making it significantly thicker than the original paint used at the start of this project. The high-build paint was applied with the high-gradation Missouri performance blend bead package and was first installed on June 1, 2020. Figure 4.5 shows the newly installed high-build waterborne paint from a vehicle, and Figure 4.6 shows a close-up of the high-build waterborne paint.

**Figure 4.5 High-Build Paint**

Field observations established that the high-build waterborne markings had a distinct color and were very easy to see. They also appeared brighter at night than either the spray thermoplastic or the original, thinner waterborne paint. Researchers measured the retroreflectivity of the high-build paint three times. The first measurements were taken on July 15<sup>th</sup>, about 40 days after initial installation. About half of the markings passed the 225-threshold for new yellow markings and this segment's overall average retroreflectivity was 219.5 mcd/lx/m<sup>2</sup>. A second set of retroreflectivity measurements was taken on September 23<sup>rd</sup>. The material was about 100 days old and its average retroreflectivity was 179.0 mcd/lx/m<sup>2</sup>. The last set of measurements of the high-build paint was performed on November 18<sup>th</sup>. The high-build paint was 160 days old. Its average retroreflectivity value was 208.9 mcd/lx/m<sup>2</sup>. This is an increase from its 100-day value, which may indicate that paint wore off over time and exposed more beads.

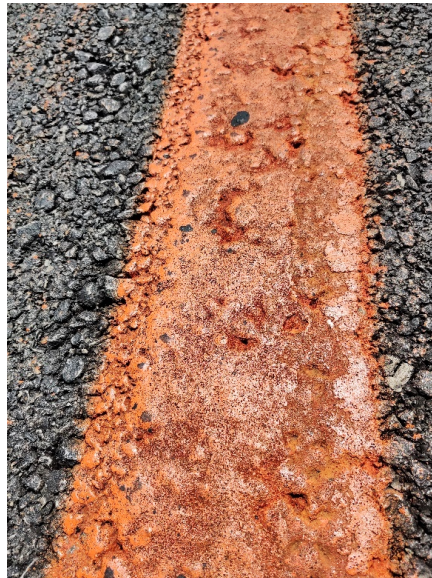
**Figure 4.6 Close-up of High-Build Paint**
