Article title: WHEEL WEAR PERFORMANCE ASSESSMENT AND MODEL VALIDATION USING HAROLD FULL SCALE TEST RIG

Keywords: Wheel profile management, wheelset maintenance, wheel wear prediction, validation, full-scale testing

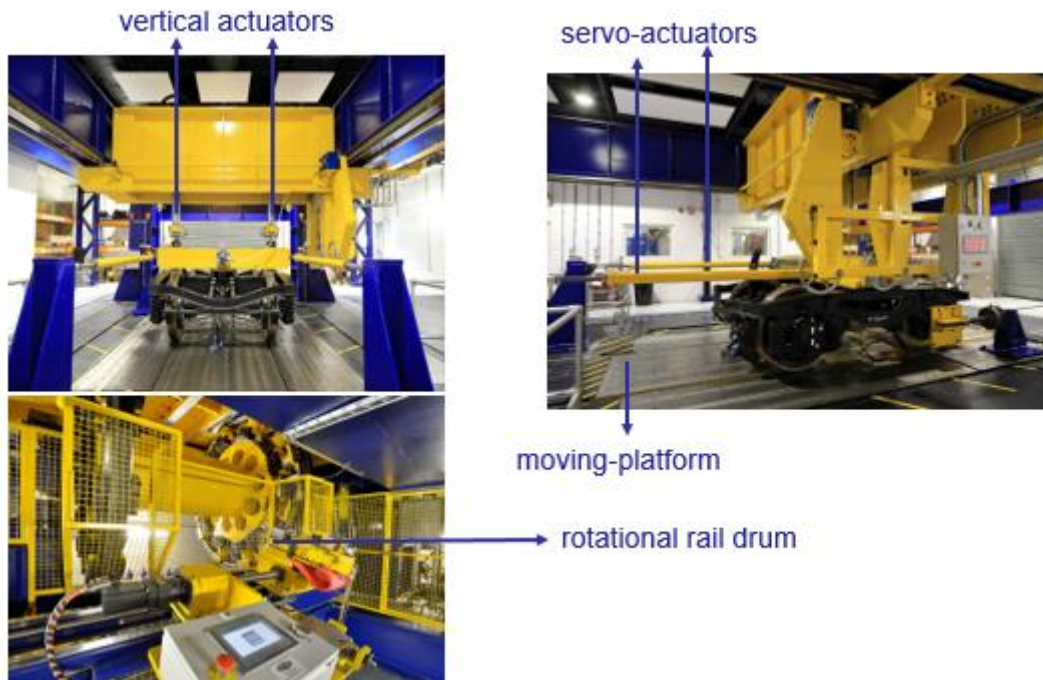
The HAROLD test rig consists of a 2 m diameter drum with two circumferential rails, a bogie moving platform and a loading frame. Figure 1 shows the test rig with its associated components from different views. As it can be seen, the D-Stock bogie was placed on the movable platform and the rotating rails are located below to rotate the leading wheelset of the bogie.

Figure 1: Full scale HAROLD test rig with its components

During the full-scale testing, servo-actuators rotate the movable platform in lateral and yaw axes to stimulate the wheel-rail lateral displacement and yaw angle (angle of attack) seen during vehicle curving. With respect to this, the wheels can experience the range of contact conditions observed in reality. Additionally, the two vertical hydraulic servo-actuators located on the loading frame enable the application of the static and dynamic vertical loading. Each actuator integrates load and displacement measurements that can be used for automatic control of the test parameters.

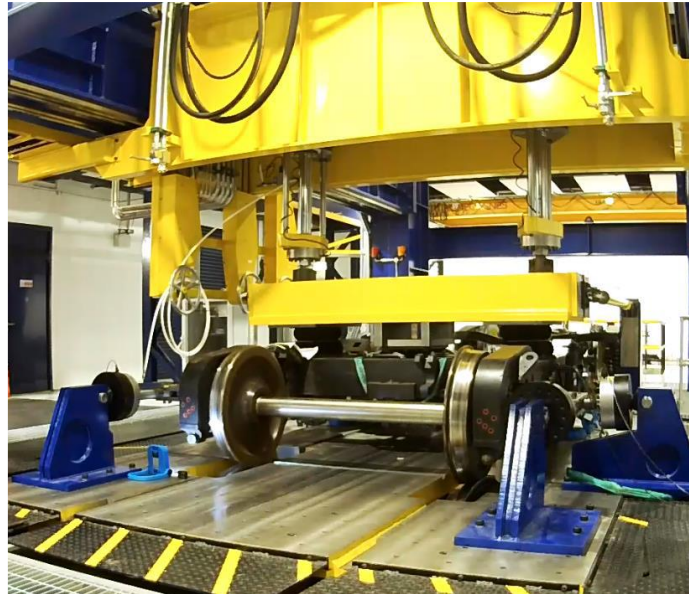
A LUL D-Stock test bogie was used and the test wheelset equipped with restored wheel on the right and a R9 steel grade wheel on the left, shown in Figure 2.

Figure 2: D-Stock bogie with restored and R9 grade wheels

The test rig's vertical hydraulic rams were linked together by a loading beam to ensure the correct interface with the D-Stock bogie's traction centre and diablo springs. The leading wheelset was fastened to adaptor plates on each axlebox and these were connected to brackets bolted onto the movable platform. The brackets ensured that the platform can move the wheelset in lateral and longitudinal axes, helping to recreate the wheel-rail shifts and yaw angle experienced during normal operations.

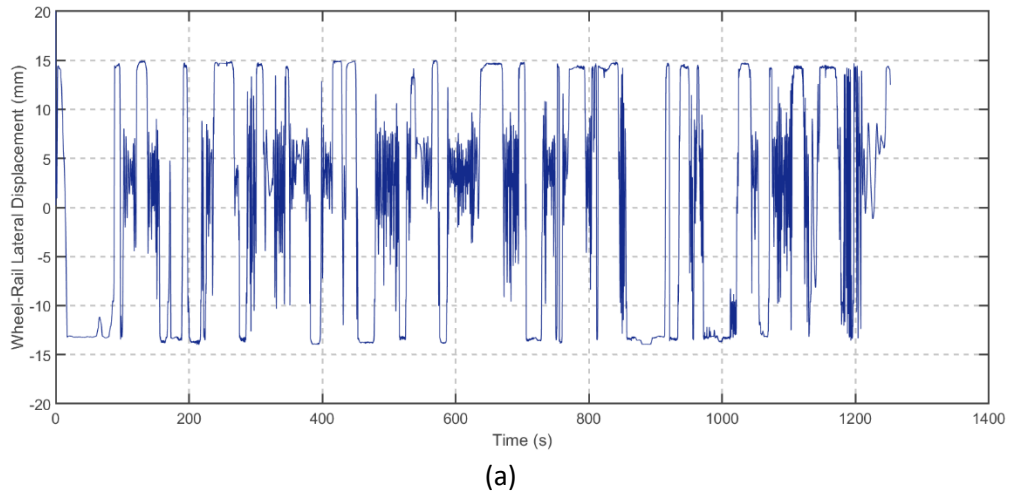
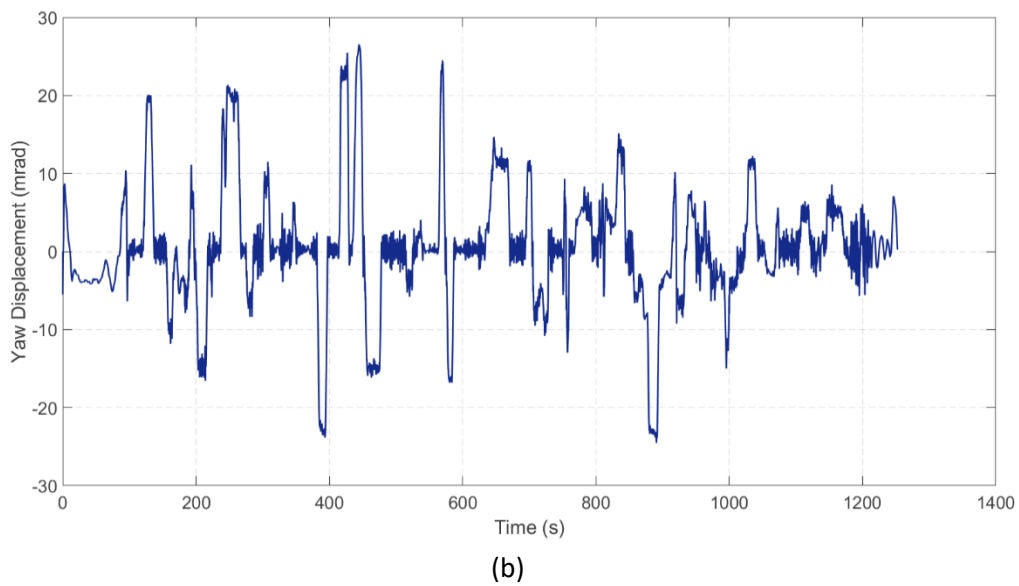
The wheelset lateral and yaw displacements computed from the simulations were used as an input to provide the wheelset trajectory generating the representative contact conditions seen during the service operations. As can be seen in Figure 3, both lateral and yaw displacements are relatively high due to curvaceous track geometry on the Bakerloo line. In order to check whether these given inputs were within the limits of the test rig, the lateral and yaw velocities were subsequently calculated and found that the maximum yaw velocity of 28 mrad/s (≈ 1.65 deg/s) is smaller than HAROLD's 2 deg/s (≈ 35 mrad/s) limit.

Figure 3: Wheel-rail lateral (a) and yaw (b) displacements on the simulated Bakerloo line

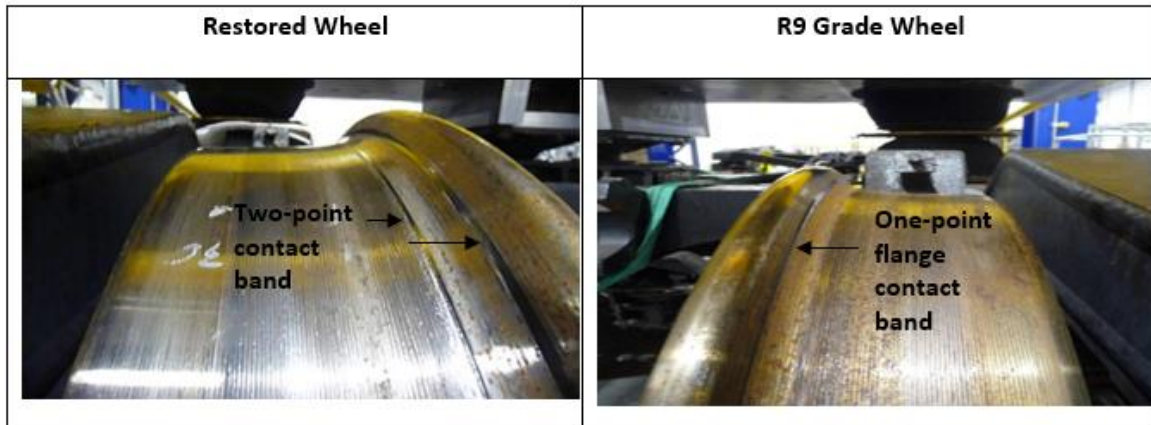
The pre-test operating sequence was carried out using the maximum lateral and yaw displacements to check the occurrence of flange contacts on both wheels. Figure 4 displays the narrow contact band

produced prior to full testing. While two-point contact can be seen on both flange and tread regions of the restored wheel, the latter was not observed on the R9 grade wheel.

Figure 4: Comparison of initial running surfaces between restored and R9 grade wheel

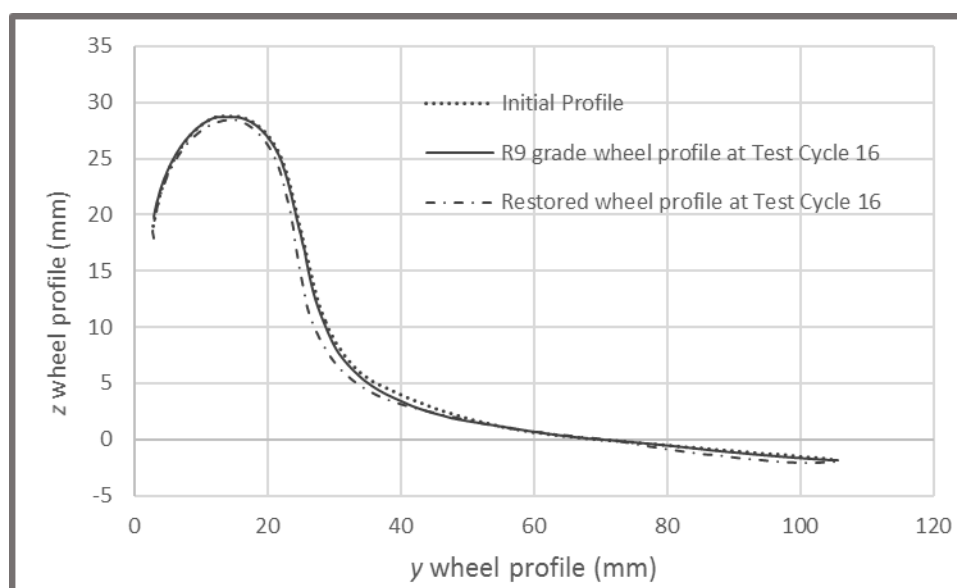
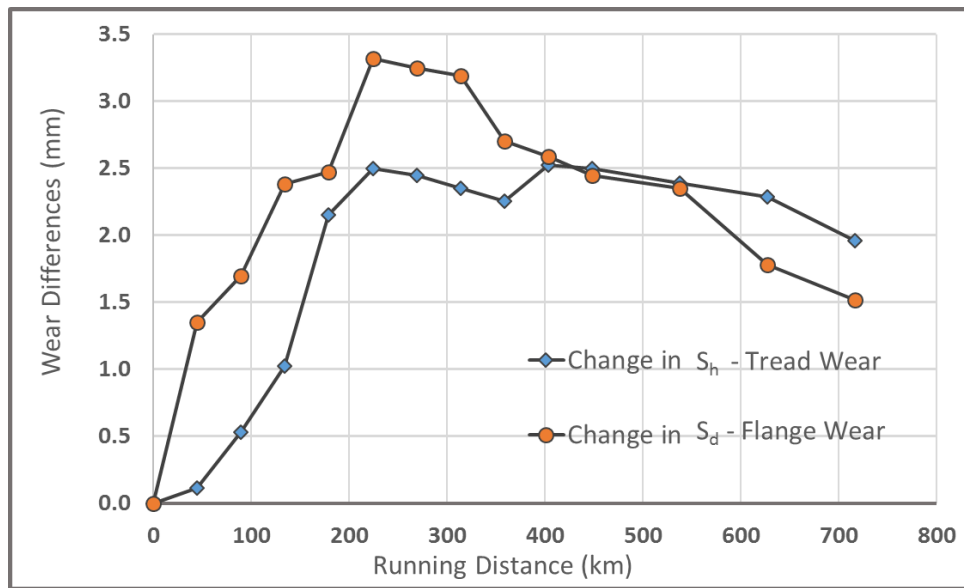
Figure 5(a) presents the initial wheel profile (before testing at Position A) and shows the worn profiles on both restored and R9 grade wheels at the end of experiment (Test Cycle 16). It can be seen that a greater wear was generated on the restored wheel particularly on flange face and tread regions. The differences in flange and tread wear from the R9 grade wheel (Figure 5(b)) also demonstrated that while the (change in S_d) flange wear is approximately 3.5 times higher, (change in S_h) tread wear is 2.5 times larger than the R9 grade wheel. As expected from the vehicle dynamics simulations, the high number of tight curves in the Bakerloo line potentially produced damaging flange contacts which in turn gave rise to larger wear rate in this region. Nevertheless, the higher initial wear experienced at the beginning which can be seen from the slope of the lines decreased as the number of cycles increased in the experiment.

Figure 5: Comparison of different wheel profile measurements (a) and differences on flange and tread wear between restored and R9 grade wheels (b)

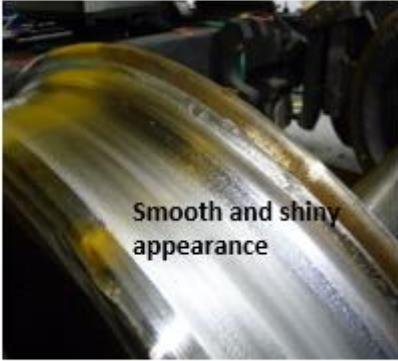
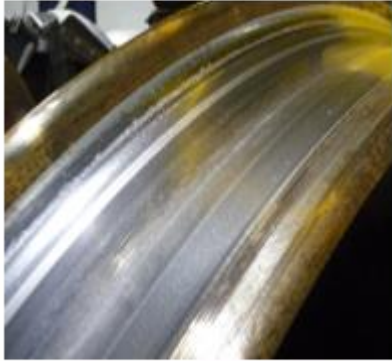
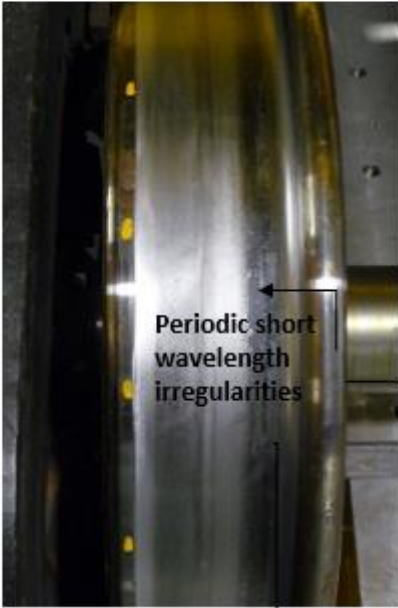
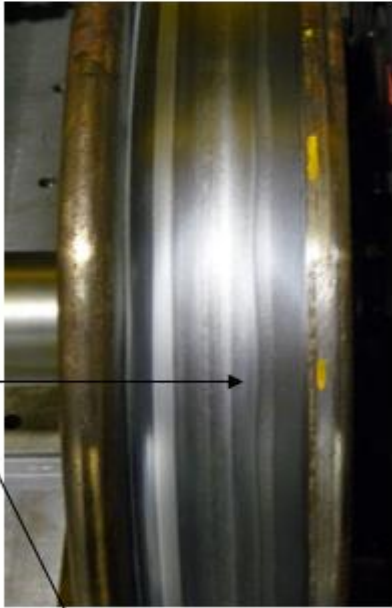
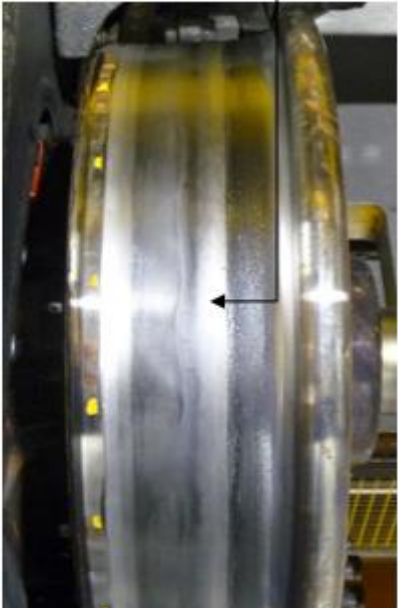
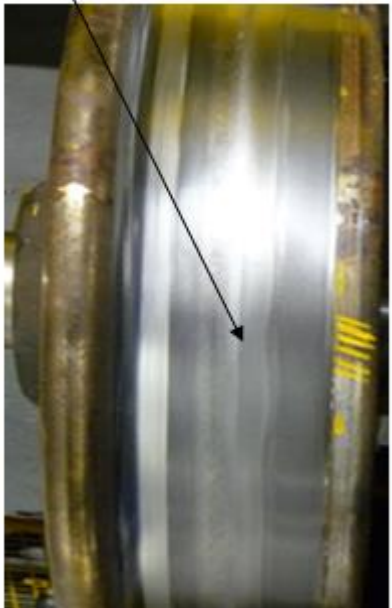
To identify any changes on the surface condition during the tests, photographs were taken following the test cycles. Figure 6 provides a summary of the key observations and illustrates the photos following the test cycles 5, 9 and 16. During the tests, a similar running bandwidth was generated on both wheels which provided confidence that they were subjected to similar trajectory. Compared to R9 grade wheel, the running surface was relatively smoother and shiny appearance with wear debris evident as a result of higher wear rate on the restored wheel. However, a band of RCF damage was also observed to have initiated in the flange root region of the restored wheel.

On the successive test cycles, a short-wavelength irregularity was observed on both wheels as can be seen from the photos provided for Test 9. This is often caused by a wheel out-of-roundness and/or higher track stiffness which could be a characteristic of the test rig. It may also be an indicative of potential sub-surface damage⁸.

<p data-bbox="587 472 799 539">Smooth and shiny appearance</p>

<p data-bbox="608 965 778 1066">Periodic short wavelength irregularities</p>

Figure 6: Key surface observations after the test cycles 5, 9 and 16

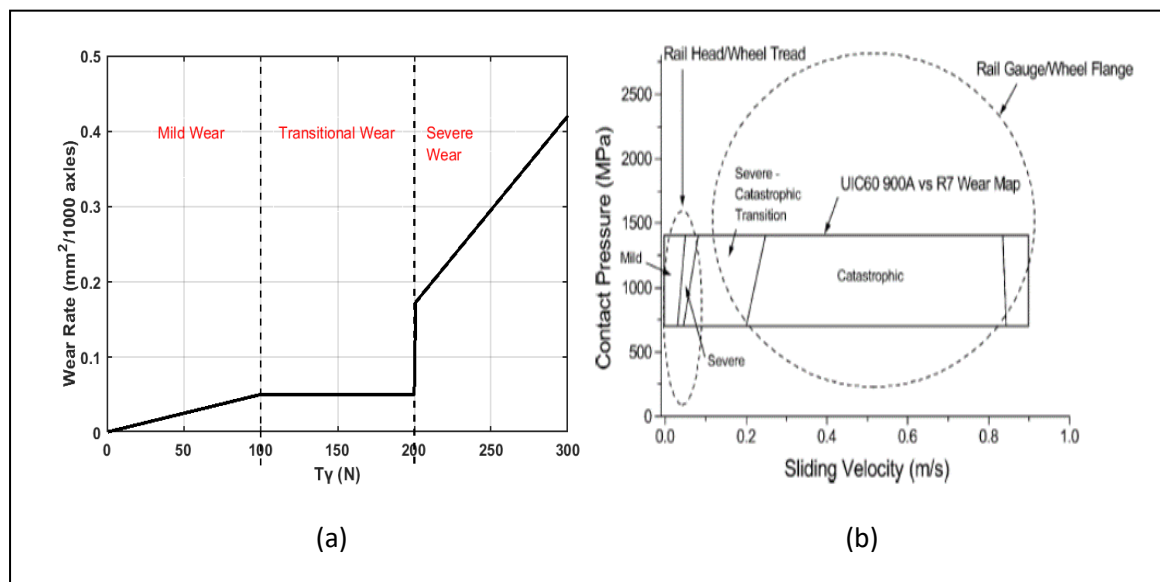
Figure 8(a) presents the model and the changes in wear rates as a result of increase in $T\gamma$ levels. The function was mainly developed considering the full-scale test results for R8T (wheel) and BS11 (rail) steels under dry conditions.

Figure 8: BRR wear function¹³ (a) Wear map for UIC 900 A rail against R7 wheel¹⁸(b)

The wear coefficient k is based on the relationship between sliding velocity v (m/s) and contact pressure P ($MPa=N/mm^2$). The variation of the k coefficients can be found by using a wear map. The regimes in this map have been defined using twin-disc and pin-on-disc tests with different rail and wheel materials under mainly dry conditions¹⁹⁻²¹. Figure 8(b) shows an example of a wear map and the (dimensionless) k wear coefficients for 900 A rail against R7 wheel. Therefore, certain scaling was required to apply in full-scale experiments. Previously, the wear rates from small and full-scales tests were compared using $T\gamma$ ($T\gamma/A$) parameters and showed good correlations^{19,21}.

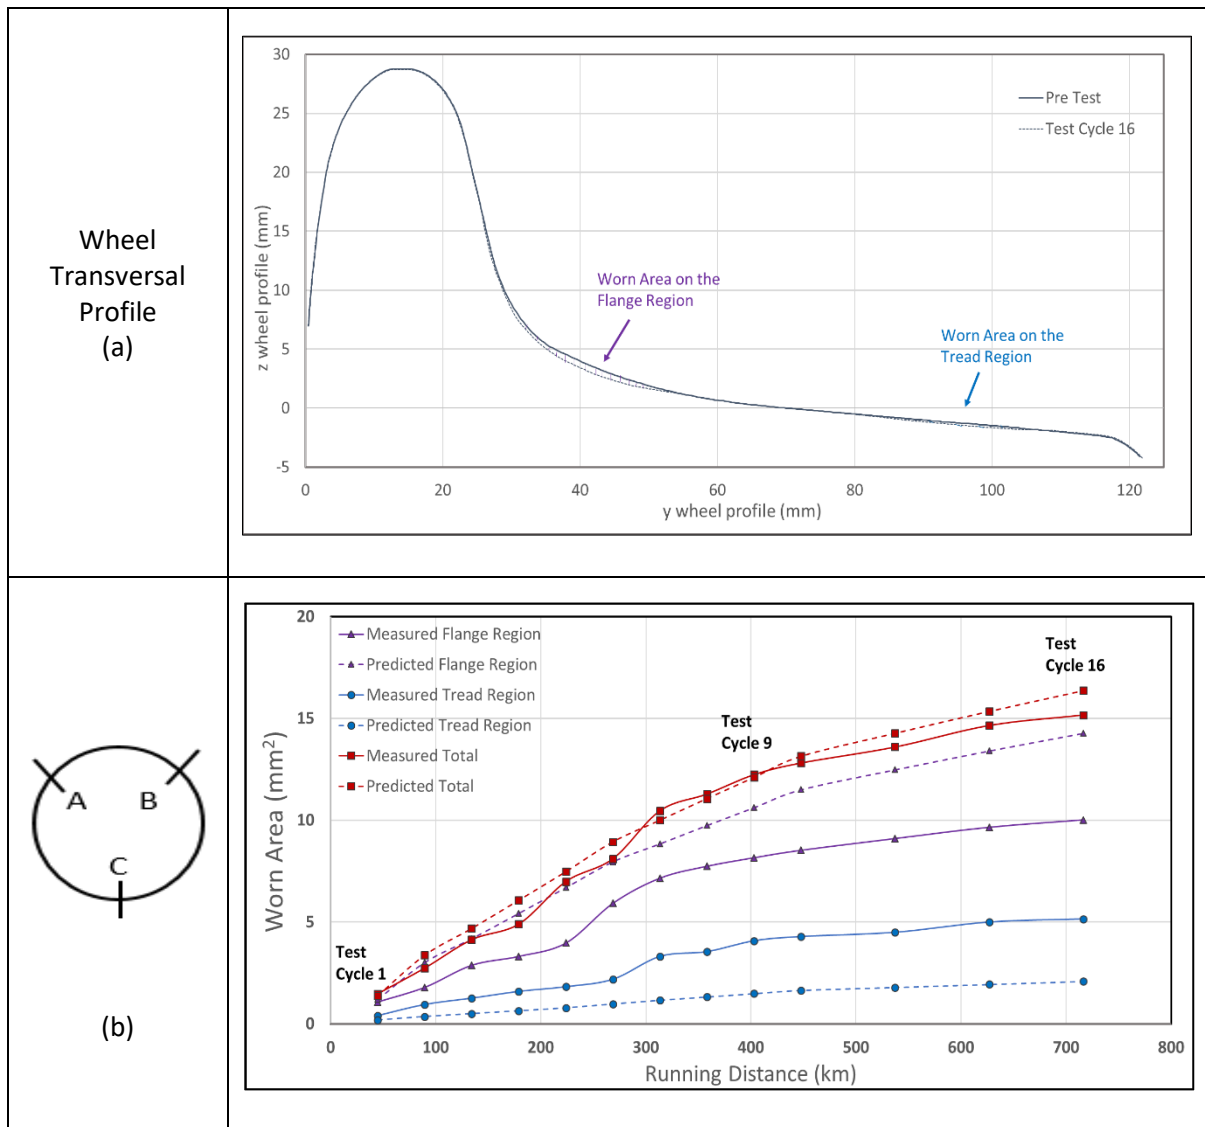
As there were no significant variations between the flange height and thickness measurements from different circumferential positions on the R9 wheel, the average worn areas were presented on Figure 9(b) and due to this, using different A, B and C profiles did not alter the predictions.

Figure 9: Transversal wheel profile differences between Pre-test and Test Cycle 16 (a) and comparison of worn area predictions and measurements on the R9 grade wheel (b)

It can be seen that although the greater energy produced at the flange contacts resulted in larger wear rates and the lower T_y values generated at tread contacts led to smaller predictions, there were no major differences between the total results. The higher initial measured worn areas showed a gradual increase and better agreement with the predictions at the beginning. But, the wear reached steady-state wear regime (a plateau) around Test 9. As the increase in running distance gave rise to higher predictions, the differences became larger after reaching this steady-state wear regime which might be caused from the hardening of the material experienced in reality. Owing to this fact, it was previously advised that the wear testing should be continued until the values reach this plateau¹⁹.

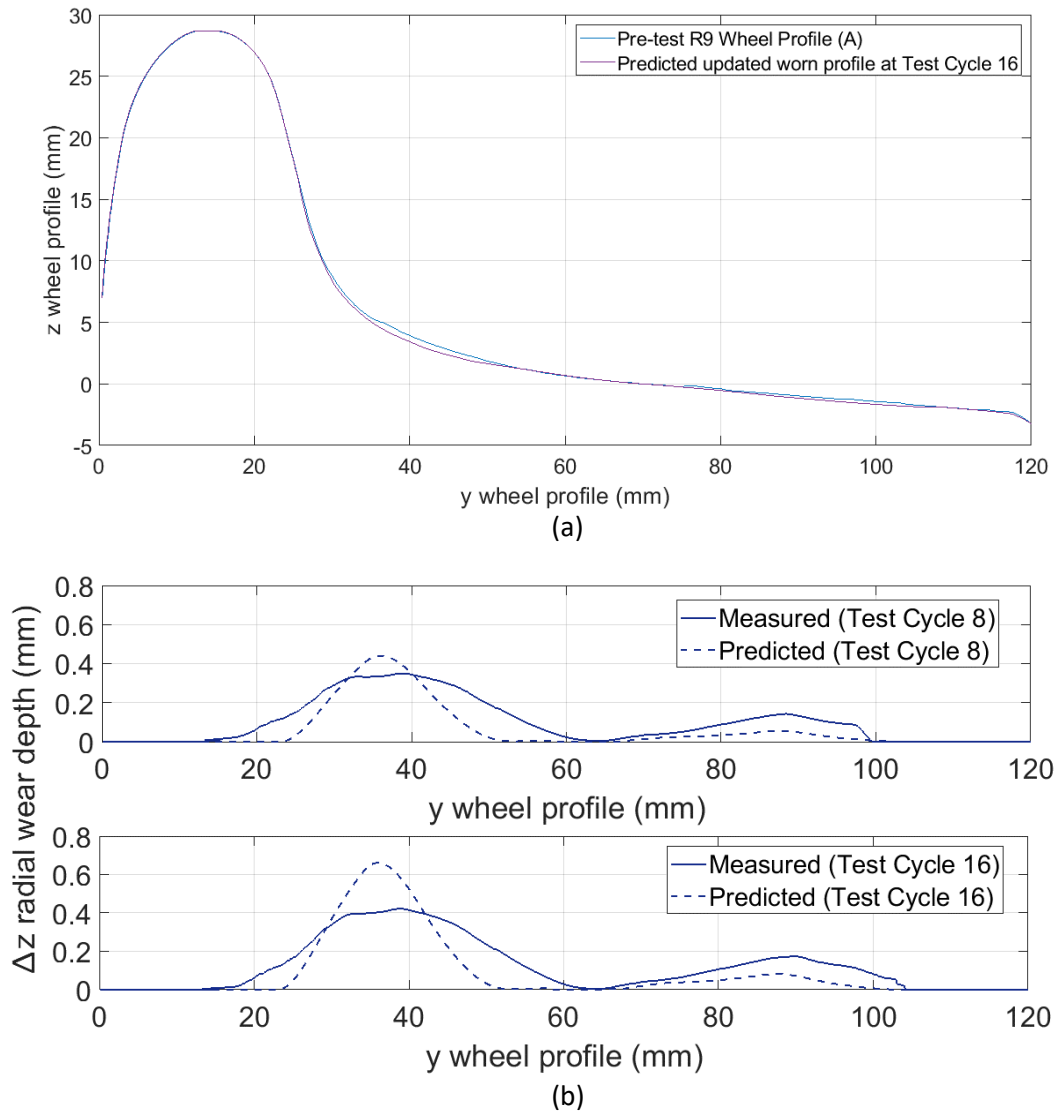
The top plot in Figure 10(a) displays the provided pre-Test profile at position A and the updated worn profile at Test Cycle 16 whilst, the lower plot (b) presents the comparison of predicted wear depth Δz with the measured values across the wheel profile under Tests 8 and 16. Similar to BRR function predictions, the higher flange and lower tread contact creep forces resulted in over- and underestimation of wear, respectively. The steady state wear regime again could not be described by this model as the differences became larger in the Test 16. In addition, while the measured wear generated wider contact bands particularly on the flange region, the predictions contacted narrower area and became limited in the flange root of the wheel.

Figure 10: Predicted updated worn profile at Test Cycle 16 (a) and comparison of Δz wear depth predictions and measurements on the R9 grade wheel (b)
