## The vulnerability of solar panels to hail

## The vulnerability of solar panels to hail.

Climate-KIC project: *'1 million near-zero energy homes in 2023'*

Teule, T.S., Appeldoorn, M., Bosma, P., Sprenger D.D., Koks, E. & De Moel, H.

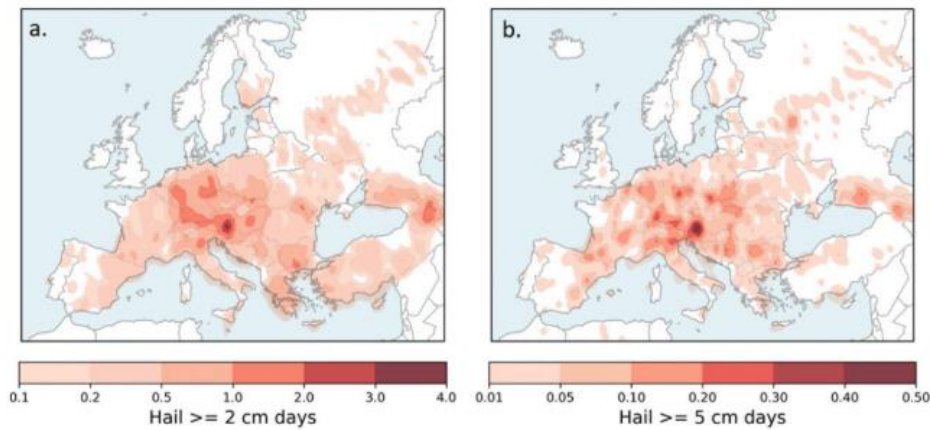
Figure 1: Mean annual number of days with (a) large & (b) very large hail (from the research of Pucik et al. (2019)).

Pucik et al. (2019) shows that large hail ( $\geq 2$  cm) occurs in similar spatial patterns but less frequent than very large hail ( $\geq 5$  cm), as can be seen in Figure 1. The highest frequencies can be found in the southeast of Austria. This area experiences large hail around three to four days a year and very large hail every two years. Other areas with a high frequency of hail are in southwestern Germany, the Po Valley in Italy, over the Ore Mountains on the border of the Czech Republic and Germany, and on the border of the Czech Republic and Poland. (Pucik, et al., 2019). Punge & Kunz (2016) also show an overview of hail event frequency in Europe. According to that study, central Europe, like Germany, Switzerland, and Austria, are highly exposed to hail hazard.

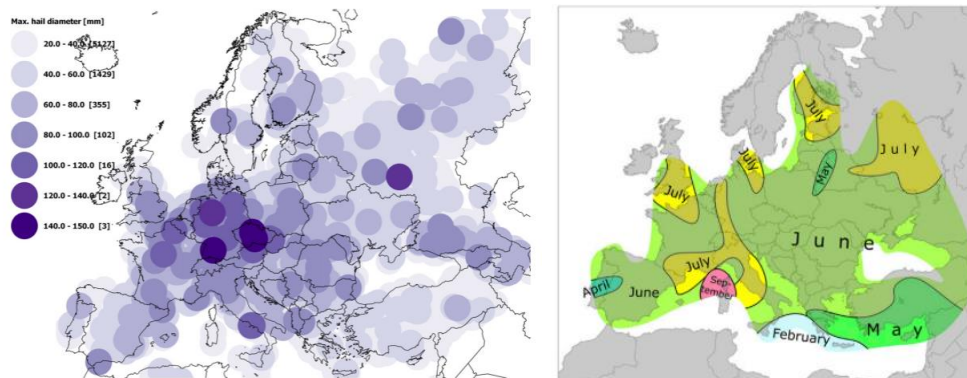
Figure 2: (a) Maximum size (mm) hailstones reported by ESWD until Sep. 2015 (from the research of Punge & Kunz (2016)). (b) The month with the most frequent large hail occurrence (from the research of Pucik et al. (2019)).

Pucik et al. (2019) confirms that large hail is mostly reported in the summer months, with June or July as the peak in most areas of Europe as can be seen in Figure 2b. In the Southern regions, the peak months differ from April in Portugal to February in the South of Italy and Greece. This is because continental areas experience the peak thunderstorm season and thus large hail, in the months with peak heating. The coastal maritime areas, such as in Italy and Greece, experience their peak in autumn to winter months as the Atlantic subtropical ridge shifts southward and deep low-pressure systems develop over the Mediterranean Sea (Pucik, et al., 2019). Suwala & Bednorz (2013) mentioned that in Central Europe most hail events occur during the first half of the warm season (April to

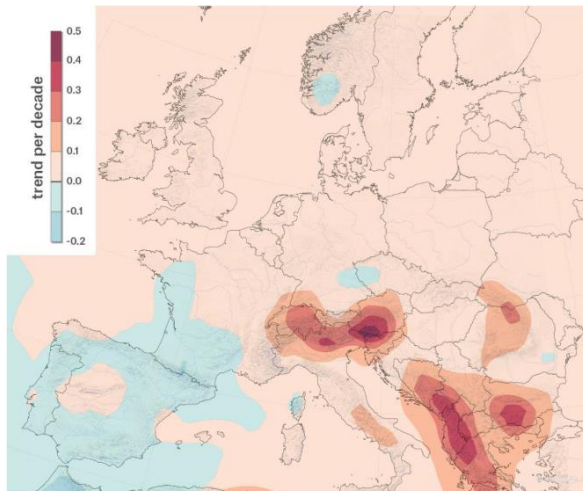
Figure 3: Trend of change in hail events from 1979 to 2015 (from the research of MunichRe (2019)).

The number of hail events increased significantly in a period of 37 years from 1979 to 2015 in Europe (MunichRe, 2019). However, these changes are not homogeneous all over Europe. The number of hail events increased the most in areas with mountains and in pre-Alpine regions (EEA, 2017). The largest increases are observed in northern Italy and on the Adriatic coast, as can be seen in Figure 3. In central Europe, in France, the Benelux and Germany smaller increases were seen. In the southwest of France and parts of the Iberian Peninsula a slight decrease is found (MunichRe, 2019).

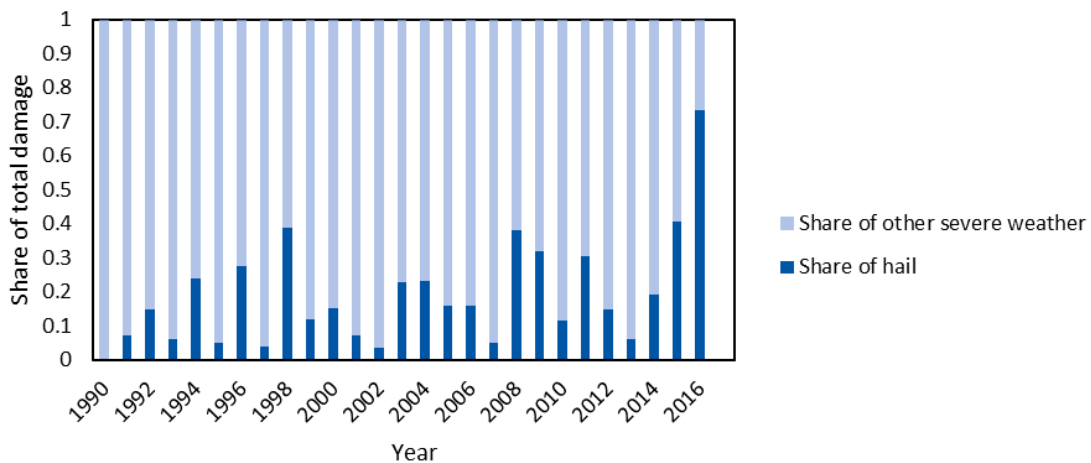
Figure 4: Average share of insured damage due to hail from all insured damage by severe weather per year from 1990 to 2016 (data from Achmea data (2019)).

The Netherlands is one of the countries in Europe that deals with damage due to hailstorms as well. Figure 4 shows an overview of the share of insured damage in the Netherlands due to hail from the total insured damage caused by severe weather (Achmea data, 2019). It can be seen that there are several years that the damage due to hail plays a large role in the total damage. For example, in 2016, 73% of all insured damage caused by extreme weather is caused by hail, but on average it makes up 19% of the total damage by severe weather. However, it must be kept in mind that the data before 2007 does not include all the damage data from the insurance company. So, the graph gives an overview of the share of hail damage, also before 2007, but it does not give the exact shares of damage.

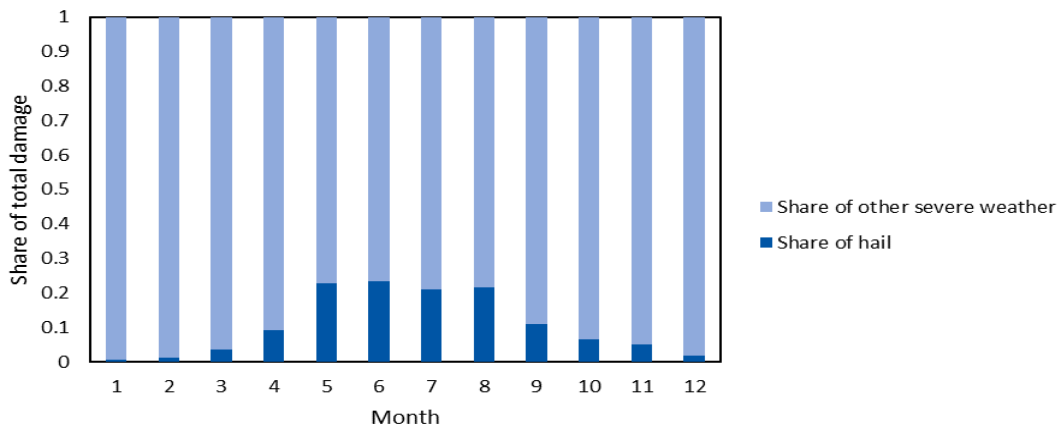
Figure 5: Average share of damage due to hail from all damage by severe weather per month from 1990 to 2016 (data from Achmea data (2019)).

Figure 5 shows the largest share of insured damage due to hail per month, averaged over the years 1990 to 2017. Hail damage occurs the most in the summer months from May to August. This is also in agreement with the findings of Pucik et al. (2019) who show that the Netherlands experiences most hailstorms in June and July. This indicates that damage is in relation to hailstone sizes, as the largest hailstones are found in summer as well, as can be read in the research of Wouters et al. (2019)).

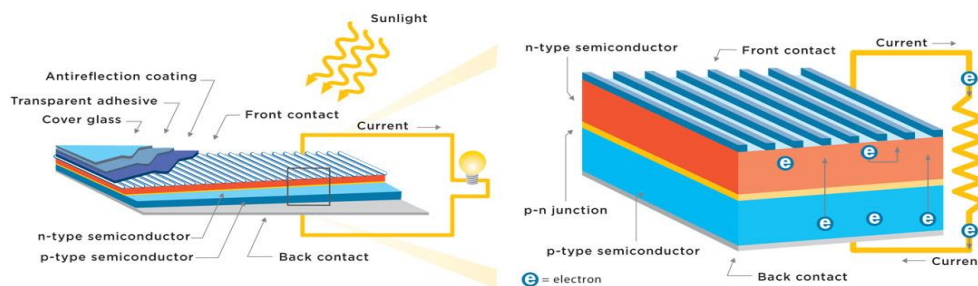
Figure 7: Fundamentals of a solar panel and solar cell (Alpine Solar, 2019).

Sunlight first encounters the antireflection layer. This layer has an optical coating, which is made to minimise the loss of light and retain the light as best as possible. In order to do this, the transmission of the light to subsequent layers is promoted. Those subsequent layers convert energy. They consist of a top-junction layer, an absorber layer, and a back-junction layer. These three layers, together with the antireflection layer, are situated between two electrical contact layers. The front electrical contact layer consists of very thin and widely spaced grid lines. Those grid lines are made to be as small as possible, in order to minimise the blockage of light. The back electrical contact layer does not have any restrictions on its surface area and therefore covers the entire back of the solar cell (Fonash et al., 2018).

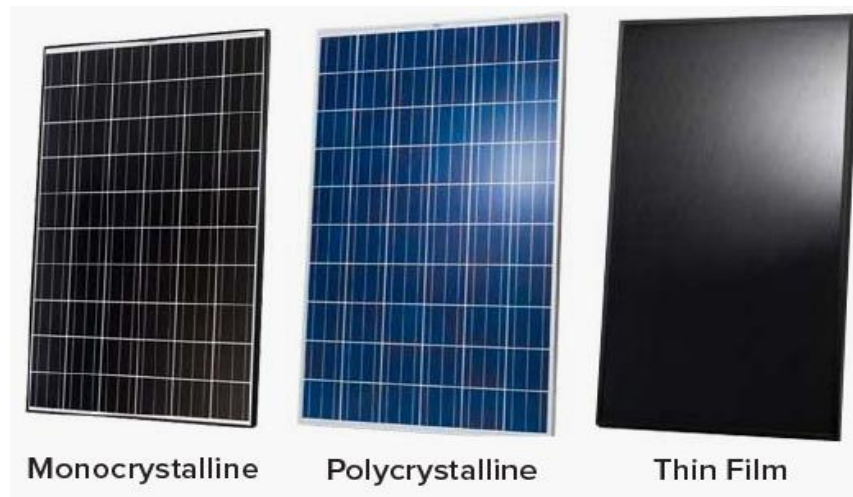
Figure 8: Three different types of solar panels (Solarmarket.com.au, 2019).

Solar panels can be divided into a few categories: monocrystalline solar panels, polycrystalline solar panels, and thin-film solar panels. The first two are silicon-based solar cells (Hussain, 2018). They are named after the material of the semiconductor and currently hold the largest market share in the Netherlands (Consumentenbond, 2019b). Monocrystalline solar panels are currently the most efficient type of solar panels (Consumentenbond, 2019b). Polycrystalline solar panels are less efficient than monocrystalline solar panels but are also less expensive. Monocrystalline panels can also be made into all-black solar panels. Those panels are aesthetically well designed and have an all-black appearance. However, all-black panels absorb more heat on the parts around the antireflection layer, which lowers the efficiency of the panel.

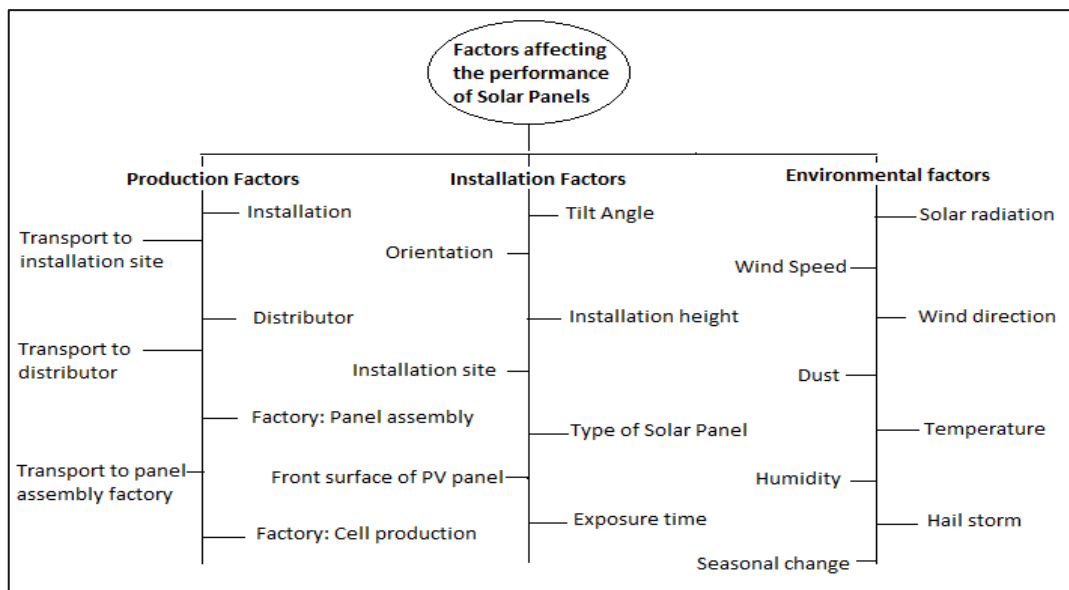
Figure 9: Factors affecting performance of solar panels, adapted from the research of Gupta et al. (2019)

Figure 10 shows an overview of these three categories. During the production solar panels can get damaged during transport, installation or already at the factory. Installation factors can affect the performance of the panels as well, by the choice in type of solar panel, the orientation, and the tilt angle of the panel for example. Environmental factors can affect the performance after the panel is installed due to wind, dust, and hail for example.

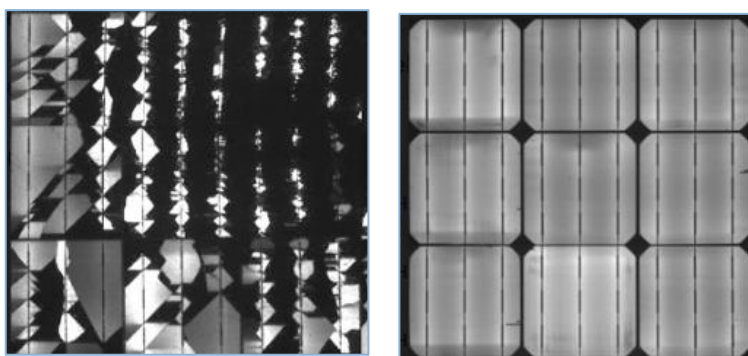
Figure 10: Results of electroluminescence of (a) visible and (b) invisible (micro-cracks) damage to a solar panel (provided by Solar Tester Nederland (2019)).

The above factors can potentially cause damage to the solar panels which can occur in different forms. The front glass surface of a solar panel can crack after the impact of an object. This type of crack is directly visible. The crack reduces the solar insolation to enter straight to the solar cell which consequently results in a lower yield (Gupta et al., 2019). Smaller cracks that are not formed in the front glass layer but in the more fragile silicon layer are called micro-cracks (Solar Tester, 2019). These micro-cracks can only be seen using special tests, an Electro Luminescence test for example. In this test, the light output increases with the voltage so areas with cracks appear as dark spots. Therefore, the test can show the shape of the cracks and can indicate the cause of the crack. For example, a star-shaped micro-crack can indicate the impact of a small object, like a hailstone. Micro-cracks usually do not show a lower yield initially, but will after a few months (Solar Tester, 2019). In Figure 11 a simple example of visible and invisible damage is given. Other methods that can inspect the damage to installed solar panel modules in the field are thermography technique and the UV-fluorescence imaging method. The thermography technique is most commonly used in the field, using a portable camera that can detect thermal hot spots indicating disconnection between modules or strings for example (Gupta et al., 2019).

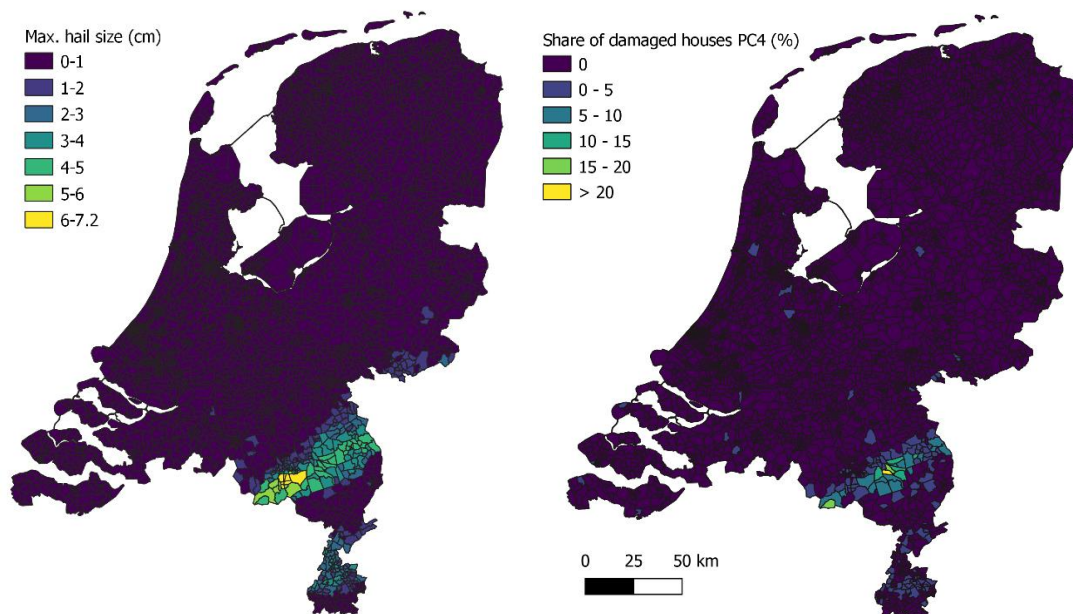
Figure 11: Hailstorm 23 June 2016 in the Netherlands (a) Max. hailstone size (cm) in postcode (KNMI (2019)). (b) Share of damaged houses of total insured houses in postcode (based on data from Achmea (2019)).

This can also be seen in Figure 12, which shows the maximum estimated hailstone sizes per postcode (PC4) in centimetres. It can indeed be seen that in the southeast of the Netherlands, in Noord-Brabant and Limburg, the largest hail occurred according to a dataset from Wouters et al. (2019). The map on the right shows the damage as a share of damaged houses of the total houses in the postcode (Achmea data, 2019). In general, the same area where the largest hail was observed also shows the highest damage, leading to areas where more than 20% of the houses were damaged by the hailstorm. However, it can also be seen that in some areas where hail sizes were large, the damage is not that large. This could be explained for example by agricultural areas that are sparsely populated, or because hail is a very local phenomenon, so even if in some postal code areas, the maximum hail size was very large this does not directly mean it was that big in the whole area.

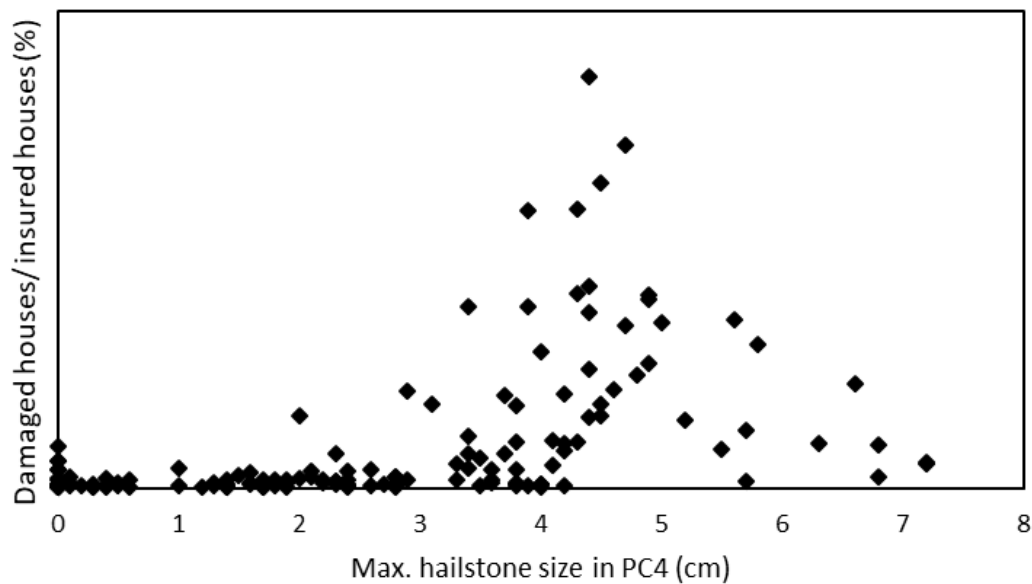
Figure 12: Share of damaged houses of total insured houses to max. hail sizes in corresponding postcode (based on data from Achmea (2019) and KNMI (2019)).

Figure 13 shows a plot of the number of damaged houses from the total number of insured houses in a postal code in relation to the maximum hailstone size in that postal code. The numbers on the y-axis are left out of the figure, as this data contains sensitive information. The figure shows that even from small hailstones damage can occur, but from a hail size of 3 cm, the damage to property is increasing substantially. It can also be seen that for larger hailstone sizes it seems that the damage is decreasing again. However, this could also be the case because there are only very few areas where these large hailstones occurred, where maybe no buildings were located.

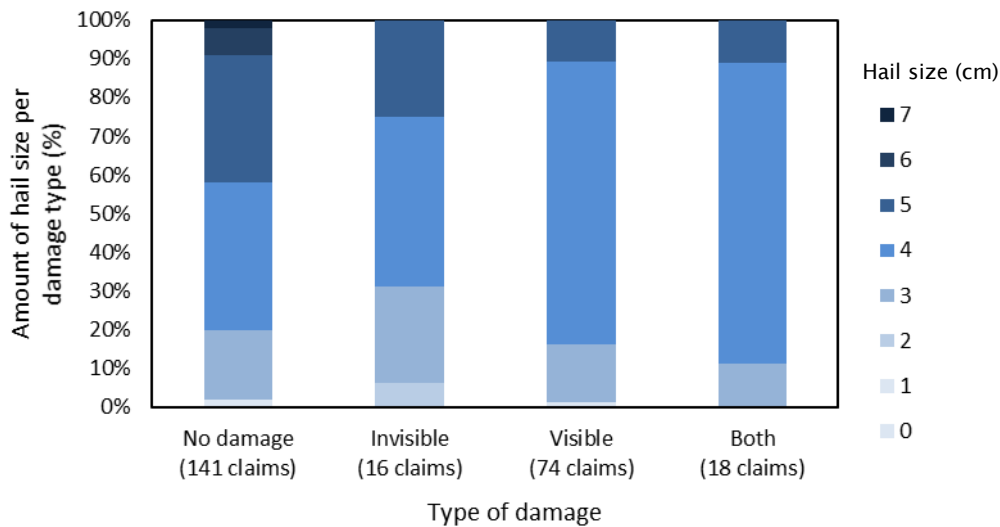
Figure 13: Share of max. hail sizes (cm) per type of damage (based on data from Achmea (2019) and KNMI (2019)).

The damage specifically to solar panels caused by the hailstorm on the 23rd of June is also analysed. In this case study, 249 insurance claims are used that included damage to solar panels caused by hail (Achmea data, 2019). These claims are divided into no damage, invisible damage, visible damage, or both types. Figure 14 shows per type of damage the maximum hailstone sizes in the postcode the claim was located in. On the locations of the claims with no damage, the largest variety in hail sizes is observed. This might be caused by the fact that, more than half of all the claims, had no damage to the solar panels. So, more claims on various locations can indicate a wider range of hail sizes. It can also be seen that in the damage categories, the hail sizes of 2 and 3 cm are decreasing from invisible damage to visible damage and that the hail sizes of 4 cm are increasing. However, it can also be seen that the larger hail sizes are decreasing a bit as well. This can again be caused by the fact that hail is very local and a maximum hail size in a postcode does not mean that this was also the exact hail size on the location of the claim. This indicates that the impact of hail stones of 4 cm or larger can make solar panels more vulnerable to become visibly damaged.

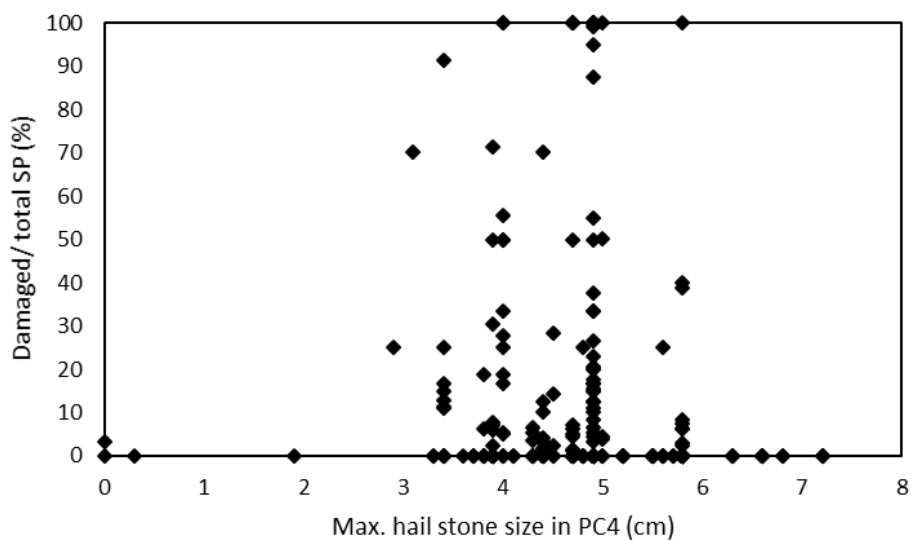
Figure 14: Share of damaged solar panels of the total number of solar panels per claim in relation to the max. hail size (cm) (based on data from Achmea (2019) and KNMI (2019)).

Figure 15 shows the share of damaged solar panels from the total number of solar panels on a building, in relation to the maximum hailstone size in the postcode where the claim was located. Most damage to solar panels starts from a maximum hail size of 3 cm or more. It can also be seen that there are two claims where the detected hail size by the radar was 0 cm, but there was some damage, this is probably related to uncertainties in the hail stone size estimation (i.e. the radar imagery augmented numerical weather model data). Larger maximum hail sizes than 3 cm, are causing more damage. The hail can cause only a few percent of the solar panels to be damaged or can lead to all the panels on a roof to be damaged. There are not many claims in postal code areas with hail with a maximum size of 6 cm or larger, so the low damage percentage factors should not be considered indicative for the overall vulnerability.

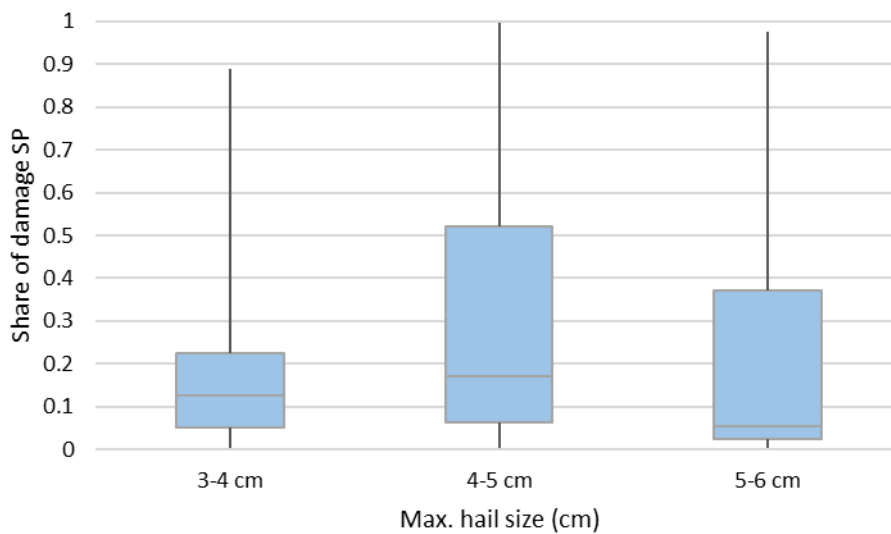
Figure 15: Share of damaged SP per claim in relation to max. hail size (cm) for 3-4 cm and 5-6+ cm

Figure 16 presents three boxplots for claims with damage with a maximum hail size of 3-4 cm, 4-5 cm and 5-6 cm. The lower hailstone sizes are not taken into account as these were only two claims. Hailstones of 4-5 cm cause on average more damage than hailstones of 3-4 cm, but also show a wider range of damage. The hypothesis is tested that solar panels that were hit by hailstones of 4-5 cm have more damage than solar panels that were hit with hailstones of 3-4 cm. The results of a t-test (one-tailed) showed that this was indeed the case ( $p$ -value = 0.063, one-tail). However, the figure also shows that hailstones of 5-6 cm show a lower average damage. This might be due to more variety in hailstones in an area with high maximum hailstone sizes. The chance that a solar panel was actually hit by such a large hailstone is not very high. A t-test shows there is no significant difference between these two groups ( $p$ -value = 0.250, one-tail).
