**SLOPE FAILURE IN CARACAS, VENEZUELA:  
THE INFLUENCE OF SQUATTER SETTLEMENT**

Thesis submitted for the degree of Doctor of Philosophy

University of London

August, 1992

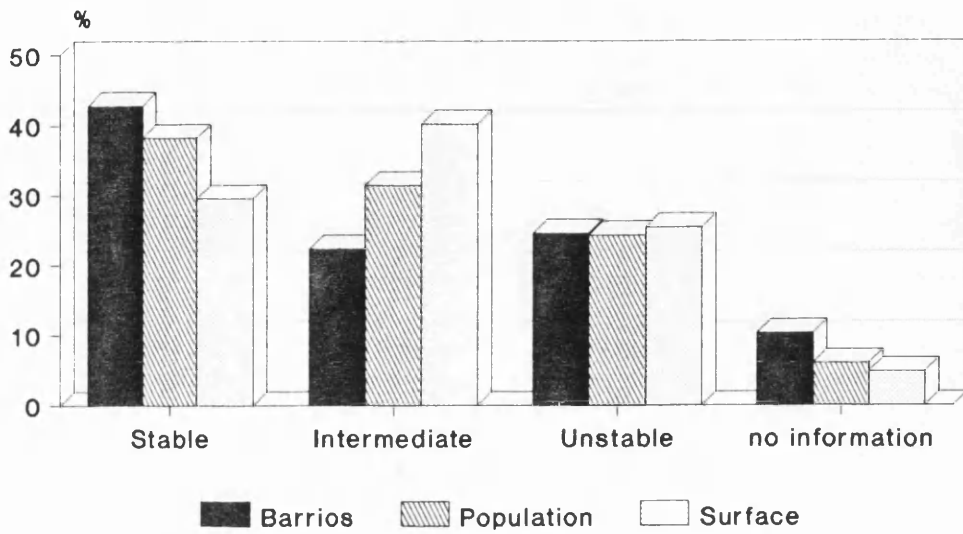
Figure 1.1: *Barrios* classified according to geotechnical conditions

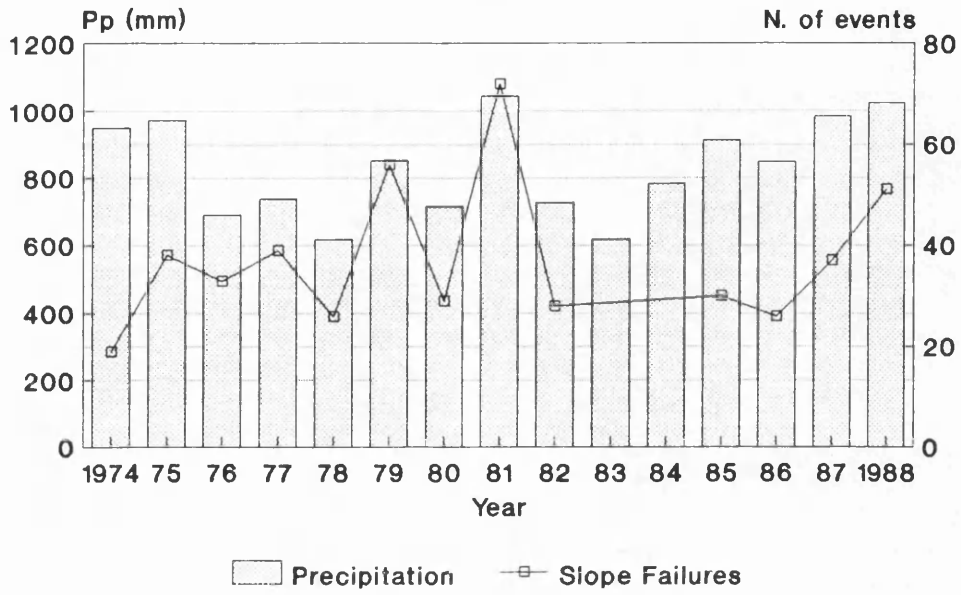
**Figure 3.2: Caracas**  
**Annual rainfall and slope failures**  
**1974-1988**

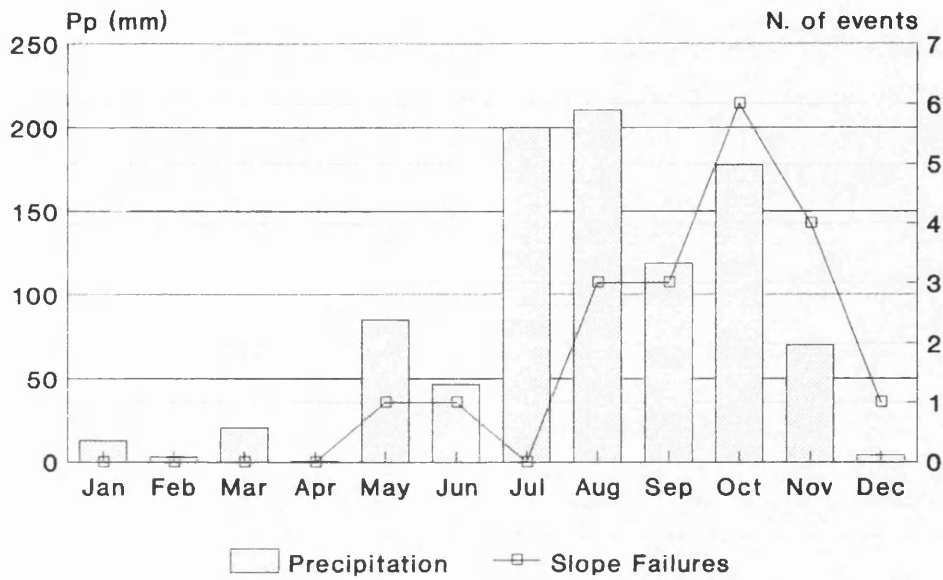
Figure 3.3:  
Monthly rainfall and slope failures  
1974

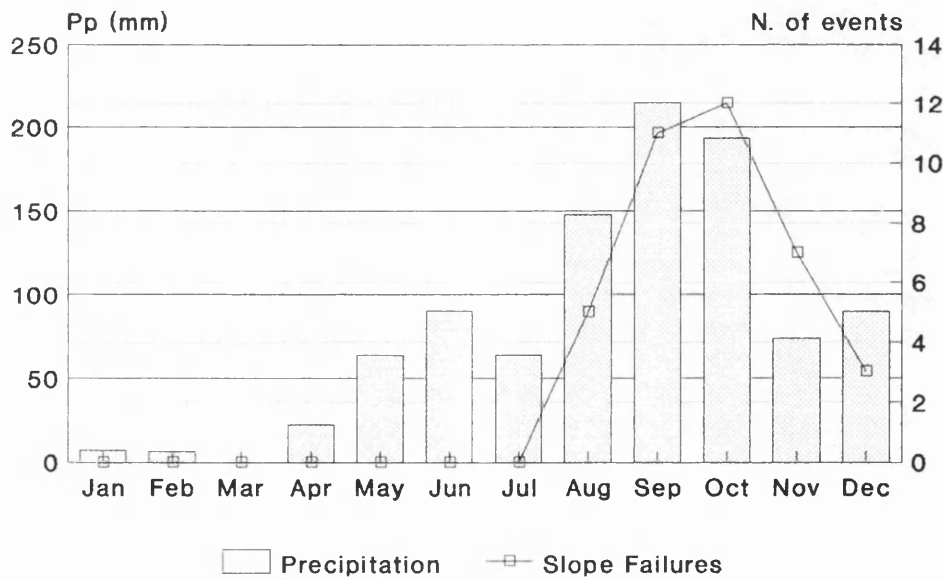
Figure 3.4:  
Monthly rainfall and slope failures  
1975

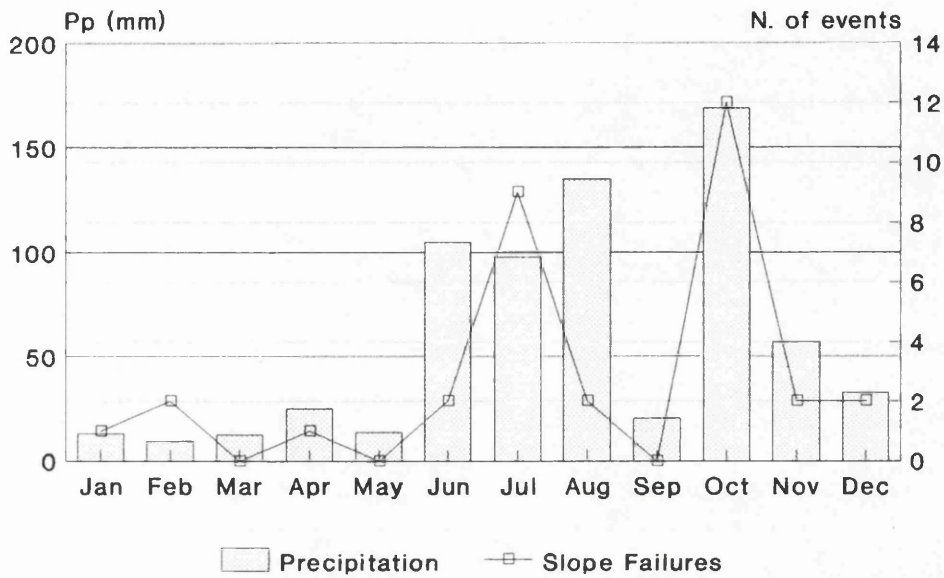
Figure 3.5:  
Monthly rainfall and slope failures  
1976

(Fig. 3.5). The consequences in *barrios* settlements were 10 deaths, 28 injured, more than 30 houses destroyed and another twelve damaged.

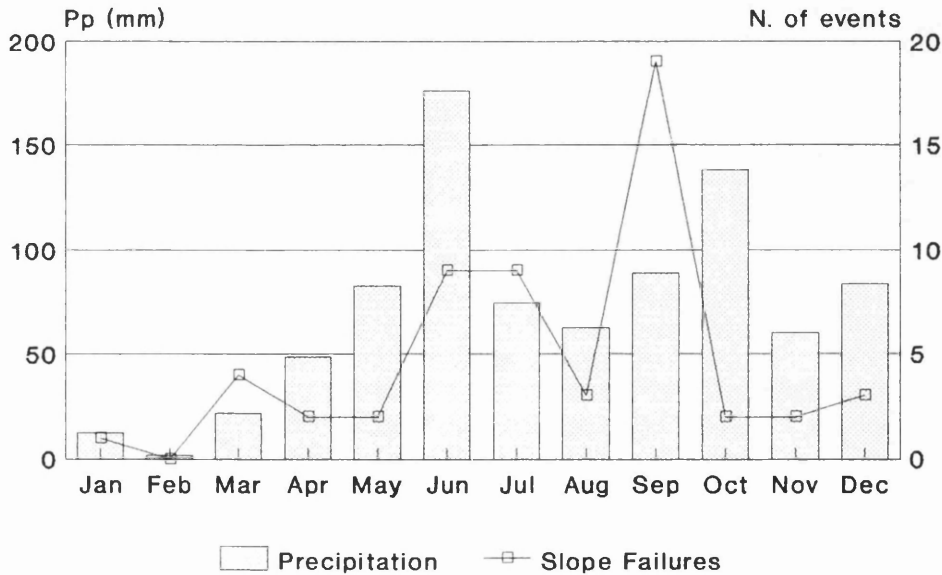
Figure 3.8:  
 Monthly rainfall and slope failures  
 1979

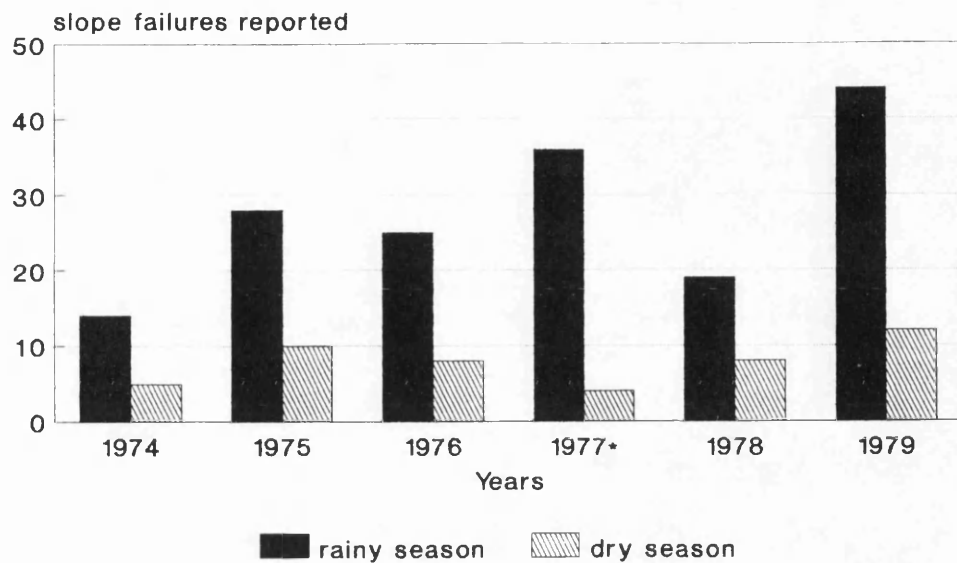
**Figure 3.9:**  
Seasonal pattern of distribution  
of slope failures, 1974-1979

\* In 1977, slope failures in November  
are included in the rainy season

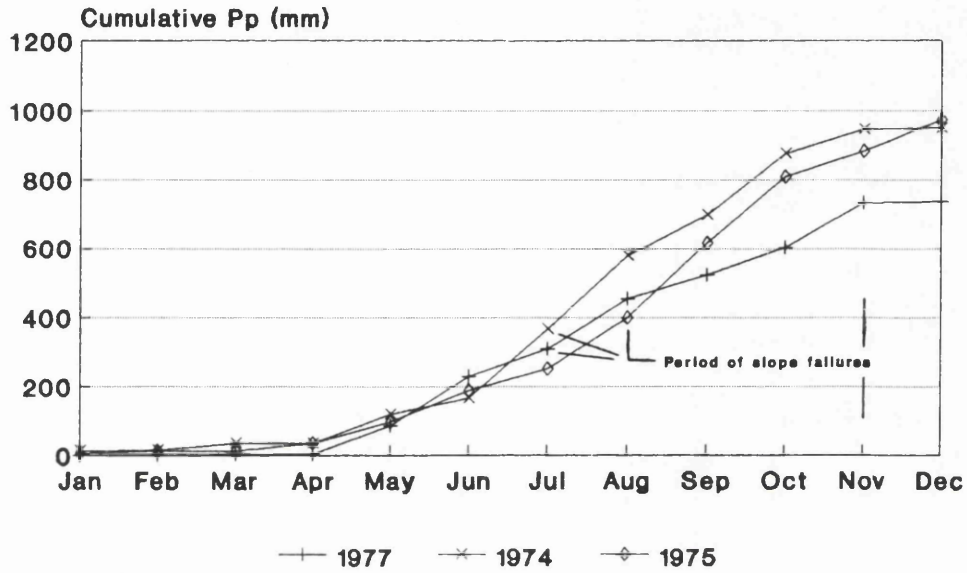
Figure 3.10:  
 Period of slope failures  
 1974 - 1975 - 1977

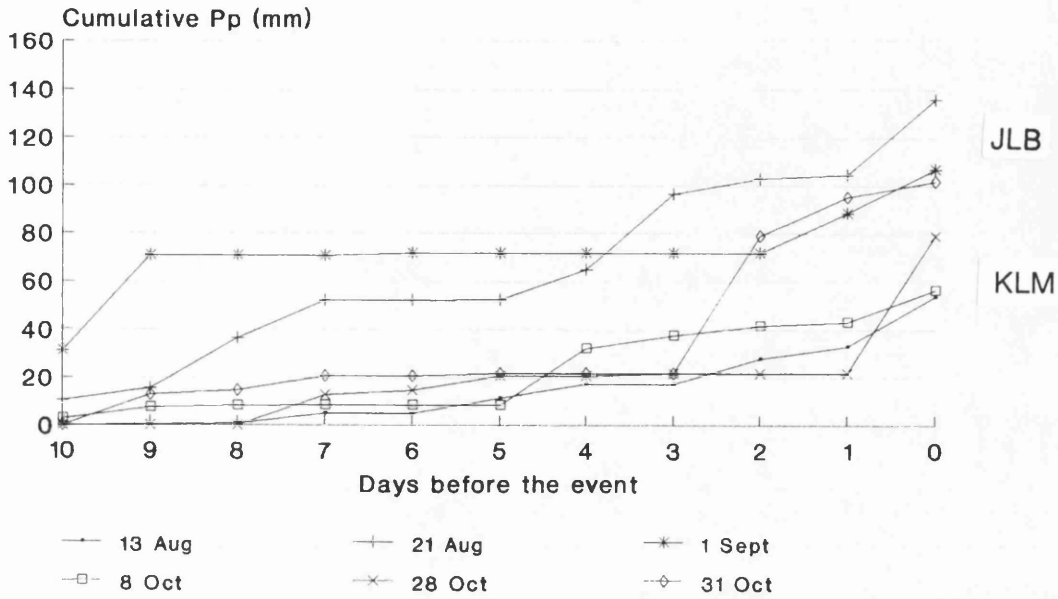
Figure 3.12a: Cumulative rainfall prior to slope failures, 1974. *Barrios*

Day 0: day of the event

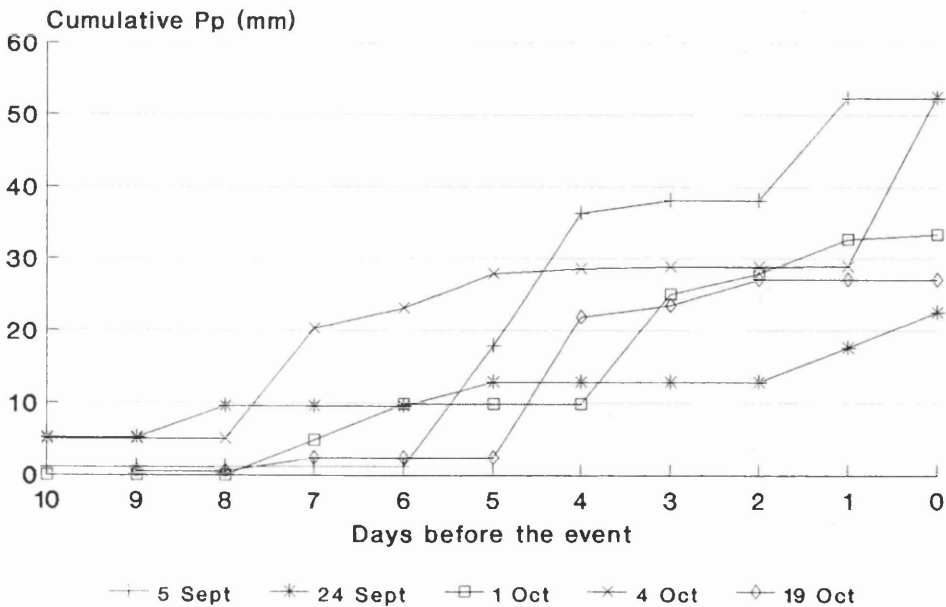
Figure 3.12b: Cumulative rainfall prior to slope failures, 1974

Day 0: Day of the event

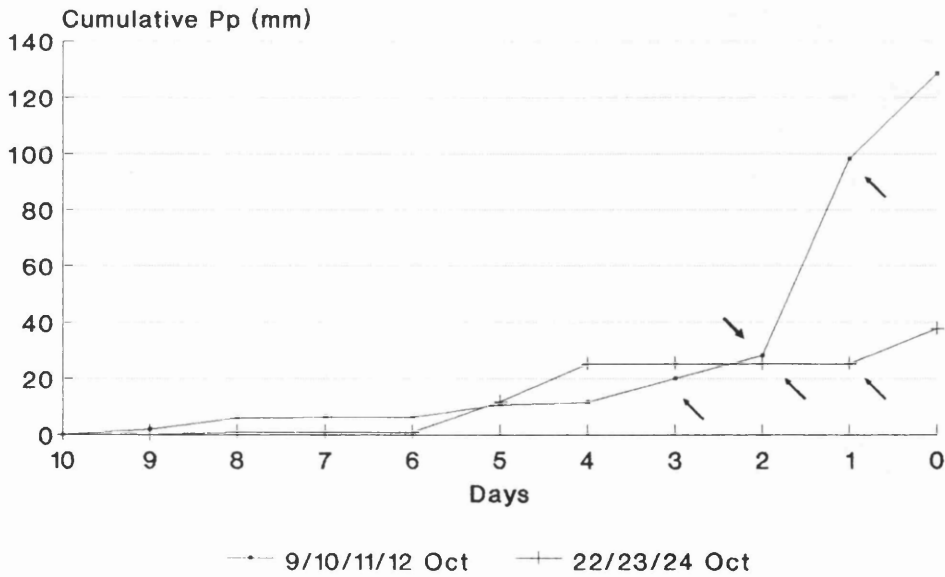
Figure 3.15b: Cumulative rainfall prior to slope failures, October 1976

Day 0: day of the event  
 Arrow indicates day in which slope failure occurred

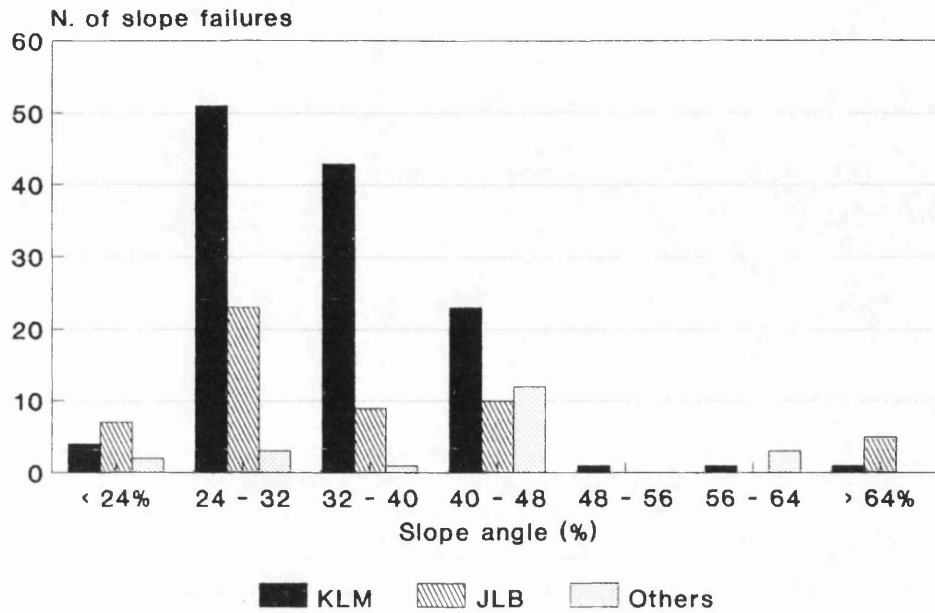
Figure 4.5: Lithology and slope angles \*

\* Frequencies for all slope failures  
 KLM: Calcareous schist  
 JLB: Quartz-mica schist

iii) More than 60% of the failures were related to the calcareous schist of the KLM-*Las Mercedes* formation. The relative area occupied by each lithological unit is given in p. 100. The relative densities of slope failures per unit area of *Las Mercedes* (KLM) and *Las Brisas* formations are as follows: 0.72/Km<sup>2</sup> for KLM; 0.21/Km<sup>2</sup> for JLB and 0.12/km<sup>2</sup> for others. These differences may be explained, as discussed further in chapter 5 (p.117), mainly by the presence of highly fractured and weathered material in the intensely folded *Las Mercedes* formation (KLM) when all other factors are held constant.

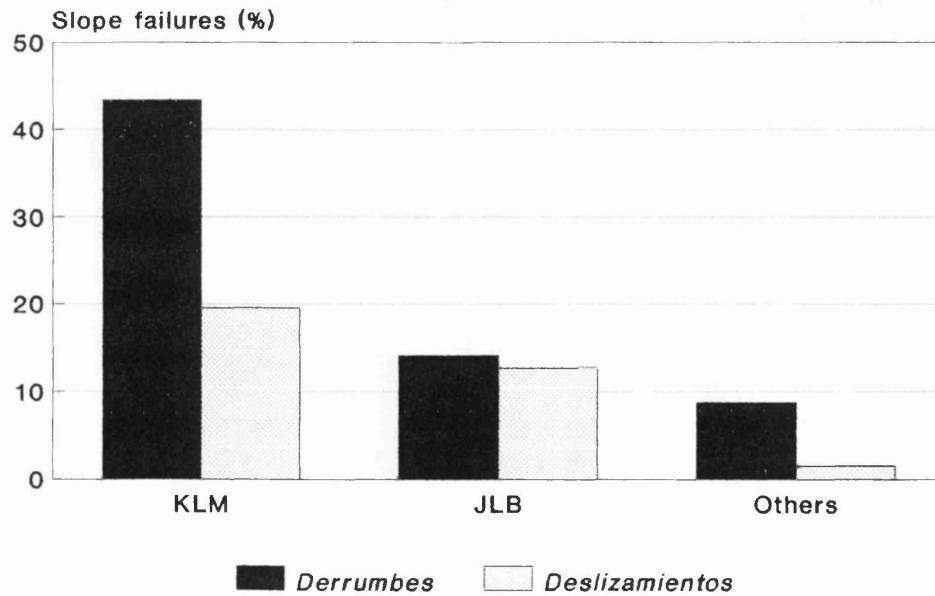
Figure 4.6: Type of slope failure and lithology

KLM: Calcareous schist  
 JLB: Quartz mica-schist

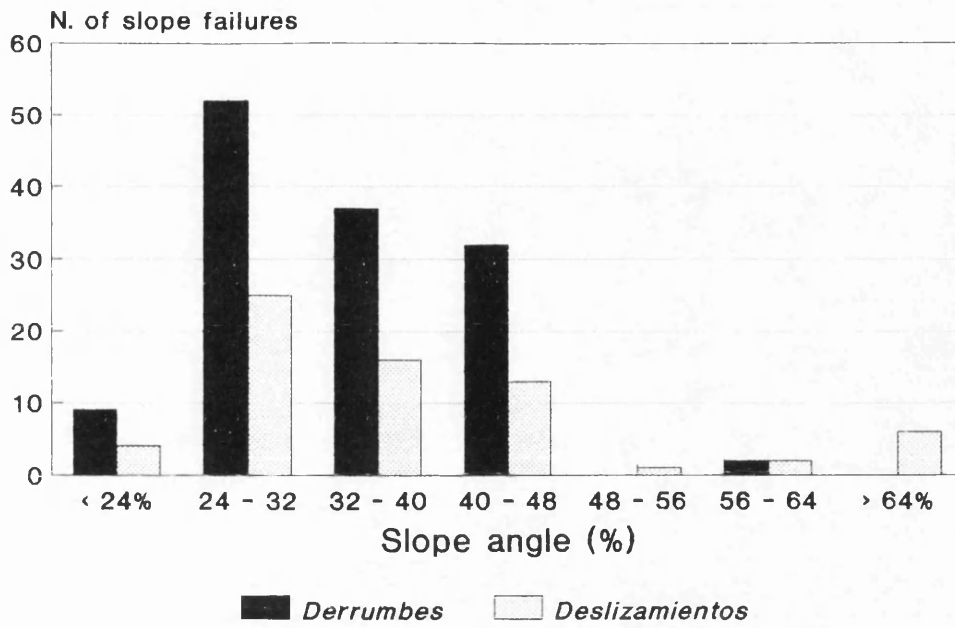
Figure 4.7: Type of slope failure and slope angles \*

\* Frequencies for all slope failures

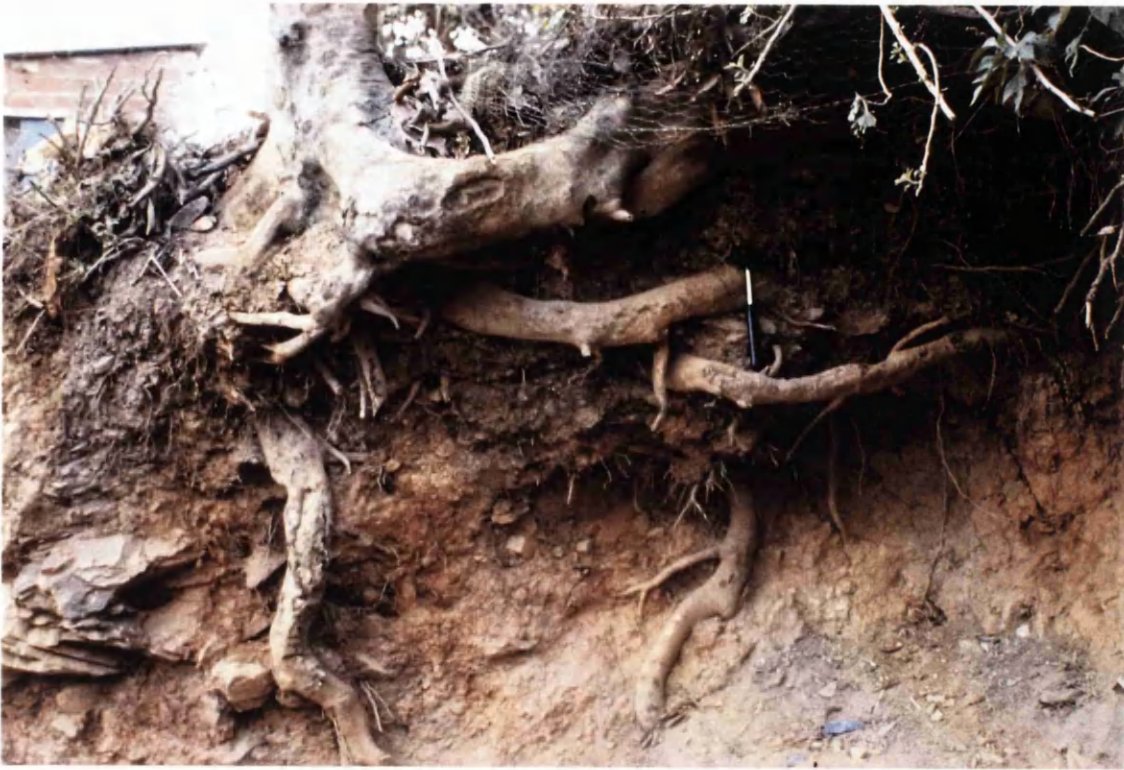
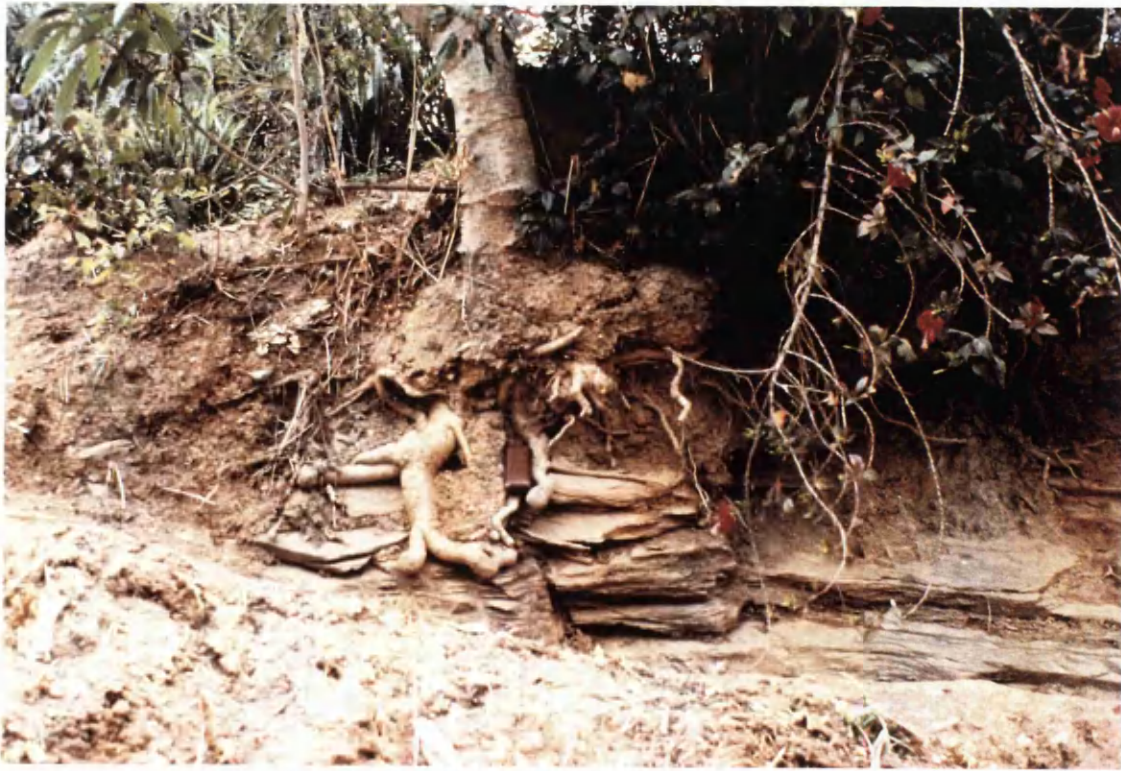
Plate 8: Root penetration of isolated trees on metamorphic rocks

The vegetation cover has been removed mainly through urban growth. Only patches of vegetation remain; isolated trees may even have an adverse effect on slope instability. Roots penetrate the thin regolith and enter the cracks and joints of the metamorphic rocks, reaching depths of 1.40 m. An example is shown in plate 8. According to Greenway (1987), roots and stems increase the roughness of the ground surface and the permeability of the soil, leading to increased infiltration capacity. So does depletion of soil moisture which may accentuate

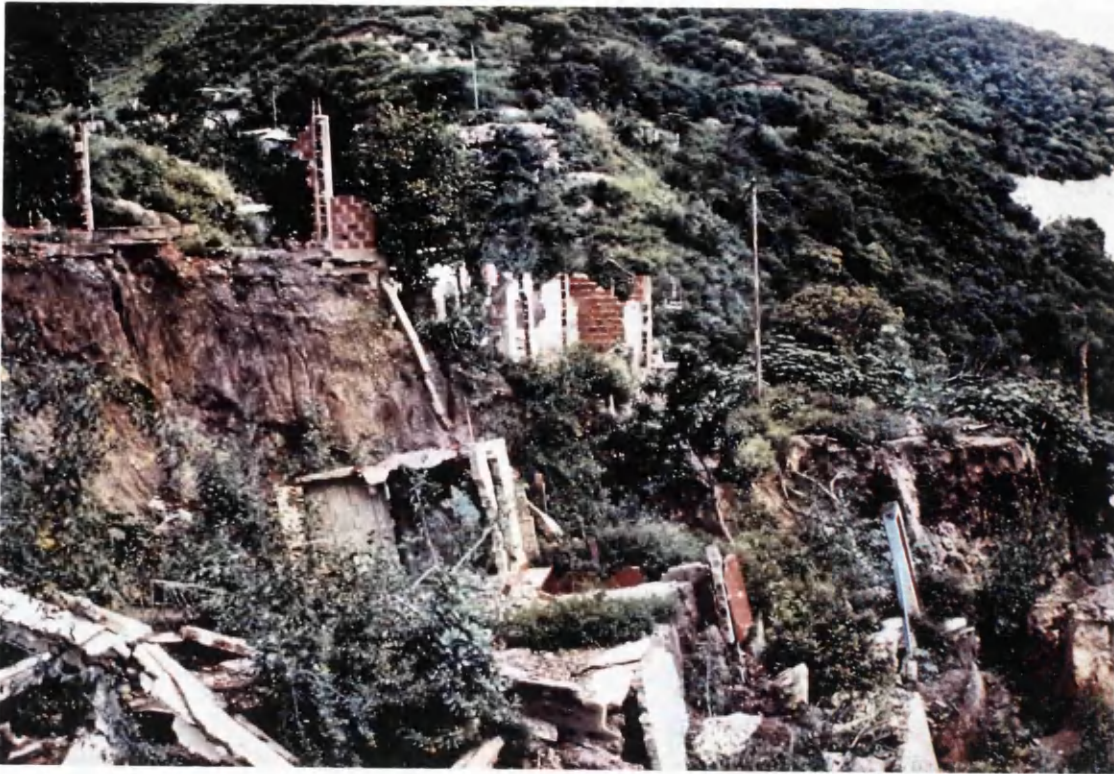
Plate 18: Area of slope failure and subsequent stabilization work. *El Ciprés*

In terms of the **foundations**, the site is usually dug up to about 1 m. In some cases the digging is done until 'the rock is felt' or until the 'soil is hard enough', as expressed by some of the informants. Some of the people interviewed were themselves builders. In those cases, special care was taken when building pillars. Detailed information about the arrangement of the pillars was given: thus iron reinforcements (*cabillas*) were buried between 80 cm to 1 m approximately. This was done by the owner of the very few houses left between the areas affected by the landslides.

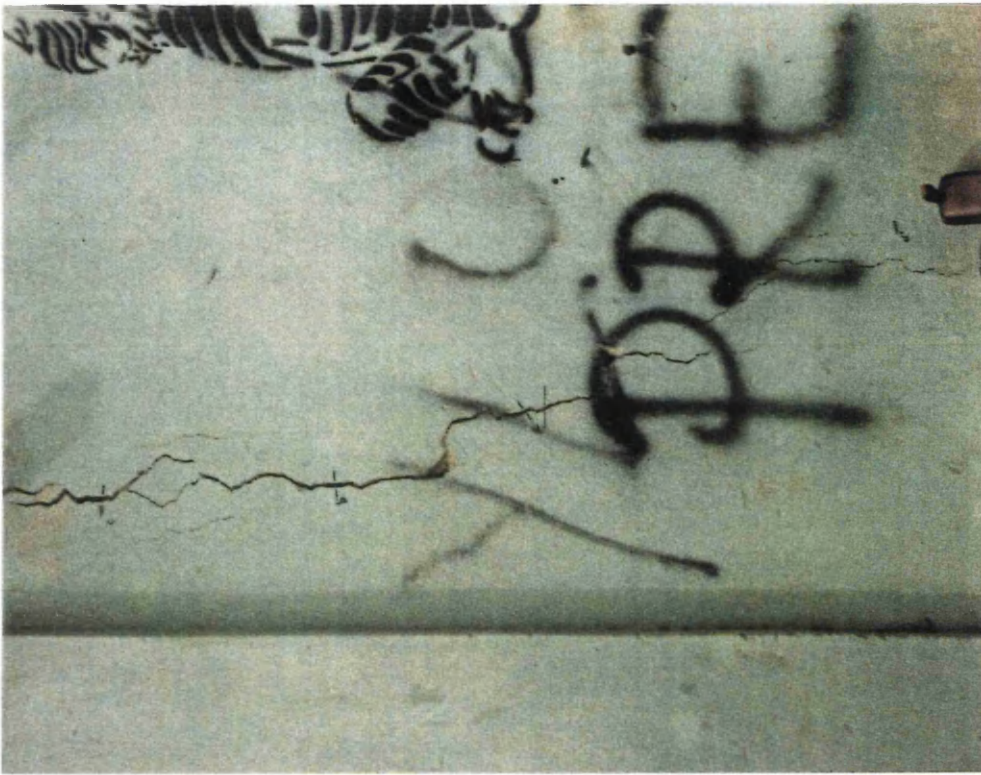
Plate 19: Cracks developed in the consolidated houses
