Working Paper

Monitoring landscape restoration efforts and associated livelihood benefits for smallholder farmers in the Upper Tana Basin of Kenya

Fred Kizito

December 2020

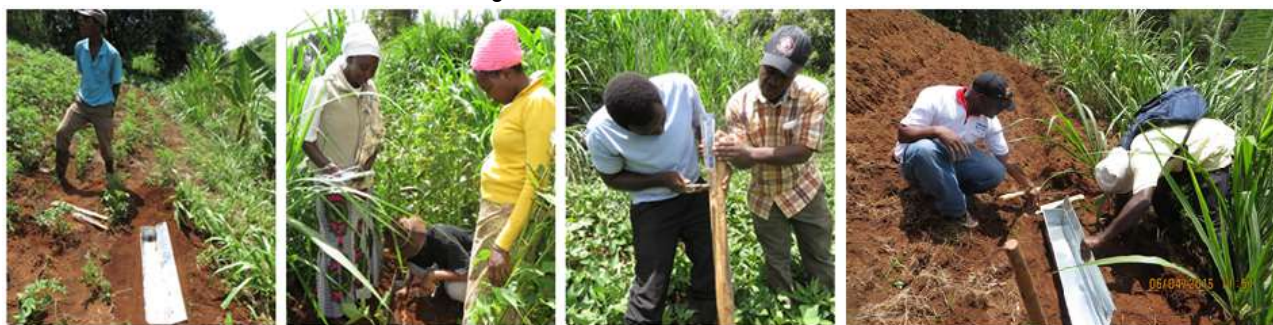
Figure 2: Photographic representation of the soil trough setup in the various plots: (1st LEFT) A soil trough installed in one of the plots with beans and Napier grass; (2nd LEFT); A CGIAR-WLE Scientist training farmers on how to read and record data from a calibrated runoff detector soil trough; (2nd RIGHT): CGIAR-WLE Scientist installing a rain gauge in one of the farms (RIGHT); CGIAR-WLE Senior Scientist supervising the installation of the soil troughs in designated experimental plots (Photo Credits, Fred Kizito).

As depicted in Figure 1, four clusters of micro-watersheds (MW1 through MW4) are arranged in sets within a larger sub-watershed; one or two treatments and one control, with similar soils, crops, and weather events. The treatment watershed represents an area in which conservation activities were targeted toward sediment control. The control represents an area in which conservation activities were not conducted forming a Before-After-Control-Impact (BACI) design. Runoff measurements were compared from representative sites prior to and again after conservation interventions were installed at specific areas within farmer fields which were selected for monitoring erosion, rainfall and runoff (Figures 2 and 3)

The farmers were trained on how to read the rain gauges, monitor runoff levels and measure the soil sediment levels in the calibrated runoff detector troughs after each rainfall event.

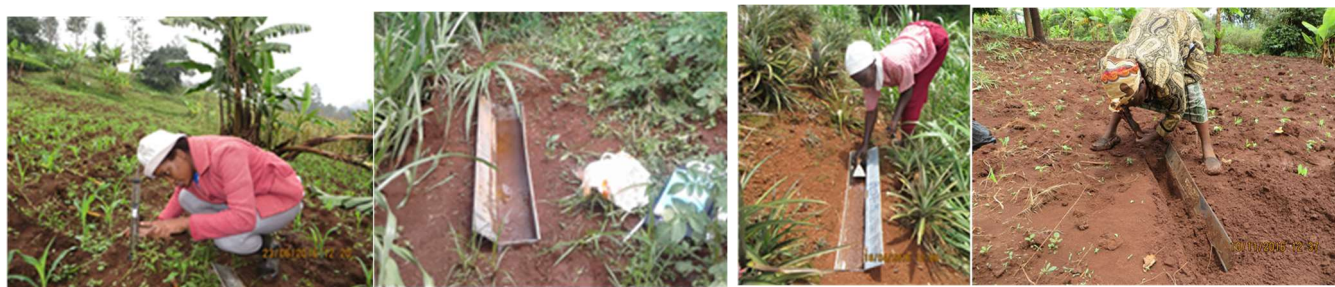
Figure 3 Photo representation of monitoring efforts at project field sites. (Left) A CGIAR-WLE research assistant reading and recording infiltration data, (2nd Left) A trough with actual runoff and soil sediment eroded after heavy rain (2nd Right and Right) A farmer emptying and registering the runoff in a trough and reading the sediment (Photo Credits, Fred Kizito).

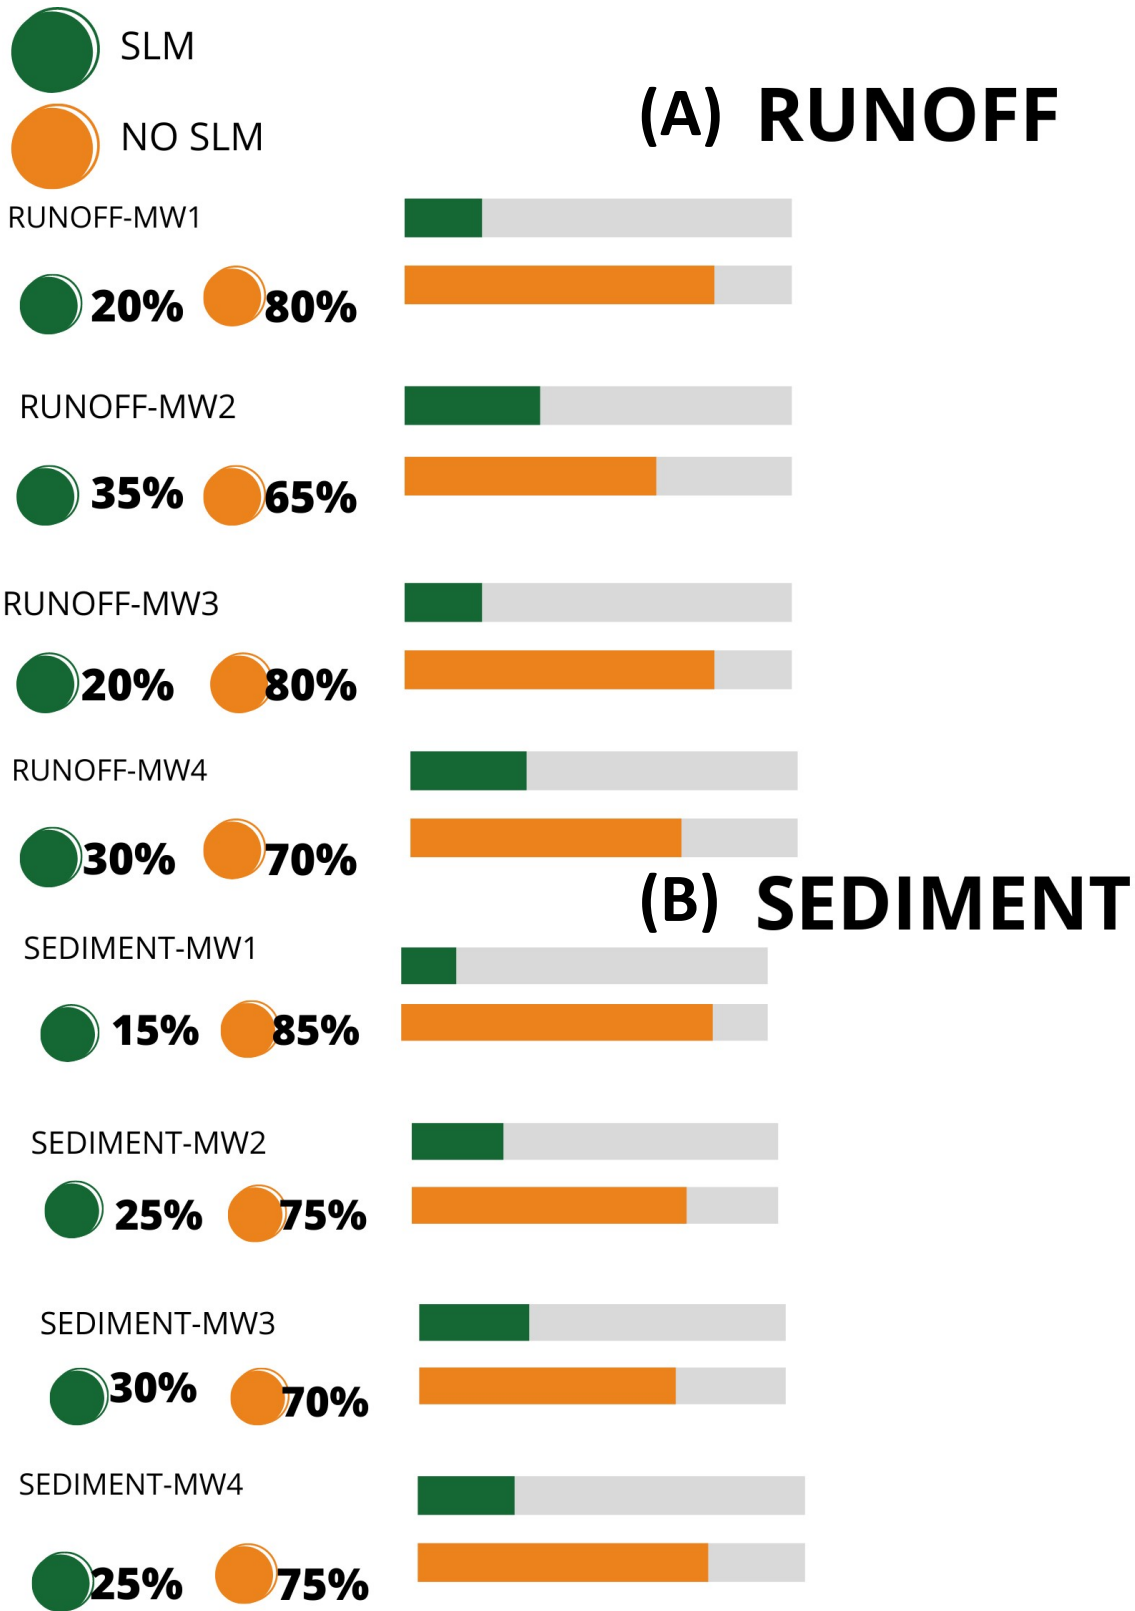
Figure 5. Variation of runoff (A) and sediment deposition (B) for the micro-watersheds 1 through micro-watersheds 4 with SLM (in Green) and without SLM (in Orange). The SLM practice had a combination of grass strips, and terraces

For all the four micro-watersheds MW1-MW4, runoff levels were consistently lower (20-35%; Figure 5A) for areas with SLM compared to higher level (65-85%; Figure 5A) for the areas with no SLM within those micro-watersheds. In a similar trend, sediment levels were consistently lower (15-30%; Figure 5B) in SLM areas compared to areas with no SLM that registered higher sediment levels (70-85%; Figure 5B).

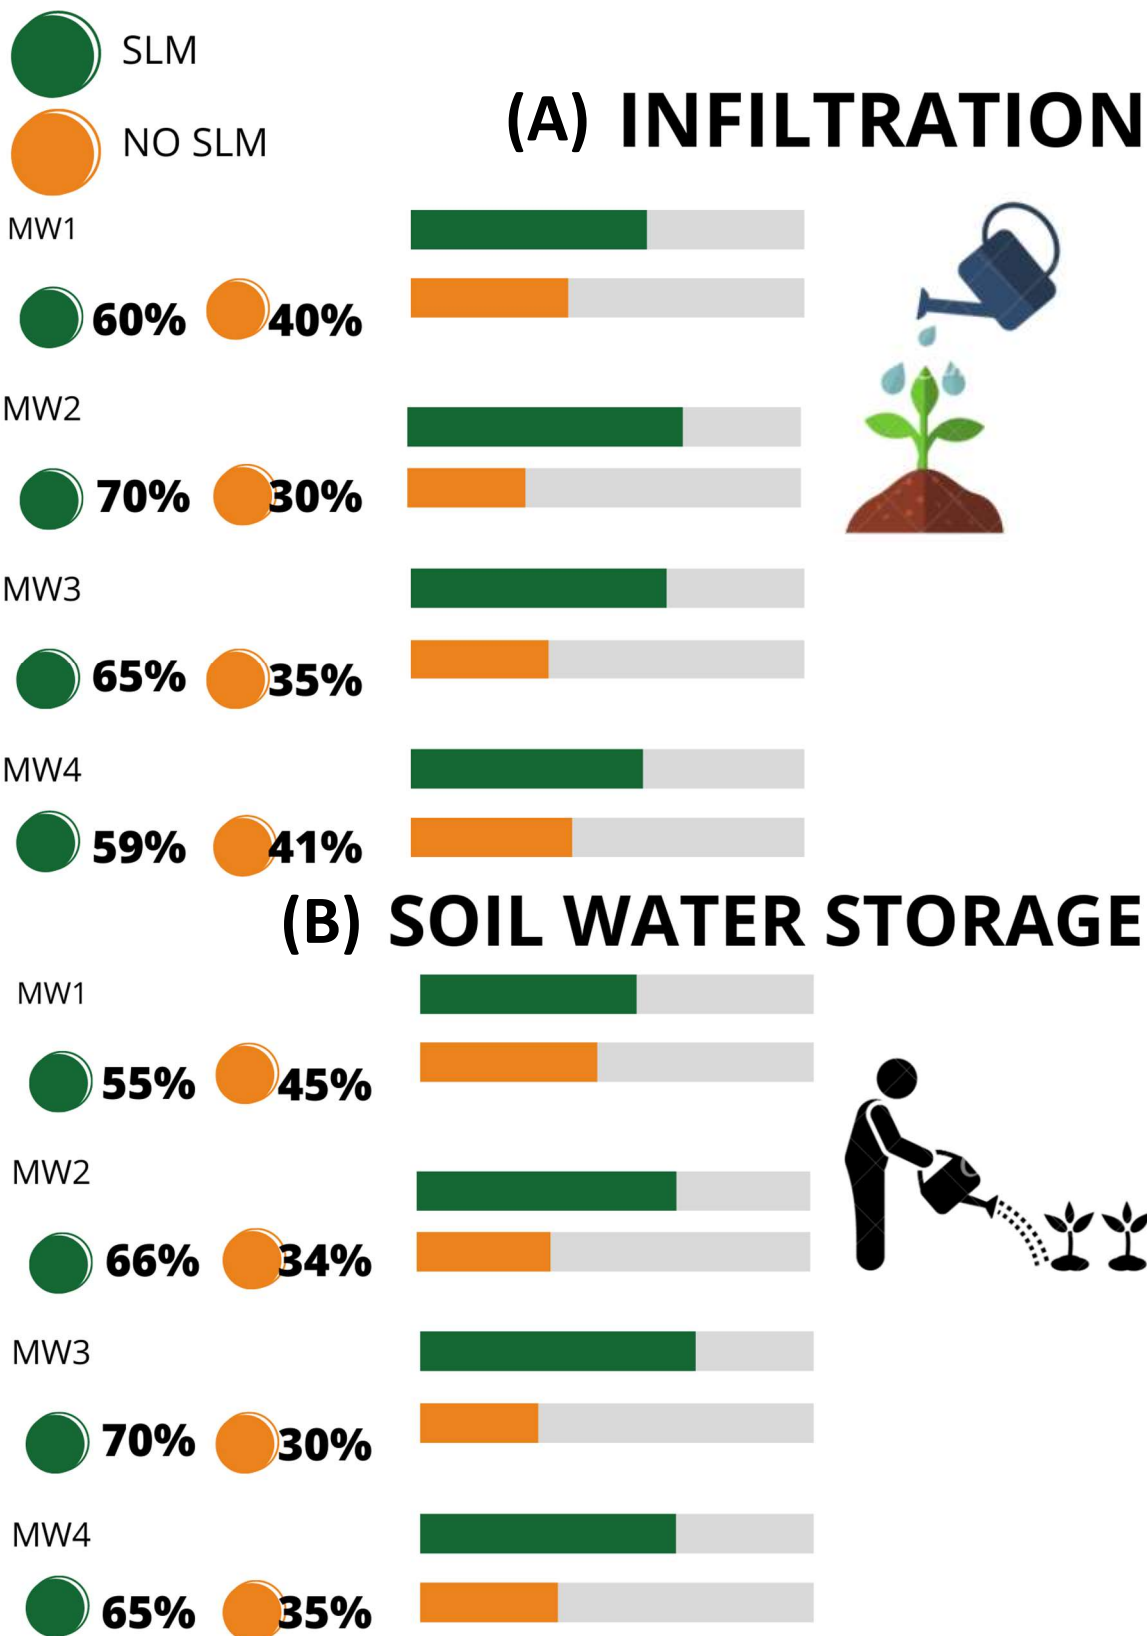
Figure 6. Variation of infiltration (A) and soil water storage (B) for the micro-watershed 1 through micro-watershed 4 with SLM (in Green) and without SLM (in Orange). The SLM practice had a combination of grass strips, and terraces.

For all the four micro-watersheds MW1-MW4, infiltration levels were consistently higher (59-70%; Figure 6A) for areas with SLM compared to lower levels (30-41%; Figure 6A) for the areas with no SLM within the micro-watersheds. Likewise, soil water storage levels were consistently higher (55-70%; Figure 6B) in SLM areas compared to areas with no SLM that registered lower soil water storage (moisture) levels (30-45%; Figure 6B). Farmers within the micro-watersheds conducted structural measures (grass strips and terraces) as well as agronomic measures (mulching) that promoted soil and water conservation through reduced runoff, evaporation and erosion, these in turn increase infiltration and moisture retention within the crop root zone.
