# Detection of Cracks and Potholes in Roads using Infrared Thermography

T. Ahmad, H. Khawaja

UIT The Arctic University of Norway, Tromsø, Norway

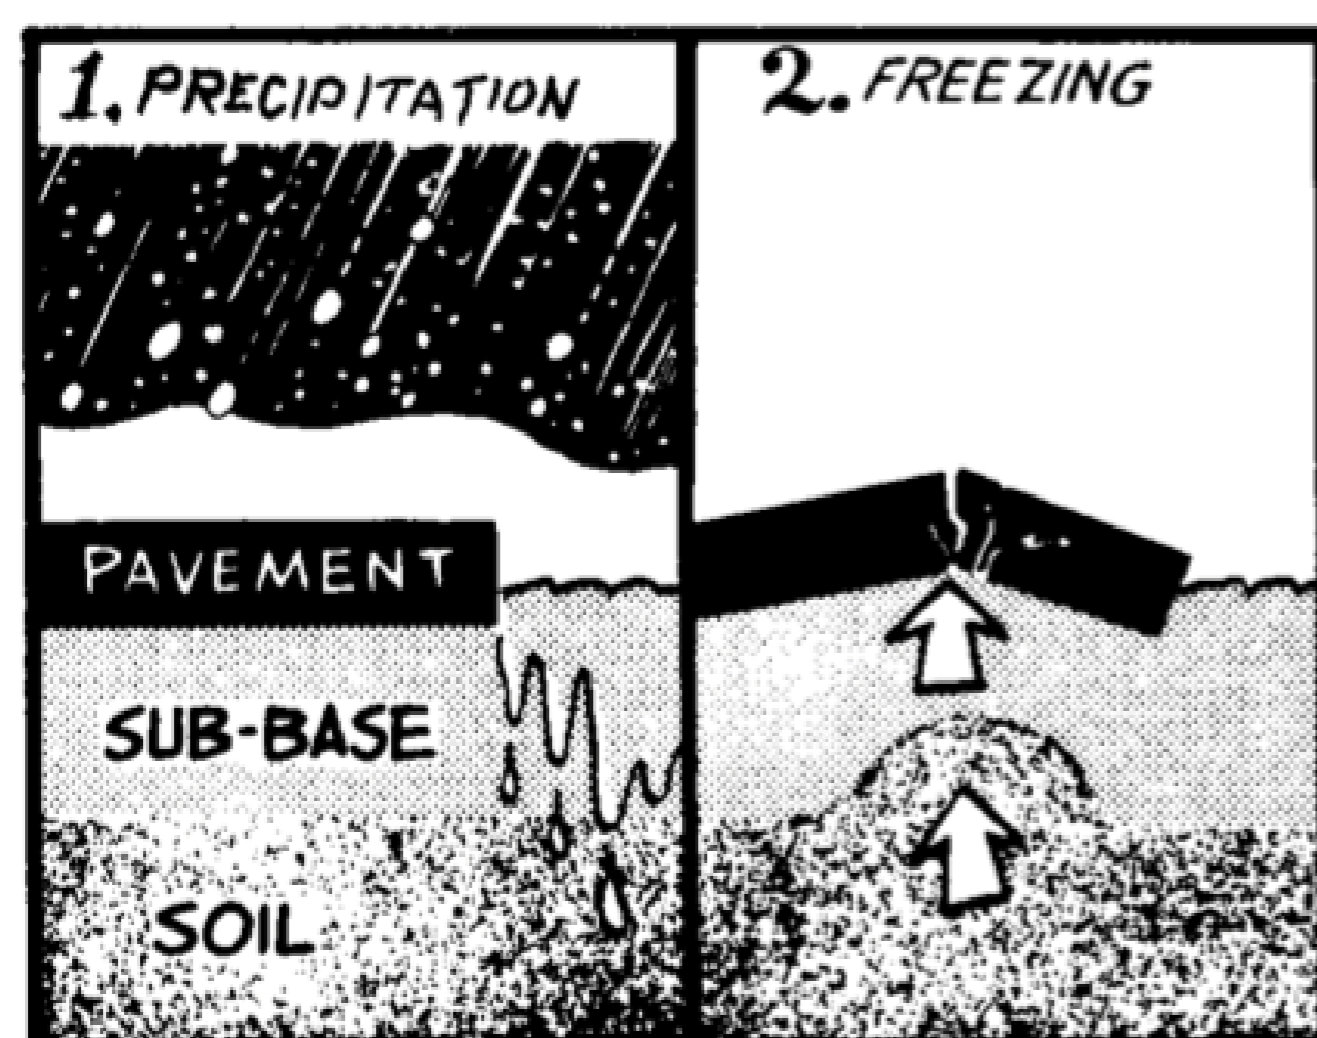
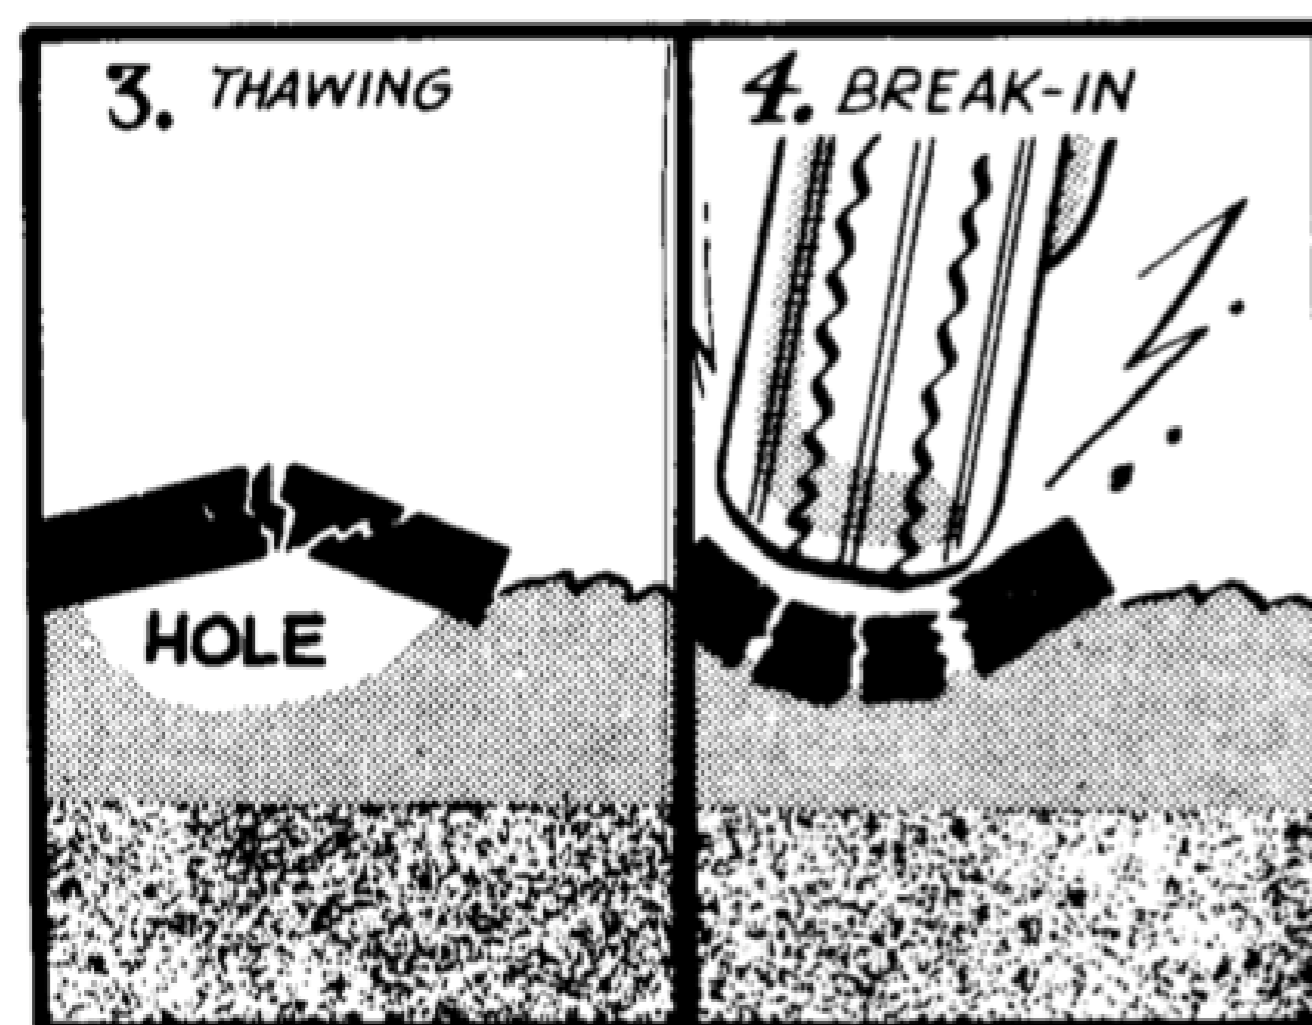
## Freezing Thawing Cycle Impact on a Road Surface

One of the most common reason for the road damages in high-north is the seepage of water, followed by the freezing/thawing cycle. Cracks have various topographical features and can be categorised based on their shape, depth, and propagation rate. One of the examples of such crack is referred to as a 'crocodile crack'. If left untreated, the 'crocodile crack' turns into even greater damage, such as potholes. Maintenance and repair cost of potholes is far larger than repairing the crack. Hence pre-emptive detection is essential for a cost-effective and an efficient solution.

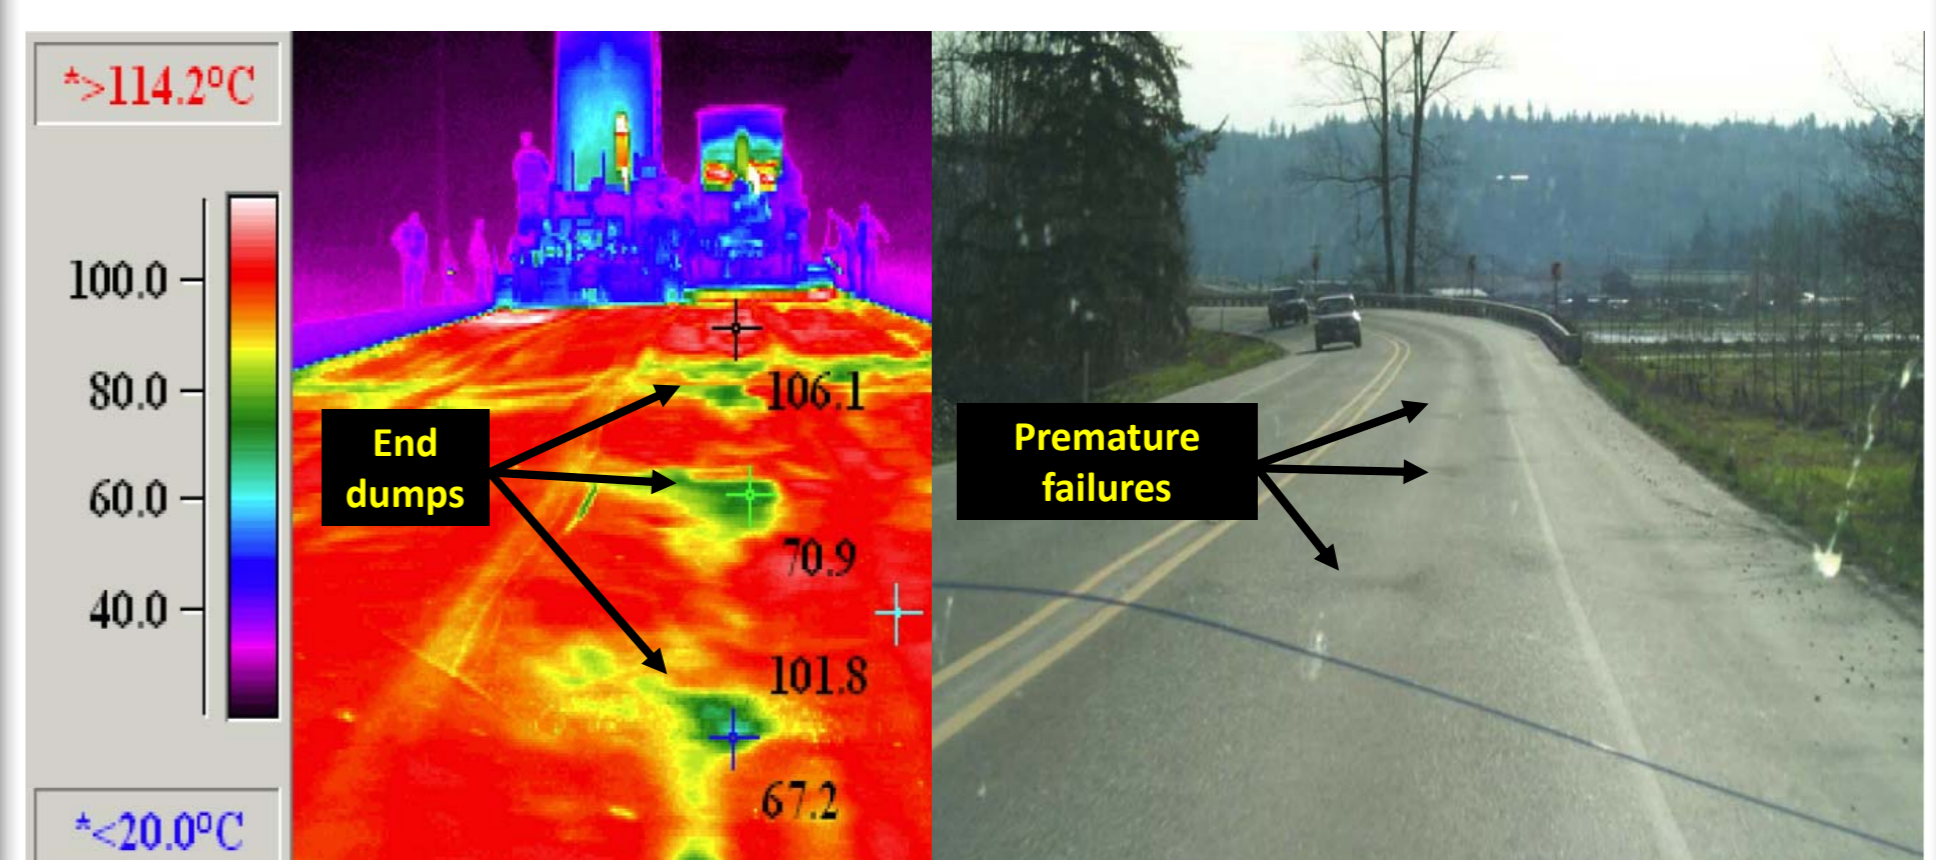
## IRT Detection Technology

Many remote sensing techniques can be used to identify the cracks/voids on the road surfaces. The given research focuses on applying infrared thermography (IRT). IRT technology can detect features based on the different thermal signature. This method would be an excellent tool for detecting the fracture/cracks. It is because of the reason that the naturally occurring water (rain, snowmelt, etc.) seeps into fractures/cracks. The water has different heat capacity than the material of road surface, and will not undergo cooling or heating as fast as roads surface, hence develop a qualitative thermal signature. This thermal image can be captured using IRT. Also, if the crack is in-depth and invisible from the surface may also be detected using IRT.

This project proposes to use IRT technology in the detecting the cracks and potholes in the roads surface. Considering that the water is the key element in damaging the roads, it is reasonable to say that IRT will be effective.
