Procedia Engineering

Advances in Transportation Geotechnics 3 . The 3rd
International Conference on Transportation Geotechnics
(ICTG 2016)

Damage Induced by Recycled Aggregates on the Short-Term Tensile Behaviour of a High-Strength Geotextile

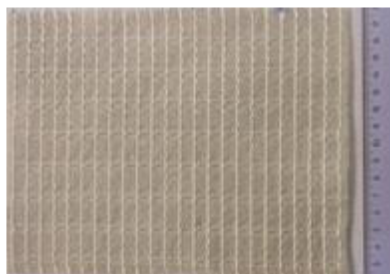
Figure 1: Photograph of the high-strength geotextile (ruler in centimeters).

This research study was carried out using a commercial available geosynthetic, frequently used as reinforcement, consisting of a polypropylene continuous-filament needle-punched nonwoven and high-strength polyester yarns (Figure 1). In order to study the effects of recycled C&DW on the short-term tensile behaviour of this geocomposite (or high-strength geotextile), intact (as supplied by the manufacturers), damaged (in the laboratory) and exhumed specimens were taken from the same roll and they were tested using the same methods and equipments.

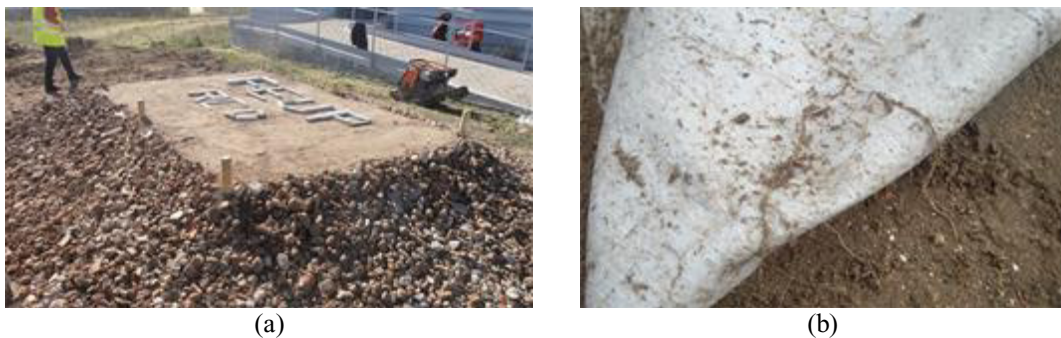
Figure 2: Trial embankments: a) one of the embankments at the end of construction; b) plant roots crossing the geotextile during exhumation.

In order to study the chemical and biological degradation induced by recycled C&DW on three distinct geosynthetics, damage trial embankments were constructed (Figure 2). It should be noted that their construction method and dimensions (2m x 3m in plan and 0.45m high) are not adequate for other purposes, namely the analysis of the embankment behaviour. The results herein presented are related to geotextile samples exhumed after 12 months of installation (Figure 2b).

Visual inspection of exhumed geocomposite samples revealed that the nonwoven geotextile was damaged by plant roots, some of them with a few millimetres in diameter (Figure 2b). Apart from these located damages, other damages visible to the naked eye were not detected. In order to evaluate the damages in more detail, Scanning Electron Microscope (SEM) analyses were carried out.

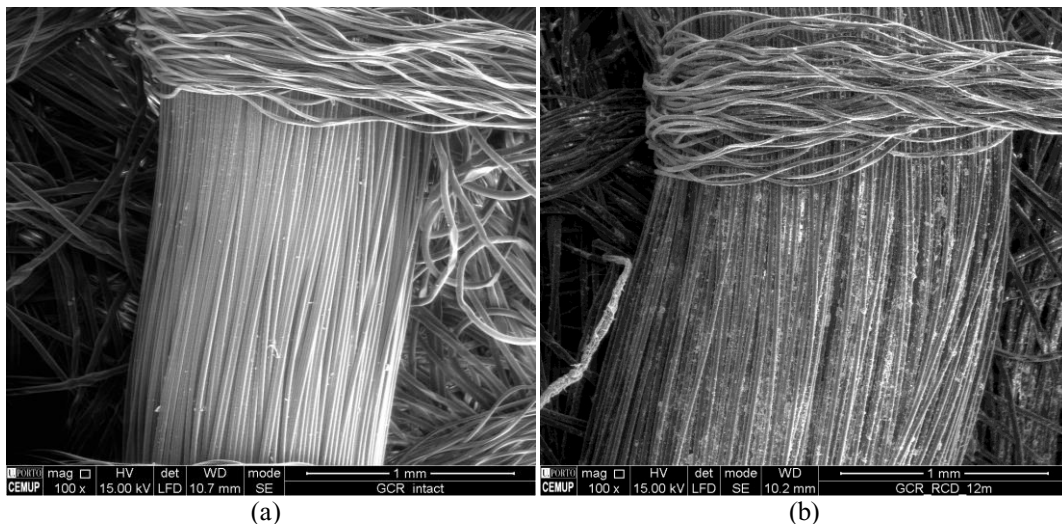
SEM images of intact and exhumed specimens of geocomposite are illustrated in Figure 3. Figure 3 (b) shows that fibres fixing the PET yarns to the base geotextile are still present even if they seem to be unrolled. PET yarns did not reveal significant damages but they are disjoined. Very small particles are held to the yarns.

Figure 3: SEM images of geotextile specimens ($\times 100$): (a) intact; (b) exhumed after 12 months.

It is important to mention that the high tensile strength of this geocomposite (when compared to other geotextiles) results mainly from the polyester (PET) yarns. Even if the visual inspection and SEM images (Figure 3) did not reveal significant damages in PET yarns, the binding of the yarns to the nonwoven geotextile remained weak, which may have caused their premature failure. This phenomenon

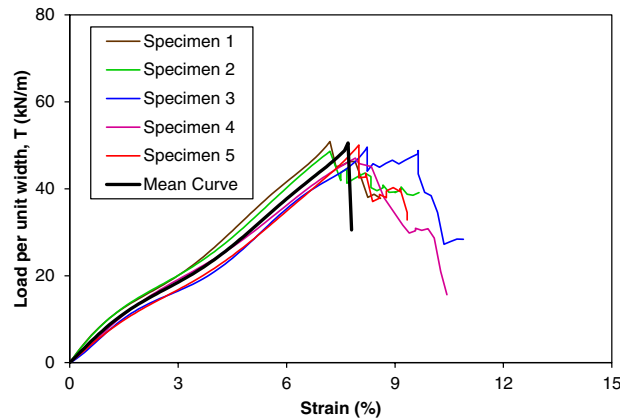
Figure 4 presents the load-strain curves of exhumed geotextile specimens subjected to tensile tests carried out according to EN ISO 10319 (2008). The mean curve is also represented in Figure 4. The maximum tensile strength (T_{\max}), the geosynthetic strain for T_{\max} ($\epsilon_{T_{\max}}$), the secant stiffness modulus at strain of 2% ($J_{2\%}$) and the secant stiffness modulus at $\epsilon_{T_{\max}}$ ($J_{T_{\max}}$) are summarized in Table 1. The mean values of these parameters and the 95% confidence intervals assuming a Student's t-distribution were also included.

Figure 4: Load-strain curves of tensile tests performed on exhumed geotextile specimens.

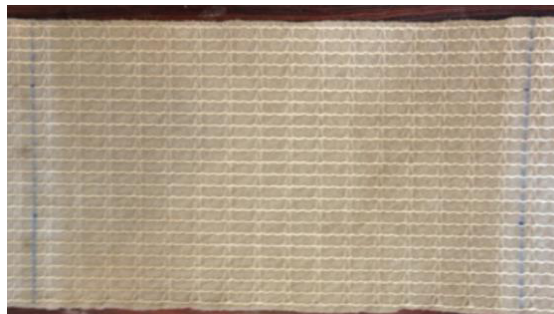
The visual inspection of geotextile specimens after the laboratory mechanical damage tests did not reveal any cuts or tears. Apart from the aggregate particles that remained adherent to the geotextile, the geocomposite was like intact (Figure 5).

Figure 5: Geotextile specimens after laboratory mechanical damage.

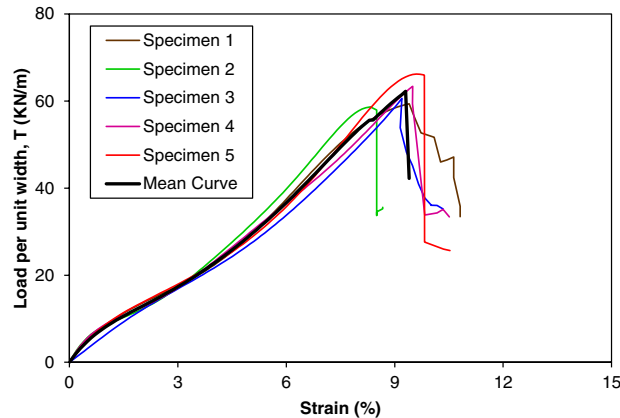
After the mechanical damage tests, the specimens were subjected to tensile load tests following similar procedures to those used for intact or exhumed specimens. The load-strain curves of damaged geotextile specimens, as well as the mean curve corresponding to the 5 tensile tests are represented in Figure 6. Table 2 summarizes the values of maximum tensile strength (T_{max}), geocomposite strain for T_{max} (ε_{Tmax}), secant stiffness modulus at strain of 2% ($J_{2\%}$) and at ε_{Tmax} (J_{Tmax}). The mean values of these parameters and the 95% confidence intervals assuming a Student's t-distribution were also tabulated.

Figure 6: Load-strain curves of tensile tests performed on geotextile specimens damaged in laboratory.

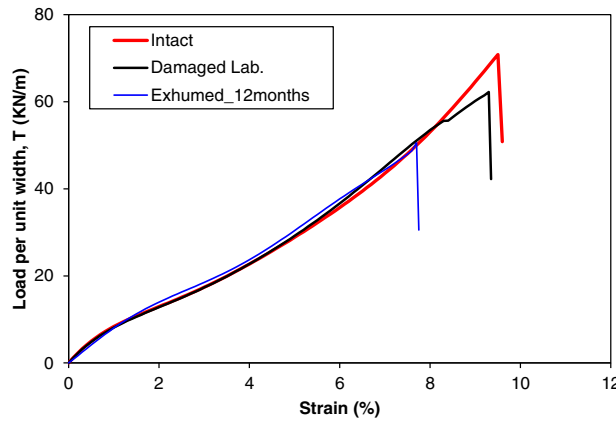
Figure 7: Comparison of mean load-strain curves of intact, damaged and exhumed specimens.
