# Proposal of liquefaction countermeasure technique by log piling for residential houses

**Abstract** During the 2011 Great East Japan Earthquake in Japan, extreme liquefaction caused extensive damage to residential houses in the Kanto Plain region with the magnitudes of the settlements and tilts larger than that was observed during past earthquakes. This paper deals with a proposal of technique of ground improvement by installing logs into loose sand layer as a countermeasure against soil liquefaction for the residential houses. Small scale shaking table tests in a 1-g gravity field were carried out using some model grounds. It was clarified that the wooden pile could increase the resistance of ground against liquefaction due to the increase of ground density by piling and the dissipation of excess pore water pressure along the surface of piles. As a result, the magnitude of settlements of the house which was set on the improved ground by piling logs became quite small.

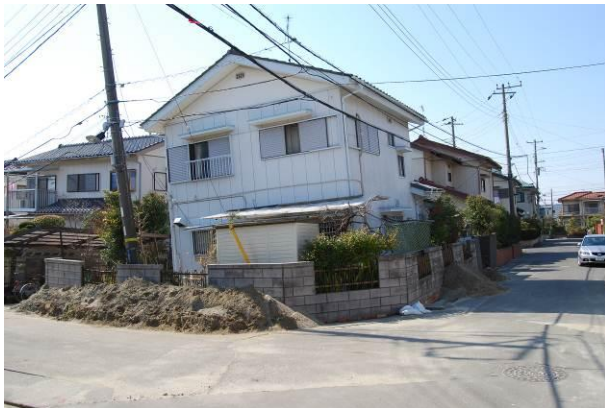
Photo 1 Settlement and tilt of residential house in Chiba city

Liquefaction during earthquakes induces such damage of existing structures as uplift or settlement, depending on the weight of structure. It is very important to mitigate damage occurring by liquefaction to take some countermeasures against vertical displacement. Liquefaction caused extensive damage to light residential and light commercial structures with the magnitudes of the settlements and tilts during the 2011 Great East Japan Earthquake as shown in Photo 1 taken in Chiba city. Many of these structures were founded on mat-type foundations that limited damage to the superstructures despite the large settlement of 50 cm over and tilt of 5 % over. Photo 2 shows the uplift of manhole in Urayasu city. The uplift of manhole was as much as 1 m and settlement of surrounding pavement was at most 30 cm. Liquefaction-induced damage to utilities caused widespread disruptions for homeowners.

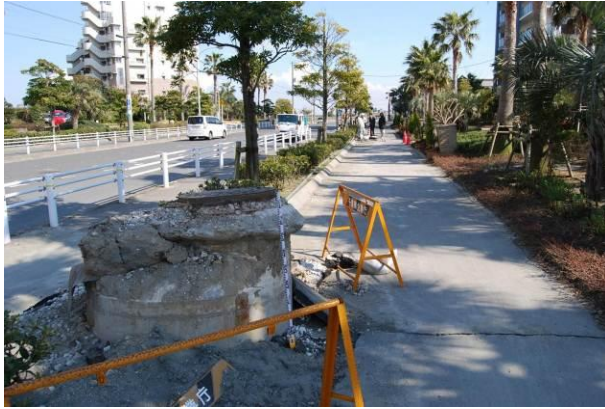
Photo 2 Uplift of manhole and settlement of pavement in Urayasu city

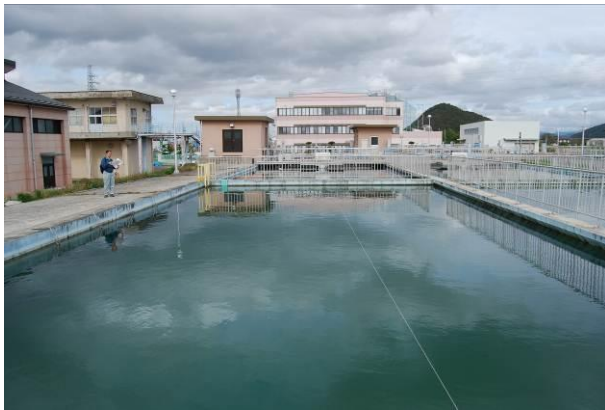
Photo 3 Sedimentation basin of the Hebita purification plant in Ishinomaki city

While those of damage were observed in many places, a structure supported by wood piles which was not damaged by soil liquefaction was existed in devastated area during the 2011 Great East Japan Earthquake. Photo 3 shows a sedimentation basin of the Hebita purification plant in Ishinomaki city. Though liquefaction occurred around the structure, the settlement and tilt of the basin was not observed. As a result of site investigation, it is clarified that this basin was constructed in 1969 supported by wood piles. About 900 pine logs measured 15 mm diameter and 3000 mm long were piled at the interval of 900 mm for the foundation of this basin. It seems that this is the evidence that wood pile is applicable to the liquefaction countermeasure technique.

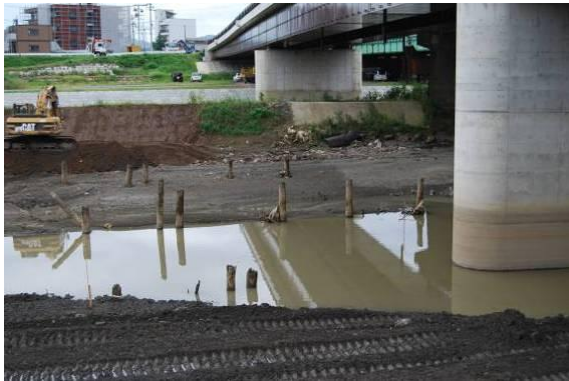
Photo 4 Former wood pile foundations near Kida Bridge

Photo 4 shows Kida Bridge across the Asuwa River that flows in Fukui city, Japan. The bridge was completed in December, 2008. It can be seen that there are a lot of head of piles made of wood in the riverbed near piers. These wood piles were used as foundations of the former Kida Bridge which was completed in 1949. It is assumed that they were placed underneath the riverbed through 59 years (Yoshida et al., 2009).

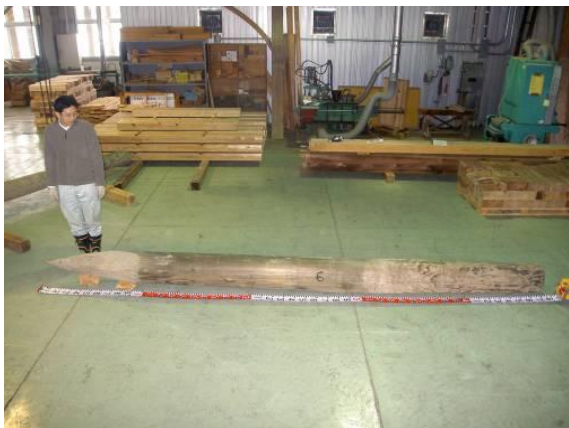
Photo 5 Wood pile retrieved from Kida Bridge

Photo 5 shows the wood pile which was retrieved from Kida Bridge. The length of the pile was about 3.5m and the diameter was about 30cm. It is clarified that the species of wood pile was cryptomeria, that is, Japanese cedar as a result of identification by using an optical microscope. According to the visual observation of wood pile, it is assumed that the top of the pile was stuck up out about 1m from the riverbed, because the area between about 1m from the top had a mark that water scraped the surface of the wood pile. The wood pile was in the gravelly sand and clay layer and the bottom of the pile was assumed to reach sandy silt layer or sand layer by referring to a borehole data near this site.

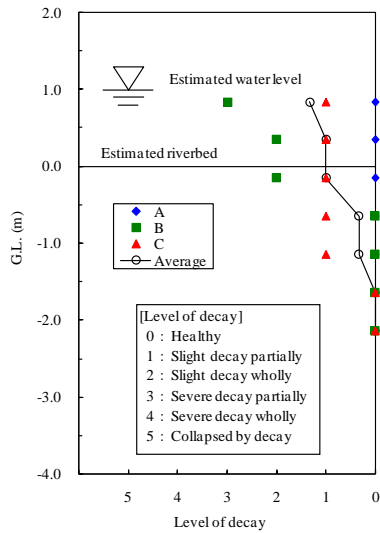
Fig. 1 Results of visual observation test

Fig. 1 shows a result of visual judging method of decay level according to JIS K 1571:2004 (Yoshida et al., 2007). Three evaluators of A, B and C observed and judged the decay level referring to the standard shown in this Figure. The positions of riverbed and water level presumed by site investigation are also shown in this Figure. Because the decay level was 1 or less under the riverbed, it is confirmed that wood pile can keep soundness in the soil under the water level.

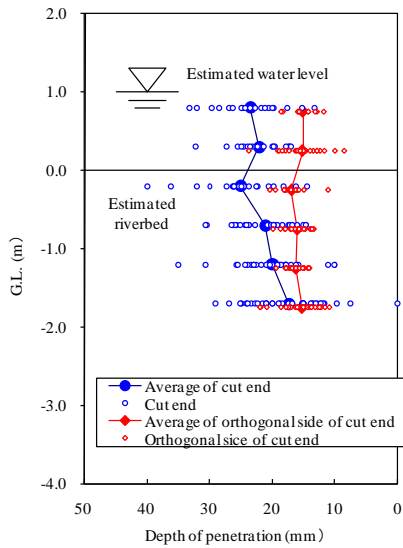
Fig. 2 Results of pylodin penetration test

Fig. 2 shows a result of the penetration test by using a Pylodin which can examine the level of decay (Yoshida et al., 2007). The Pylodin was a device to compare depths of penetration by a pin stricken with a certain force. If the level of decay is high, the surface of wood become soft and the depth of penetration become large. The standards of decay is considered that the depth of penetration is 30mm or over. The shape of test piece was a discoid by cutting out the wood pile and the thickness of the piece was 10cm. The penetration tests were conducted on two sides of wood piles. One was the side of cut end and the other was the orthogonal side of cut end. Although the values vary widely at the same ground level as shown in Fig. 2, it is clarified that the wood piles keep health because the most of average values were less than 30mm.

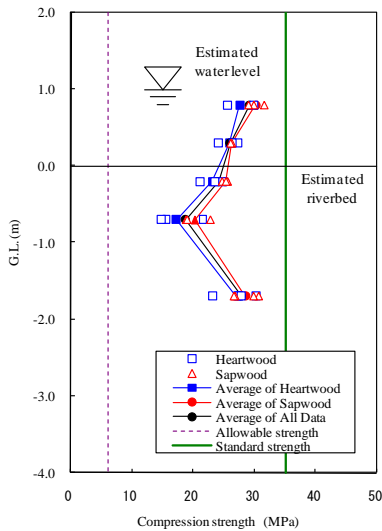
Fig. 3 Results of compression test

Fig. 3 shows a result of compression test according to JIS Z 2101:1994 (Yoshida et al., 2008). The size of test piece was 30mm square and 60mm in height and they were made by cutting out the discoid which was used for the Pylodin penetration test. The standard compression strength of Japanese cedar and allowable stress used for design of wood pile foundation are also shown in this Figure. It is considered that the test pieces have three to

five times strength of the allowable strength.

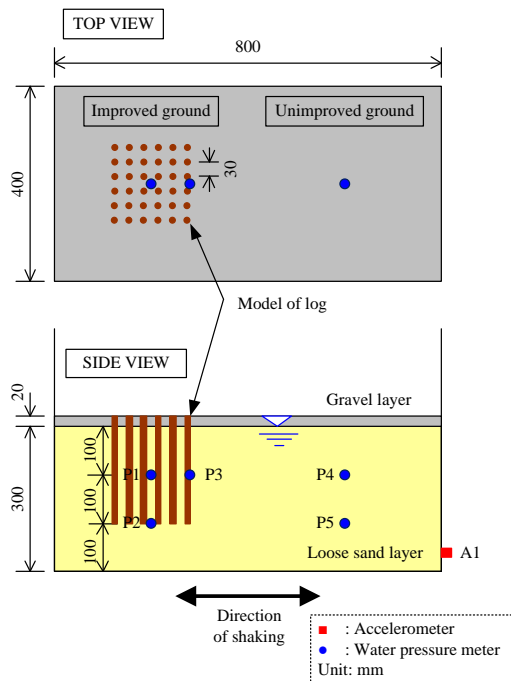
Fig. 4 General view of model ground and transducers

Fig. 4 illustrates cross sections of top and side view of a model ground with locations of transducers (Yoshida et al., 2008). The model ground was set up in a rigid acrylic container that measured 800 mm long, 400 mm wide and 540 mm high. The tests were conducted by using a composite ground which consists of two parts. One was improved area that model of logs made of Japanese cedar got by thinning in Fukui prefecture were installed in loose sand layer which was shown in left side of Fig. 4, the other was unimproved area. The loose liquefiable sand layer was made of silica sand No.7 and the relative density was about 35%. The physical properties of sand are listed in Table 1. The model of log made by scaling down 1/25 of the wood pile of Kida Bridge and measured 12 mm diameter and 220 mm length.

The shaking table tests were conducted as follows: 1) Pore water pressure transducers were installed at the locations as shown in Fig. 4. 2) The container was first filled with water to 300 mm high from the bottom. Then a sieve with a 2 mm mesh was moved back and forth below water surface, pouring wet sand through water to form a uniform sand layer with the thickness of 300 mm. 3) Excess water above the sand layer was soaked up so that the water surface was level with the surface of the sand layer. 4) Accelerometers were installed at the locations as shown in Fig. 4. 5) Thirty six logs were installed into the loose sand layer slowly with an interval 30mm, except the top of log with a length 20mm. 6) No. 5 gravels were laid over the loose sand layer with a thickness 20mm. 7) The model ground was shaken in the horizontal direction with the sinusoidal wave of 100 gal in peak amplitude, 5 Hz in frequency and 5 seconds in duration time as shown in Fig. 5. The pore water pressures and the response accelerations were recorded simultaneously on the data recorder. 8) After the excess pore water pressure had completely dissipated, the vertical displacements of logs and ground surface were measured by a point gauge. 9) The processes of 7) to 8) repeated five times with different amplitude which was from 100 gal to 180 gal at intervals of 20 gal.

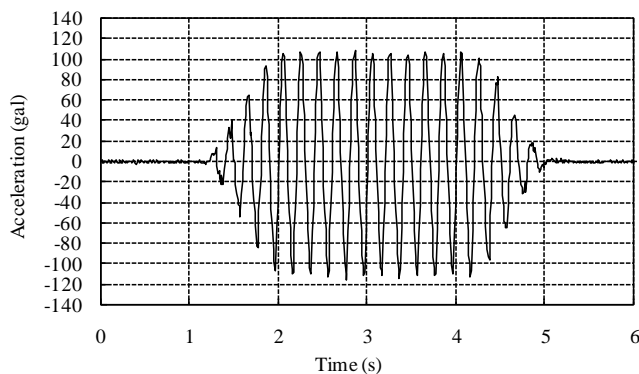
Fig. 5. Time history of input acceleration

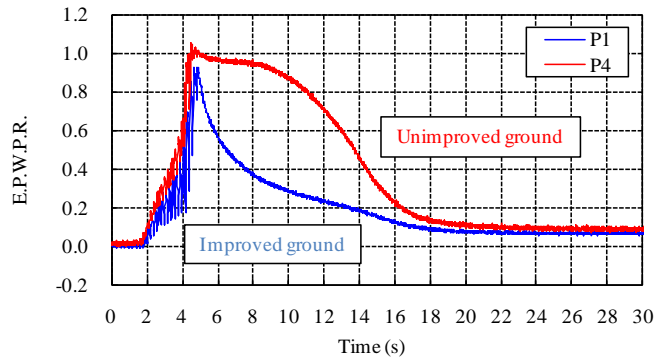
Fig. 6 Time histories of excess pore water pressure ratio

Fig. 6 shows time histories of excess pore water pressure ratios located at 100 mm in depth from ground surface after undergoing shaking of 120 gal. In case of unimproved ground, the excess pore water pressure ratio reached 1.0 and the ground completely liquefied. However, in case of improved aground, the maximum value of excess pore water pressure ratio decreased and the velocity of dissipation was extremely fast.

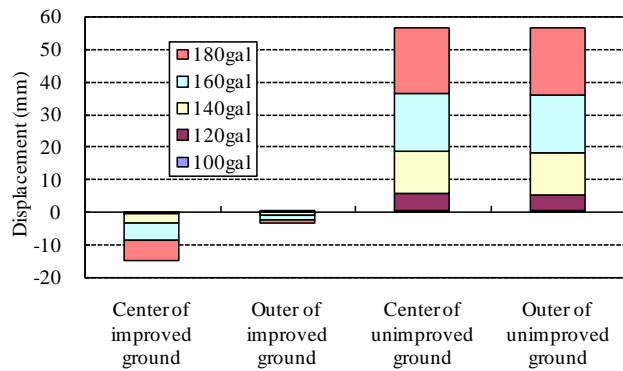
Fig. 7 Vertical displacement of ground surface

Fig. 7 shows the accumulation of settlement in soil layer. The settlement ratio is defined as a vertical displacement of soil layer divided by initial thickness of the ground, and the residual vertical displacement was accumulated after fifth shaking. The negative value in the Figure means upheaval of ground. Though the settlement became about 60cm after fifth shaking in unimproved ground, the upheaval occurred due to the floatation of logs.

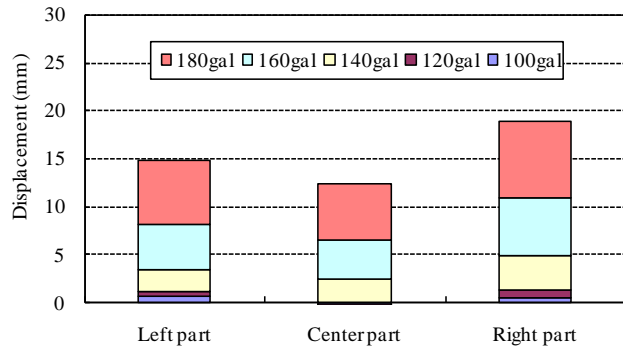
Fig. 8 Vertical displacement of logs

Accumulated vertical displacement of logs at the left, center and right part of improved area after fifth shaking

is shown in Fig. 8. All of the displacement means flotation of logs. It is clear that the flotation occurred since the input acceleration exceeded 140gal. The flotation of logs in the center part enclosed with a lot of logs was less than that in the outer part of improved ground. It seems that the flotation of logs caused the upheaval of ground in the improved area.

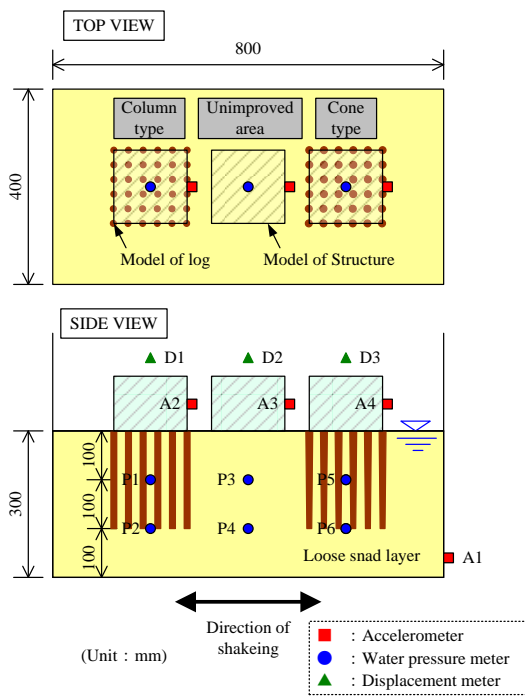
Fig. 9 General view of model ground and transducers

Fig. 9 illustrates cross sections of top and side view of a model ground with locations of transducers (Yoshida et al., 2009). The container and sand were same as Fig. 4. The tests were conducted by using a composite ground which consists of three parts. The left part was improved area installed by column type logs, the right part was also improved area installed by cone type logs and the center part was unimproved ground. The shape of cone type log was copied from real wood pile. The model of log in case of the column type measured 12mm diameter and 200 mm length. The diameter of top was 14mm and that of bottom was 10mm in case of the cone type. The volume of both models was same. The underside of structure model was 150mm square and the weight was 6000g.

locations as shown in Fig. 9. 2) The container was first filled with water to 300 mm high from the bottom. Then a sieve with a 2 mm mesh was moved back and forth below water surface, pouring wet sand through water to form a uniform sand layer with thickness 300 mm. 3) Excess water above the sand layer was soaked up so that the water surface was level with the surface of the sand layer. 4) Thirty six logs were gradually installed into the loose sand layer with an interval 30mm. 5) The models of structure were placed over the each area. 6) Accelerometers and displacement meters were installed at the locations as shown in Fig. 9. 7) The model ground was shaken in the horizontal direction with the sinusoidal wave of 80 gal in peak amplitude, 5 Hz in frequency and 5 seconds in duration time as shown in Fig. 10. The pore water pressures and the response accelerations were recorded simultaneously on the data recorder. A vertical displacement of structures was also measured by a laser displacement meter. 8) After the excess pore water pressure had completely dissipated, the vertical displacements of logs and ground surface were measured by a point gauge. 9) The processes of 7) to 8) repeated three times with different amplitude which was from 60 gal to 100 gal at intervals of 20 gal.

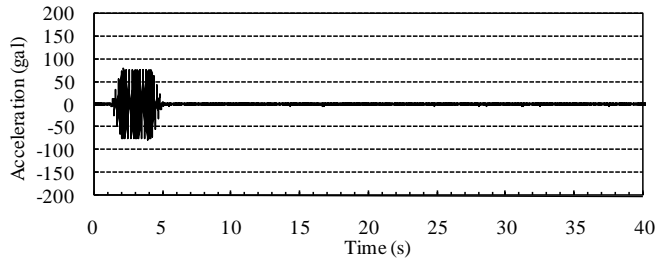
Fig. 10 Time history of input acceleration

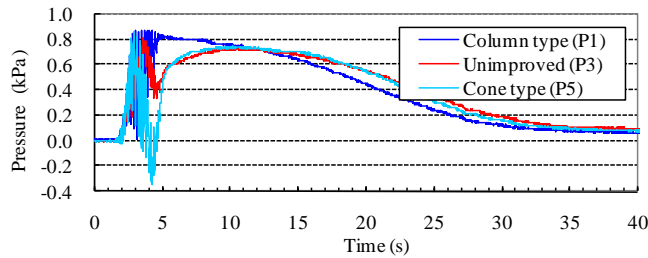
Fig. 11 Time history of excess pore water pressure

Fig. 11 shows the time history of excess pore water pressure located at 100mm in depth from ground surface after undergoing shaking of 80gal, and the result of comparing the column type log, unimproved ground and the cone type log. Fig. 12 also shows the time history of settlement of model structures in the same case. The excess pore water pressure reached the maximum value after two seconds when the shaking began. It seems that the ground did not liquefied because the pressure did not reach the effective overburden pressure of 3.4kPa. However, the pressures decreased rapidly after indicating the maximum value and increased again. The time of beginning of this phenomenon correspond to the settlement of structure model as mentioned below. The settlement of structure model started when the excess pore water pressure reached maximum value and it stopped with the end of shaking in the case of improved ground. However, the settlement of the unimproved ground increased continuously until the pressure completely dissipated. It is confirmed that the settlement of structure was mitigated due to the friction of logs eve if the ground softened by generating the excess pore water pressure. Moreover, it seems that the effect of cone type log was relatively low as compared with the column type log. It is considered that the cone type log has the advantage of the area of facing the ground. However, because the excess pore water pressure generated in the ground dissipated from the lower layer of the ground toward the upper layer, the dissipation time of column type log which had small drainage area became longer than the column type.

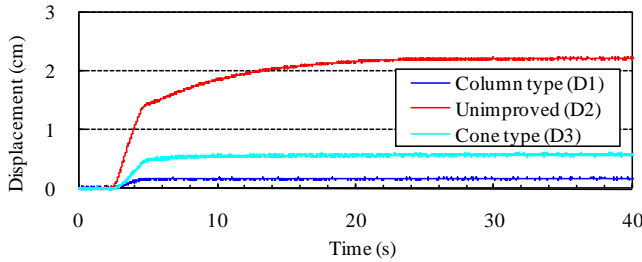
Fig. 12 Time history of settlement of structure model

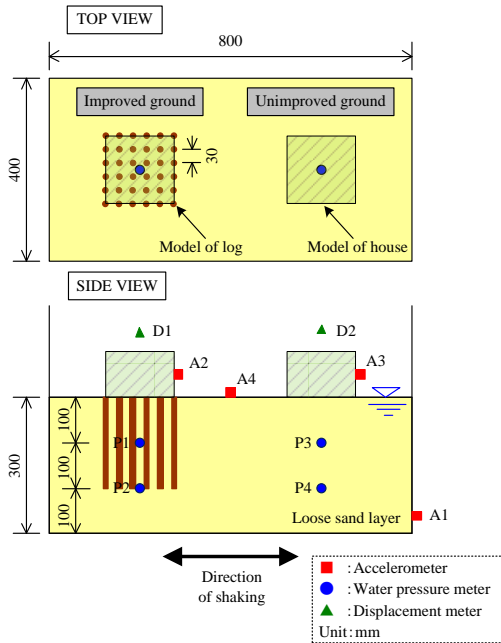
Fig. 13 General view of model ground and transducers

To investigate relation between duration time of shaking and settlement of house, shaking table tests were conducted using the model ground. Fig. 13 illustrates cross sections of top and side view of a model ground with locations of transducers. The container, materials and way to make model ground were similar as shown in above chapter. The tests were conducted by using a composite ground which consists of two parts. One was improved ground where thirty six logs were installed which was shown in left side of Fig. 13, the other was unimproved ground. The density of loose liquefiable sand layer was controlled from 40 % to 60% by preliminary shaking using 300 sinusoidal waves with a frequency of 5 Hz, whose amplitude was 100gal. A model of log measured 12 mm diameter and 200 mm long. A model of house was made by water-resistant wood that measured 150 mm square and 112 mm high. The ground contact pressure of house was  $1.5\text{kN/m}^2$  which was scaled down one tenth of two-story wooden house with a mat foundation. Input wave used in the tests was sinusoidal wave with a frequency of 5 Hz and a peak magnitude of 120 gal. The duration time of shaking was 10, 30 and 60 second.

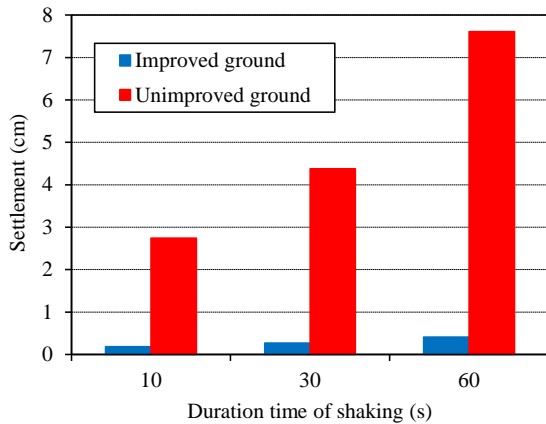
Fig. 14 Relationship between duration time of shaking and settlement of house

Fig. 14 shows residual settlement of house in relation to the duration time of shaking. It is obvious that the settlement of house increased with increase of shaking time in case of unimproved ground, but the settlement was reduced about one twentieth in case of the improved ground though the duration time was 60 second. In the previous study (Yoshida et al., 2010), it is clear that bearing capacity of ground where logs were installed could be improved due to densifying the loose sand around logs, dissipating the water pressure along the periphery of logs and restraining the shear deformation by composite ground with soil and wood in addition to

skin friction of log. According to the results as mentioned above, it is considered that these effects would be expected even if the duration time of shaking might increase.

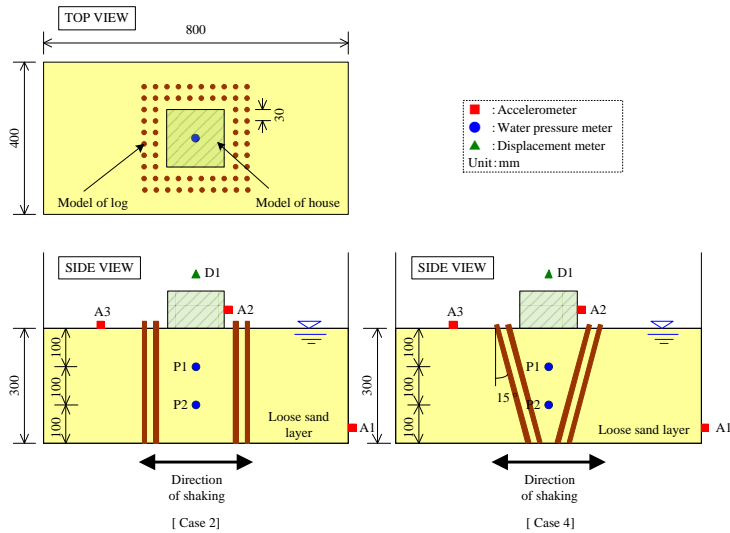
Fig. 15 General view of model ground and transducers

To propose how to apply the technique of log piling for existing house, shaking table tests were conducted using the model ground. Fig. 15 illustrates cross sections of top and side view of a model ground with locations of transducers. The container, materials, model of house and way to make model ground were similar as shown in above chapter. A model of log measured 12 mm diameter and 300 mm long. Four types of way to install logs were adopted in this study. Case 1 was the ground without installing logs. In Case 2, the logs were installed around foundation of house. The top and bottom of log did not be fixed. In Case 3, the top of logs were fixed. In Case 4, the logs were installed into the ground with an inclination of 15 degree. The relative density of loose sand layer was about 40%. Input wave used in the tests was sinusoidal wave with a frequency of 5 Hz and a peak magnitude of 120 gal. The duration time of shaking was 20 second.

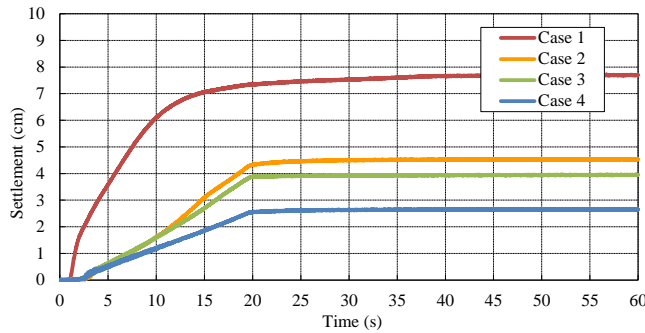
Fig. 16 Time histories of settlement of house

Fig. 16 shows the time histories of settlement of house. It is clear that the log piling around the foundation of

house (Case 2, 3, 4) was effective to reduce the settlement of house as compared with unimproved ground (Case 1). Though most settlement in all cases occurred during shaking, the settlement stopped with the end of shaking in case of improved ground. The most effective way was Case 4 and the settlement was reduced about one third of unimproved ground. If the ground liquefies below the base of house, the house settles and the liquefied soil moves laterally. Therefore the logs around the foundation of house can prevent the lateral movement of soil. This function was more effective by fixing the top of logs in Case 3. Furthermore it is confirmed that the most effective way to install logs was Case 4 because the deformed area could be smaller by installing logs with the inclination.
