# Damage by the 2011 Great East Japan Earthquake

Masakatsu Miyajima  
Kanazawa University, Japan

- Outline of the earthquake and damage
- Damage to water supply facilities
- Unusual phenomena; an abrupt increase in flow rate and a decrease in water pressure of water distribution system in spite of no damage to pipelines
- Conclusions

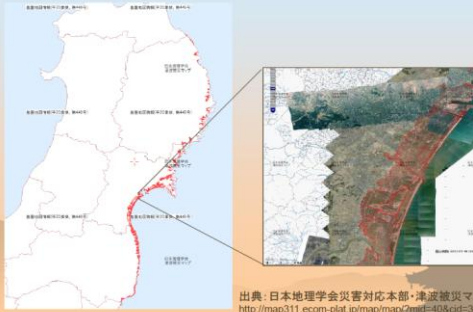
## Damaged area by tsunami

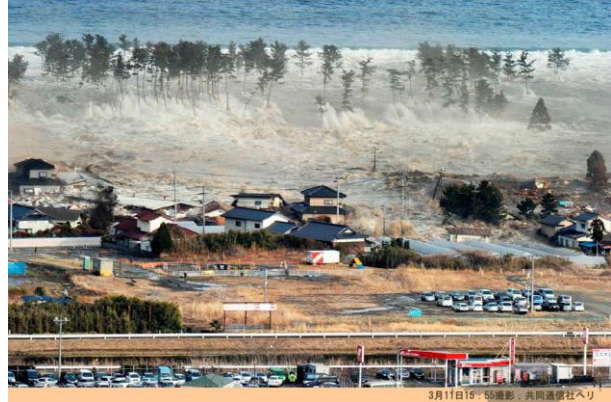
## Great tsunami hit residential area.

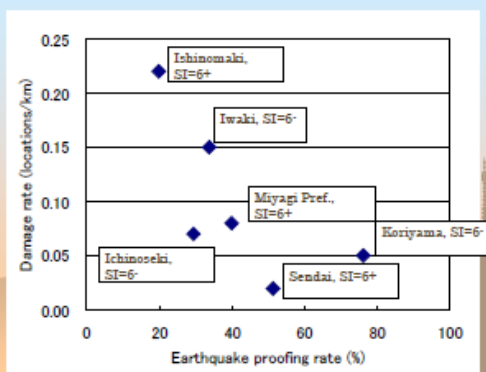
## Earthquake proofing rate and damage rate

- The entire damage to water supply pipelines is not revealed in flooded areas by tsunami. We must collect all damage data and analyze it to learn the lessons from this disaster.
- Effect of earthquake-proofing for pipeline was verified. We must accelerate the earthquake proofing, especially for aged facilities.
- Force of tsunami acted on a buried pipe is not clear. The effect of tsunami must be studied soon.

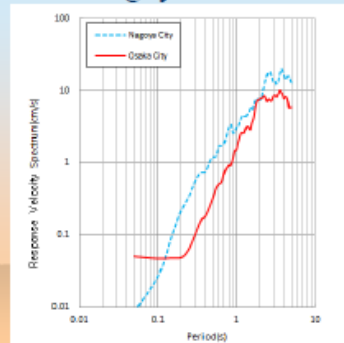
## Response velocity spectra at Nagoya and Osaka
