**MULTI-SCALE ANALYSES OF GRANULAR FLOWS FOR
DISASTER RESILIENCE ENHANCEMENT**

A Dissertation
Presented to
The Academic Faculty

In Partial Fulfillment
of the Requirements for the Degree
of Doctor of Philosophy in the
School of Civil and Environmental Engineering

Georgia Institute of Technology
December 2019

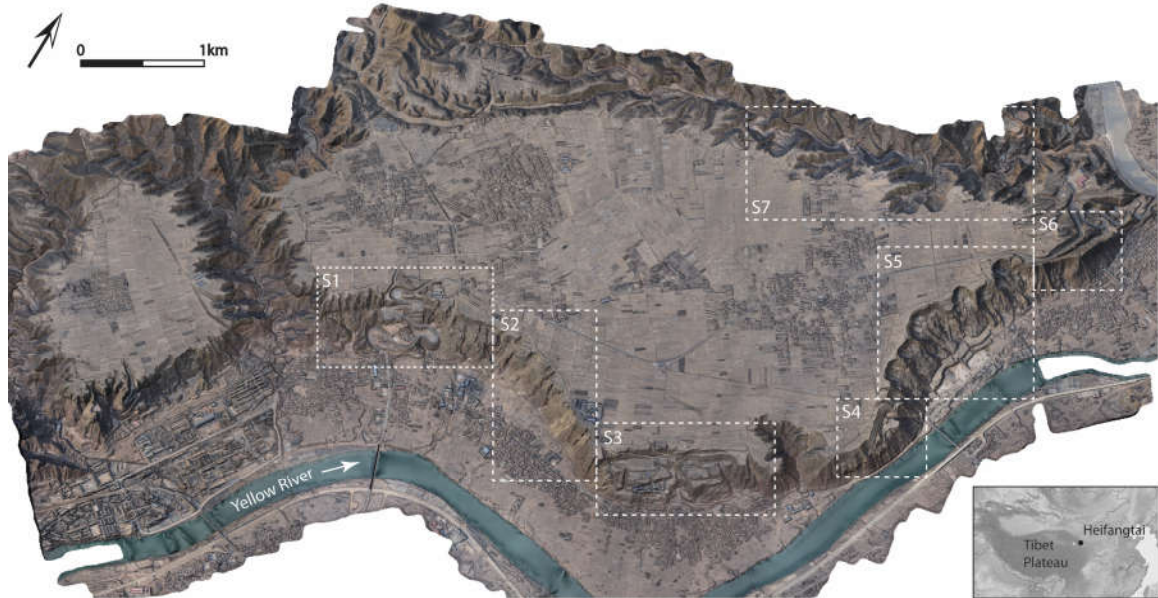
Figure 2.2 – Landslide distribution along the margin of HFT; landslide sections (S1 – S7) are discussed in Peng *et al.* (2018) and details are summarized in Table 1.

Heifangtai (HFT) is an arid loess terrace (area: $\sim 12 \text{ km}^2$) of the Yellow River in the loess plateau of China (Figure 2.2); it consists of four layers in the sequence of the Malan silty loess (thickness: 30-50 m), clay (3-20 m), gravel (1-10 m), and bedrock comprises sandstone with mudstone partings and the bedding plane dipping $135^\circ \angle 11^\circ$. The thickness of the exposed rock stratum is greater than 70 m. The average annual precipitation and evaporation are 287.6 mm and 1600 mm, respectively (Zhou, 2012). Local inhabitants were re-settled in the terrace since the 1960s due to the nearby construction of a hydropower station. Agricultural irrigation was started on the terrace surface by pumping water from the adjacent Yellow River, covering an area of 7.5 km^2 (exceeding 83% of terrace surface), with an annual consumption of water varying from $6 \times 10^6 - 8 \times 10^6 \text{ m}^3$ (Lin *et al.*, 2014). The groundwater level has increased by 20 m at an average rate of 0.18 m/yr. There is no prior knowledge of the groundwater status before irrigation.

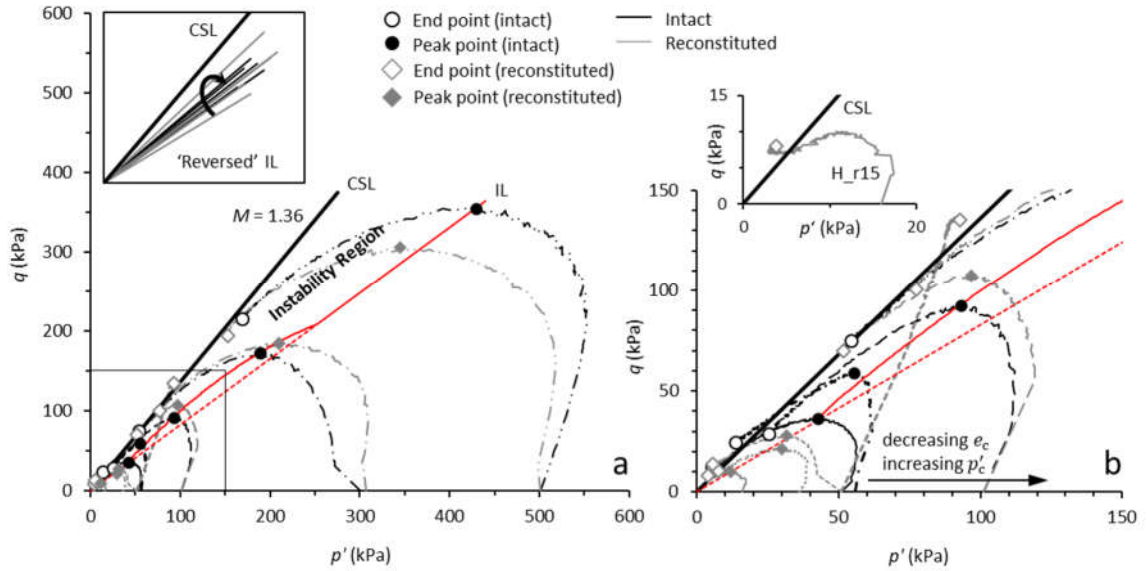
Figure 3.5 – Undrained stress paths of intact and reconstituted silty loess (HFT) samples. (a) the varying instability lines and region for intact samples with similar initial void ratio; (b) enlargement on stresses less than 150 kPa, with dilative tendency showing temporary flow instability for the reconstituted sample at confining stress of 15 kPa.

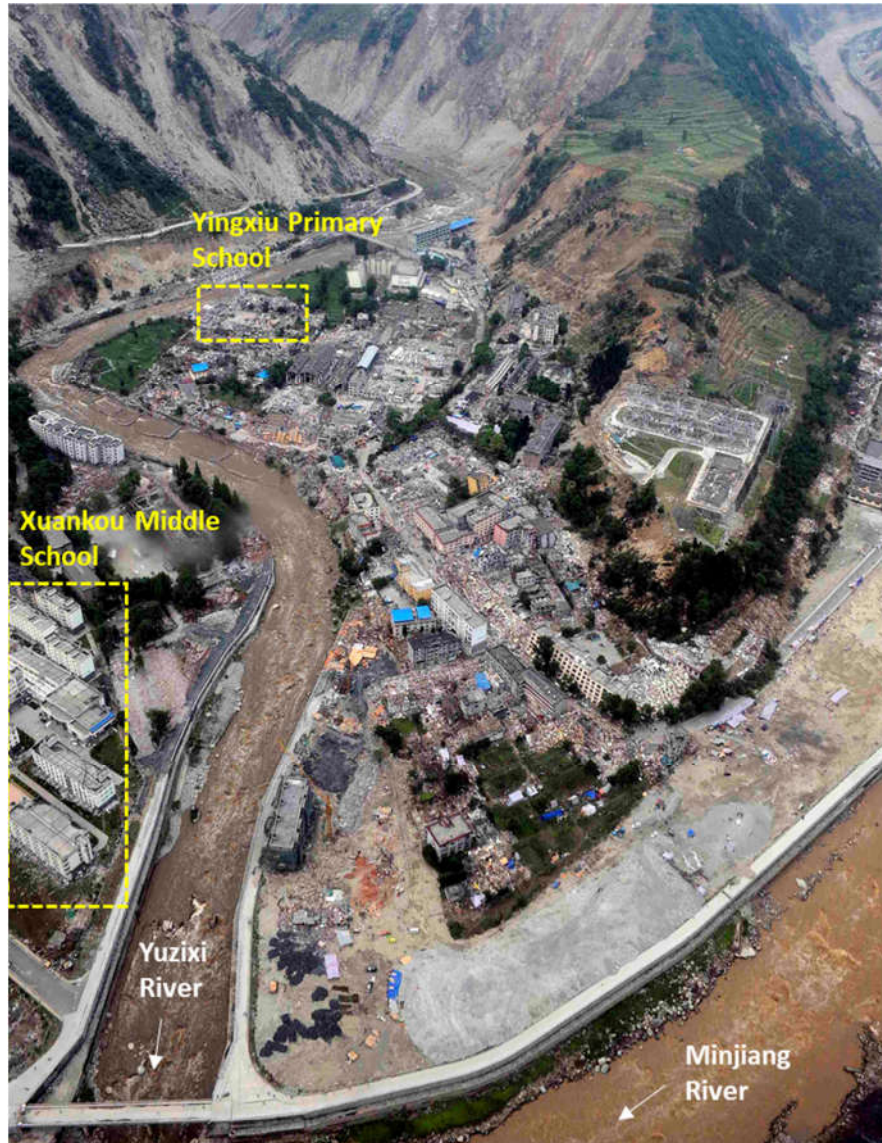
Figure 6.2 – Post-earthquake aerial image shows the ruins of Yingxiu town (N-facing), including the Yingxiu Primary School (300 m from YBF) and the Xuankou Middle School (500 m from YBF) (image: May 14, 2008; credit: Xinhua News Agency).

More than 80% of the building structures were destroyed or partially damaged as they underwent vertical and horizontal ground displacements during the earthquake. The

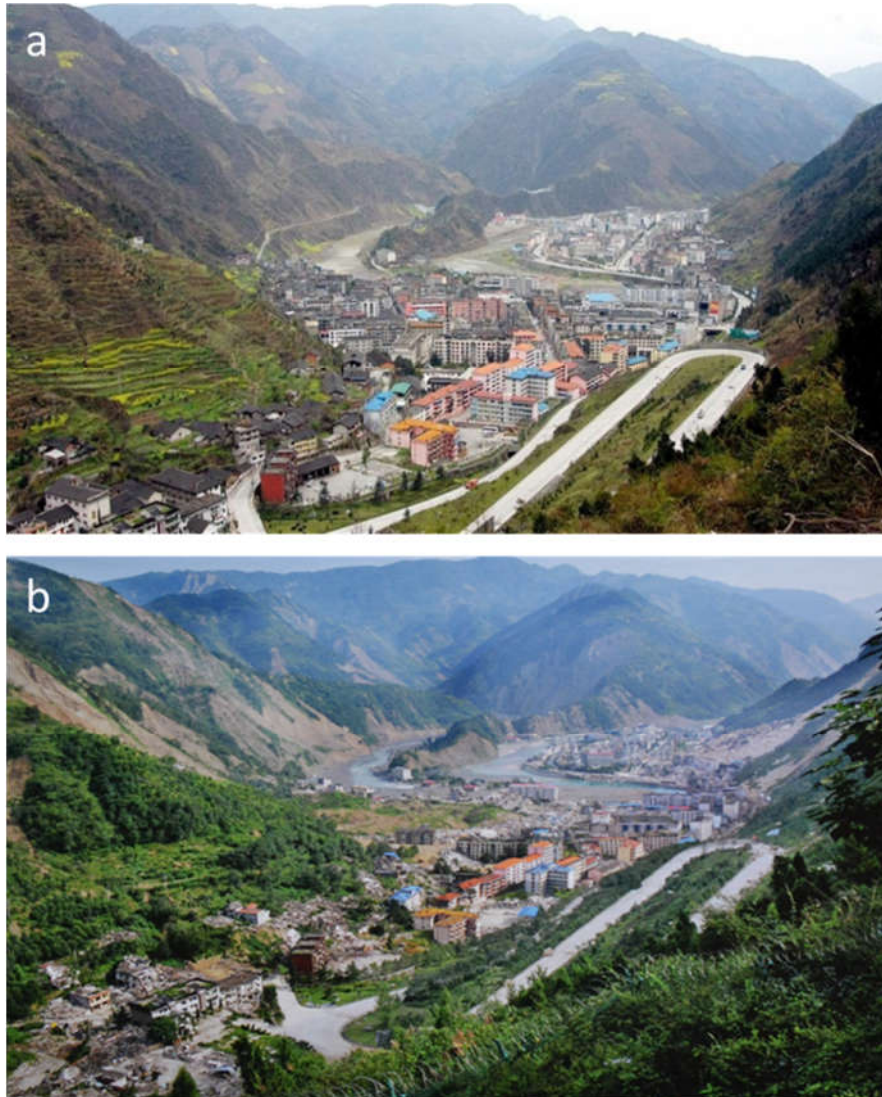
Figure 6.3 – The pre-/post-earthquake old Beichuan town (N-facing): (a) pre-earthquake image (ca. 2007); (b) post-earthquake image (image: August 3, 2008) (China Institute of Geological Environmental Monitoring, 2009).

The pre-/post-earthquake comparison of old Beichuan town is illustrated in Figure 6.3. The old Beichuan town was the county seat of the Beichuan County; the town was combined with Qushan town and a newly developed area that forms the old and new part of the town separated by the Jianjing River. The town is surrounded by hillslopes, as the relief was characterized by the transitional zone between the eastern margin of the Tibetan Plateau and the Sichuan Basin (Wang, 2009; Zhang *et al.*, 2009).

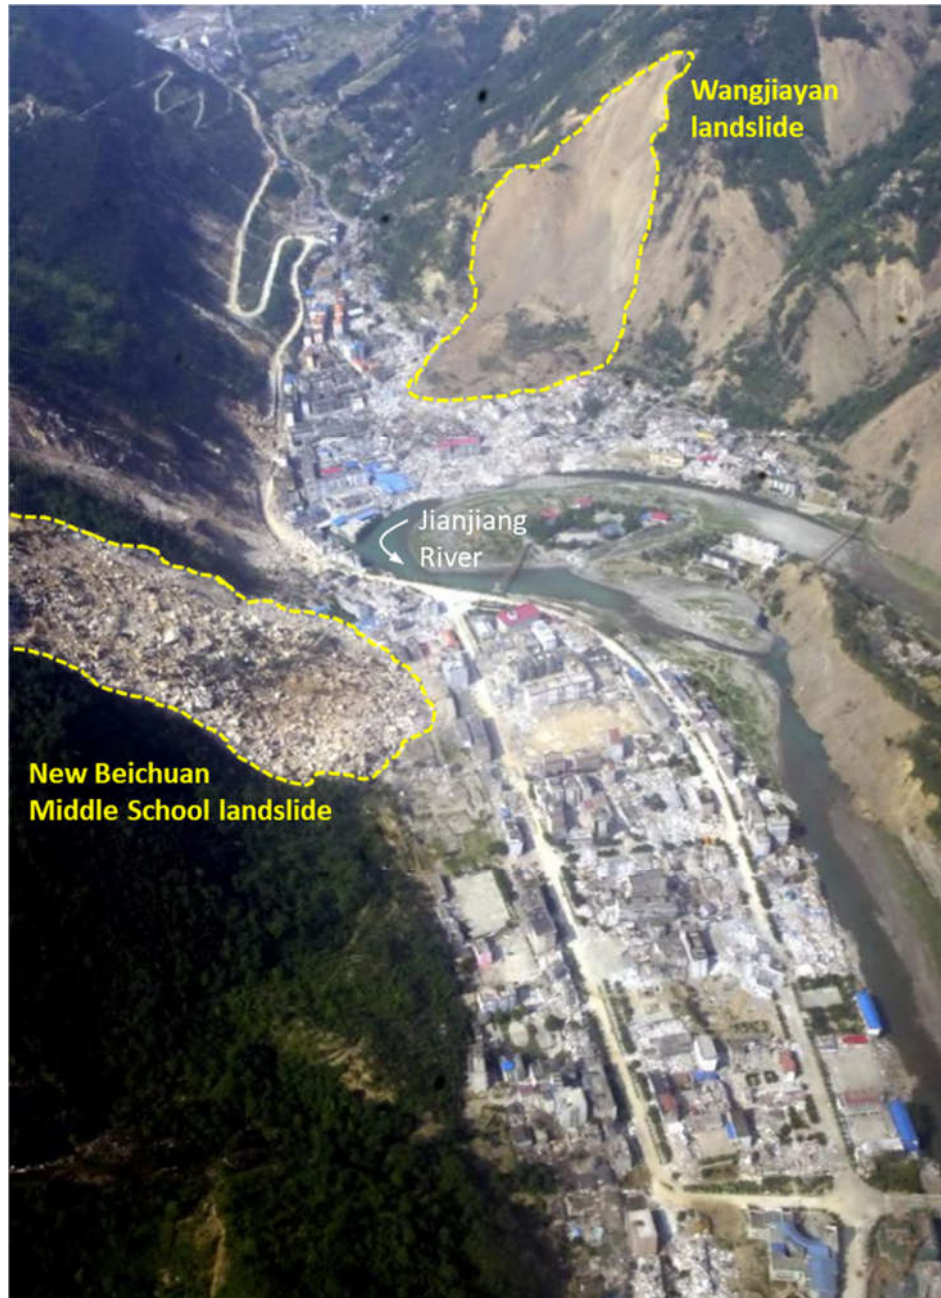
Figure 6.4 – Post-earthquake aerial image showing the ruins of the old Beichuan town (S-facing) (image: May 27, 2008; credit: Xinhua News Agency).

i.e. the Wangjiayan landslide and the New Beichuan Middle School landslide (Figure 6.4); they were responsible for more than 2,000 deaths (Huang & Li, 2009).

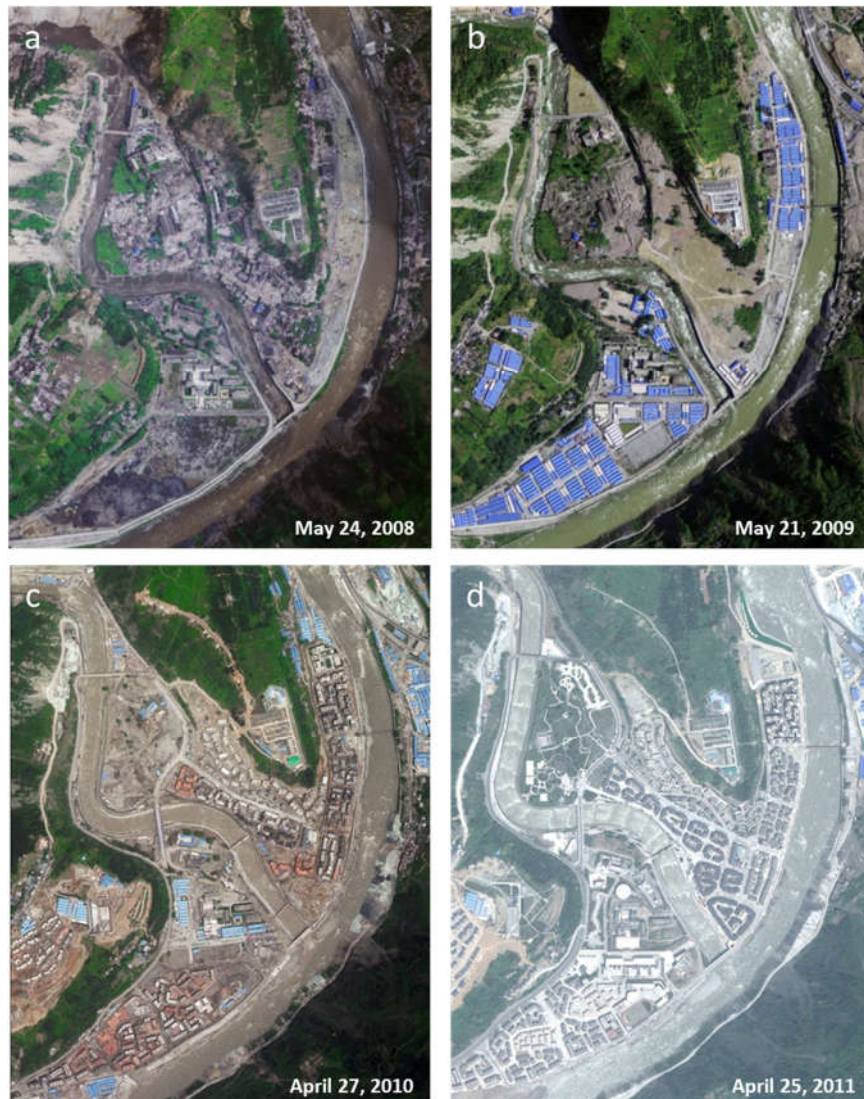
Figure 6.6 – Satellite images showing reconstruction process of Yingxiu: (a) earthquake damage; (b) temporary structures; (c) initial phase; (d) final phase (image courtesy of the Center of Earth Observation and Digital Earth, CAS).

The reconstruction process of Yingxiu is illustrated in Figure 6.6 and Figure 6.7. The on-site reconstruction of Yingxiu town started immediately after the earthquake. The *Regulations* divided the reconstruction into two phases, including a three-year short-term reconstruction (2008-2010) and a ten-year long-term development (2011-2020).

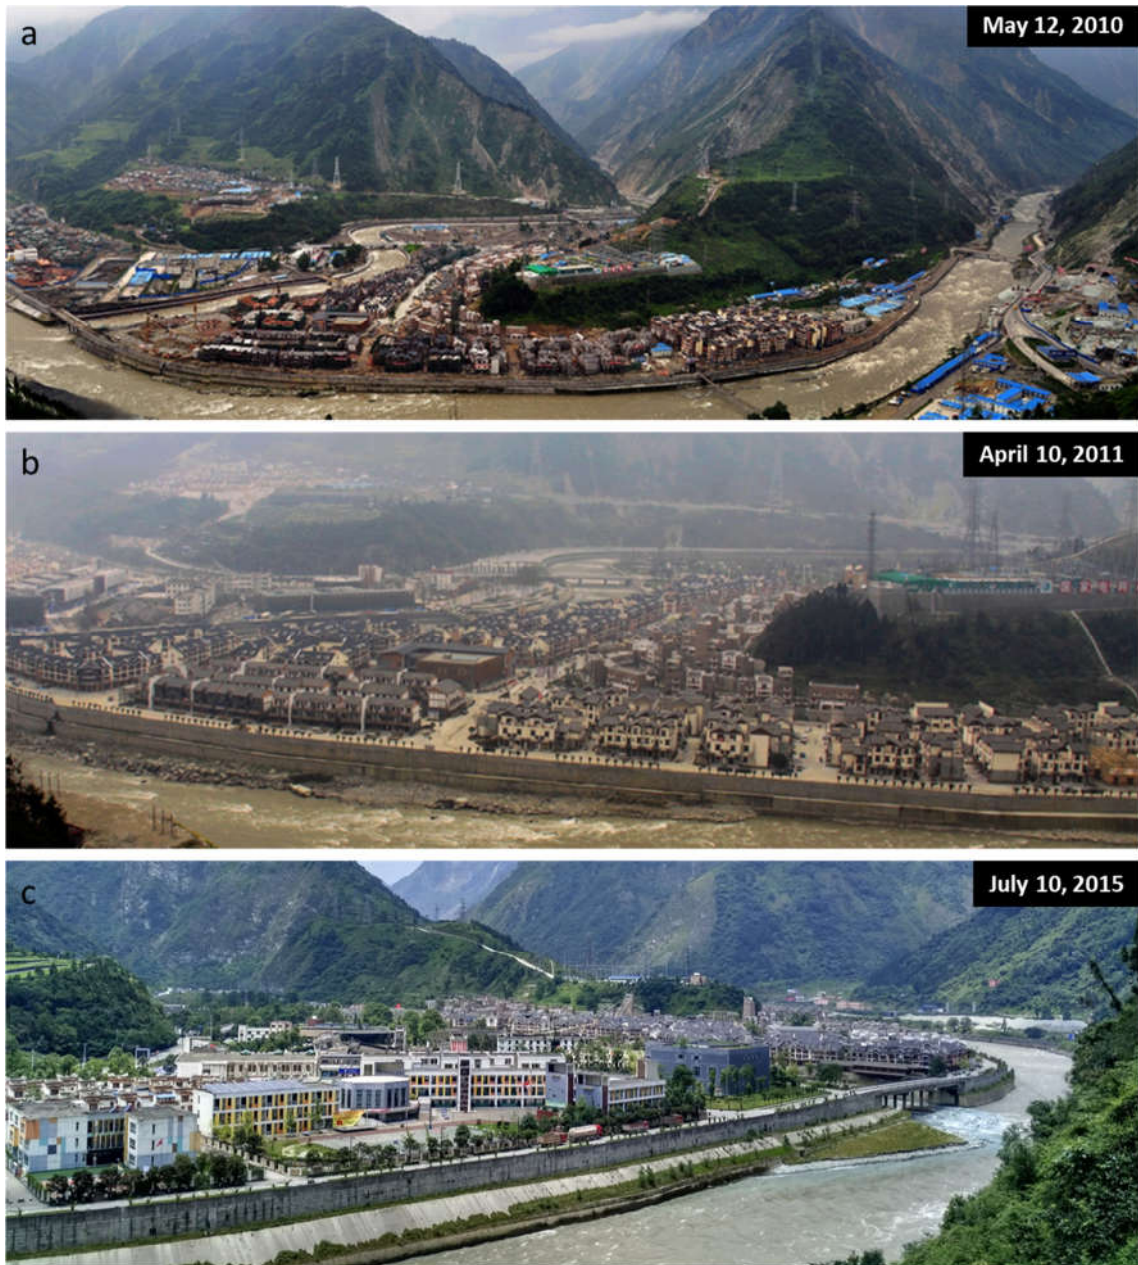
Figure 6.7 – Post-earthquake reconstruction process of Yingxiu town: (a) north and center part (credit: SKLGP); (b) center part (credit: SKLGP); (c) south part.

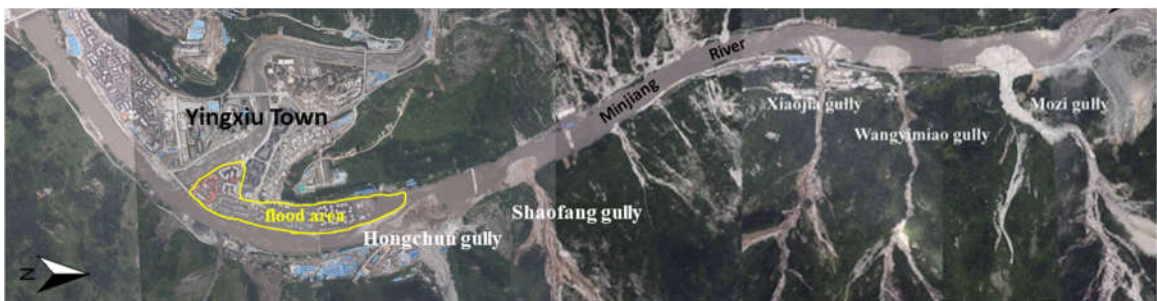
Figure 6.8 – A stitched aerial image of the debris flow occurred on August 12-14, 2010 on the upstream of Yingxiu town (image: August 15, 2010) (after Tang *et al.*, 2012b).

The rainfall event on August 12-14, 2010 caused severe damage to the reconstruction with flood inundation, which was resulted from the blockage of the Minjiang River due to the debris flows that occurred at the immediate upstream (Figure 6.8). The precipitation

reached 163 mm in 2 hours on the morning of Aug 14, 2010; it triggered debris flows around 3:00 AM local time and lasted for about 2 hrs (Xu, 2010). The volume of debris flow from the Hongchun gully was estimated as $7.5 \times 10^5 \text{ m}^3$ (Huang & Li, 2014). The flood level in the north part of Yingxiu town was 2-3.5 m (Figure 6.9); the flood remained in that area for more than 7 days (Tang *et al.*, 2011a). The debris flows caused 13 fatalities with 59 missing and evacuation of more than 8000 people in Yingxiu.

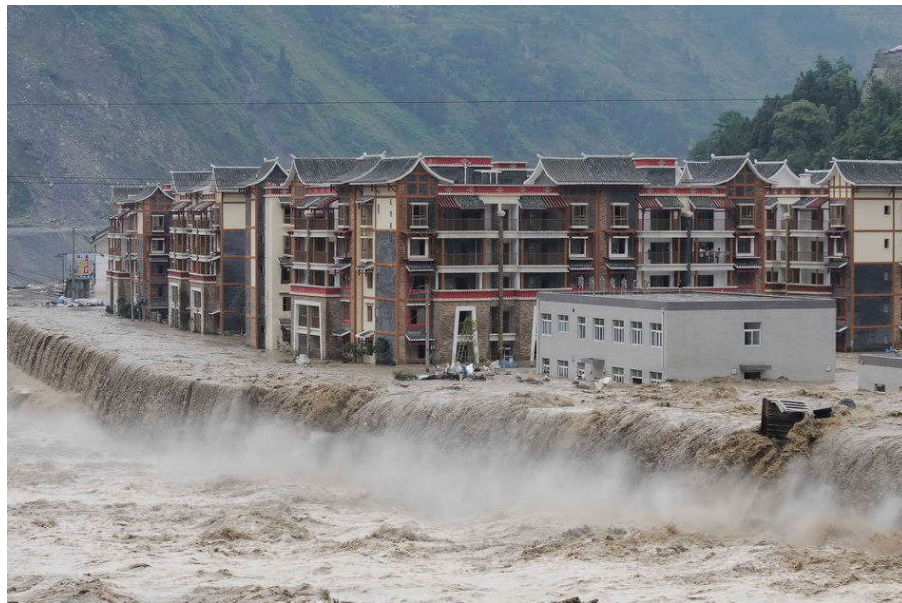
Figure 6.9 – Urban flooding in the reconstructed Yingxiu town during debris flow events on August 12-14, 2010 (image: August 15, 2010; credit: SKLGP).

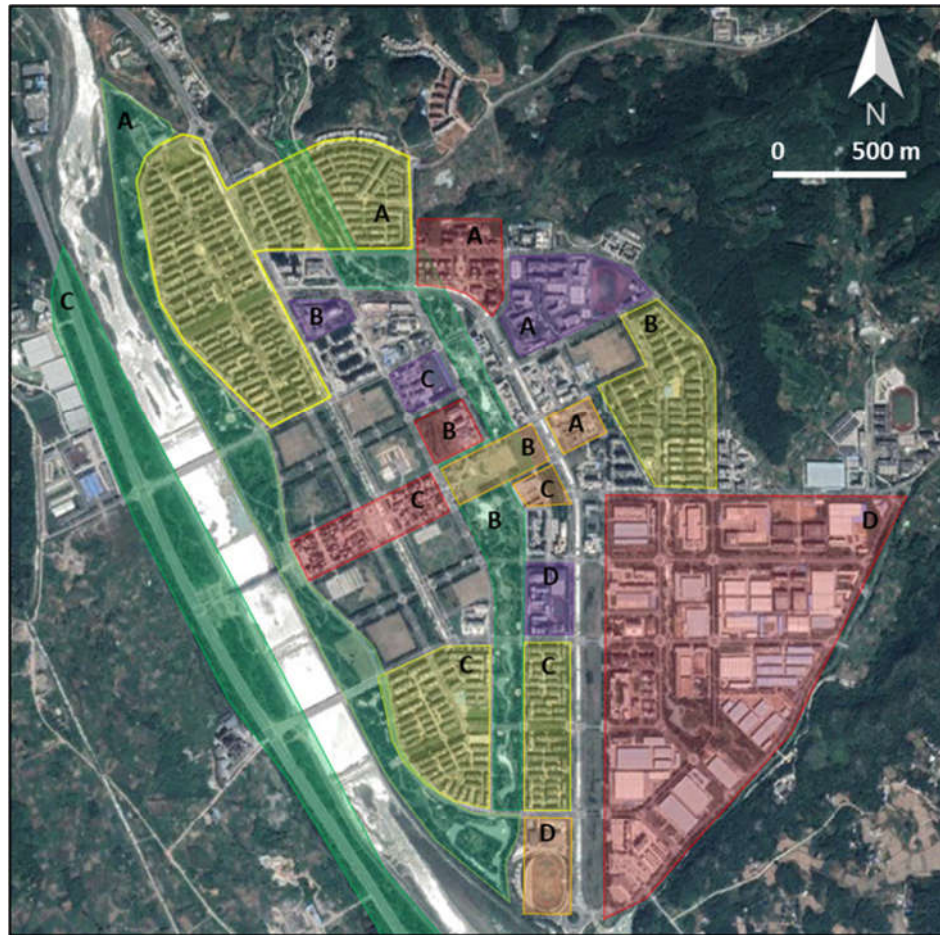
Business/Public Service	Museums/ Arts Center/Stadium	Residential Areas	Scenic Drive/Byways	Schools/ Hospitals
A	County Hall	Culture Center	Wenquan	Anchang River Scenic Byway	Beichuan Middle School
B	New Beichuan Grand Hotel	Wenchuan Earthquake Museum	Baiyangping	Yongchang River Scenic Byway	Central Hospital
C	Shopping Walkways	Performing Arts Center	Hongqi	Anbei Scenic Drive	No.1 Yongchang Elementary School
D	Shandong Industrial Zone	Stadium			No.2 Yongchang Elementary School

Figure 6.11 – Map of the Yongchang town showing the land use plan superimposed on the satellite image of the town (Google Earth image: September 9, 2016).

Figure 6.11 illustrates the land use plan in Yongchang town; the matrix shows the five key categories incorporated in the plan (China Academy of Urban Planning and Design, 2008). The designed seismic resistance of the buildings and lifelines is VIII (Mercalli Intensity scale) and the PGA is $0.2g$, in accordance to the updated Design Code GB50011-2010 (Ministry of Construction of China, 2010). The reconstruction started on May 12, 2009. The area used for reconstruction is about 3 km^2 as of the end of 2010. The relocated residents are more than 40,000 in 2010 and was anticipated to increase to about 70,000 by the end of 2020. More than 11,000 apartments were constructed by the end of 2010. The living conditions are greatly improved in Yongchang town as compared to the old Beichuan town (Liu *et al.*, 2017b). Dunford & Li (2011) discussed the poverty alleviation goal that is featured strongly in the Overall Plan, which attempted to address the poverty issues through resettlement of the rural population. Reflecting that particular consideration, an industrial park was constructed in Yongchang town for short-term employment and long-term economic development. The industrial park occupies nearly $1/3$ of the reconstructed area with 28 companies and factories resettled or established by the end of 2011.

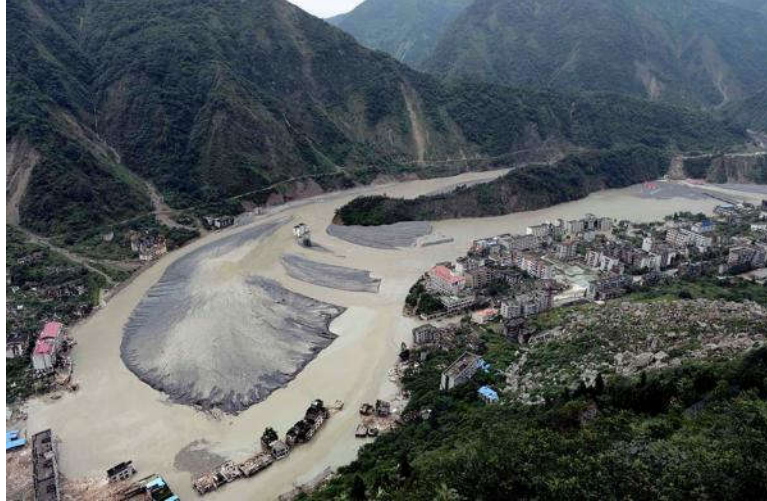
Figure 6.13 – Flooded old Beichuan town after the intense rainfall on July 8-9, 2013 (image courtesy of SKLGP).

The extreme rainstorm on July 8-9, 2013 inundated 80% of the town, especially the ruins near the river embankment. The cumulative daily precipitation reached 285 mm, which increased the water level of the Tangjiashan Quake Lake by 8 m, which resulted in a peak flood discharge of 5000 m³/s into the Jianjiang River and flooded old Beichuan town (Figure 6.13). The flooding event caused 1 death and 15 missing. Fan *et al.* (2015) argued that such an extreme rainfall that occurred on July 8-9 can be attributed to human-

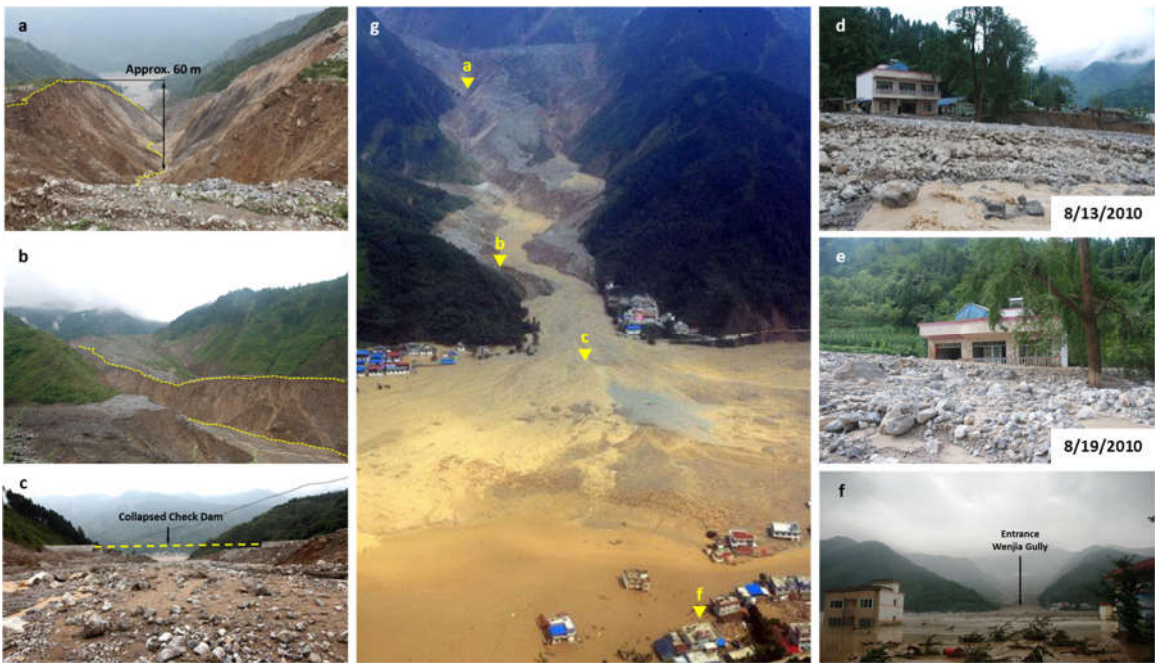
Figure 7.4 – The devastating debris flow occurred on Aug 13, 2010: (a) deep incision due to channelized erosion on the 1300m Platform; (b) widened debris flow channel near the exit of the gully; (c) failure of the last check dam (after Tang *et al.*, 2012); (d) a buried house in Qingping village; (e) increase in the thickness of the deposit after a subsequent debris flow; (f) submerged area near the outlet of the gully; (g) aerial image of the debris flow with approximated locations of the images presented herein.

The debris flow occurred on Aug 13, 2010 has been well studied and presented in the literature (Xu, 2010; Ni *et al.*, 2012; Tang *et al.*, 2012a; Xu *et al.*, 2012c; Yu *et al.*, 2013, 2014; Zhou *et al.*, 2014a), as shown in Figure 7.4. A heavy rainstorm concentrated between 14:00 on Aug 12 and 01:00 on Aug 13 (daily cumulative rainfall $R_d = 220$ mm; peak rainfall intensity $I_{max} = 70$ mm/hr). According to eyewitnesses, the debris flow occurred after 01:00 on Aug 13 and lasted for about 2 hours, which coincided with the duration of the rainfall.

The heavy rainfall generated intense surface run-off, and saturated the loose deposit and produced a large erosion channel with a depth of 60 m and a gradient of 60° (Figure 7.4a and Figure 7.4b). The debris flow was intercepted by the check dam at the outlet of the gully until its failure (Figure 7.4c). The estimated debris volume exceeded 4.5×10^6 m³ and it covered a total area of 635,000 m² in Qingping (Xu *et al.*, 2012c). The debris flow deposit has an average thickness of 7 m, with a maximum thickness of over 15 m (Figure 7.4f). The deposits blocked the Mianyuan River (Figure 7.4g) along with compounding debris flows in the area, including a large-scale event in Zoumalin Gully located 4 km upstream of Wenjia gully. The Qingping village was severely damaged and partially buried

by the debris flows, which caused 7 casualties, 39 injured and 497 houses buried (Yu *et al.*, 2013). Another debris flow occurred on Aug 19, which interrupted the construction of the rapid-response mitigation measures and deposited an additional $17.6 \times 10^4 \text{ m}^3$ of sediment; the subsequent event also caused severe damage to Qingping village while the community was recovering from the previous event (Figure 7.4d and Figure 7.4e).

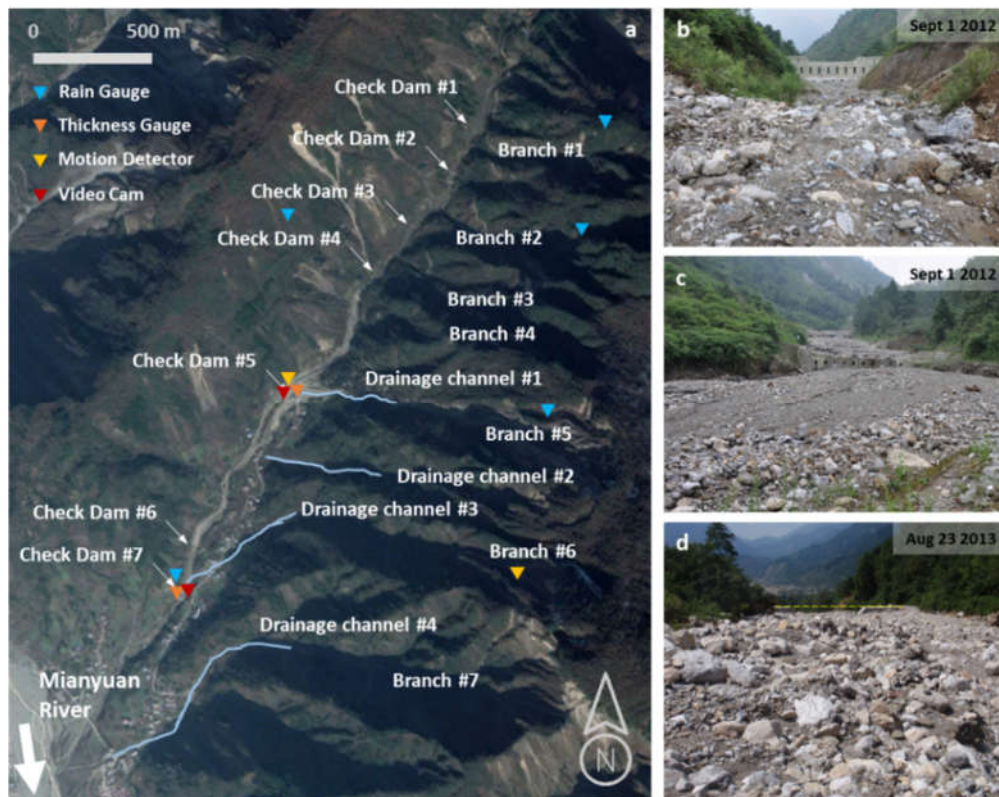
Figure 7.15 – The conventional mitigation system and post-mitigation debris flows in the Zoumalin gully: (a) satellite image of the gully and the mitigation system, some small-scale check dams are omitted for clarity (Google Earth image: December 22, 2014); (b) debris flow deposits overflowed check dam #4 (after debris flow on Aug 24, 2012); (c) submerged check dam #6 (after debris flow on Aug 15, 2013).

A large amount of loose sediment was deposited by co-seismic landslides in the Zoumalin gully, with no prior reports of debris flow before the Wenchuan earthquake. The conventional mitigation system consists of 7 large check dams in the main gully, 4 drainage channels in the branches with small sectional barriers, and an additional 3 barriers located between check dam #4 and #5 (Figure 7.15).

The layout of the EWS devices is presented in Figure 7.15, which contains the rain gauges in the main gully and several branches at different elevations. Motion detectors and

thickness gauges are deployed to sense surface movements for debris flows, which can also be verified by monitoring cameras at various locations. Details on the EWS framework in Qingping is discussed by Huang *et al.* (2015a). The intense rainfall events on Aug 17, 2012 and Jul 8, 2013 resulted in two large-scale debris flows. The debris flow in 2012 filled most of the basins of the check dams and blocked the drainage channels (Figure 7.15a and Figure 7.15b); the basins were later emptied. The debris flow in 2013 overflowed the check dams (Figure 7.15c) and resulted in severe damage to the building structures near the drainage channel #1 and #2.
