## Experimental Assessment of the Current Load Rating Procedures for a Corroded Steel Ridge Girder in Massachusetts

**EXPERIMENTAL ASSESSMENT OF THE CURRENT LOAD RATING  
PROCEDURES FOR A CORRODED STEEL BRIDGE GIRDER IN  
MASSACHUSETTS**

MASTER OF SCIENCE IN CIVIL ENGINEERING

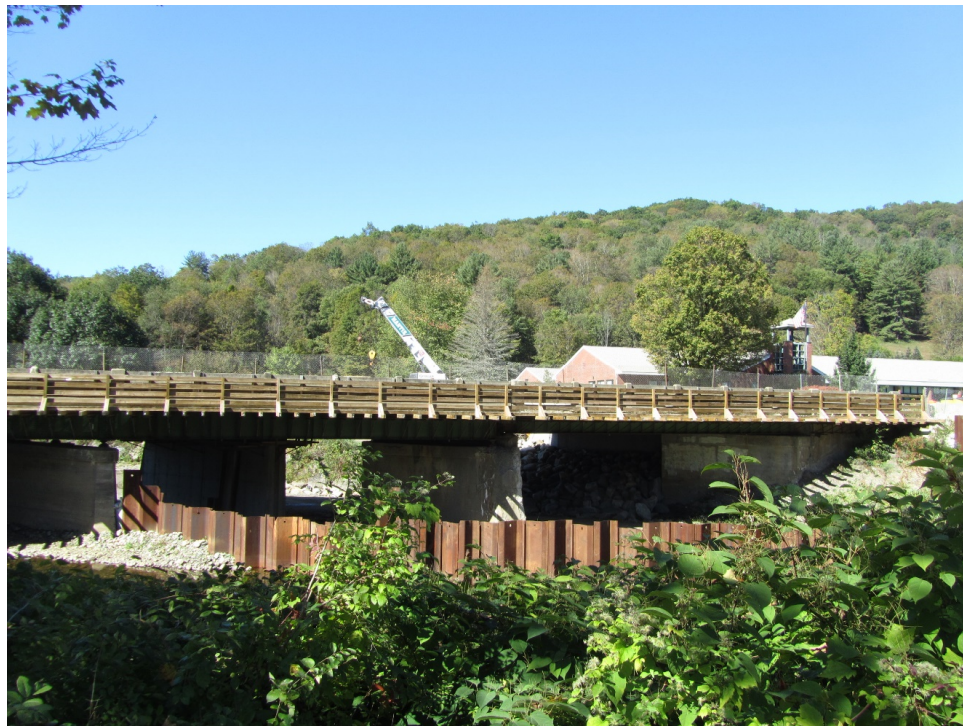
Figure 2.1: Bridge ID C18028-0KQ-DOT-NBI, Colrain, Massachusetts; approach span pictured on the right.

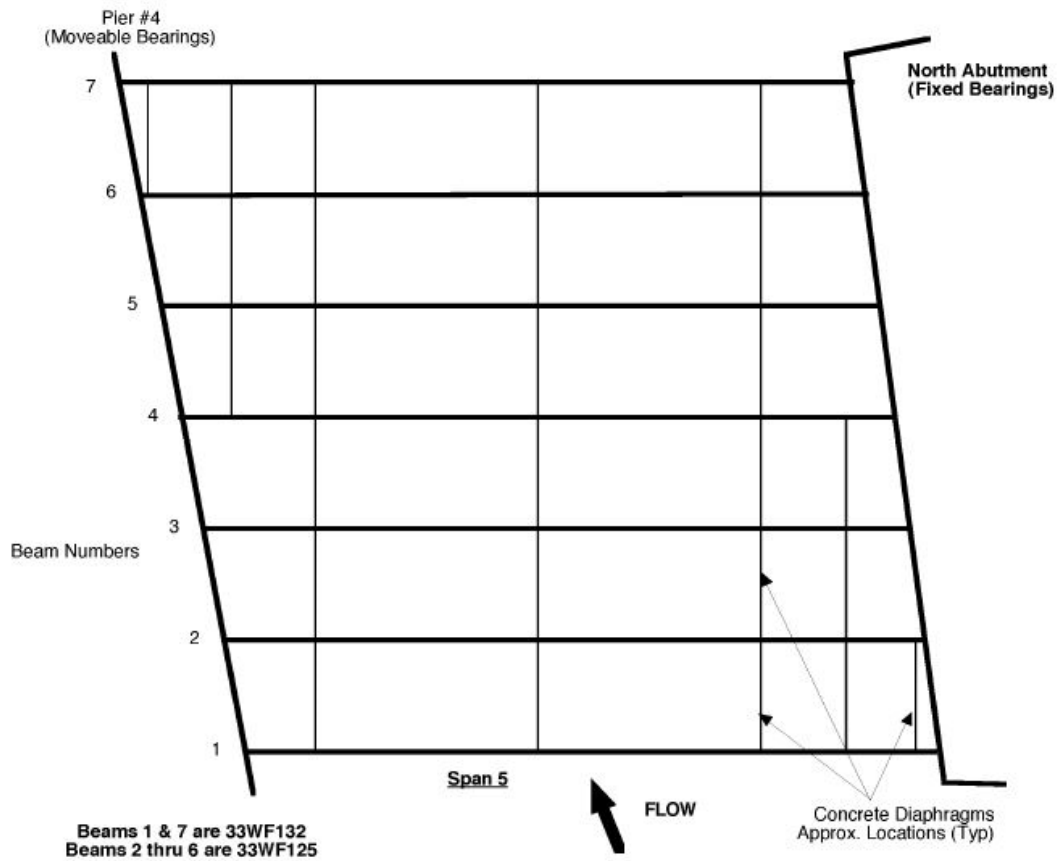
Figure 2.2: Span 5 Structural Layout

In 2017 the bridge received a condition rating of 3 (poor), with a documented average daily traffic (ADT) of 1,440 vehicles (NBI 2017). Around the time of this study, MassDOT decided to undergo replacement of the approach spans (1 & 5). Both of which were carried by a superstructure of seven simply supported, unstiffened, rolled steel girders, where a significant amount of deterioration had developed at the girder ends. The system of girders relied on a series of concrete end and intermediate diaphragms. For a plan view of the framing for span 5, see figure 2.2.

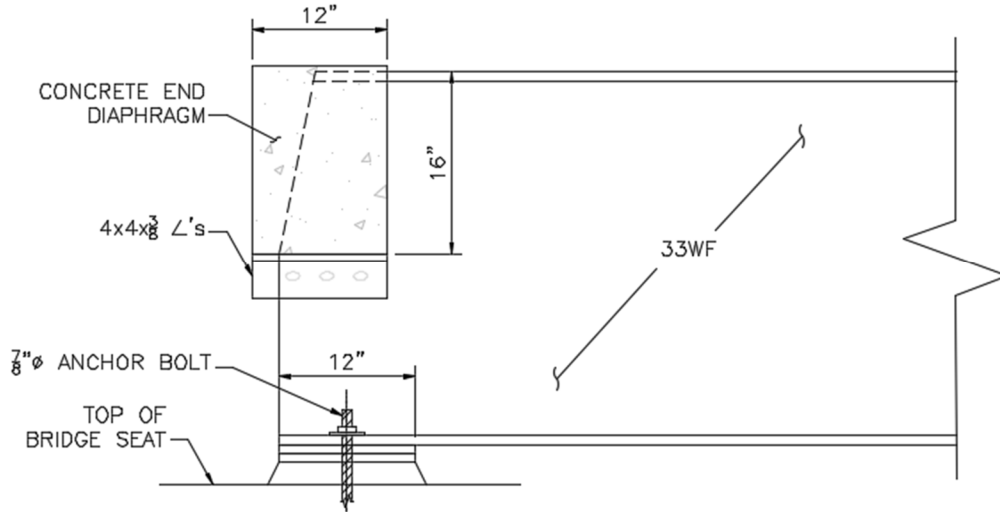
Figure 2.3: Bearing Details

forces. The bearings go to the end of the girder, allowing no beam overhang past the bearing, refer to Figure 2.3 for a detail of the bearing condition. The span supports two

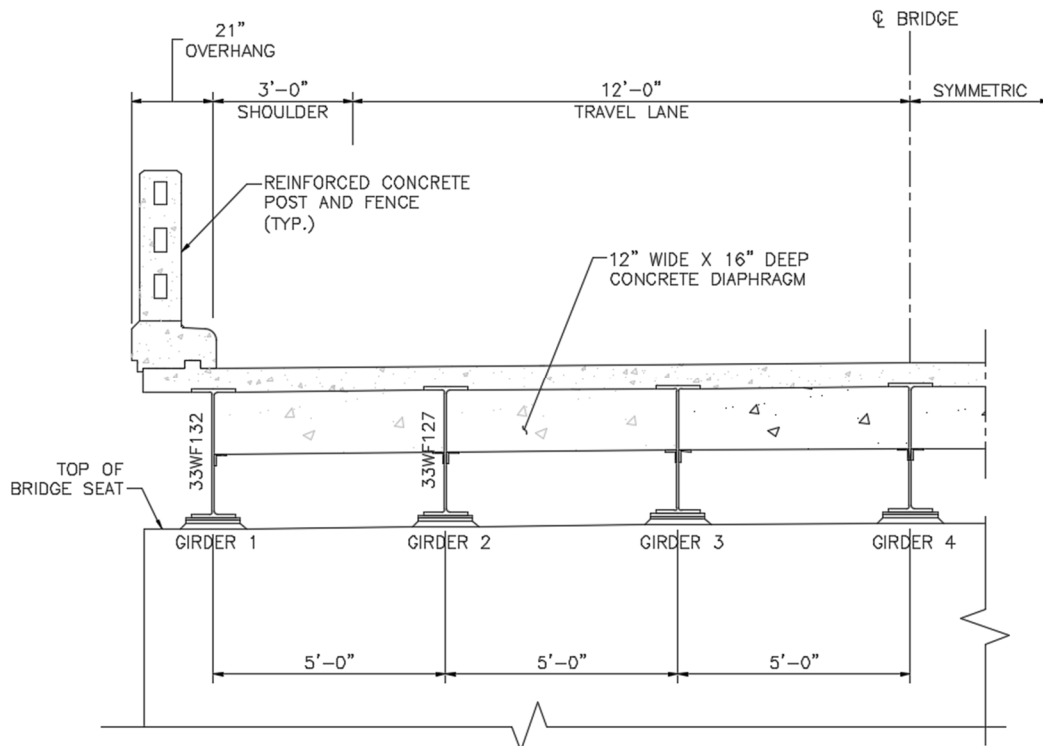
Figure 2.4: Cross Section View at Bearing

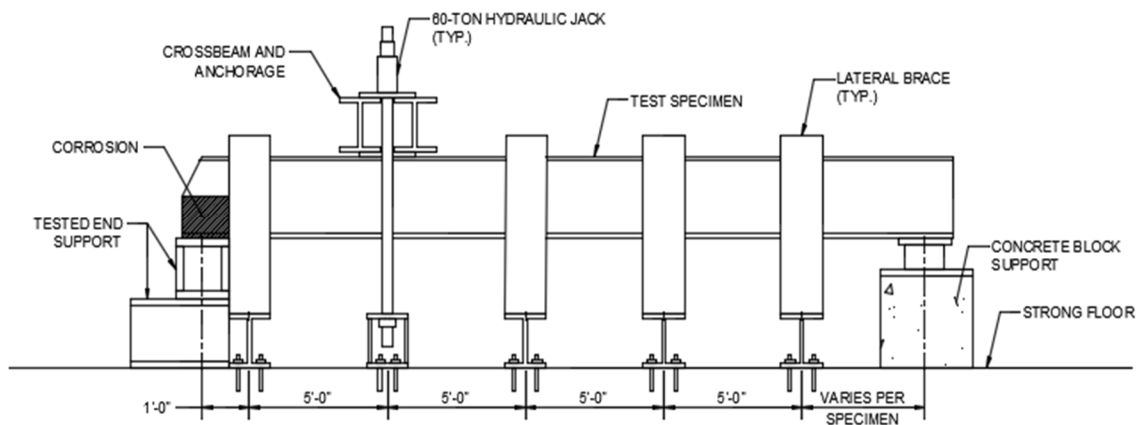
Figure 3.1: Typical Experimental Set-Up

The experiments for this thesis were carried out in the University of Massachusetts Amherst's (UMass Amherst) Brack Structural Testing Laboratory. The lab was set up with an 80' x 30' strong floor, with tie down spots centered every five feet. With a maximum tensile capacity of 200 kips, the tie down spots could distribute this force over four, 1-1/8"-8 anchor bolt holes equally spaced at eight inches. Due to length restriction in the structural lab, it was determined to field cut the original 50-foot-long bridge specimens roughly in half longitudinally. Reducing the length keeps the full-scale aspect of the girder end, while not affected the natural corrosion developed along the complete end. The design of the braces for the testing rig followed the procedures in the AISC Steel Construction Manual (SCM) (AISC 2016) based off the work of Joseph Yura done on beam bracing (Yura 2001). The vertical supports were supplied from previous research projects done at UMass Amherst, which were sufficient to resist the maximum expected load throughout the

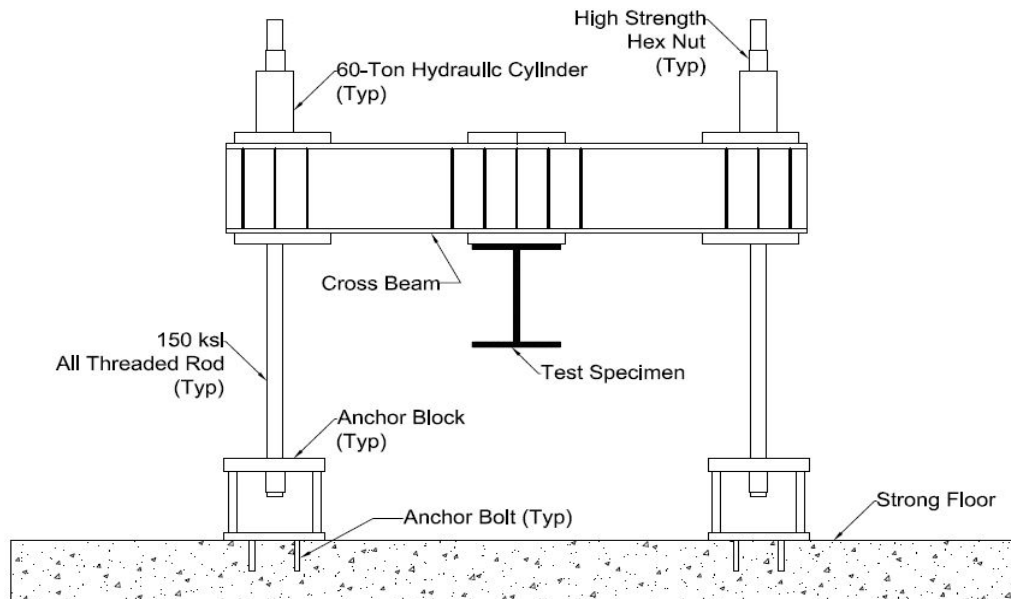
Figure 3.2: Loading Configuration for Experimental Set-Up

A three-inch space was left between the beams, along with a 2" Ø hole in the two end cover plates to allow passage of a ten-foot-long, 1-3/4" Ø anchor rod. The maximum stress to be developed in the rod is 83.15 ksi, thus, 150 ksi all threaded anchor rods were selected. The rods were restricted by high strength hex nuts above the hydraulic cylinders and on the inside on anchor blocks in the strong floor. The anchor blocks were comprised

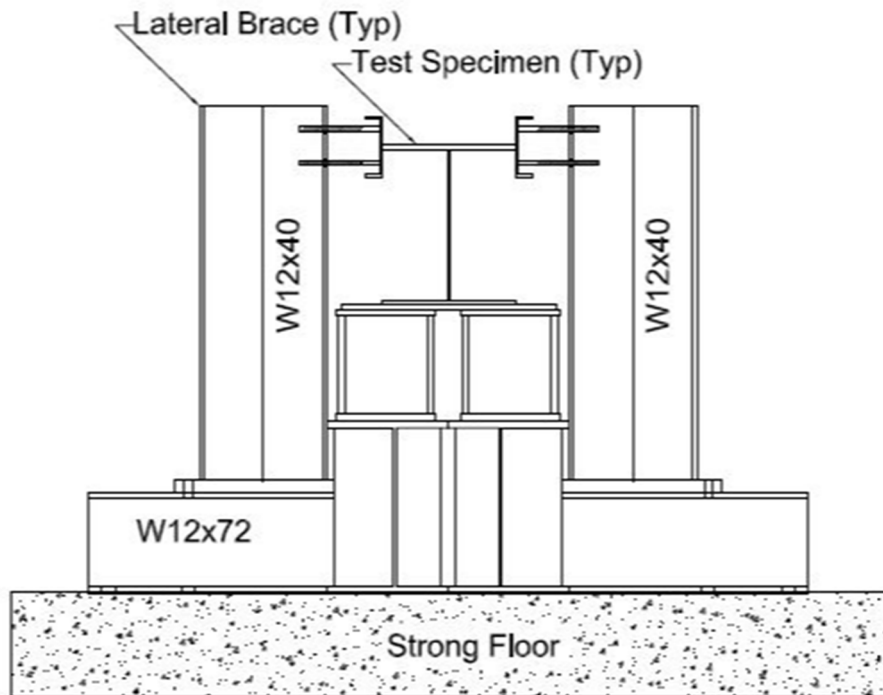
Figure 3.3: Lateral Support at Beam End

Refer to Figure 3.3 for a front view of the lateral torsional buckling brace at the tested end bearing location.

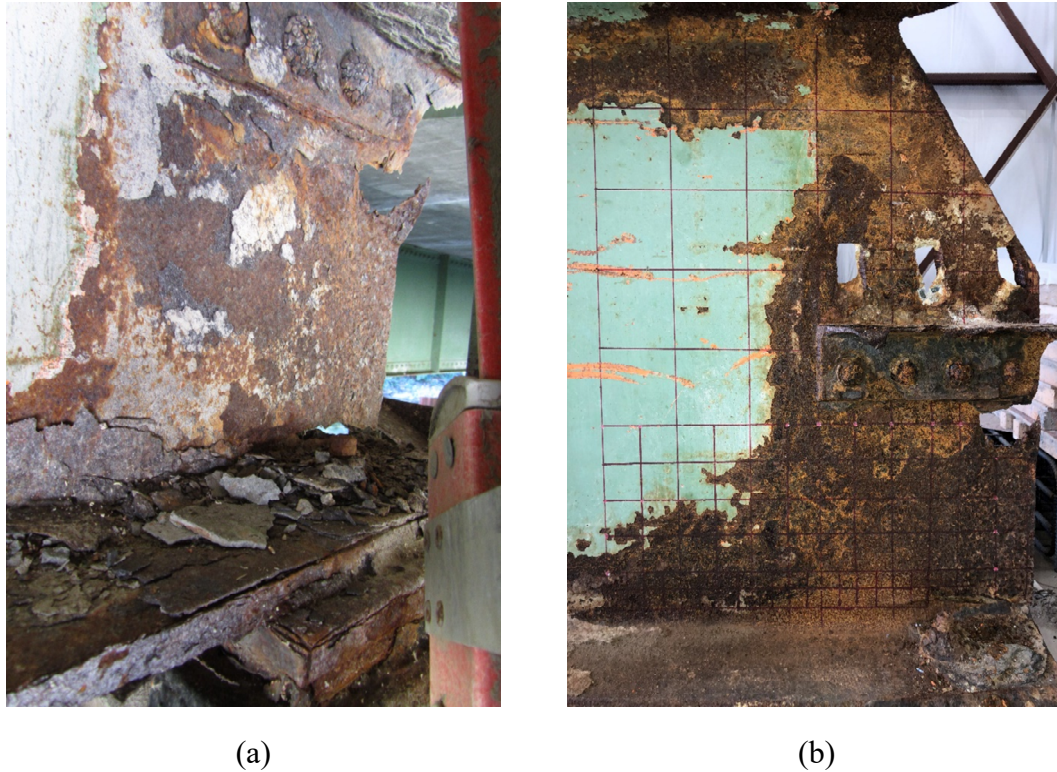
Figure 3.4: Test Specimen 1 a) before deconstruction in the field, b) before testing in the lab.

The girder end had significant corrosion damage, with a combination of severe thickness loss and multiples holes in the web, see Figure 3.4 for a side view of the girder end. The

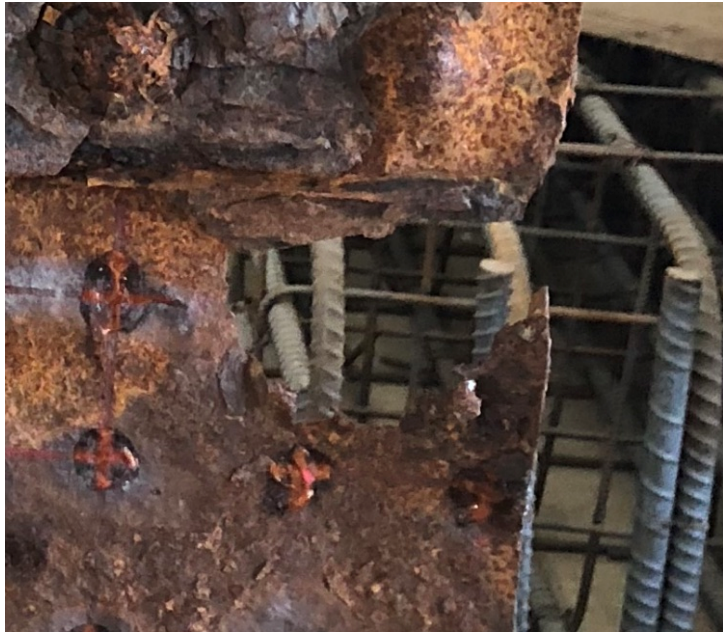
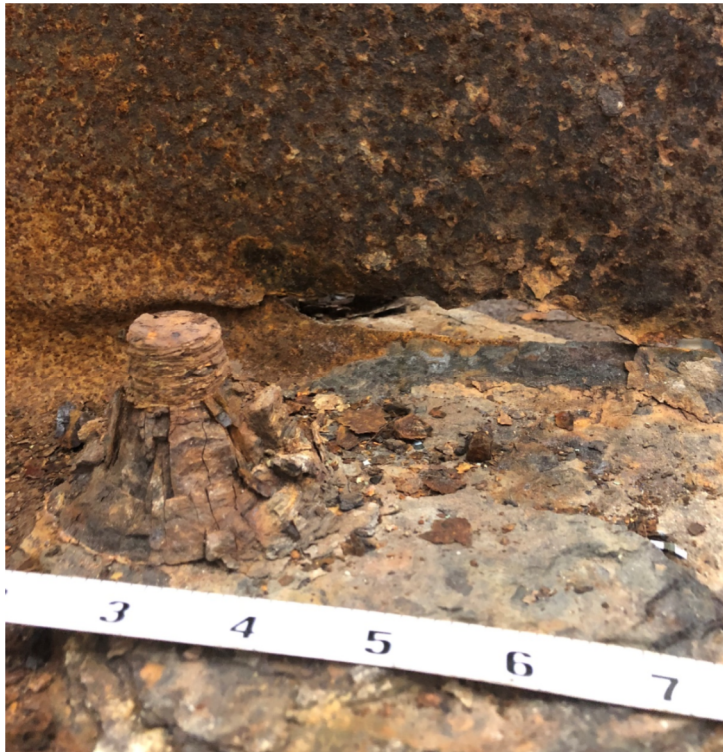
Figure 3.5: (Top) 2"x3" hole under end diaphragm; (Bottom) 5"x2" hole next to crippled section at web-flange connection.

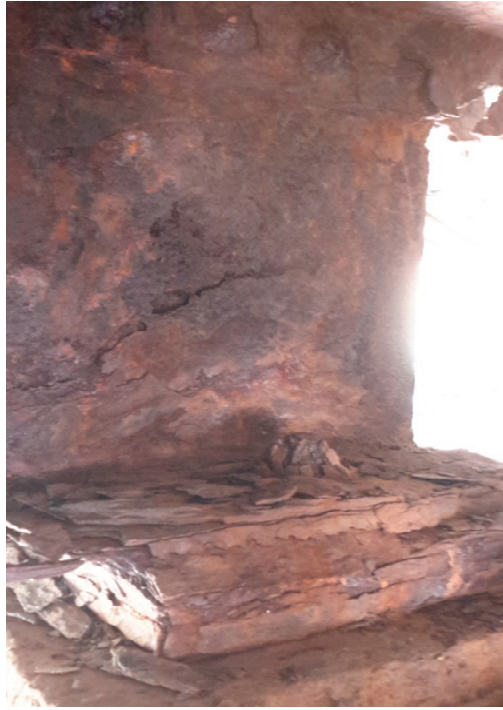
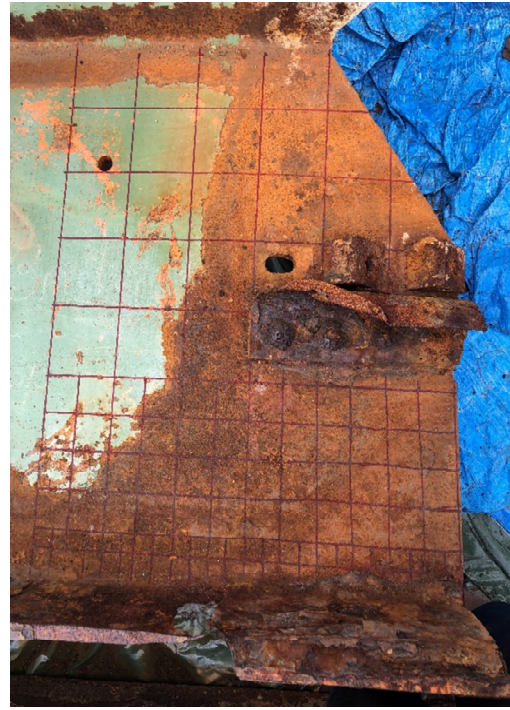
Figure 3.6: Test Specimen 2 a) before deconstruction in the field, b) before testing in the lab.

As seen, the flange at the bearing plate has been completely corroded, leaving a 5" x 3" hole at the connection. The web was corroded more aggressively along the bottom portion; however, a 45° angle of deteriorated web can be seen going across the length of the bearing plate, refer to Figure 3.7. It will be assumed this will be the expected failure region for this specimen. In conjunction with this deteriorated region, the web also had an initial out of plane displacement of 1.5" from its original  $\bar{C}$ . Previous inspection reports stated initial signs of out of alignment for the web, which ensures this imperfection was not caused due to deconstruction. Specimen 2 had an average remaining thickness in the bottom 4 inches of web along the bearing of 0.32 inches. This specimen differs because there is no hole along the web-flange connection at the girder end.

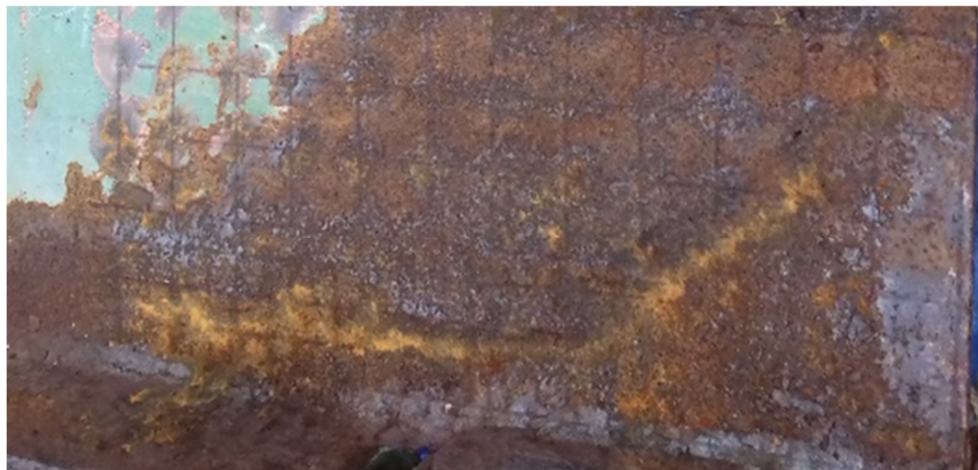
Figure 3.7: 45° Deteriorated Region in Web

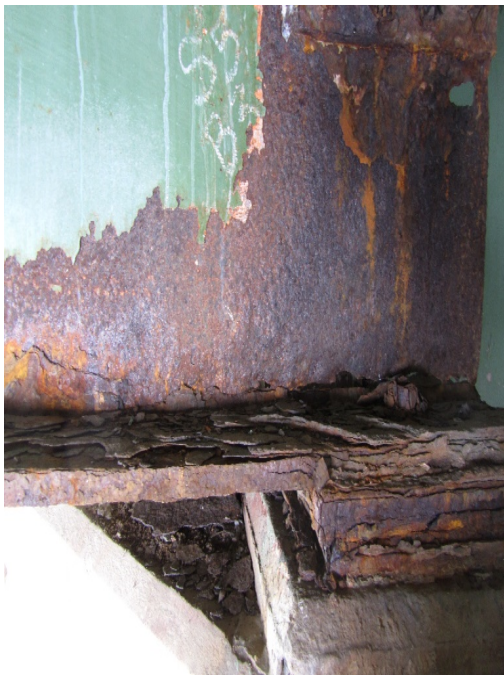
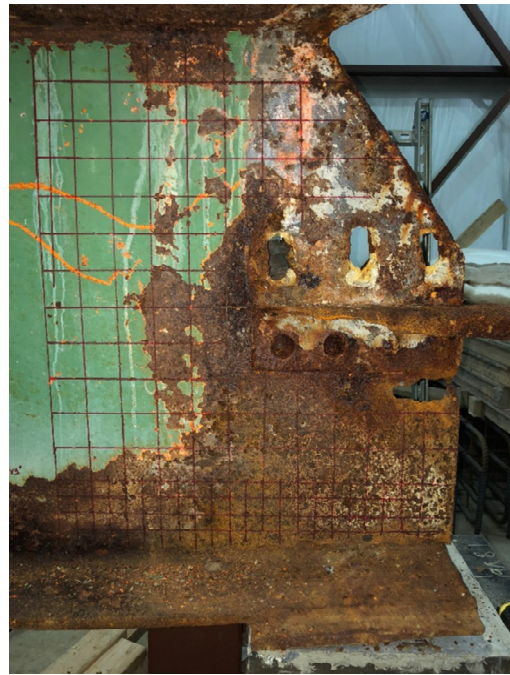
Figure 3.8: Test Specimen 3 a) before deconstruction in the field, b) before testing in the lab.

The final specimen was girder 3 in span 5, see Figure 3.8. The beam type for this specimen was a 33WF125, the geometric and section properties follow that listed in Table 2.1. The critical conditions of the girder included severe deterioration of the web and multiple holes. Similar to specimen 1, this girder had a whole in the web under the location of the concrete diaphragm, which measured 4" x 2". Observed along the bottom 18" of the web-flange connection is a slit that creates a discontinuity between the two, see Figure 3.9. Unlike the previous specimen with a large hole at the web-flange connection, very little vertical displacement needs to occur before the web is back in contact with the flange. Specimen 3 had an average remaining thickness in the bottom 4 inches of web above bearing of 0.29 inches, neglecting hole area.

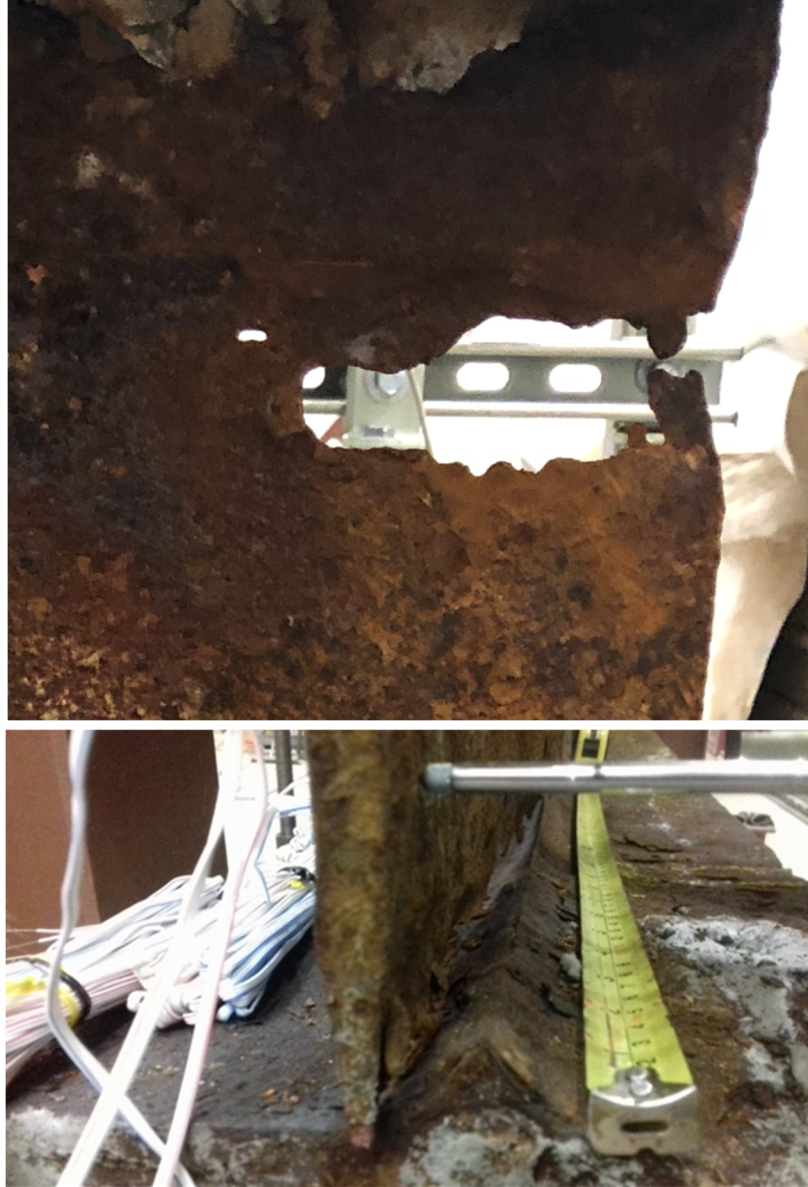
Figure 3.9: (Top) 4"x2" hole under end diaphragm; (Bottom) Initial Out-of-Alignment and Web-Flange Discontinuity.

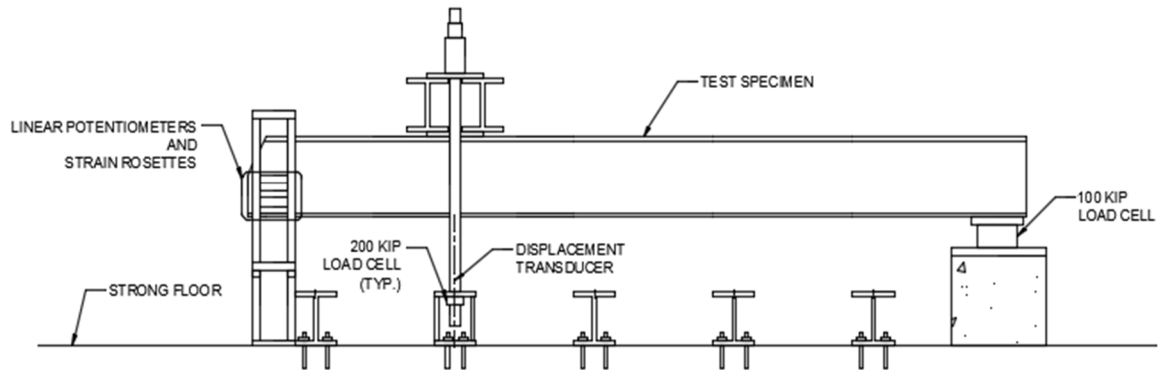
Figure 3.10: Typical Instrumentation Set-Up  
Note: Lateral Bracing and Tested End Support Not Shown for Clarity

represents a typical view of the instrumentation layout. For details on the relative location of linear potentiometers and strain rosettes see Chapter 4 of this paper.

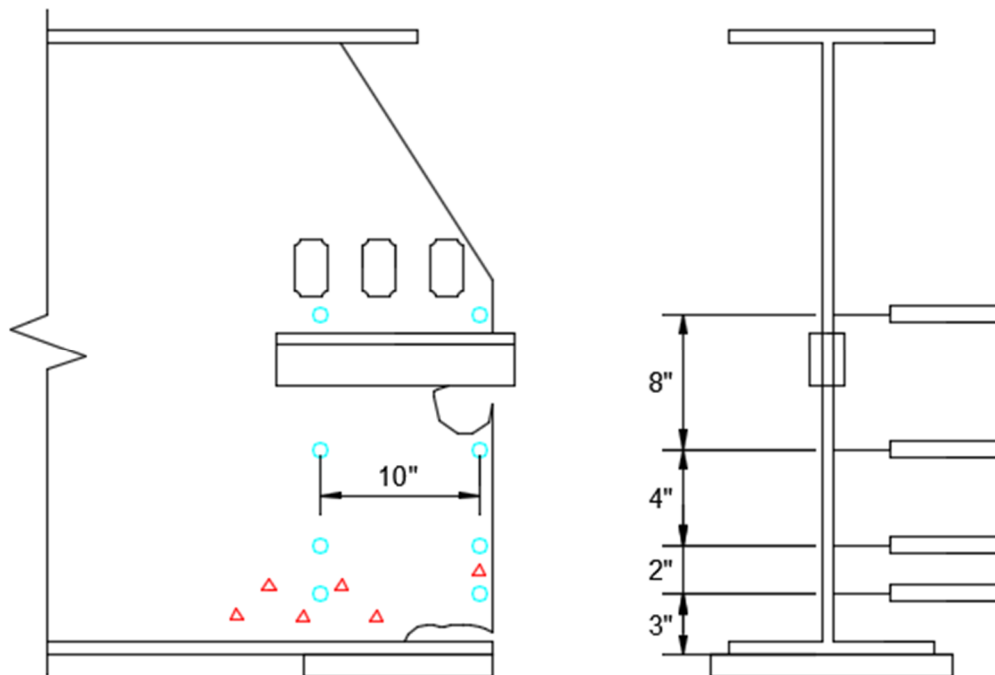
Figure 4.1: Specimen 1 Instrumentation Placement  
 Note: Circles represent location of linear potentiometers and triangles represent location of strain rosettes.

Specimen 1 was denoted as a 33WF125 and was interior girder 4 from the north approach span of the candidate bridge. The specimen measured a total length of 27 feet – 8 inches and had an initial effective span length of 24 feet between supports. The specimen was instrumented with eight linear potentiometers and six strain rosettes in the corroded

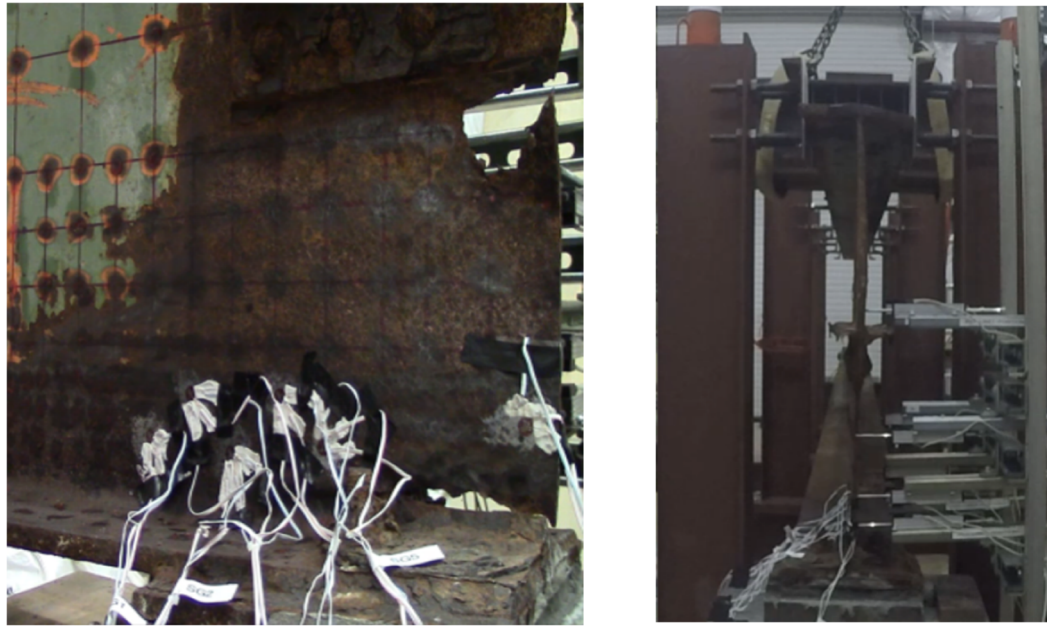
Figure 4.2: (Left) Strain Rosettes (Right) Linear Potentiometers

instruments where Figure 4.2 is a photo of instruments on the specimen before loading, Table 4.1 lists the coordinates of the strain rosettes.

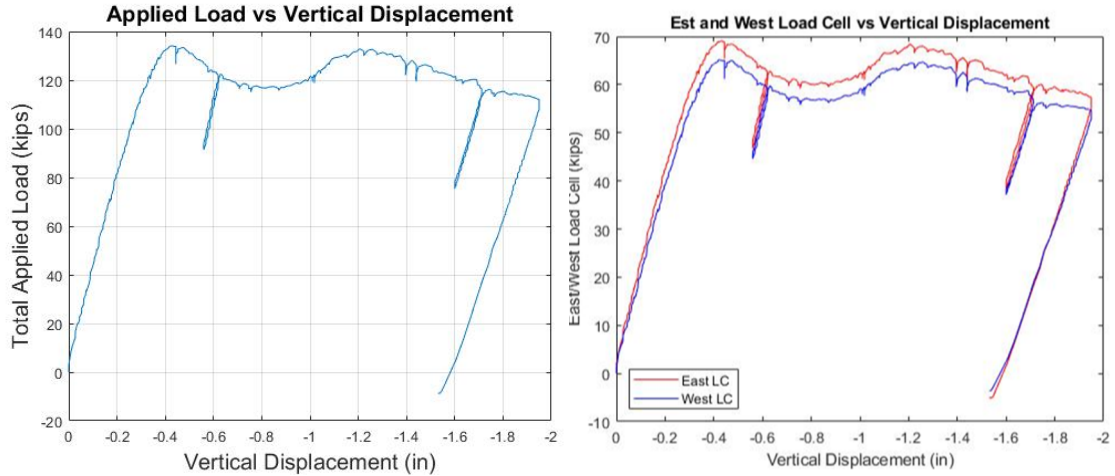
Figure 4.3: (Left) Applied Load – Vertical Displacement Curve (Right) Measured Force Applied by Hydraulic Cylinder on Each Side of Crossbeam.

Specimen 1 was loaded to a maximum applied force of 134.08 kips with a corresponding vertical displacement of 0.48-inches. The specimen stayed stable throughout the experiment and did not experience a large variation in applied load on each side of the crossbeam, see Figure 4.3 for the load-displacement curve.

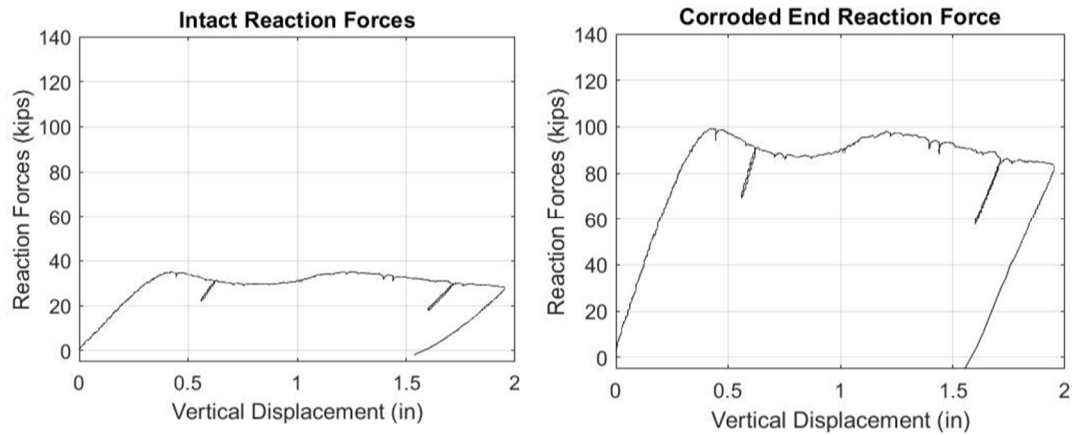
Figure 4.4: (Left) Recorded Reaction Force at Intact End  
(Right) Calculated Reaction Force at Corroded End

calculate the reaction force at the corroded end. Figure 4.4 represents both the intact end and corroded end reaction force from the applied loading.

The corroded end reached a max reaction force of 99 kips at a displacement of 0.48-inches. According to the geometric layout of the tested span the loading is at 6-feet from the center line of bearing on the tested end, leaving 18-feet from loading to intact. Statics says the load distribution from the applied loading to the intact end should equal 25%. Figure 4.5 shows the distribution of load throughout the experiment to the intact end. Two other effective span lengths were also investigated: outer edge to outer edge of bearing resulting in an effective span length of 25-feet and inside edge to inside edge of bearing resulting in an effective span length of 23-feet. The results show that throughout the duration of loading the effective span length stays around the centerline of bearing, however, after the web began bearing on the anchor bolt the bearing force focused on the outside edge of the corroded end but stayed on the inside edge of the intact end, keeping the same effective span length but allowing closer to 27% of the load to be distributed to the intact end.

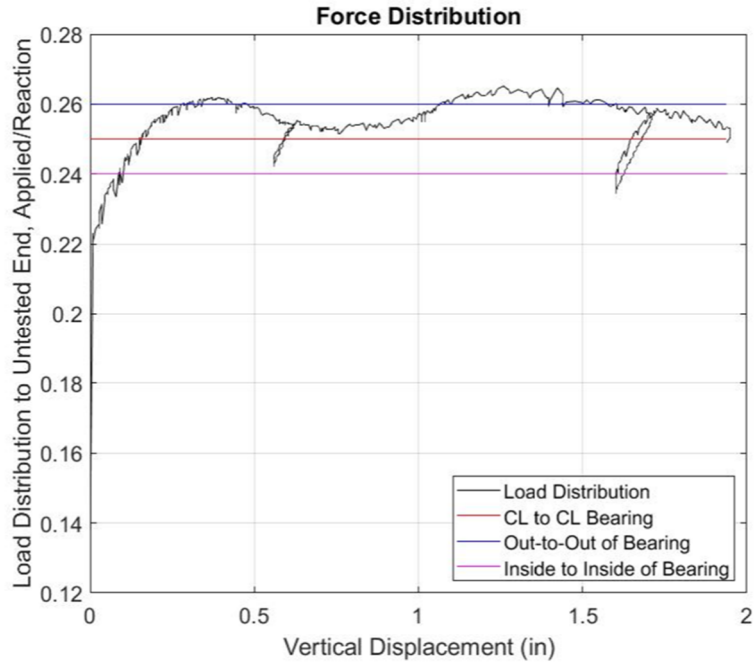
Figure 4.5: Force Distribution to Intact End for Specimen 1

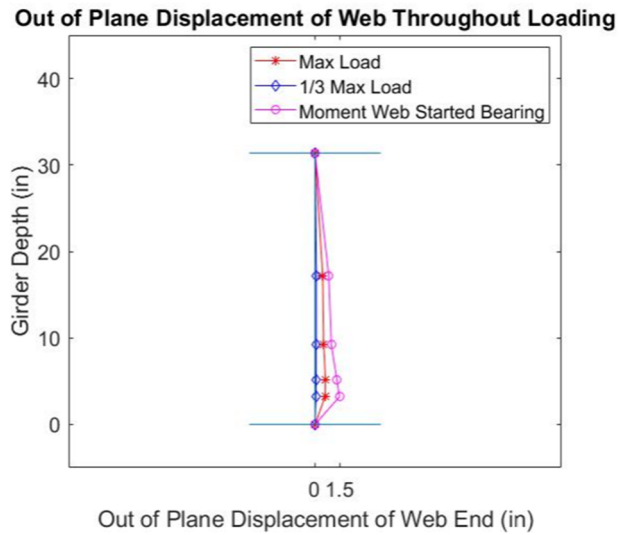
Figure 4.6: Lateral Deformation of Corroded End

The linear potentiometers were used to capture the failure mode of the corroded end and were placed in two vertical columns of four potentiometers spaced 10-inches apart (see Figure 4.1). The outside column, capturing the lateral displacement right at the girder end

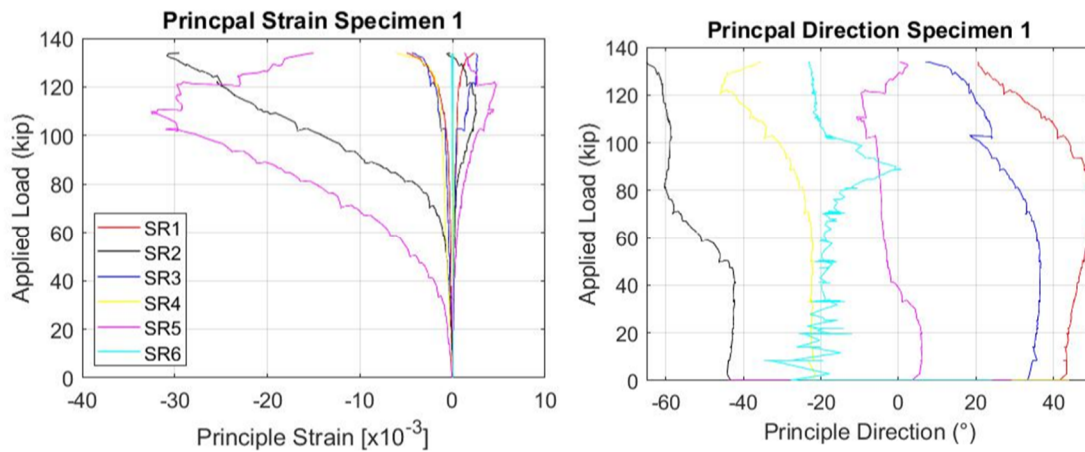
Figure 4.7: (Left) Principal Strain in Web for Specimen 1  
(Right) Principal Strain Direction in Web for Specimen 1

In order to validate a shear dominated loading and how the strains within the web vary throughout loading, the strain rosettes were analyzed to determine the Principal strain and direction. Figure 4.7 presents the Principal strain and directions for each of the six rosettes installed on the web of specimen 1.

The legend in the Principal strain figure also applies to the corresponding Principal strain direction figure. Strain rosette 5 recorded larger compressive (negative) strains due to its position directly over bearing, whereas strain rosette 2 recorded more compressive strains as the experiment progressed due to it become the location where the web began folding onto itself. The remaining rosettes recording compressive and tensile (positive) strains which means shear strains were present in the web. Using the data presented in Figure 4.7 a visual representation of the changing Principal direction and magnitude is presented in Figure 4.8, where half peak load strains are represented in red and peak load strains in blue.

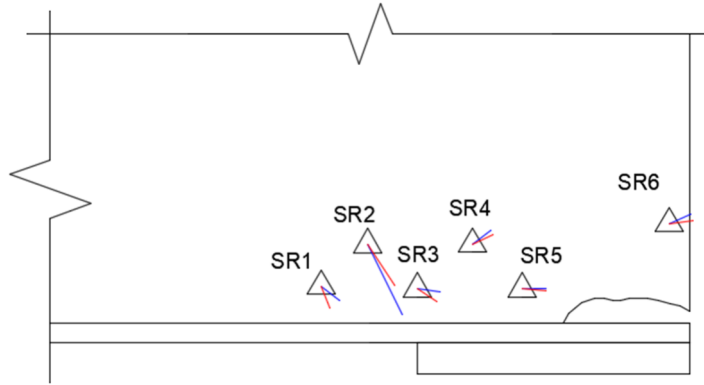
Figure 4.8: Principal Strain Directions Specimen 1

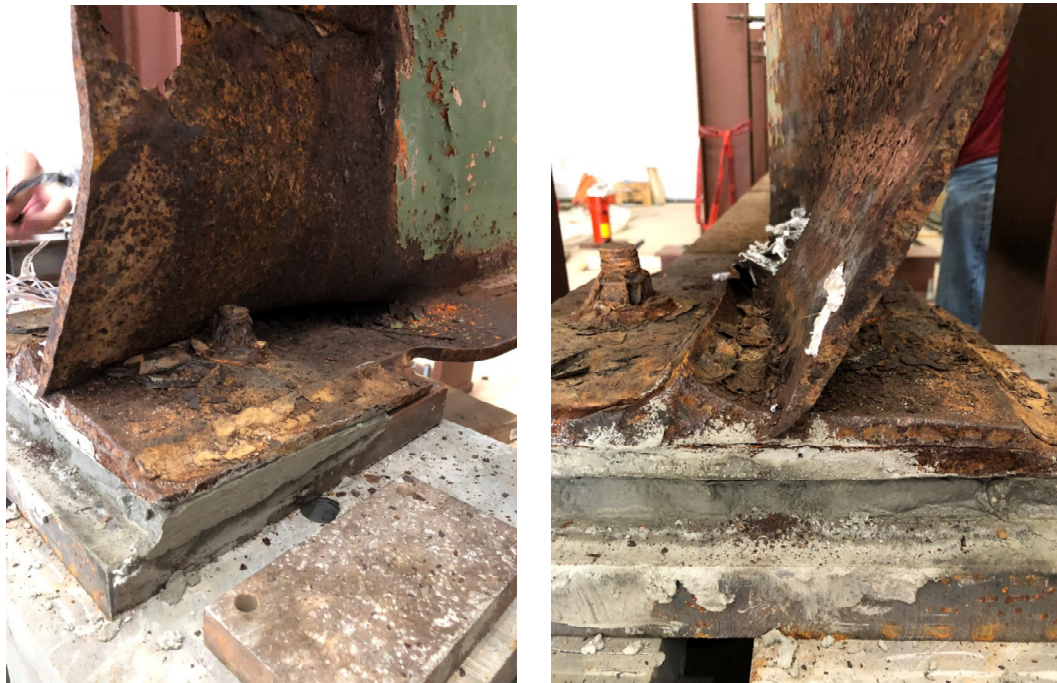
Figure 4.9 shows the failed bottom of web at the end of loading for specimen 1. The web resting on the anchor bolt can be seen and the sliding of the web end occurred due to the hole above bearing.

Figure 4.9: Residual Deformation of Corroded Web End

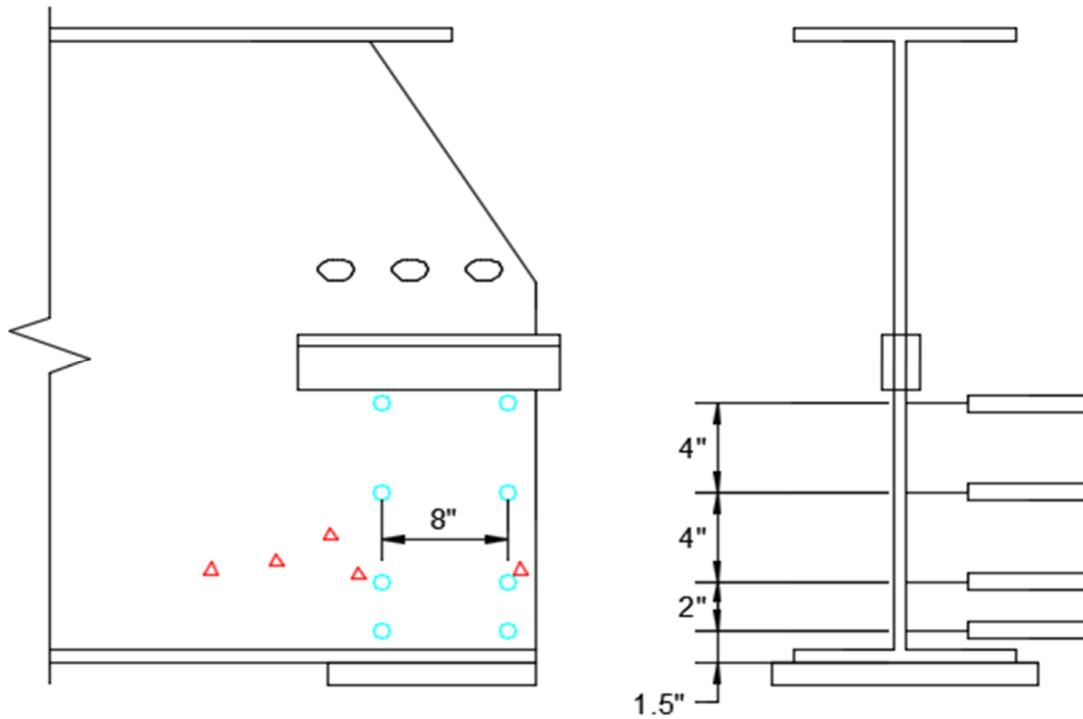
Figure 4.10: Specimen 2 Instrumentation Placement  
Note: Circles represent location of linear potentiometers and triangles represent location of strain rosettes.

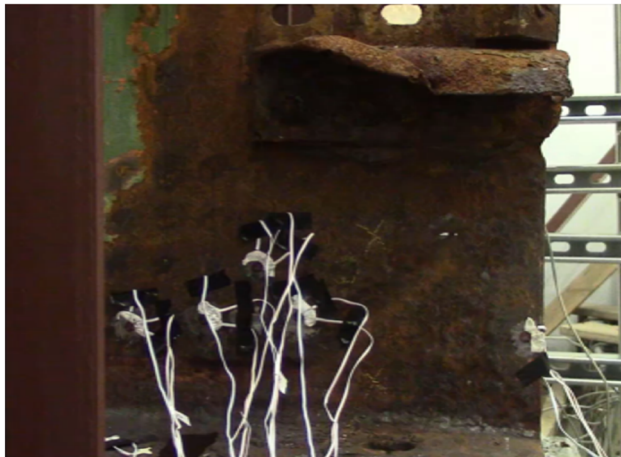
Figure 4.11: (Left) Strain Rosettes (Right) Linear Potentiometers

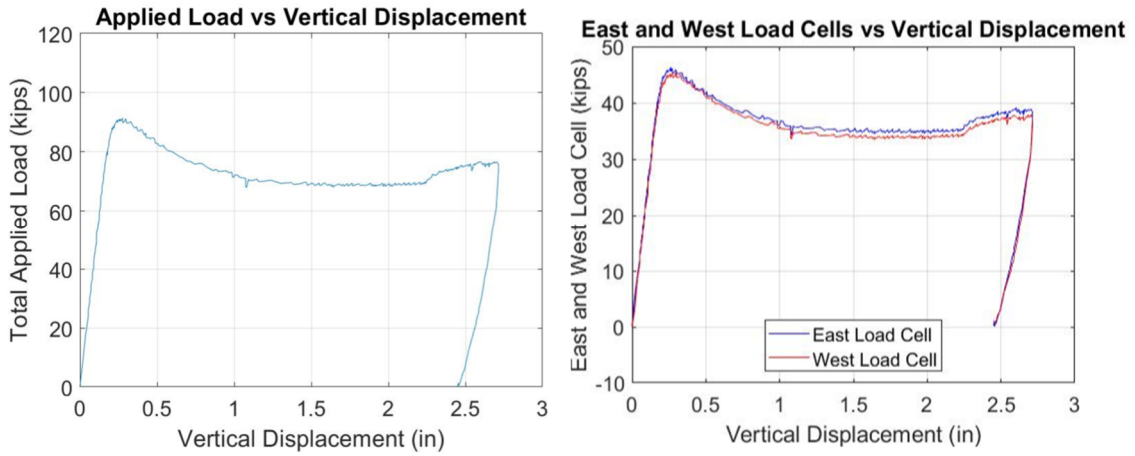
Figure 4.12: (Left) Applied Load – Vertical Displacement Curve  
(Right) Measured Force Applied by Hydraulic Cylinder on Each Side of Crossbeam.

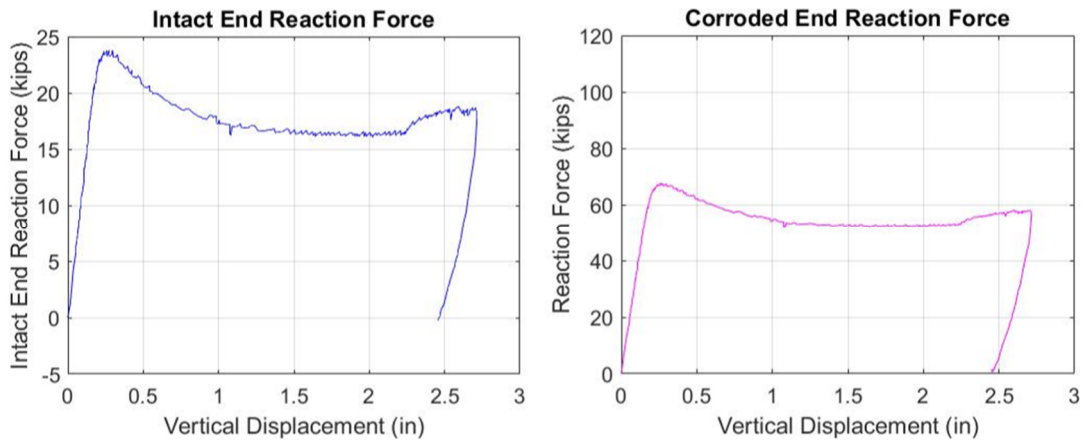
Figure 4.13: (Left) Recorded Reaction Force at Intact End  
(Right) Calculated Reaction Force at Corroded End

The corroded end reached a max reaction force of 67.6 kips at a displacement of 0.3-inches. According to the geometric layout of the tested span the loading is at 6-feet from the center line of bearing on the tested end, leaving 16 feet – 9 inches from loading to intact. Statics

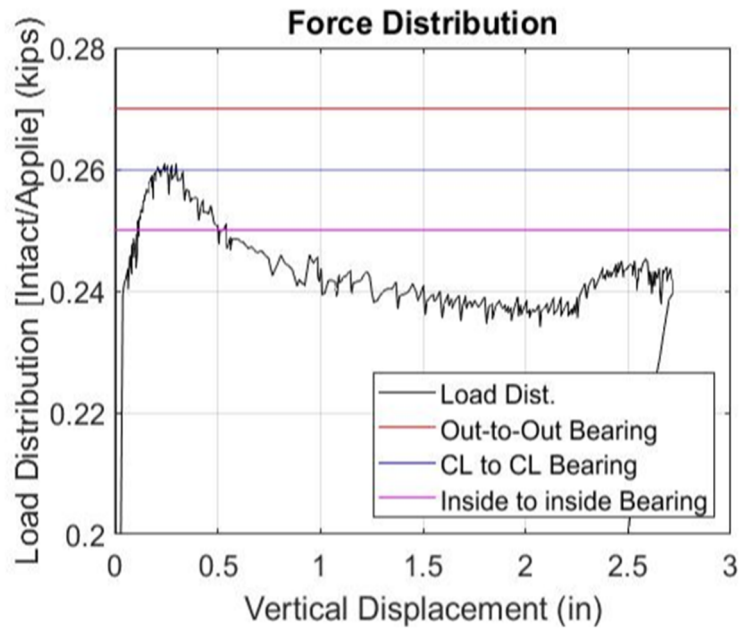
Figure 4.14: Force Distribution to Intact End for Specimen 2

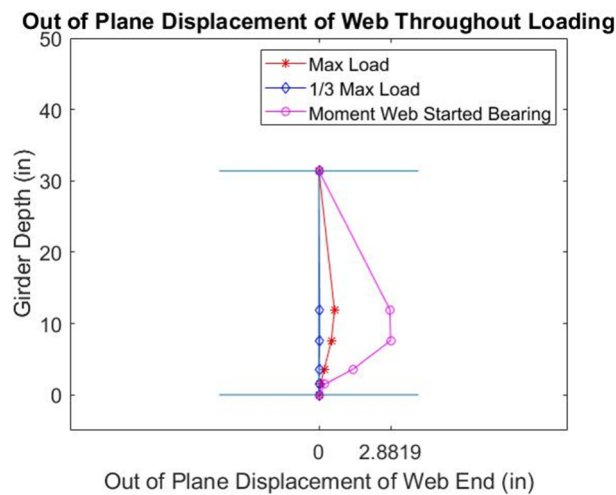
Figure 4.15: Lateral Deformation of Corroded End

The linear potentiometers were used to capture the failure mode of the corroded end and were placed in two vertical columns of four potentiometers spaced 8-inches apart

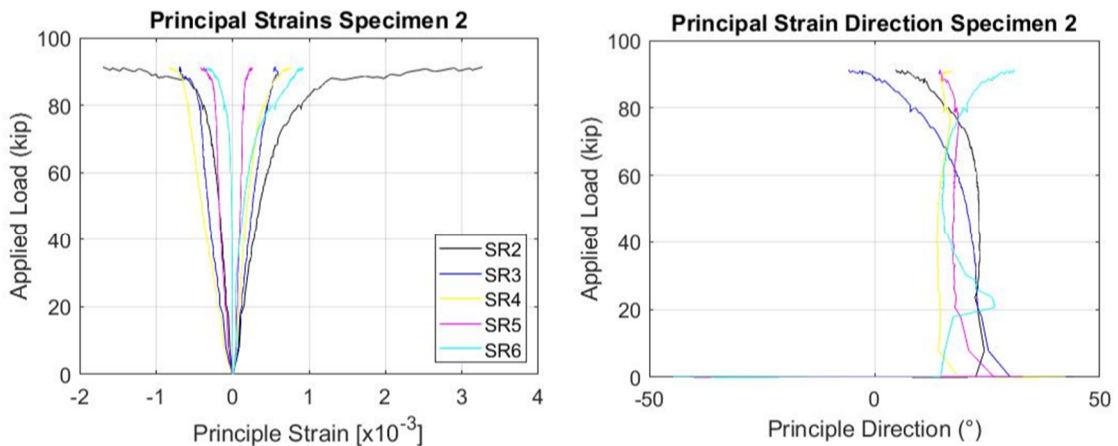
Figure 4.16: (Left) Principal Strain in Web for Specimen 2  
(Right) Principal Strain Direction in Web for Specimen 2

In order to validate a shear dominated loading and how the strains within the web vary throughout loading, the strain rosettes were analyzed to determine the Principal strain and direction. Figure 4.16 presents the Principal strain and directions for each of the five rosettes installed on the web of specimen 2.

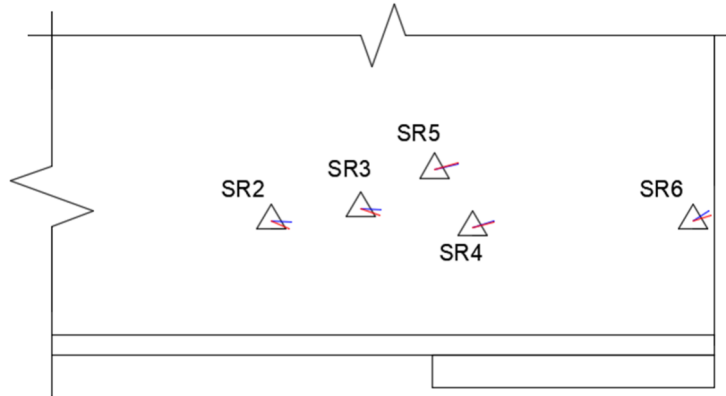
Figure 4.17: Principal Strain Directions Specimen 2

and magnitude is presented in Figure 4.17, where half peak load strains are represented in red and peak load strains in blue.

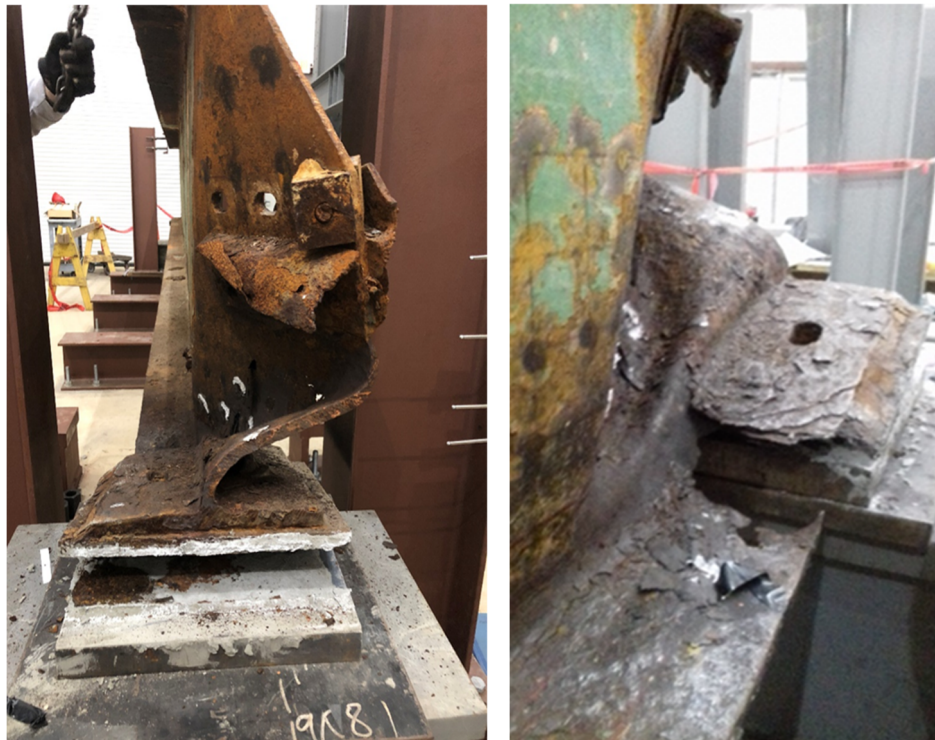
Figure 4.18 shows the failed web and uplift at the end of loading for specimen 2. The web failure can be seen to follow the previously defined 45° corroded region on the web.

Figure 4.18: Residual Deformation of Corroded Web End

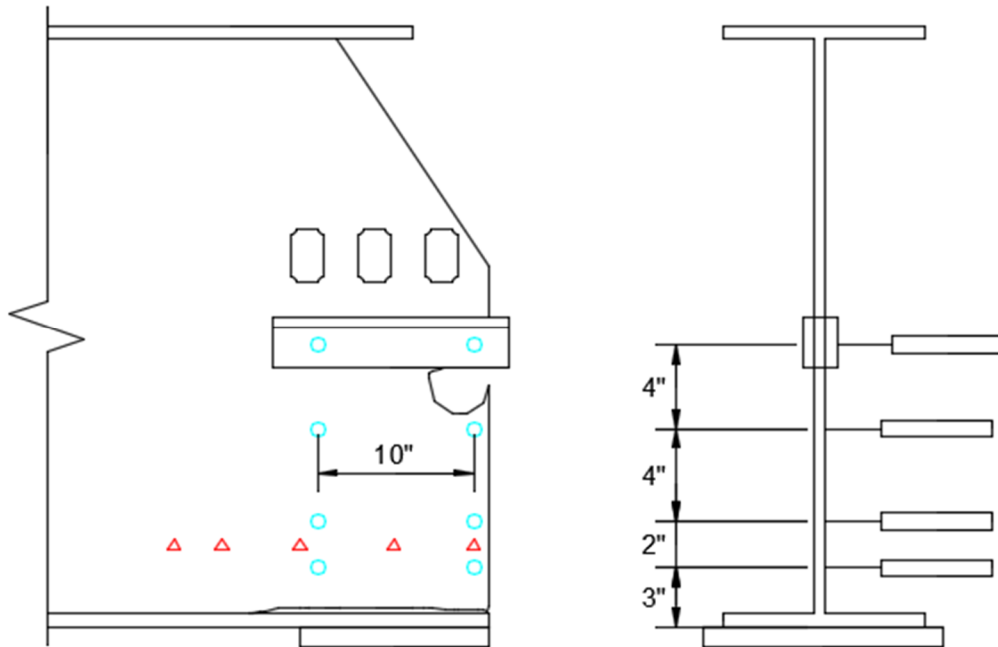
Figure 4.19: Specimen 3 Instrumentation Placement  
Note: Circles represent location of linear potentiometers and triangles represent location of strain rosettes.

Specimen 3 was denoted as a 33WF125 and was interior girder 3 from the north approach span of the candidate bridge. The specimen measured a total length of 27 feet – 11 inches and had an initial effective span length of 24 feet – 6 inches between supports. The specimen was instrumented with eight linear potentiometers and six strain rosettes in

the corroded area of the tested end. Figure 4.19 is a detail representation the geometric locations of the instruments where Figure 4.20 is a photo of instruments on the specimen before loading, Table 4.3 lists the coordinates of the strain rosettes. Strain rosette 3 was placed on the flange to gain data for possible future analysis and will not be included in the results.
