## Experimental Assessment of the Current Load Rating Procedures for a Corroded Steel Ridge Girder in Massachusetts

**EXPERIMENTAL ASSESSMENT OF THE CURRENT LOAD RATING  
PROCEDURES FOR A CORRODED STEEL BRIDGE GIRDER IN  
MASSACHUSETTS**

MASTER OF SCIENCE IN CIVIL ENGINEERING

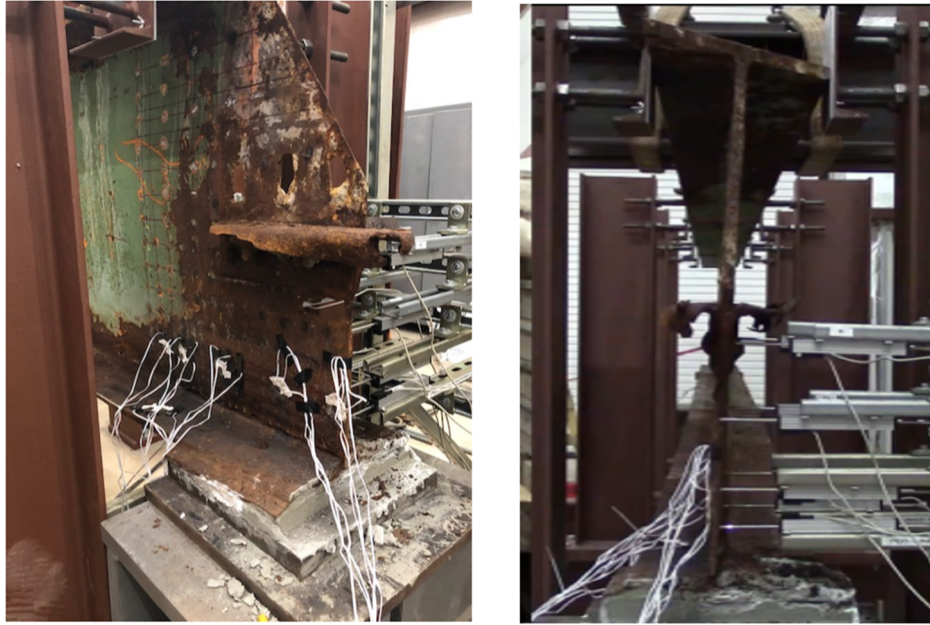
Figure 4.20: (Left) Strain Rosettes (Right) Linear Potentiometers

the corroded area of the tested end. Figure 4.19 is a detail representation the geometric locations of the instruments where Figure 4.20 is a photo of instruments on the specimen before loading, Table 4.3 lists the coordinates of the strain rosettes. Strain rosette 3 was placed on the flange to gain data for possible future analysis and will not be included in the results.

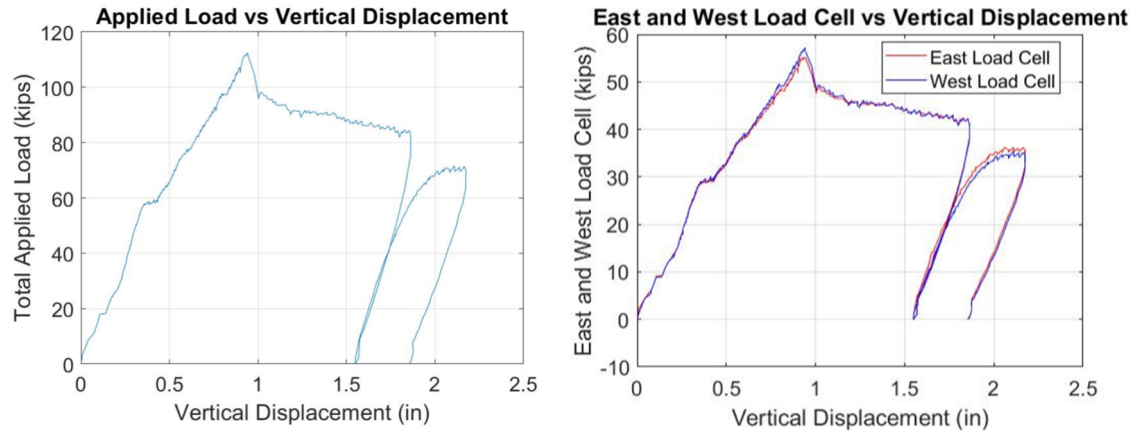
Figure 4.21: (Left) Applied Load – Vertical Displacement Curve (Right) Measured Force Applied by Hydraulic Cylinder on Each Side of Crossbeam.

Specimen 3 was loaded to a maximum applied force of 112.45 kips with a corresponding vertical displacement of 0.95-inches. The specimen stayed stable throughout the experiment and did not experience any variation in applied load on each side of the crossbeam, see Figure 4.21 for the load-displacement curve.

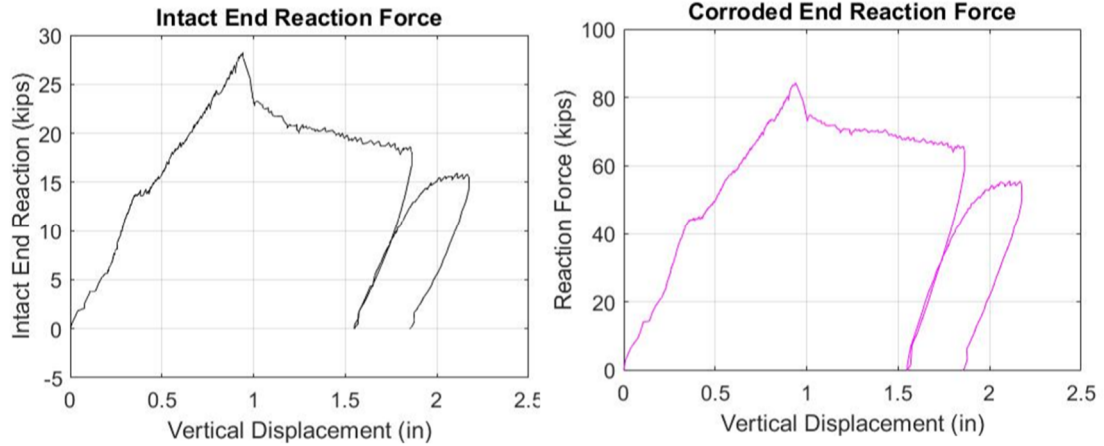
Figure 4.22: (Left) Recorded Reaction Force at Intact End  
(Right) Calculated Reaction Force at Corroded End

After the peak load was reached the applied force began to decrease and the girder never found a new equilibrium as in the previous two specimens. As the specimen was loaded the web began sliding across the face of the bottom flange due to the 18-inch long discontinuity along the web-flange connection. Unlike specimen one with a taller hole over bearing, the web did not bear down on the flange and see an increase in reaction force. At the untested and intact end of the specimen was a load cell recording the load being transferred throughout the beam, which using static equilibrium can be used to calculate the reaction force at the corroded end. Figure 4.22 represents both the intact end and corroded end reaction force from the applied loading.

The corroded end reached a max reaction force of 84.3 kips at a displacement of 0.95-inches. According to the geometric layout of the tested span the loading is at 6-feet from the center line of bearing on the tested end, leaving 18 feet – 6 inches from loading to intact. Statics says the load distribution from the applied loading to the intact end should equal 24.5%. Figure 4.23 shows the distribution of load throughout the experiment to the intact end. Two other effective span lengths were also investigated: outer edge to outer edge of bearing resulting in an effective span length of 25 feet – 6 inches and inside edge to inside edge of bearing resulting in an effective span length of 23 feet – 6 inches. The results show that throughout the duration of loading the specimen does not attain the effect span length except for at peak loading. Directly after the peak load the specimen immediately lost all resistance and the load distribution shows no load being gained and only vertical displacement occurring. Unlike the other specimens, this specimen showed to hold little elastic response and failed immediately from peak.

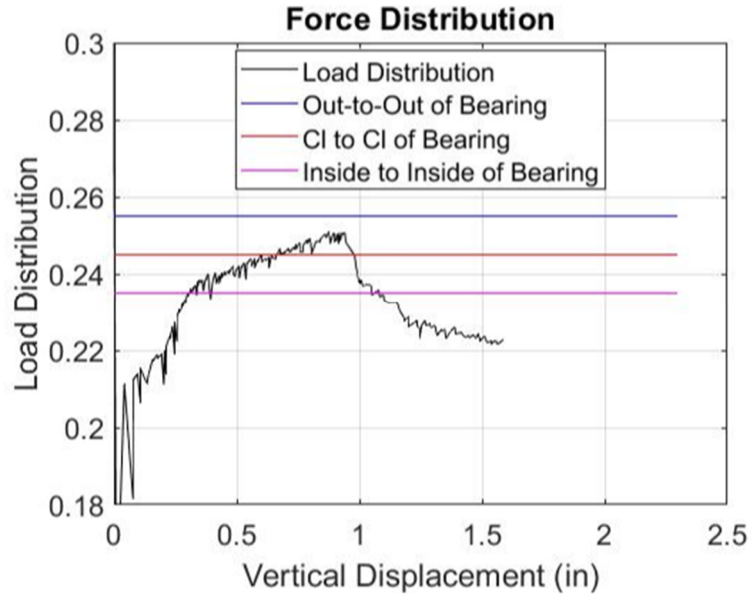
Figure 4.23: Force Distribution to Intact End for Specimen 3

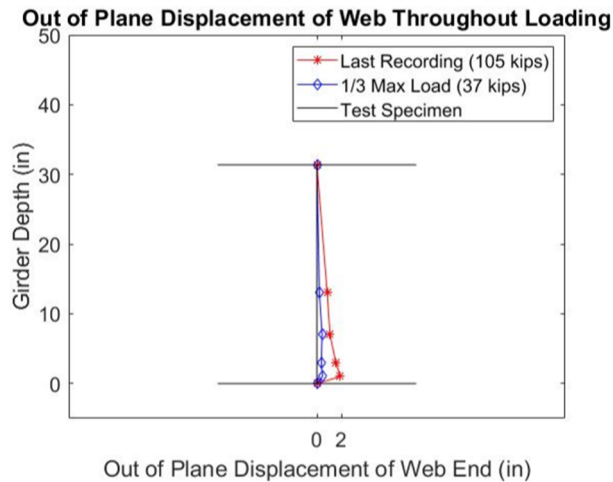
Figure 4.24: Lateral Deformation of Corroded End

The linear potentiometers were used to capture the failure mode of the corroded end and were placed in two vertical columns of four potentiometers spaced 10-inches apart (see Figure 4.19). The outside column, capturing the lateral displacement right at the girder end

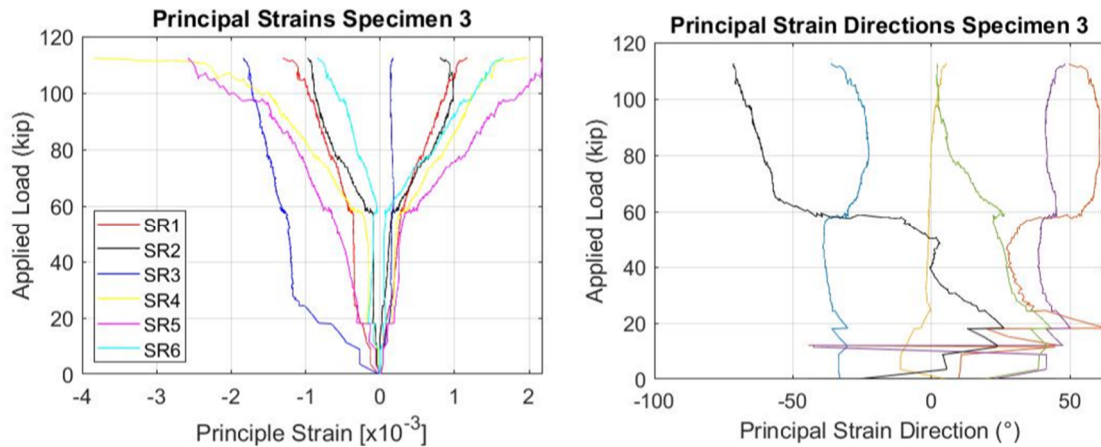
Figure 4.25: (Left) Principal Strain in Web for Specimen 3  
(Right) Principal Strain Direction in Web for Specimen 3

In order to validate a shear dominated loading and how the strains within the web vary throughout loading, the strain rosettes were analyzed to determine the Principal strain and direction. Figure 4.25 presents the Principal strain and directions for each of the six rosettes installed on the web of specimen 3.

The legend in the Principal strain figure also applies to the corresponding Principal strain direction figure. All rosettes recorded equal and opposite compressive (negative) and tensile (positive) strains which means shear strains were present in the web. A shear dominated failure occurred with the presence of a separation in web-to-flange connection. Using the data presented in Figure 4.25 a visual representation of the changing Principal direction and magnitude is presented in Figure 4.26, where half peak load strains are represented in red and peak load strains in blue.

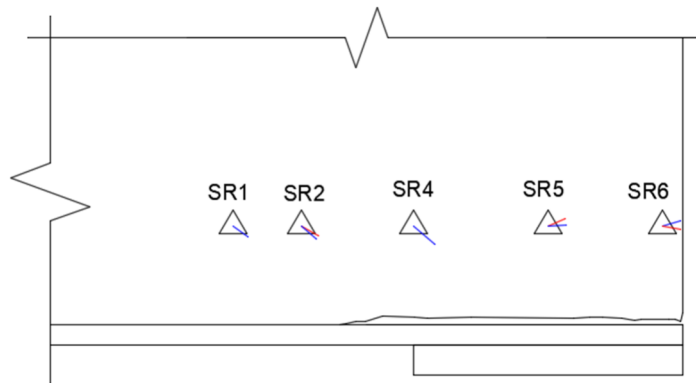
Figure 4.26: Principal Strain Directions Specimen 3

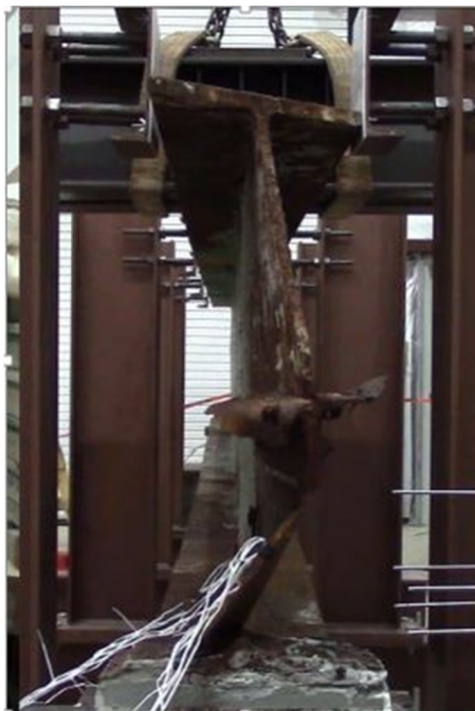
Figure 4.27 shows the failed bottom of web at the end of loading for specimen 3. The web resting on the anchor bolt can be seen and the sliding of the web end occurred due to the hole above bearing.

Figure 4.27: Residual Deformation of Corroded Web

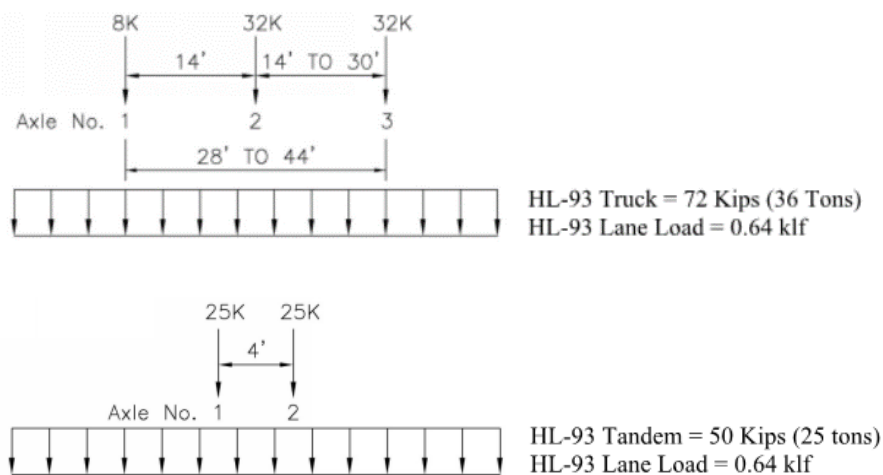
**Figure C.1 Design Loading for Bridge Load Rating**

The LRFR method requires a design loading of HL-93. This includes an HL-93 vehicle or a tandem with a uniform lane load of 0.64 kips per linear foot. The details of this loading are listed in Figure C.1 (MassDOT, 2019).

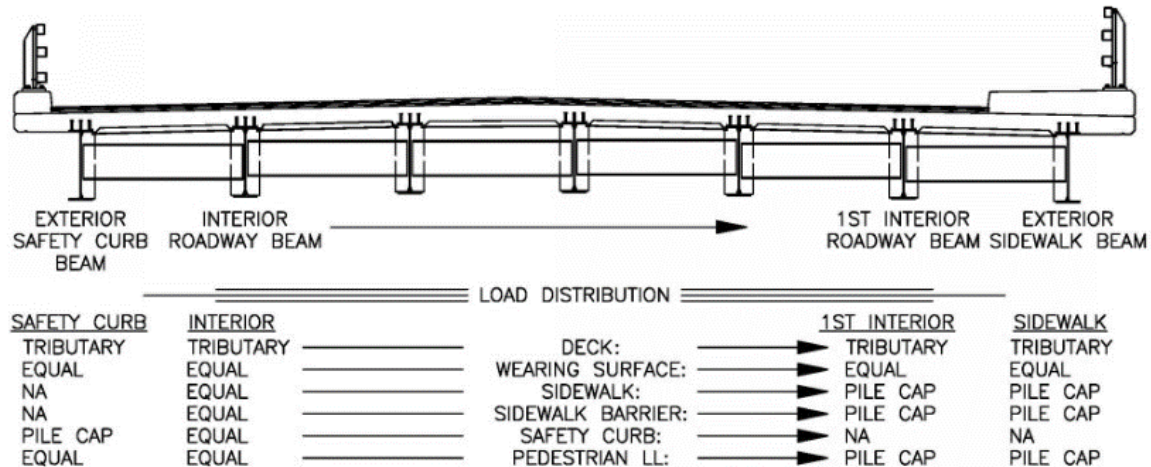
**Figure C.3 Distribution of Loads for Stringer Bridges**
