**BEHAVIOUR OF CONCRETE STRUCTURES  
REPAIRED WITH A NOVEL AND  
SUSTAINABLE COMPOSITE JACKET**

A Thesis submitted by

**Ali Abdulkareem Mohammed**

**2021**

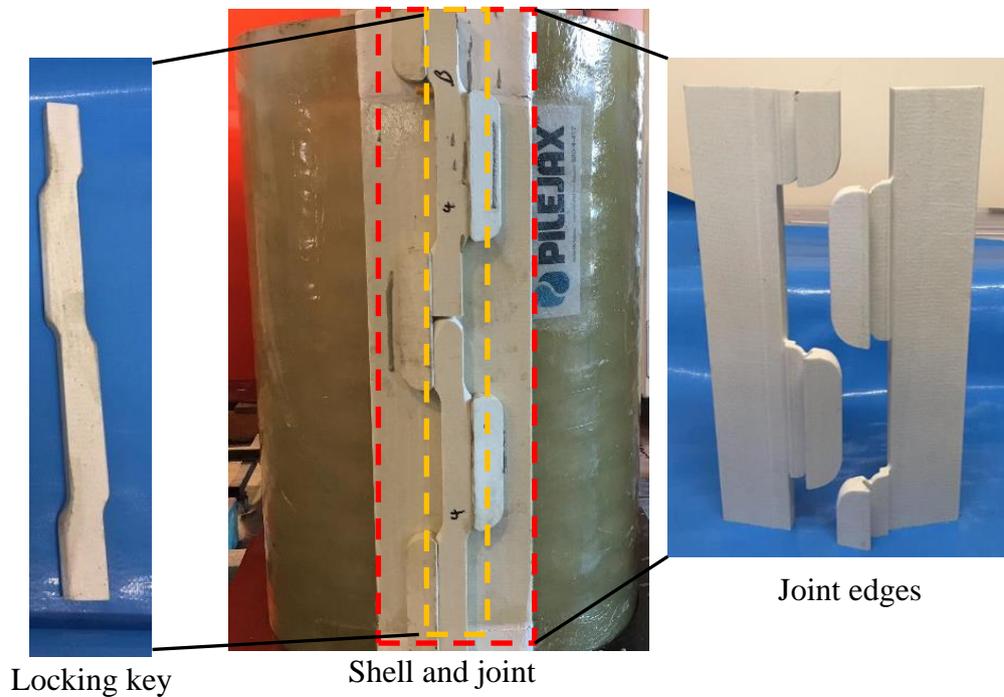
Figure 1.1. Novel GFRP jacket

Recently, a novel and sustainable pre-fabricated FRP jacket that can be quickly and safely installed due to its easy-fit and self-locking mechanical joining system has been developed (Figure 1.1). This innovative joining system comprises two interlocking edges that can easily fit into each other, similar to the teeth of a zipper. A FRP locking key is placed between the interlocking teeth, which can be slid or levered only one pitch length, thus causing wedging of the joint edges together with a uniform force distribution along the entire length of the joint. This repair system works by wrapping the prefabricated FRP jacket around the damaged structure and placing a grout infill between the jacket and the repaired structure, producing a cylindrical confinement. This system also serves as protective environmental shield and permanent formwork. Manalo et al. (2014) evaluated the effectiveness of this FRP jacket numerically, using Strand7 finite element (FE) program and experimentally subjecting the jacket to internal pressure. The results showed that the FRP jacket can sustain an internal pressure of up to 2 MPa, which substantially exceeds the industry standard for internal bursting pressure required of a concrete pile repair system and a permanent concrete formwork jacket. However, the actual behaviour of this prefabricated FRP repair system has not yet been fully investigated and its structural contribution to the damaged member is yet to be determined.

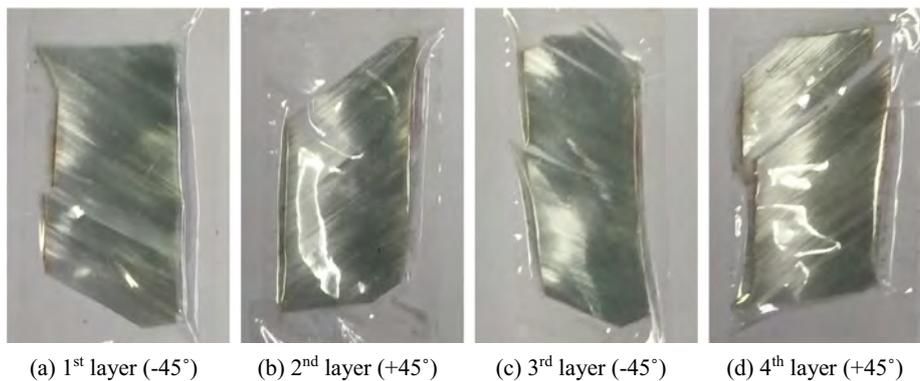
Fig. 2. Stacking sequence of the GFRP tube.

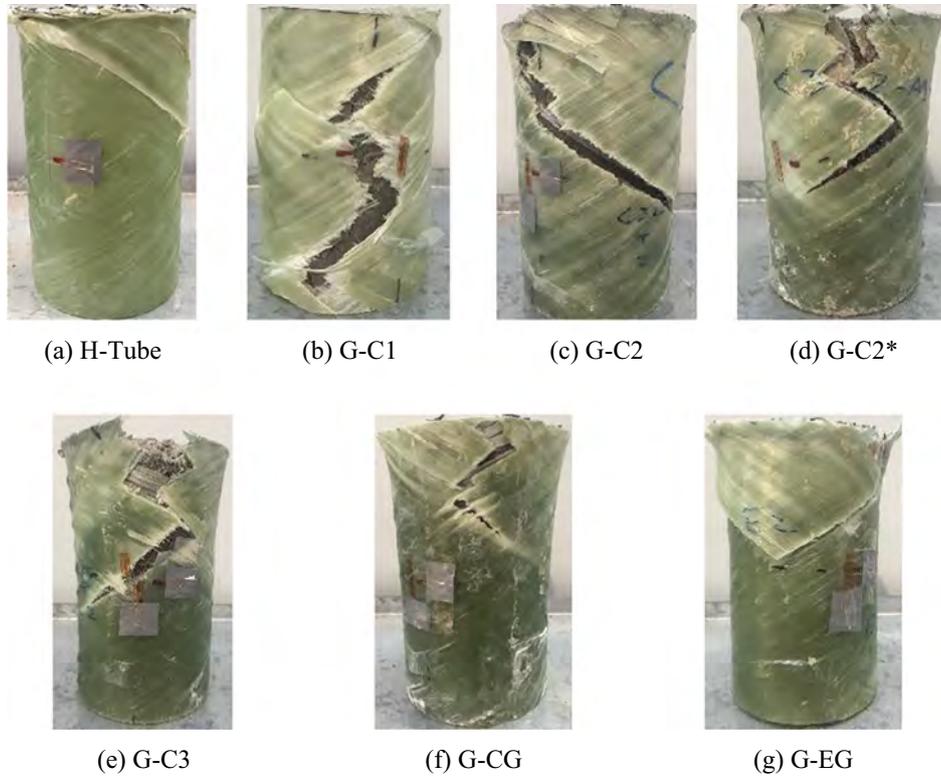
Fig. 8. Typical compression failure of hollow and filled GFRP tubes.

G-C<sup>#</sup> exhibited a failure mode that was characterised by the longitudinal cracks perpendicular to the fibre orientation. G-C1 (Fig. 8b) exhibited the most violent and most severe degree of failure among the G-C<sup>#</sup> specimens, owing to the rupture of fibres through its entire height, followed by G-C2 (Fig. 8c) and G-C3 (Fig. 8e), respectively, which exhibited local fibre rupture at the top portion. Interestingly, this localised failure was also reported

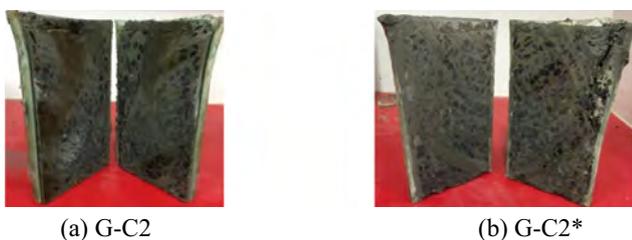
Fig. 9. Post-failure configuration of G-C2 and G-C2\*.

Fig. 8d presents the post-failure configuration of G-C2\*. As can be seen in the figure, G-C2\* exhibited nearly similar failure as G-C2, but with a lesser degree of fibre's rupture. G-C2\* appeared to confine the fibre rupture along the height of the tube and prevented the propagation of fibre rupture around the tube, suggesting the influence of internal surface roughening. In fact, it was evident in G-C2 (Fig. 9a) that the whole concrete cylinder was completely detached from the surface of the tubes while G-C2\* showed otherwise (Fig. 9b), wherein some concrete was attached to the tubes owing to the epoxy grout and concrete gravel that enhanced the bonding between the concrete infill and the tube.

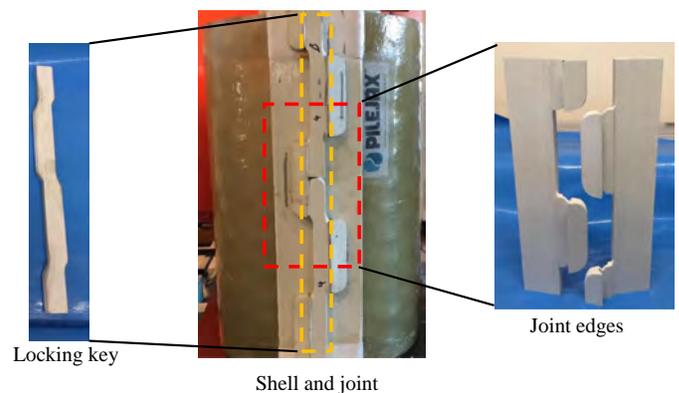
**Fig. 2.** Novel GFRP jacket.

Recently, a new type of FRP composite jacket (Fig. 2) that can be quickly and safely installed due to its easy-fit and self-locking mechanical joining system has been developed (Joinlox 2014). This innovative joining system is comprised of two interlocking edges that can easily fit into each other, similar to the teeth of a zipper. A FRP locking key is placed between the interlocking teeth, which can be slid or levered only one pitch length, thus causing wedging of the joint edges together with a uniform force distribution along the entire length of the joint. Manalo et al. (2014) determined the most suitable joint materials and assessed the capacity and behavior of this system when subjected to internal pressure.

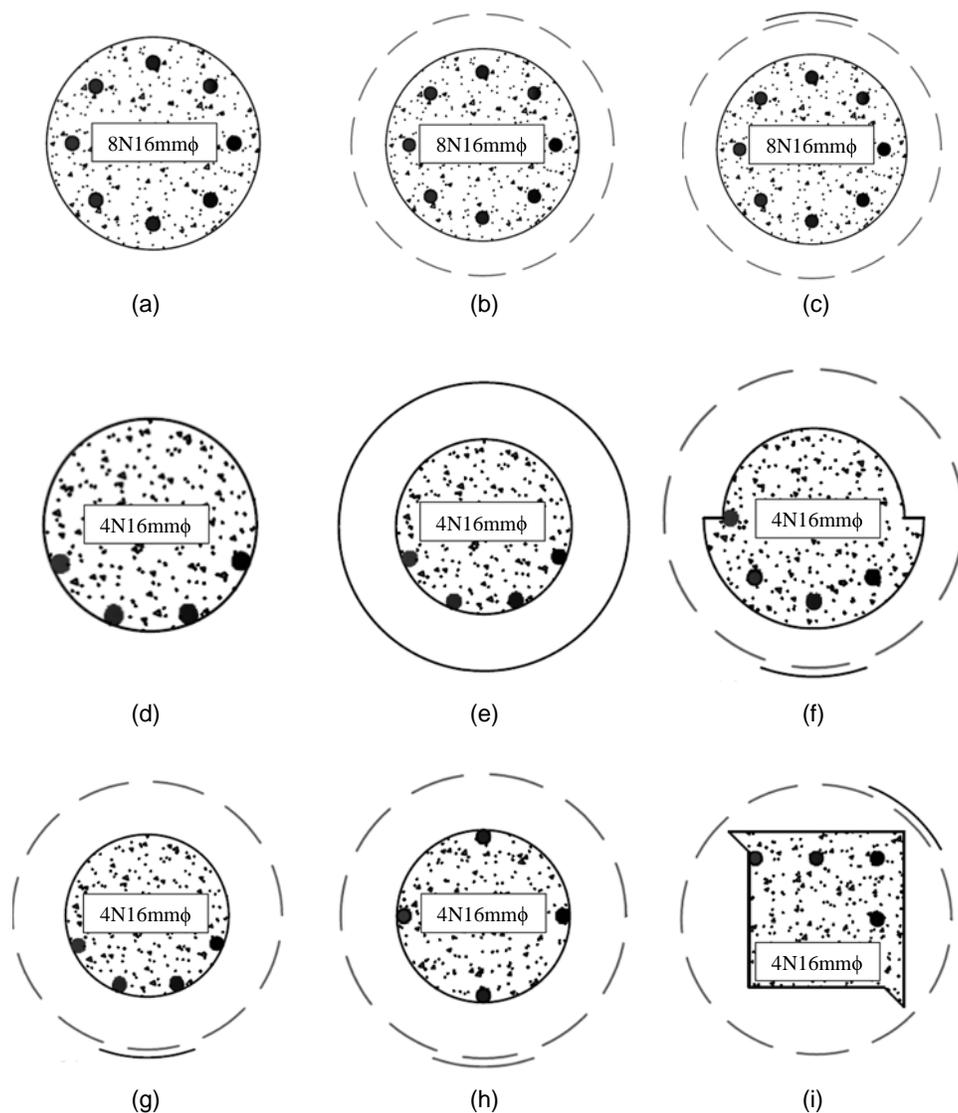
**Fig. 3.** Test specimen details and configuration: (a) C-0-0; (b) C-0-0-S; (c) C-0-0-J; (d) C-50-100; (e) C-50-100-G; (f) C-50-50-J; (g) C-50-100-J; (h) C-50-100-J\*; and (i) S-50-50-J.

Fig. 3 summarizes the details and configurations of the columns tested in this study. Nine large-scale circular concrete columns (250-mm diameter by 1,000-mm height) and one large-scale square concrete column (220 mm by 220 mm by 1,000 mm height) were cast and tested up to failure. All of the columns were longitudinally reinforced with eight 16-mm steel bars (equivalent to 3.28% of the column's gross cross-sectional area) and were transversely reinforced with steel ties spaced uniformly at 50 mm center-to-center with a 30-mm concrete cover. The column size was designed based on the maximum capacity of the test equipment. Because the accelerated corrosion process takes significant time to simulate low levels of corrosion damage and is suitable mostly for small-scale specimens, that is, RC cylinders (da Fonseca et al. 2014; Maaddawy 2008), a new approach was adopted to simulate the steel corrosion damage by cutting the longitudinal reinforcement in the test region and replacing them with nonstructural PVC pipe (16-mm diameter) to prevent the concrete from occupying the steel volume and to maintain the alignment of the longitudinal reinforcement at both

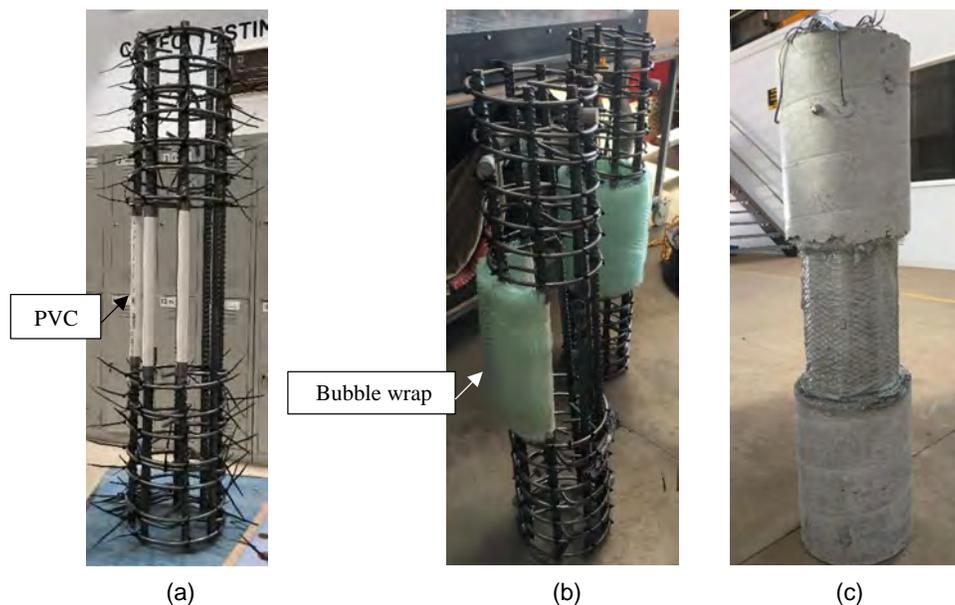
**Fig. 4.** Fabrication of column specimens: (a) corrosion damage; (b) concrete cover damage; and (c) damaged column.

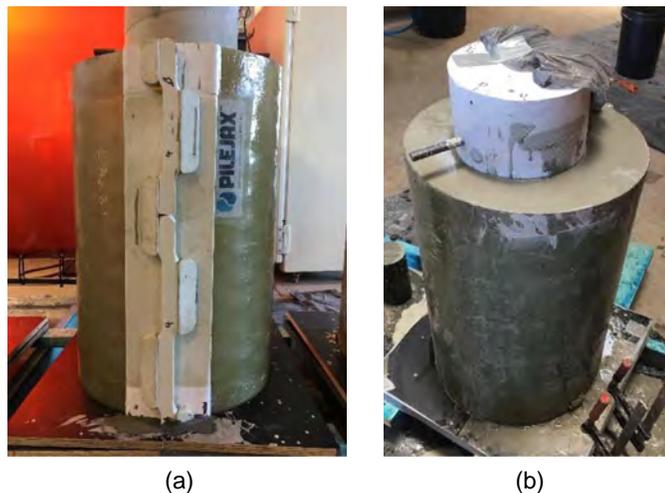
**Fig. 5.** Installation of GFRP jacket and infill: (a) placing the jacket; and (b) grout-filled annulus.

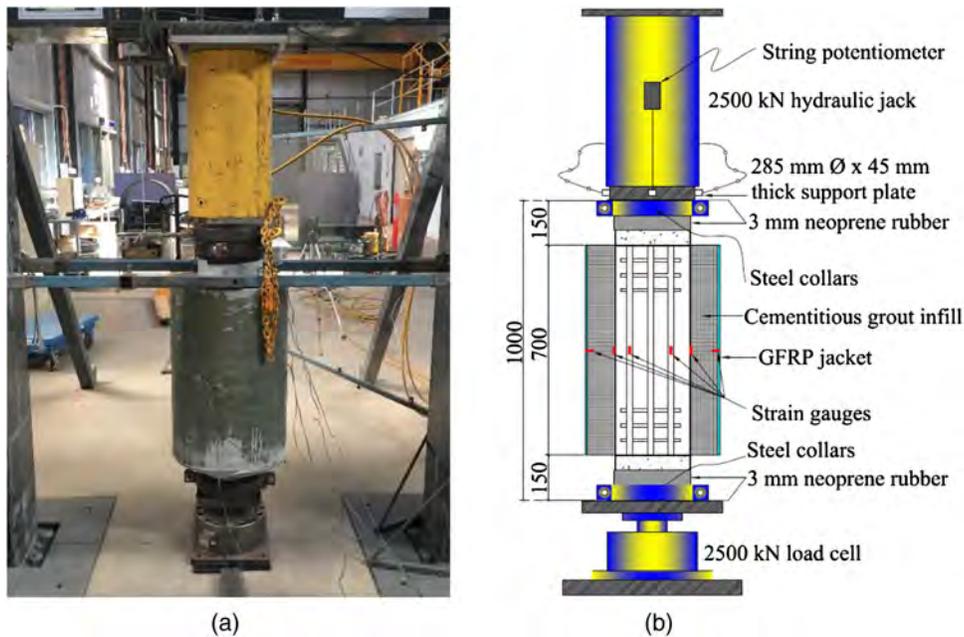
Fig. 6. Compression test set-up of columns: (a) actual test setup; and (b) schematic diagram (dimensions in millimeters).

The columns were subjected to monotonically increasing axial concentric loads and were tested to failure in displacement control mode using a hydraulic jack, and both the pre and postpeak

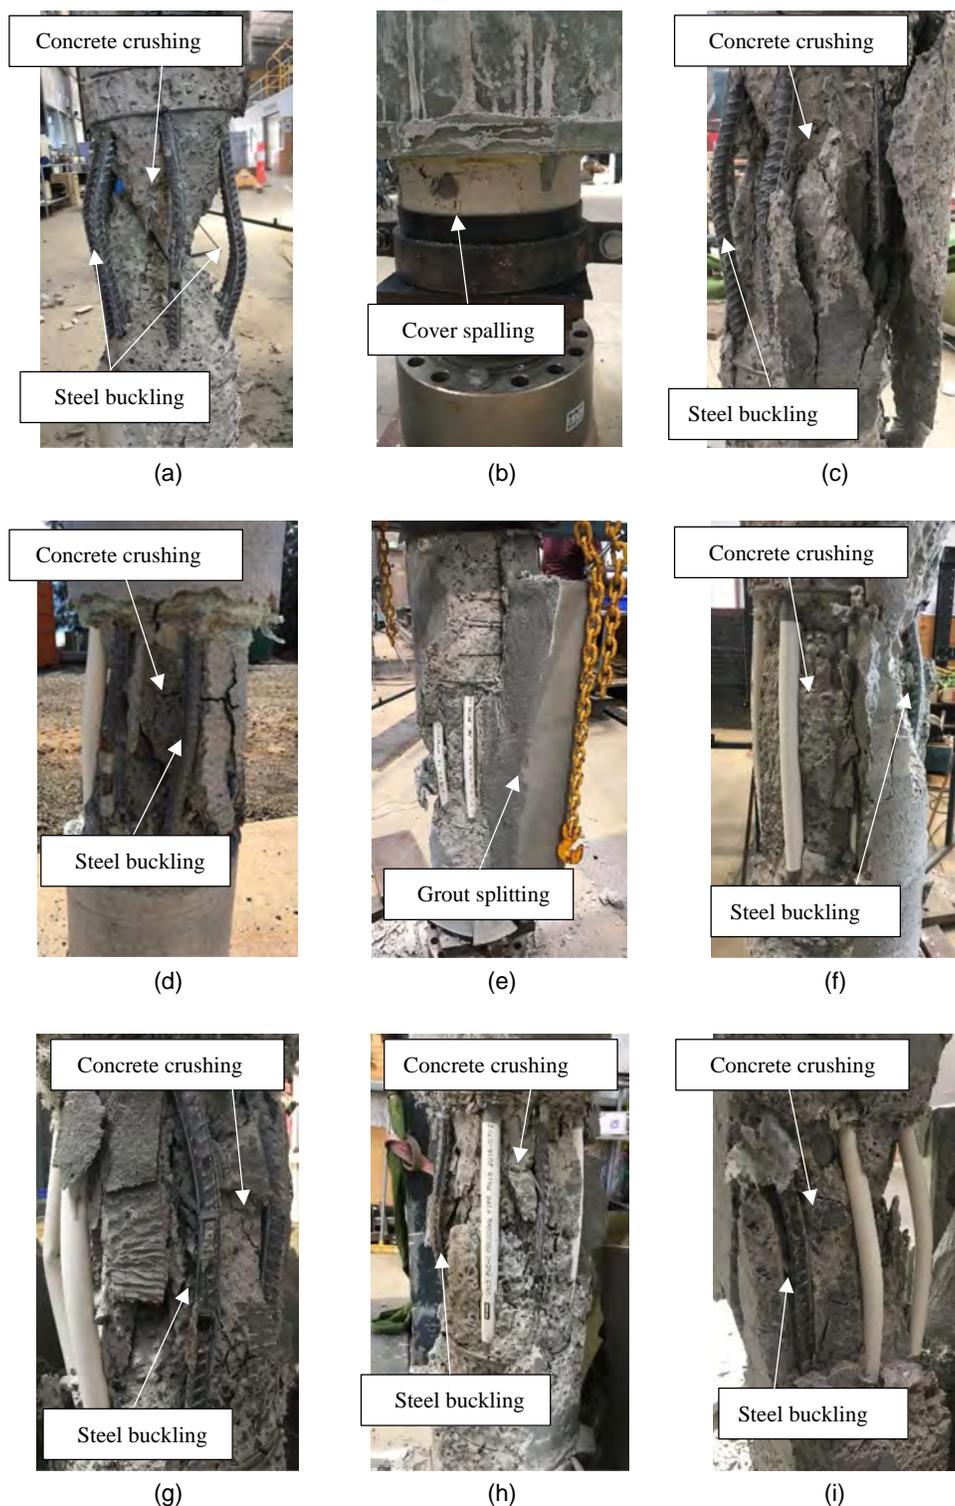
**Fig. 7.** Failure modes of tested columns: (a) C-0-0; (b) C-0-0-S; (c) C-0-0-J; (d) C-50-100; (e) C-50-100-G; (f) C-50-50-J; (g) C-50-100-J; (h) C-50-100-J\*; and (i) S-50-50-J.

Different failure modes were observed in columns repaired with FRP jackets. As shown in Fig. 7(c), the failure of column C-0-0-J was initiated by the crushing of the concrete and buckling of the longitudinal steel bars, which pushed the concrete and grout radially outwards and tensioned the jacket circumferentially. Although buckling of PVC pipes was observed in specimens with simulated steel corrosion, it did not contribute to the overall strength and did not affect the overall failure behavior of the tested columns because of the significantly lower modulus of polyvinyl chloride (only approximately 4 GPa) relative to steel bars. Thus, the observed buckling of PVC pipe was only secondary to the crushing of the adjacent concrete. Several hairline cracks were observed in the grout. With an increase in the applied load, minor concrete cracking and crushing were observed outside the jacketed section near the loading and support points, whereas hairline cracks that developed in the grout increased in number and width. Prior to the peak load, the crack underneath the joint widened significantly, wherein sounds of resin cracking and fiber rupturing were heard, followed by jacket failure at the joint from rupturing of the teeth [Fig. 8(a)] and complete opening of the jacket [Fig. 8(c)]. However, no damage was observed in the GFRP shell. At failure, the cementitious grout infill

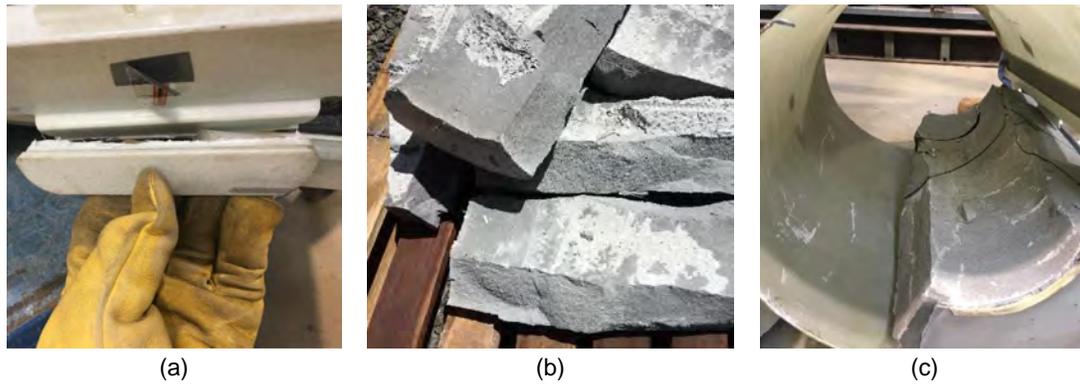
**Fig. 8.** Specific failures in components of repair system: (a) rupture of the GFRP jacket's teeth; (b) large pieces of broken grout infill; and (c) debonded GFRP jacket and grout infill.

with increasing damage given a reduction in the strength of the core column. Interestingly, column C-0-0-S did not fail, and the sleeve had no signs of damage along its height. The test was stopped after reaching the maximum loading capacity of the test equipment. However, minor hairline cracks were observed in the grout, whereas wide cracks and marginal concrete spalling were observed in concrete at the top and bottom of the jacket, which created stress concentration.

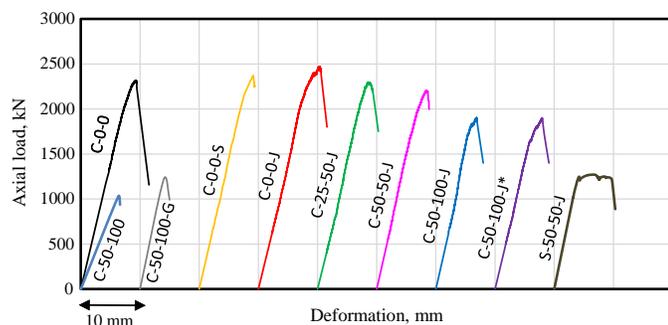
**Fig. 9.** Load-deformation curves.

Fig. 9 presents the relationships between the axial load ( $P$ ) and deformation of the tested columns. The load-deformation of column C-0-0 consisted of a relatively linear ascending segment up to an applied load of 2,260 kN, with a stiffness of 279 kN/mm (the slope of the initial segment of the load-deformation curve, particularly between 30% and 60% of the maximum load). Ultimately, the column failed at 2,319 kN and could not sustain more load. Similar behavior was observed in column C-50-100, which behaved linearly until the failure load (1,027 kN) but with a stiffness of 170 kN/mm. Column C-50-100-G failed at a load almost similar to that of the damaged column with no repair but with a stiffness similar to that of the undamaged column. The jacketed specimen with zero damage (C-0-0-J) indicated ascending linear behavior with a stiffness of 285 kN/mm. When the load reached 2,000 kN, a slight drop in the stiffness and nonlinear behavior were observed until the final failure (2,403 kN), which is attributed to the cracking of grout as indicated in Fig. 11(a). Similar behavior was observed in other circular jacketed specimens. However, the degree of non-linearity increases due to the widening of the radial cracking in the grout. Nevertheless, columns C-25-50-J and C-50-50-J yielded axial strength and stiffness of 2,298 kN and 284 kN/mm, and

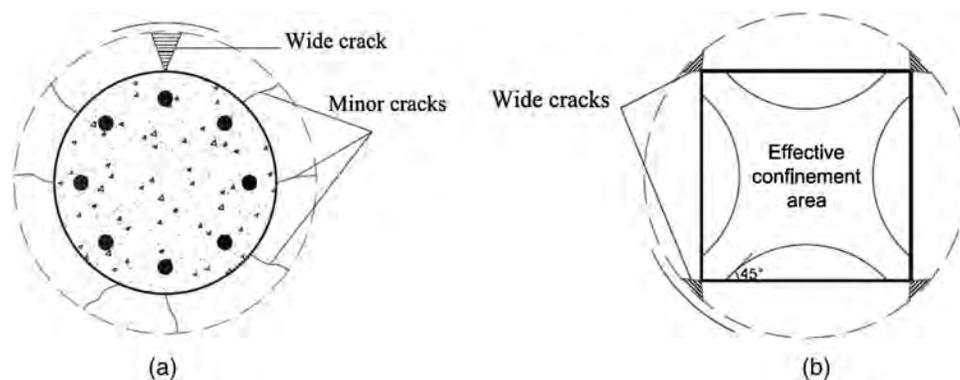
Fig. 11. Development of cracks in grout material and stress concentration in jacketed columns: (a) circular section; and (b) square section.

However, several hairline cracks originating from the column, propagating toward the jacket, and distributed along the circumference were observed in the grout prior to the final failure, whereas the width of the crack underneath the joint dramatically increased, as depicted in Fig. 11(a). Interestingly, higher strain readings were recorded in the joint rather than the jacket. This finding can be attributed to the discontinuity of the joint and its low transverse stiffness, which is less than that of the GFRP jacket, leading to premature failure of the joint without the GFRP jacket reaching its failure stress. A similar failure mechanism was observed in the square column [Fig. 10(b)] but with no minor crack development along the circumference. The jacket failed immediately after reaching the load level of 1,250 kN without fully deriving the benefits of confinement effects due to the stress concentration at the corners

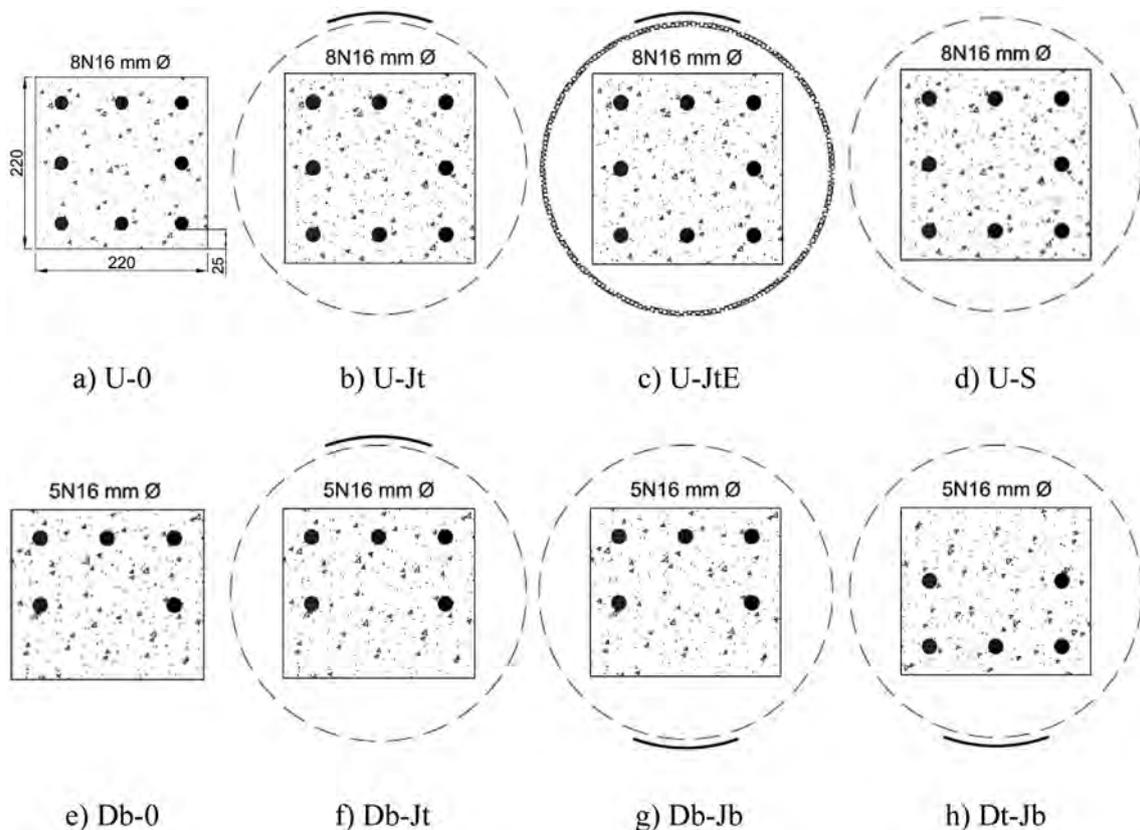
Fig. 5. Details and configuration of test specimens.

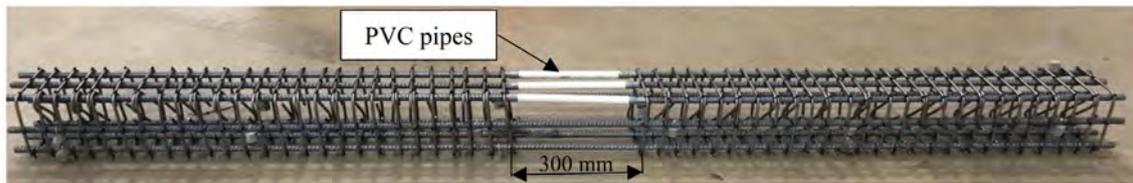
Fig. 6. Fabrication of beams reinforcement cage with simulated damage.

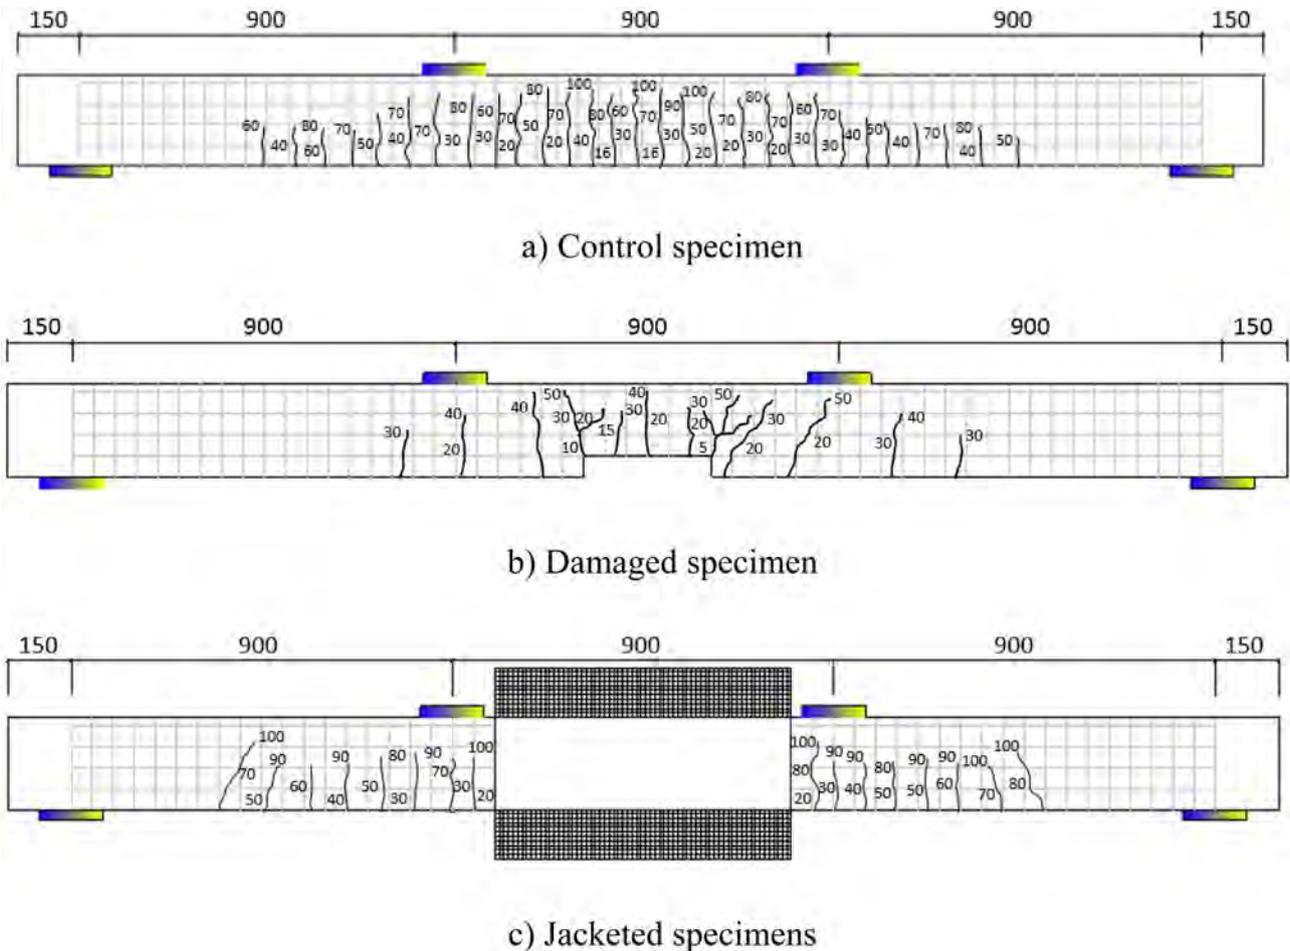
**Fig. 9.** Crack pattern of tested beams.

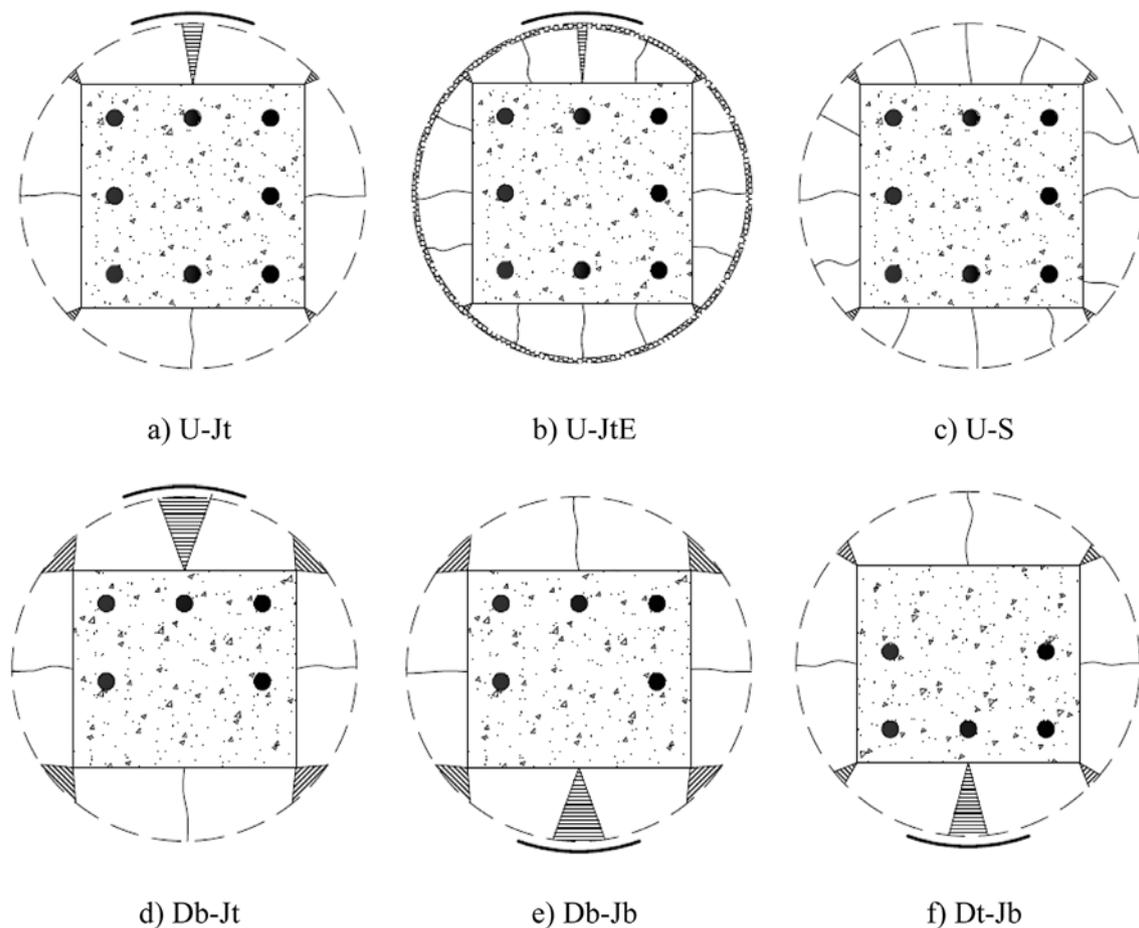
Fig. 10. Propagation of cracks in the grout infill.

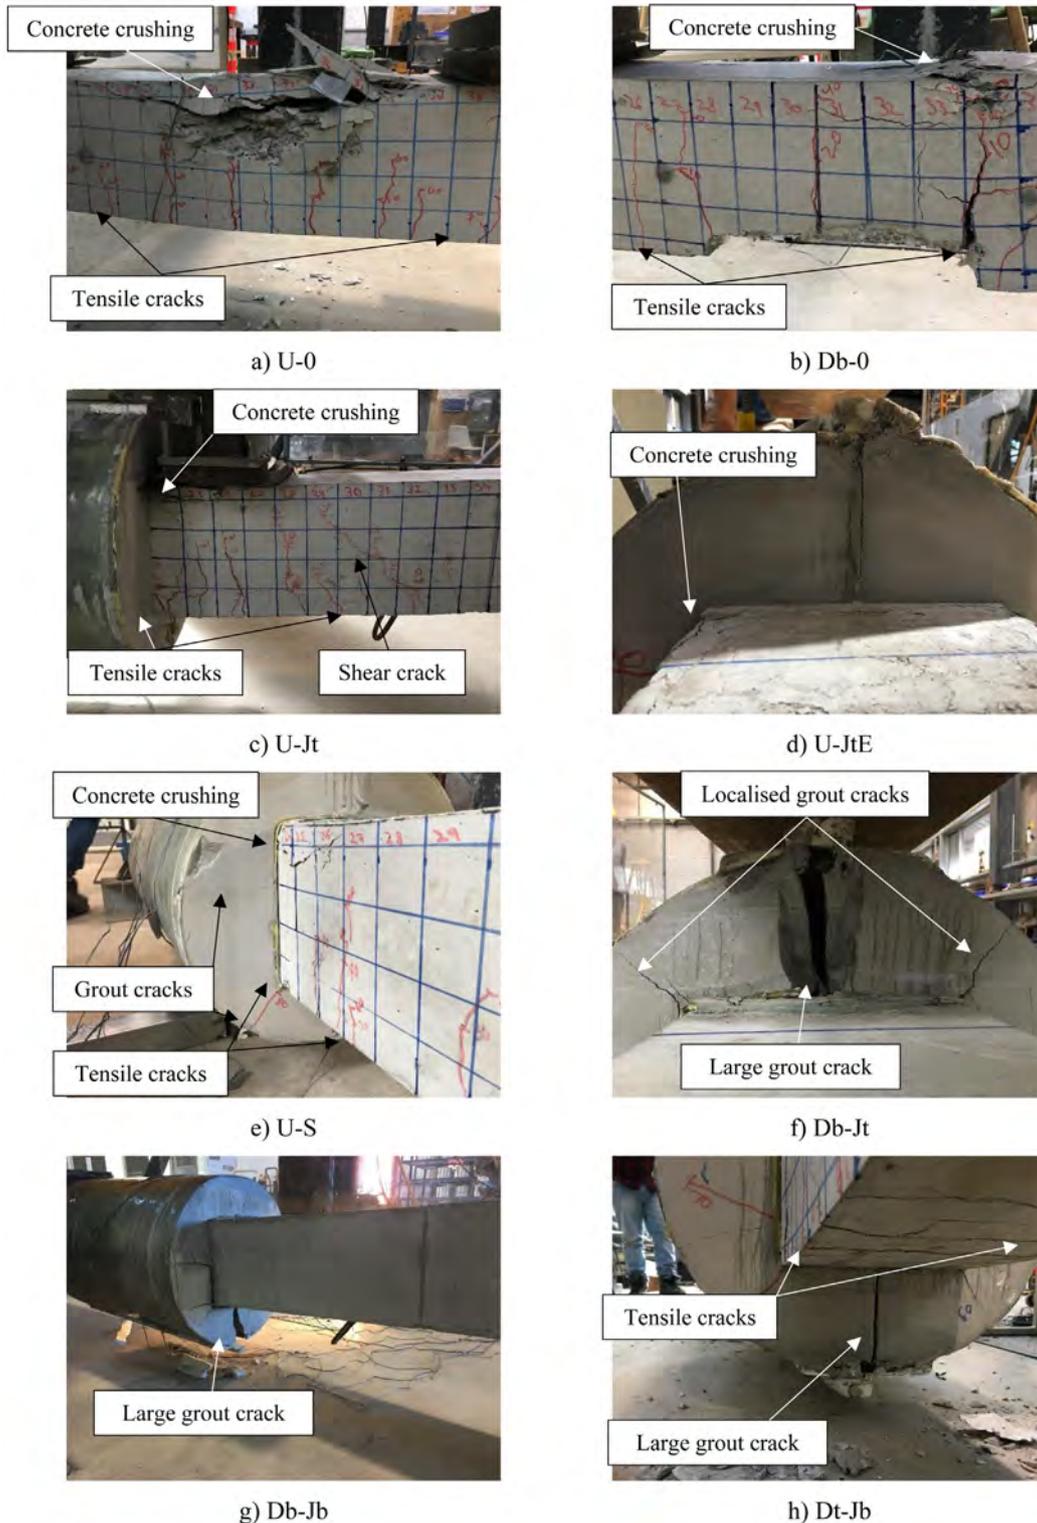
Fig. 11. Failure mode of the tested specimens.

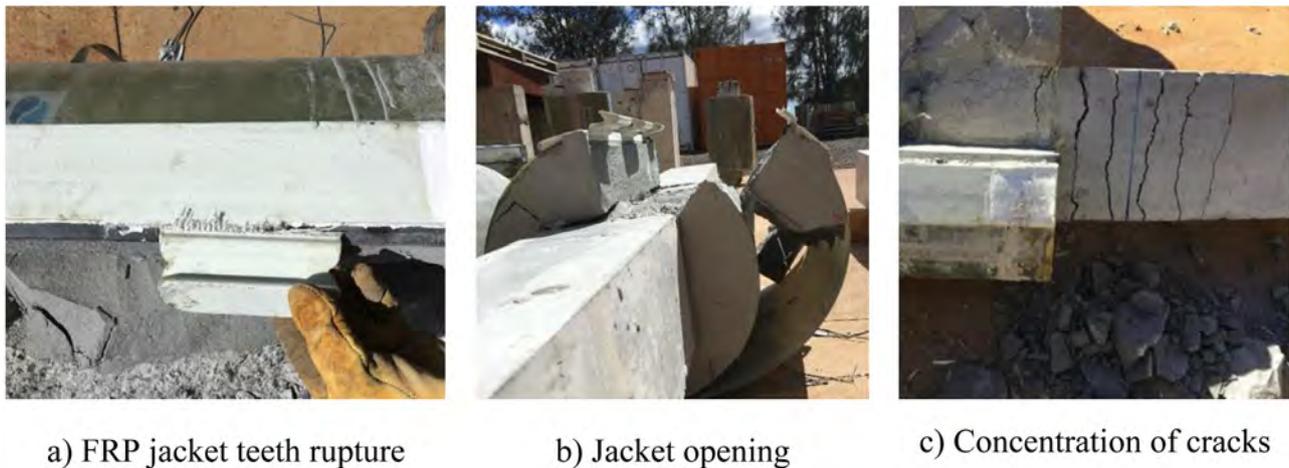
Fig. 12. Failure of the jacket.

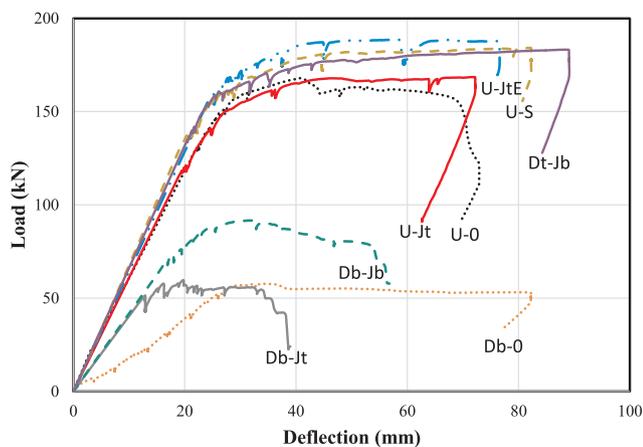
Fig. 13. Load-deflection curves of the tested specimens.

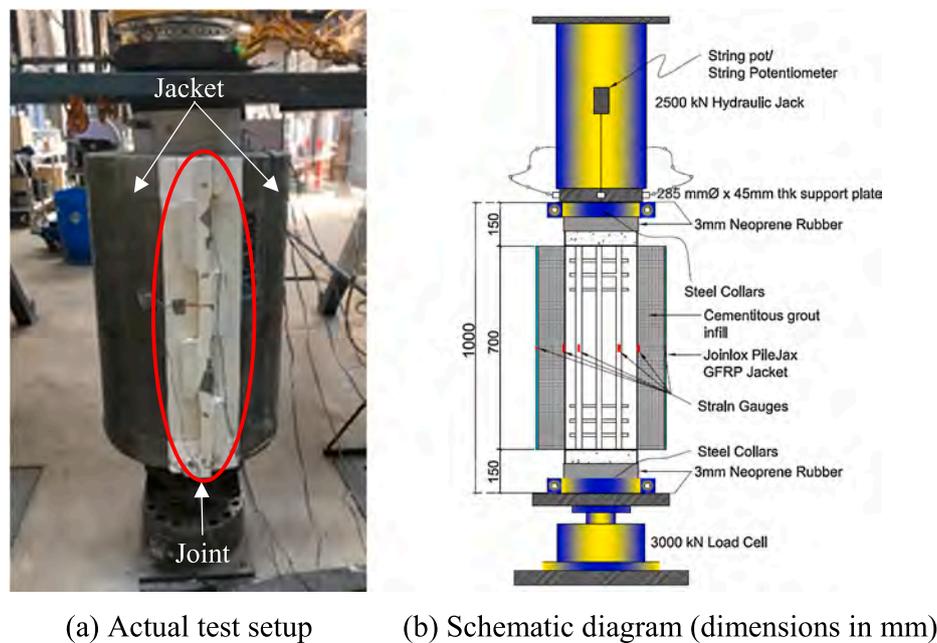
Fig. 3. Test set-up of columns.

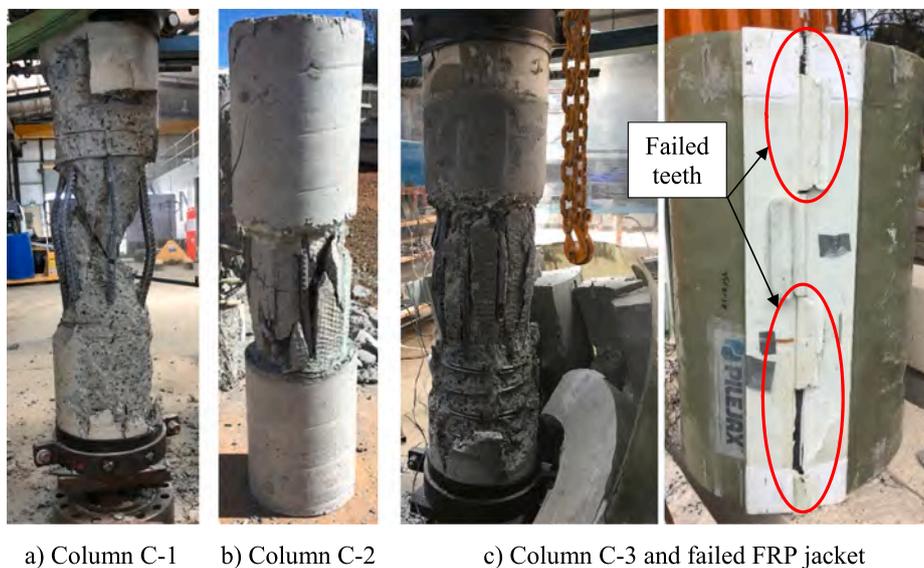
Fig. 4. Failure mode of the tested columns.

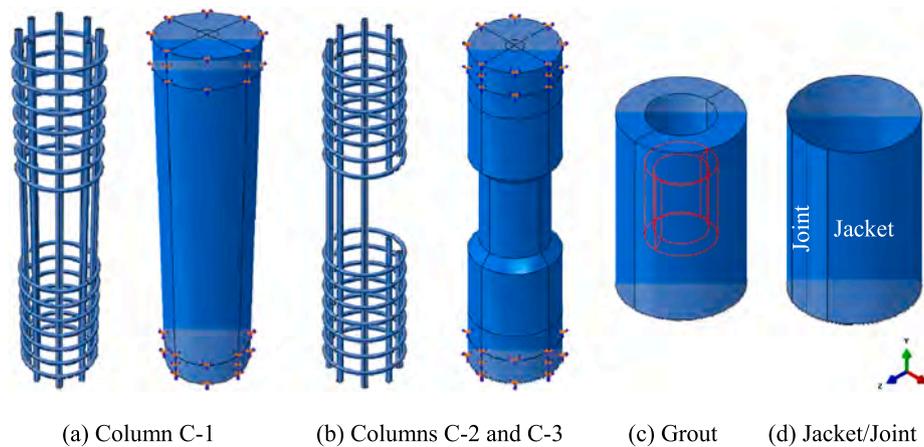
Fig. 7. Modelled columns and repair system.

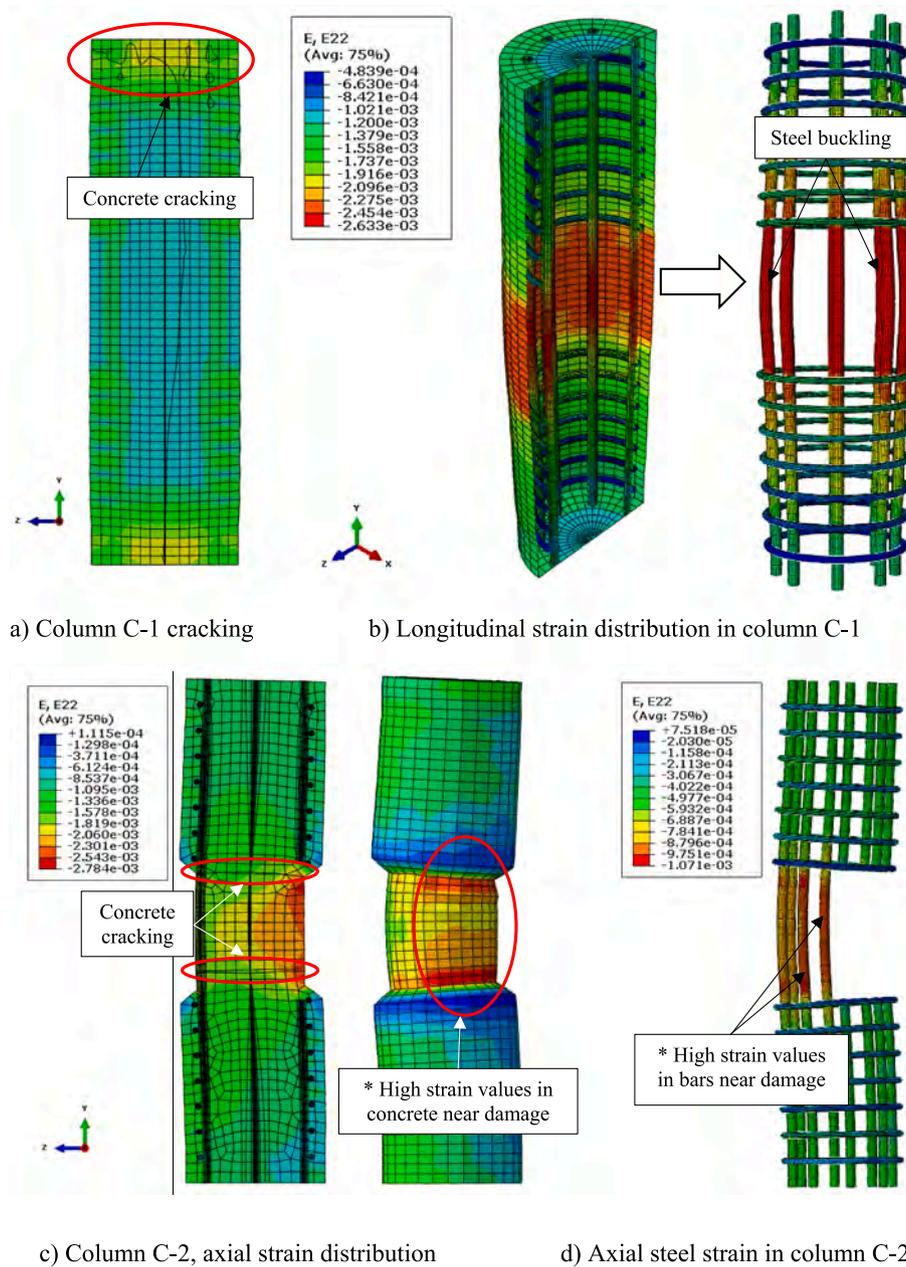
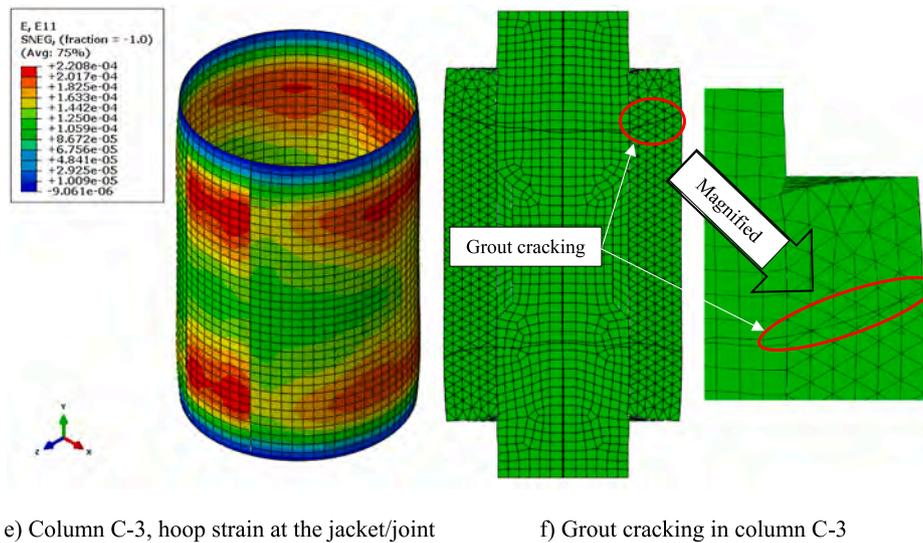
Fig. 9. Failure mode of simulated columns.

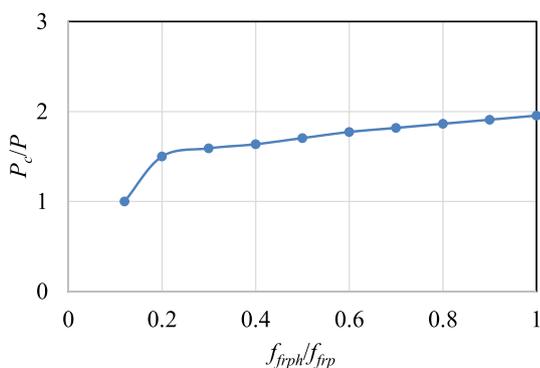
Fig. 10. Level of joint strength improvement ( $f_{frph}/f_{frp}$ ) versus axial strength enhancement of the repaired member ( $P_c/P$ ).

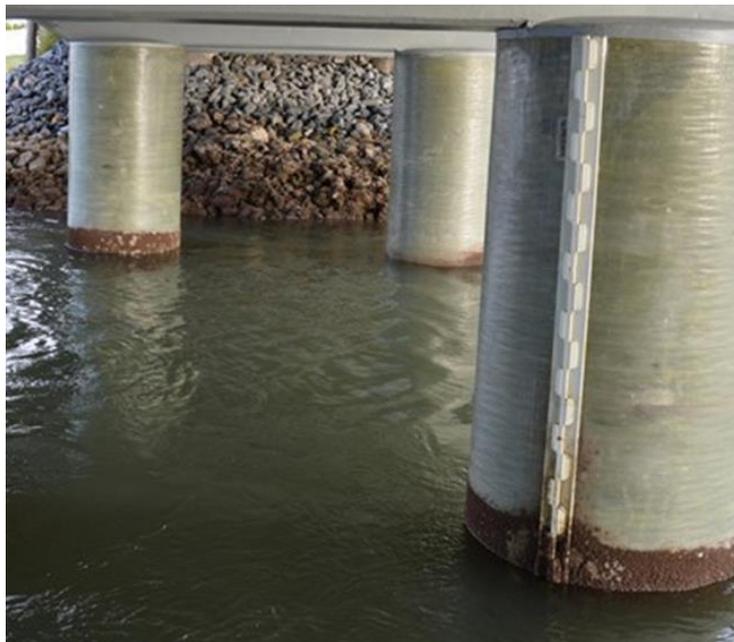
Figure 7.1. Novel FRP jacket utilisation in actual repair project
