**PERFORMANCE OF REINFORCED CONCRETE
BEAM WITH EMBEDDED GALVANIZED STEEL
AS LIGHTNING DOWN CONDUCTOR CABLE**

UNIVERSITI SAINS MALAYSIA

2019

**Thesis submitted in fulfilment of the requirements
for the degree of
Doctor of Philosophy**

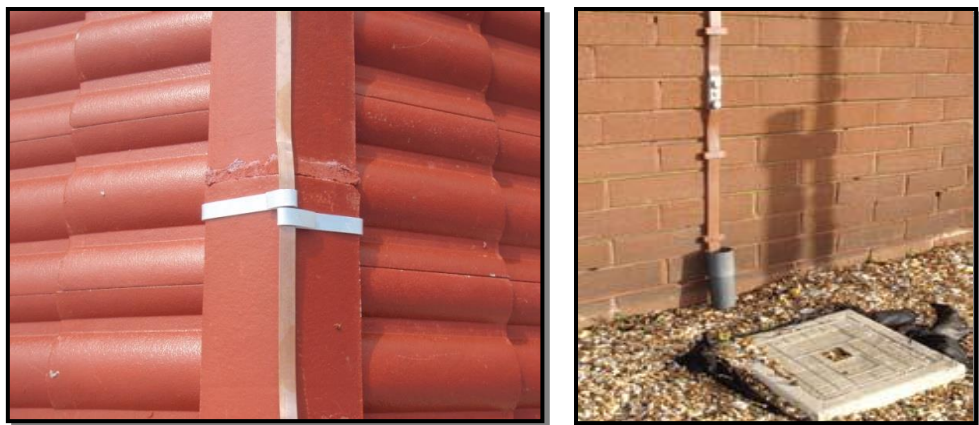
In order to create a system to protect buildings from this natural phenomena, the Lightning Protection System (LPS) was introduced in the 20th century (Heidler, Zischank, Flisowski, Bouquegneau, & Mazzetti, 2008). LPS is needed to reduce equipment damage and the loss of human life caused by direct lightning strikes and fires. The main function of LPS is to transfer the lightning strikes to the ground. LPS can be classified into two categories; external LPS and internal LPS. Internal LPS is an electronic device called the Surge Protection Device (SPD). It is usually installed inside buildings to protect electrical equipment from direct lightning strikes. In the case of external LPS, the conductor wire of LPS is bonded externally to the roof structure, wall structure and finally transferred into the ground, as shown in Figure 1.2.

Figure 1.2 : Externally bonding LPS to structure

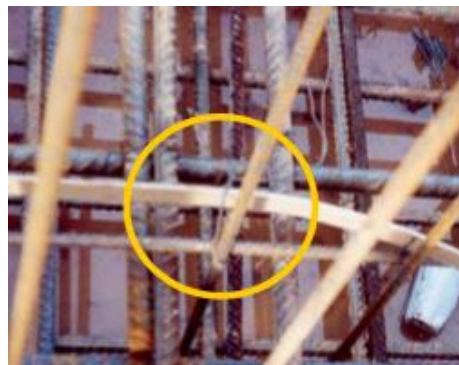
In practice nowadays, no detailed guidelines are available on the installation of down conductor cables inside concrete structures. As shown in Figure 1.6, the gaps between the cable and steel reinforcement could promote the transfer of electric current to the nearest conductor material. This process could cause damage to concrete structures as the process can create sparking or explosion within the concrete structure. Figure 1.7 shows the placement of the cables in concrete columns. No clamping was applied to the cable and the cable was left hanging freely from the structure. The installation of non-regulated cables could create possible danger.

Figure 1.6: Placement of the conductor cable in concrete beam (Kokkinos et al., 2006)

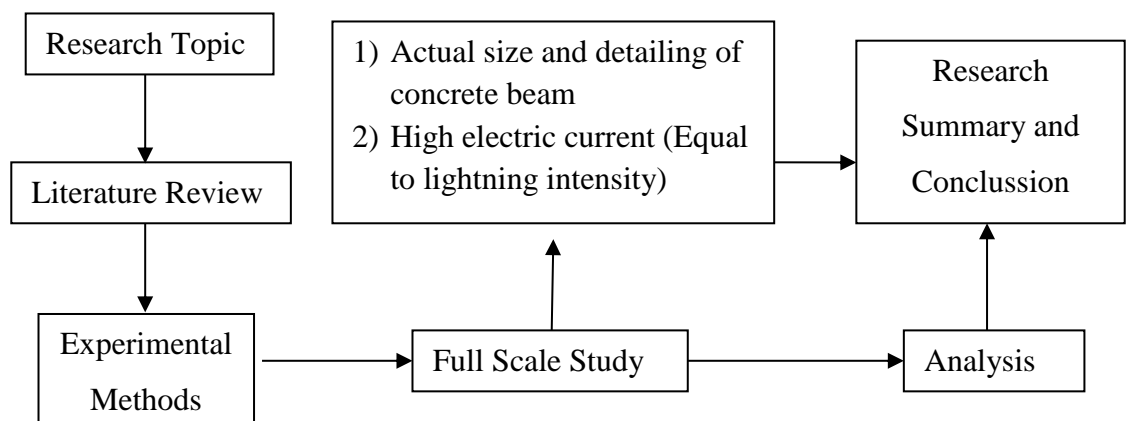
Various stages of research work are involved in this study in order to answer the research questions and objectives. The flowchart of the research work is shown in Figure 1.8 below.

Figure 1.8: Summary of research methodology

The full-scale experimental study uses reinforced concrete beams with a cross section of 200 mm x 300 mm. The concrete grade used is C30 while the main reinforcement sizes of 2T12 and 2T10 were used for the bottom reinforcement and top reinforcement, respectively. The link used measured 6 mm. The reinforcement tensile strength was 500 N/mm². The high current was set up from the lowest 15 kilo-ampere (kA) to the highest 45 kA in the full-scale study as the minimum lightning current was 1.5 kA. The experiment work was conducted at Universiti Teknologi MARA, Permatang Pauh, Pulau Pinang, involving both heavy structure and high electric current laboratories. Details of the experimental work are explained in Chapter 3.

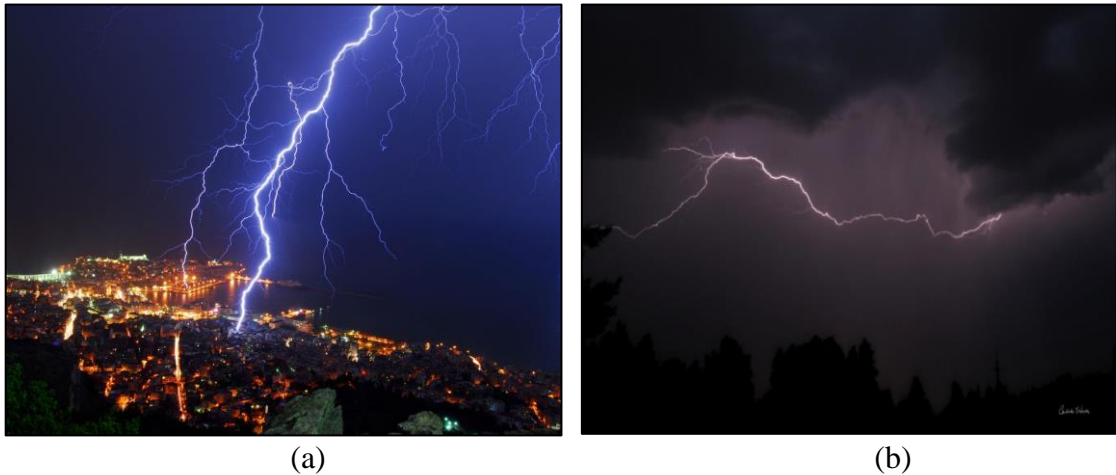
Figure 2.3: (a) Cloud-to-ground flash and (b) Intercloud flash (Wirth)

Cloud-to-ground flash is the most dangerous among all types of lightning as it has a high impact on living things or objects (Fahmee, 2016). The majority of flashes develop near the centre of lower negative charge and disperse negative charge to the earth (Arif, 2009). High rise buildings are affected by this type of flashes although they normally strike to the ground. Figure 2.3 (a) shows a typical cloud-to-ground flash that happened in Kavala, Greece.

Cloud flash does not strike the ground because it discharges the flash to the air around the storm through its visible path (Fahmee, 2016). There are two categories of cloud flashes namely, intra-cloud flash and inter-cloud flash. The intra-cloud flash occurs in the same thundercloud which contains both positive and negative charges. The flash is produced between the thundercloud boundaries only. Inter-cloud flash happens between two different clouds as it will emit charges to the ground (Fahmee, 2016). It is called cloud-to-cloud lightning and is visible from the ground. Inter-cloud flash happens the least compared to other types of lightning (Song, 2005). Figure 2.3 (b) shows a typical inter-cloud flash.
