Aalto University
School of Engineering

Quantification of deformation trends in a sublevel caving mine using mobile 3D laser scanning

Master's thesis submitted in partial fulfilment
of the requirements for the degree of Master of
Science in Technology

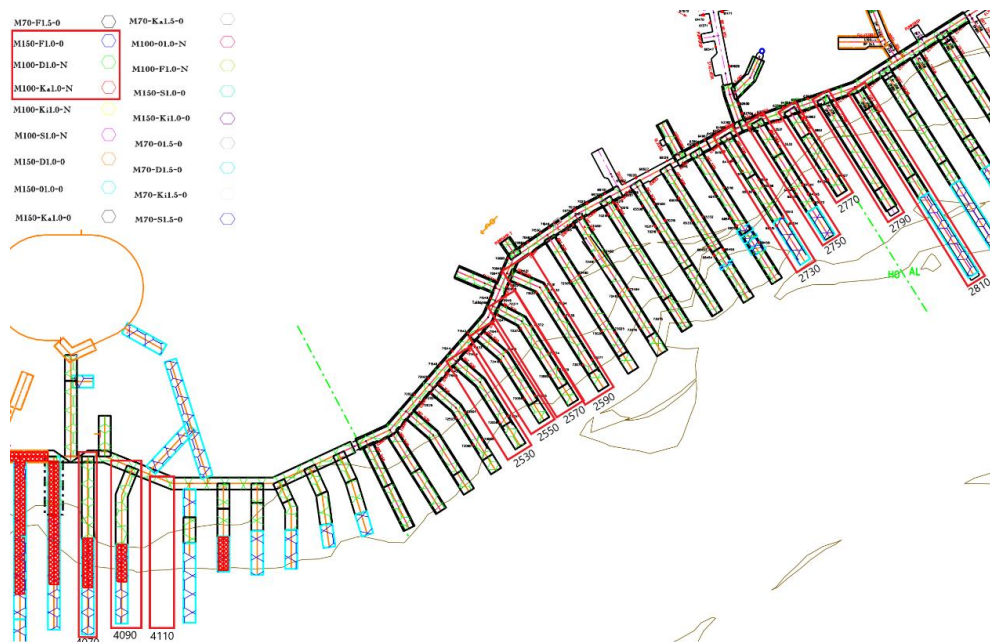
Figure 13: Support classes in the research area at Level 1051 and 1052 with marked crosscuts (MicroStation V8i)

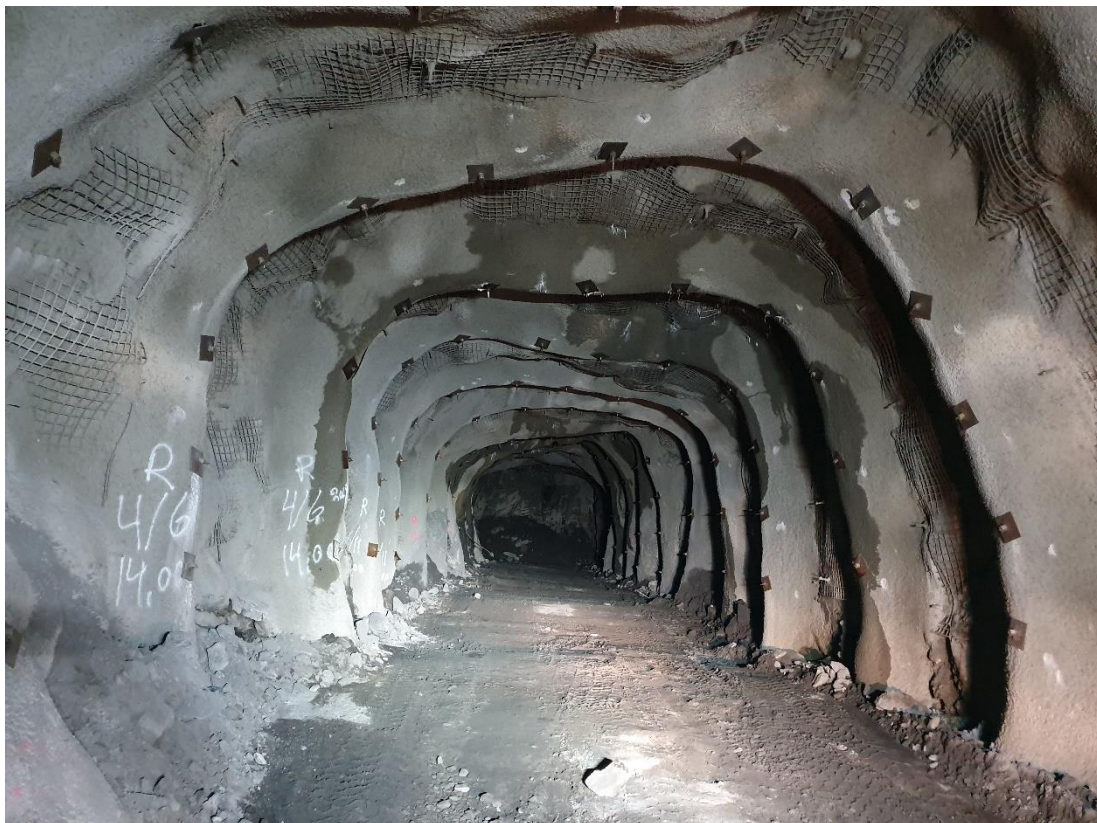
Figure 14: Crosscut PR996, 4110 with installed fibrecrete arches

Fibrecrete arches are also used locally in crosscuts. For instance, in PR996o4110 twelve fibrecrete arches are installed (Figure 14). Also, in other areas such as HO and AL from level 1023 to 1080 a number a fibrecrete arches are installed. In total the research area has more than 50 fibrecrete arches as an additional support measure. A more detailed description of the current conditions is in Chapter 4.

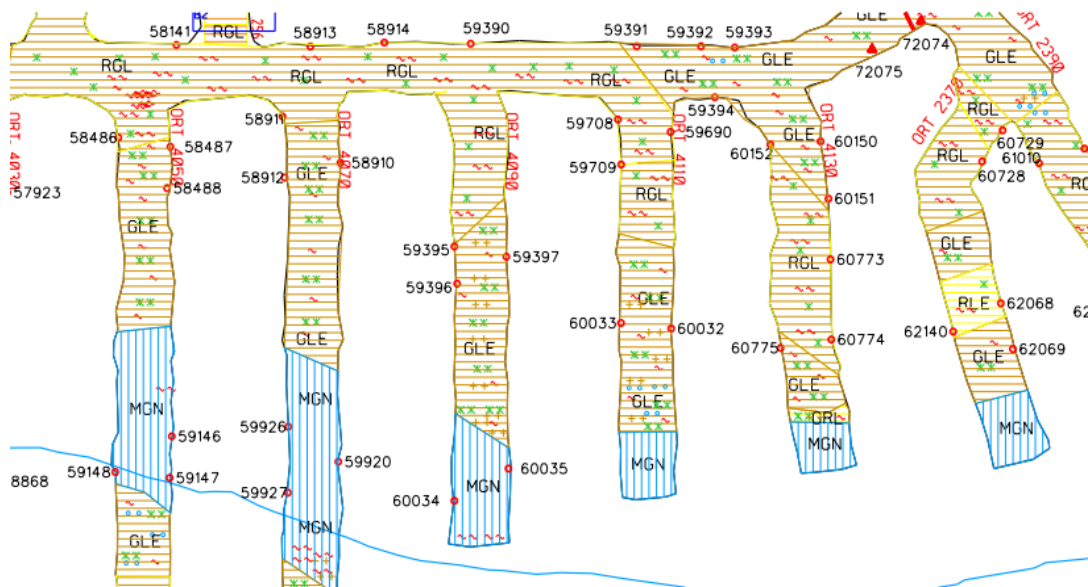
Figure 15: Layout of PR 996 with geological features (MicroStation V8i)

In PR 996 drift 4090 and 4110 are of central interest (Figure 15). In 4090, floor heave measurements as well as convergence measurements are available by previous researches. Additionally, there are geological records and own observations from field work given.

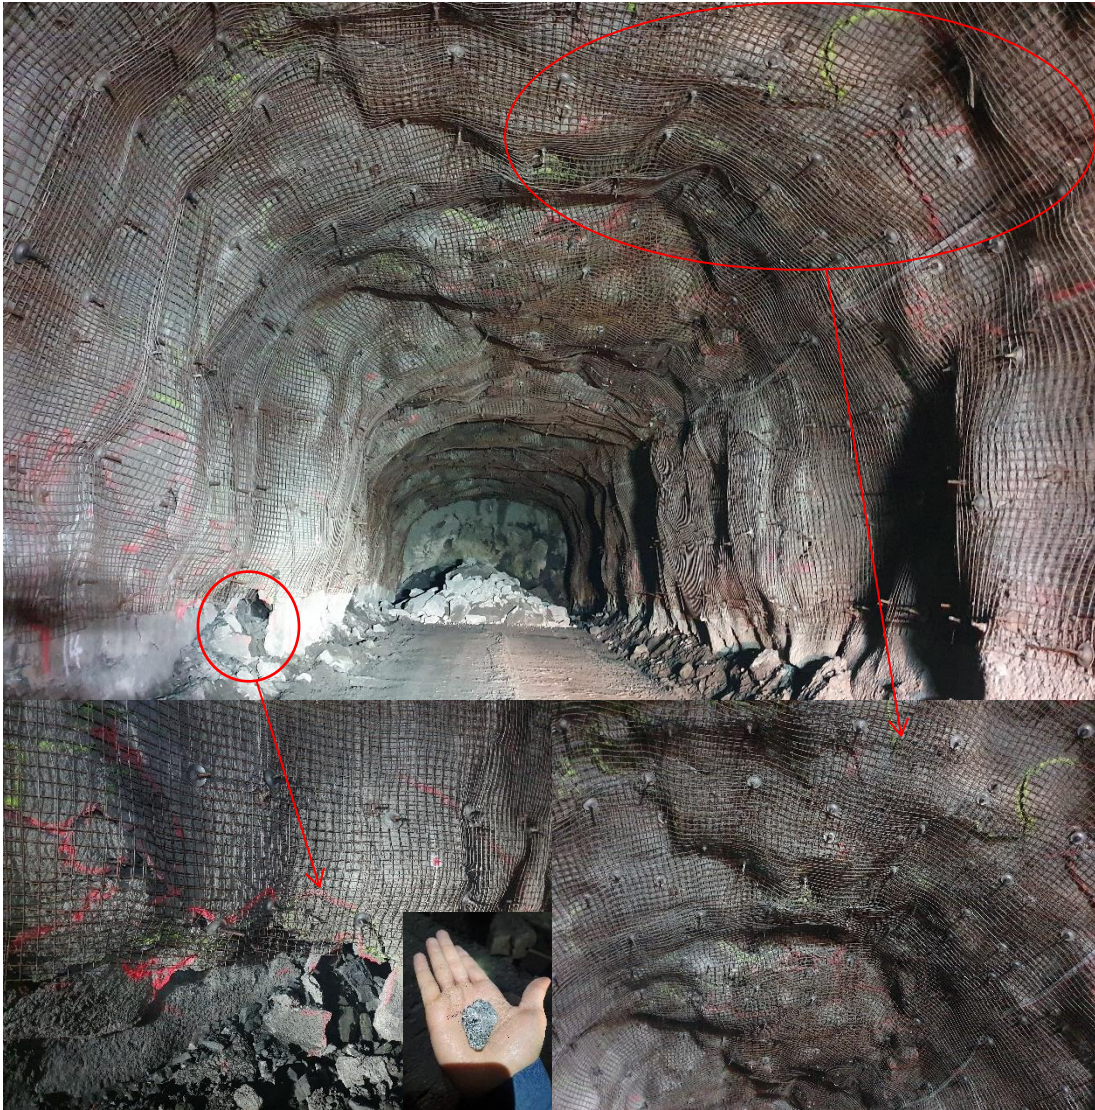
Figure 16: Current state of PR 996o4090 drift

Figure 16 shows 4090 as of section four, the area with the most visible changes and impact. Most activity occurs between sections four and seven, with section five appearing to be the most active area. In section seven the orebody starts, so the most active area is defined by grey leptite with a higher biotite content (Figure 15). Many of the bolts in the area are loaded and there are many fibrecrete flakes in the shoulders and roof held by the mesh. On the lower left wall, the fibrecrete has cracked and fallen off under the mesh. This has revealed loose pieces of rock. The

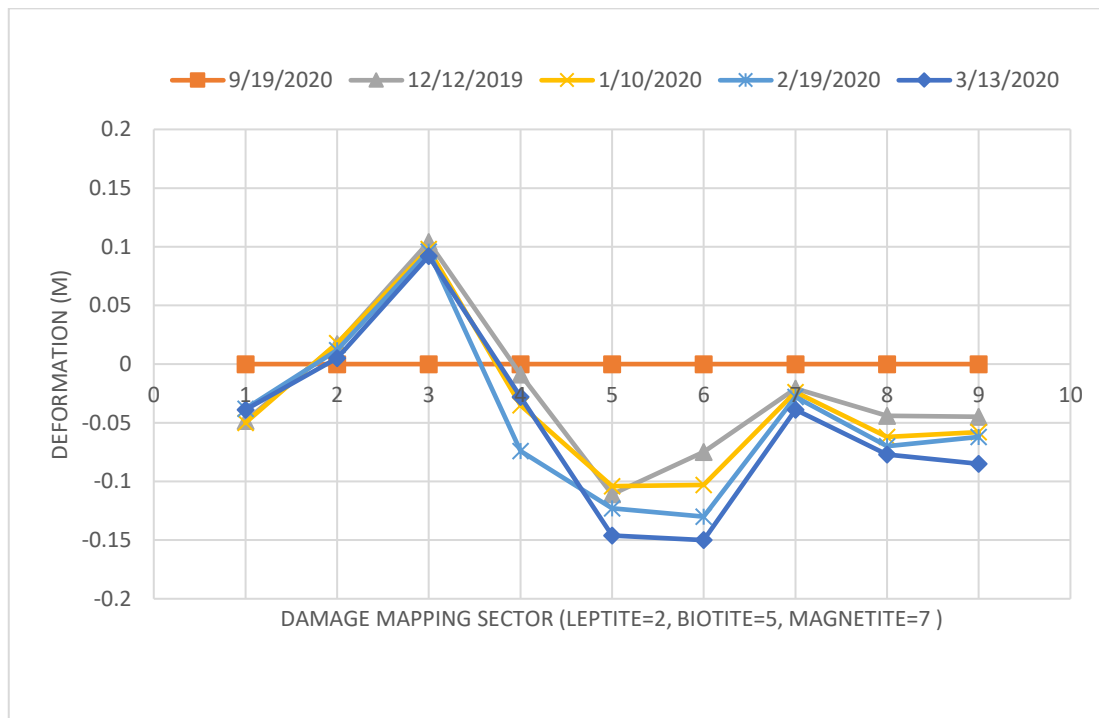
Figure 17: PR996o4090 Wall-to-Wall Convergence/Divergence (by Jones, 2020)

Figure 17 shows the wall-to-wall distance over six months in the drift for different sections which is measured manually with a laser range finder. Positive values represent divergence and negative values represent convergence compared to the first. The measurement series had already started before the project. Within six months the distance decreased by 0.15 m for section five and six at a regular and ongoing pace. In section three there was an increase of 0.1 m in the first three months, but nothing happened in the following three months. The measurements fit the field observations.

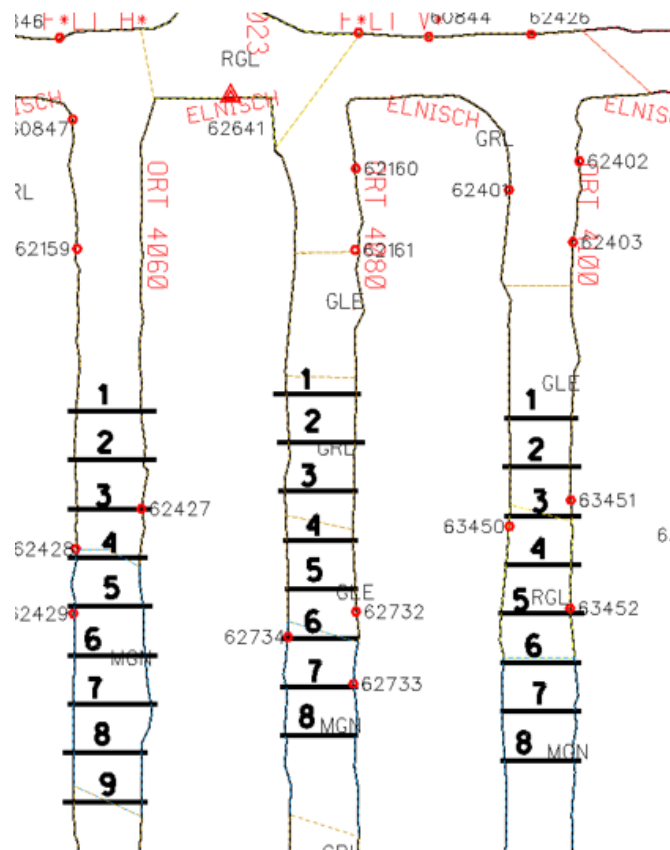
Figure 22: PR 1023 measurement profile for floor heave investigation (by Jones 2020)

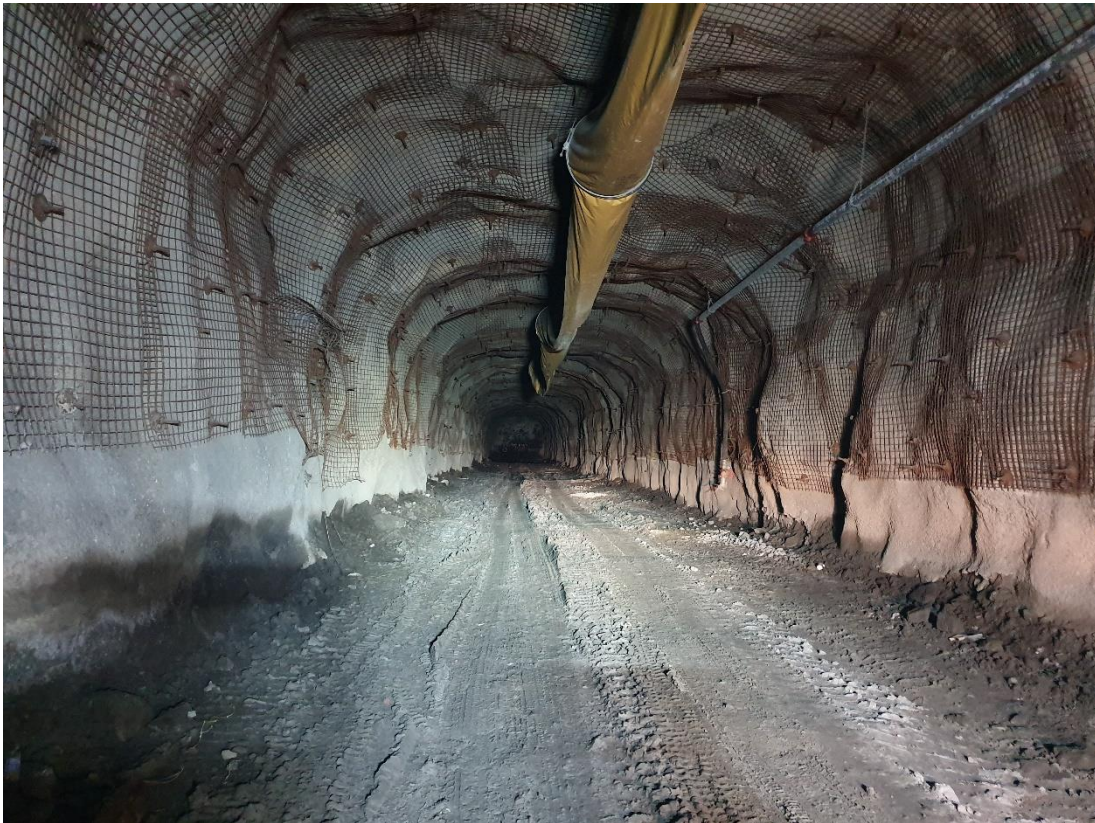
Figure 23: Current state in PR 1051o4070

In PR 1051 drift 4070, 4090 and 4110 are a part of the research area. There is no data of previous work here. The level shows little deformation compared to the two levels above. Drift 4070 is a good reference for all the drifts in the research area of PR 1051 (Figure 23). The drift perimeter has not changed much and the fibrecrete on the lower walls does not show any weaknesses.

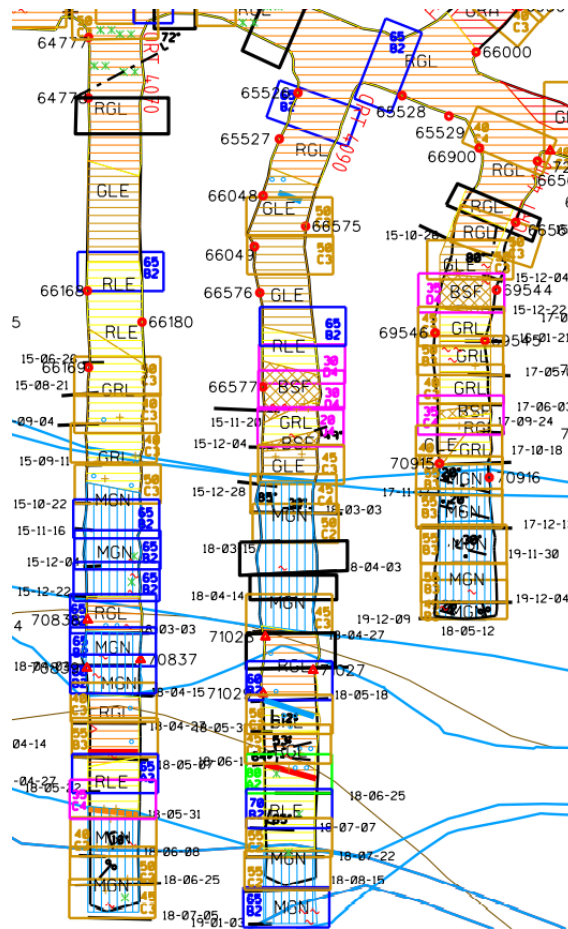
Figure 24: Layout of PR 1051 with geological features (MicroStation V8i)

Figure 24 shows the rock types as well as the GSI-values in PR 1051. All three drifts are starting with red grey leptite and a transition to grey leptite. In drift 4090 and 4110, there are biotite schist parts in the leptite close to the orebody that have a low GSI-value of 20-35 with fair to poor surface conditions and a disturbed structure resulting in a decreased interlocking of rock pieces. The other parts in the area are defined with a GSI-Value of 45-65, good to fair surface conditions and a better interlocking of rock pieces.

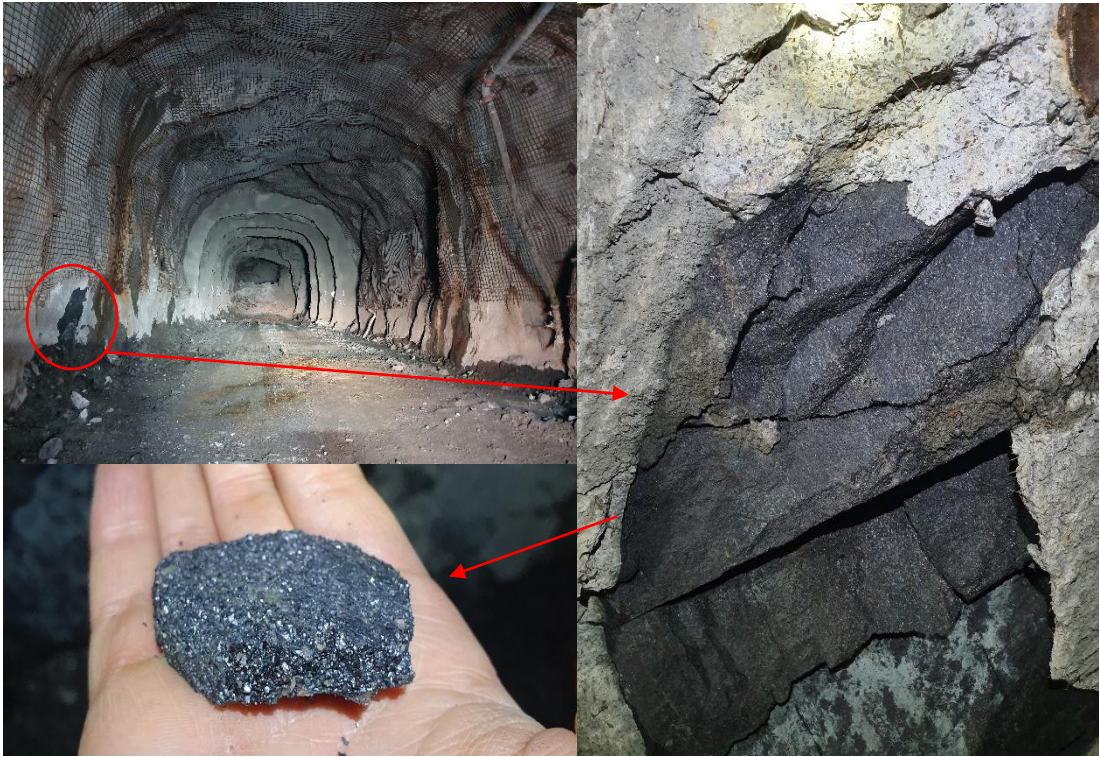
Figure 28: Current state in HO1051o2730

In 2730 there are more than six shotcrete arches and a possible floor heave 5 m after the end of the ventilation hose (Figure 28). Behind it there is water on the floor and in front of it are almost no detectable cracks and other changes. The area behind the floor heave shows characteristics that indicate deformations such as loaded bolts, cracks in the fibrecrete up to the loosening of it resulting in the rock being visible. The exposed rock formation shows a loose biotite with many spaced joints. The taken rock sample can be pulverized in one hand and appears very weak. 2750 has five shotcrete arches and no visible floor heave. The zone looks a little better but also has several cracks. Although there is biotite schist at the entrance in 2770, which should make it more unstable, the drift looks better than the other two.

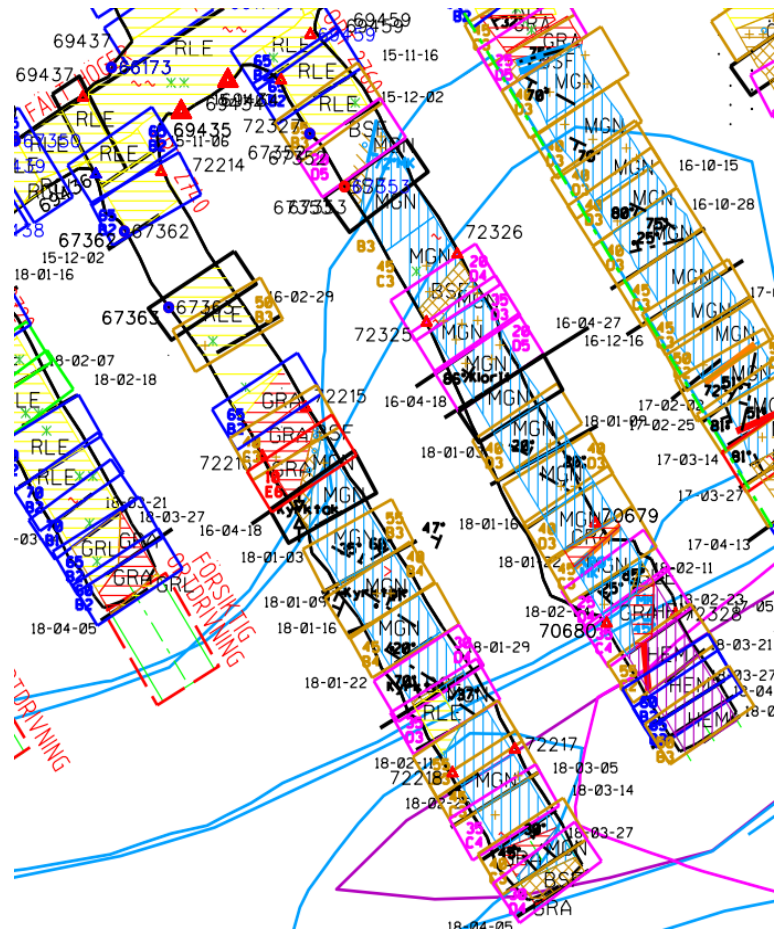
Figure 29: Layout of HO 1080 with geological features (MicroStation V8i)

Drift 2740 and 2760 in HO 1080 are also designated as research area (Figure 29). In 2760 wall-to-wall measurements are given by earlier research. Additional information came from own field observations and geologic records. Both drifts start with red leptite. In 2760 the orebody is closer to the entrance. At the ore contact zone there is a thin biotite schist formation which occurs also more common in the magnetite for the first time. The schist has a GSI-value of 20-35 with poor surface conditions. Due to the intrusions, the magnetite is also weaker with a GSI-value of 40. The magnetite in 2740 can be characterized as similar. The difference is that in 2740 granite and a weaker biotite schist with a GSI-value of 10 and very poor surface condition at the ore contact zone is abundant. 2740 looks a little different compared to the other drifts (Figure 30). There are two large rock falls and therefore two holes

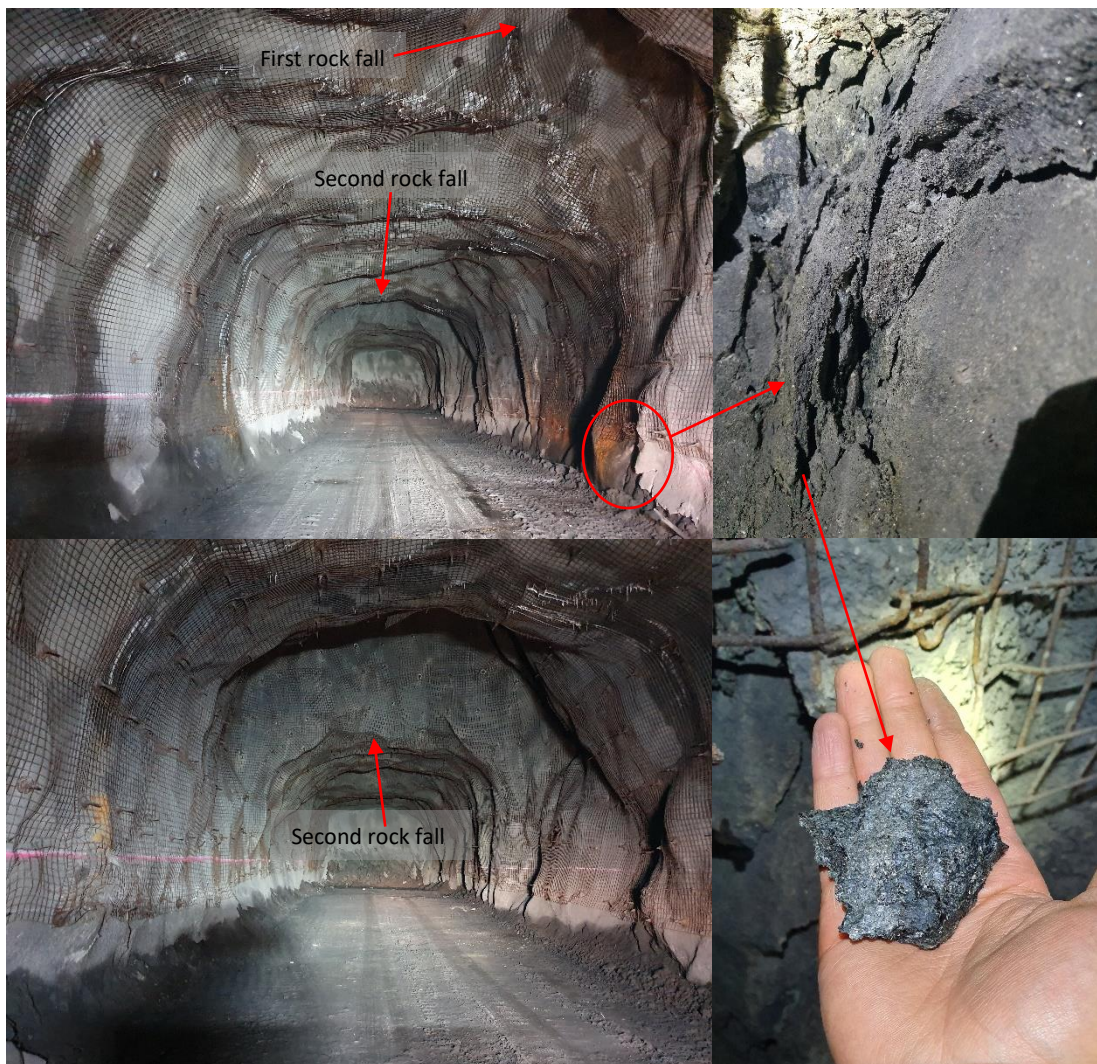
Figure 30: Current state in HO 1080o2740

in the roof. Up to the first hole in the right roof, there are hardly signs of deformation in the drift. From that point on the walls are wet in some points like next to the rock fall on the left side and in front of the second rock fall which is located close to the end of the drift. On the lower right wall at the level of the first hole fibrecrete has fallen off and the rock is showing through. The outcropping rock has a very fine schistosity and falls off at the slightest touch. In 2760 a lot of cracks can be detected as well as water. The conditions are close to 2740, but without the rock falls.

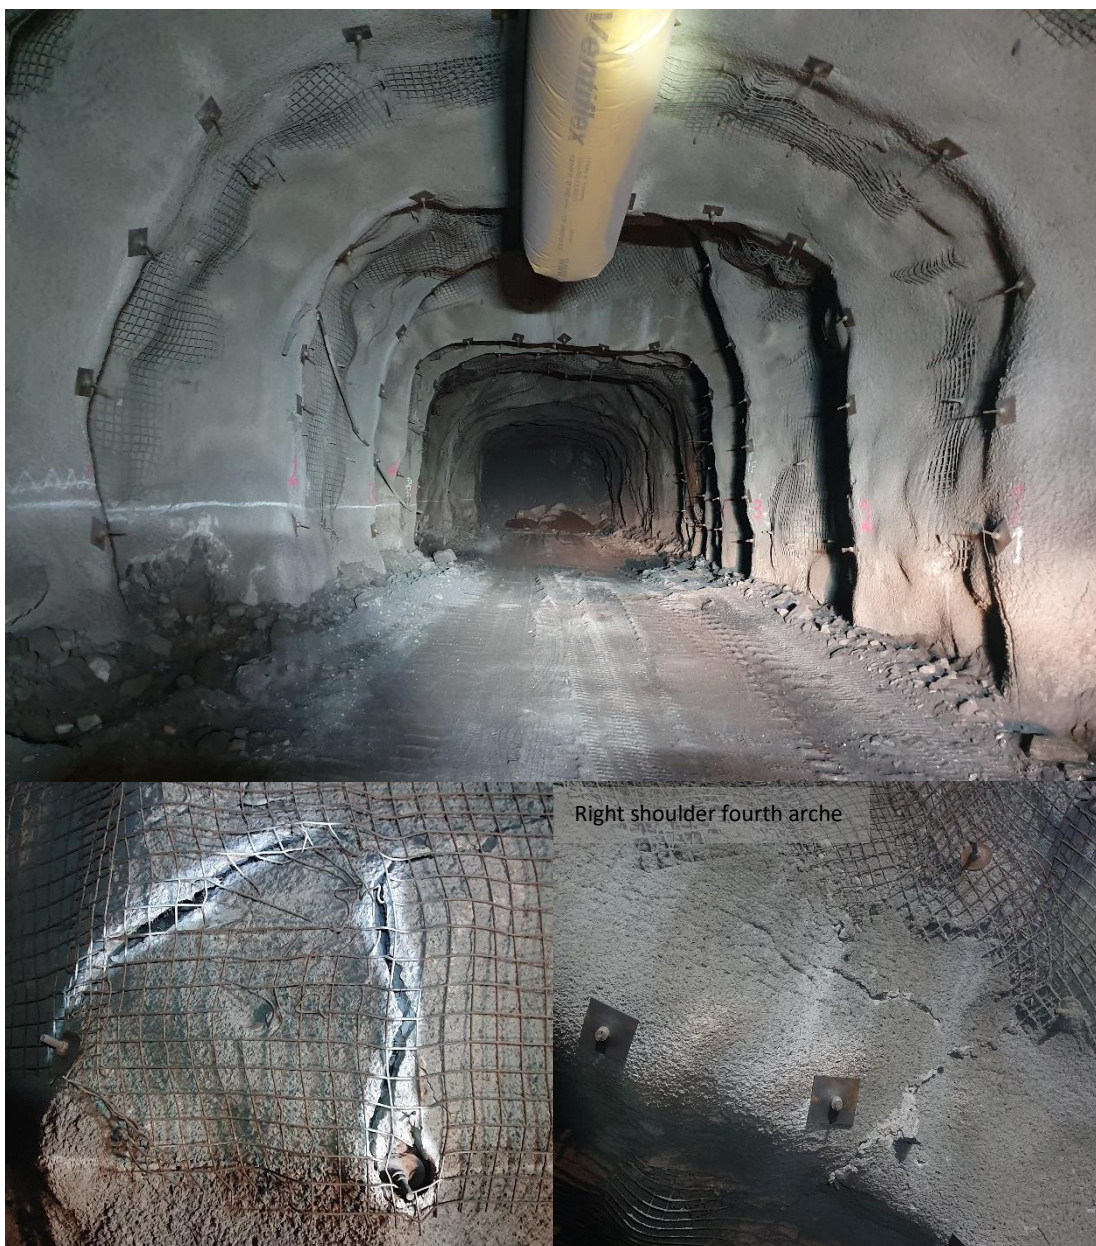
Figure 32: Current state in AL1052o2810

2790 has six shotcrete arches to stabilize the area. There is water between arche four and six, but there are no other irregularities. In 2810 there are five shotcrete arches. Arche two has a large crack on the left side and arche four has one on the right shoulder. There is also a large crack in front of the first one. The beginning of the tunnel seems to be in better condition. 2790 looks better compared to 2810.

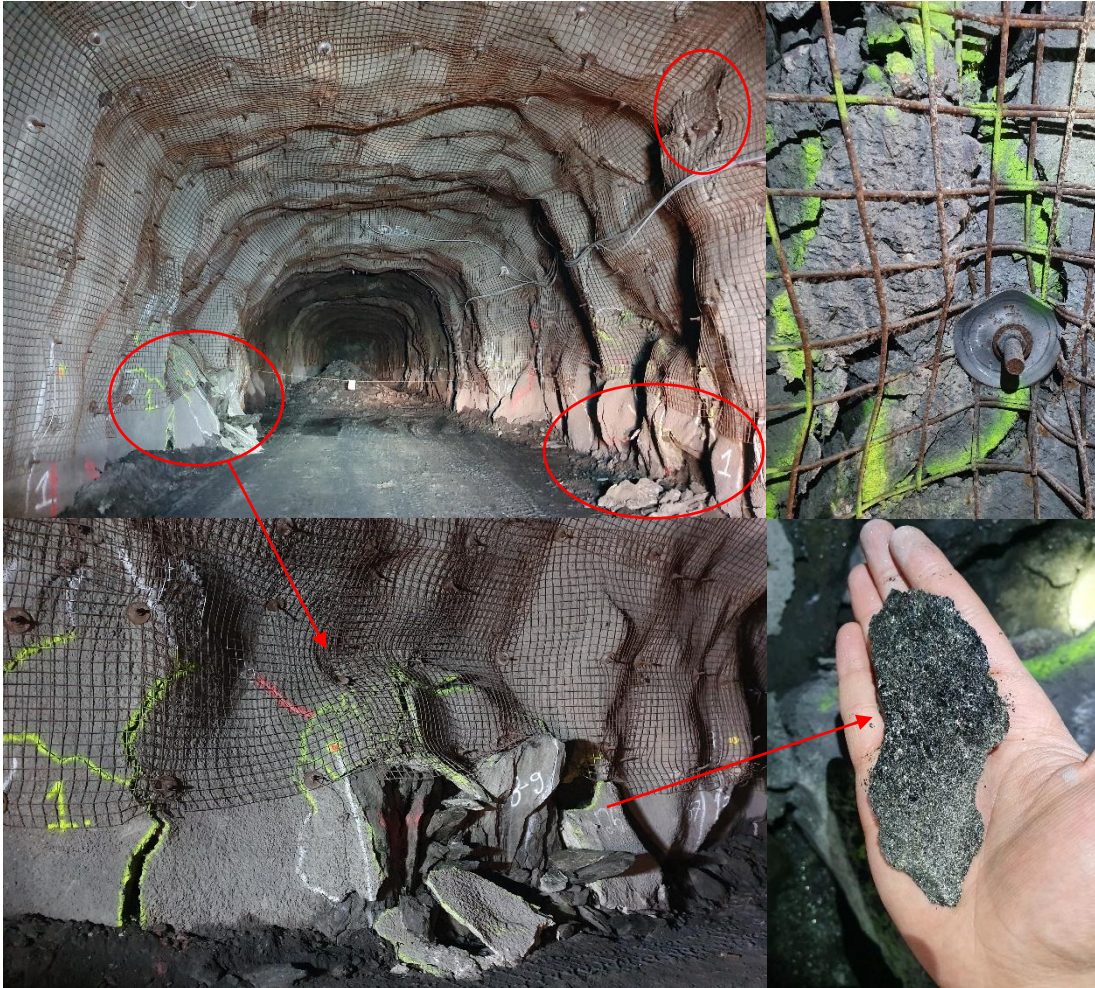
Figure 34: Current state in AL 1082o2800

Drift 2800 and 2820 show a high occurrence of biotite schist at the first ore contact zone with weak rock mechanical properties (Figure 33). The schist has a GSI-value of 20-30 with poor surface conditions and many intersecting discontinuity sets. The first part of the orebody seems to be competent rock, but later parts show a decreased GSI-value and intrusions of biotite schist and granite. 2780 also has a weak ore contact zone with biotite schist abundance with a GSI of 25, but in a smaller extend. Figure 34 shows the current condition from drift 2800. This is one of the most affected areas. Many bolts are loaded, cracks are long and wide and the fibrecrete is loosening at the bottom of the walls, causing the rock to break through. The cracks

are beginning to connect and are getting longer as well as wider, resulting in less stability. As the rock piece shows it is mostly biotite schist at the areas where the rock breaks through. 2780 and 2820 are also affected by the consequences of deformation but are in a better condition.

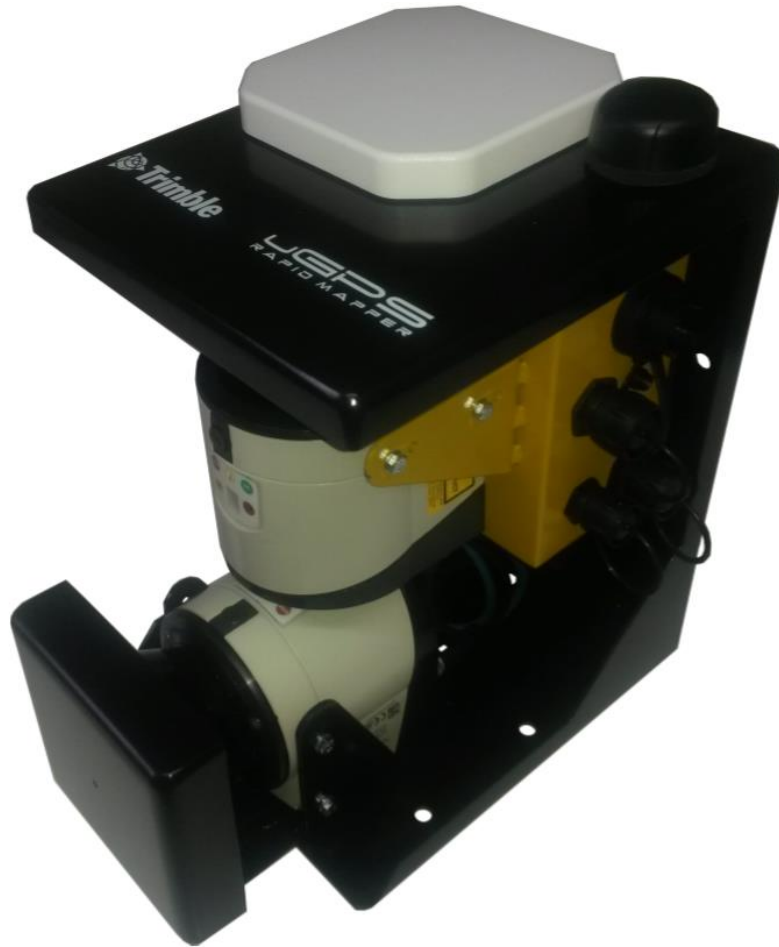
Figure 36: The uGPS Rapid Mapper™ (Peck Tech Consulting Ltd., 2020)

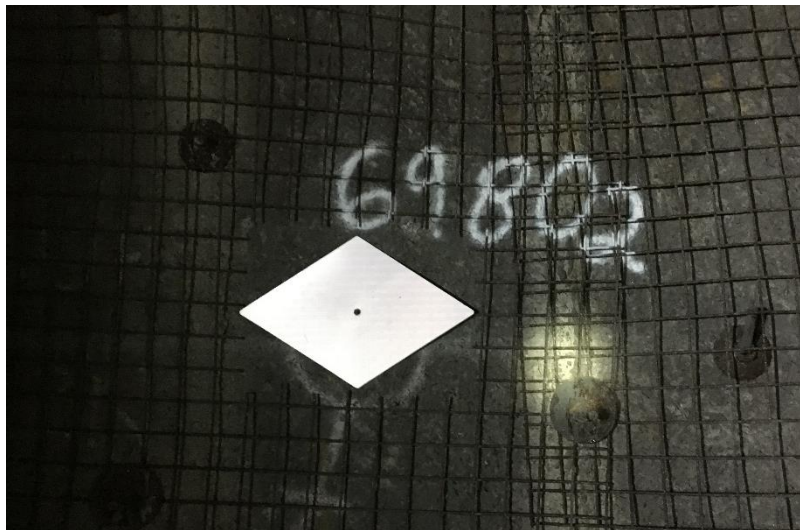
Figure 37: LiDAR target installed in a drift

Prior to scanning the area must be prepared through several steps. For the geo-referencing and alignment of the scans LiDAR targets need to be installed, surveyed and documented with information about the target's identification, position, and purpose (Figure 37). Additional information about the route of each scan is also included. The data is recorded in a CSV-file and defined as the control points file. Scanning without targets to check the roughness of the surface or other interests is possible, but for comparing scans the geo-referencing is obligatory. While installing the targets several points must be followed:

- Higher distance leads to higher accuracy errors
- A target is required at the start and end point of every scan
- Targets should be preferably installed in the height of the scanner
- Long axis parallel to the tunnel to ensure a high enough reflection
- Possibility to survey must be ensured

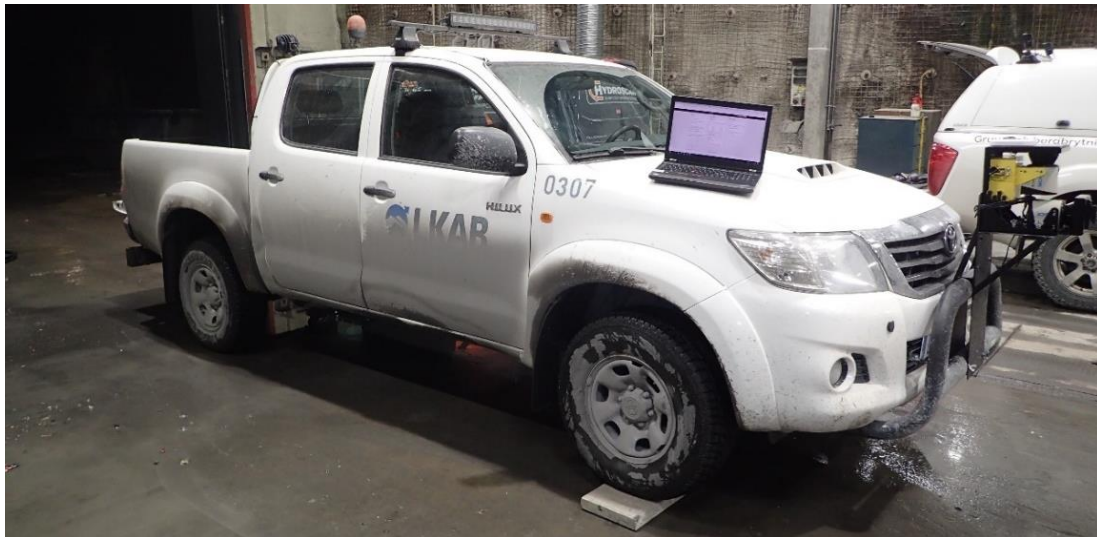
Figure 39: Calibration procedure with wood under the front wheels

In order to determine the impact of the calibration on the scientific work with the uGPS Rapid Mapper™, the calibration was carried out with same and different slopes instead of on a plane surface. For this purpose, gradients of 0°, 1°, 5° and 10° were chosen to scan the same area three times with every calibration setting. Figure 39 shows the experimental setup used for this experiment. To simulate a calibration on a slope, wood was placed under the front wheels. Since the method proved to be impractical above a slope of 5°, washers were placed under the uGPS Rapid Mapper™ in the further test series. Drift PR1051o4090 was then scanned as described in the test procedure.

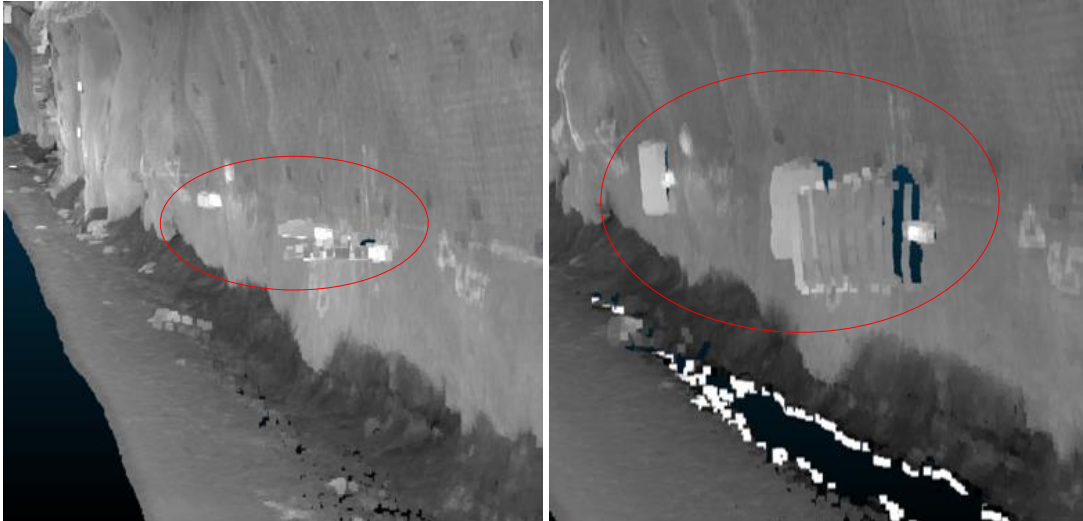
Figure 45: Scans of installed objects of test 1 & 2 without artificial deformation (CloudCompare)

The first test was completed with thin, 5 cm objects. After the first test in AL1052o2810 with the thin wooden objects it became clear that wider objects in z-direction are needed for the convergence monitoring even though the thin objects are identifiable in the actual scans (Figure 45). Therefore, new sketches were made and the three objects were enlarged for the second run, where the height was increased to 60 cm by adding wooden plates. The test procedure stayed the same with a deformation rate of 2 cm and a maximum deformation of 8 cm in the same drift.

Since no visual deformation could be detected in the convergence monitoring analysis with the first test design due to the 5 cm thin objects, the test results will not be discussed further.

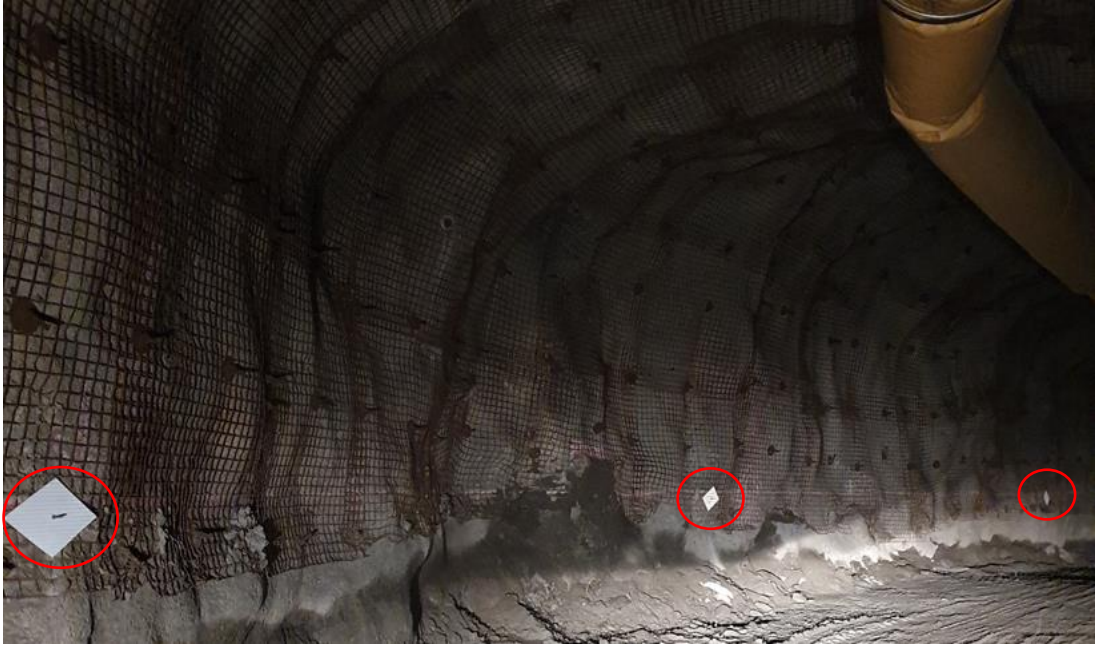
Figure 47: Test design with additional unsurveyed targets

The applied repeatability test was performed in HO1051o2590 by placing four additional unsurveyed targets between the two existing surveyed ones (Figure 47). The drift was then scanned ten times in a row without varying parameters. Convergence monitoring was used to see whether there is no deformation or whether there were any anomalies that would affect the repeatability. With the four additional targets attached, a statistical analysis was performed on the variation of the size of the targets in xy- and z-direction. In this analysis, the distance between the targets was from 11.5 to 12.6 m and a total of 60 values per direction were available.

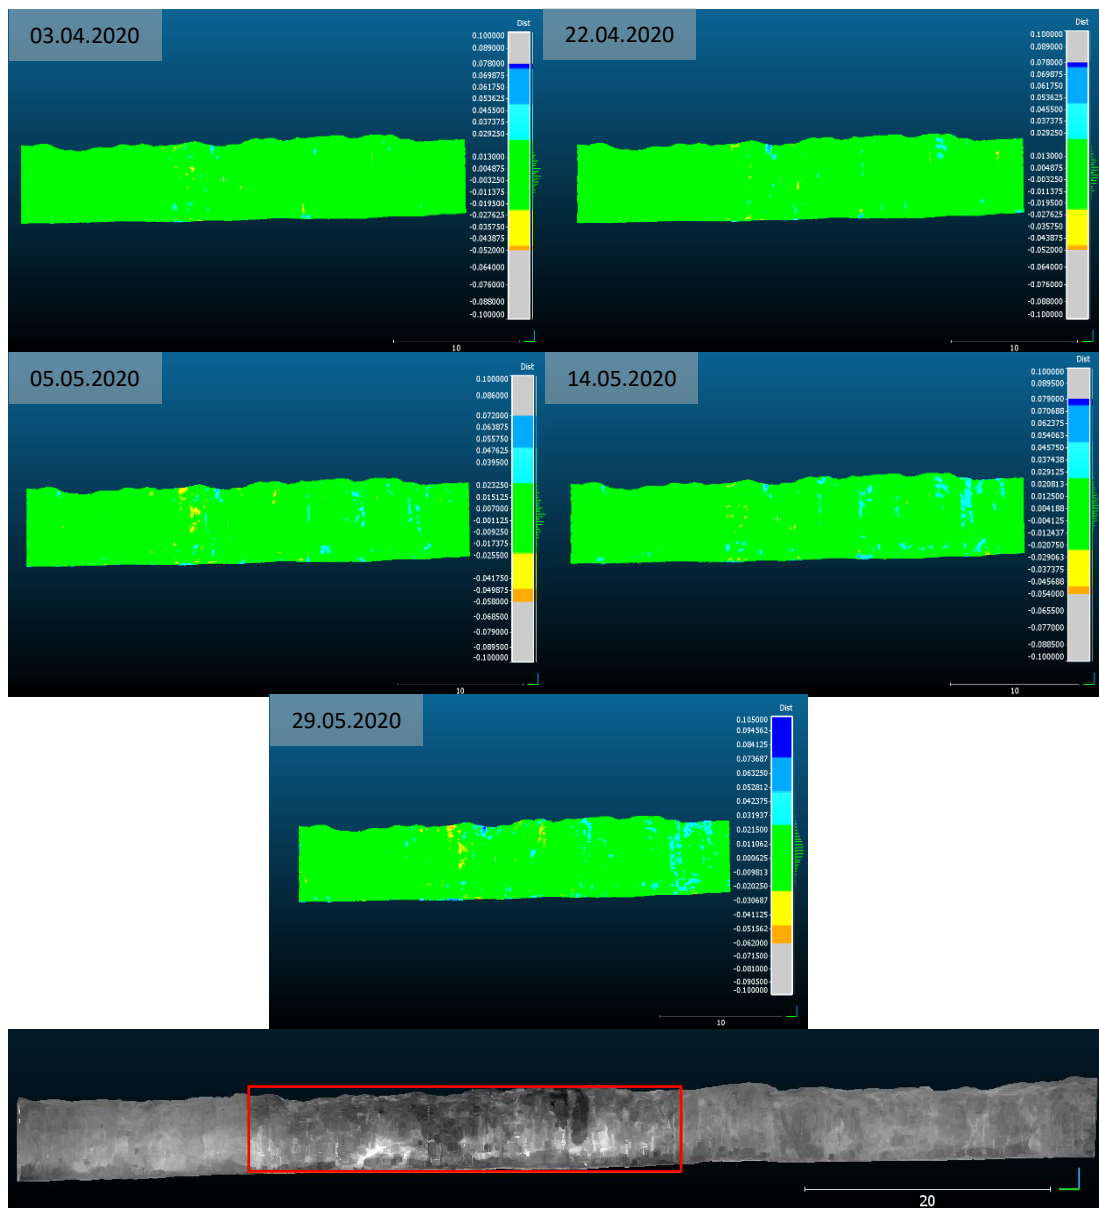
Figure 56: PR1023o4080, convergence monitoring on the right wall with 19.03.2020 as reference, square indicates convergence monitoring area (CloudCompare)

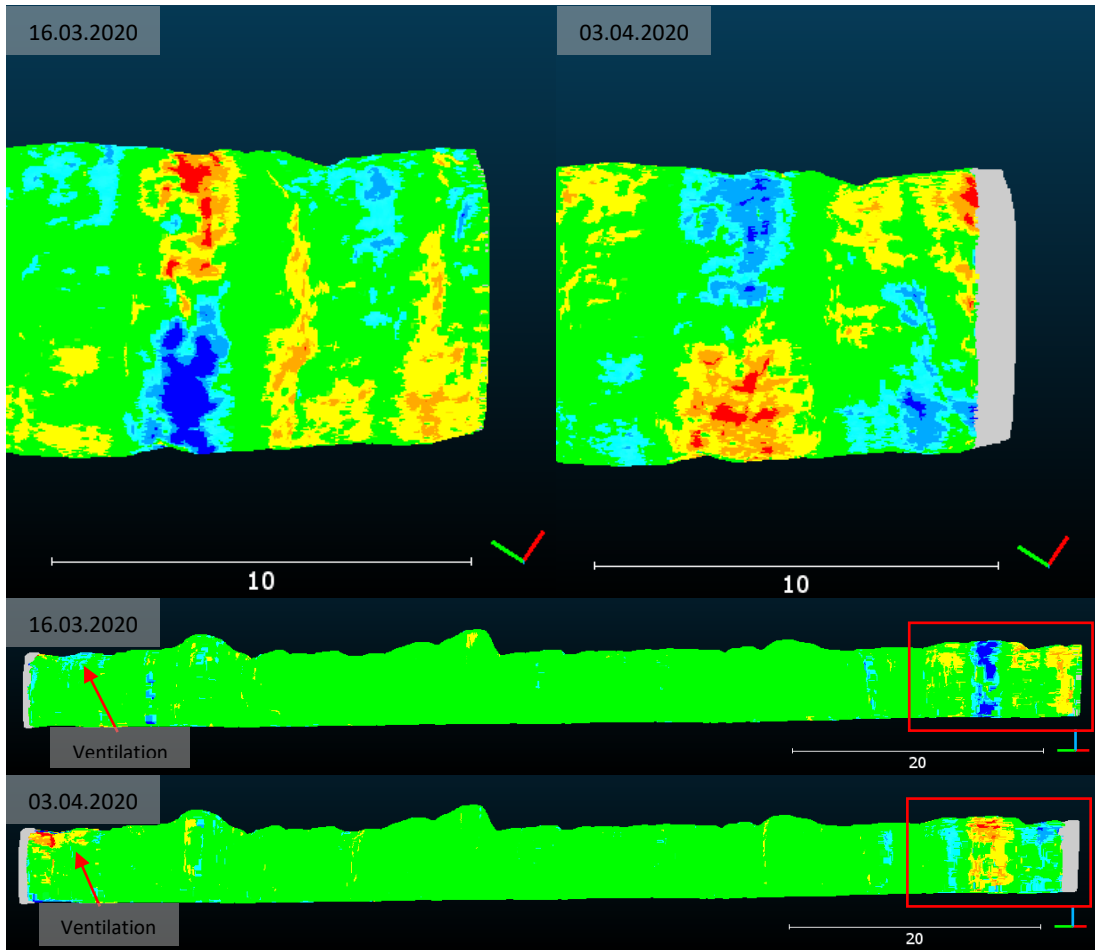
Figure 59: AL1082o2780 convergence monitoring with scan from 26.02.2020 & convergence-divergence error, squares indicate error bands at the end of the drift (CloudCompare)
