ASSESSMENT OF THE LONG-TERM
PERFORMANCE OF GFRP BARS SUBJECTED TO
DIFFERENT ENVIRONMENTAL EXPOSURES
UNDER HIGH SUSTAINED LOADS

Thèse de doctorat
Spécialité : génie civil

Yasin ESMAEILI HESAR

Sherbrooke (Québec) Canada
janvier 2021

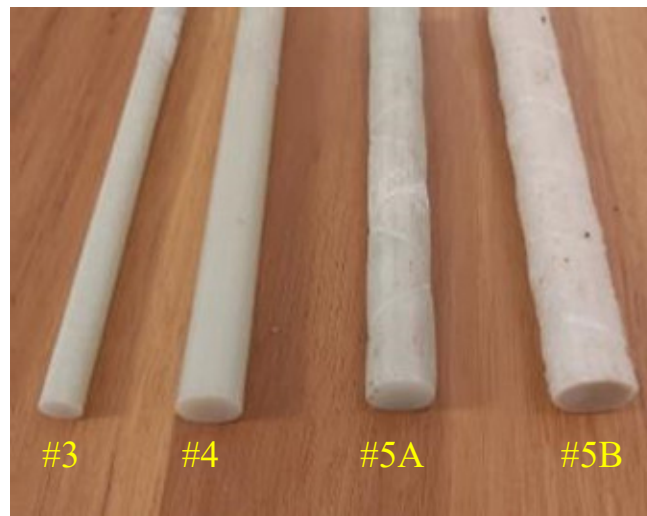
Fig. 3-1. GFRP bars used for creep rupture tests.

The creep rupture test specimens included three different bar sizes #3, #4 and #5 (diameters of 10 mm, 13 mm, and 16 mm, respectively). Two types of #5 GFRP bars were used in this study with different constituent materials and fiber contents. Type A was sand coated with a helically wrapped surface, while Type B was helically grooved, as shown in Fig. 3-1. On the other hand, the #3 and #4 GFRP bars had a smooth surface. The bars were manufactured according to a pultrusion process and were comprised of vinyl-ester resin and E-CR glass fibers meeting the requirements of ASTM D578 (ASTM 2018). The physical and mechanical properties of the specimens and the pertained testing method are presented in Table 3-1. The properties in Table 3-1 were measured for five different replicates cut from the bars based on the test requirement. Generally, the physical and mechanical properties of the GFRP bars were following the requirements of ASTM D7957 (ASTM 2017) and CSA S807 (CSA 2019b) specifications. Table 3-1 shows that the GFRP had various tensile strength and modulus, ranging between 1123-1670 MPa and 51-69.2 GPa, respectively.

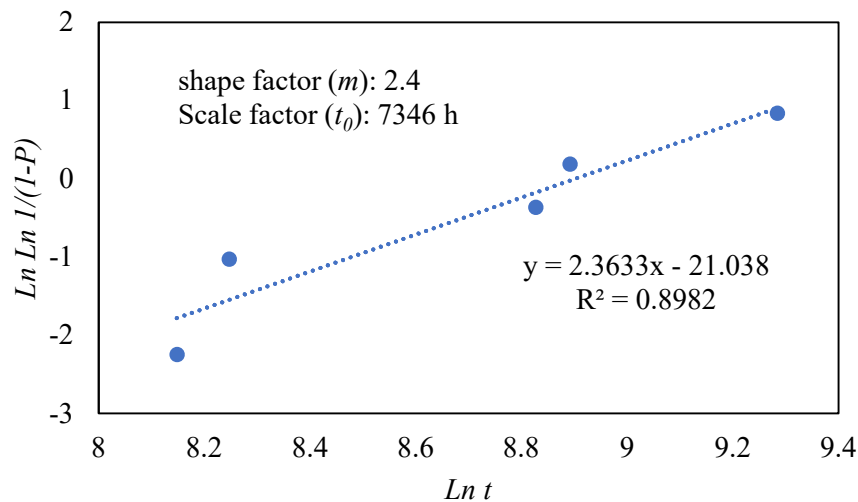
Fig. 3-3. Weibull distribution parameters for a #3 bar subjected to Group A conditioning at 60% sustained load.

Determining the Weibull parameters on the basis of creep rupture requires transforming Eq. (1) into a graph with the x - and y -axes representing $\ln(t)$ and $\ln \ln[1/(1-P)]$, respectively, where the distribution equation appears as a straight line with a regression line. Therefore, the slope of the bar determines the shape factor (m) and the intersection of the regression line with $\ln(t)$ equates t_0 . Fig. 3-3 explains this transformation and determination of the Weibull parameters, for instance, for a #3 bar at 60% stress level under Group A conditioning.

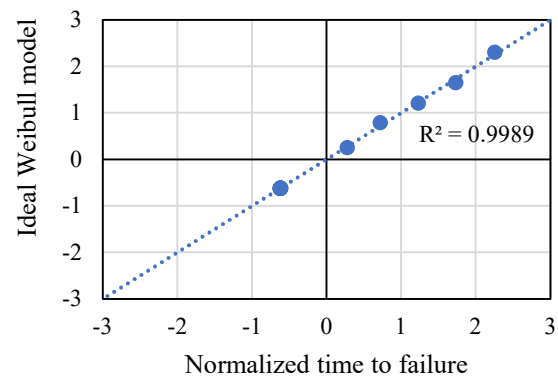
Fig. 3-6. Actual time to failure fitting to Weibull model for a) bar #3, b) bar #4, c) bar #5A, d) bar #5B, subjected to conditioning type A

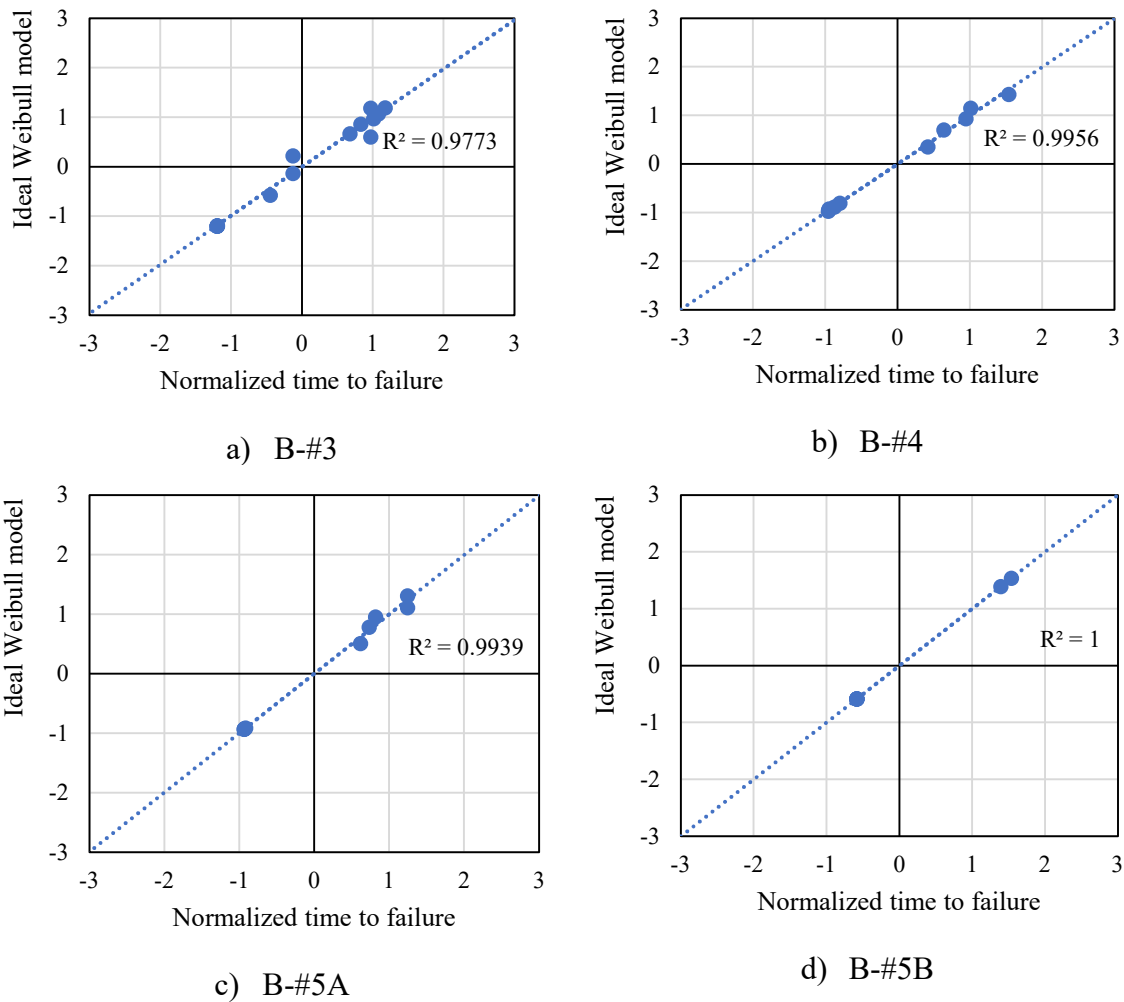
Fig. 3-8. Actual time to failure fitting to Weibull model for a) bar #3, b) bar #4, c) bar #5A, d) bar #5B, subjected to conditioning type B.

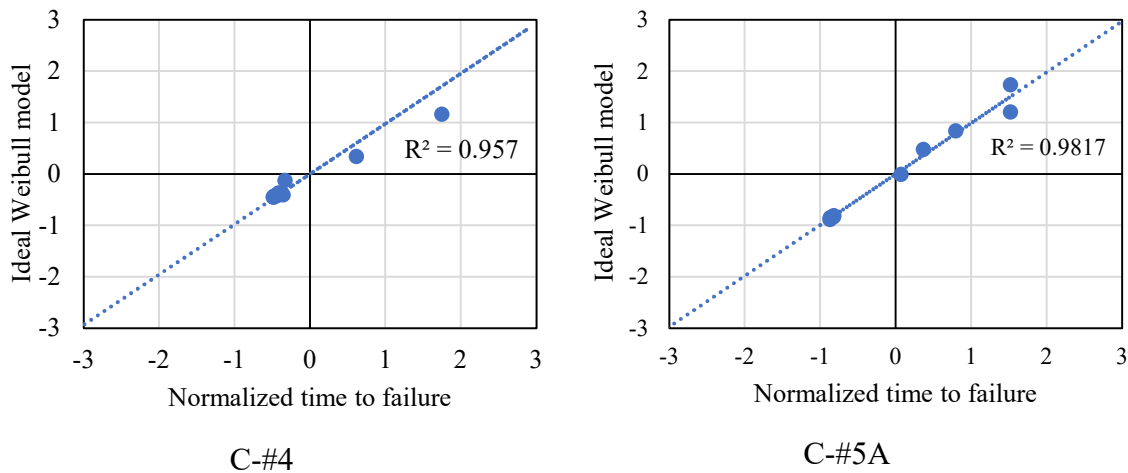
Fig. 3-10. Actual time to failure fitting to Weibull model for a) bar #4, b) bar #5A, subjected to conditioning type C.

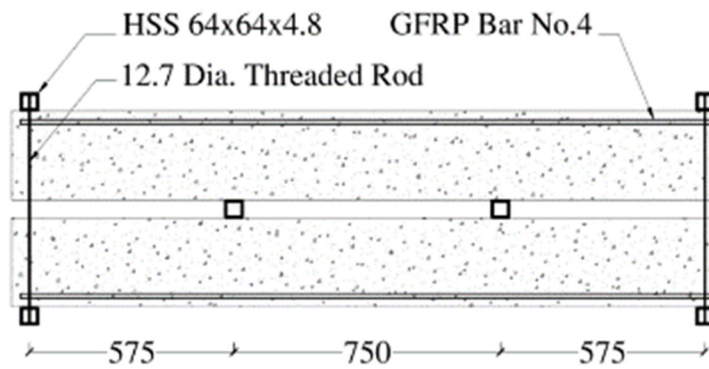
**Fig. 4-3. Apparatus used to apply the sustained load (all dimensions are in mm)**

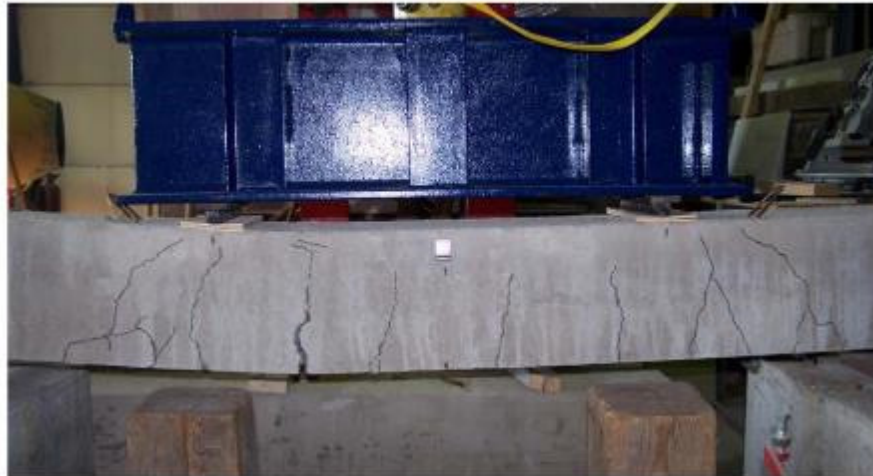
Fig. 4-7. Typical failure of the unconditioned beams

After testing, the results of the conditioned beams were compared to their unconditioned counterparts in terms of flexural behavior, cracking pattern, and failure mode. The conditioned and unconditioned beams have failed with a similar behavior. As anticipated from their initial design, both have indicated a flexural–tension mode. Nonetheless, the crack spacing was found to be negligibly greater (average of 120 ± 30 mm) in the conditioned beams. However, the total number of cracks in both the conditioned and unconditioned beams were identical, as illustrated in Figs. 4-7 and 4-8. This may refer to the adequate bond strength between the GFRP bar and concrete.

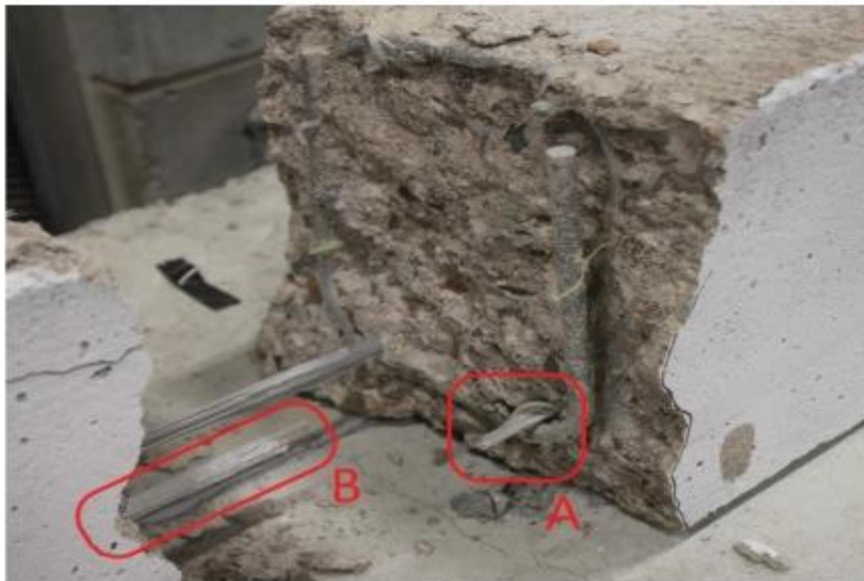
Fig. 4-9. Failure mode of GFRP bars in an aged beam

When GFRP bars are subjected to tensile tests, they usually exhibit a broom-like rupture (Benmokrane et al. 2002b; El-Hassan et al. 2017) due to individual fiber fracture over a large length of reinforcing bar. This is why, with flexural-tension failure of the beams, all the GFRP bars used in the aged beams experienced a different mode of failure with an almost flat fracture surface. The bars marked A and B in Fig. 4-9 are examples of the flat failure mode. A similar failure mode was also reported by Mukherjee and Arwkar (2006) for conditioned GFRP bars. A justification for this phenomenon can be failure over a short

length. When the bars are placed in concrete, a bunch of fibers are ruptured along a certain length by the surrounding concrete, whereas they rupture individually over a longer length during tensile testing.

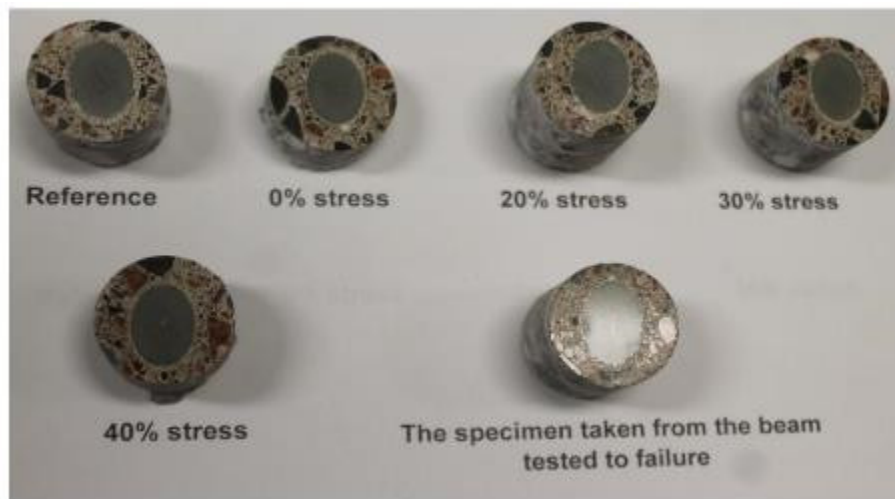
Fig. 4-12. Illustration of drilled samples

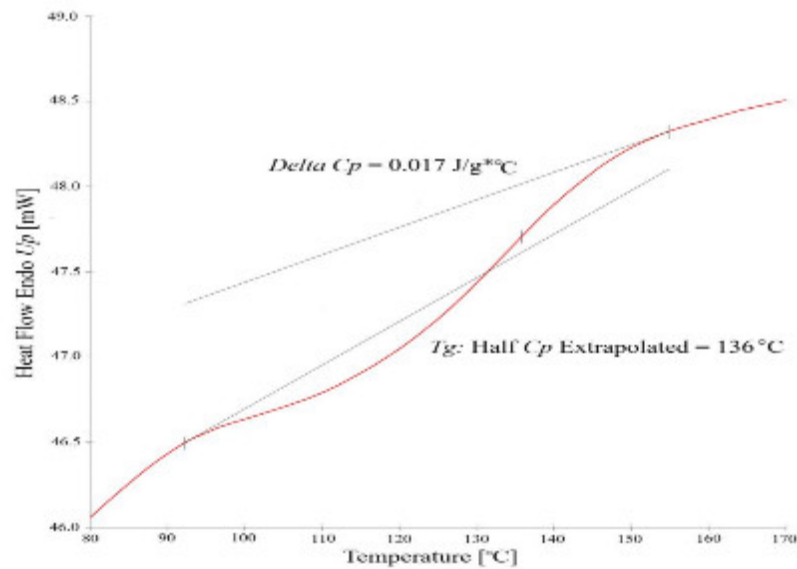
Fig. 4-15. A typical calorimetry curve indicating 100% cure ratio of the GFRP bar

According to CSA S807 (CSA 2019b), the minimum values of T_g and cure ratio are equal to 110°C and 95% for bars with high durability resistance (DI). Considering the obtained results, all of the conditioned and control specimens had shown values higher than the limit requirement of CSA S807 (CSA 2019b). In addition, no sign of post-curing issue was observed, because the resin had been fully cured during the manufacturing process. The T_g value dropped from 136°C for the control specimens to 126.5°C for the conditioned specimens with 40% sustained stress. This decrease (6.9%) in the T_g values of the conditioned GFRP specimens was still very low and cannot be attributed to resin degradation, as proven below with FTIR analysis.

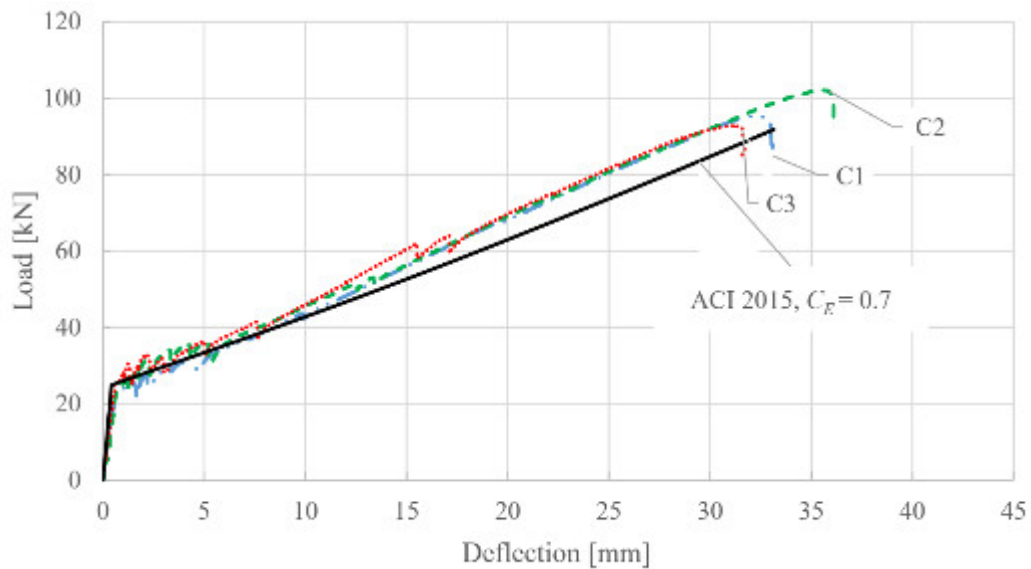
Fig. 4-18. Comparison of the deflection values obtained from experimental tests with those predicted by ACI440.1R (ACI 2015) model for the conditioned beams

Fig. 4-18 compares the distribution of the experimental deflections for all three conditioned beams with those calculated according to ACI440.1R (ACI 2015). Despite some minor discrepancies, the predictions of ACI440.1R (ACI 2015) model fits the curves of the conditioned beams with a reliable accuracy, provided that the environmental coefficient factor is employed in the prediction model.

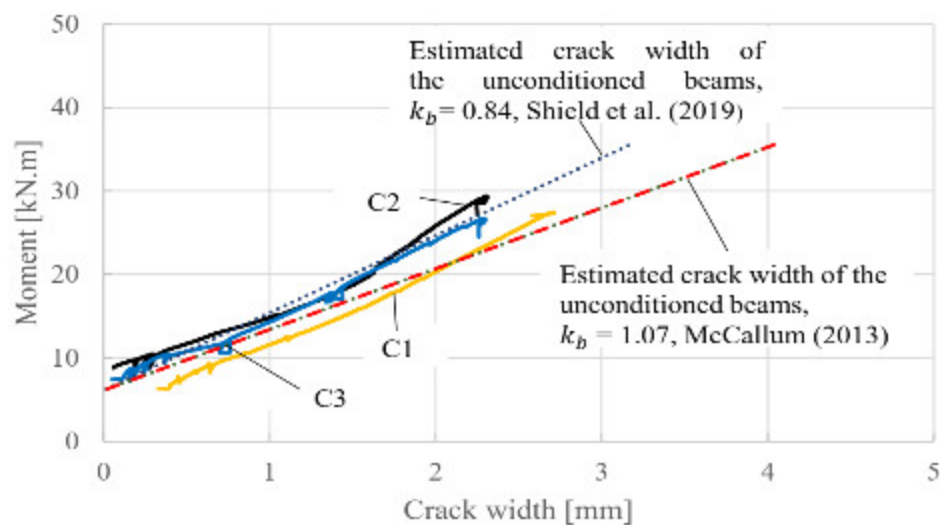
Fig. 4-19. Comparison of the crack widths of the unconditioned beams (calculated values) and the conditioned beams (experimental values)

Fig. 4-19 compares the predicted crack width of the unconditioned beams with those measured during testing of the conditioned beams. Despite some discrepancies that might be attributed to the inherent feature of the concrete and analytical prediction, the crack-width curves of the conditioned beams (C1, C2, and C3) were analogous with the predictions provided by both k_b values adopted.
