ACOUSTIC EMISSION MONITORING OF PREFABRICATED AND PRESTRESSED REINFORCED CONCRETE BRIDGE ELEMENTS AND STRUCTURES

Dryver R. Huston, Principal Investigator
The University of Vermont
College of Engineering and Mathematical Sciences

November 2018

Research Project
Reporting on VTRC 16-3

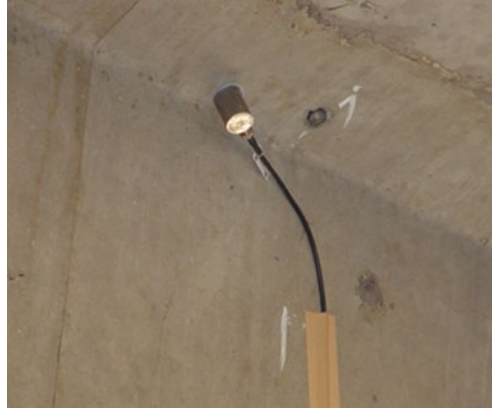
Figure 1.2: Acoustic emission sensor attached to a concrete girder (reference)

Advantages of AE monitoring are: 1. The sensors easily attach to the surface of the structure, are removable and reusable (Figure 1.2); 2. AE can detect, locate and assess subsurface nonvisible cracks; 3. The technology is mature with applications across a variety of structure types, including concrete; 4. Software and data analysis procedures are available for a variety of conditions, including those specific to concrete cracking; 5. AE-based codes, standards, test and continuous monitoring procedures (ASME, RILEM, ASTM), have been in place since the 1980s (Huang and Nissen, 1997); and 6. Certain industries, in particular pressure vessel manufacturing, use accept/reject criteria based on the level of AE signal production. The pre-stressed character of pressure vessels and pre-stressed girders are similar enough to lend credence to the possibility of developing similar accept/reject criteria for girders.

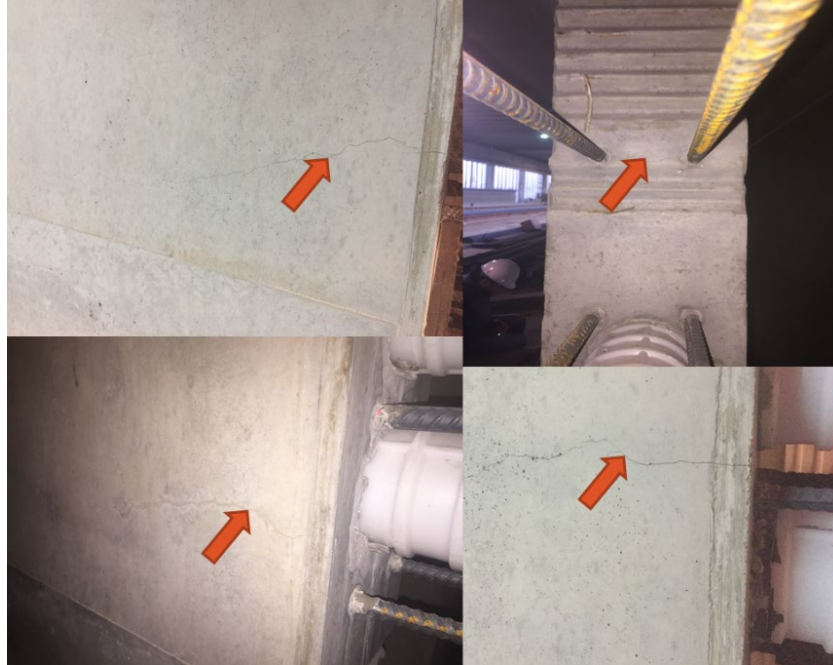
Figure 1.3: Recorded end zone cracking of bulb tee

The three major types of characteristic end zone cracking appearing in NEXT beams and NEBT girders include; horizontal web cracking, inclined web cracking, and Y cracking. Eccentric loading is a common source of horizontal web cracking. Pre-tensioning strand distributions are typical sources of inclined web cracking and Y cracking. Both horizontal and inclined web cracking are typically small enough that they close under service loading. Y cracking does not normally close under service loading and therefore has the greatest potential for durability issues (Okumus and Olivia, 2013). Figure 1.3 shows examples of horizontal web cracks observed during this study.

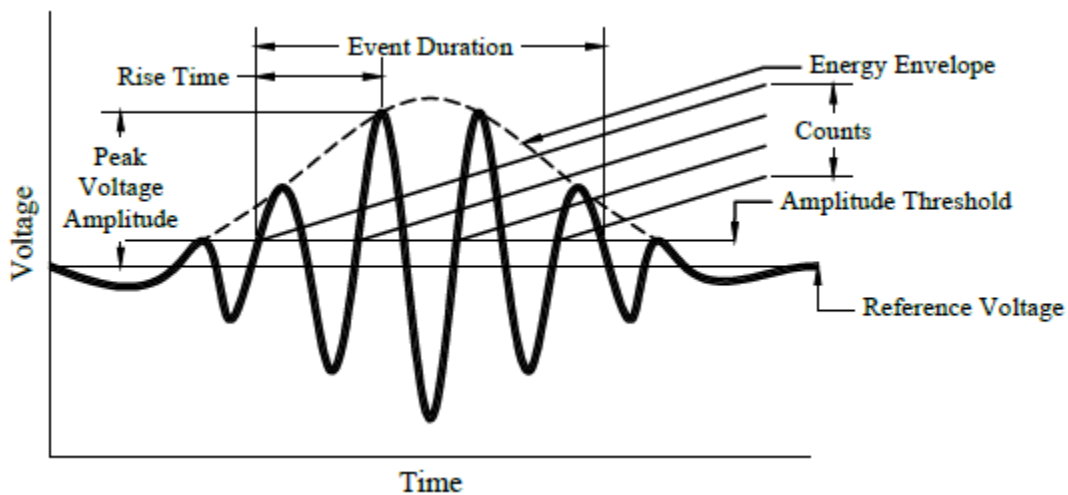
Figure 2.10: Parametric analysis of typical measured waveform features

The AE signals carry additional information beyond TOA, largely in the detailed shape of the waveform. Such information correlates to the details of the AE source and the path traveled. There are two main types of AE source differentiation techniques (Kaphle, 2012b). The first is a feature-based analysis where an analysis of the specific waveform extracts and records a set of features, also known as parameters, describing the wave form. Typical features include amplitude, duration, counts-to-peak, and peak frequency as illustrated in Figure 2.10. Others are available. Subsequent processing of waveform features extracts information.

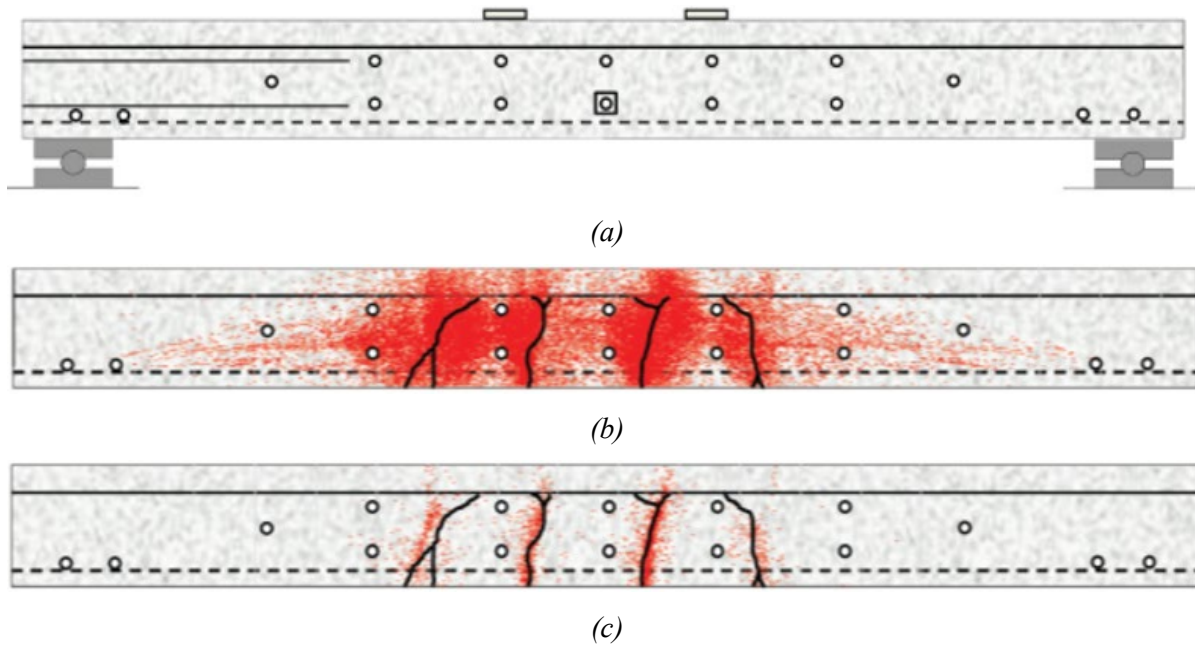
Figure 2.12: AE event amplitude and duration filtering for crack correlation (a) laboratory beam and AE sensor array, (b) unfiltered AE event location, and (c) filter AE event locations correlated to observed cracking (ElBatanouney et al., 2014)

A study by ElBatanouney et al., 2014, used an amplitude and duration filter to eliminate AE events not correlated to crack formation during a laboratory test of cyclically loading a reinforced concrete beam to failure. Figure 2.12 shows how a careful choice of filter settings can reduce AE event location estimates from a diffuse swath of points centered on the cracks, Figure 12.b, to a smaller set of points that provide a superior alignment with the observed cracks, Figure 12.c.

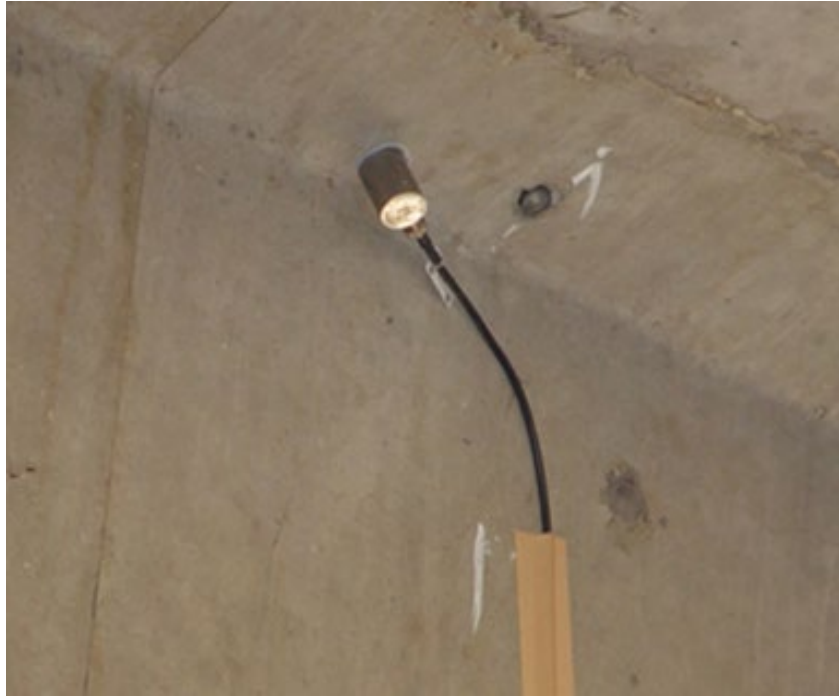
Figure 3.1: Acoustic emission sensor attached to a concrete girder (Figure courtesy Mistras Group)

The goal is to select an instrumentation package to measure the occurrence and location of cracking in prefabricated and pre-stressed bridge girders during fabrication and during transport to bridges sites. AE testing is the primary measurement technique. The method attaches sensors onto the surface of the girder with adhesives, connects the sensors to the data acquisition unit with coaxial cables and collects data continuously throughout the cycle. Figure 3.1 show a typical sensor installation.

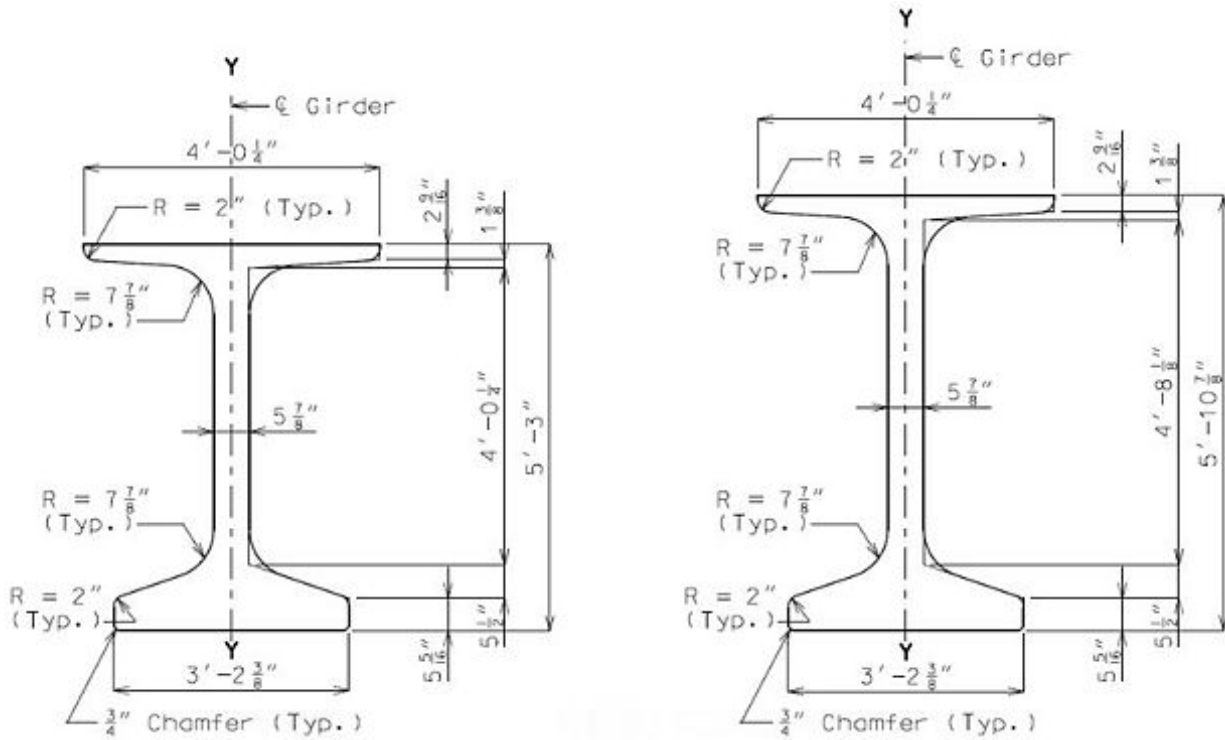
Figure 4.1 Typical Bulb Tee cross-section shapes for use in pre-stressed concrete girders (MoDOT, 2018)

Figure 4.1 shows the cross section of a pair of typical bulb tee girders. The actual girder to be instrumented remains to be determined. This will also affect mounting details. Figure 4.2 shows the AE system on top of a girder. Figure 4.3 shows how an array of AE sensors would detect an incipient crack. Precise timing combined with triangulation methods produce the location estimate.

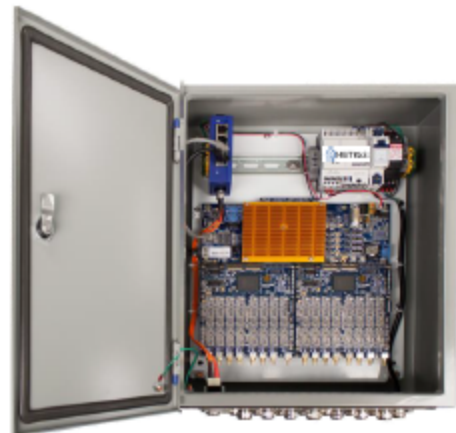
R6IC LP-AST Sensor with weather resistant coating.

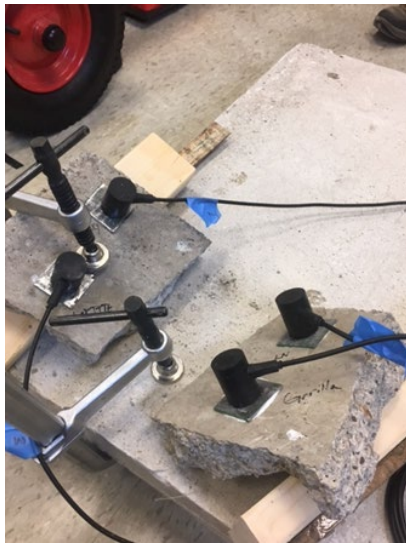
Figure 4.9: Fracture test of small concrete slab: (a) broken slab, (b) test results with transducer location (green dots) and estimated damage location (red dots)

5. **Concrete slab fracture** – This damage test applied a 3-point bending load to a small concrete slab, using a screw-driven adjustable length wood clamp. The slab contained no reinforcing and broke suddenly. This is a failure mode that should not occur often in transportation structures with conventional reinforcing, but nonetheless provided some useful data, including the detection of precursor microcracking before the major cracking, Figure 4.9.

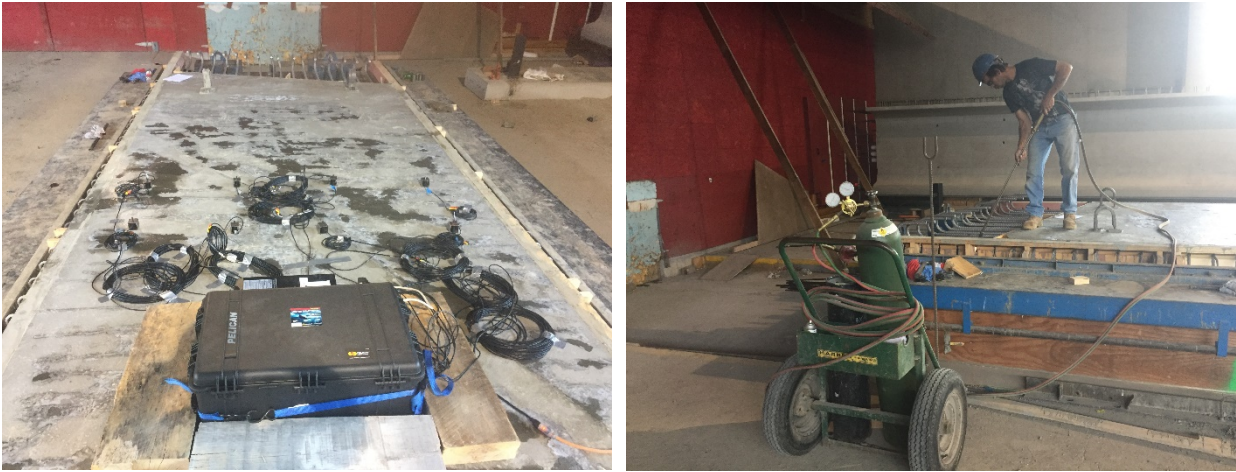
Figure 6.1: NEXT beam field testing of detensioning with 38 recorded events (a) field testing equipment setup, (b) torch cutting of pre-tensioning strands, (c) plan view of AE events on NEXT beam, (d) section view of NEXT beam, and (e) profile view of NEXT beam

The instrumentation recorded 38 AE events during the detensioning process as illustrated in Figure 6.1. The torch cutting of pre-stressing strands was synchronized to cut wires from the same strand simultaneously on each side of the NEXT beam in a gradual process that sequentially releases the entire tension within that strand and transferring the load into the beam. The strand cut sequence followed a pattern that alternated sides of the beam cross section in an effort to balance the load transfers, in a manner similar to the pattern used to tighten wheel lug nuts. The loading exerted on the beam by strand cutting was less dynamic than originally anticipated, primarily due to the slow cutting of individual wire within the strands releasing only a relatively small amount of energy per cut. The recorded AE events tended to occur closer to the end of the NEXT beam with multiple events stacked onto one another and occurring along the underlying integral girder containing the tensioning strands.

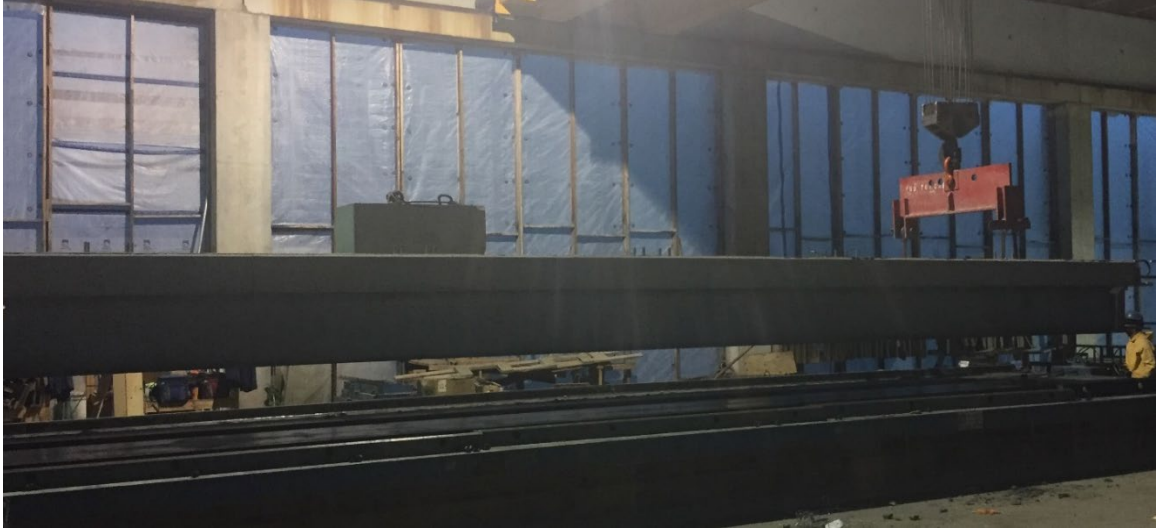
Figure 6.2: NEXT beam field testing of craned form removal with 20 recorded events (a) crane lifting, (b) plan view of AE events on NEXT beam, (c) section view of NEXT beam, and (d) profile view of NEXT beam

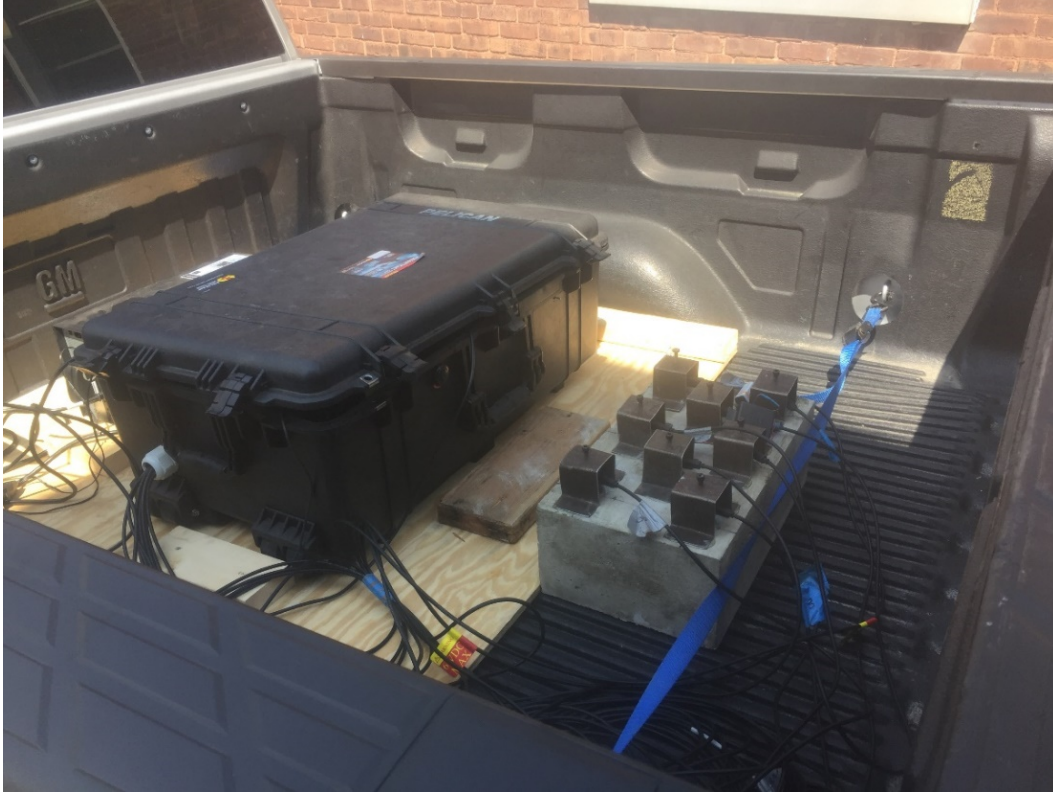
Figure 7.1 Pilot transport test AE equipment set-up

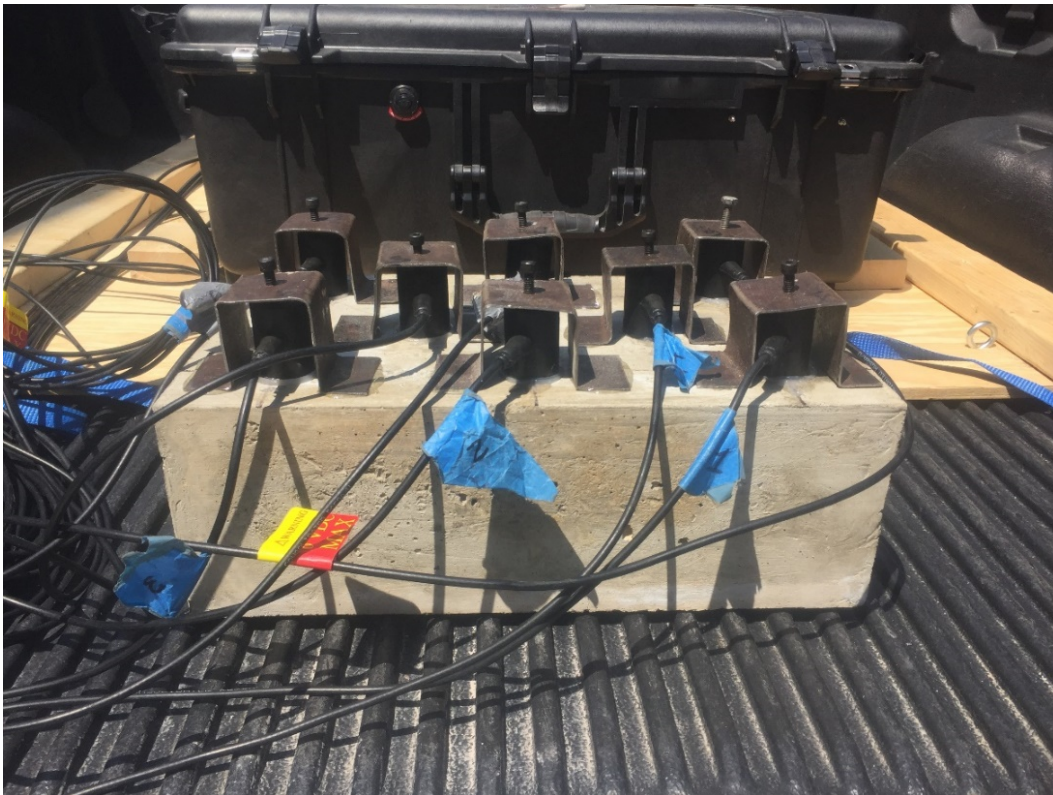
Figure 7.2 AE sensor connection to concrete block with U-shape brackets

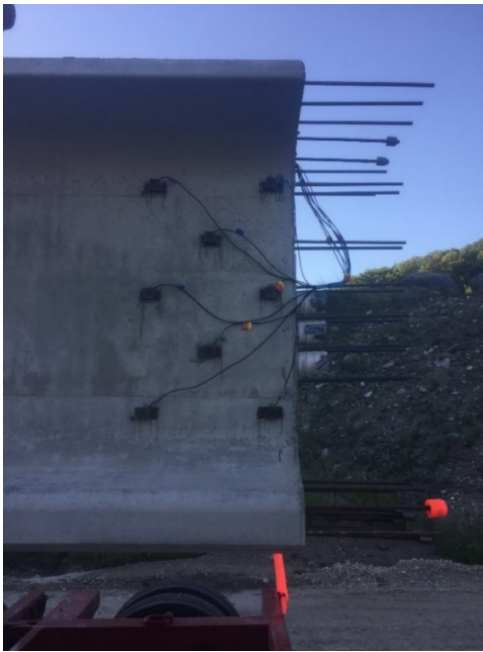
Figure 7.5: Transport Test 1 – AE measurements of the end zone vertical web of a straight NEBT during transport with 673 recorded AE events. (a) Photograph of 2-D sensor array, (b) Photograph of equipment set-up, (c) Cross-section of NEBT tested, (d) Profile view of NEBT including AE event locations, sensors, and observed cracks.

AE event monitoring of the end zone of a straight section of a NEBT proceeded over the course of roughly 160 miles (258 kilometers) in transport from the fabrication location to the installation location. **The number of recorded AE events totaled 673.** Figure 7.5 shows the spatial distribution. The AE events tended to occur in the upper half of the web section of the NEBT. Figure 7.6 shows the recorded AE events from Figure 7.5 plotted by amplitude, with a coding by dot size and color. The amplitude plot of AE events show a weak clustering pattern between AE events of different amplitudes but there appears to be small pockets of low amplitude AE event clusters near the top of the beam. Travel along a secondary highway (US 7) from Middlebury, VT to Burlington, VT produced events at a higher rate than along the interstate (I-89 and I-91) from Burlington, VT to Rockingham, VT, Figure 7.4. An examination of the NEBT girder following transport found no new cracks and no new growth of the existing cracks.

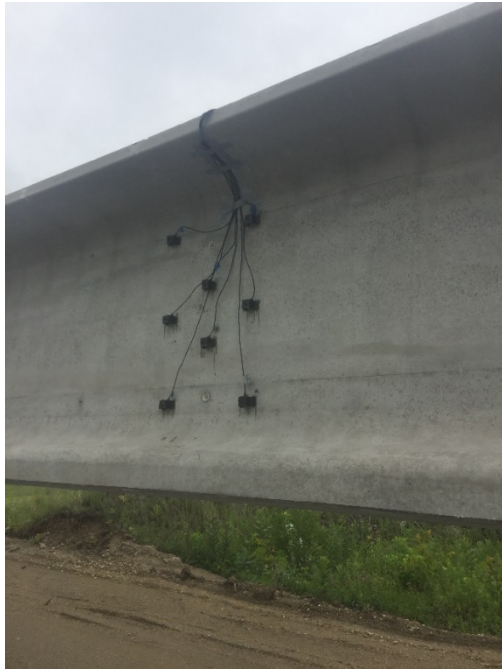
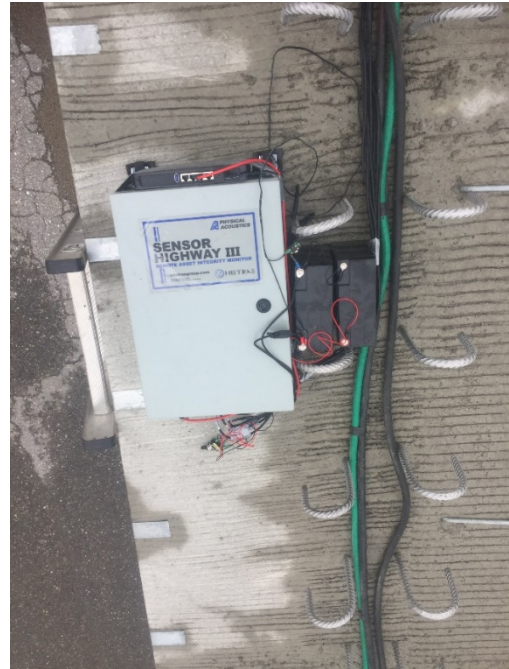
Figure 7.10: Transport Test 2 – AE measurements of the mid-span vertical web of a straight NEBT during transport with 2,628 recorded AE events. (a) Photograph of 2-D sensor array, (b) Photograph of equipment set-up, (c) Cross-section of NEBT tested, (d) Profile view of NEBT including AE event locations, sensors, and observed cracks

The sensor configuration of the second transport test was a 2-D planar triangular grid array placed mid-span of the straight section NEBT, Figure 7.10. **The number of recorded AE events totaled 2,628.** The recorded AE events tended to occur in the upper half of the web section of the NEBT. Travel along a secondary highway (US 7) from Middlebury to Burlington produced events at a slightly higher rate than along the interstate (I-89 and I-91) from Burlington to Rockingham, Figure 7.4. Visual observation found that no new cracks formed and the existing cracks did not grow during transport.

Figure 7.11 shows the recorded events of Figure 7.10 plotted by amplitude coded as dot size and color. The amplitude plot of AE events show a clustering of medium medium-high amplitude AE events (yellow: 80dB – 89dB) in the upper right portion of the NEBT girder with a high concentration of low amplitude (blue: 60dB – 69dB) and medium-low amplitude AE events (green: 70dB – 79dB) AE events are concentrated in the upper third of the NEBT girder. High amplitude AE events (red: 90dB – 99dB) are infrequent and not clustered, but diffuse, in location.

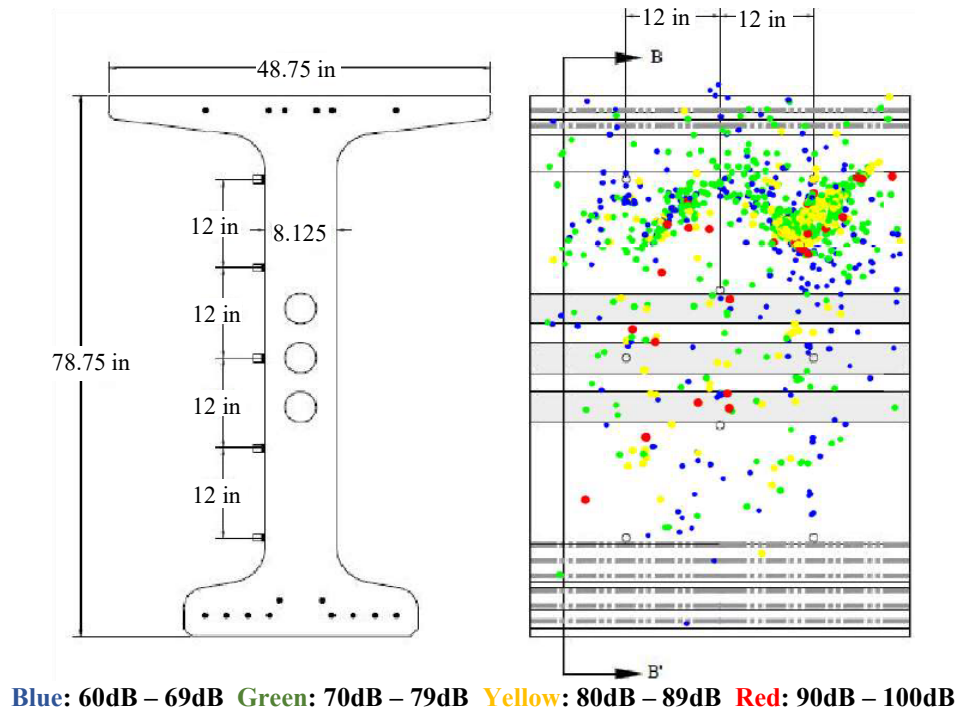
Figure 7.11: Transport Test 2 – AE measurements plotted by amplitude of the end zone vertical web of a straight NEBT during transport with 2,628 recorded AE events.

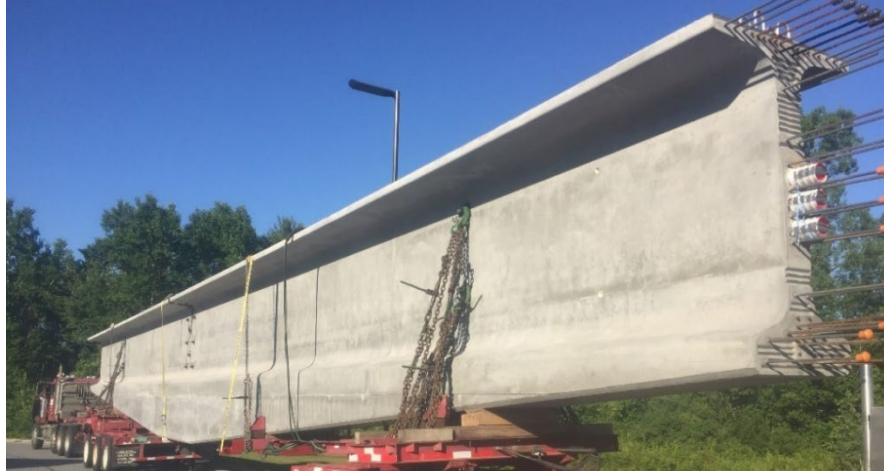
Figure 7.17: Transport Test 3 – AE measurements of the mid-span vertical web of a hammerhead NEBT during transport with 91,723 recorded AE events. (a) Photograph of girder on truck with 2-D sensor array and equipment set-up, (b) Mid-span cross-section of tested NEBT, (c) Profile view of NEBT including AE event locations and sensors. Note that the post-tensioning strand ducts are at a higher location in the mid-span cross sections of (b) and (c) than at the end zone as shown emerging from the end of the section face in (a).

The monitoring of the middle region of a hammerhead NEBT ran over the course of roughly 160 miles (258 kilometers) in transport from the fabrication location to the installation location. **The number of recorded AE events totaled 91,723.** The recorded AE events tended to occur in the lower two thirds of the web section of the NEBT modeled. Travel along a secondary highway (US 7) from Middlebury to Burlington produced events at a slightly higher rate than along the interstate (I-89 and I-91) from Burlington to Rockingham, Figure 7.4. A visual observation of the girder found no new cracks or growth of existing cracks during transport.

The recorded AE events are depicted in Figure 7.17 were also plotted by amplitude as shown in Figure 7.18. The amplitude plot of AE events shows a high concentration of low amplitude (blue: 60dB – 69dB), medium-low amplitude (green: 70dB – 79dB), and medium-high amplitude AE events (yellow: 80dB – 89dB) AE events in the “belly” of the NEBT girder with high amplitude (red: 90dB – 99dB) AE events being limited in quantity and diffuse.

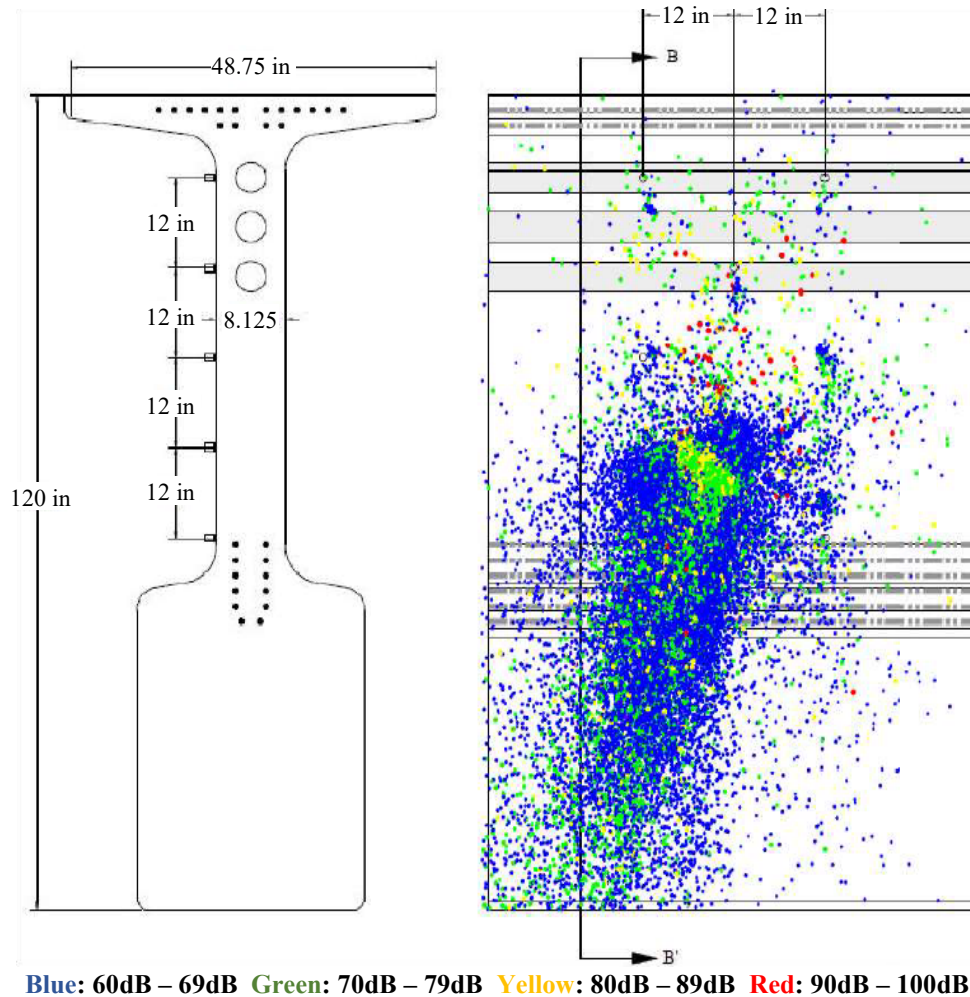
Figure 7.18: Transport Test 3 – AE measurements plotted by amplitude of the end zone vertical web of a straight NEBT during transport with 91,723 recorded AE events.

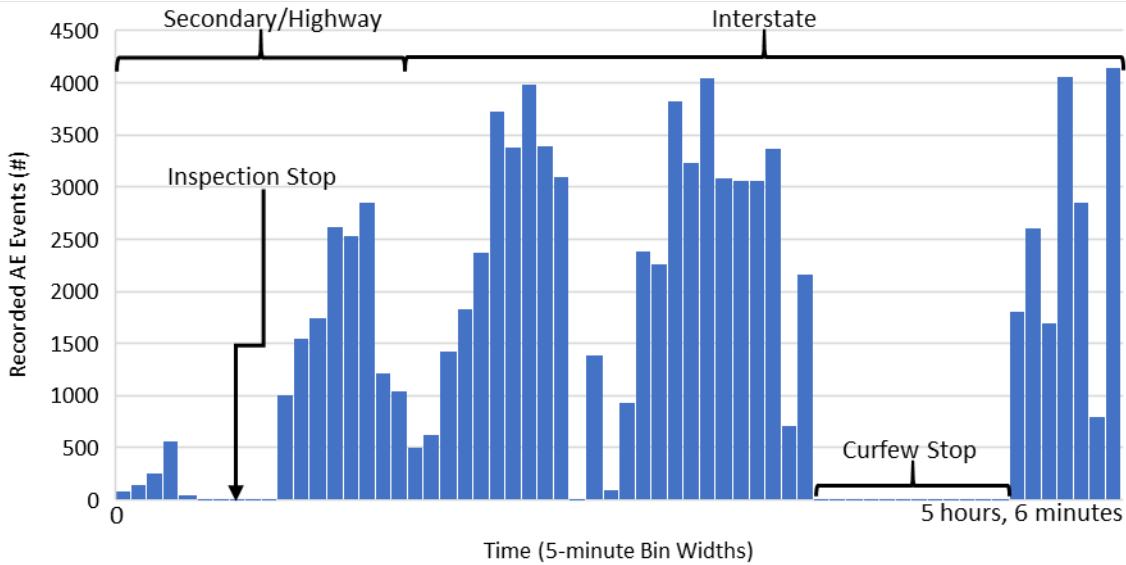
Figure 7.19: AE event density during transport testing of middle zone region of hammerhead NEBT, with a total event count of 91,723

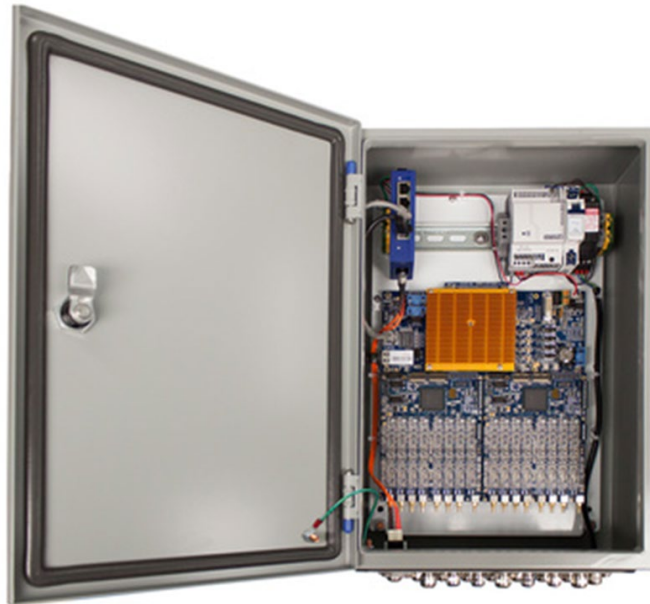
Figure 9.2: Mistras AEwin™ Sensor Highway III (Physical Acoustics, 2018)

The AE monitoring equipment used in this study was an 8-Channel Mistras AEwin™ Sensor Highway III monitoring system, associated AEwin™ processing software, and an eight PK6I sensor array. The design and configuration of this measurement system is for field testing of civil infrastructure. The setup and selection followed the manufacturers' recommendations and ASTM standards (ASTM E1316-18a, 2018; ASTM E3100-17, 2016; Physical Acoustics, 2018). The PK6I sensor is a medium-frequency, resonant AE sensor with an integral, ultra-low noise, low-power, filtered 26 dB preamplifier, which can drive up to 200 meters of cable and operates at a resonant frequency of 60 kHz frequency (Physical Acoustics, 2018). The Mistras AEwin™ Sensor Highway III monitoring system can expand up to 32 high speed AE and over 100 slower speed channels with supplemental transducer. A NEMA-4 enclosure houses the AEwin™ Sensor Highway III, allowing for outdoor use. The system has wireless (WiFi) and Ethernet 10/100/1000 BT communications interfaces. An AE monitoring schematic along with an image of the Mistras AEwin™ Sensor Highway III appear in Figures 9.1 and 9.2. Table 9.1 lists the specific equipment items acquired as part of the Mistras AEwin™ Sensor Highway III system.

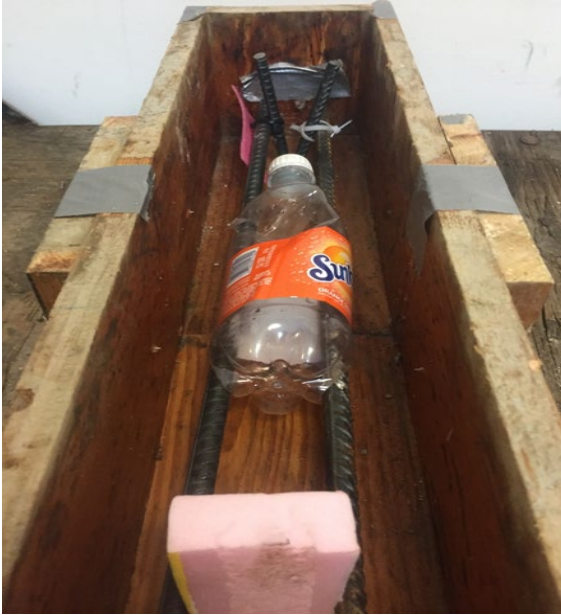
(a)

Proof-of-concept tests determined if in-house AE test equipment could detect voids, using a small reinforced concrete beam ($30 \times 5 \times 5 \text{ in}^3$) with internal voids created with a plastic bottle and Styrofoam inserts, 9.6.a. Frequency sweeps using AE transducers with one operated as an active source and the other operating as a receiver appear as the setup in 9.6.b, data from solid beam 9.6.c and data from section with void 9.6.d. The section with the void sustains a high-frequency standing wave as suggested in 9.5.b. 9.7.a shows the same beam undergoing ground penetrating radar (GPR) tests. The GPR B-scan traces indicate the likely location of a void. A conclusion from this test is that AE and GPR testing can detect this relatively large void. It should be noted that in this case, the GPR does not have to penetrate through a dense mesh of reinforcing, as is common in prestressed girders and is commonly a challenge for GPR imaging.

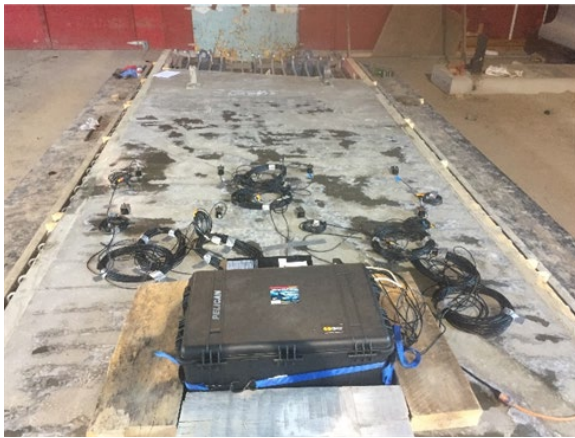
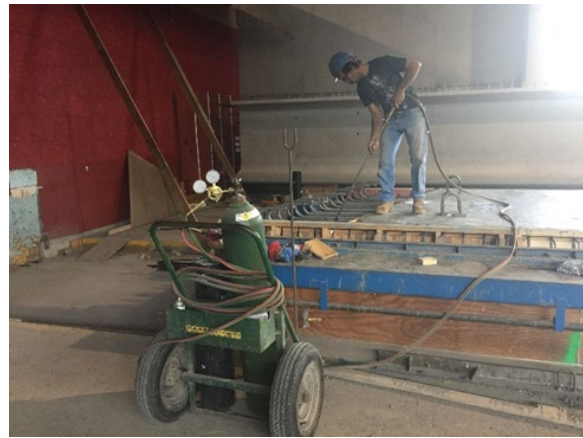
Figure 9.8: NEXT beam field testing of detensioning (a) field testing equipment setup, (b) torch cutting of pre-tensioning strands

Figure 9.8 shows the equipment on top of a NEXT beam in the Carrara fabrication plant, along with the detensioning operation. Figure 9.9 shows the equipment in place and testing of the end of a Northeast Bulb Tee girder.

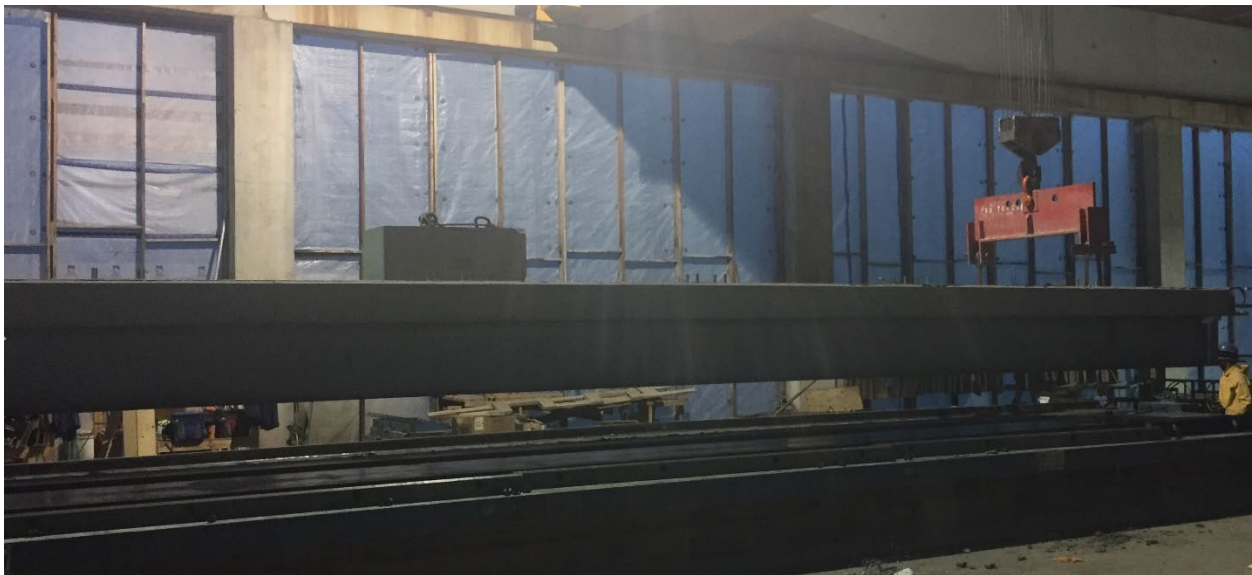
Figure 9.10: NEXT beam field testing of craned form removal

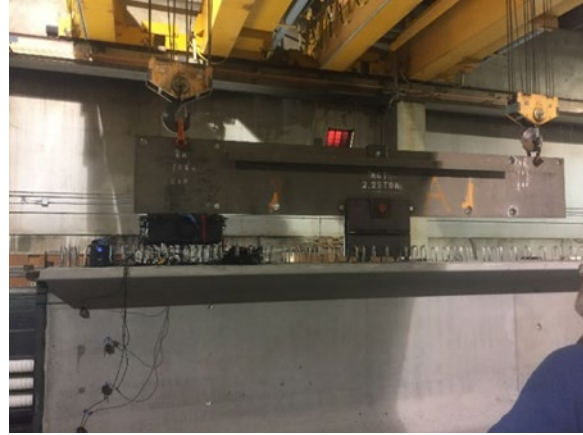
Figure 9.11: Northeast Bulb Tee beam field testing of detensioning (a) AE equipment setup, (b) gantry crane connection to Northeast Bulb Tee

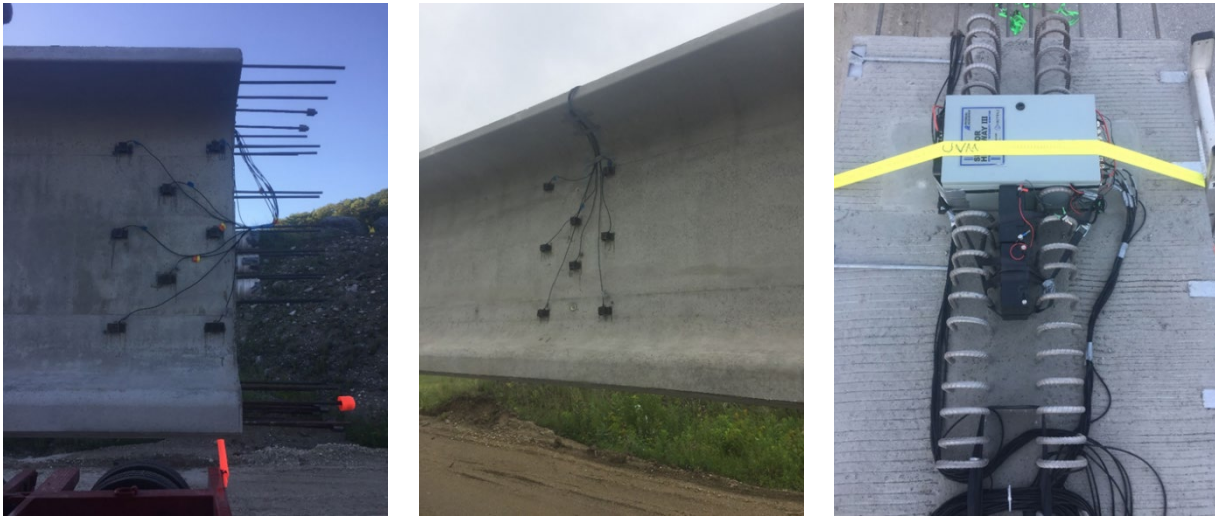
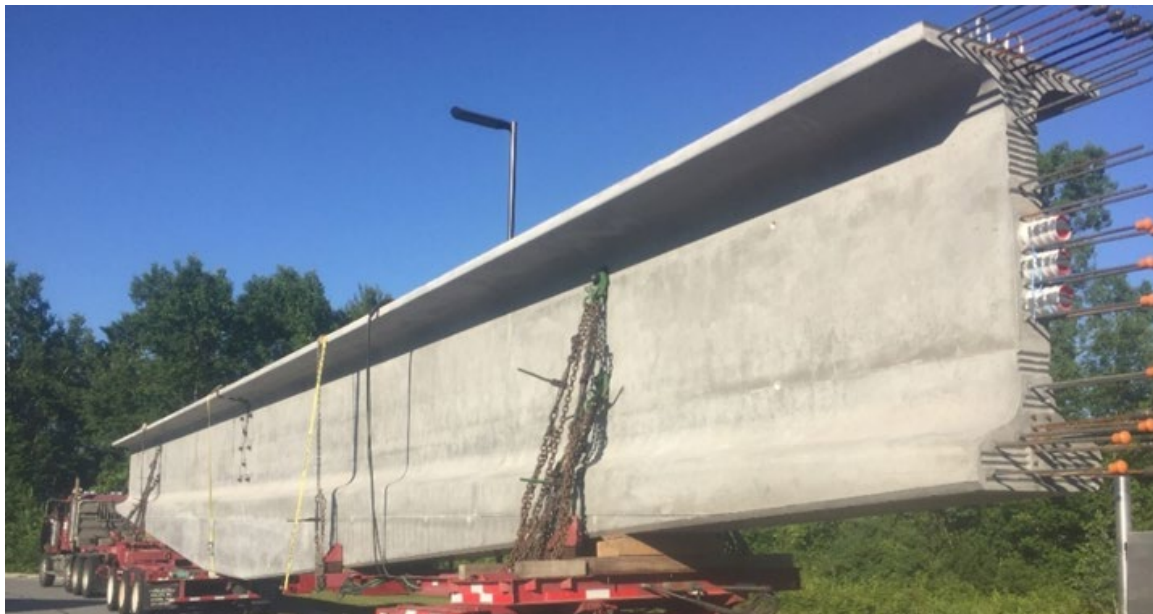
Figure 9.12: Northeast Bulb Tee beam transport testing (a) straight section end zone testing, (b) straight section middle zone testing, (c) AE transport equipment set-up, and (d) hammerhead section middle zone testing

Modifications to both the equipment and attachment procedure mitigated these concerns. The AEwin™ Sensor Highway III which is in an outdoor rated metal housing, was placed directly on the top of the NEBT girder between deck rebar. Gorilla tape secured the wireless router to the outside of the AEwin™ Sensor Highway III. Additional modifications to the AEwin™ Sensor Highway III and wireless router were to receive power from two motorcycle batteries connected in parallel. The placement of this assembly was on top of the NEBT girder using an extension ladder and secured to the NEBT girder with 2-inch wide heavy duty ratchet straps looped all the way around the NEBT girder, Figure 9.12. U-shaped brackets with set screws secured the sensors to the beam by: 1. Adhering the U-shaped brackets to the beam with quick setting epoxy and allowing adequate time to harden; 2. Applying high vacuum silicone grease to the sensor wear plates; 3. Placing the sensors in the U-shape brackets and secured with a set screw. Zip ties secured excess cable lengths to the exposed rebar on the top of the beam. Placing a waterproof back pack cover

over the AEwin™ Sensor Highway III with wireless router and a tarp over the AEwin™ Sensor Highway III and batteries protected the instruments from rain.
