High Speed Ground Penetrating Radar for Road Pavement and Bridge Structural Inspection and Maintenance

Final Report

Project Number: SPR-RSCH017-738

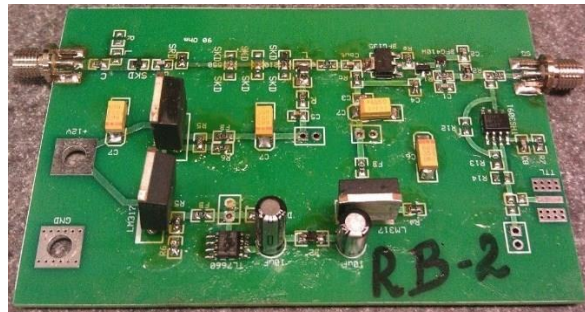
Fig. 3. Pulse generator circuit board

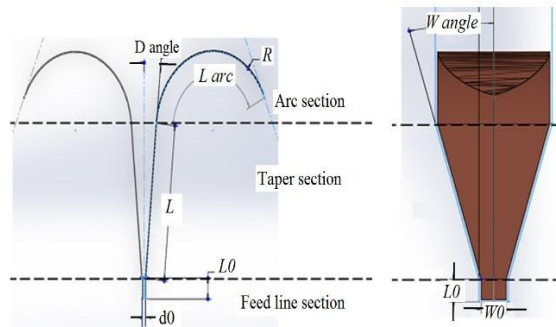
Fig. 5– Top view and side view of the horn antenna

Fig.5 illustrates our developed UWB antenna. As shown, the antenna structure consists of three sections: feed line, waveguide taper segment and a rounded shaped aperture. The feed line and the taper section can be modeled as a series of N parallel-plate transmission line segments. Each segment consists of two metal plates that are separated by a dielectric media with varying width.

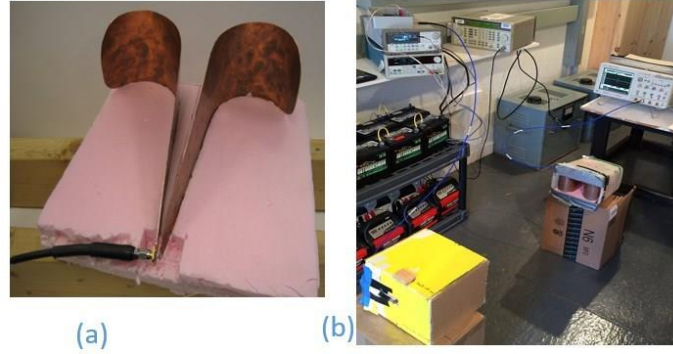
Fig. 8 (a) the fabricated antenna (b) direct pulse signals transmission and receiving

Fig. 8 shows the fabricated antenna and the antenna test setup. While in Fig. 9, both the measured and simulated S11 parameter curves are plotted. As can be observed, the antenna achieves good impedance across a wide spectrum from 600 MHz up to 6 GHz.

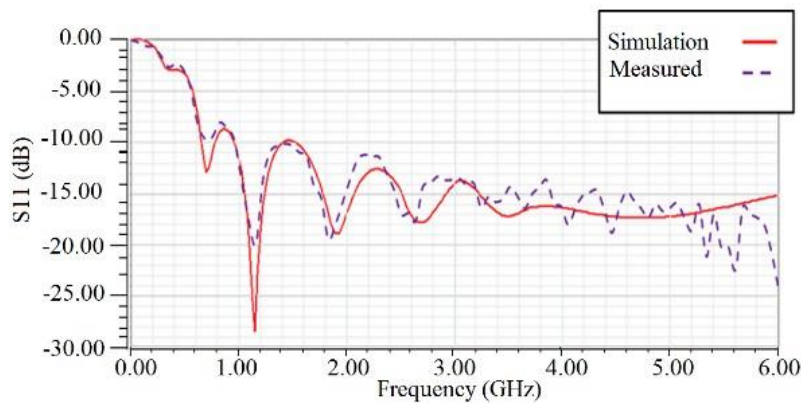
Fig. 9. S11 parameter simulation and measurement

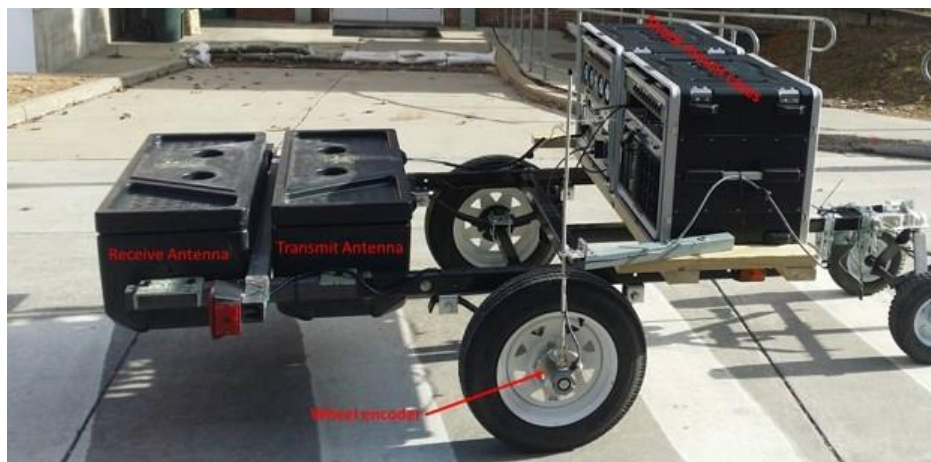
Fig. 10. UVM GPR System mounted on a trailer

As illustrated in Fig. 10 and Fig. 11, the mounting structure for our air-coupled GPR system on a trailer has been developed. Our major design consideration concentrates on system reliability with the following features:

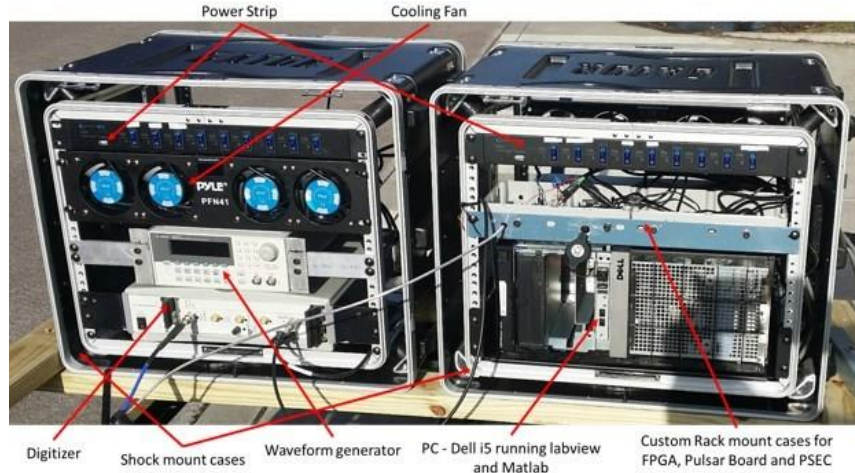
Fig. 11. UVM GPR System integrated into shock mount cases

As illustrated as Fig. 11, all the GPR functional elements are integrated into the shock mount cases: (1) a Radio Frequency (RF) pulsar board; (2) a data acquisition unit comprised of a high-speed real-time digitizer and a high-speed data transmission and storage unit; (3) a multi-core computer; (4) a Field-Programmable Gate Array (FPGA) based digital controller; (5) power strip and cooling fan.

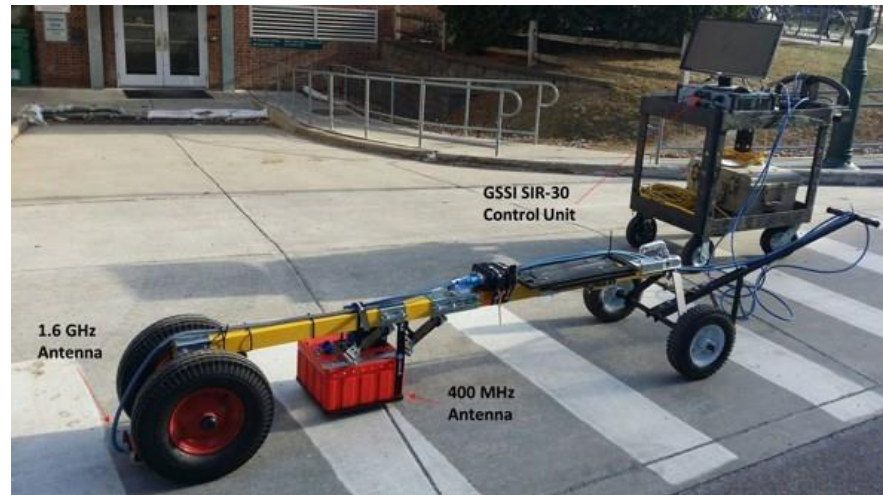
Fig. 12 GSSI SIR-30 dual-antenna installation

For this project, a GSSI SIR-30 GPR was purchased as the reference system. We developed the mounting structure to have two sets of antennas installed, a 400 MHz antenna and a 1.6 GHz antenna. The configuration enables GPR to operate in the dual-channel dual-band operation mode with the wheel encoder trigger. The mounting structures are shown in Fig. 12.

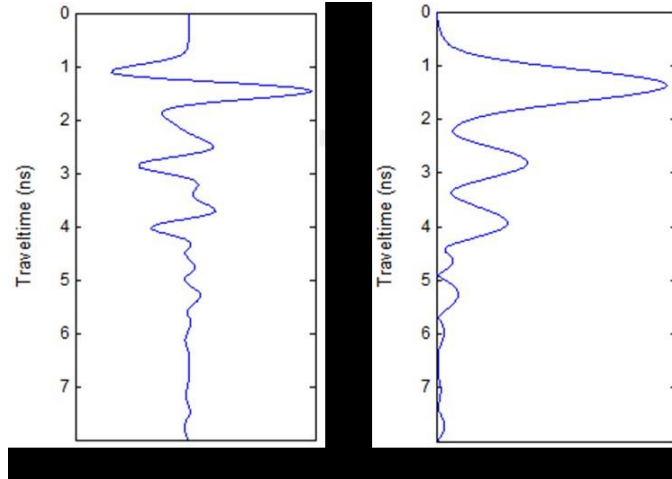
Fig. 13 Hilbert transform for signal power characterization: (a) GPR A-Scan trace; (b) GPR A-Scan envelope.

Fig. 13 demonstrates signal power characterization using the Hilbert transform. The signal in Fig. 13(a) is a GPR A-Scan waveform produced from two scatters. In the A-Scan waveform, the first pulse is the antennas' direct coupling, while the second and third pulses are the reflection signal from the 1st and 2nd scatters correspondingly. The transmitting pulse signal is the Ricker wavelet (the second order derivatives of Gaussian function), the backscattering pulse from each object or layer interface shows three peaks. Fig. 13(b) shows the waveform produced by the Hilbert transform where the three peaks become much more discernible.

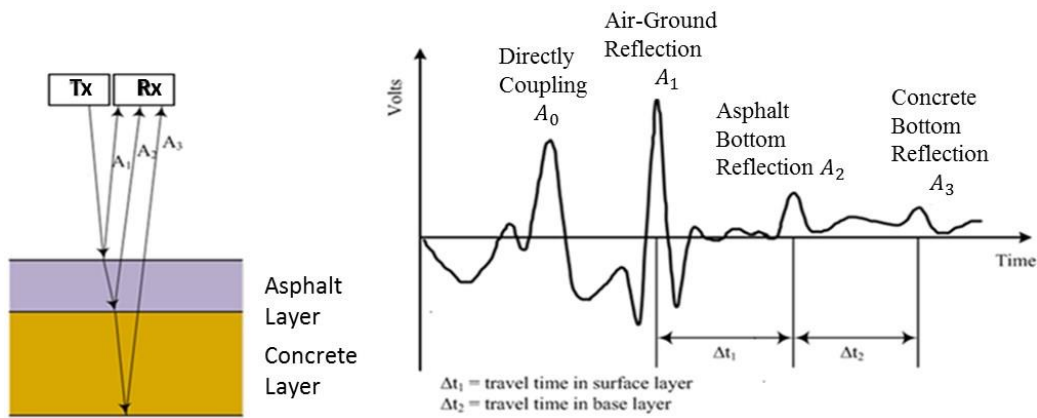
Fig. 14 GPR Asphalt Pavement Test Scenery

Fig. 14 demonstrates the GPR asphalt pavement inspection scenery. The 1st echo in the A-Scan trace shows the antenna directly coupling signal, the 2nd echo is the air-ground reflection signal, and the 3rd echo is the asphalt bottom surface reflection signal. Thus, upon the Hilbert transform processing, the 2nd and 3rd signal peaks are extracted, and the time instances for the 2nd signal peak and the 3rd peak are recorded as t_1 and t_2 respectively

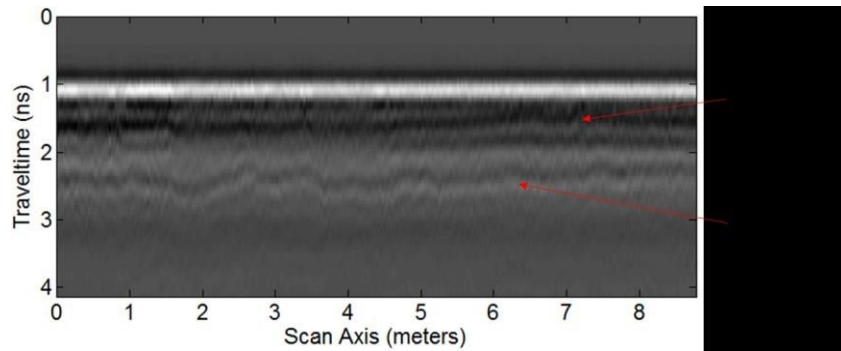
Fig. 16 B-Scan Image for One Scan Line on the 1st Test Site

Fig. 16 plots the B-Scan image for one scan line at the first test site. In the image, the air-ground interface and asphalt pavement bottom surface are marked respectively. The thickness of the asphalt pavement on this scan line is relatively even and smooth. Combining all 7 scan lines, the thickness map for the first test site is plotted in Fig. 17. The horizontal axis in this figure specifies GPR travel distance in the scan direction, while the vertical axis specifies the width of the scanning area. The color-to-thickness mapping is shown on the right. From the thickness map, it is observed that at the center portion of this on-campus driveway, the asphalt pavement thickness is smaller than that the border portion. We think it is because this driveway has a single lane, most traffic loads utilize the center portion of the road, which causes the center portion of the pavement to be thinner.

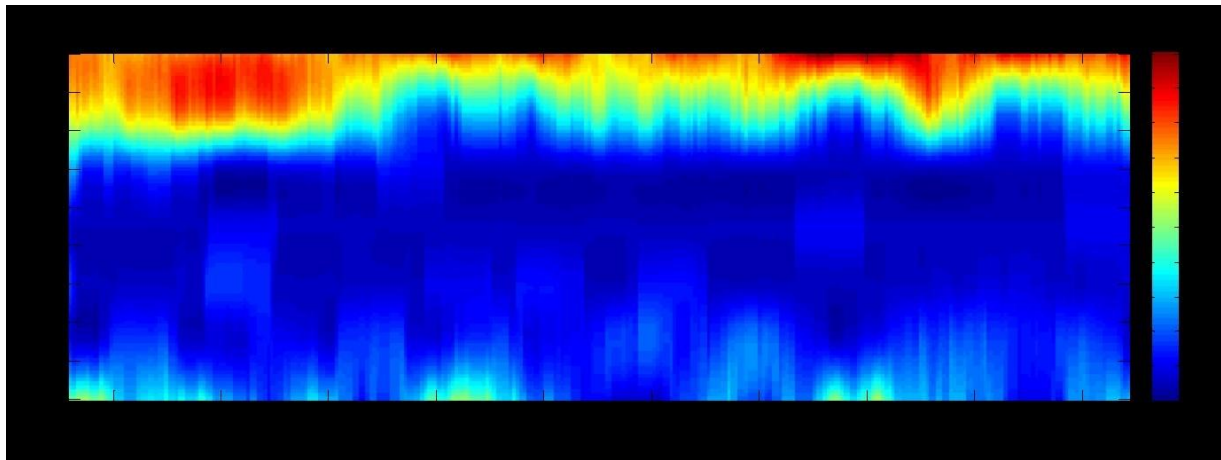
Fig. 17 Asphalt Pavement Thickness Map for the 1st Test Site

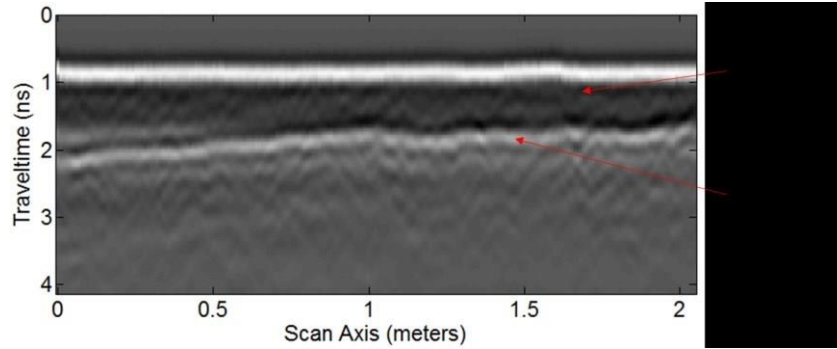
Fig. 18 B-Scan Image for One Scan Line on the 2nd Test Site

Fig.18 plots the B-Scan image for the 2nd GPR scan line on the second test site. The air-ground interface and asphalt pavement bottom surface are marked in the B-Scan image respectively. The thickness of the asphalt pavement on this scan line decreases from the starting point to the ending point. Combining all 5 scan lines, the thickness map is plotted in Fig. 19.

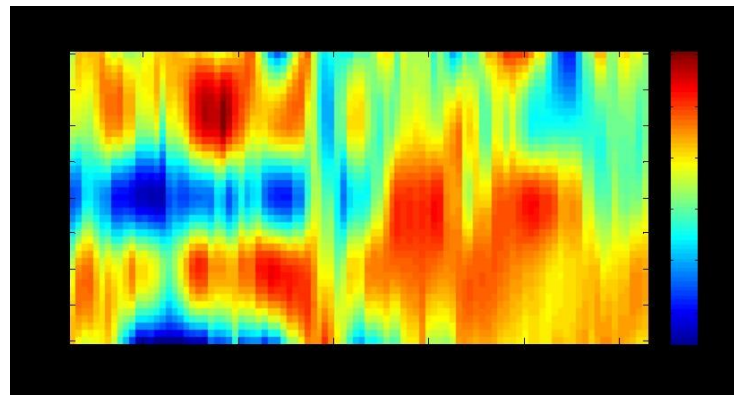
Fig. 19 Asphalt Pavement Thickness Map for the 2nd Test Site

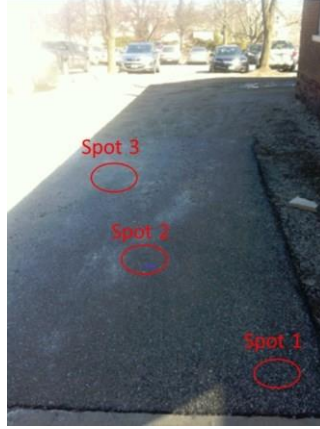
Fig. 20 Asphalt Pavement Dielectric Constant Monitoring Test Spots

In the experiment, three spots on a 2nd on-campus test sites were marked and selected for measurement, which are depicted in Fig. 20. The 1st test spot was located at the border of the road pavement. The 2nd test spot was located at the center portion of the road. This spot has a pit where water was accumulated. The 3rd test spot was also located at the center portion of the asphalt pavement. Two weeks of successive GPR tests on these 3 spots are performed. The dielectric constant for these 3 spots were calculated and recorded after each test. Note, the dielectric constant of water is much higher than the pavement, therefore a higher dielectric constant indicates a higher degree moisture.

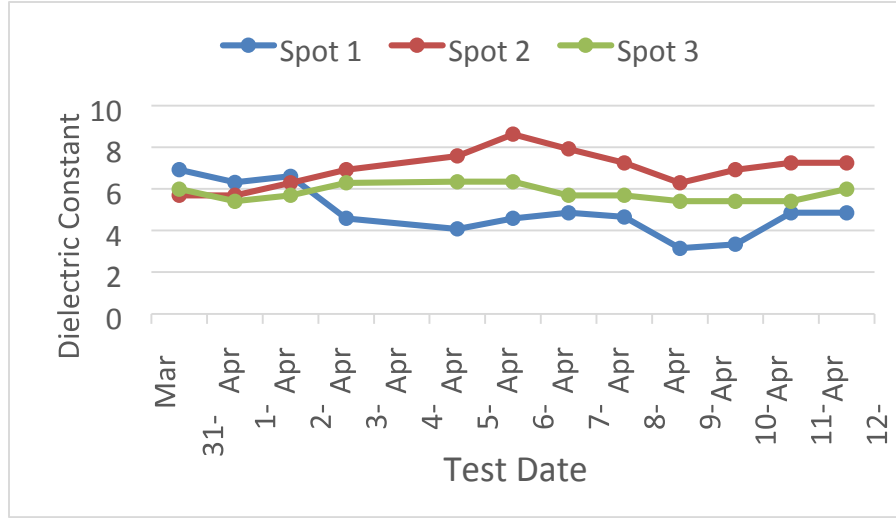
Fig. 21 Dielectric Constant of 3 Test Spots

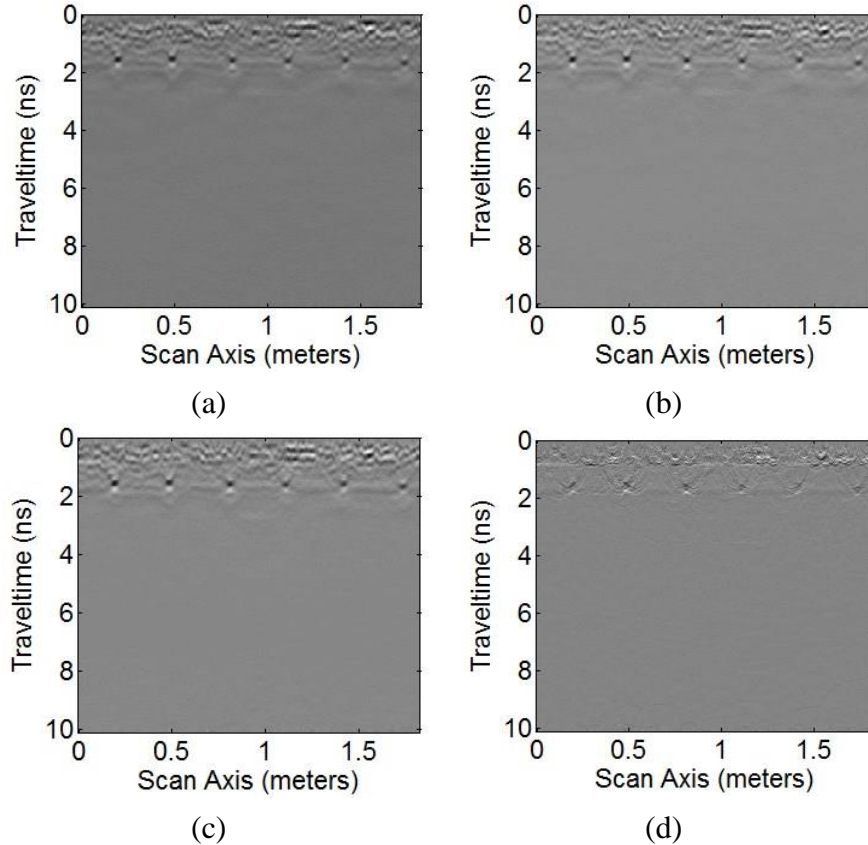
Fig. 24 Compressive OFDM GPR reconstructed B-Scan with various p :
(a) $p=100\%$; (b) $p=60\%$; (c) $p=30\%$; (d) $p=5\%$

Selected B-Scan images are displayed in Fig. 24. In the experiment setup, six rebars buried in the concrete walkway were expected to be detected. When p is higher than 30%, the reconstructed B-Scan image was obtained with a good fidelity. When p is reduced to 5%, the reconstructed image becomes fuzzy, however, the signature patterns corresponding to six rebars are still recognizable.

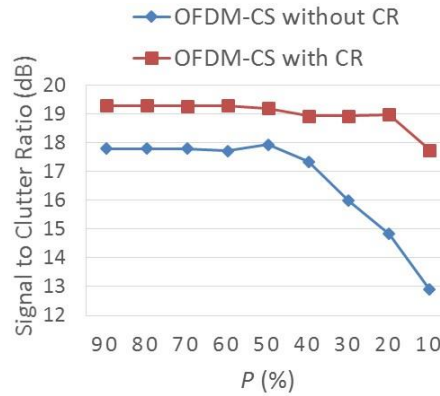
Fig. 25 SCR under various values of p for compressive OFDM GPR with and without clutter removal

Signal-to-Clutter ratio (SCR) is a metric characterizing the power ratio of the backscattering signal from the targets under test and from the ground surface reflection. To quantitatively evaluate the performance of the compressive OFDM GPR sensory system, SCR of the reconstructed B-Scan images under different values of p were calculated. The results are depicted in Fig. 25. For the clutter removal coupled compressive OFDM GPR sensory system, the SCR of the reconstructed B-Scan image was stable and higher than 19 dB when p was higher than 20%. When $p = 10\%$, SCR slightly dropped to 17.8 dB. However, for the compressive OFDM GPR without clutter removal, the SCR dramatically decreased from 18 dB to below 13 dB when p was reduced from 50% to 10%.

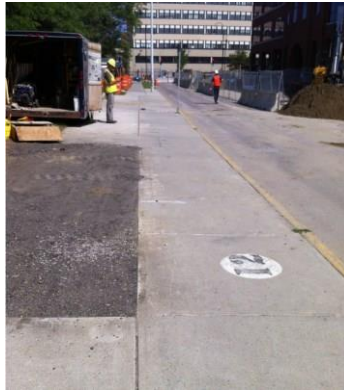
Figure 31 Test Site at St. Paul Street

The physical GPR test site picture is shown in Figure 31, and the whole test route displayed on Google Map is shown in Figure 32. During the GPR test, a parallel bi-directional (south-to-north and north-to-south) inspections were performed. The GPR scan direction is illustrated in Figure 33.

In September 2015, a GPR road test was conducted at St. Paul Street, downtown Burlington where there was a road construction project between Pearl St. and Cherry St. With the assistance of Peterson Consulting, Inc., we accessed the construction site and conducted GPR field inspections on both the concrete sidewalk and asphalt pavement road.

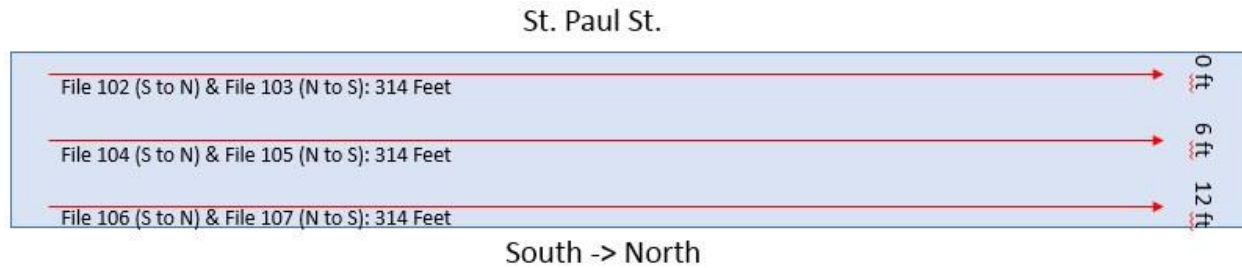
Figure 33 Road Scan Directions

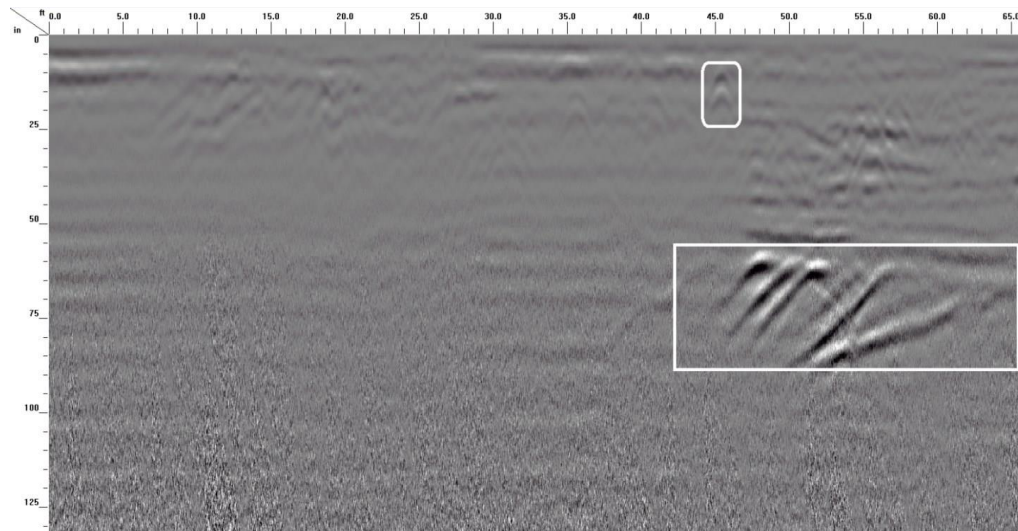
Figure 34 Processed B-Scan image: 0-65 feet horizontal range

The processed GPR results from the parallel inspection scans were combined and plotted in one B-Scan image. Detected objects and regions of interest are marked by the white outlined rectangles in the B-Scan image. In the image, the horizontal axis specifies the distance from the starting location of the scan, while the vertical axis shows the depth of the object. Figure 34 shows the processed B-Scan image corresponding to a segment with a horizontal range between 0 and 65 feet. A pipe shown as a hyperbola in the figure was detected at a depth of 12 inch. Another region of interest was buried at a depth of 60 inches.

A metal pipe, as shown in Figure 43, was also excavated from a depth of about 12 inches. The diameter of this metal pipe was 3 inches. This excavation result agrees with our GPR test result shown in Figure 34.

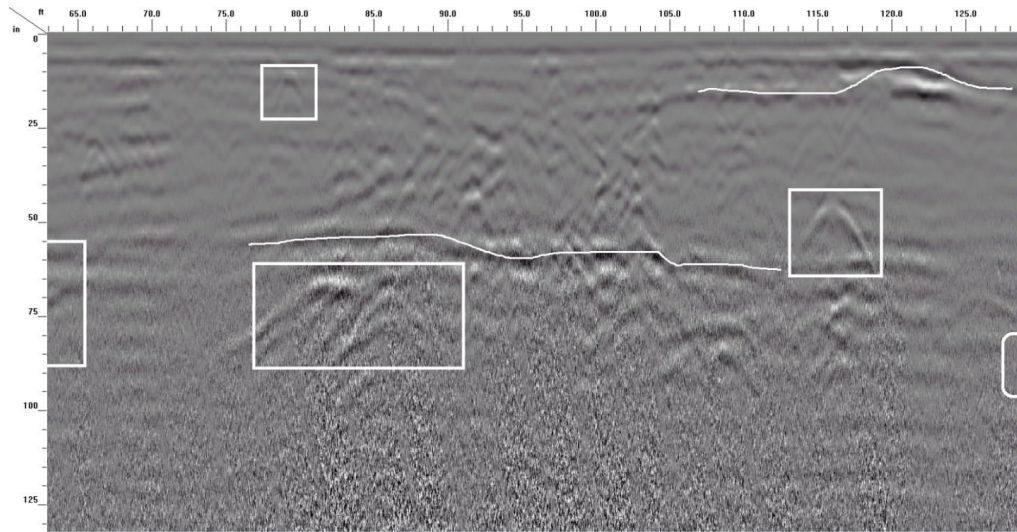
Figure 35 Processed B-Scan image: 65 -125 feet horizontal range

Figure 35 shows the processed B-Scan image corresponding to the segment with a horizontal range between 65 and 125 feet. A pipe at the 78th ft mark and at a depth of 12 inches is shown as a hyperbola in the figure below. Another pipe at the 116th ft mark and at a depth of 40 inches was also detected. Those two pipes are marked by white outlined rectangles. Two layers were also detected and marked by white lines.

Checking the excavation site, a layer buried about 60 inches deep was detected, marked in Figure 42. This layer's burying depth and horizontal location agree well with our GPR inspection results that are shown in Figure 35.

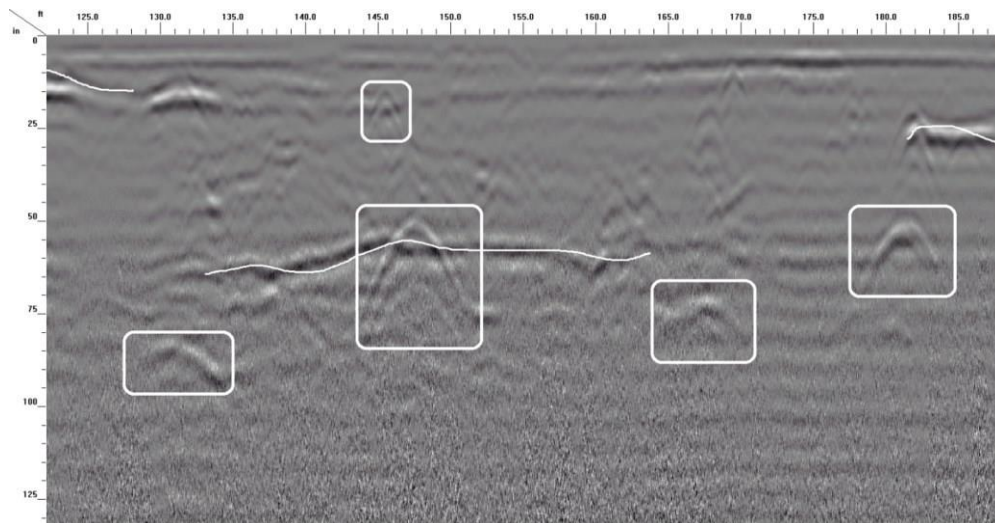
Figure 36 Processed B-Scan image: 125-185 feet horizontal range

Figure 36 illustrates the processed B-Scan image of the segment with a horizontal range between 125 and 185 feet. Five pipes were detected and marked by the white outlined rectangles. One layer was detected from 133 ft to 165 ft at a 60 inch depth.

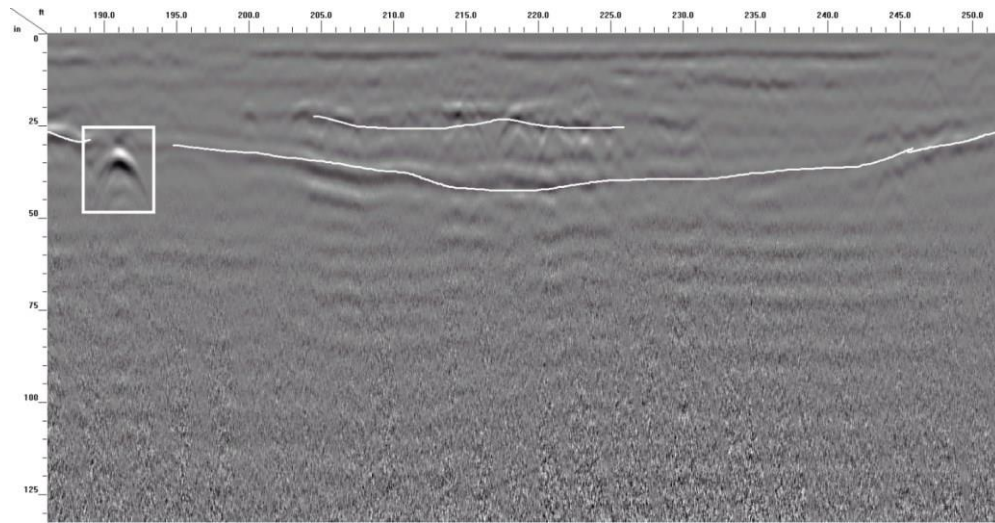
Figure 37 Processed B-Scan image: 185-250 feet horizontal range

Figure 37 shows the processed B-Scan image 185-250 feet away from the starting point. One pipe was detected at 190 ft, two layers were detected and marked by white curves.

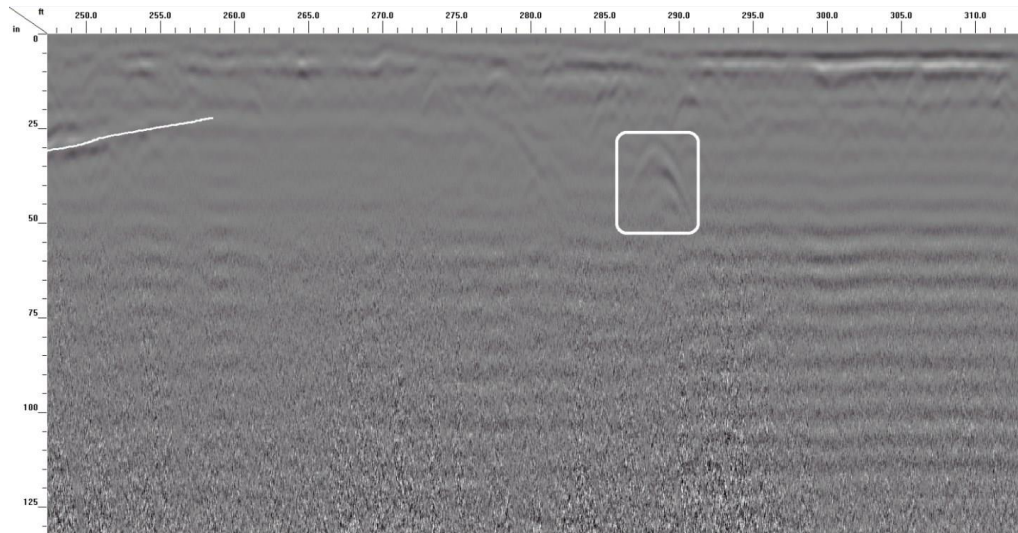
Figure 38 Processed B-Scan image: 250-315 feet horizontal range

Figure 38 shows the processed B-Scan image from the segment with a horizontal range between 250 and 315 feet. One pipe was detected and is depicted as a hyperbola at the 288 ft mark.

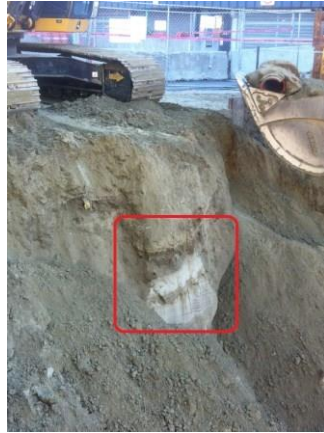
Figure 42 A layer is observed which is consistent with the GPR result in Figure 35

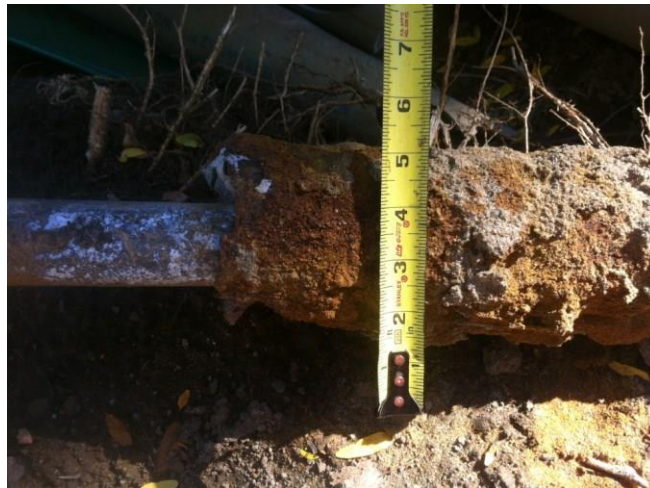
Figure 43 An excavated pipe which was consistent with the GPR result in Figure 34

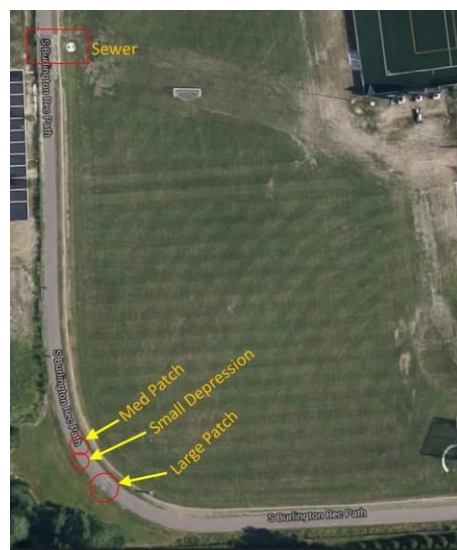
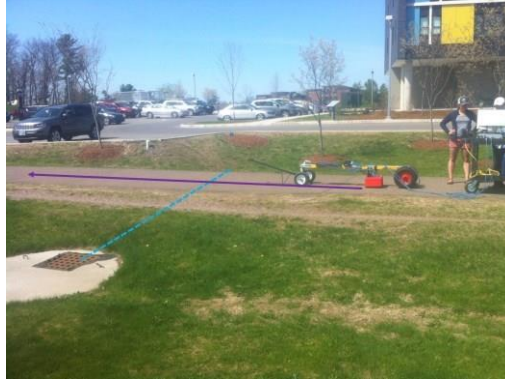
Figure 45 The photo of the test site with underground sewer

The GPR inspection on a test spot with an underground sewer was performed. The location of this test spot is displayed on Google Earth, and the physical test site picture is shown in Figure 45. The direction of the GPR movement is from right to left.

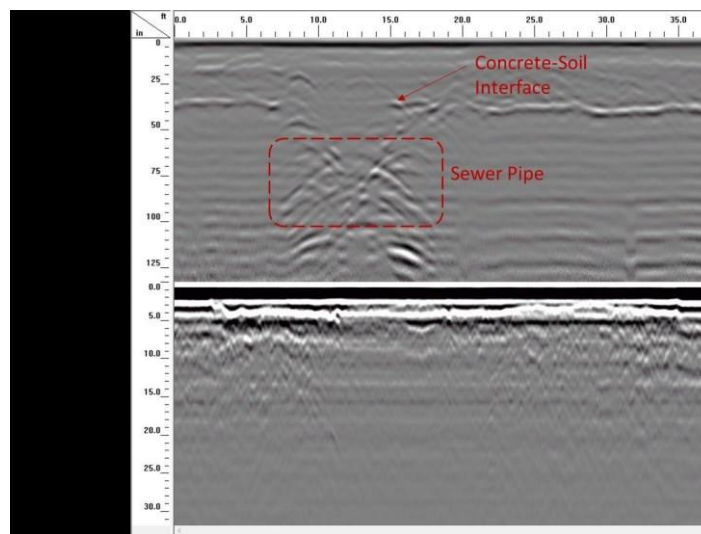
Figure 46 B-Scan Image of Sewer from 400 MHz (Top) and 1.6 GHz (Bottom) Antenna Sets

The B-Scan images obtained with the 400 MHz and 1.6 GHz antenna sets are displayed in Figure 46. The 400 MHz B-Scan image shows the underground object at a deep depth (> 3 feet or 36 inches). In the B-Scan image, a cylinder object shows hyperbolic signature. The hyperbola representing the sewer can be observed at a 70 inch depth in the 400 MHz B-Scan image. Also, the subsurface concrete-soil interface was observed at a 37 inch depth.

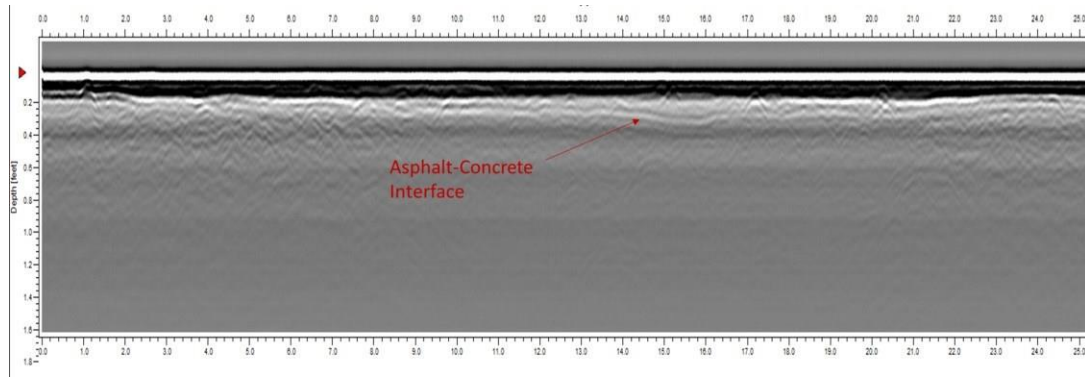
Figure 47 B-Scan Image of Sewer from 2.3 GHz Antenna Set

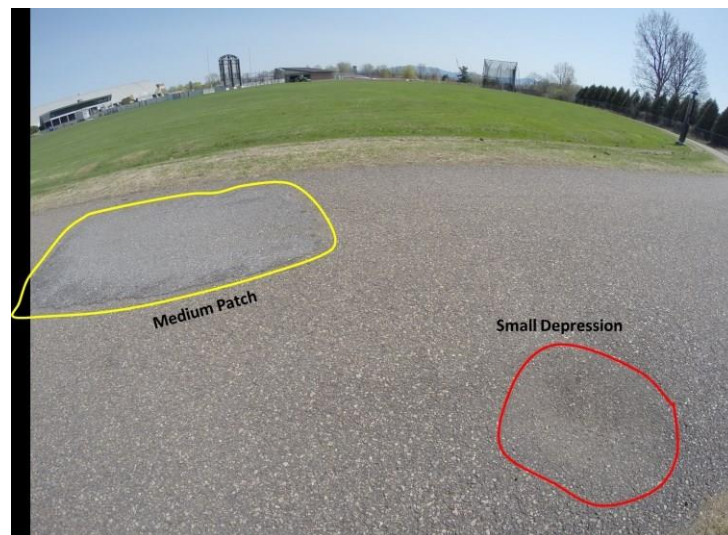
Figure 48 Test Spot with Medium Asphalt Patch and Small Asphalt Depression

A GPR inspection on a test spot with a medium size asphalt patch on the surface was performed. The physical test site picture is shown in Figure 48. The medium size asphalt patch is marked with a yellow circle.

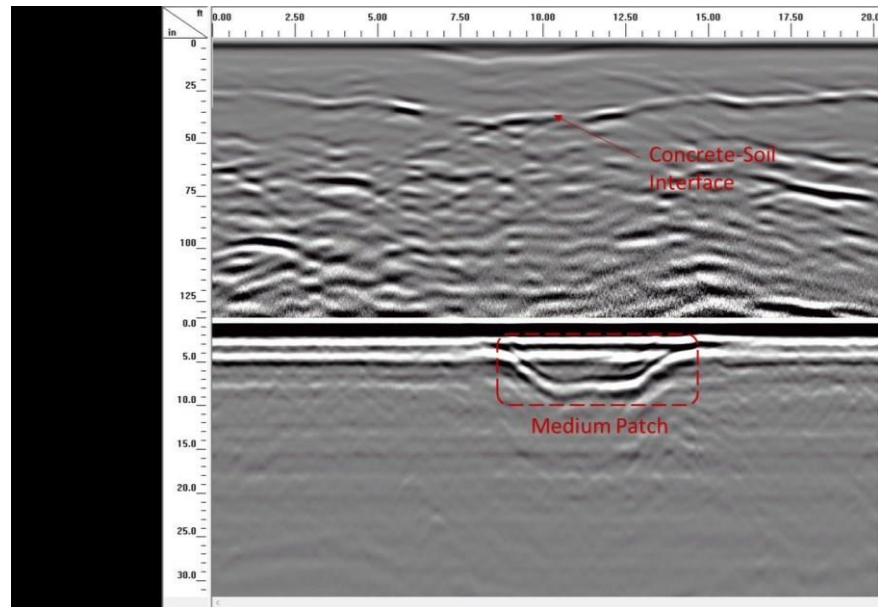
Figure 49 B-Scan Image of Medium Asphalt Patch from 400 MHz (Top) and 1.6 GHz (Bottom) Antenna Sets

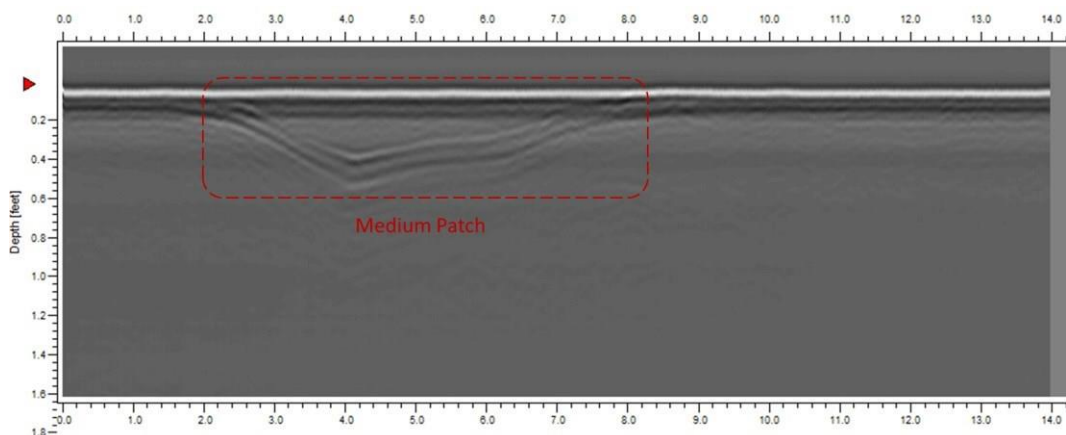
Figure 50 B-Scan Image of Medium Asphalt Patch from 2.3 GHz Antenna Set

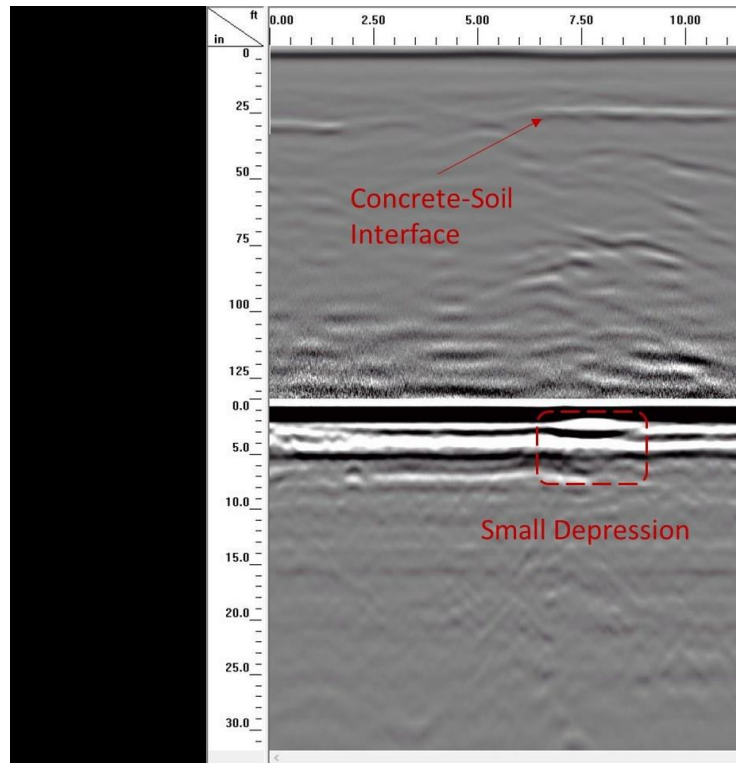
Figure 51 B-Scan Image of Small Asphalt Depression from 400 MHz (Top) and 1.6 GHz (Bottom) Antenna Sets

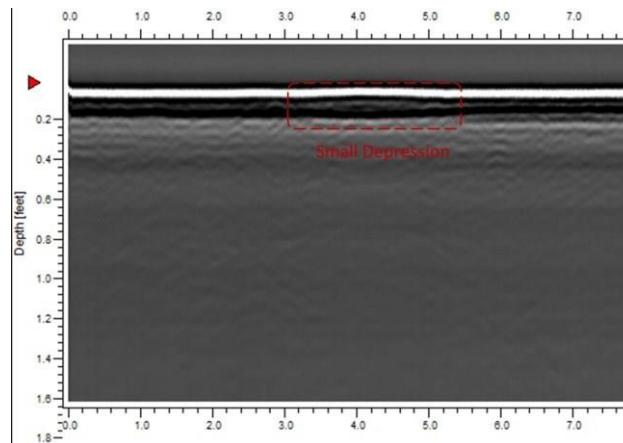
Figure 52 B-Scan Image of Small Asphalt Depression from 2.3 GHz Antenna Set

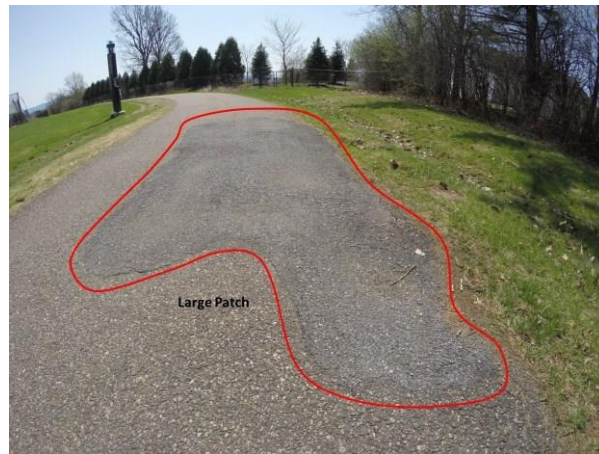
Figure 53 Test Spot with Large Asphalt Patch

45. The physical test site picture is shown in Figure 53. The large asphalt patch is marked with a red curve.

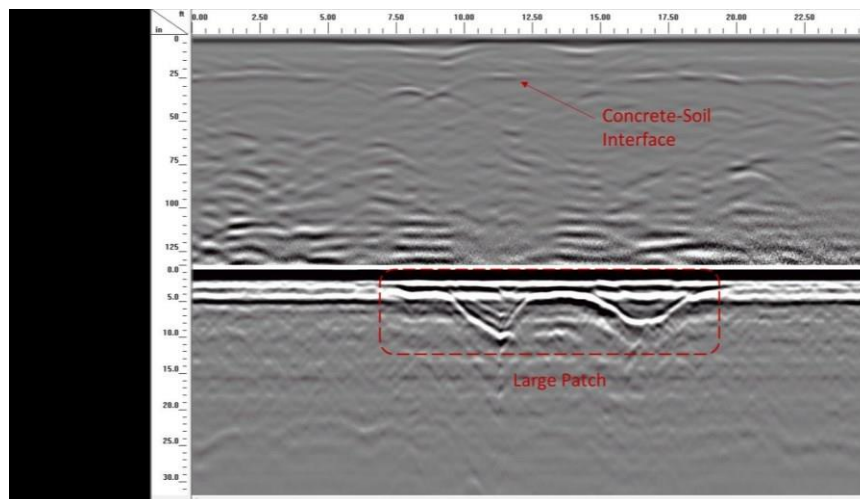
Figure 54 B-Scan Image of Large Asphalt Patch from 400 MHz (Top) and 1.6 GHz (Bottom) Antenna Sets

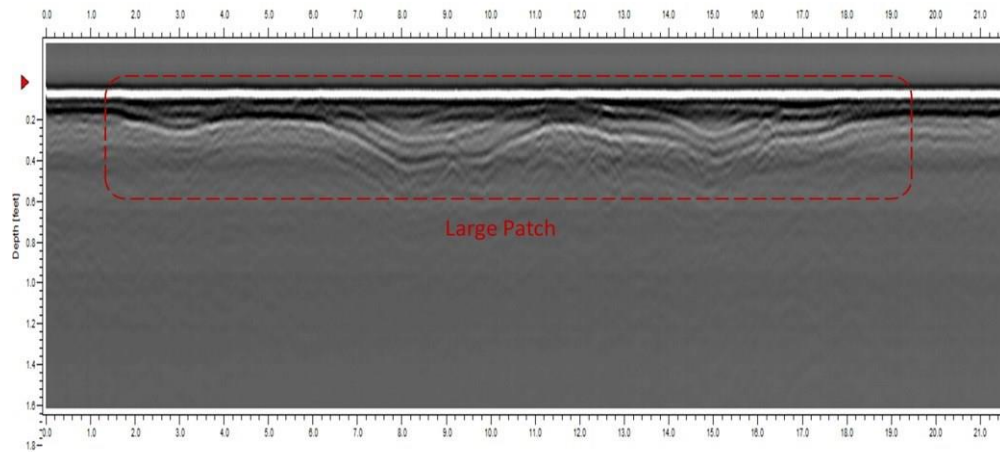
Figure 55 B-Scan Image of Large Asphalt Patch from 2.3 GHz Antenna Set

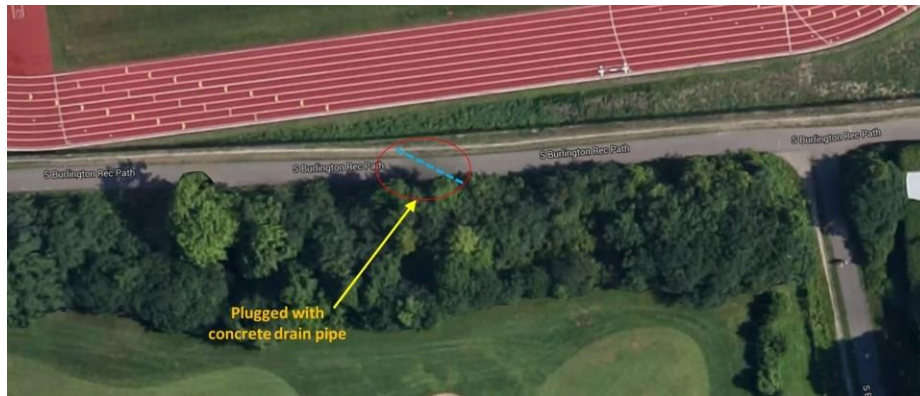
Figure 56 Test Site on Google Earth

A GPR inspection of a test spot plugged with a concrete drain pipe was performed. The location of this test spot is marked in red in Figure 56. The physical test site picture is shown in Figure 57. The asphalt pavement also had small cracks on the surface which can be observed in Figure 57 (b).

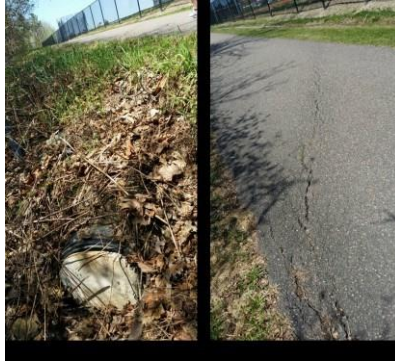
Figure 57 (a) Test Spot Plugged with Concrete Drain Pipe;
(b) Asphalt Pavement Crack on the Surface

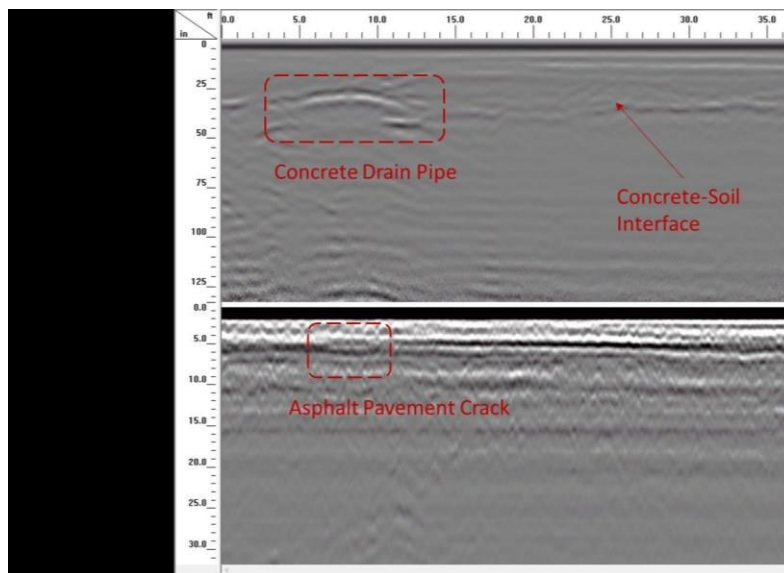
Figure 58 B-Scan Image of Underground Concrete Pipe and Surface Asphalt Crack from 400 MHz (Top) and 1.6 GHz (Bottom) Antenna Sets

The B-Scan images are displayed in Figure 58. The hyperbola representing the underground concrete drain pipe was detected at a 26 inch depth in the 400 MHz B-Scan image (the top image). Also the subsurface concrete-soil interface can be detected at a 40 inch depth. In the 1.6 GHz B-Scan image (the bottom image), the cracks on the asphalt pavement surface was detected and marked by a red rectangle.

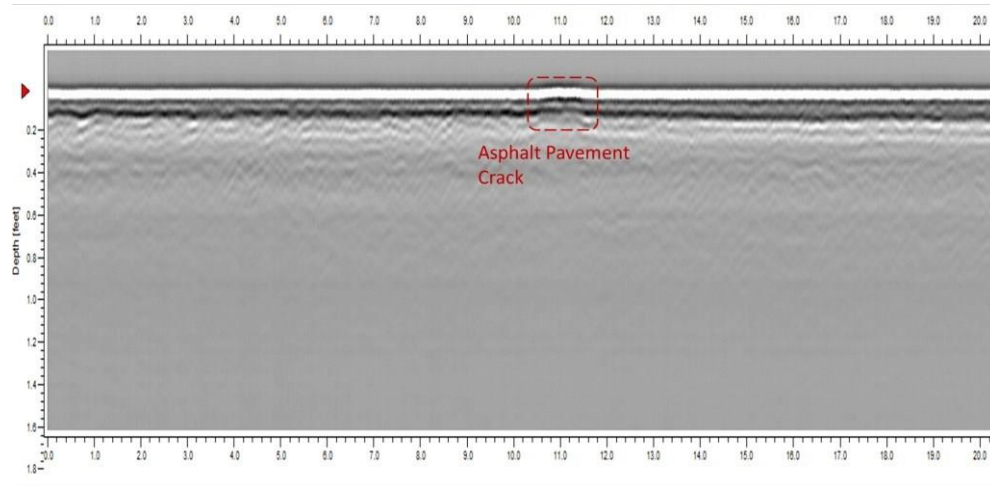
Figure 59 B-Scan Image of Underground Concrete Pipe and Surface Asphalt Crack from 2.3 GHz Antenna Set

Figure 59 displays the B-Scan image from the 2.3 GHz antenna set. In this B-Scan image, the cracks on the asphalt pavement surface can be detected, which is marked by a red rectangle.

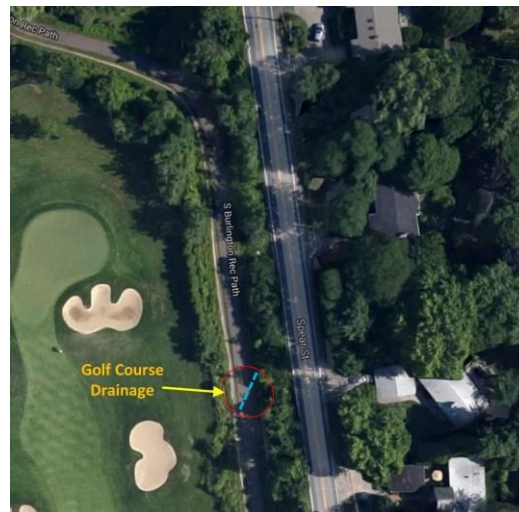
Figure 60 Test Site on Google Earth

A GPR inspection of a test spot with underground golf course drainage was performed. The location of this test spot is marked by a red curve in Figure 60. The physical test site picture is shown in Figure 61.

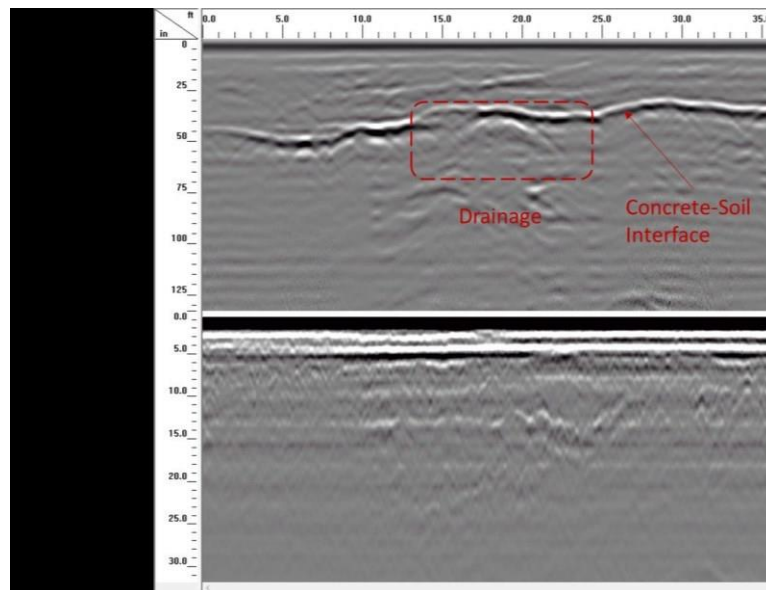
Figure 62 B-Scan Image of Underground Golf Course Drainage from 400 MHz (Top) and 1.6 GHz (Bottom) Antenna Sets
