Citation: Corradi, Marco, Castori, Giulio and Borri, Antonio (2020) Repairing brickwork panels using titanium rods embedded in the mortar joints. *Engineering Structures*, 221. p. 111099. ISSN 0141-0296

Repairing brickwork panels using titanium rods embedded in the mortar joints

This paper investigates repairing brickwork masonry walls using smooth titanium rods. Firstly, numerical analyses were carried out following a detailed micro-modelling strategy and then an experimental research program was undertaken in the laboratory. Solid clay brick specimens were initially tested, without strengthening, and subsequently re-tested, after repair, using titanium rods. Rods were embedded into the horizontal joints using an epoxy paste or a cement mortar. A double-sided repair was considered. Shear tests were carried out on four brickwork panels, under diagonal loading. The mechanism by which the diagonal shear load was carried was analyzed, varying from the uncracked state, to the final, cracked state, for both control and repaired wall panels. The results demonstrate that it is partially possible to restore the panels' original in-plane shear capacity by embedding titanium rods into the

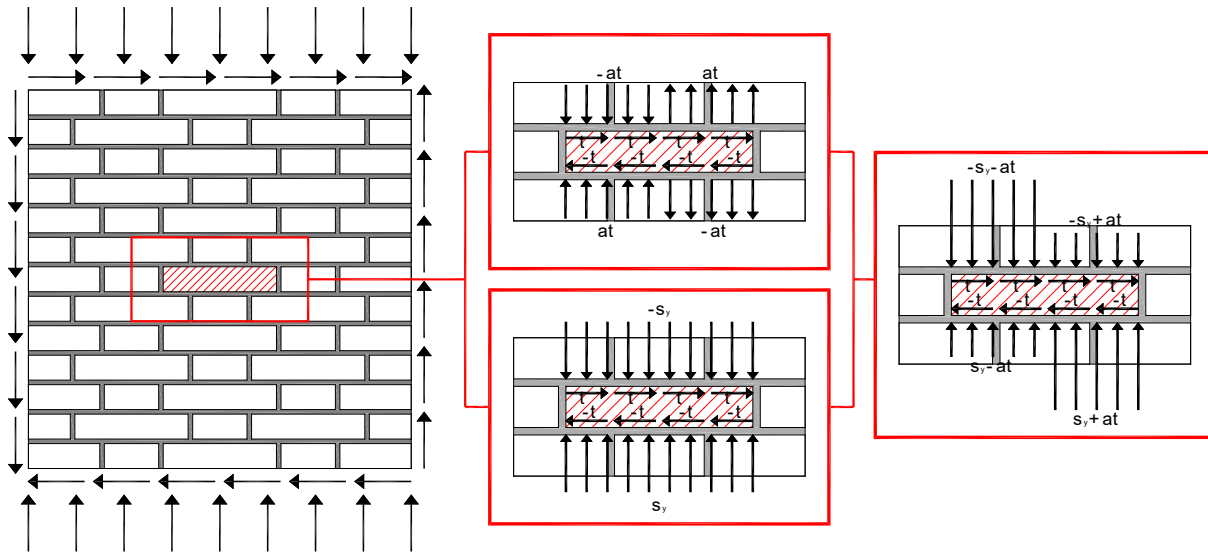
215
 216 Figure 3: Non-uniform stress distribution at the brick near the panel's centroid due to compression/shear
 217 stresses.

206 This approach, together with the assumption of a non-isotropic and heterogeneous material in
207 which rigid rotations of brick units (much stiffer than mortar joints) and deformations of mortar
208 joints can be induced, is similar to the formulation proposed by Mann and Müller [33]. Under these
209 hypotheses, assuming a macroscopically homogeneous shear state, equilibrium can be attained
210 only by normal stresses ($\pm\alpha\tau$) produced by shear stresses ($\pm\tau$) leading to a non-uniform distribution
211 of the compressive stresses along the mortar joints (Figure 3).

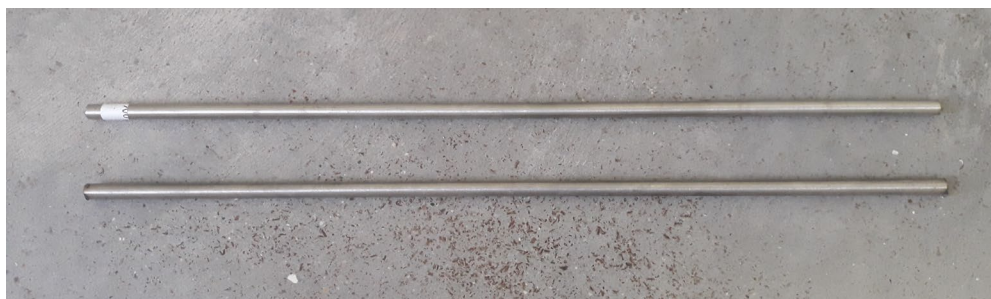
Figure 13: The titanium rods used for repair.

427 A commercially available 7 mm-diameter titanium rod was used in the current study (Figure 13).
428 Rods are produced by Tifast, located in Narni, Italy [48]. The experimental program initially
429 included characterisation of titanium rods [49] to determine their Yield and tensile strengths (Table
430 2).

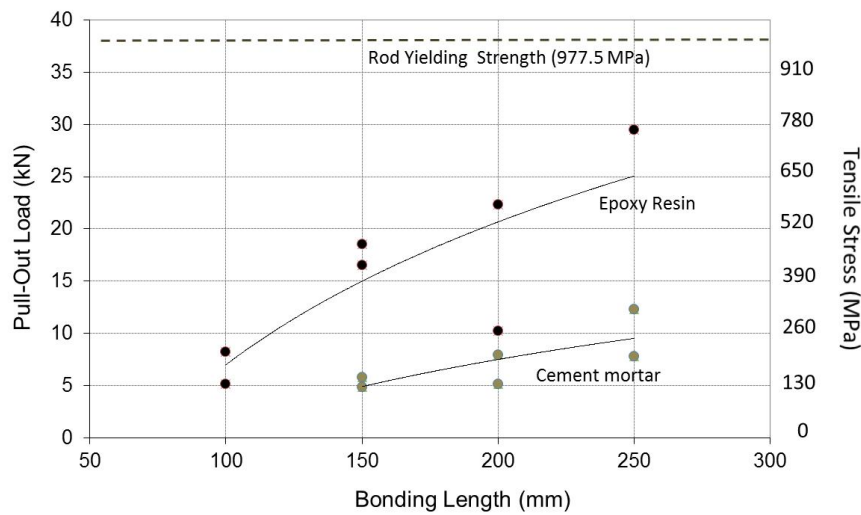
472
 473 **Figure 14: Bonding length vs. failure load/tensile stress for pull-out tests.**

460 In order to prevent slippage phenomena, it was decided to use a high-strength cement mortar and
 461 a thixotropic (no-shrinkage) epoxy. Thirteen bond tests (pull-out tests) were carried out in the
 462 laboratory: titanium rods were inserted into a 25 mm-diameter steel tube, filled with mortar or
 463 resin. In this pull-out test, a titanium rod confined in a filled tube was pulled out and the pull-out
 464 load and the front displacement were recorded: although the confinement action activated by the
 465 steel tube is different from the one in the mortar joint, it is believed that test results are comparable
 466 with the expected behavior of the titanium bars inside the mortar joints. Figure 14 shows the results
 467 in terms of pull-out loads and bond length. It can be noted that the use of an epoxy guaranteed a
 468 high bond with small bond lengths. By using a bond length of 150 mm, it was possible to reach a

469 maximum (average) shear stress of 2.94 MPa. This value is much higher than the shear strength of
 470 the masonry [51-52], making unnecessary to reach higher shear stresses at interface epoxy-rod. A
 471 bond length of 150 mm was selected for the subsequent shear tests on repaired wall panels.

474 With regard to the use of the cement mortar, it was noted that lower pull-out loads and shear stresses
 475 were recorded. These values were about 67, 59, 65% smaller compared to corresponding tests using
 476 the same bond length (150, 200, 250 mm, respectively). Taking into consideration the typical shear
 477 strength of brickwork masonry [47], it was decided that a bond length of 175 mm (total rod length
 478 350 mm) could be sufficient to repair a crack in a brickwork wall. A trend line of the pull-out load
 479 is also plotted for the tests carried out using the epoxy and cement mortar. The failure mode of all
 480 bond tests was due to the pull-out of the titanium rod from the metal cylinder. The cement mortar
 481 or the epoxy remained always fully attached to the metal cylinder.

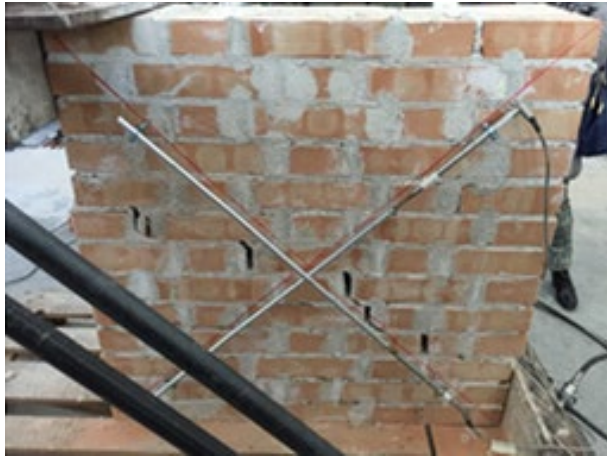
Figure 15: Typical diagonal cracking of control URM wall specimens.

507
 508 Since shearing force predominated, the system acted as an in-plane loaded membrane and shear
 509 cracks developed along the diagonal in compression. This terminated the initial uncracked mode.
 510 Cracks followed a zig-zag pattern inside the mortar joints or at interface brick-to-mortar (Figure
 511 15).

512
513
514 For URM specimens, no-damage or very limited damage was observed in the bricks at the end of
515 the test. After failure, the thickness of the shear cracks increased: the effect of mechanical
516 interlocking along the shear crack progressively reduced: this caused a gradual loss of the panel's
517 lateral capacity. At the end of the shear test, this varied between 30 and 50% of the maximum
518 diagonal load.

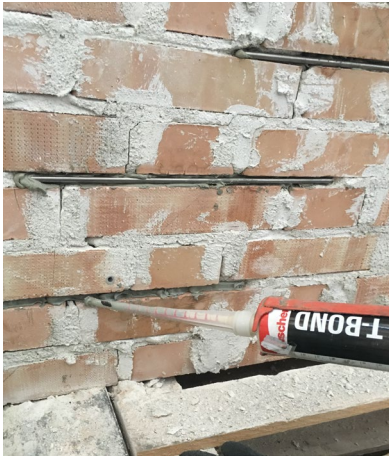
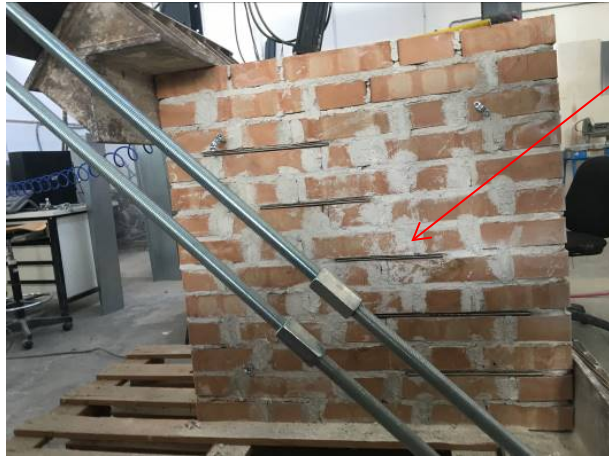
Strain gauge

Figure 17: A repaired wall panel using titanium rods for crack stitching.

596 A bonded resistance strain gauge was applied on a titanium rod, before embedment into the
 597 horizontal joint and epoxy application. The strain gauge was bonded to the rod and protected from
 598 contact with the epoxy with a small piece of plastic tape. The instrumented rod was the one near
 599 the centroid of the panel surface (Figure 17). The strain gauge was applied at rod mid-point.

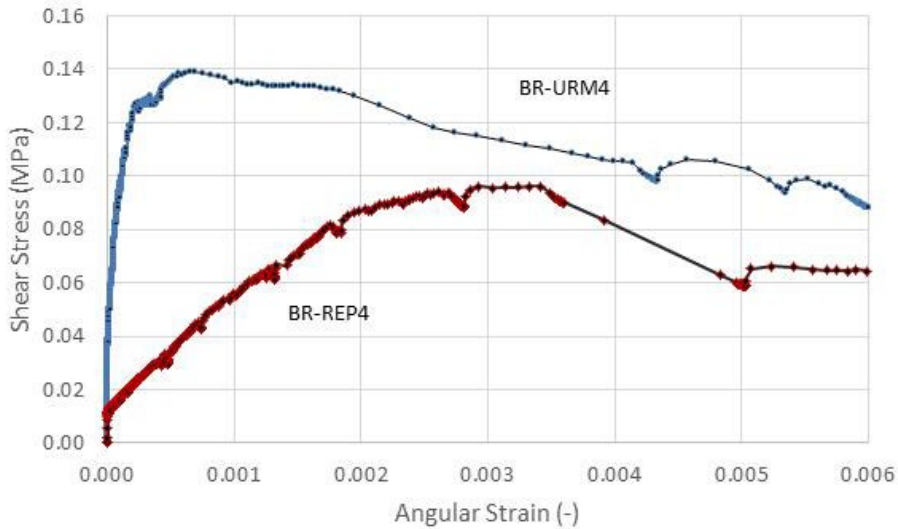
Figure 18: Angular strain vs. shear stress for tests No. BR-URM4 and BR-REP4.

560 **However, the panel's response in terms of shear deformations, although linear, was not likely**
561 **elastic. Figure 18 shows that panel BR-REP4 highly deformed in shear (at maximum lateral load,**
562 **angular strain was in the range 0.0030-0.0033 mm/mm). This large value of the angular strain**
563 **clearly demonstrates that other phenomena of cracking occurred in the panel: it should be remarked**
564 **here that the titanium rods were not effective in repairing the crack *inside* the panel. Furthermore,**
565 **other small shear cracks started developing near the repaired area, with a progressive extension of**
566 **their length.**

584 It could be interesting to comment on the reduced lateral capacity of the repaired panels, compared
 585 to URM panels (Figure 18): firstly, it should be remarked here that the titanium rods were only
 586 located along the superficial area of bed joints (on both panel's sides): the cracked vertical joints
 587 and the internal area of the cracked panels were not affected by the application of the rods.
 588 Furthermore, only every other bed joint was repaired with the rods: all this weakened the
 589 effectiveness of the repair method, and it provides an explanation for the missing ability to restore
 590 the original lateral capacity after repair. The basic idea was to study a non-invasive, localized,
 591 repair intervention: this was the rationale for the use of a inorganic matrix (cement mortar), and
 592 short titanium bars. However, tests results clearly demonstrated critical aspects and important
