Analytical and Numerical Investigation of a Mechanically Stabilized Earth Wall on I-15

ANALYTICAL AND NUMERICAL INVESTIGATION OF A MECHANICALLY
STABILIZED EARTH WALL ON I-15

DOCTOR OF PHILOSOPHY

Civil and Environmental Engineering

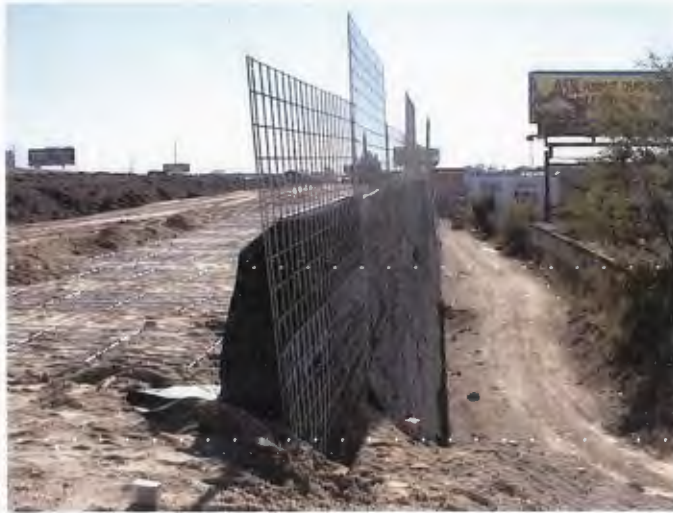
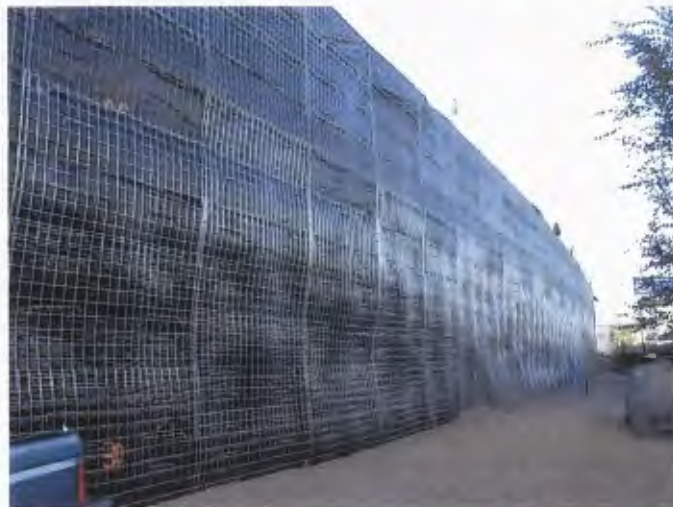
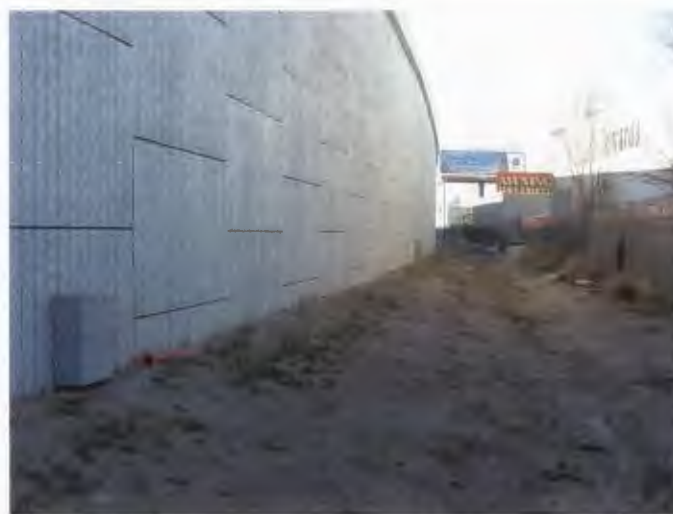
Fig. 1.3 Photographs showing Wall R-346-1C during and after construction

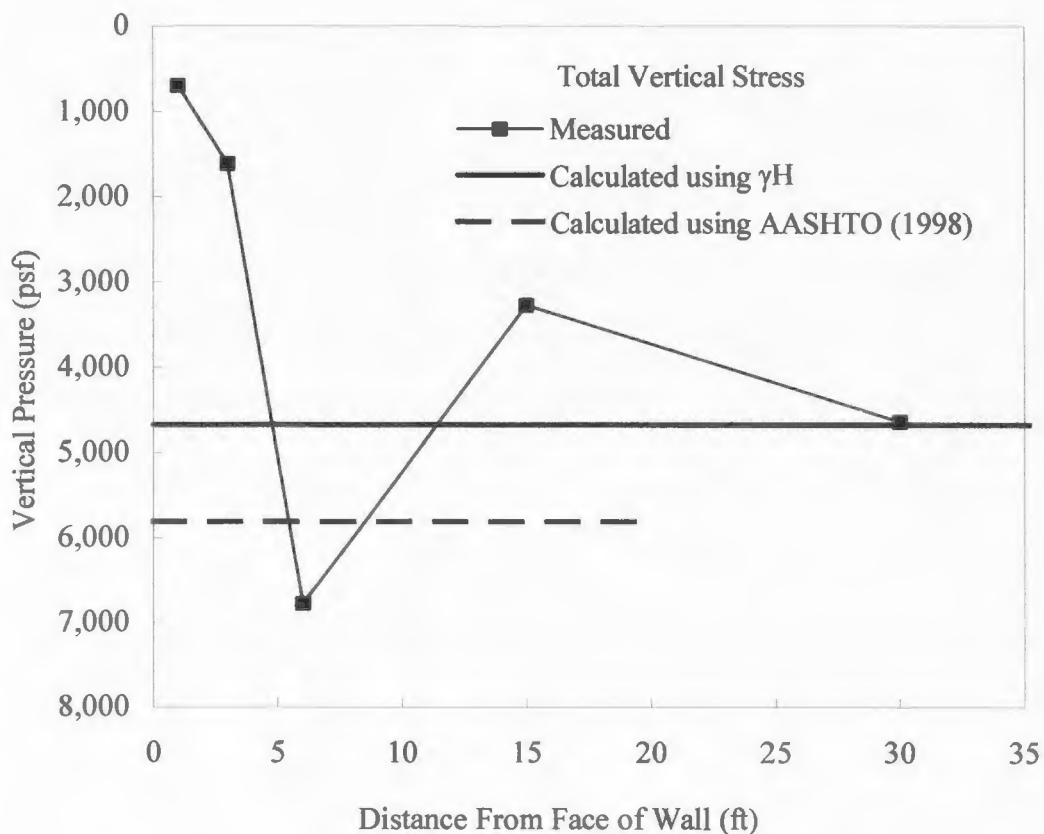
Fig. 1.5 Plot of vertical pressure versus distance from wall face during time in which surcharge was applied to the wall

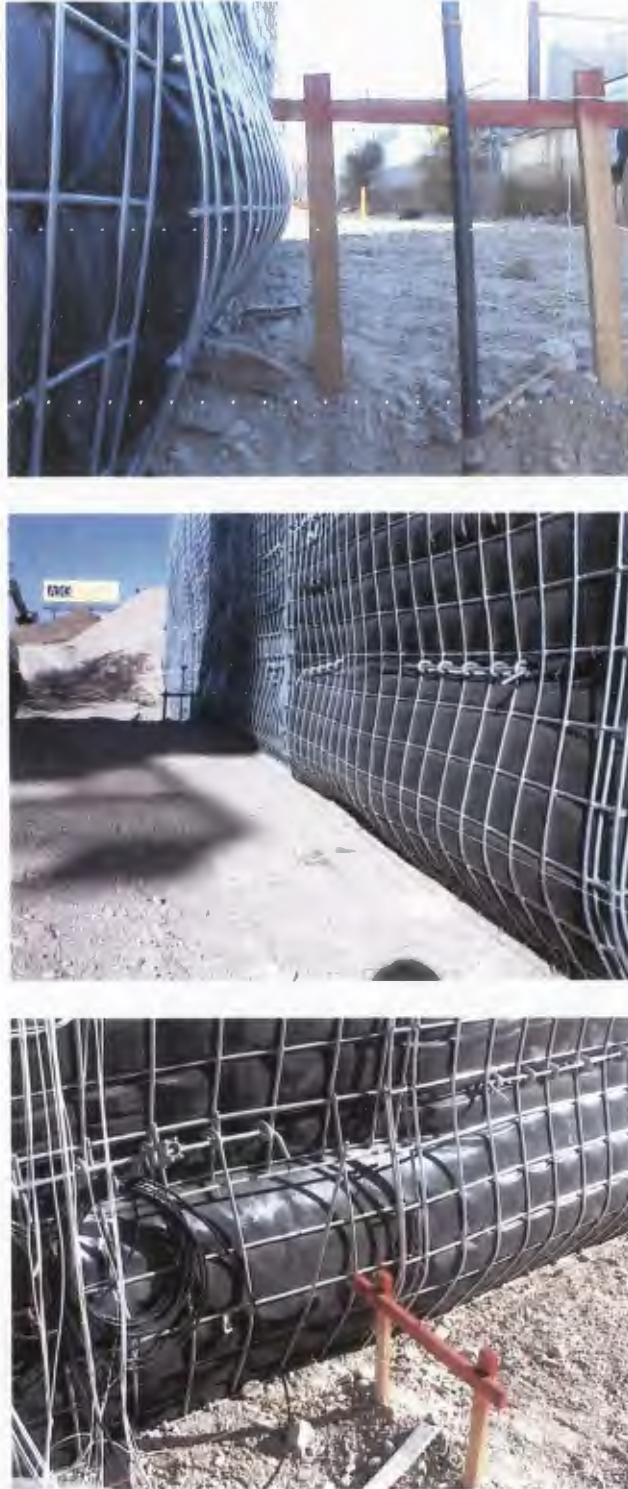
Fig. 3.3 Photographs showing deformations and toe bulges of first-stage wall face during construction

MSE walls on soft clay foundations are typically subjected to significant deformations. Similar walls built earlier at other locations on this same project had experienced more than 3 ft (0.9 m) of settlement (Bay et al., 2003a, Report UT-03.11). One significant benefit of two-stage walls is their ability to withstand such significant settlement without problems. However, some of the walls on this project had exhibited large deformations such as bulging, sagging, and negative batter of the wall face, which led to some concern. It was not apparent whether these deformations were associated with overstressing of the wall or whether they were merely localized deformations near the face of the wall. Excessive bulging of the wall face, especially at the toe of the wall, was an additional concern since it was causing problems with the constructibility of the second stage of the wall. Also, some toe bulges were large enough that the welds in the fascia panels were breaking, causing concern about the structural stability. Photographs showing toe bulging are shown in Fig. 3.3.

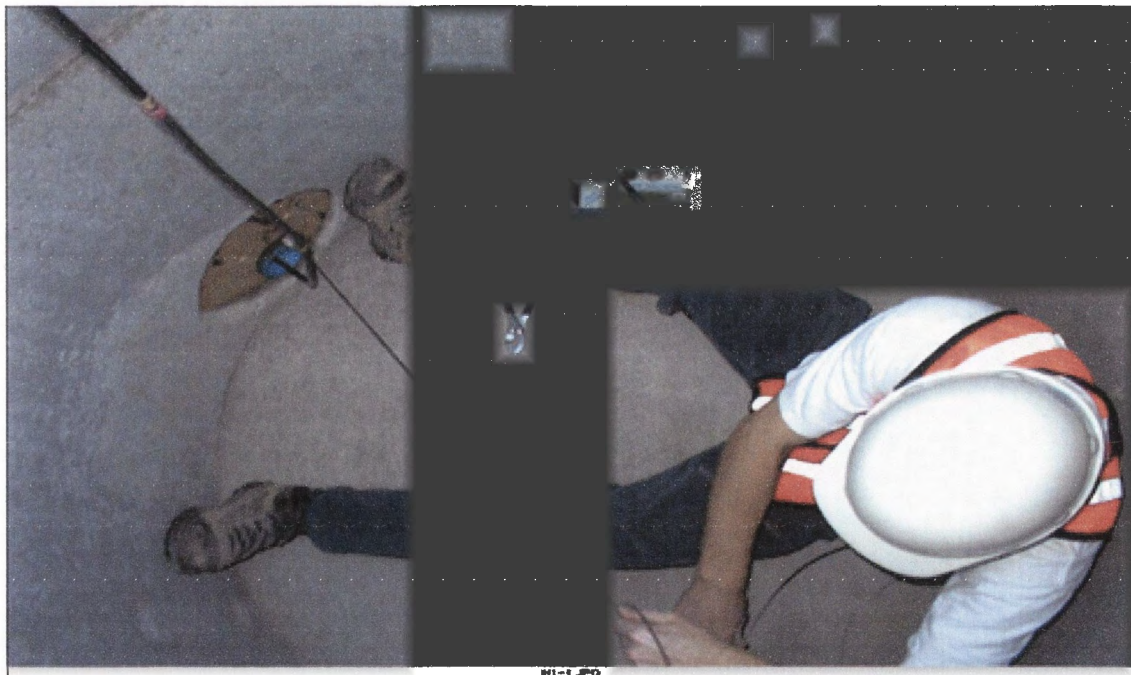
Fig. 3.9 Photograph showing the inside of the manhole where horizontal inclinometer No.1 (H1) is located

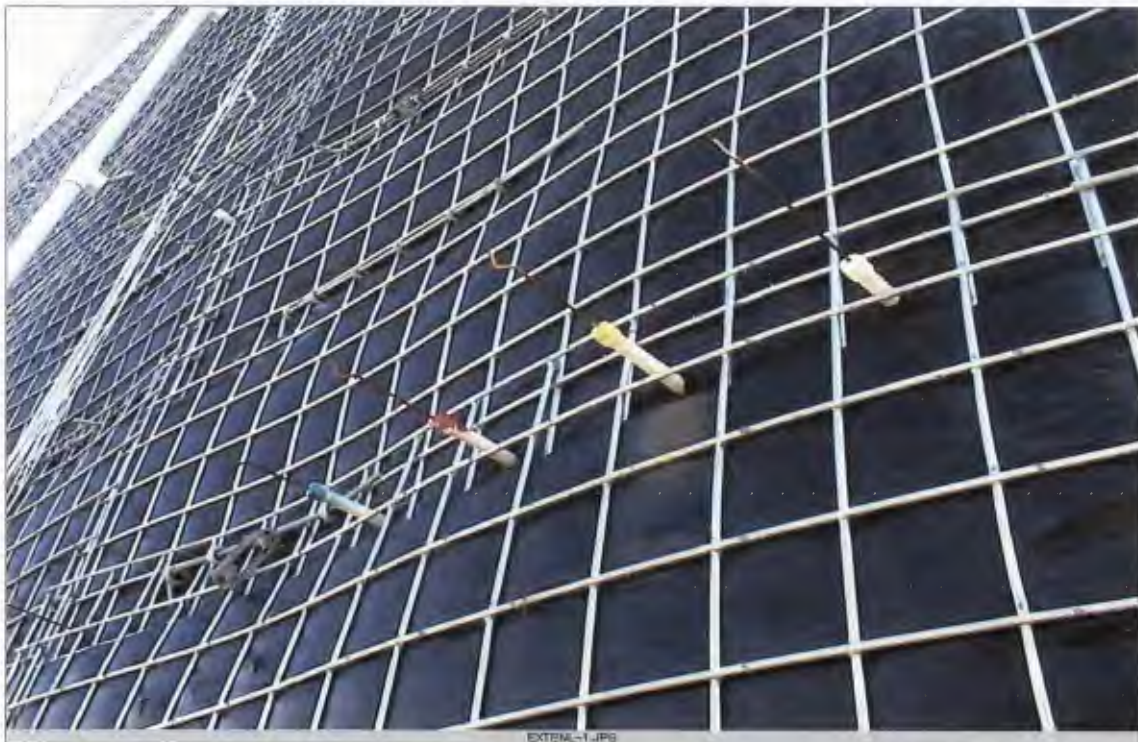
Fig. 3.13 Photograph showing horizontal extensometers protruding from wall face

0.5 inch (12.7 mm) PVC end caps to prevent soil from entering the pipe. Fig. 3.13 is a photograph showing the horizontal extensometers protruding out of the face of the wall.

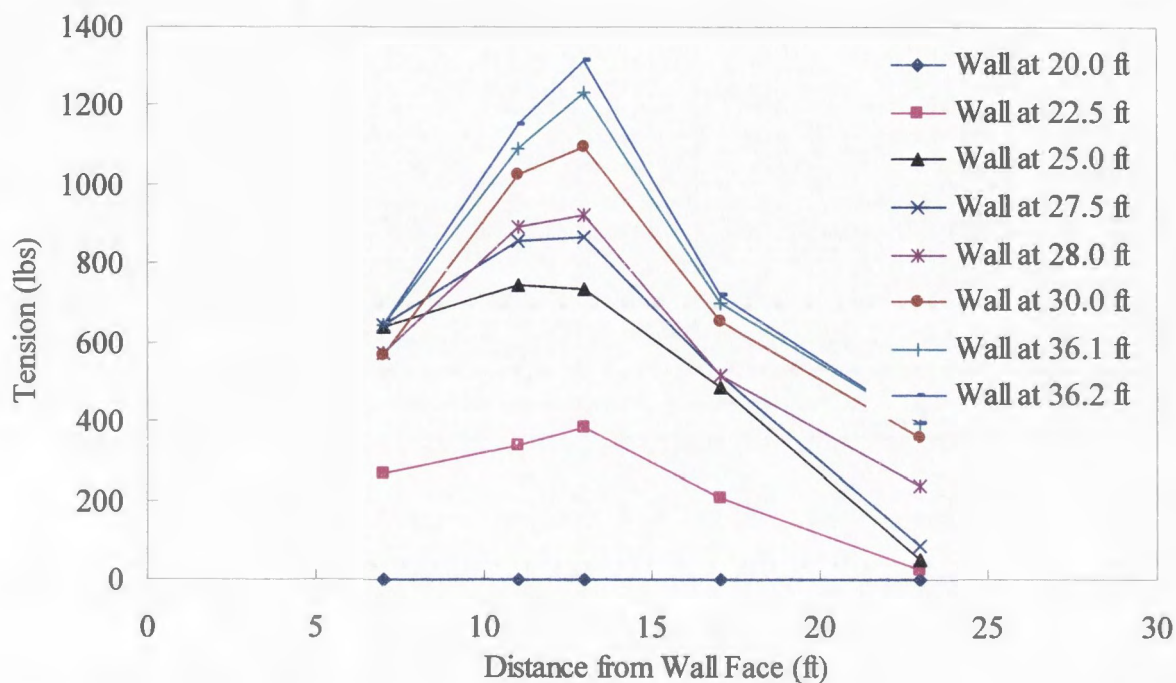
Fig. 3.16 Example of measured tension distribution in the longitudinal wires for a bar mat positioned 20.0 ft from the base of the wall in the primary and intermediate reinforced section

The maximum tension measured in the individual longitudinal bars was much less than the allowable tension to which the bars could be subjected. The minimum ratio of the allowable yield stress to the tensile stress existing in the longitudinal bars of the reinforcement is 2.5 for one strain gage position, with only four gage positions having ratios less than 5.0 (out of more than 90 functional positions). Thus, the vast majority of the bar mats are subjected to tensile forces less than 20 percent of the yield strength of the

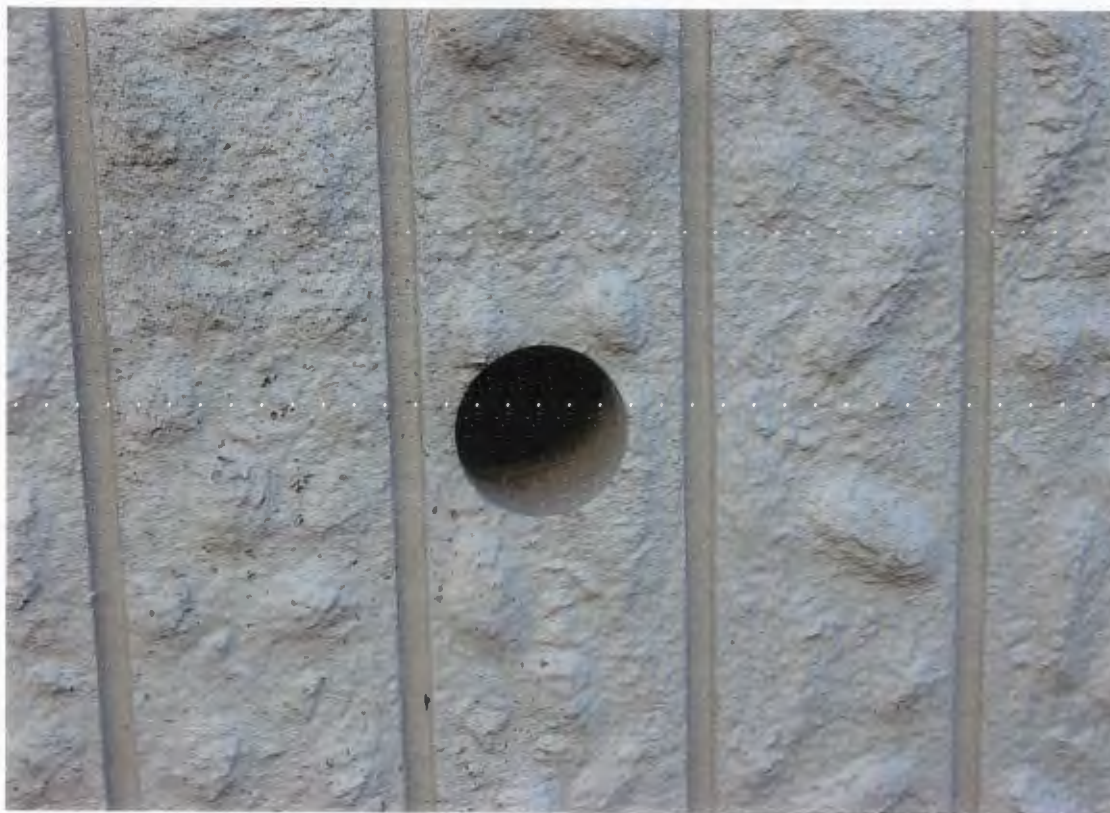
Fig. 3.17 Hole cored in secondary stage concrete fascia panel to allow access (Inclinometer H2)

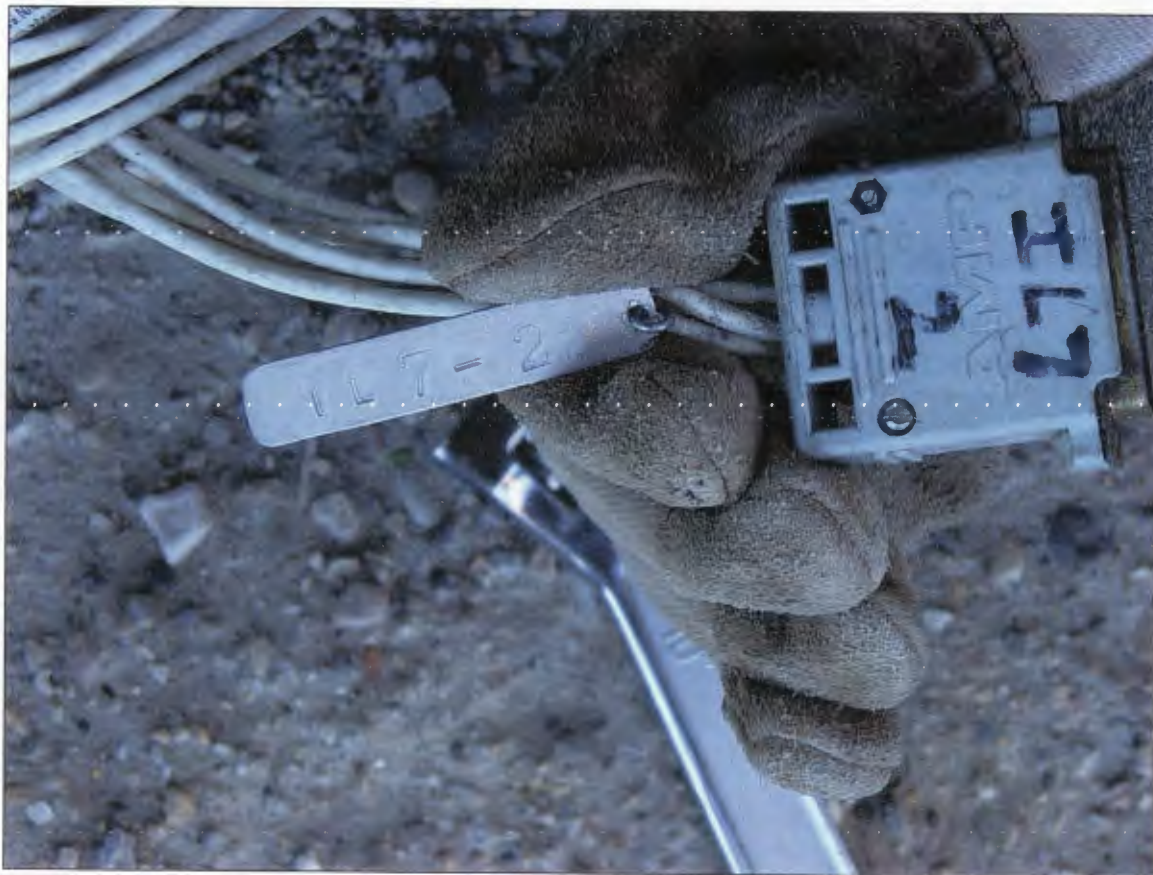
Fig. 3.18 Aluminum tags used to label the strain gage connectors

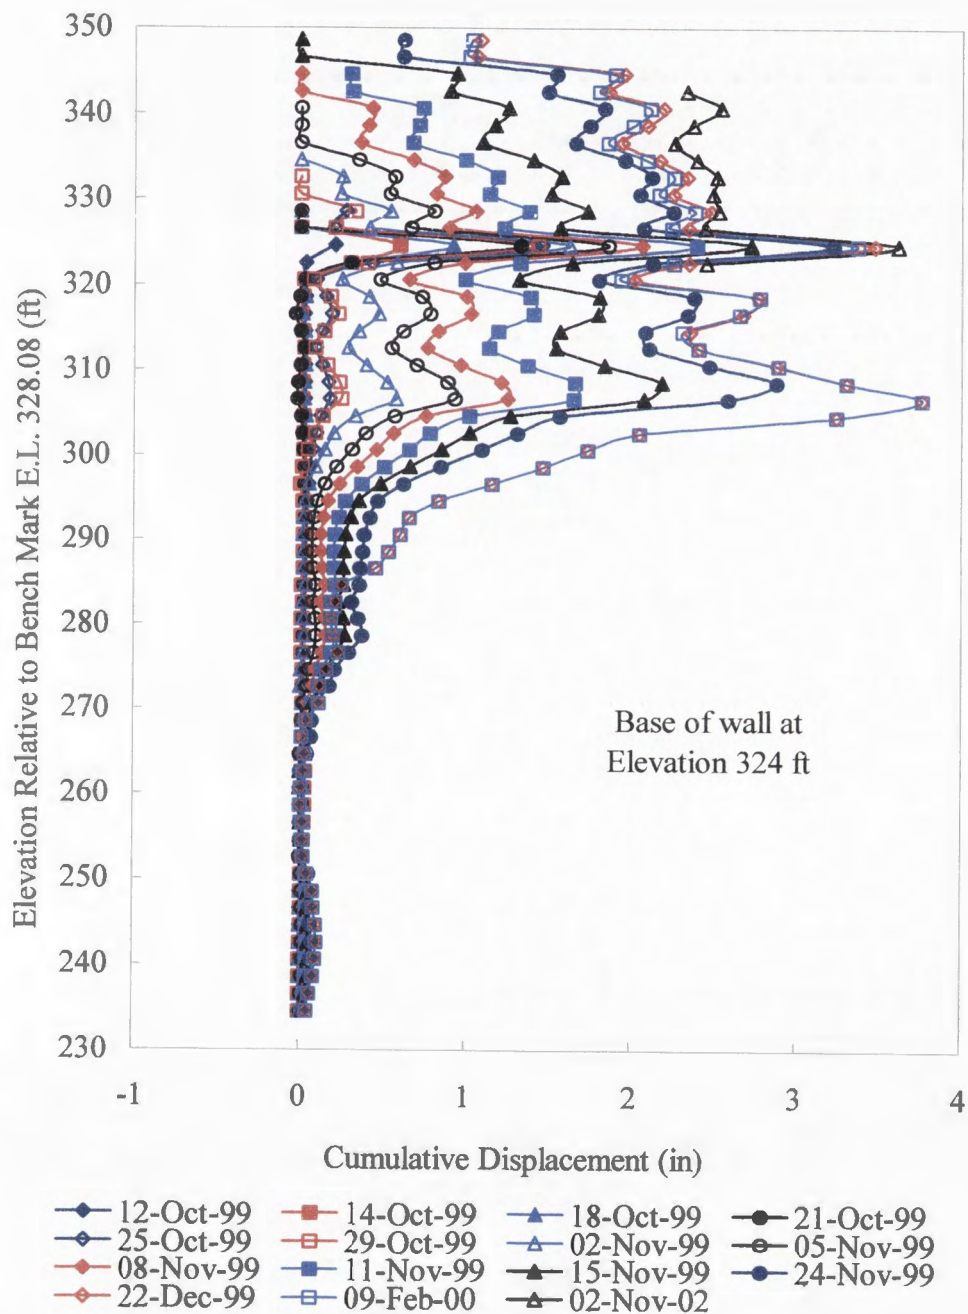
Fig. 3.25 Plot of vertical inclinometer measurements for inclinometers located 3 ft from wall face, within wall footprint

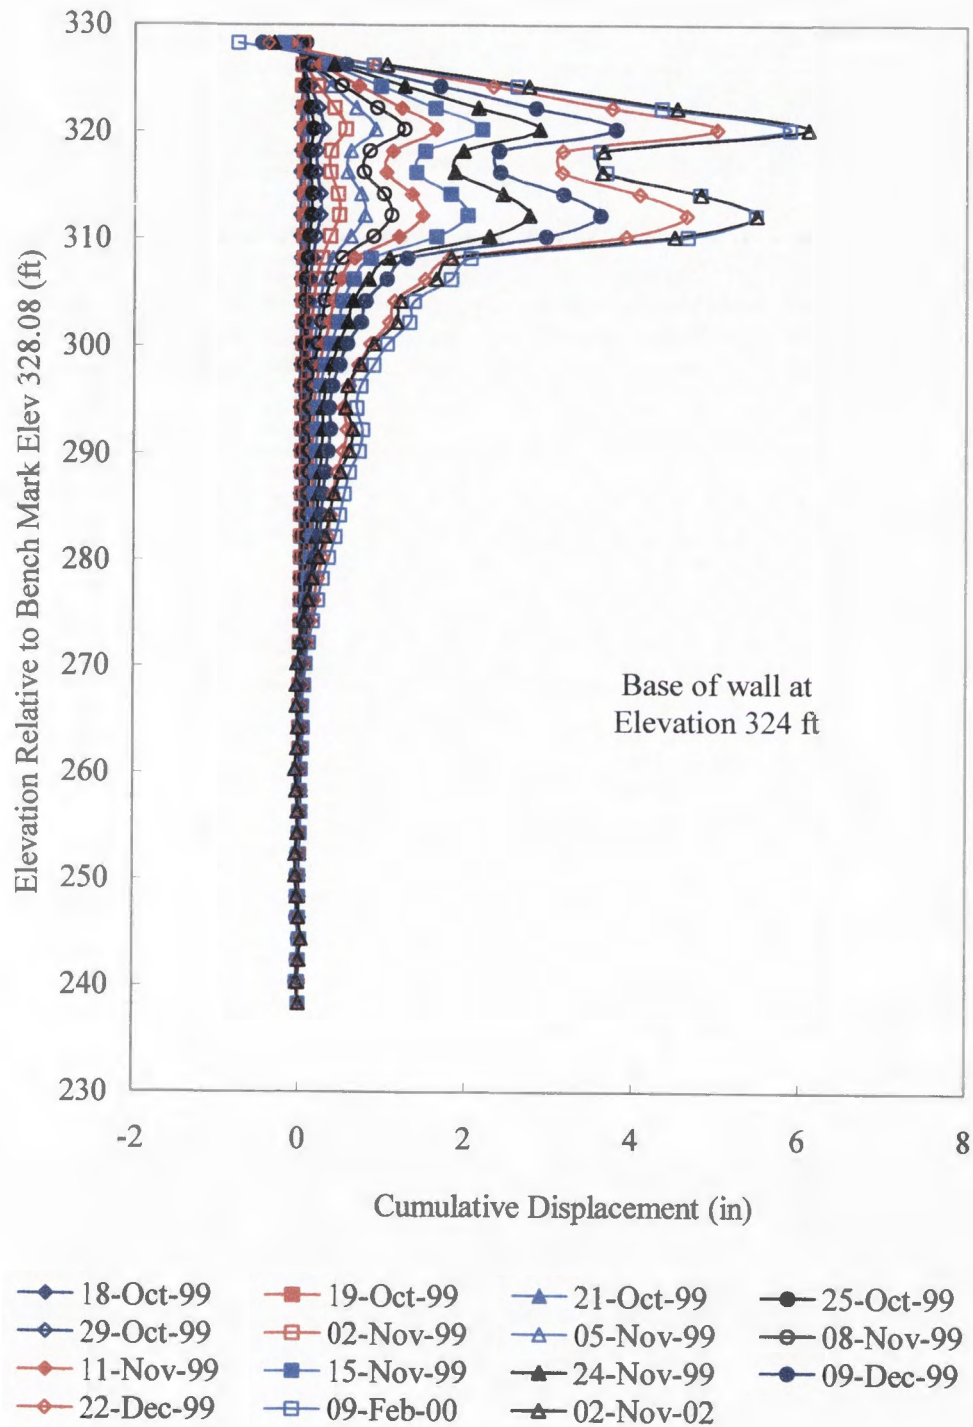
Fig. 3.26 Plot of vertical inclinometer measurements for inclinometers located 8 ft from wall face, outside wall footprint

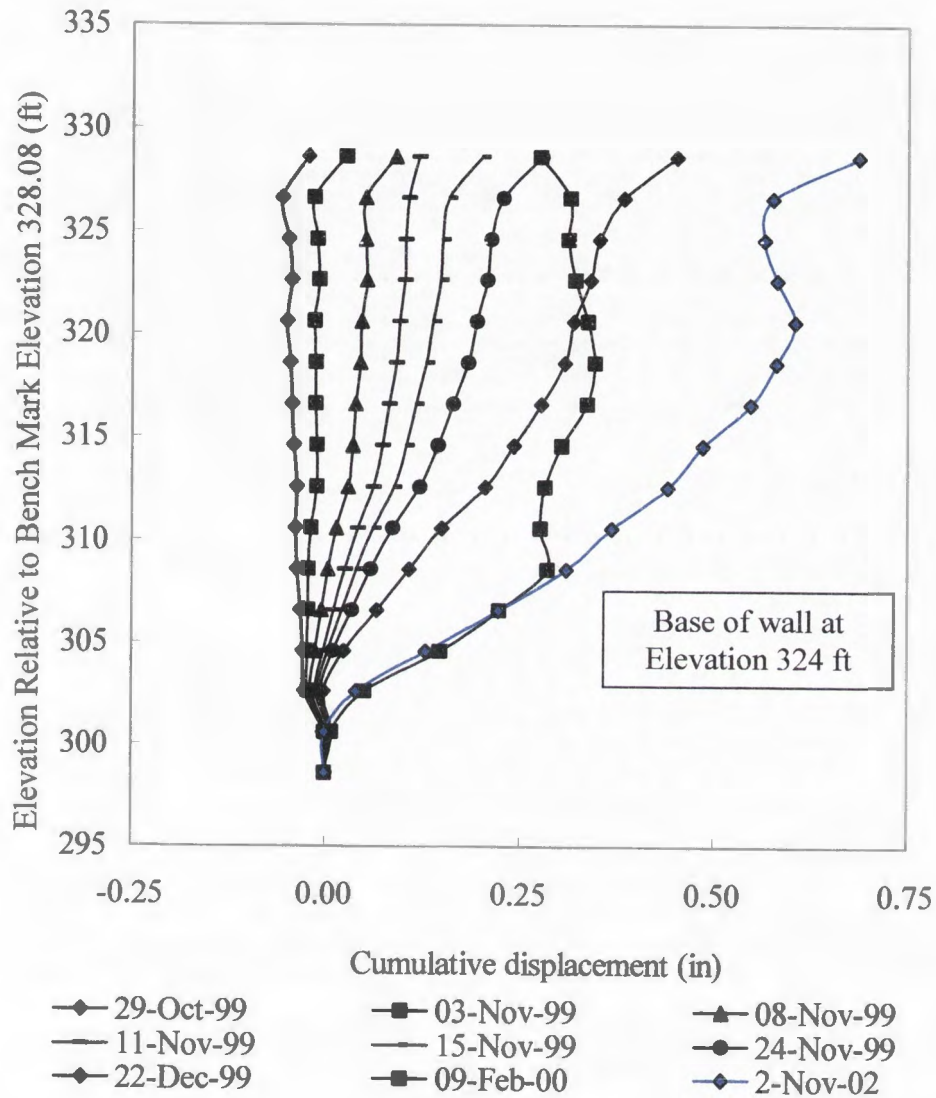
Fig. 3.27 Plot of vertical inclinometer measurements for inclinometers located 31 ft from wall face, outside wall footprint and outside wick drain zone

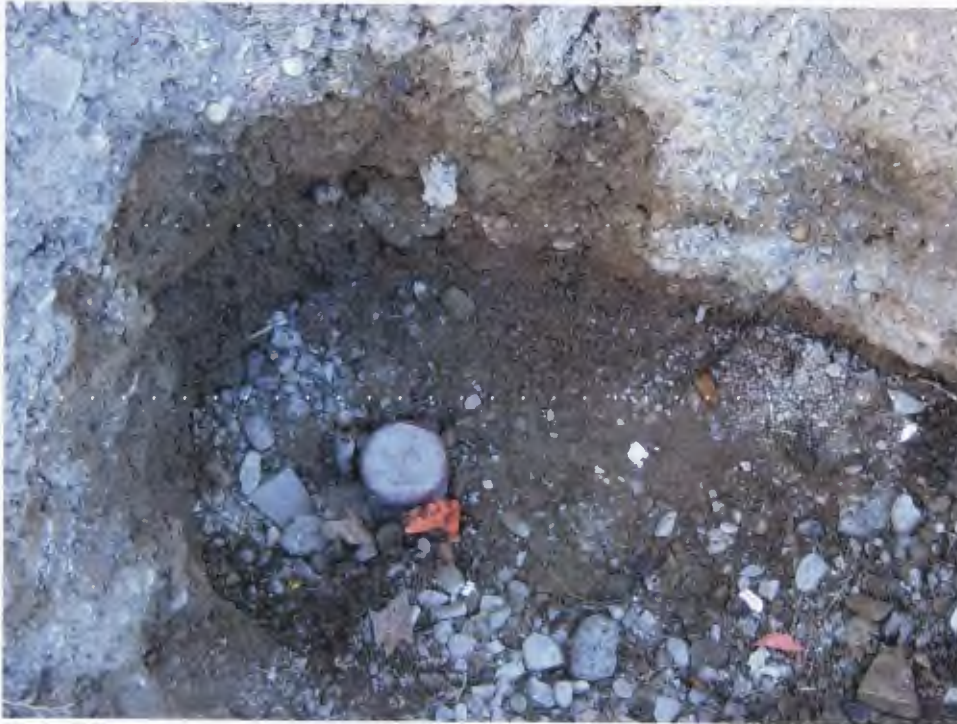
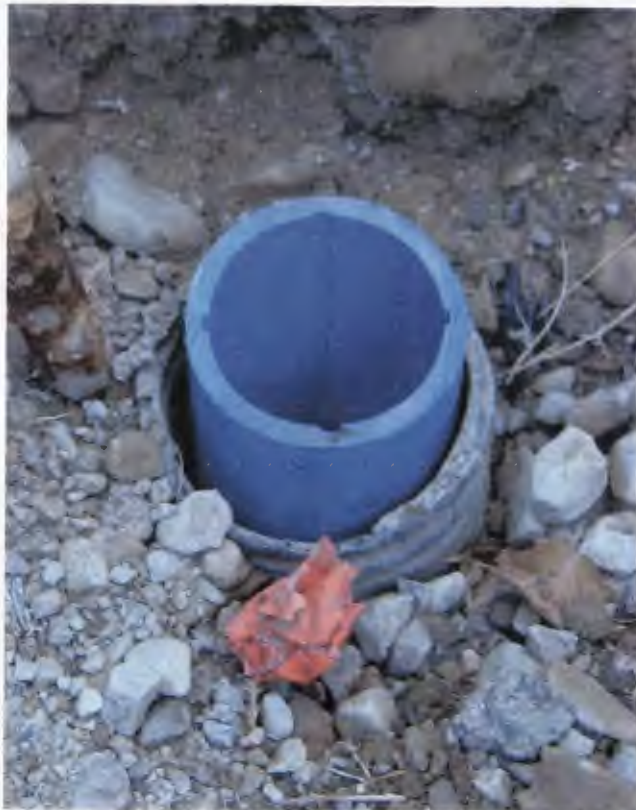
Fig. 3.31 Additional photographs showing the recovered inclinometer I2 casing

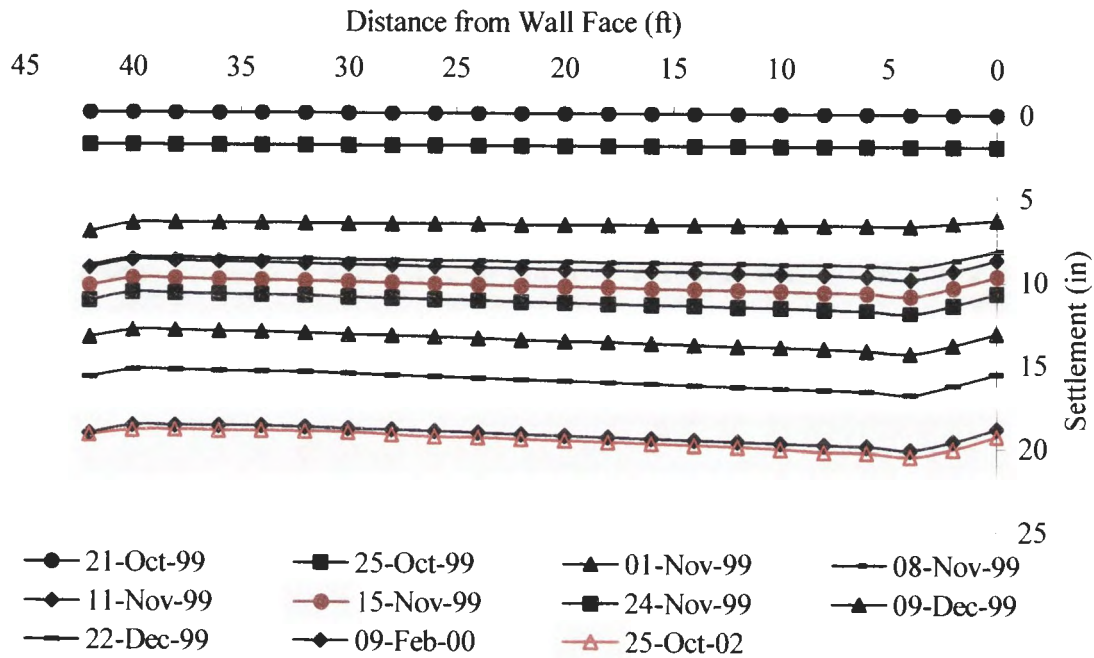
Fig. 3.38 Updated horizontal inclinometer H2 beginning at an initial height of 8 ft in the wall fill and originating at the wall face

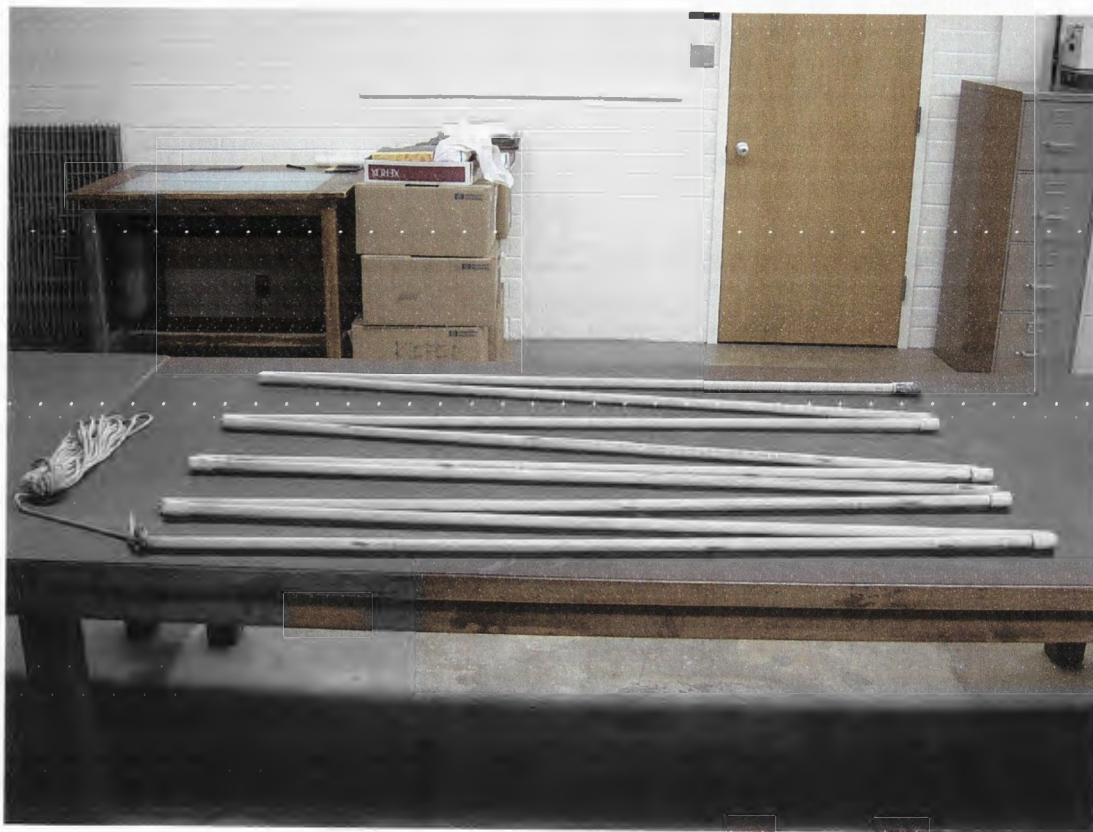
Fig. 3.39 Photograph showing the interconnectable PVC pipes used to push the horizontal inclinometer into the H2 casing

instead of attempting to rethread a cable to pull the inclinometer into the casing. As a result, ten 5 ft pieces of 0.75 inch PVC pipe were purchased with connection sleeves glued to one end of each. A rope was threaded through the pipes and sleeves, such that the pipes would not become disconnected in the hole and become irretrievable. As the inclinometer was pushed into the hole in 5 ft lengths, additional sections of pipe were added that allowed the inclinometer to be pushed the entire distance into the hole. This allowed the problem with the missing cable to be overcome. A photograph of these interconnectable PVC pipes is given in Fig. 3.39.

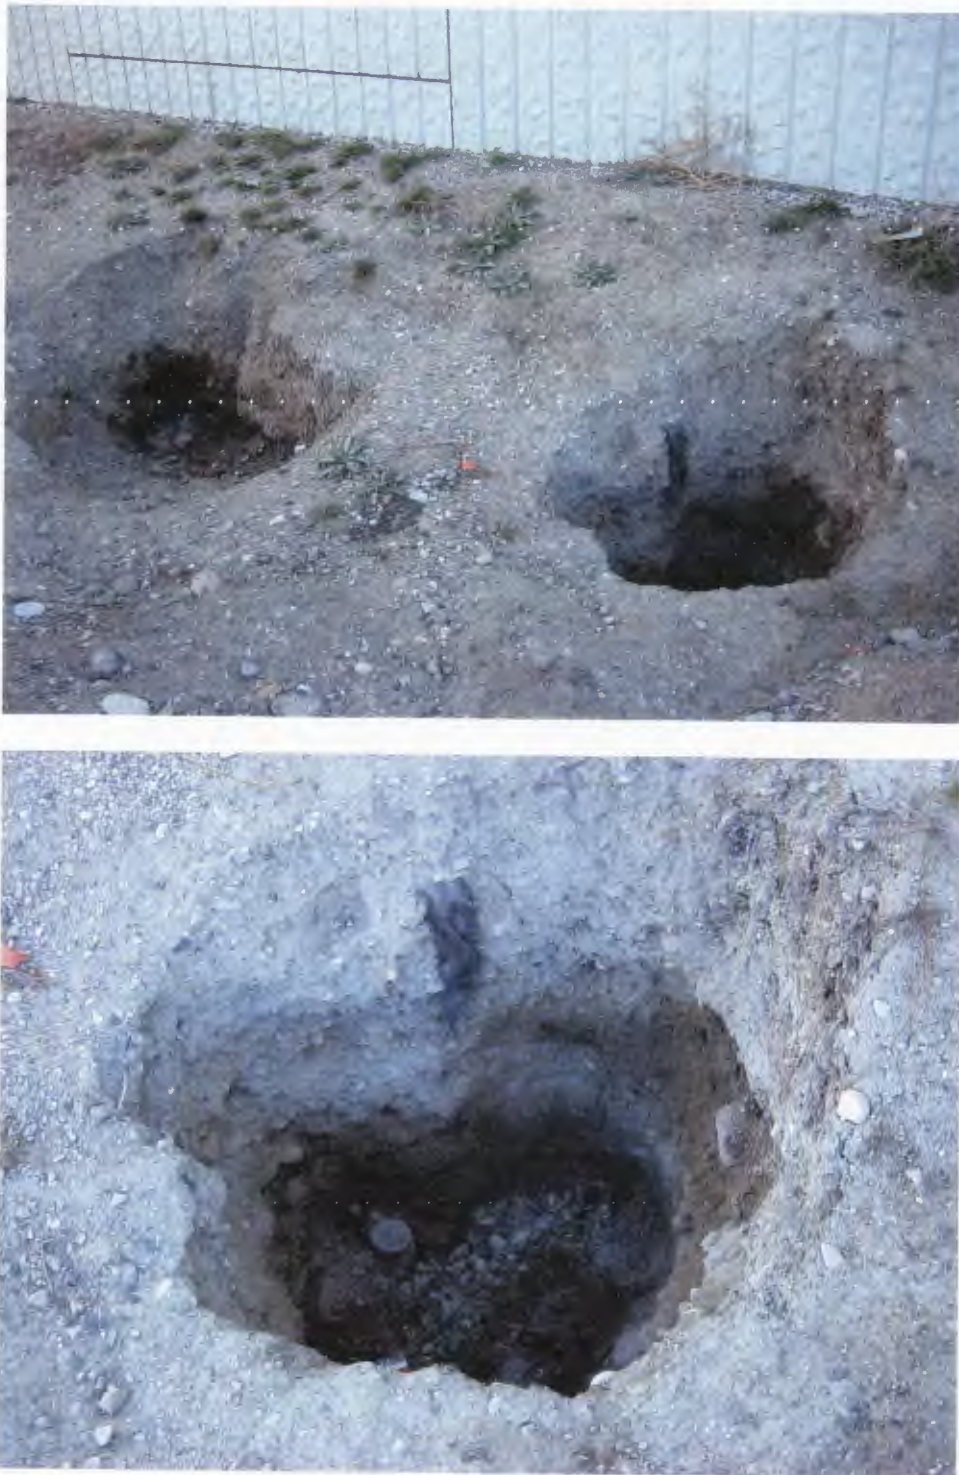
Fig. 3.51 Photographs of recovered Sondex casing S2 (at right in upper photograph)

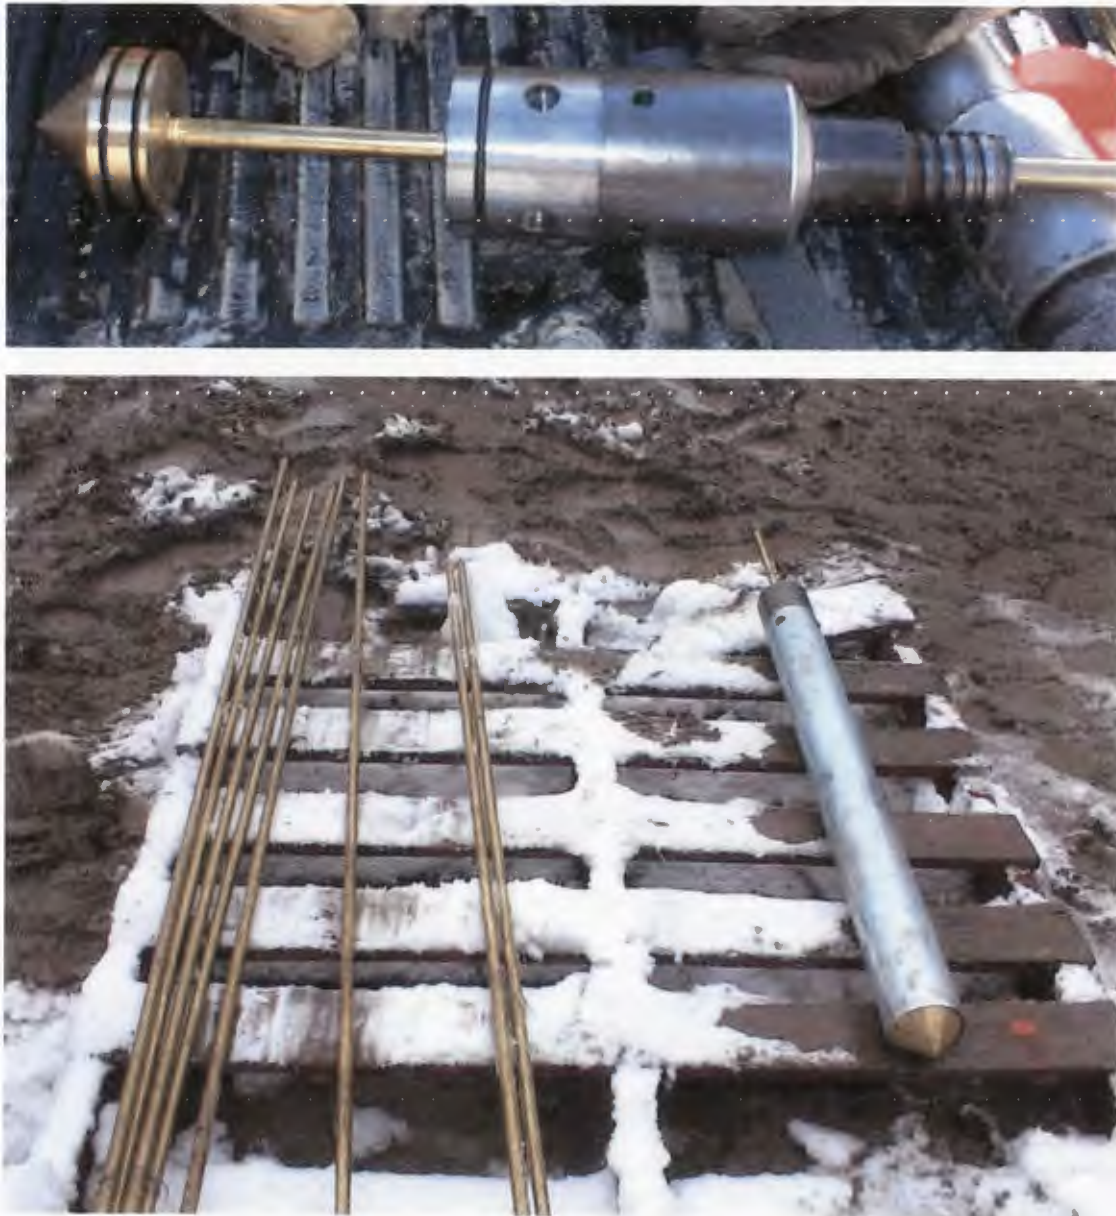
Fig. 4.2 Photographs of fixed piston sampler
