**CRANFIELD UNIVERSITY**

**VISUAL INSPECTION RELIABILITY FOR COMPOSITE  
AIRCRAFT STRUCTURES**

**PhD THESIS**

**October 2009**

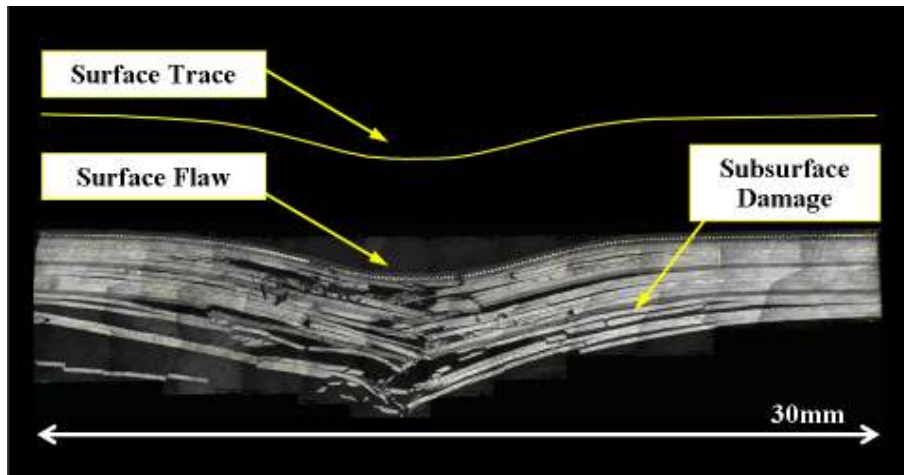
Figure 2.05 – Cross section through 30J, Ø20 mm impact to a bronze mesh incorporated, painted, 17ply AS4/8552 CFRP laminate [from Boulic 2007]

Abrate 1998 and Shyr & Pan 2003 demonstrate that for thick laminates, the propagation path of the cracking in a laminate takes the form of a triangular shape, with the upwards point at the centre of the impact site, as seen in figure 2.05. For thin laminates, the path is inverted [Abrate 1998; Shyr et al. 2003]. Examples published by Aktas illustrate that the planar shape of the delamination area depends on the fibre orientations of the plies, that the delamination is not always circular, and that the delamination extends furthest in the 0° fibre direction [Aktas 2008]. Damaged matrix material is unable support the reinforcing fibres, which subsequently buckle and fail when subjected to compressive loads in the fibre direction. Delamination and matrix cracking due to impact damage reduces the compressive strength of composite materials [Dorey 1989; Papanicolaou & Stavropoulos 1995; Mitrovic et al. 1999; Cartié & Irving 2002; Brookes 2004]. 40 mm of delamination in a 7 mm thick laminate is sufficient to cause a 50% reduction in compression after impact (CAI) strength [Brookes 2004].

When observing figure 2.05, one can clearly see that the traced line of the surface indentation, or impact dent, has a complex curved shape. The dent has not only width and depth, but also a sectional profile, which requires further information in order to be fully described. To this effect, Aktas et al. 2008 appear to be the first to have published a realistic diagrammatic sectional representation of impact damage, as seen in figure 2.06, although no quantitative delamination or dent sizes are given in their results.

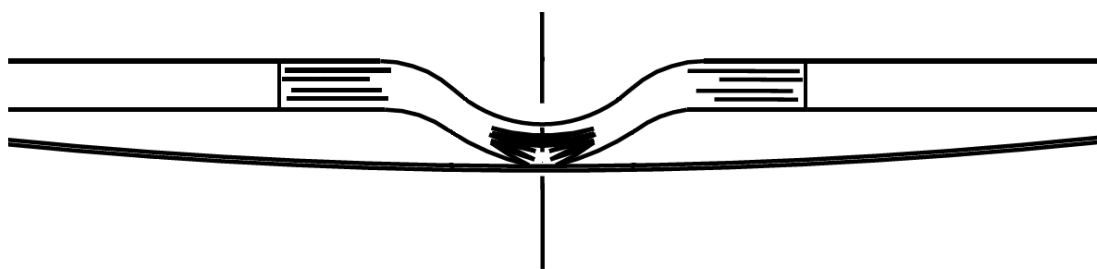
Figure 2.06 - Typical cross sectional profile of impact damage to composite laminate, From Aktas et al. 2008

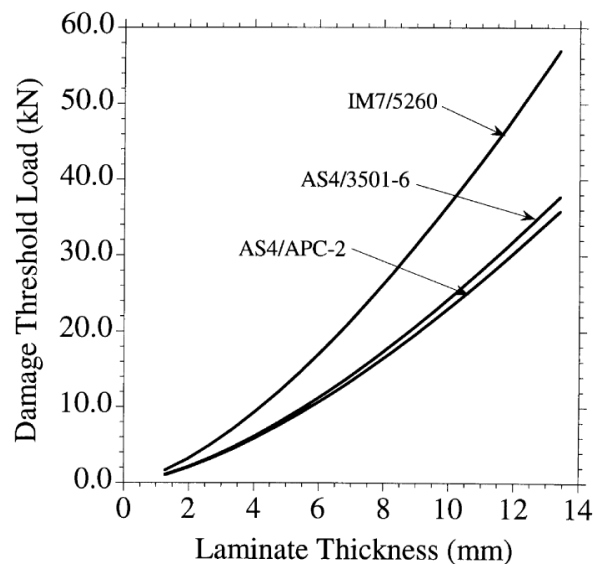
Figure 2.07 – Damage threshold vs. thickness, from Schoeppner & Abrate 2000

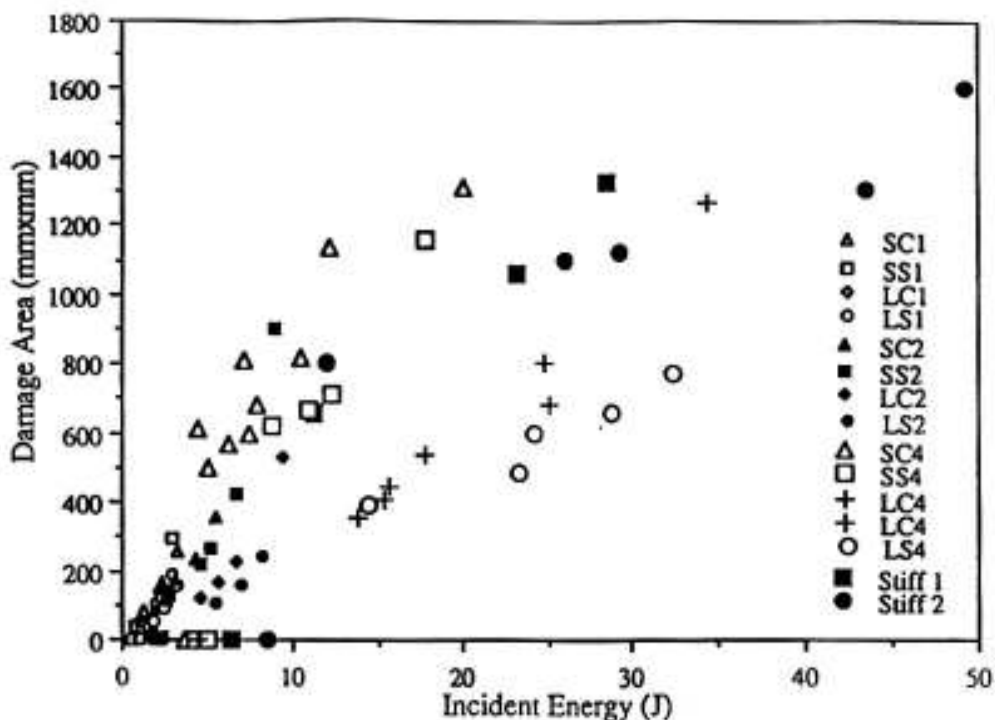
Figure 2.08 – Impact Energy/ Delamination Area plot from Davies et al. 1994

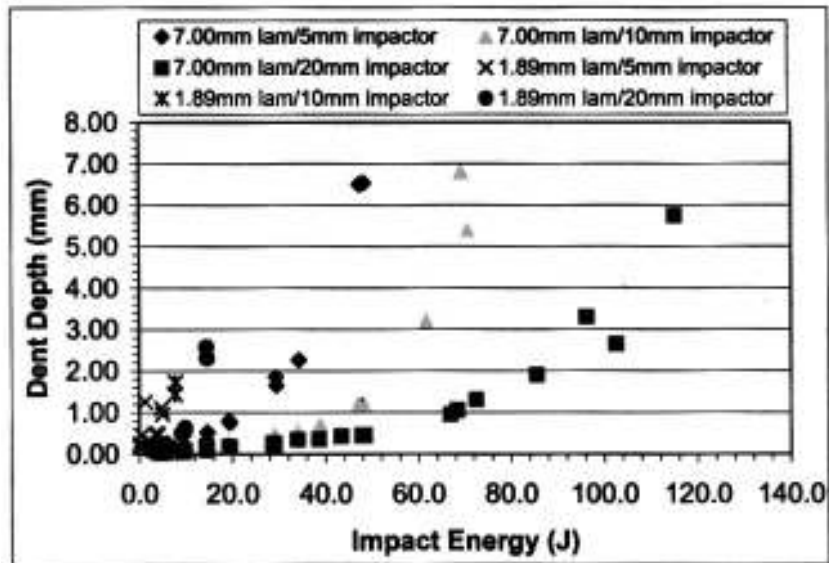
Figure 2.09 – Impact Energy/ Dent Depth plot from Brookes 2004

is given by  $\frac{1}{2}mv^2$ , impactor mass and velocity can affect damage size. Additionally, high velocity impacts do not allow sufficient time for the laminate to flex before generating high impact forces capable of breaking and crushing the plies, thus high velocity impacts are more likely to result in penetration than surface dents [Matthews & Rawlings 1994]. However, variations of impactor mass or velocity at the same impact energy have been demonstrated to have no effect on damage size for low velocity impacts [Robinson & Davies 1992]. Davies et al. [1994] demonstrated delamination sizes of 500~900 mm<sup>2</sup> for 10J impacts and 700~1300 mm<sup>2</sup> for 30J impacts (see figure 2.08). Studies by Brookes 2004 and Cartié & Irving 2004 have also demonstrated greater delamination at higher impact energies. Dent depth is also affected by impact energy [Brookes 2004; US DoD MIL-HDBK-17 Vol. 1 2002], and Brookes demonstrated dent depths ranging from below 1 mm to greater than 6 mm across and energy range of 0~60J, with variations in dent depth for the same impact energy depending on the impactor size and the laminate thickness (see figure 2.09).

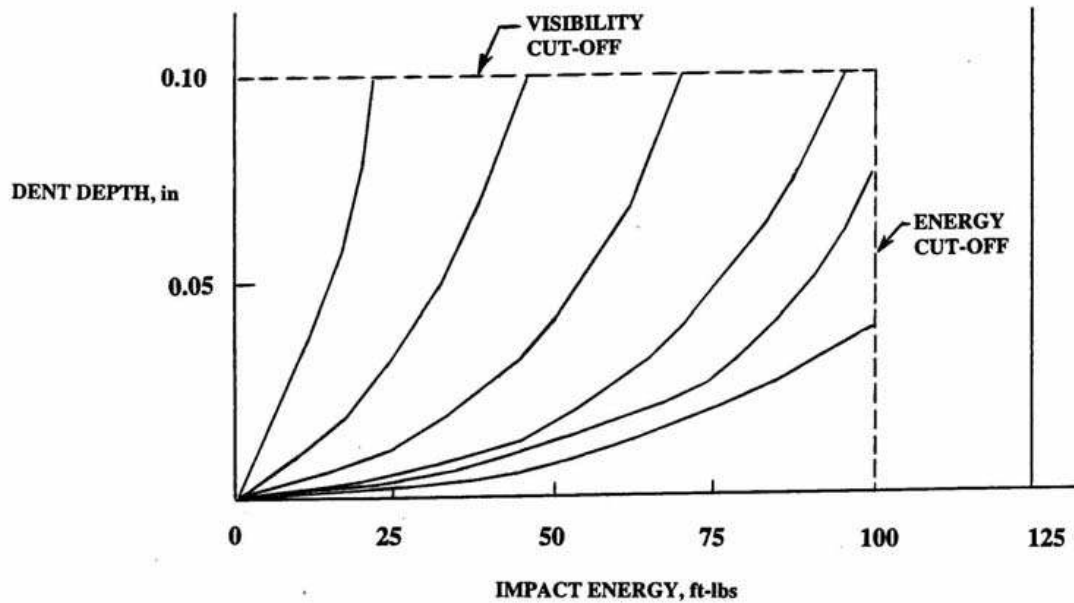
Figure 2.13a – test results demonstrating the higher energies required to produce the same dent depth, from MIL-HDBK-17 3F, 7-38 [US DoD 2002].

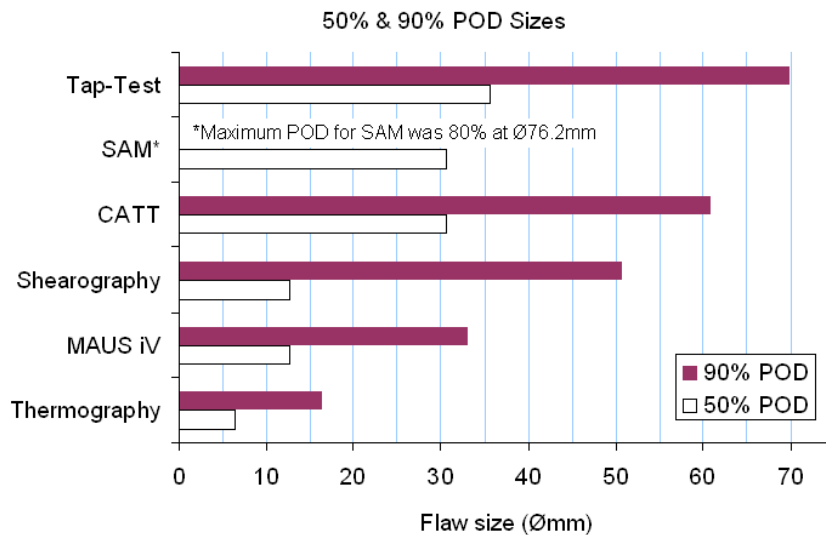
Figure 2.14 – NDT/NDI capabilities, from Roach 2007

Non-destructive inspection (NDI) of composites can also be performed by several other mechanical methods, including tap-testing, computer aided tap testing (CATT), ultrasonic testing (C-scan), shearography, thermography and scanning acoustic microscopy (SAM). The probabilities of detection for each method were investigated by Roach in 2007, and the results are presented in figure 2.14.

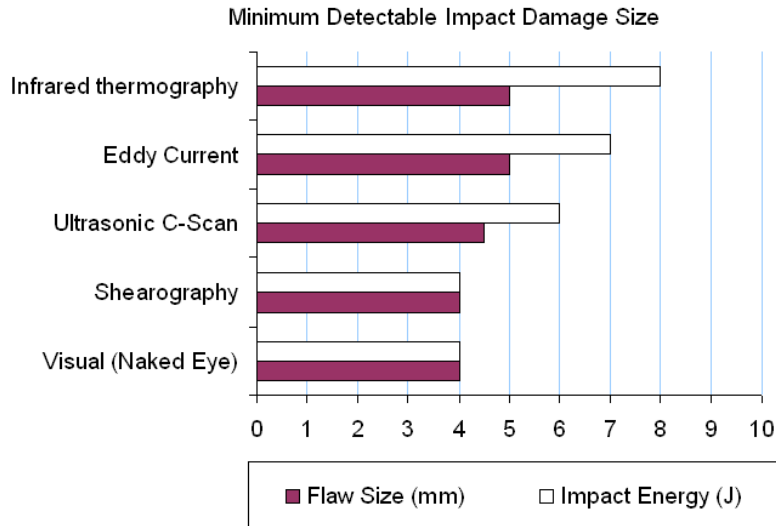
Figure 2.15 – NDT capabilities, from Gros et al. 1998

NDT methods were also investigated by Gros et al. in 1998, and the results are presented in Figure 2.15. Gros et al. choose to describe minimum size detectable in terms of the impact energy that could be detected, as opposed to a description of the delamination size. Gros et al. did present a plot of surface flaw size (length, mm) vs. impact energy, allowing the minimum detectable impact energy and minimum detectable surface flaw size to be shown together in figure 2.15. The results of Gros et al. demonstrate that visual inspection is highly efficient at detecting small sizes of impact-damage surface flaws. However, it is important to remember that the other methods would be capable of detecting delamination damage regardless of whether a surface flaw is indentation, whereas visual inspection is reliant on the presence of a surface indentation.

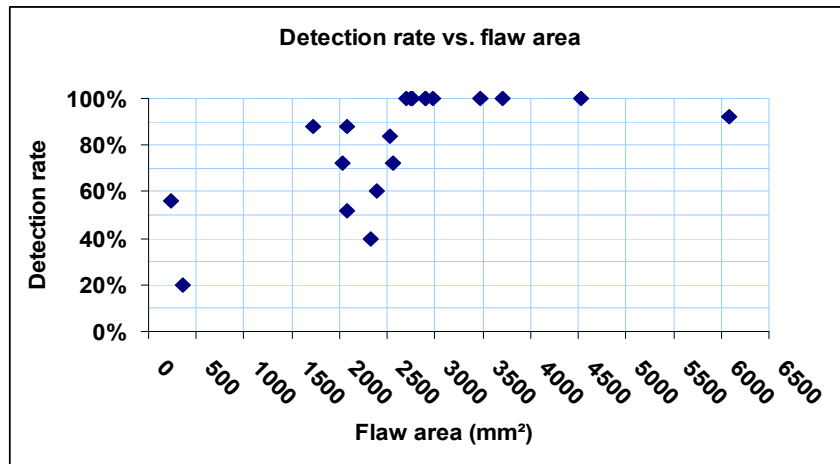
Figure 2.17 – Plot of detection rate vs. flaw areas from Gant 2007

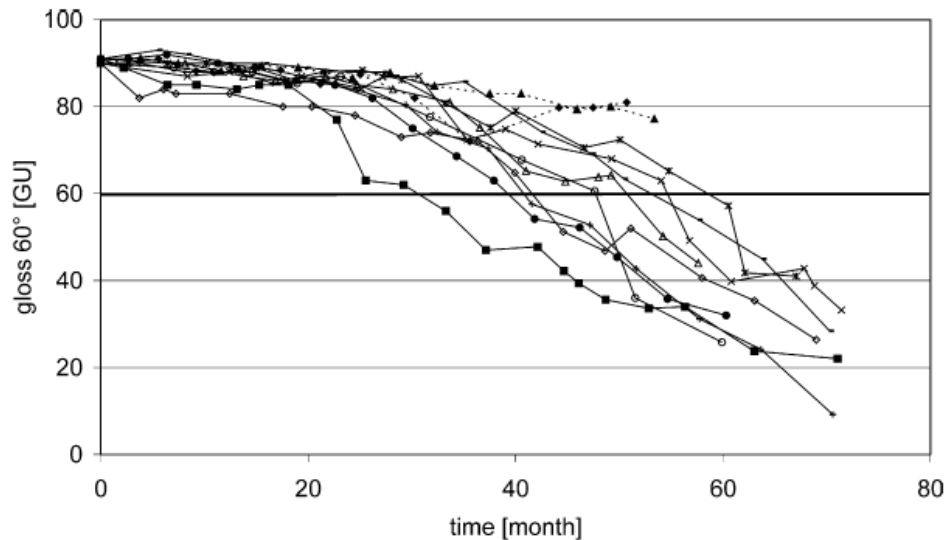
Figure 2.39 – Plot detailing aircraft paint gloss degradation with time, from Guseva et al. 2003

The topcoat paints used by airlines to paint liveries are usually applied as a glossy colour coat. Over a period of several months, environmental effects can lead to dulling of the paint surface, resulting in a less glossy surface finish. A piece of black coloured glass would be expected to give the maximum reading of 100 gloss units (GU). Gloss levels for freshly applied aircraft paint usually exceed 90gloss units (GU) [PRC-DeSoto 2003; Akzo Nobel 2006 & 2008]. However, experimental data from Guseva et al. 2003 (see figure 2.39) show a reduction in paint gloss to 60GU after 40 months of service, and a reduction to 40GU after 60 months of service.

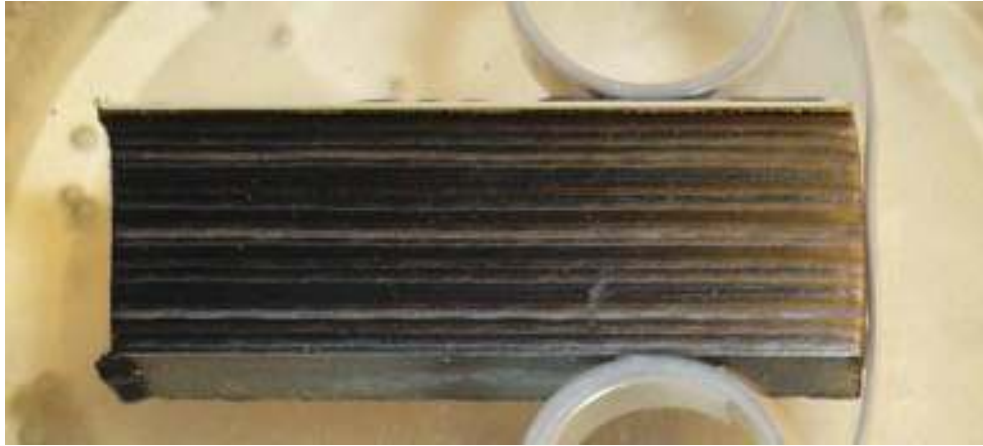
Figure 4.01 – Section through 33ply laminate with painted surface to the top

correct. Figure 4.01 shows a section through the laminate, which is free of significant voids or resin rich areas.

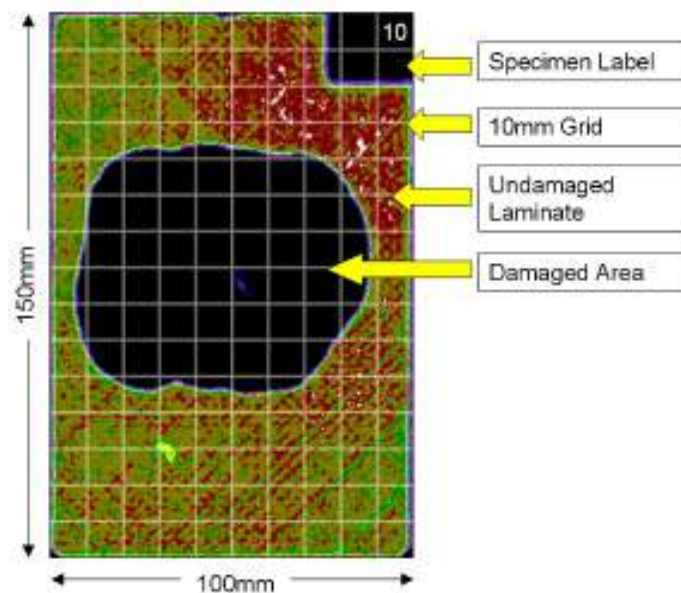
Figure 4.02 – C-Scan of 40J impact damage from Ø87 mm on 33ply painted, laminate with bronze mesh

Each coupon was C-Scanned after impact, in order to measure the sub-surface delamination damage at the impact site. Images of the C-Scan data were produced as bitmap format screen captures from the ANALYSIS program [Richards Computer Products 1991]. The bitmap images were fitted with a 10 mm grid using suitable image processing software, and used to measure to the width of the sub-surface damage (delamination) to the nearest 1 mm. By using a square count method, or where possible, an area calculation based on measurements taken from the image, the area of the delamination can be measured. Figure 4.02 illustrates a typical C-Scan image of an impact-damaged coupon.

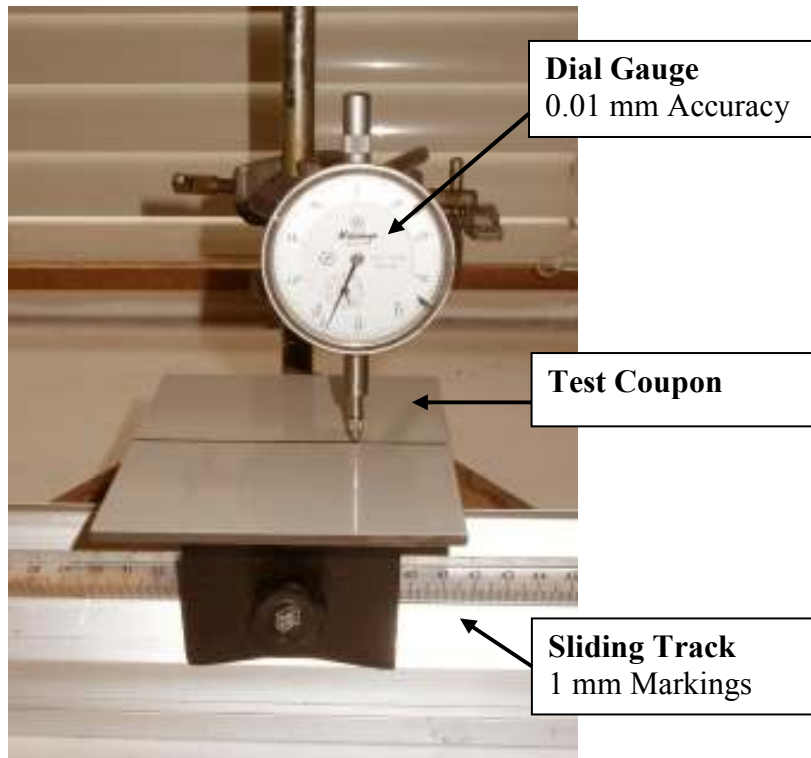
Figure 4.05 – Dial gauge setup for measuring vertical depth vs. horizontal distance.

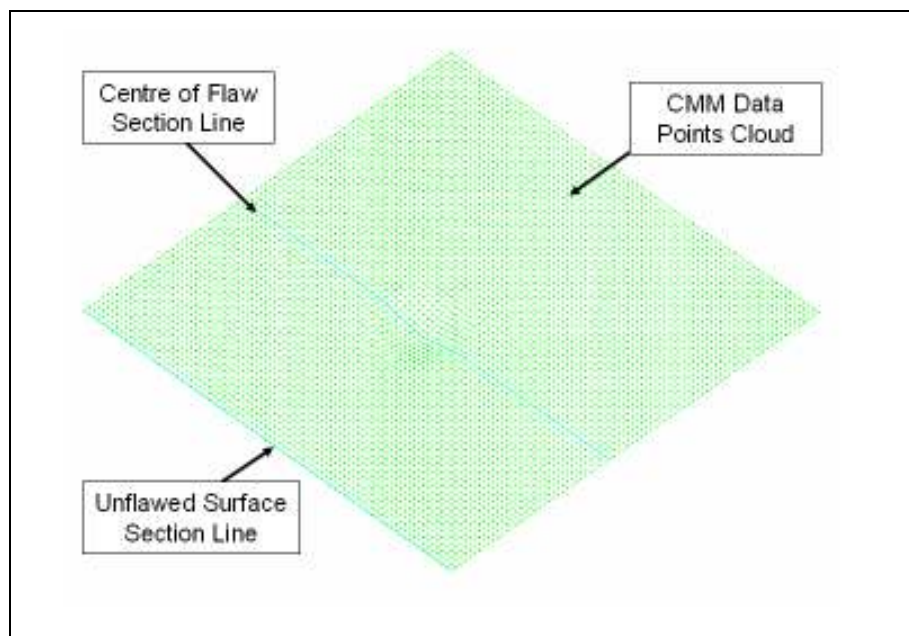
Figure 4.07 – Section line positions on CMM data points cloud

In order to measure the surface flaws caused by hemispherical tip impacts, using the CMM data, the series of points representing the surface flaw centre, and a series of points on the coupon surface close to the flaw area were identified within the CMM point cloud data (see figure 4.07) by producing section lines through the points cloud. Once these two sections were isolated within the CMM points cloud, the other section lines were removed leaving only two section lines as seen in figure 4.07 & 4.08.

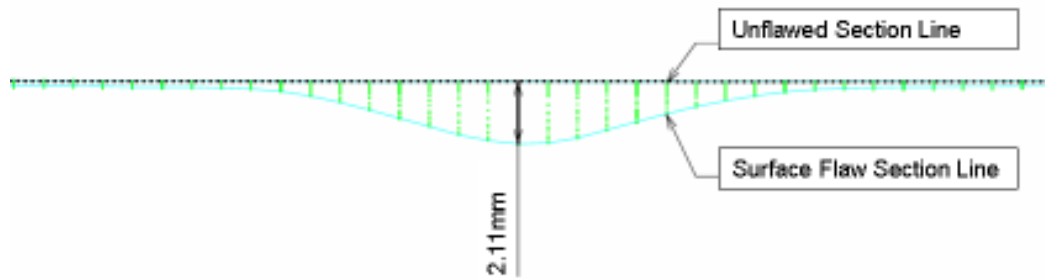
Figure 4.08 – section lines obtained from 2.11 mm deep surface flaw using CMM machine, vertical data lines are 1 mm spaced

Vertical (Z-axis) depth measurements were made every 1 mm along the line (figure 4.08). The depth measurements were made using a second section line, made through the coupon surface outside of the flaw area, as the origin.

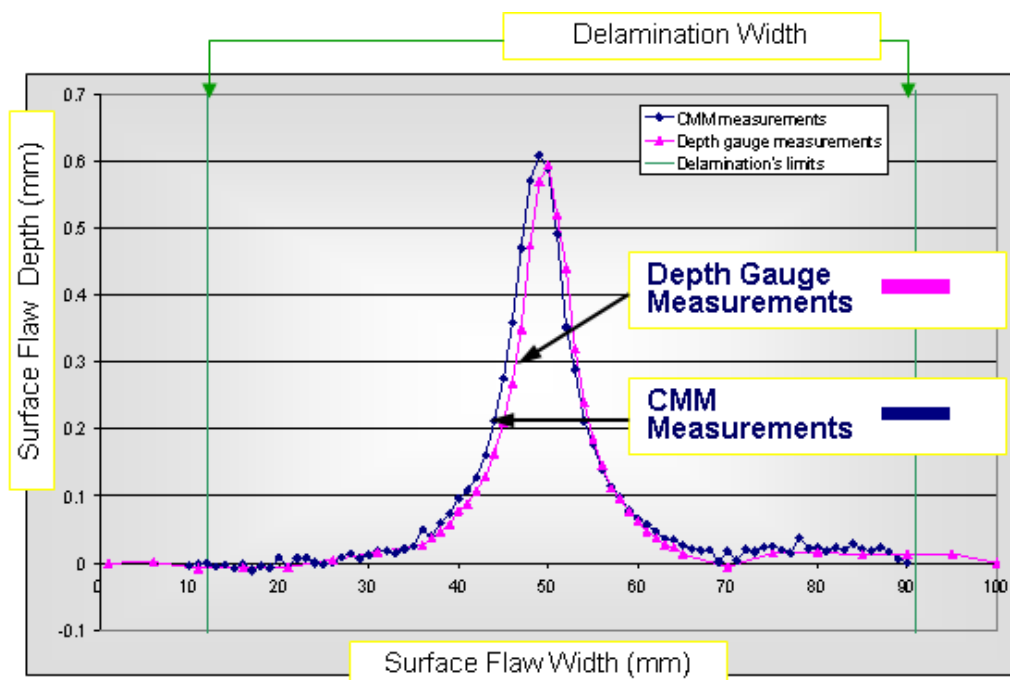
Figure 4.09 – typical graphical representation of depth gauge, CMM and C-Scan measurements of impact damage and surface flaw on a coupon.

The depth measurements from the CMM data were also plotted using Excel, and by placing them alongside the depth gauge measurements and subsurface damage width measurement from the C-Scans of each coupon, a clear picture of the damage morphology could be obtained (See Boulic, 2007). An example is given in figure 4.09.

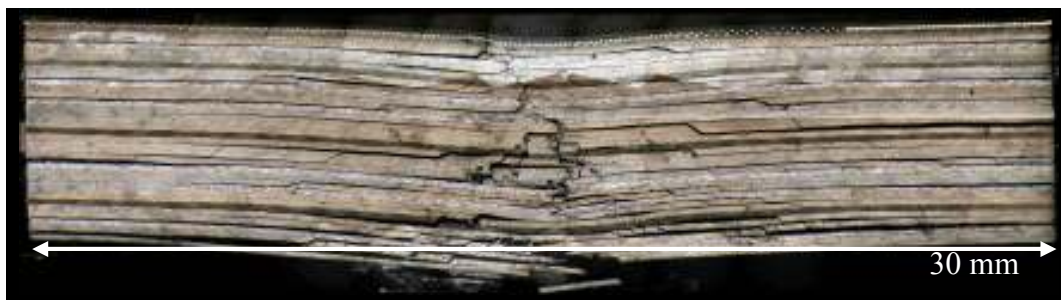
Figure 4.10 – Section through 50J, Ø20 mm impact on 33ply painted, mesh covered laminate

Selected fully finished, impact damaged coupons were cut into a 30 mm square, with the centre of the square placed at the centre of each surface flaw. The squares were set into resin, ground back and polished so that the section ran through the centre of the surface flaw.

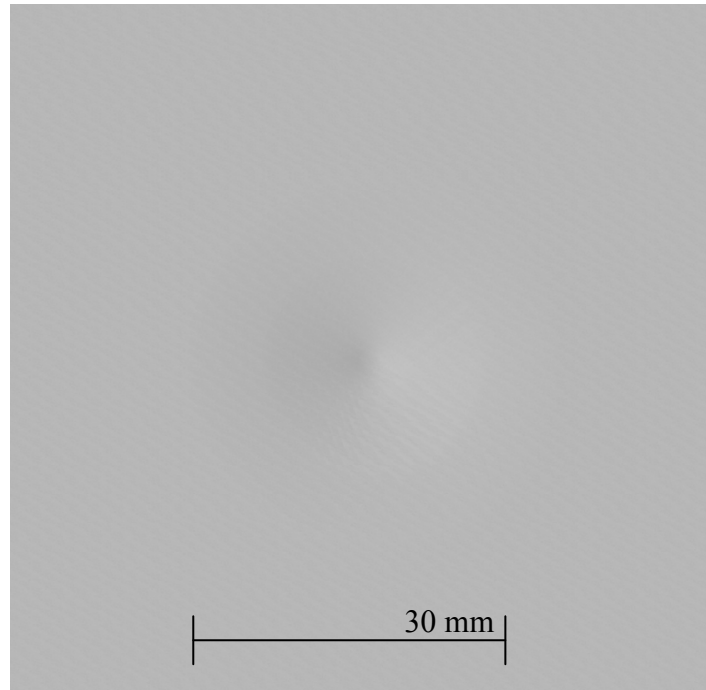
Figure 4.14 – Virtual specimen flaw, representing Ø20 mm/33ply 46J impact damage (Ø29.96 mm / 0.57 mm deep)

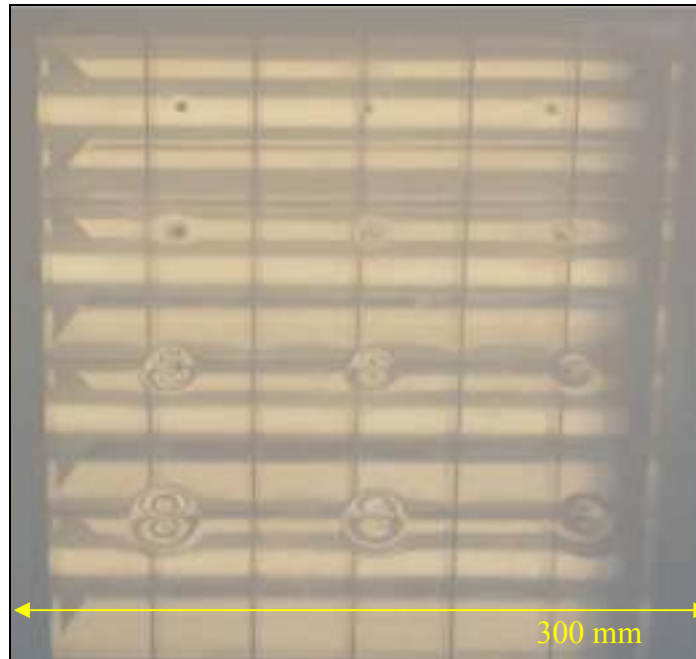
Figure 4.15 – Test piece containing machined surface flaws

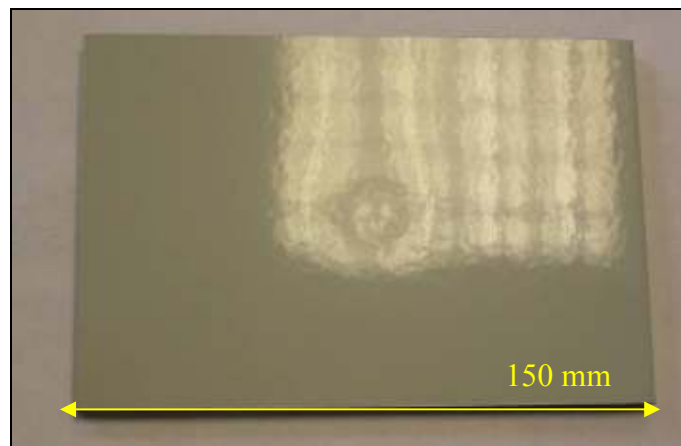
Figure 4.16 – Impact damage surface flaw on a painted/ bronze mesh CFRP laminate

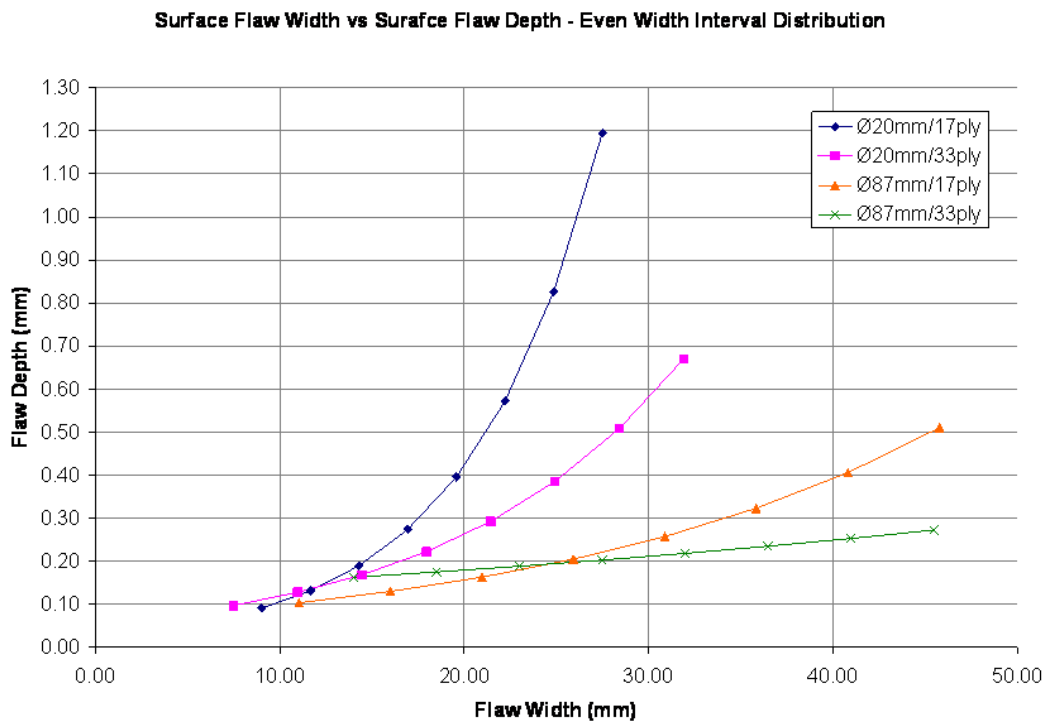
Figure 4.28 – Plot of flaw widths vs. flaw depths with even distribution between flaw widths

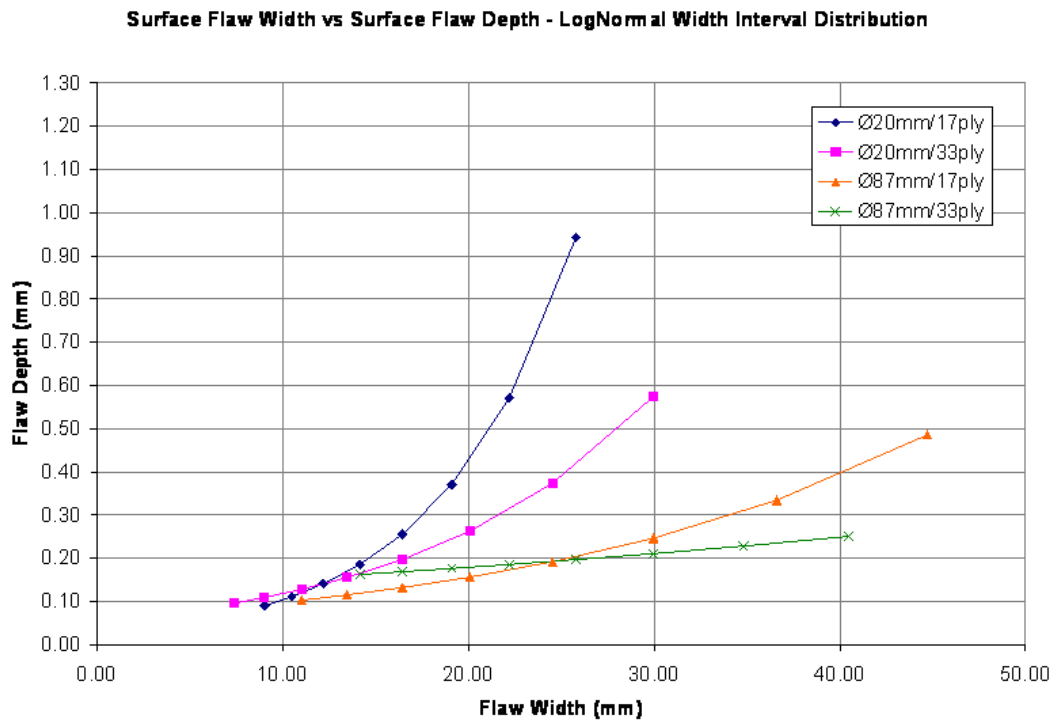
Figure 4.29 – Graph of flaw widths vs. flaw depths with even distribution between lognormal of flaw widths

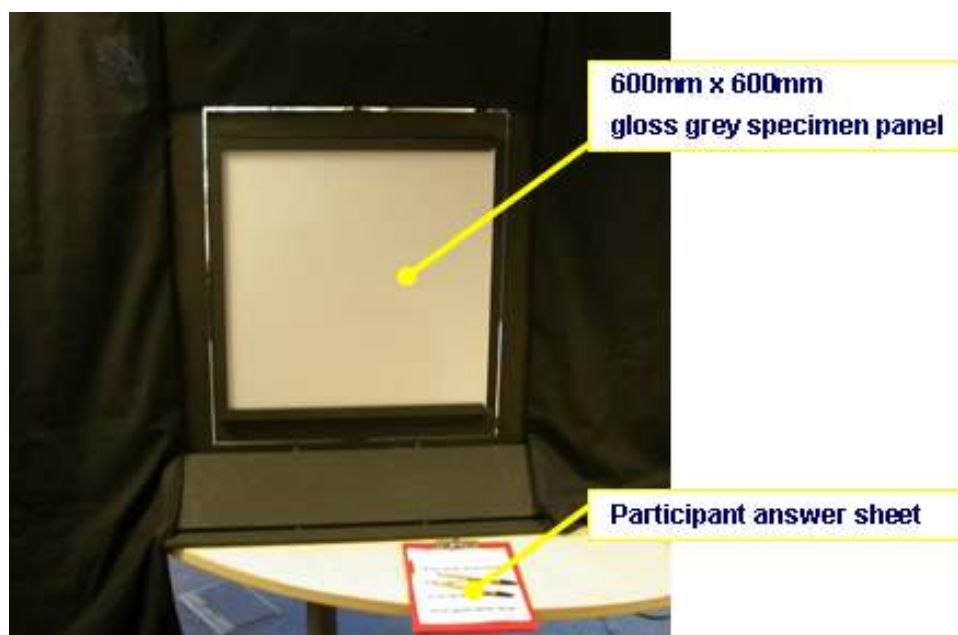
Figure 4.31 – Specimen display stand for visual inspection trials

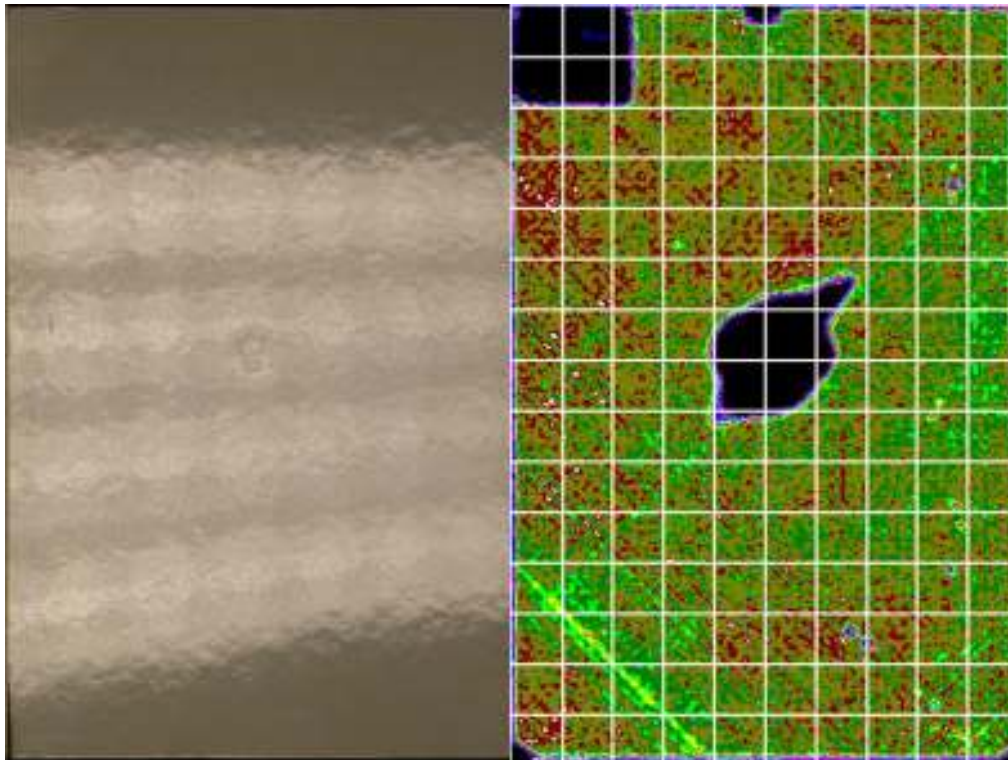
Figure 5.01 – Photograph and C-Scan of 10J / Ø20 mm impact on 17ply painted CFRP laminate

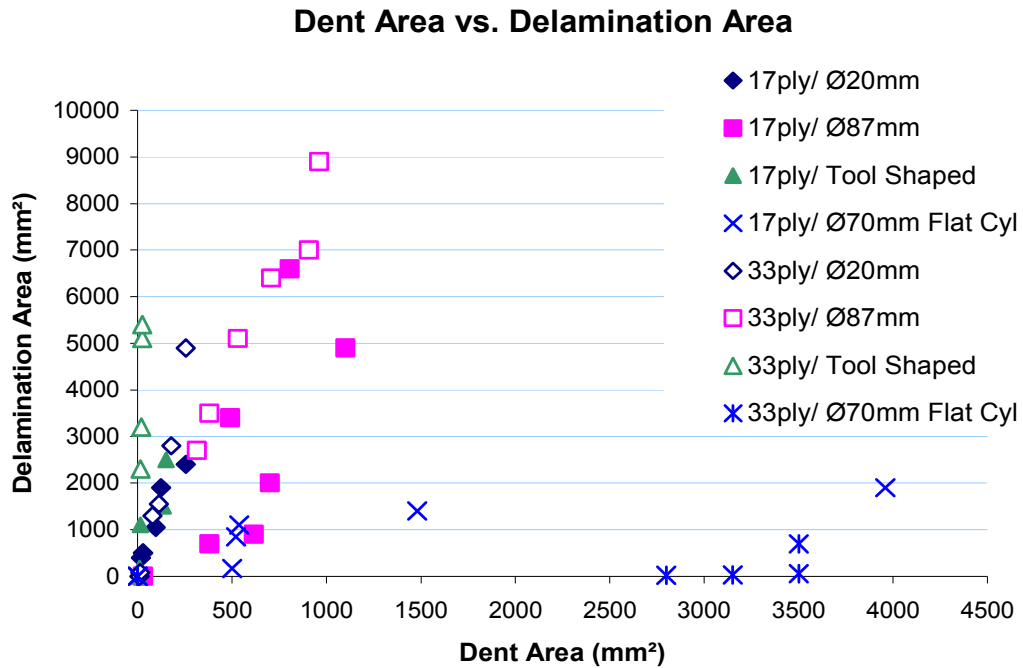
Figure 5.04 – Plot of surface flaw area vs. delamination area for impacts on fully-finished laminate

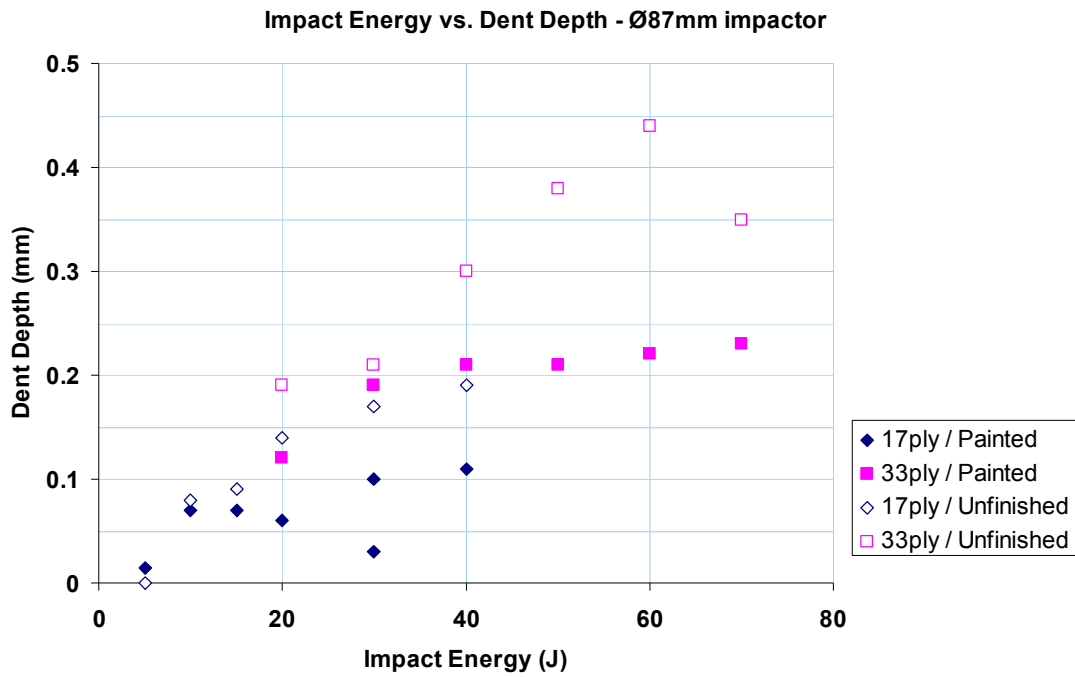
Figure 5.13 – Impact energy vs. Flaw depth plot for Ø87mm impactor

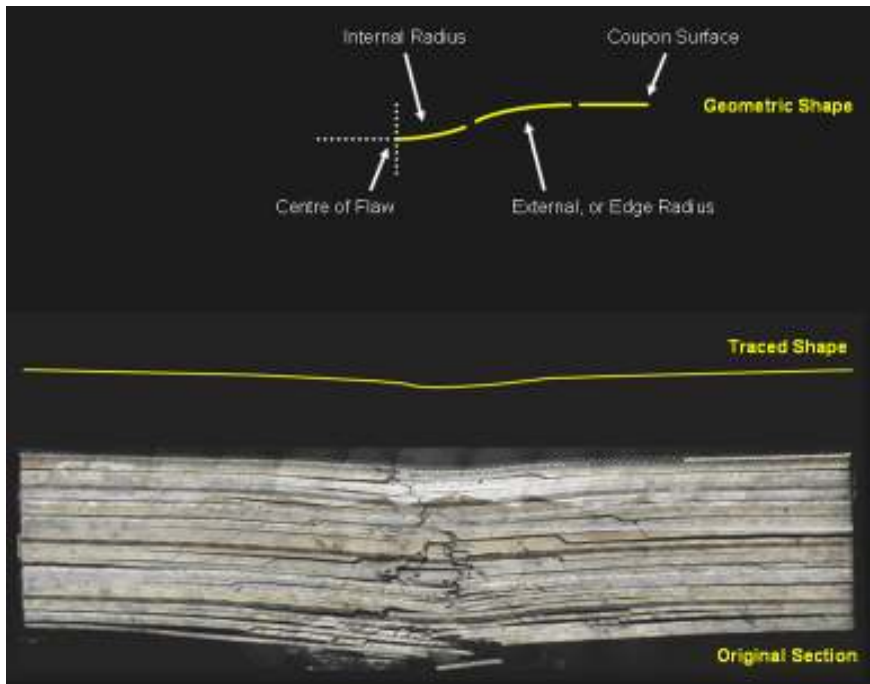
Figure 5.20 – Ø20 mm/50J Surface flaw on a 33ply coupon

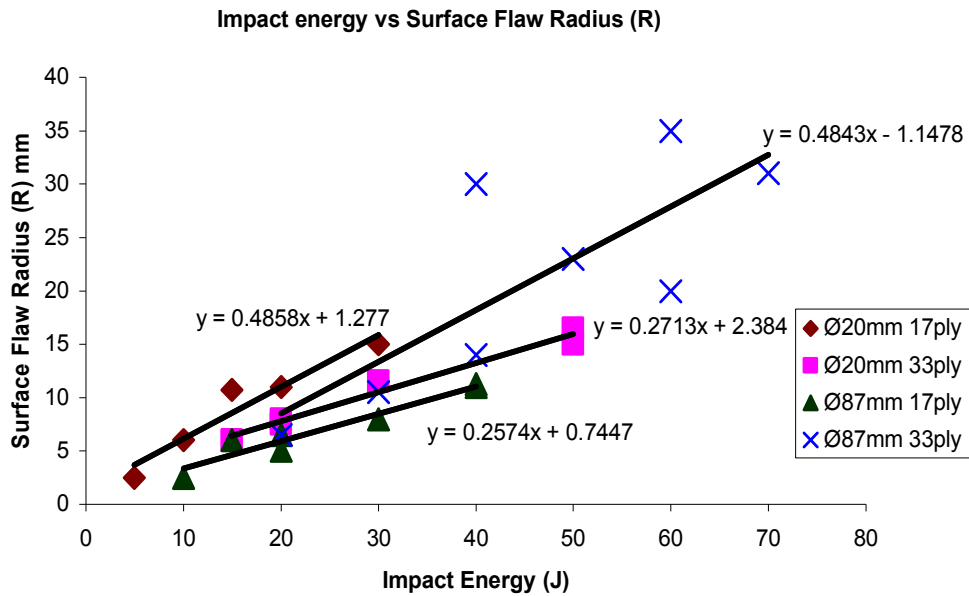
Figure 5.23 – Plot of impact energy vs. surface flaw radius with linear lines of best fit

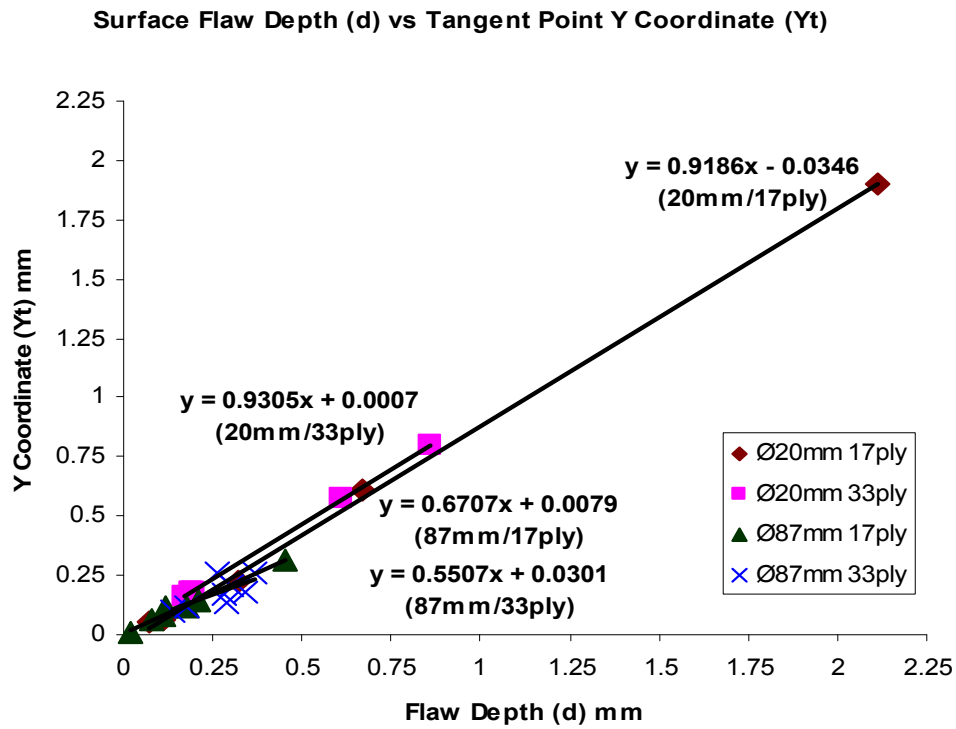
Figure 5.26 – Plot of surface flaw depth vs.Yt with linear lines of best fit

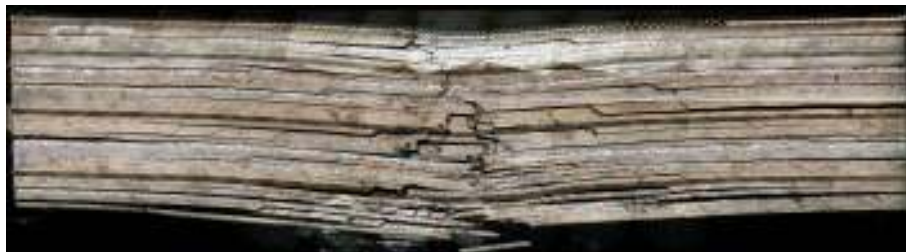
Metallographic section image of Ø20mm/50J impact (from Boulic, 2007)
