## STRENGTHENING ELEMENTS OF STEEL STRUCTURES FOR CONTROLLING FATIGUE FRACTURE

The article deals with the issues of reliable operation of steel structures of mine hoisting machines. It is proposed to strengthen the “weak points” of the braking device beam structure, which will further prevent the formation and growth of cracks in the body of the metal structure. The article presents the results of examining steel structures of mine hoisting machines by the methods of non-destructive testing and the percentage of various damages is determined. The article discusses the method for controlling fatigue failure of steel structures through the use of strengthening elements to reduce their metal consumption and increase resistance to fatigue failure, while completely eliminating the use of expensive high-strength alloys.

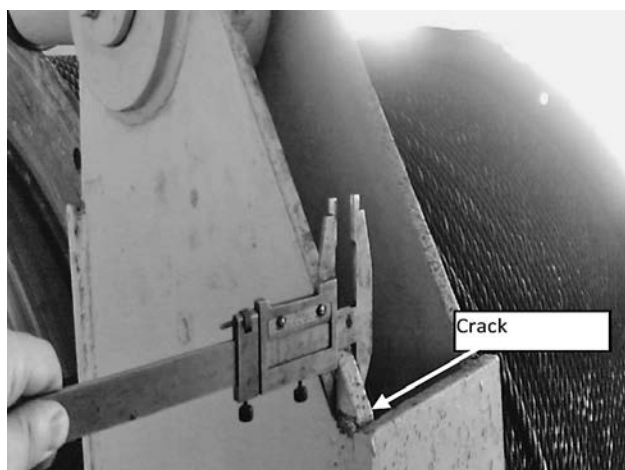
**Figure 1** Location of the crack in the beam body

ening elements for controlling fatigue cracks is considered and the practical results of their application are given in [7]. There were analyzed the causes and factors affecting the mechanism of fatigue failure of steel structures [8]. The results of studying fatigue cracks in metal structures were also studied [9, 10]. The literature sources discussed above made it possible to obtain the information of the problem of fatigue failure of structures in long-term operation. The cause of the formation of cracks is the presence of stress concentrators in the “weak points of the structure”. To confirm the idea put forward regarding the use of strengthening elements, in April 2020 a comprehensive survey of 53 mine winders in operation at the Arcelor Mittal JSC was carried out using a USN 60 ultrasonic flaw detector from the Krautkramer Company. Based on the results of the survey, a list of identified defects was compiled: 40,3 % were wear or damage to the BD hinge joints and 59,7 % were fatigue cracks in steel structures of the BD (beams, rods, drum), which coincides with the results of surveys carried out earlier [1, 7]. The largest number of cracks was found in the BD beam, about 19 % of them. Figure 1 shows a photo of the location of a fatigue fracture with a fatigue crack in the body of a steel beam under a layer of protective paint.

The main way to repair the beam in the case shown in Figure 1 is cleaning the place with the detected crack from paint, cutting the crack using electric arc welding to restore the integrity of the structure, treating the seam, and re-painting. As practice has shown, this method does not fully solve the problem. After the repair, the cracks develop again within 2 to 8 months. In this case, repeated repairs are required, and if it was multiple, the replacement of the entire beam. If to mount strengthening elements on the side faces of the beam, the problem of fatigue failure is completely removed. This has been proven by the given periodic visual observation within 6 months and repeated examination using an ultrasonic flaw detector. As a result, the fatigue crack is completely localized and its development is stopped. Similar results are presented in works [1, 7].

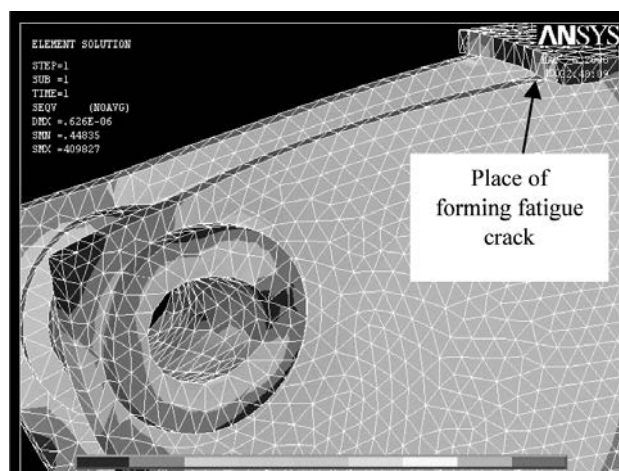
**Figure 2** Computer model of the BD beam

At the initial stage, it is required to develop an adequate computer model of the beam using the ANSYS program. The method of determining the parameters of the reinforcement of the technical unit structure requires preliminary simulation of a real beam of the MHM in exact accordance with its real geometric parameters and the full adequacy of the applied load. This will make it possible to determine the values of maximum stresses and strains that will occur in the beam during operation. The model makes it possible to identify "structural weaknesses" in which fatigue cracks can develop. The cause of the formation and growth of cracks is the presence of stress concentrators, which lead to fatigue failure of the beam structure. Elimination of stress concentrators will significantly increase the structural safety margin. The use of strengthening elements of the braking device beam structure will extend the service life and ensure the required reliability; the theoretical substantiation of these statements was given earlier in [1, 7].

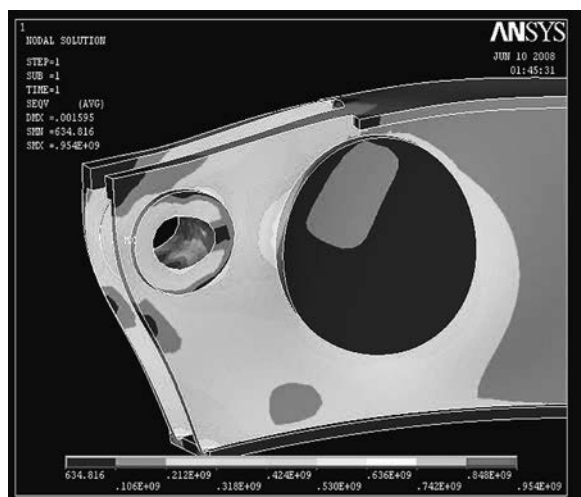
**Figure 3** Computer model of the beam with strengthening elements

This model performed the best when compared to the standard 20 mm beam structure of similar steel. The idea proposed by the designers to increase the thickness of the beam walls to 40 mm (ST10 steel) was tested. This would prevent fatigue failure of the beam in emergency-hazardous zones of cracking but it would significantly increase its metal consumption, which would negatively affect the operation of the entire brake mechanism of the MHM. The model of beam No. 26 with strengthening elements is shown in Figure 3.

It is visualization of the SSS pattern. Strengthening elements allow eliminating mechanical stress concentrators and «structural weaknesses» where cracks have formed in practice.

The elements of the type «rib» and «disc pad» are used, namely their combination. Their geometrical parameters were also established, according to the recommendations of [1, 7]. It was proposed to reinforce the beam with strengthening elements and form its profile according to the computer model shown in Figure 3.

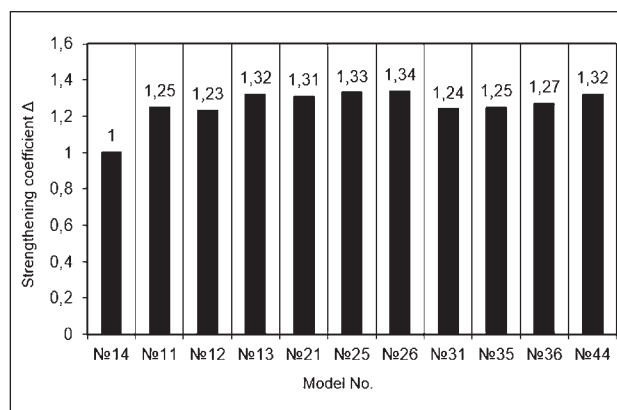
**Figure 4** Results of calculating the coefficient of the structure reinforcement  $\Delta$  for 11 computer models of the beam.

Using the research results, the calculation of the reinforcement showed its relationship with the bearing capacity of the beam structure. Increasing this parameter is noted when using strengthening elements. The conventional design has the coefficient  $\Delta = 1$ , and the beam design No. 26 with strengthening elements has the coefficient  $\Delta = 1,34$ ; this is the best result. In this case, the thickness of the walls and the material of the beam are identical (Figure 4).

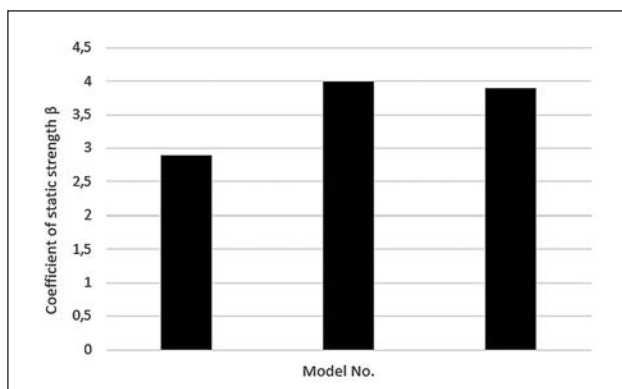
**Figure 5** Results of calculating static strength of the BD bean structure: No. 14 is a standard structure with the wall thickness of 20 mm; No. 26 is a strengthened structure with the wall thickness of 20 mm; No. 44 is a structure without strengthening elements with the wall thickness of 40 mm.

It is possible to select the shape and geometrical parameters of the strengthening elements to increase the supporting structure. Analyzing the diagram in Figure 5, we can conclude that the shape-optimized strengthened structure No. 26, with the wall thickness of 20 mm, is capable of operating with the same margin of safety as design No. 44 without strengthening elements with the wall thickness of 40 mm.

Figure 5 shows the results of calculating the coefficient of static strength  $\beta$  for the BD beam structure. Analyzing the diagram, we can conclude that structures No. 26 and No. 44 have similar strength.
