Citation: Richardson, Alan and Pasley, Jack (2015) Bacterial crack repair to concrete. Concrete, 49 (7). pp. 29-30. ISSN 0010-5317

## Bacterial crack repair to concrete

Alan Richardson and Jack Pasley, Northumbria University

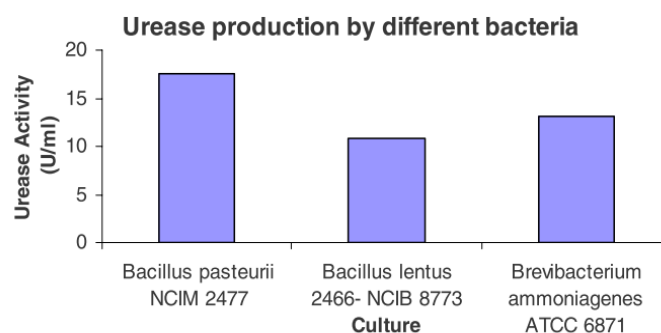
Figure 1- Urease Production by Different Bacteria (Sarda et al., 2009)

*Sporosarcina pasteurii* (Previously *Bacillus pasteurii*), is able to aid in the urease production which, in turn, hydrolyses urea to ammonia and CO<sub>2</sub> (Bang et al., 2001). Such urease production from *Sporosarcina pasteurii* (*S. pasteurii*) was witnessed by (Sarda et al., 2009), stating among the other microbial cultures *S. pasteurii* NCIM 2477 was able to produce the most urease (Figure 1) .

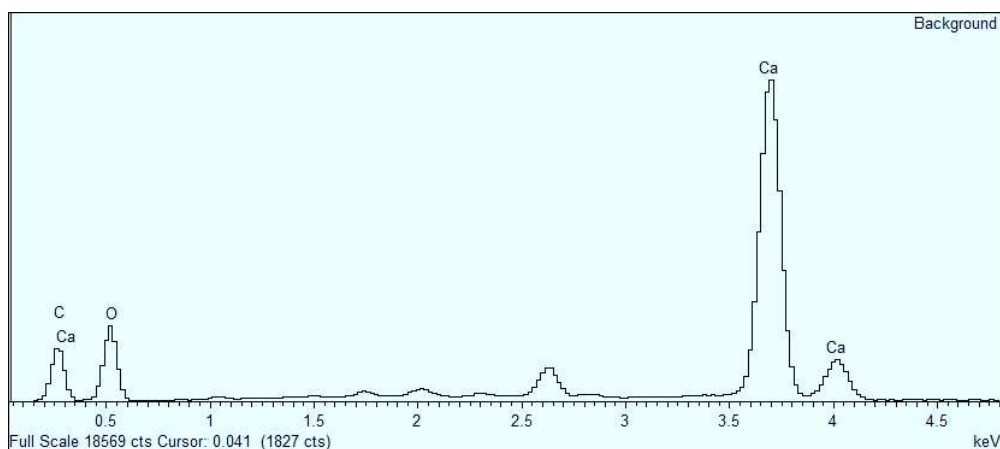
Figure 2 - Energy Dispersive Spectroscopy (EDS) image

The bacterial residue was examined at the surface (foreground) and at the intersection between the calcite and the concrete (background), using an Energy Dispersive Spectroscopy (EDS) image analysis technique and the chemical component parts are displayed in Table 1 and Figure 2.

The Energy Dispersive Spectroscopy (EDS) results were tested alongside a MOH's hardness test and hydrochloric acid test which showed the calcite formation was within normal hardness associated with the formation of calcite and the acid test showed the material to be of an alkaline nature,

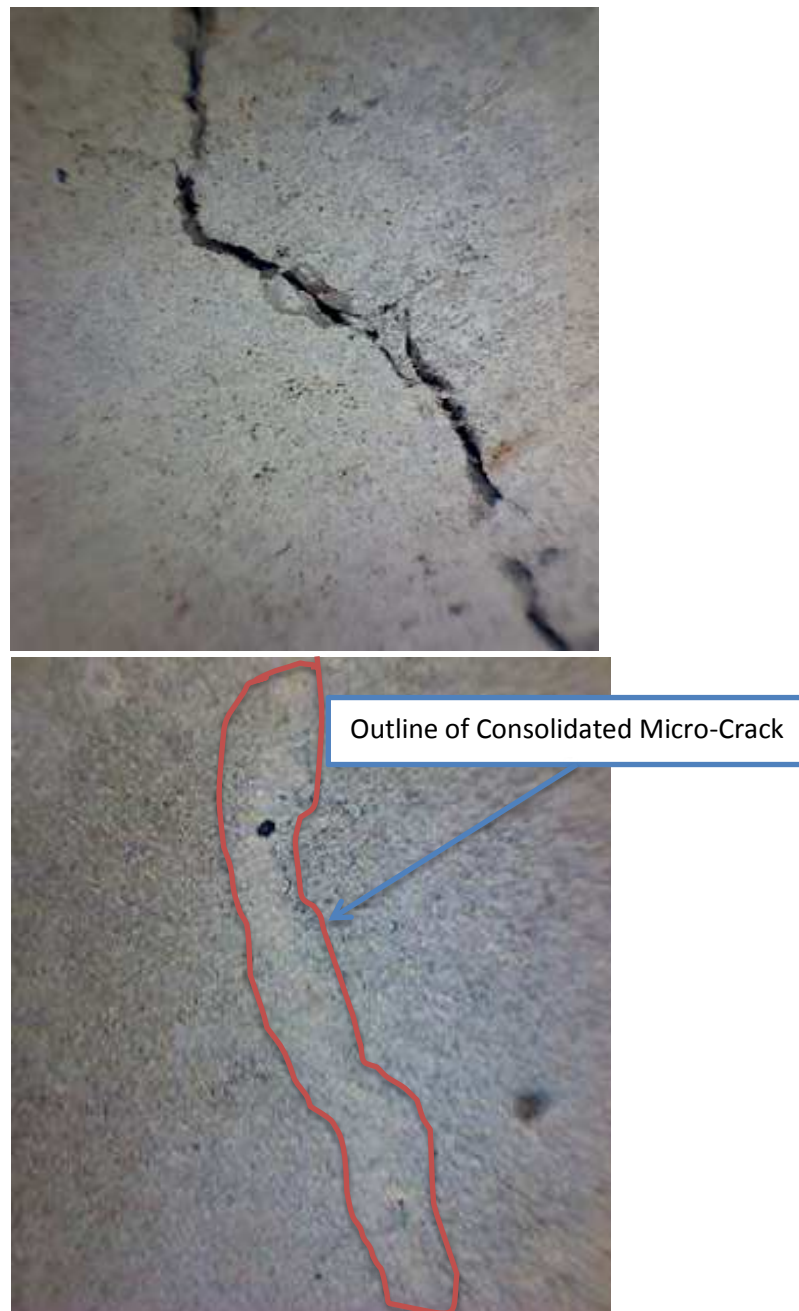
Figure 3 – Above cracked fibre beam and below MICP sealing the crack

The effectiveness of the MICP crack healing properties are displayed in Figures 3 and 4

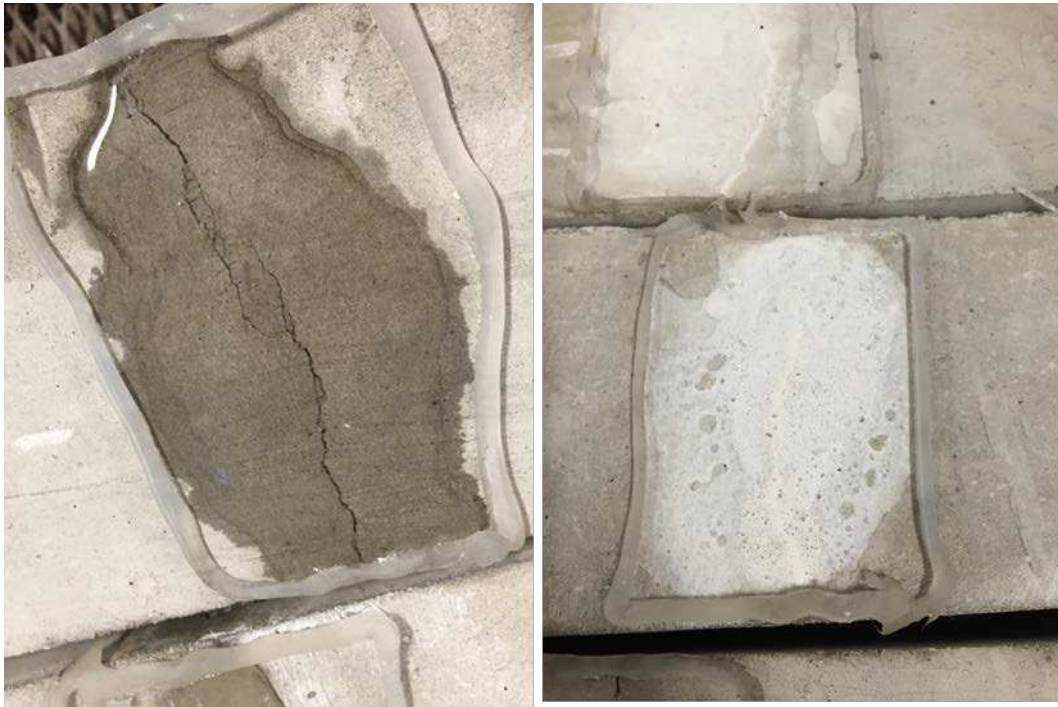
Figure 4 – Cracked concrete beam on left and healed concrete beams to the right.
